EDGEWOOD ARSENAL TECHNICAL REPORT

EM-TR-76064

PROOF TESTING OF A CANDIDATE
CATEGORY 3 SUPPRESSIVE SHIELD

August 1976

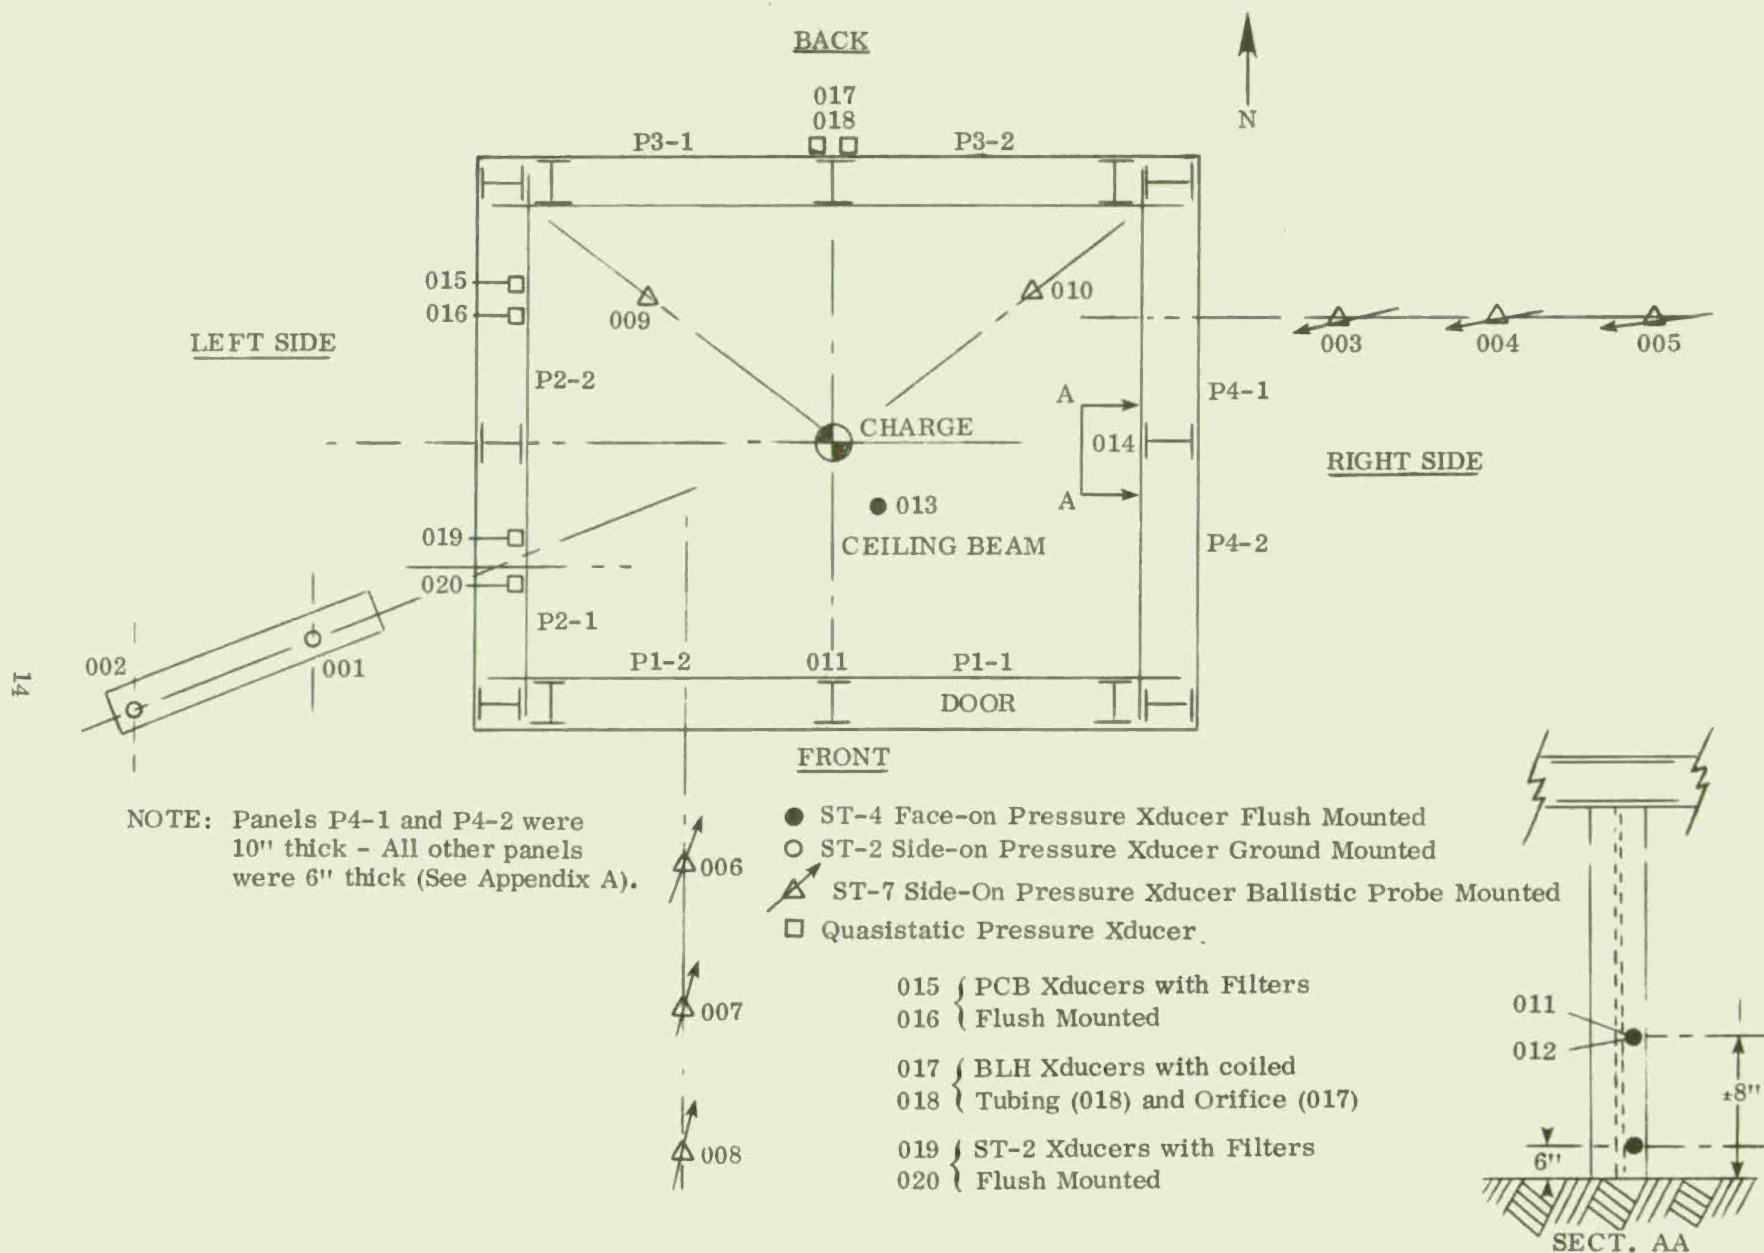
Figure 4. Schematic Diagram of Category 3 Test Instrumentation Arrangement

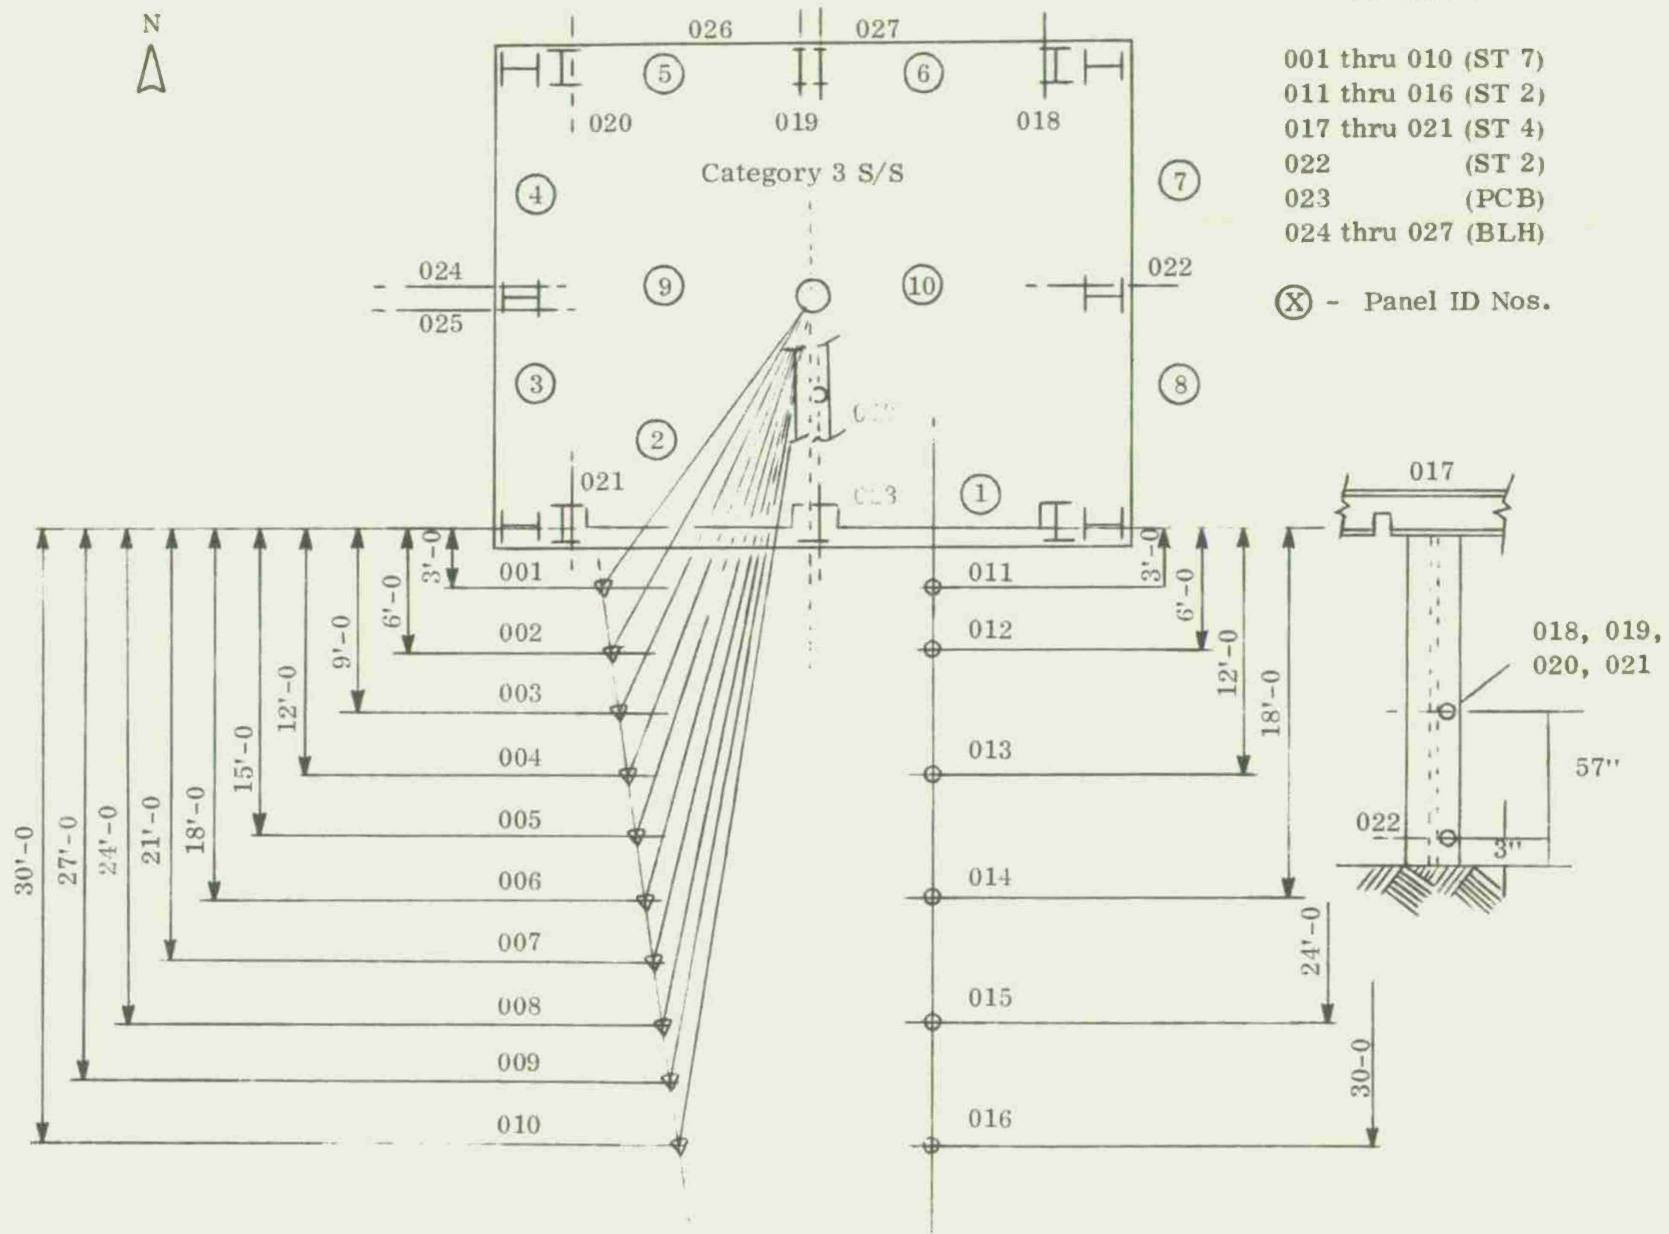
Figure 5. Category 3 Transducer Locations Tests B2-2 and B3-2

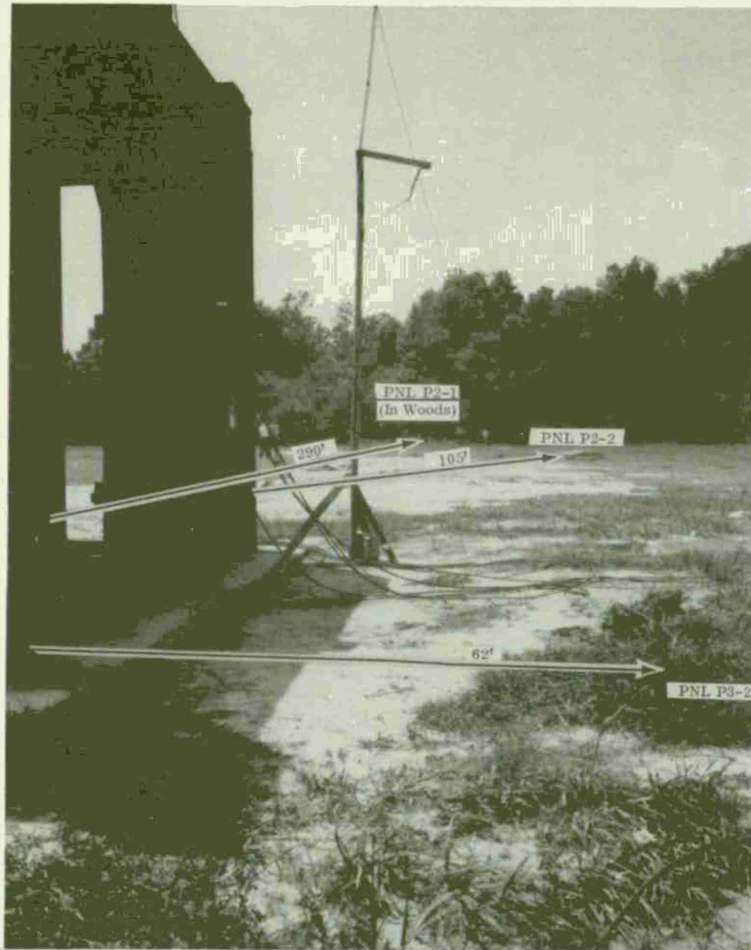
Figure 8. Category 3 Test B3-1 Proof Pressure Test - Ejected Panels Location and Direction

4.1 Structural Damage. Test B3-1 caused a catastrophic failure of 3 of the 10 panels (9 panels plus 1 door panel). Failure occurred in the panel frames at the corners of the structural frame (see figures 6 and 7). This permitted the panels to exit the structure with a minimum deformation of the opposite side of the panel frame and by partial shear and bending of the top and bottom portions of the panel frame. Panel No. P2-1 was found approximately 290 feet to the west from the shield where its forward motion was arrested by a 10-inch diameter oak tree. The adjacent panel, No. P2-2, was 105 feet to the west and Panel No. P3-2, 62 feet north (see figure 8). The outer layer of perforated steel plate of Panel 4-2 (see figure 6) failed by ripping in the center of the panel indicating the membrane strength of this member had been exceeded. Figure 9 shows the relative movement of the structure in relation to the ground plan.

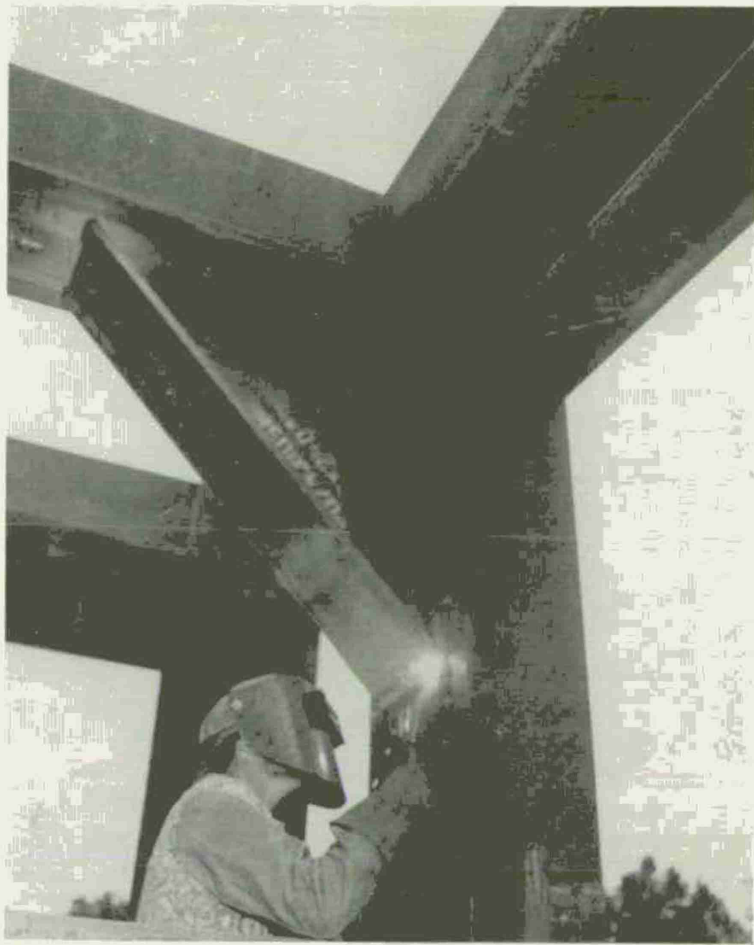
Figure 11. Category 3 Test B3-2 Proof Pressure Test - New Phase II Design Gusset Installation

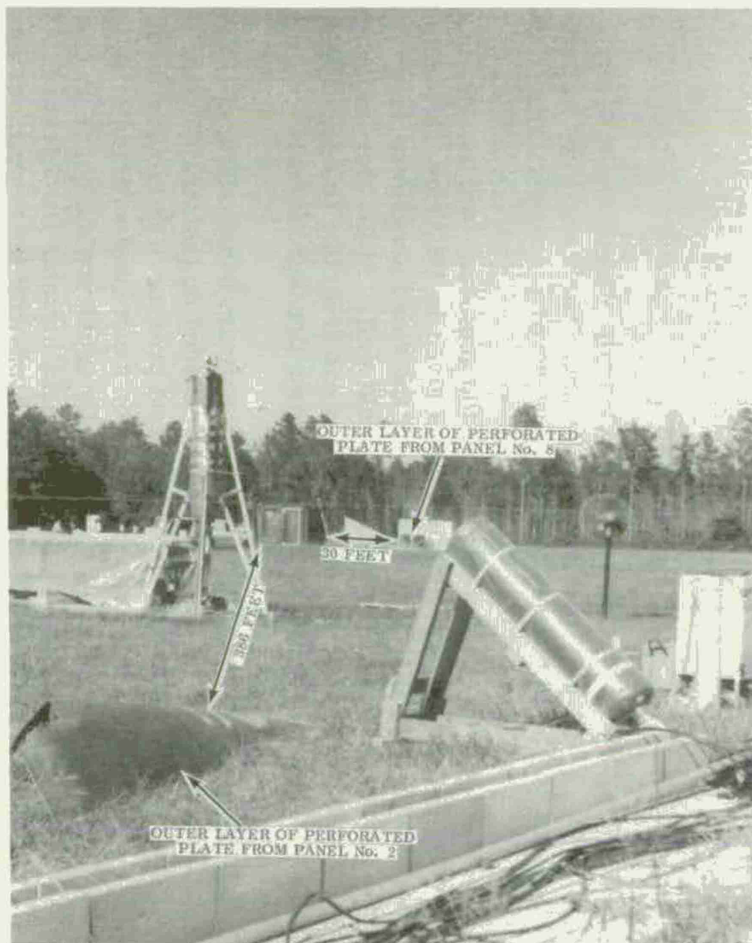
Figure 16. Category 3 S/S Damage From Test B3-2

Damage to the perforated plates from test B3-2 demonstrated that the perforated plates failed from the blast loading and did not develop the full membrane strength by which panels of this type have previously been designed. Figures 12 through 16 illustrate the structural damage of the shield from test B3-2. No apparent damage occurred to the structural frame. Figure 17 shows the explosive set-up for test B3-1 which was identical to that for test B3-2 except for the 2-lb. smaller charge.

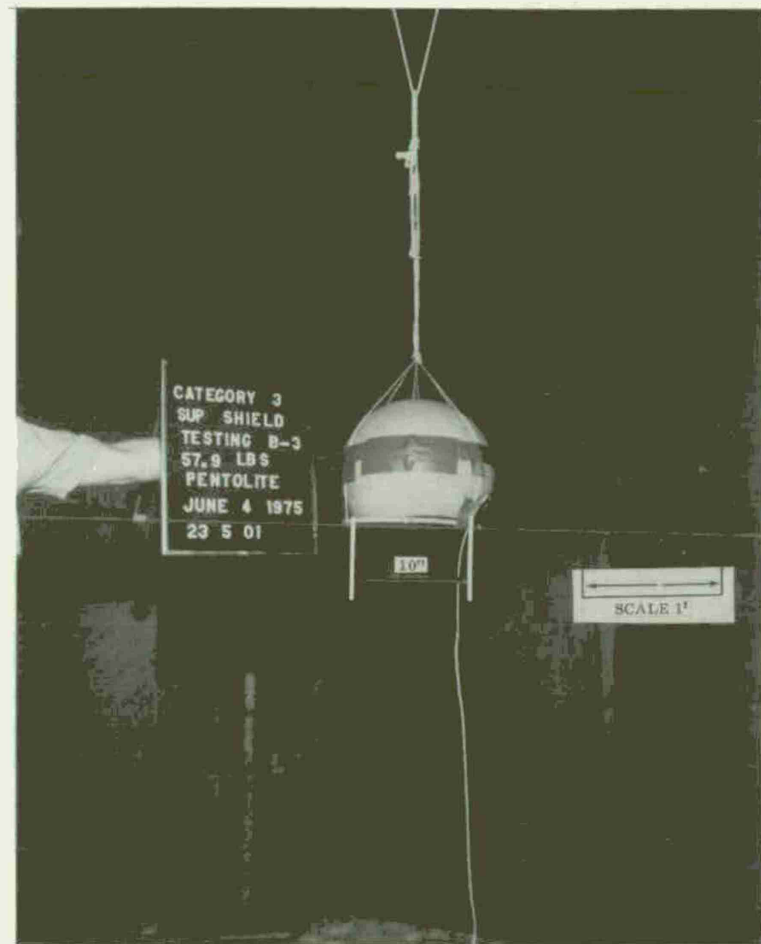
Figure 17. Category 3 Test B3-1 Setup, Explosive Charge

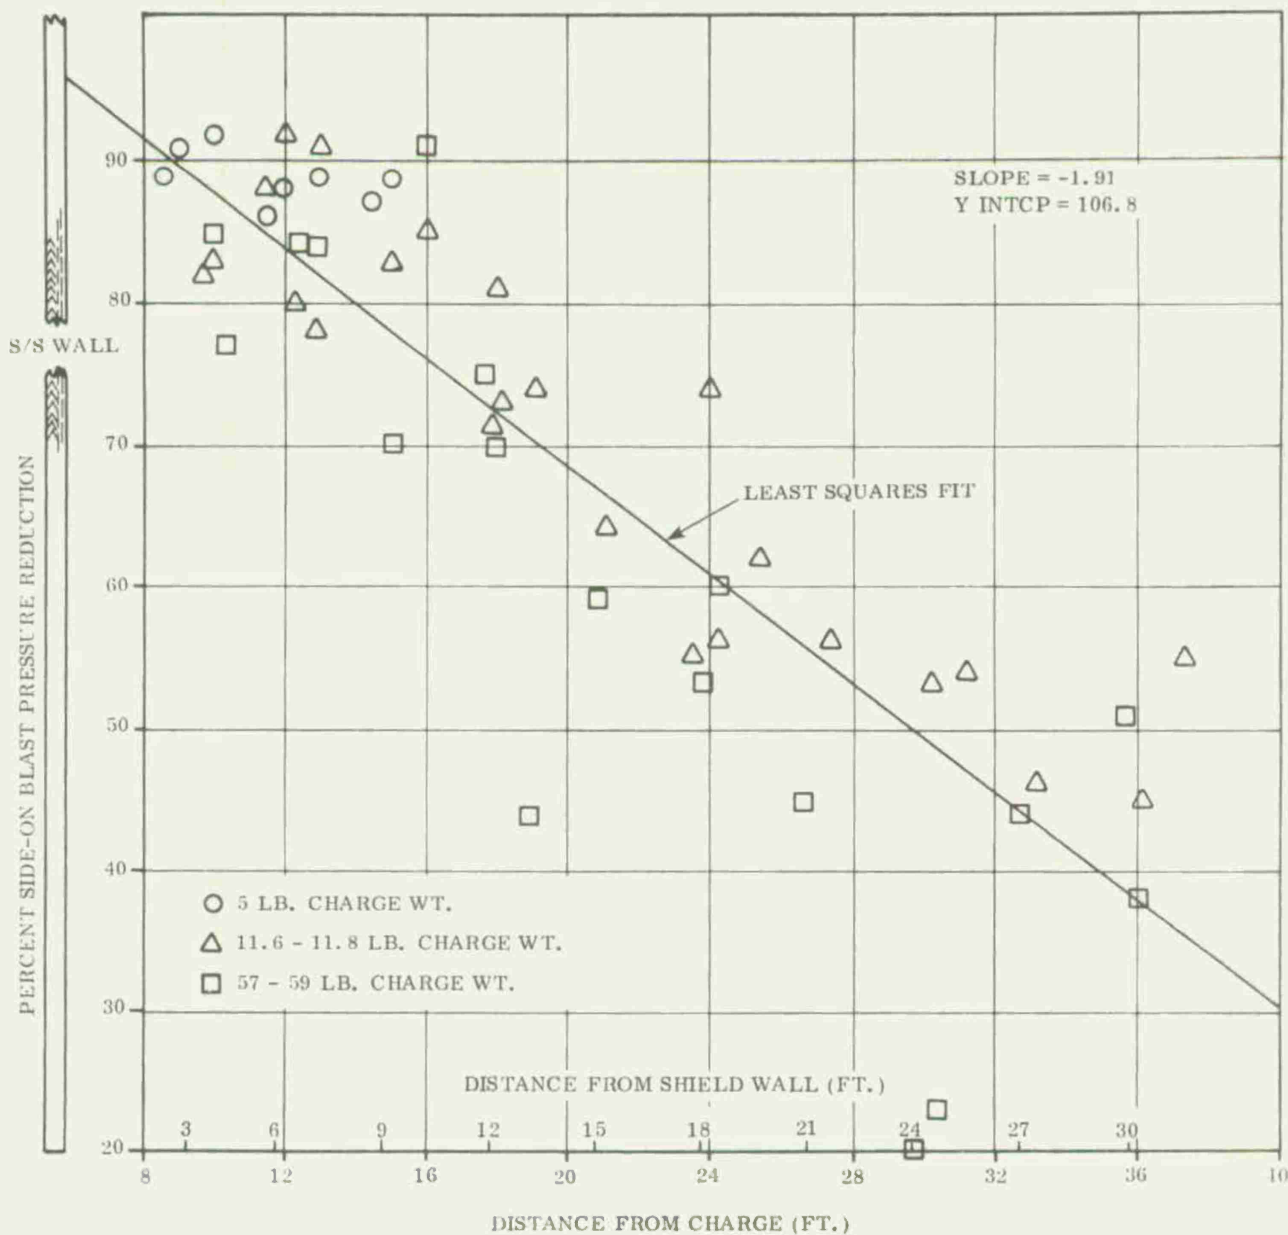
Figure 18. Category 3 Suppressive Shield Percent Reduction of Side-on Blast Pressure Versus Distance from Charge (Ft.) Tests B1-1, B2-1, 2, B3-1,2.

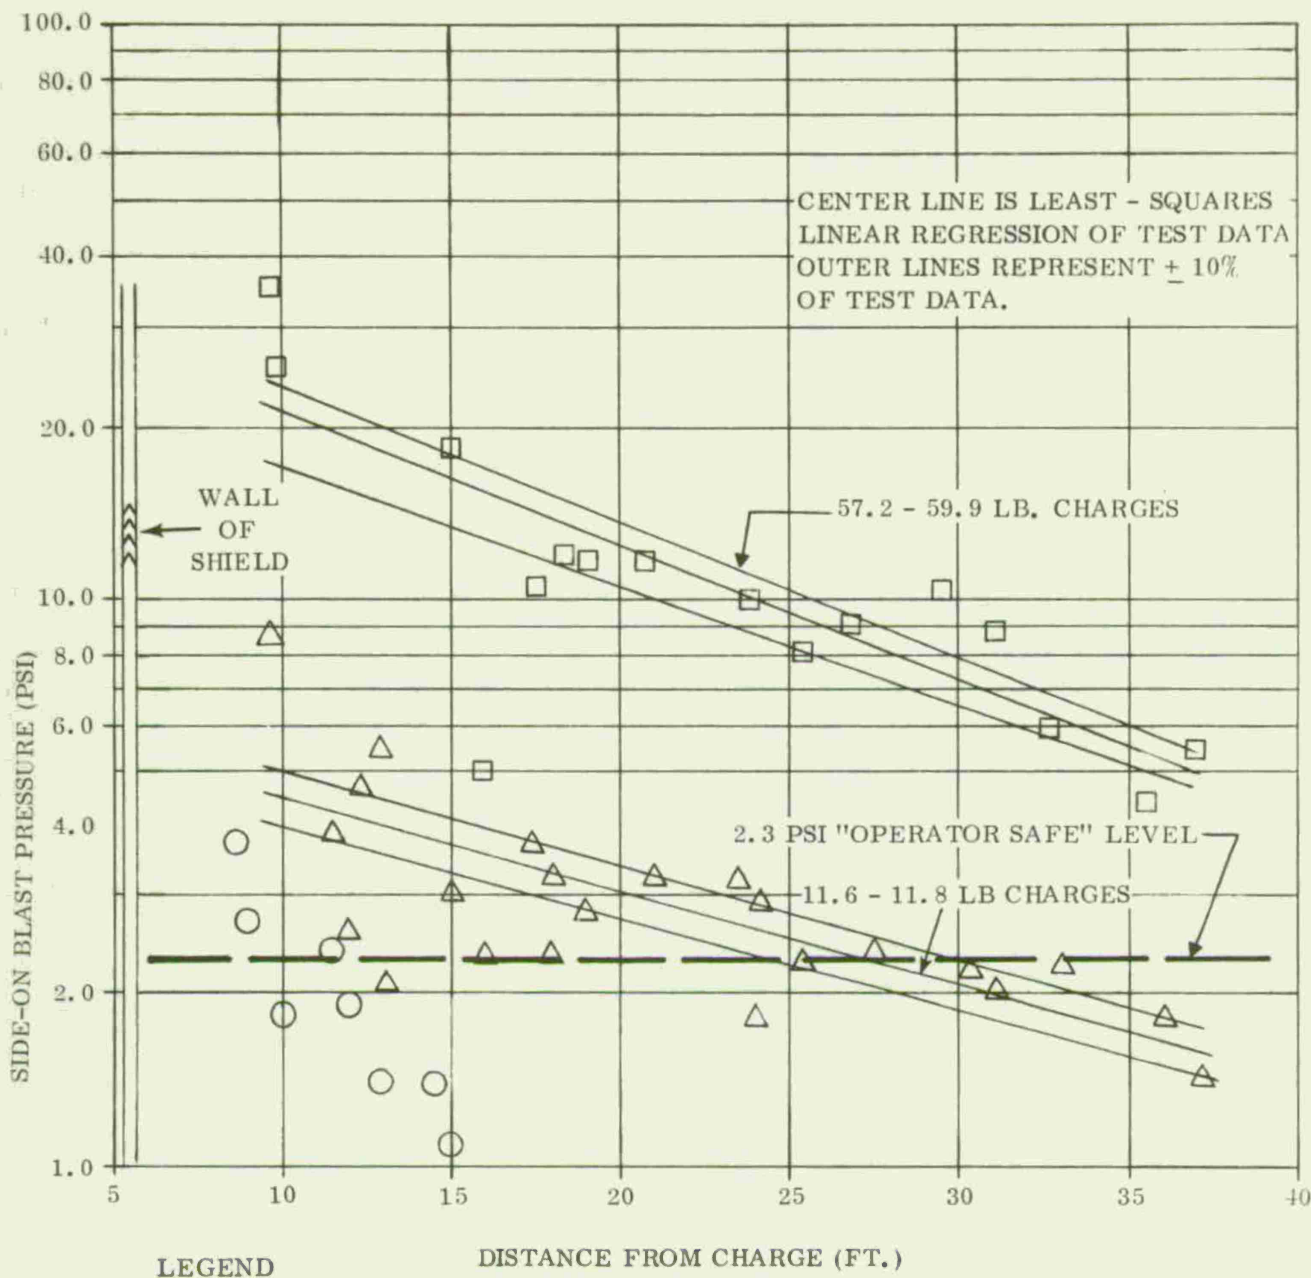
Figure 19. Category 3 Suppressive Shield External Side-On Blast Pressure (PSI) Versus Distance from Charge (Ft.)

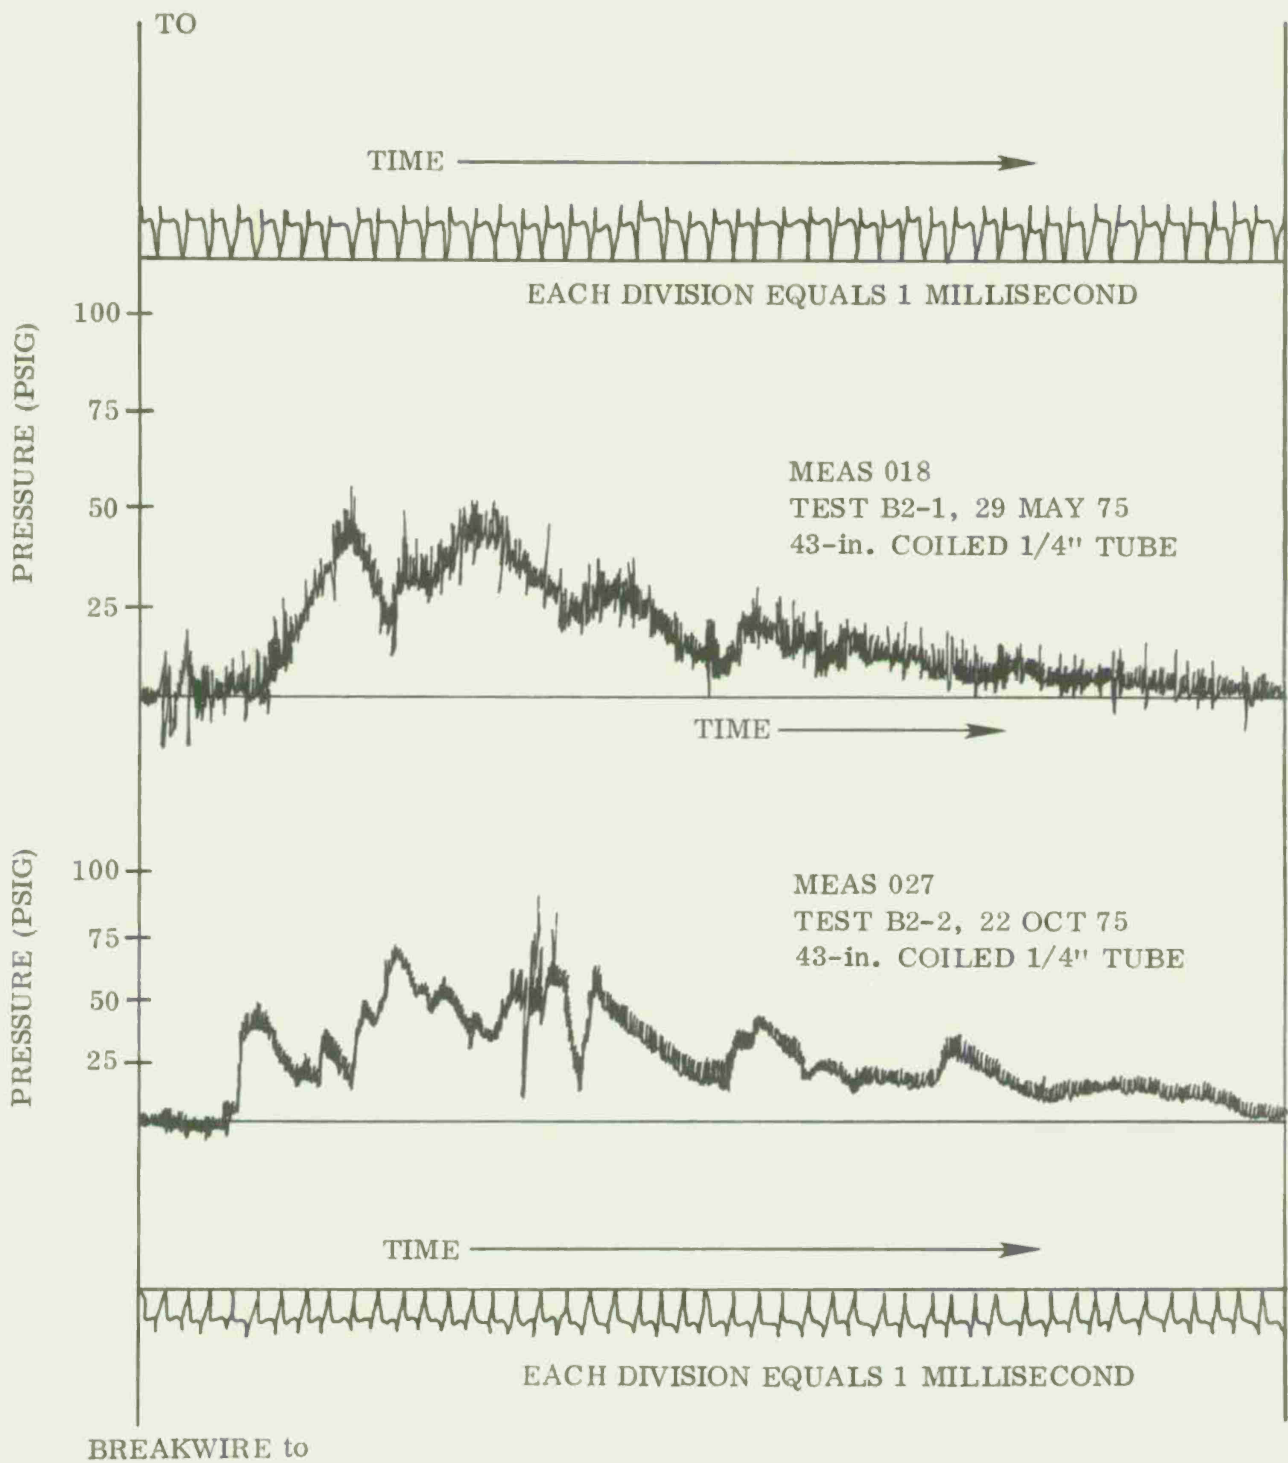
Figure 20. Category 3 Test Series B2, Fragmentation Tests, Quasi-Static Pressure versus Time (Psig versus MS)

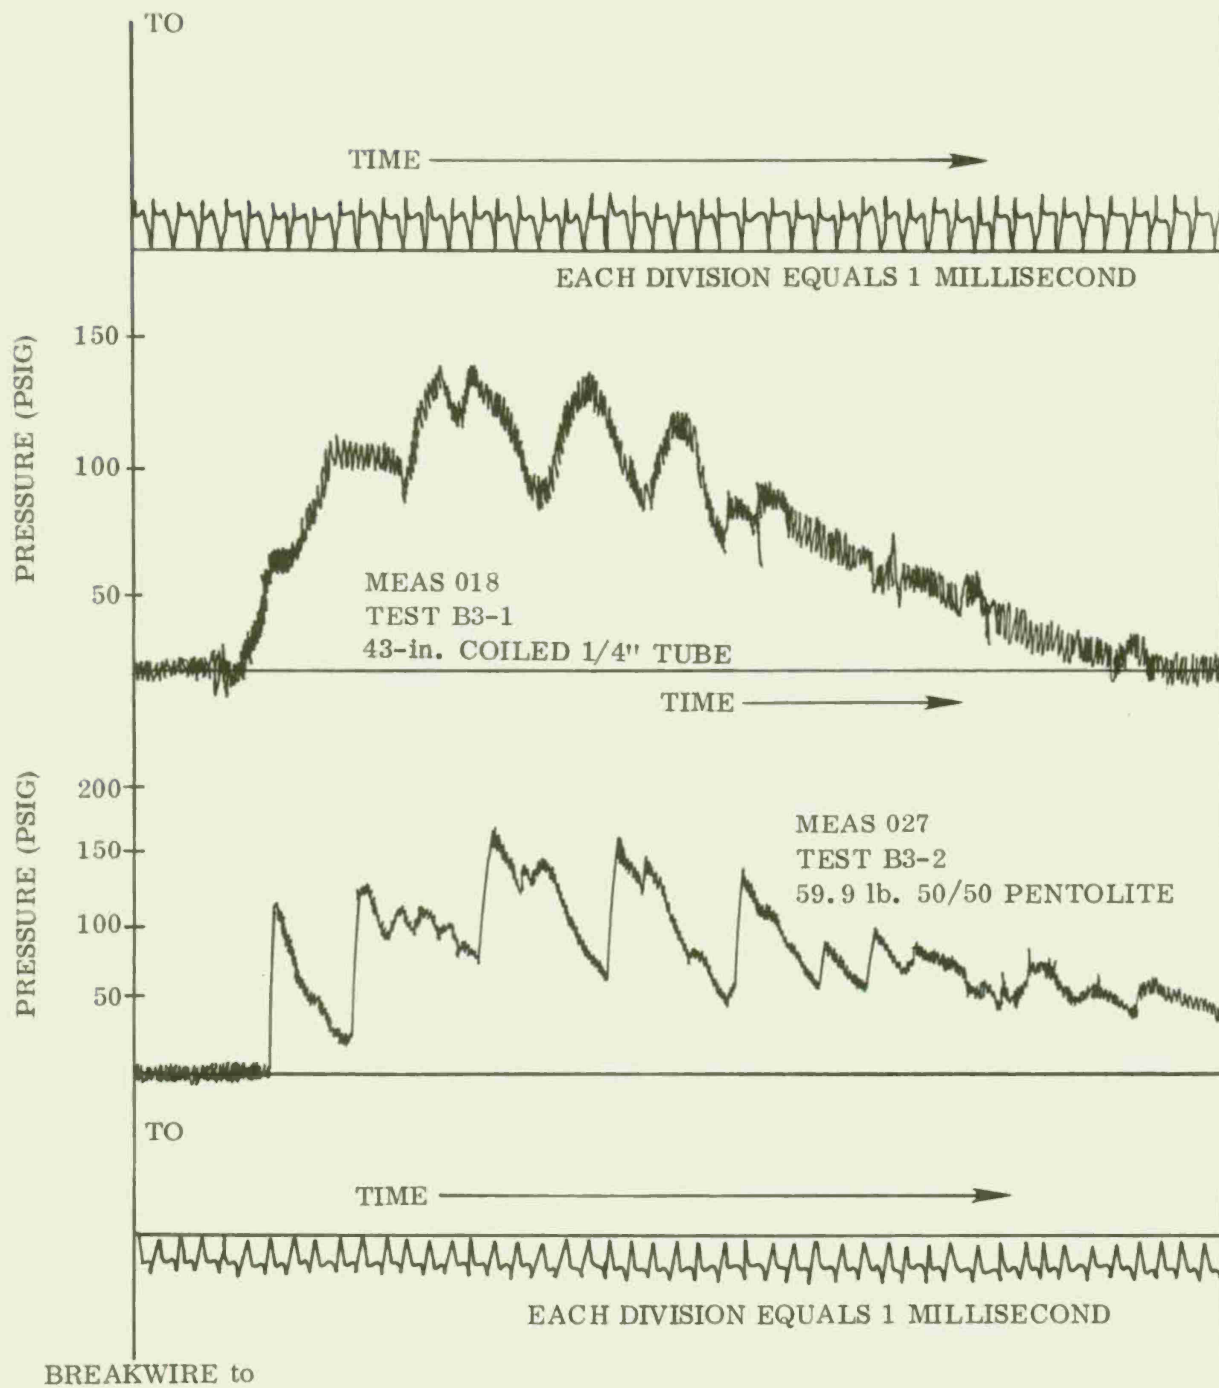
Figure 21. Category 3 Test Series B3 Quasi-Static Pressure versus Time (Psig versus MS)

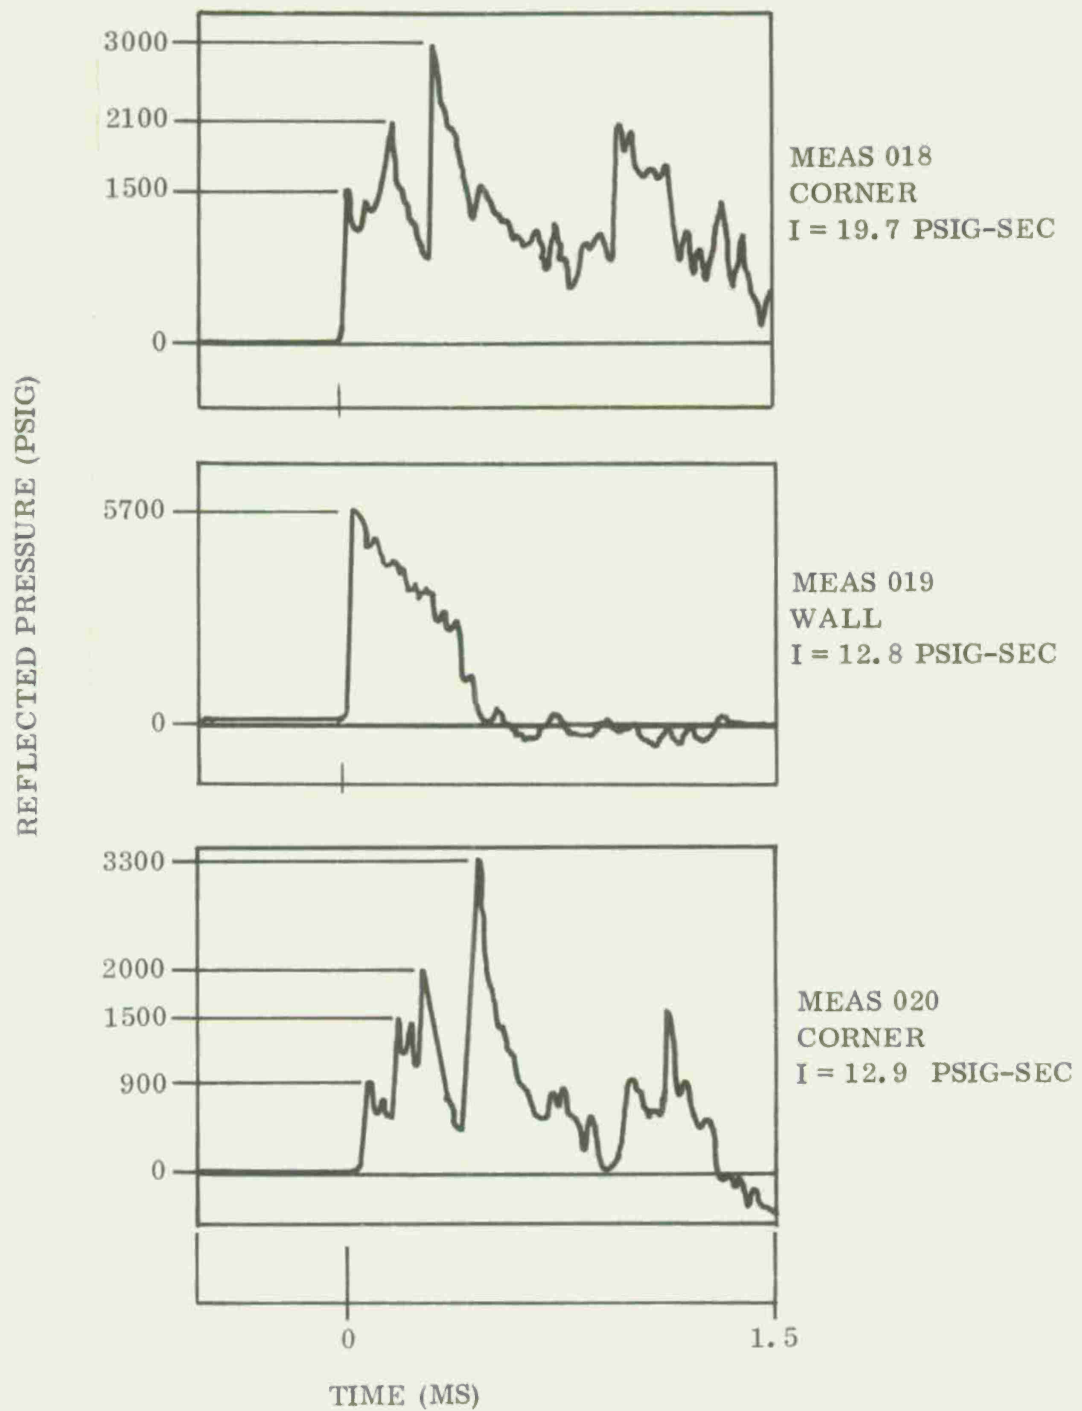
Figure 22. Category 3 Suppressive Shield Pressure (PSIG) versus Time (MS)
Test B3-2 Reflected Pressures

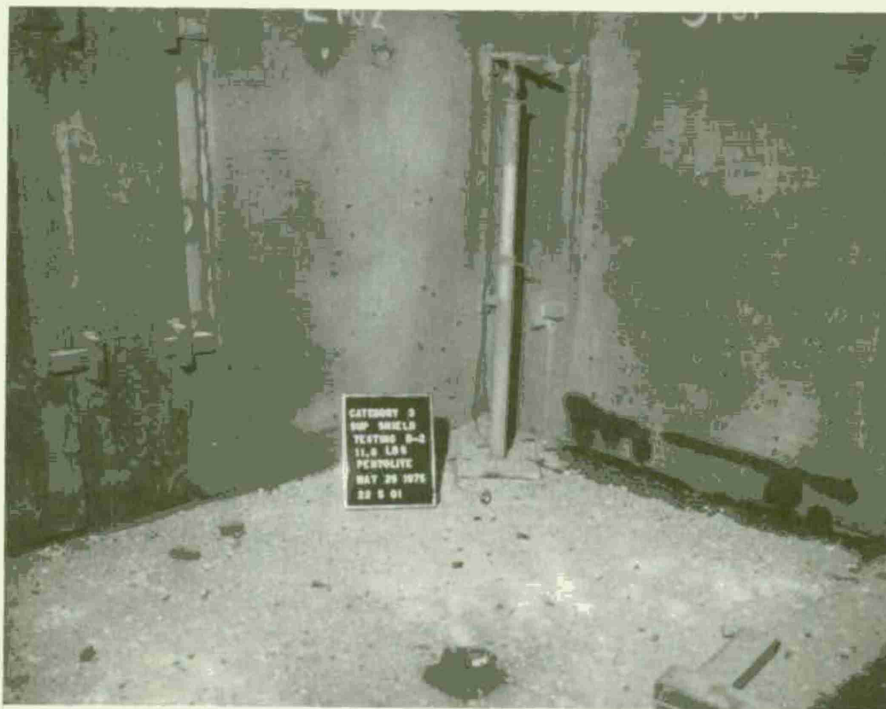
Figure 28. Category 3, Test B2-1, Typical Fragment Damage to Concrete Floor

B2-1 and B2-2 inflicted similar damage to the shield and yielded the same general type and size of fragments. Fragment damage to the shield walls is shown in figures 25 through 28. The wall panels suffered severe fragment damage to the inside layer of perforated plates and the concrete floor. No damage occurred to the ceiling panels. One fragment (approximately 1-1/2" x 3/8" x 16 gauge) from test B2-1 penetrated the shield and escaped. The penetration, however, was in an area of "poor fit" or gap between the panels and the main frame, which afforded only a 3/8-inch single steel thickness rather than the 3/4-inch spaced armor design requirement. This gap was eliminated when the new panels were installed for test B2-2 and no fragments escaped the shield. During test B2-1, one fragment penetrated the flange of a wall column 1.1 inches thick but was retained by the shield. In test B2-2 fragment penetrations in the frame member and panel frame angles greater than .85 inches were observed, but all fragments were retained inside the shield.

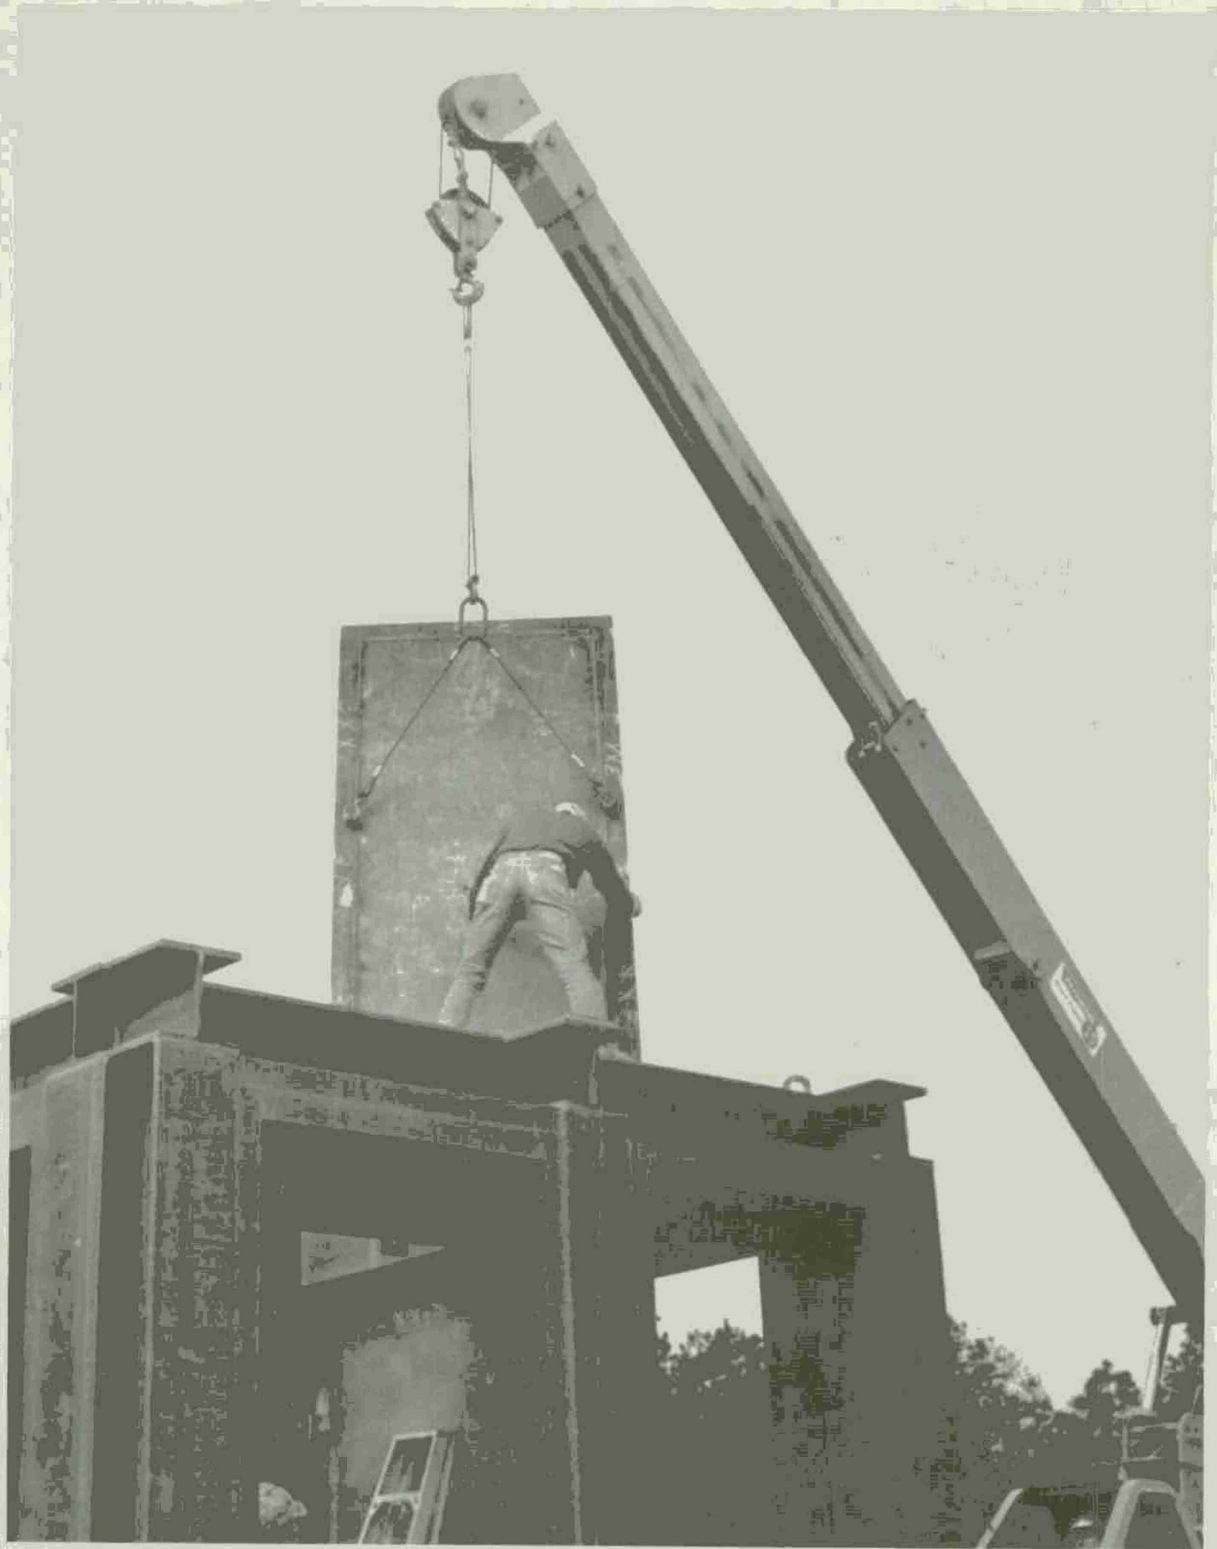
Category 3 Suppressive Shield

Insertion of wall panels into structural frame.
