HOT CORROSION OF HIGH  
TEMPERATURE ALLOYS.

JOHN STRINGER

Department of Metallurgy and Materials Science,  
University of Liverpool,  
P.O.Box 147, Liverpool L69 3BX,  
England.

Final Scientific Report : 15 May 1972-14 May 1975.

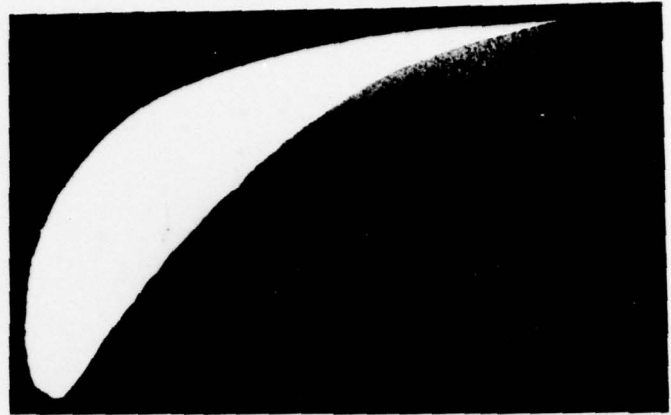
Figure 1(b) An unetched section of a similar blade in a badly affected region.

Figure 1(a) shows the concave surface of a Nimonic 100 first-stage turbine blade from an Olympus engine after 401h running at approximately 870°C. Figure 1(b) shows a section of a similar blade, and Figure 1(c) shows the corrosion product at higher magnification. There is an outer oxide layer, rather porous; an intermediate layer of mixed oxide and metal, and finally an inner layer consisting of fine lighter-grey particles in a metal matrix. This innermost layer is shown in more detail in Figure 1(d). All these figures are taken from Smith et al (7). The outer oxide layer is essentially NiO, with some  $\text{NiCr}_2\text{O}_4$  spinel. The intermediate layer is essentially Ni-rich fragments in a  $\text{Cr}_2\text{O}_3$  matrix although again there is some spinel. The light grey particles are chromium-rich sulphides, and the metal in the inner layer is depleted in chromium. Very similar pictures of the corrosion of 713C blades operated in the Pacific for 600h are shown by Schirmer and Quigg (16).
