AEDC-TR-76-172

**VIBRATION TESTING OF THE TE-M-604-4 IUE
ROCKET MOTOR (THIOKOL P/N E 28639-03)**

**VON KÁRMÁN GAS DYNAMICS FACILITY
ARNOLD ENGINEERING DEVELOPMENT CENTER
AIR FORCE SYSTEMS COMMAND
ARNOLD AIR FORCE STATION, TENNESSEE 37389**

**NATIONAL AERONAUTICS AND SPACE ADMINISTRATION
GODDARD SPACE FLIGHT CENTER
GREENBELT, MARYLAND 20771**

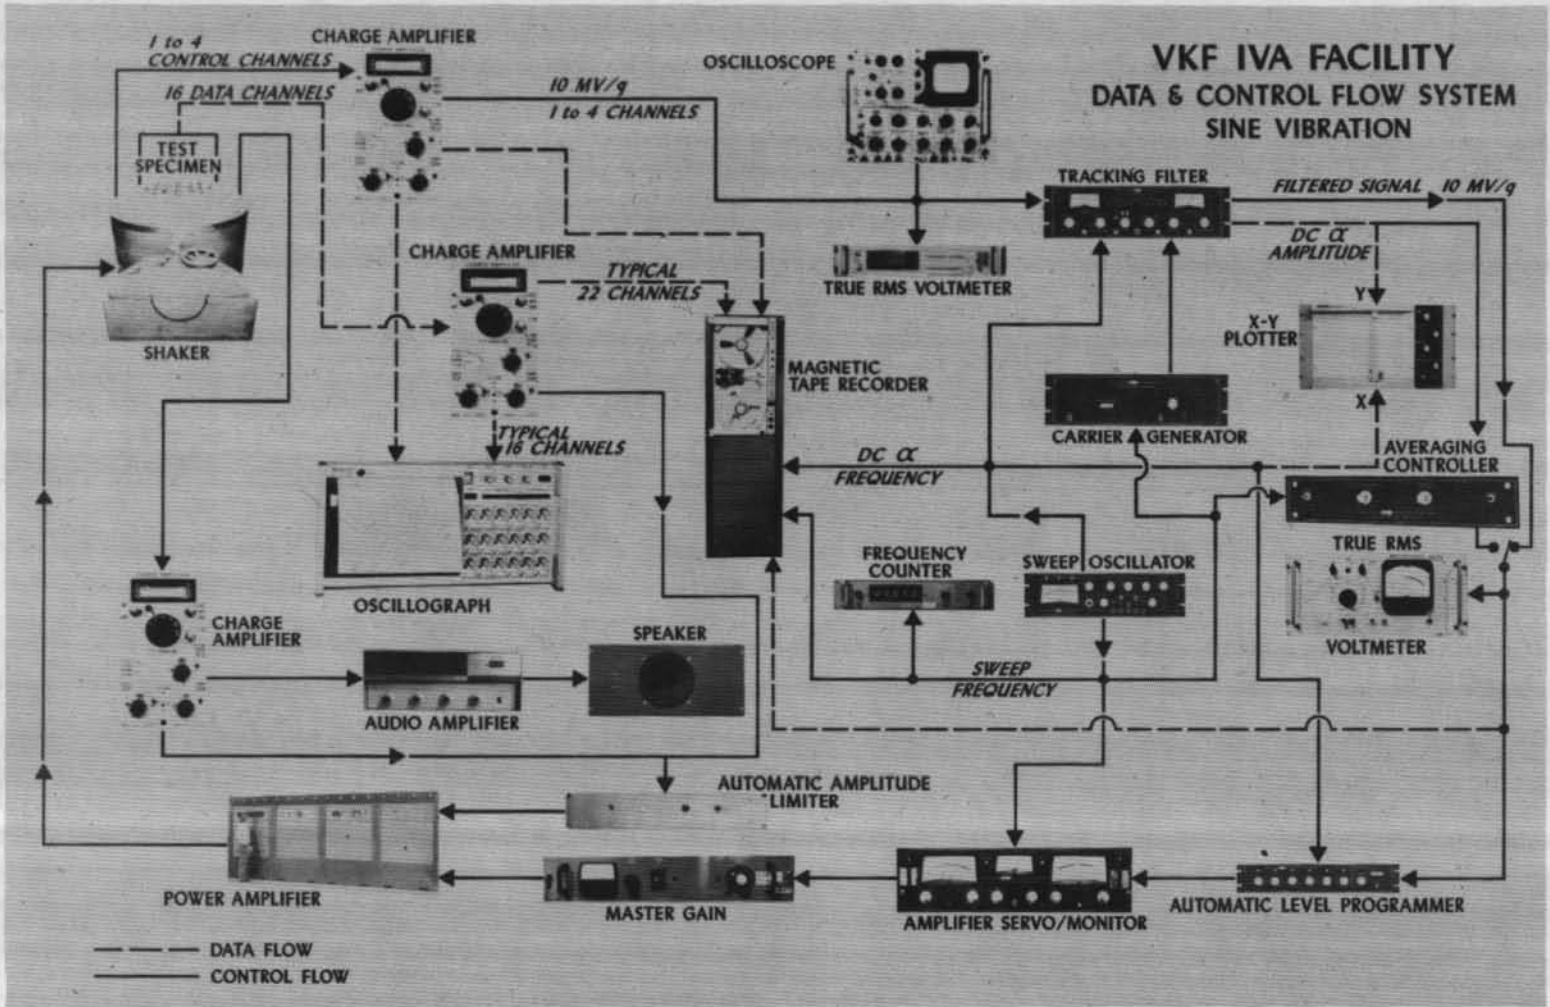
Figure 1. IVA test unit and test equipment locations.

The Impact, Vibration, and Acceleration Test Unit consists of the vibration system, a shock machine, and a centrifuge. The equipment (Fig. 1) is housed in the "S" Building of the VKF. The test control room is separated from the test area by a reinforced concrete wall.

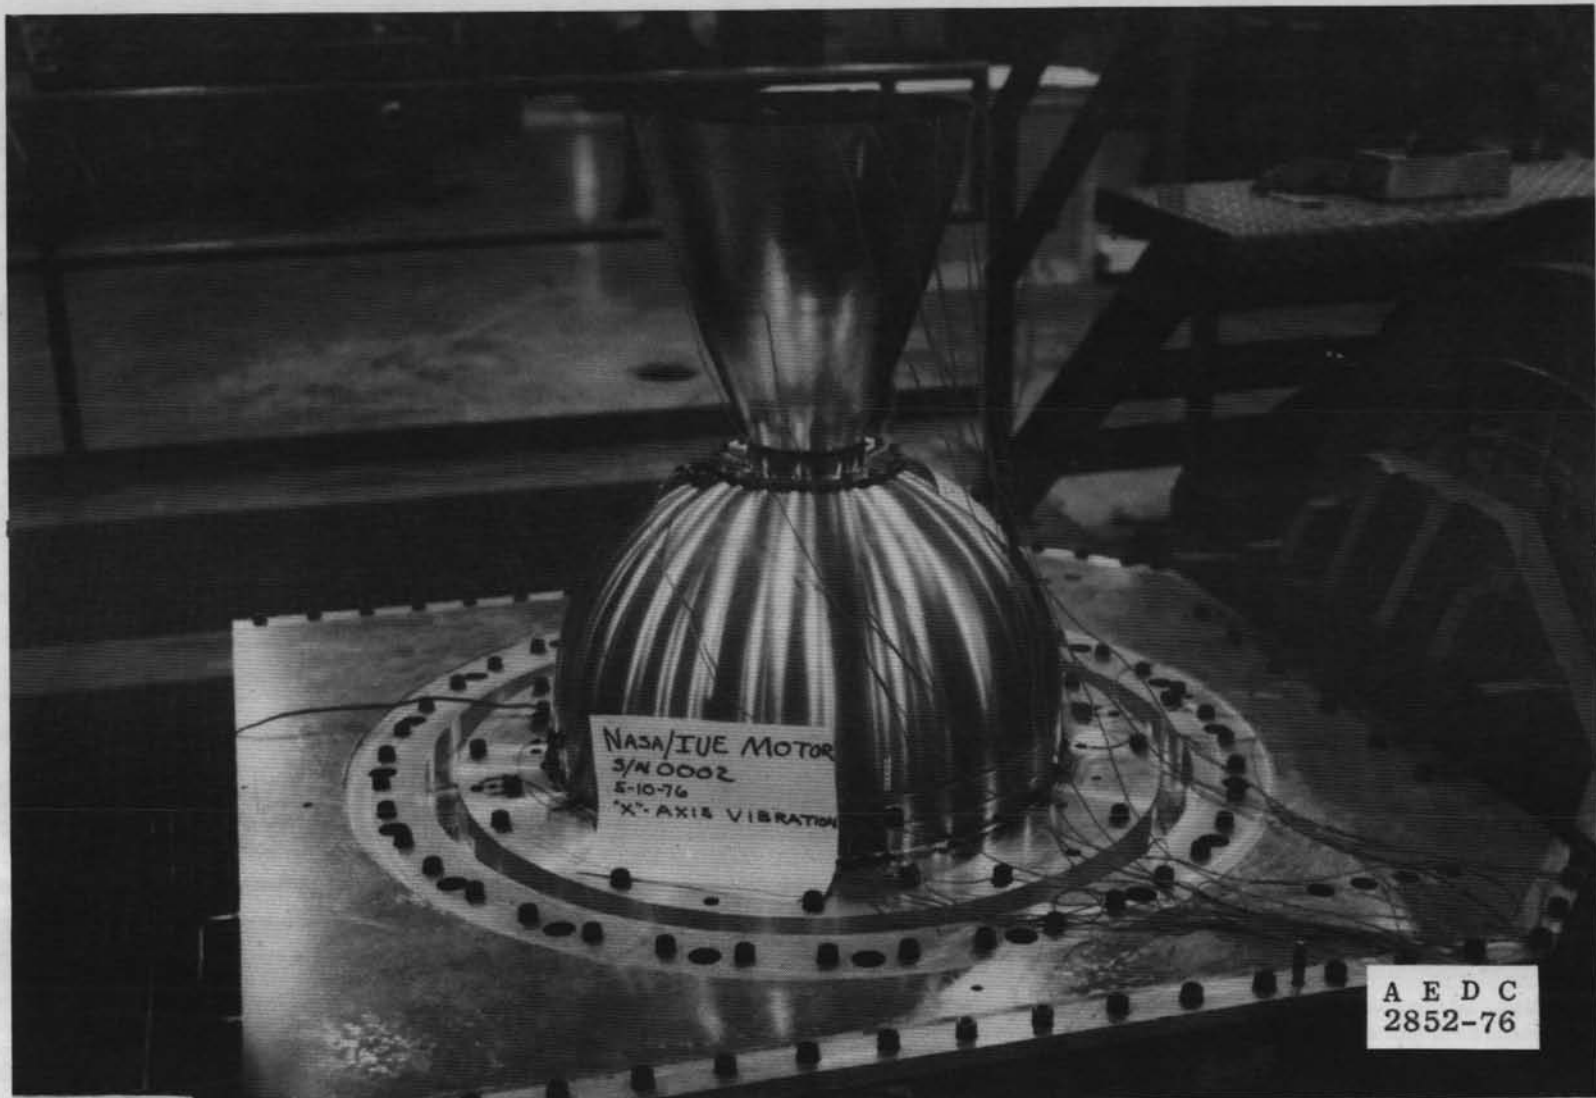
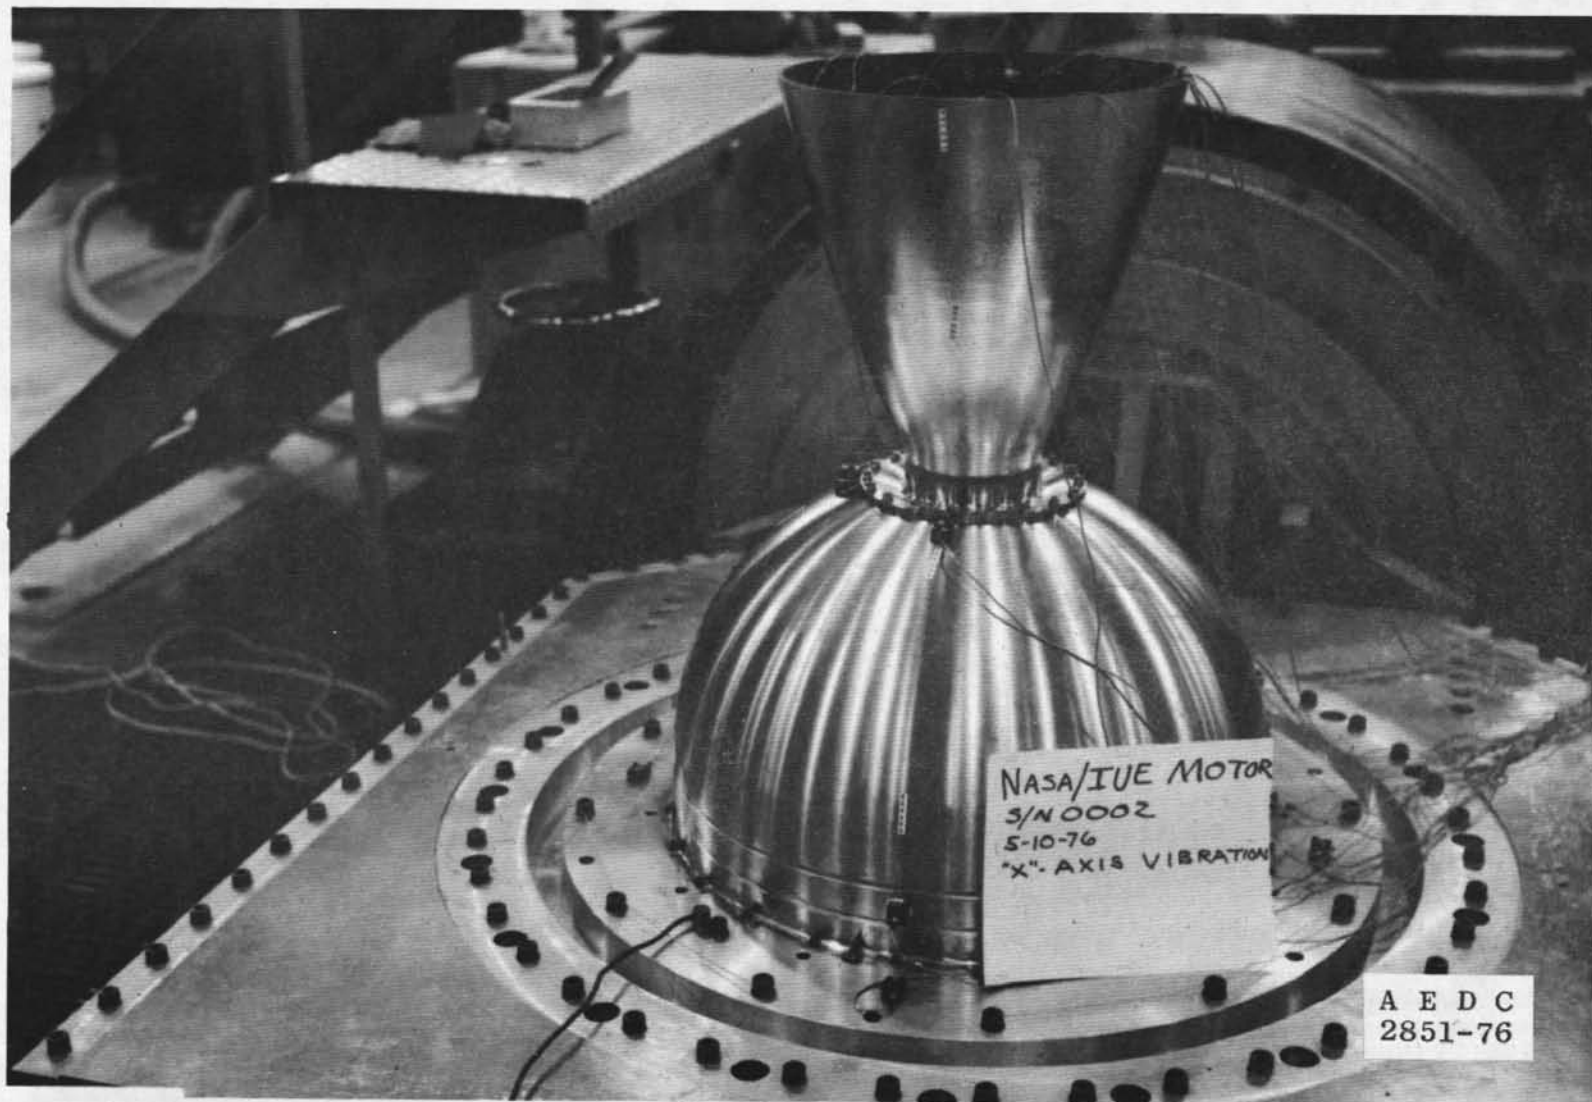
Figure 11. X-axis motor installation photographs.

The IUE motor (S/N 0002) was installed in the lateral axis vibration fixture in preparation for X-axis testing. Installation photographs, including accelerometers, are shown in Fig. 11. The X-axis 0.5-g sine survey was then conducted. The X-Y plots of all acceleration signals recorded during this survey are shown in Fig. 12. All X-Y plots were made from the magnetic tape recording following completion of the entire test program, except for the closed loop control plot and the control average online plot. All data channels were displayed on the recording oscillograph following the individual vibration tests.

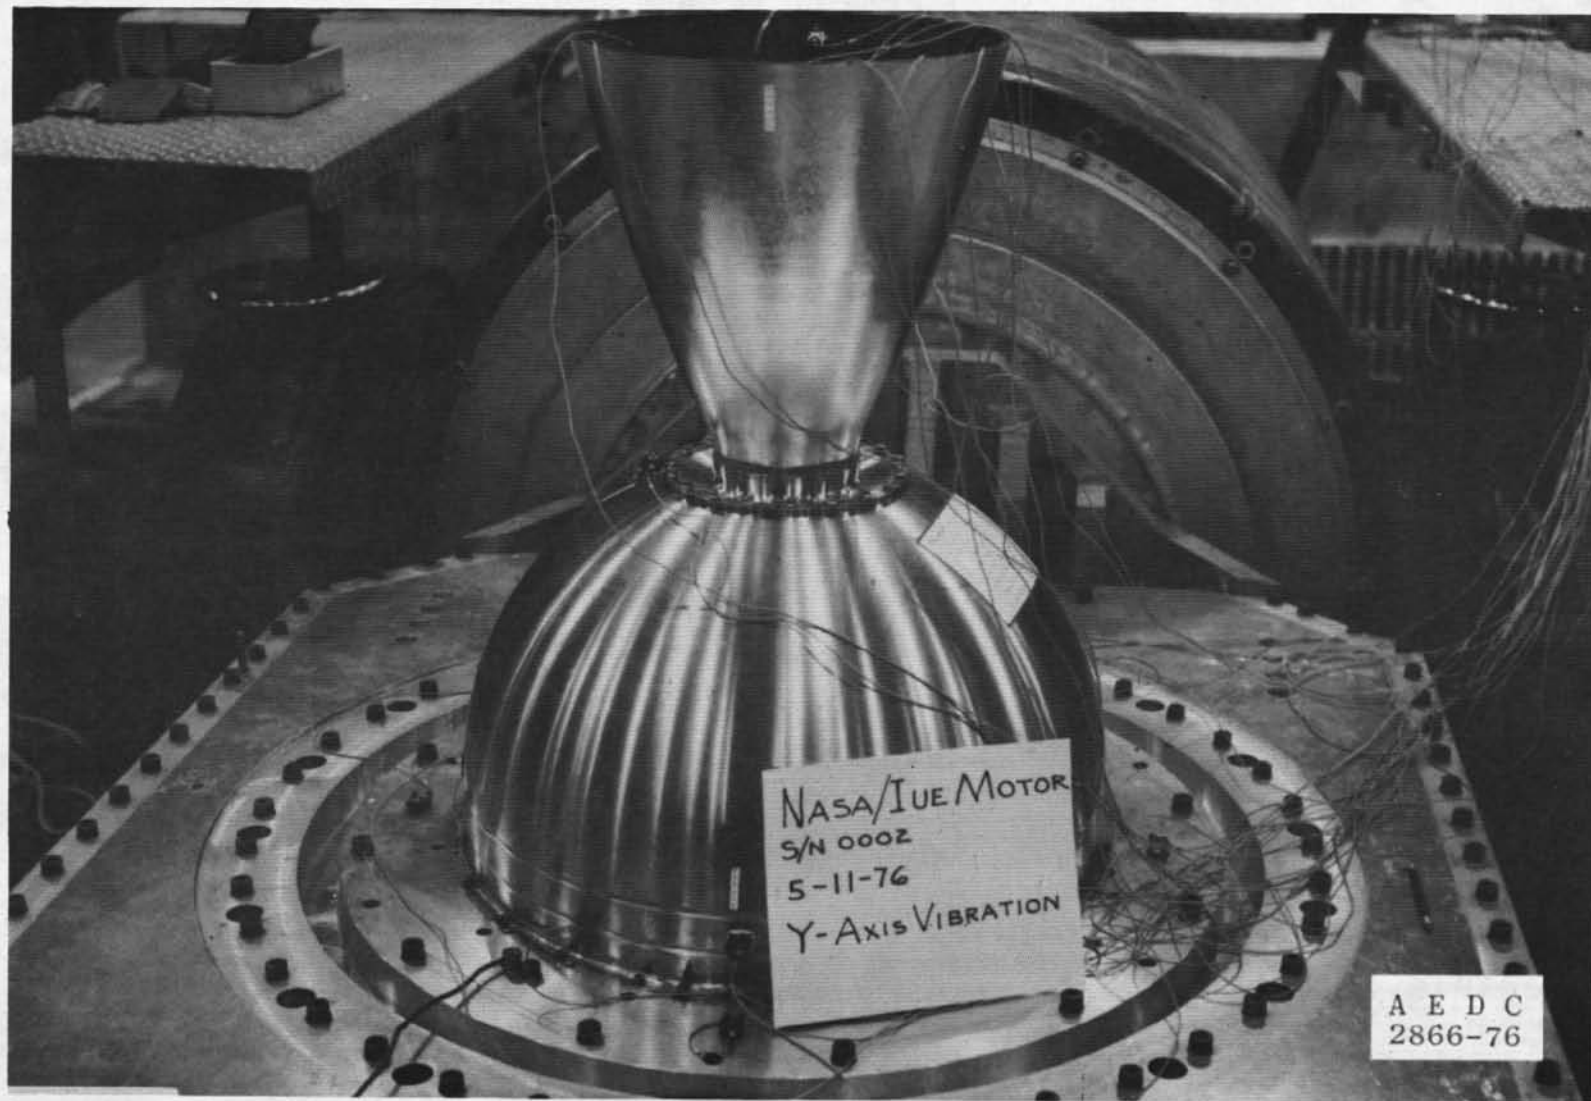
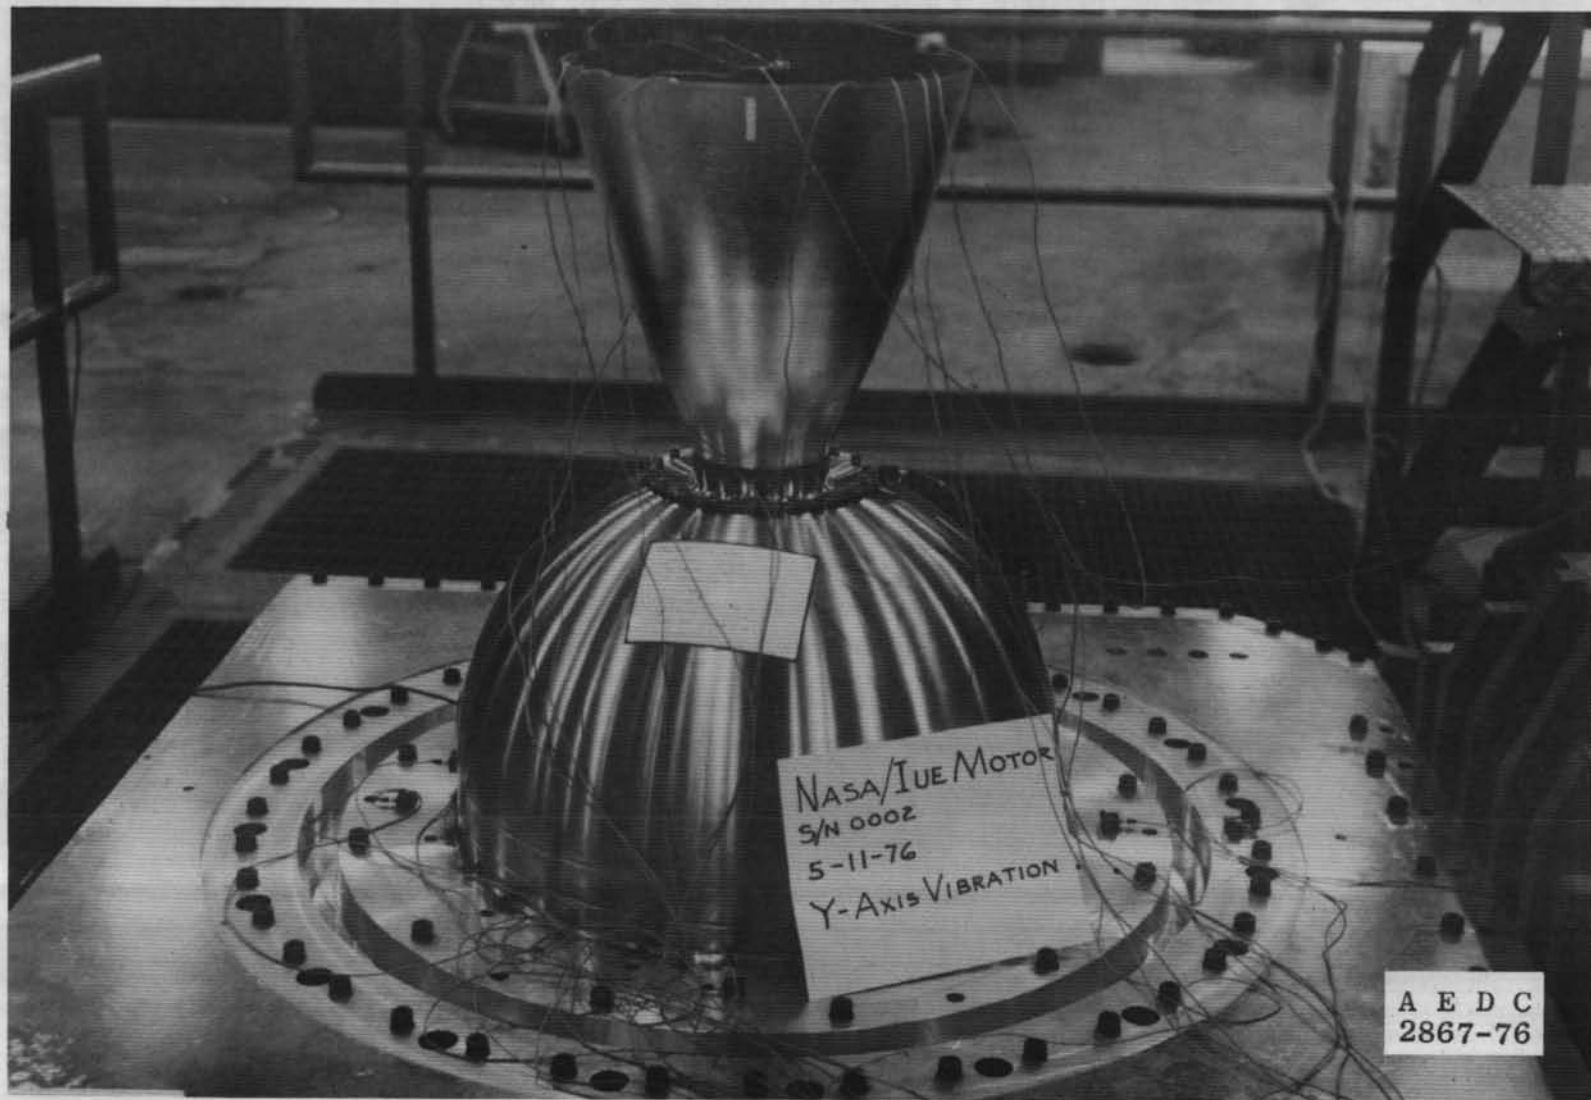
Figure 16. Y-axis motor installation photographs.

The Y-axis test program was conducted in the same manner as the X-axis test. Installation photographs for the Y-axis are shown in Fig. 16. The 0.5-g sine surveys and qualification level sine and random vibration test results are shown in Figs. 17 through 20. No significant acceleration differences were noted with the X-axis test results, as would be expected due to the motor symmetry.

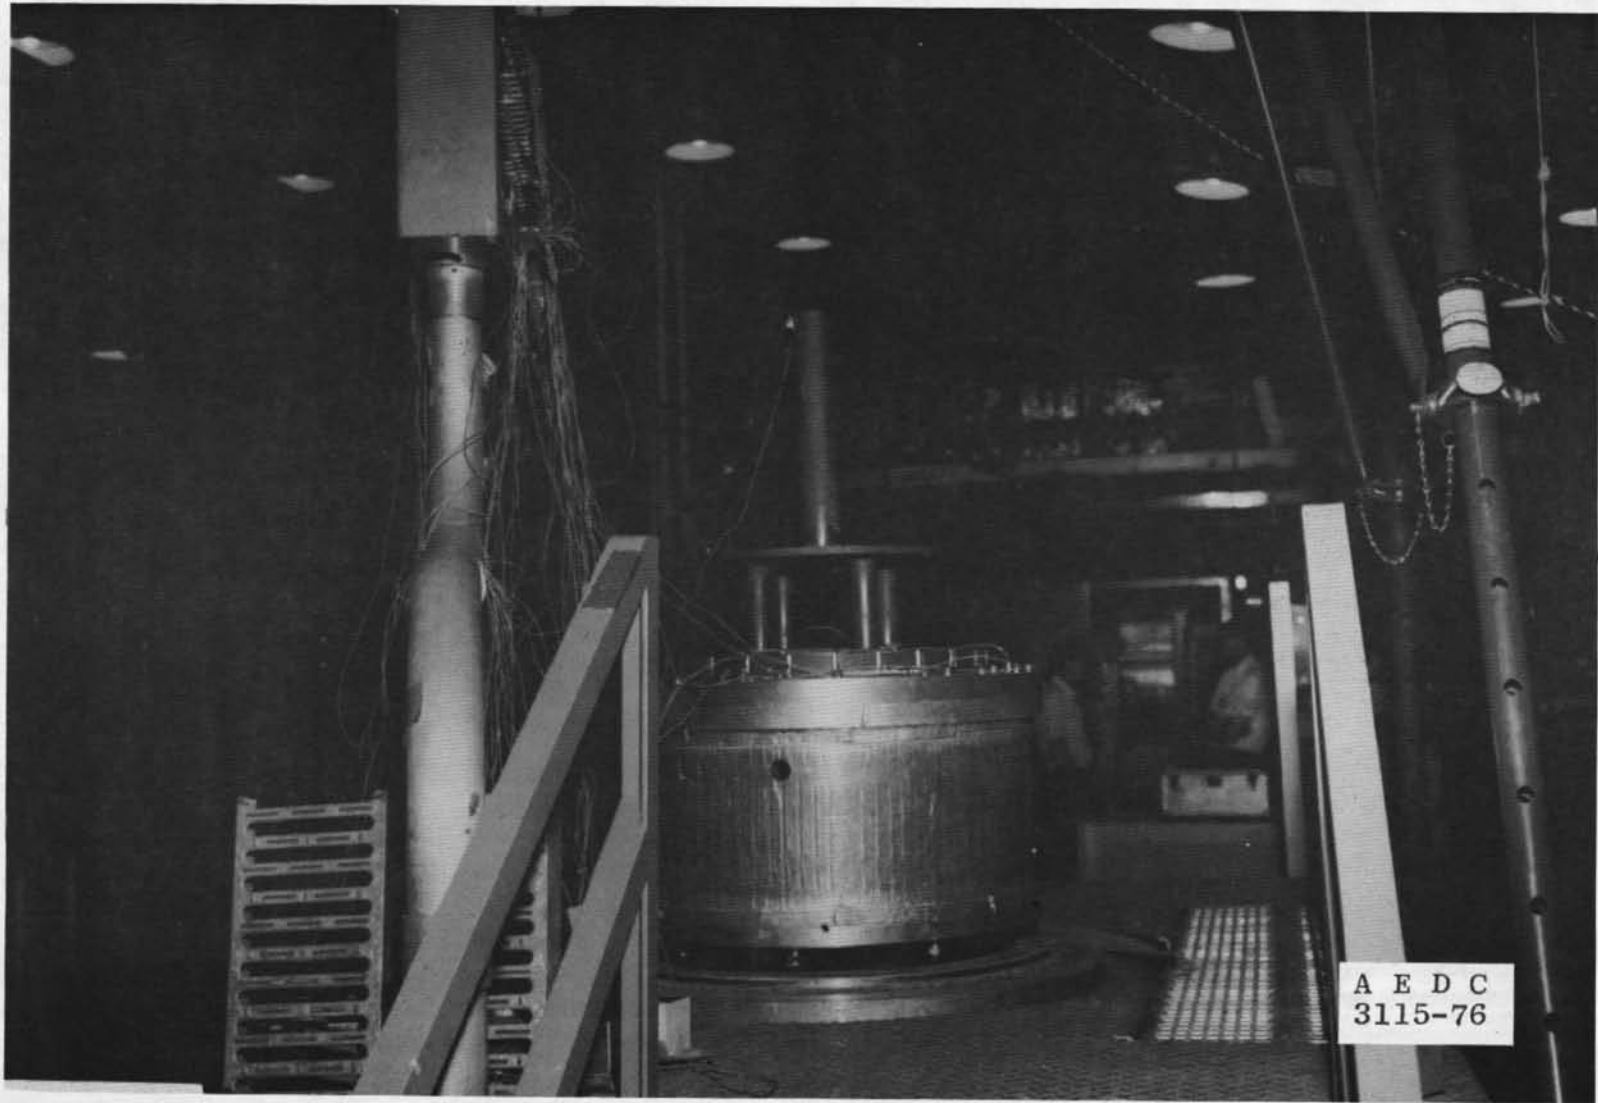
Figure 22. Thrust axis installation photographs: mass simulator.

The thrust axis fixture/mass simulator installation photographs are shown in Fig. 22, and the vibration test results in Figs. 23-27. Due to the number of input level changes required in the qualification level sine sweep (Fig. 5a) this test was conducted in 5- to 75- and 75- to 2,000-Hz sweep ranges. The only problem encountered during the mass simulator test was the loosening of the mounting bolts, noted during the removal of the simulator from the fixture following the final 0.5-g sine survey. This was attributed to the use of a slightly overlength bolt. As this problem would not be encountered with the IUE motor installation, the thrust axis procedures and fixture were considered satisfactory.

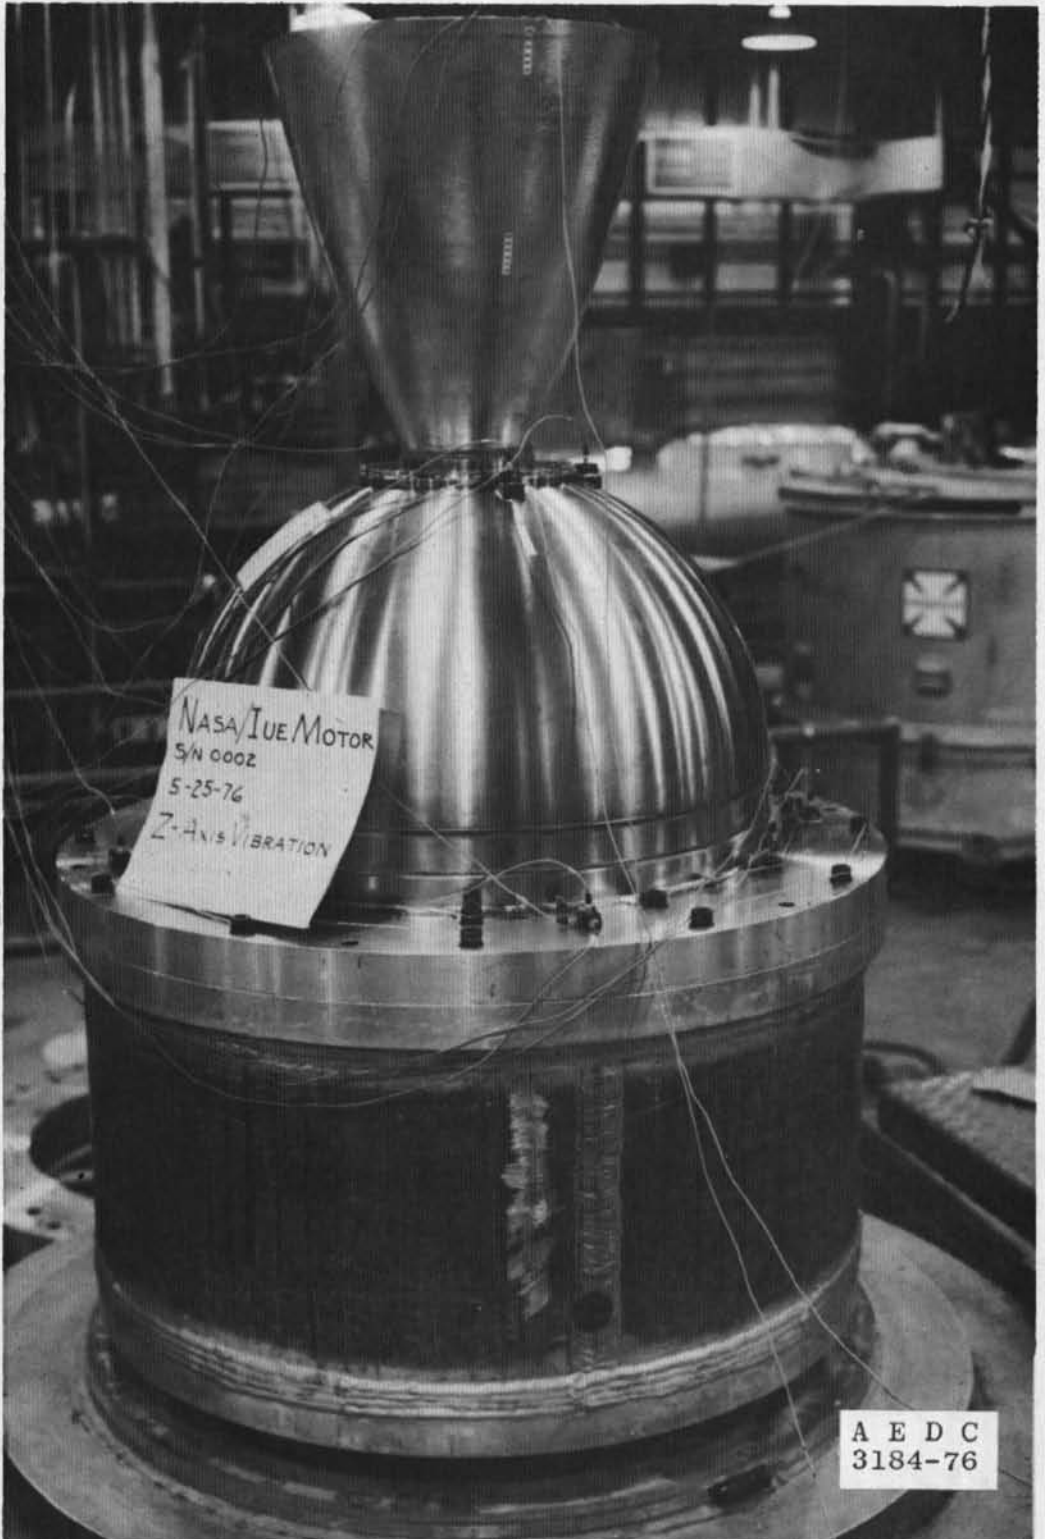
Figure 28. Z-axis installation photographs.

The qualification testing of the IUE motor in the thrust (Z) axis was similar to the lateral axis program, a low level sine survey prior to and following qualification level sine and random testing. The photographs of the motor installed in the thrust axis fixture are shown in Fig. 28. The results of the first 0.5-g sine survey are shown in Fig. 29. A nozzle resonance mechanical transmissibility factor (Q) of approximately 40 was noted at the 328-Hz resonant point. Due to this higher than anticipated Q value, a second sine survey was conducted at a 1.0-g input to verify the linearity of the magnification. The results of this survey are shown in Fig. 30. A Q value of 44 at
