J **12**
Special Report 77-30

PAVEMENT RECYCLING USING A HEAVY BULLDOZER MOUNTED PULVERIZER

September 1977

Prepared for
DIRECTORATE OF MILITARY CONSTRUCTION
OFFICE, CHIEF OF ENGINEERS
By
CORPS OF ENGINEERS, U.S. ARMY
COLD REGIONS RESEARCH AND ENGINEERING LABORATORY
HANOVER, NEW HAMPSHIRE

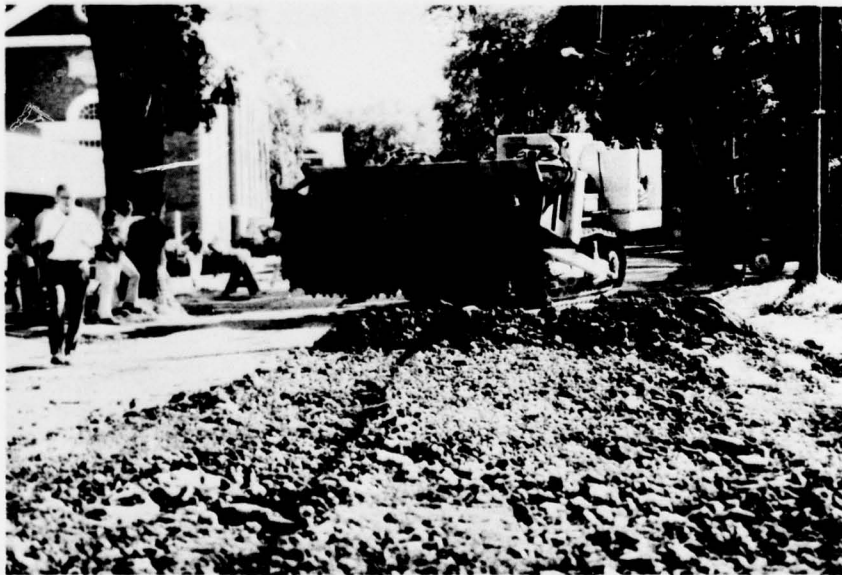
Photo 4: First pass on North Main Street,
Hanover, New Hampshire.

At the test site on North Main Street the Town was undercutting the street approximately 24 in. for reconstruction. Samples of the granular base course and black base beneath the 4-5 in. asphalt concrete pavement were obtained. The machine was moved up to the edge of the 24 in. vertical cut with the drum horizontally overhanging approximately 12 in. The drum was operated in the climb milling mode with the tractor in reverse gear, which means the pavement cuttings were forced down into the base material before being discharged at the front of the machine. The drum speed was 15 rpm and set at a depth of 6 in. The machine was backed down the street an average speed of 10 ft/min, resulting in an area of 120 square feet of pulverized pavement six inches deep in one minute. The pavement was pulverized to a relatively uniform gradation (Appendix B, photo 4).
