12  
AFALD/PTPT REPORT NO. 77-40  
AFPEA PROJECT NO. 77-P7-37

PERFORMANCE EVALUATION OF SHIPPING CONTAINERS

GBU-15 GUIDED BOMB SYSTEM

AIM 9J-1 CANARDS

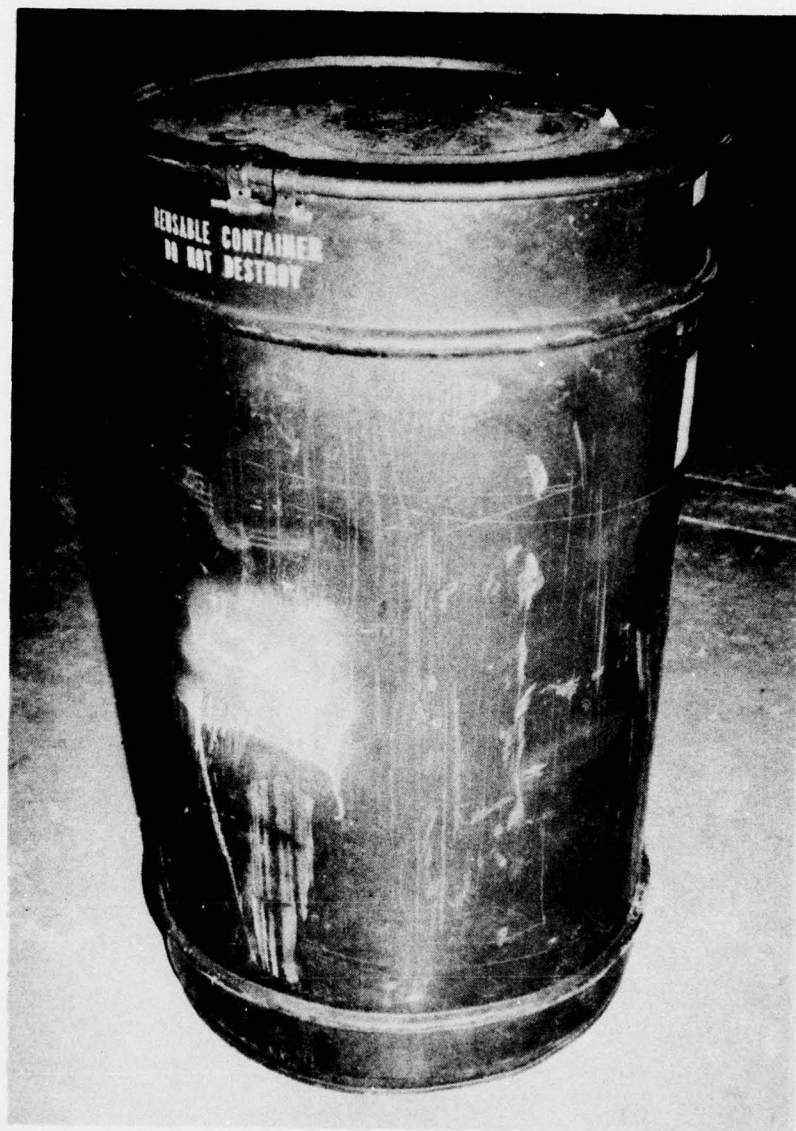
FIGURE 1

WCU-38 COMMON CONTROL CONTAINER (POST TEST)

### A. WCU-3B Container (Figure 1)

Results: No visible damage, container deflected 0.11 inches.

Results: No loss of pressure.

Post test functional check indicated the WCU-3B Module to be fully operational.

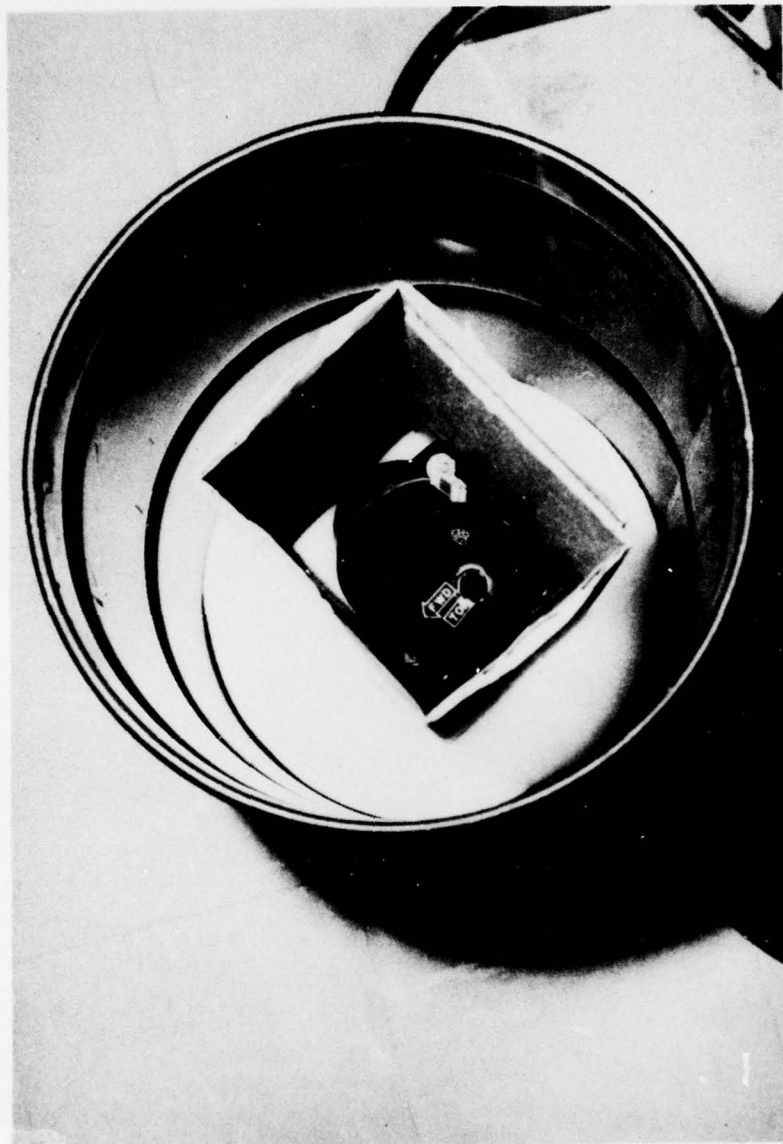
FIGURE 3

SBW-22/B GYROSCOPE DISPLACEMENT CONTAINER

C. SBU-22/B Displacement Gyroscope Container (Figure 3)

Results: Large leak was located on the drum seam and the test was terminated.

Post test functional checks indicated the SBU-22/B Gyroscope to be fully operational.

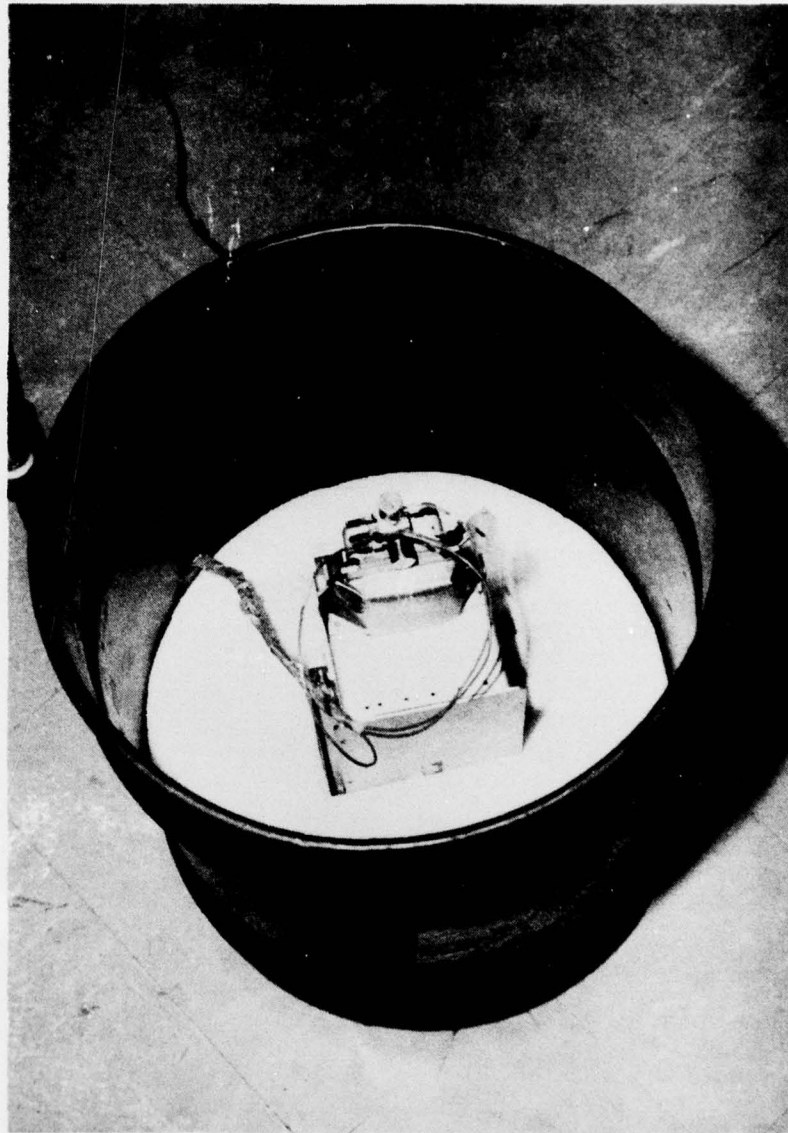
FIGURE 4

AN/DWW-1 AUTOMATIC PILOT CONTAINER ACCELERATION LOCATION  
FOR DROPS 1-4

D. AN/DWW-1 Automatic Pilot Container (Figure 4)

NOTE: During testing the accelerometers came off of the Autopilot and were relocated for test 5 and 6.

Post test functional check indicated the AN/DWW-1 Automatic Pilot to be fully operational.
