FEASIBILITY OF CUTTING ALUMINUM ALLOYS WITH A 6-KILOWATT LASER

Boeing Commercial Airplane Company
P.O. Box 3707
Seattle, Washington 98124

Technical Report AFML-TR-77-66

Final Report for Period
15 March 1976 – 15 March 1977

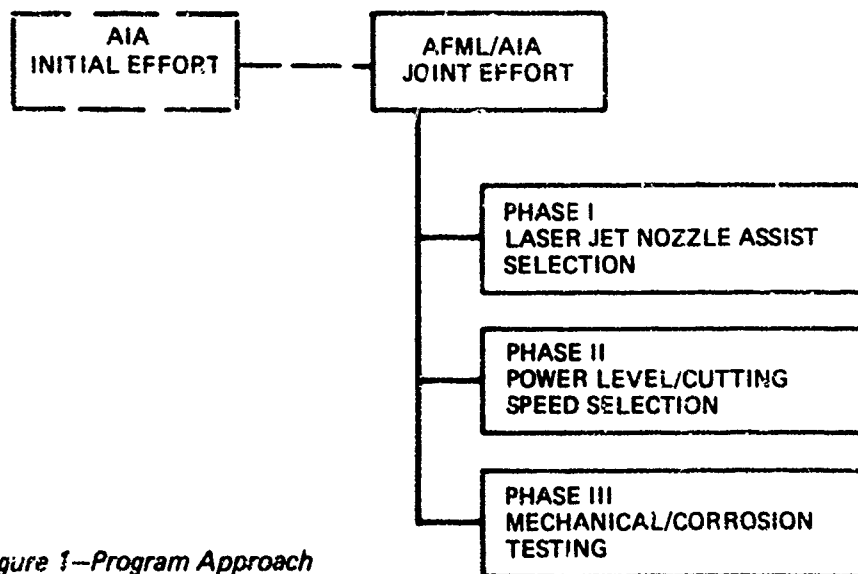
Figure 1—Program Approach

The experimental approach to achieving the program objective was divided into three phases (see figure 1). Objectives were:

1. To optimize the cutting technique over a limited range of variables.
2. To conduct tensile, smooth fatigue, notched fatigue, intergranular corrosion, and metallurgical analyses of edges produced by milling, blanking, and laser cutting so that the edges produced by the different processes could be compared for suitability for different applications (figure 1). The milled edge specimens were included as a reference standard. The work was scheduled as shown in the flow chart given in figure 2. A detailed test plan is presented in figure 3 showing tests, number of specimens and spares, material, thickness, and responsible company.

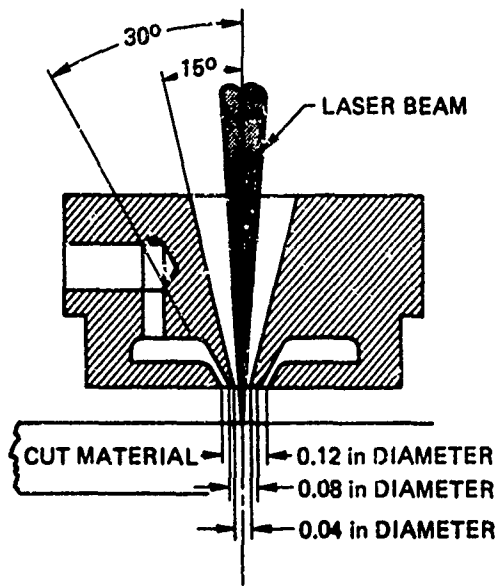
Figure 10—Concentric Jet-Assist Configuration

Phase I of the laser cutting parameter investigation evaluated four different jet configurations (figures 10 through 13). The cuts produced in 0.063-inch-thick 7075-T6 aluminum by each jet is illustrated in figure 14. Note that the cut width shown in all figures were due to mounting techniques and do not represent actual kerf widths. The coaxial jet configuration was selected on the basis of resulting visual edge structure.

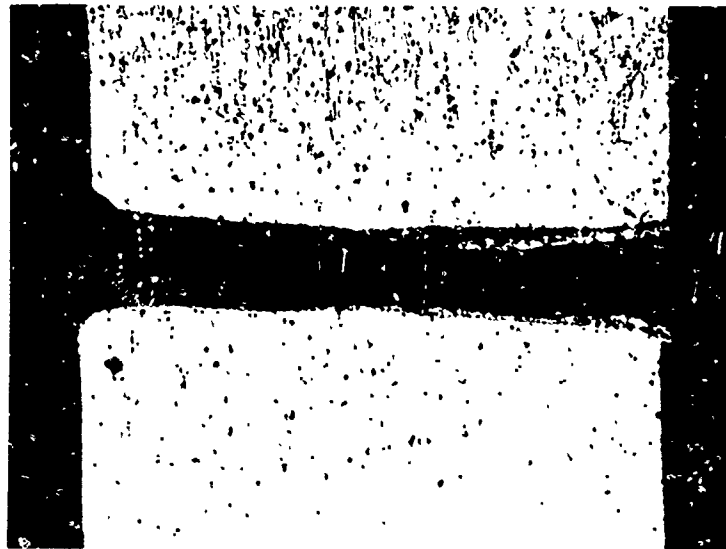
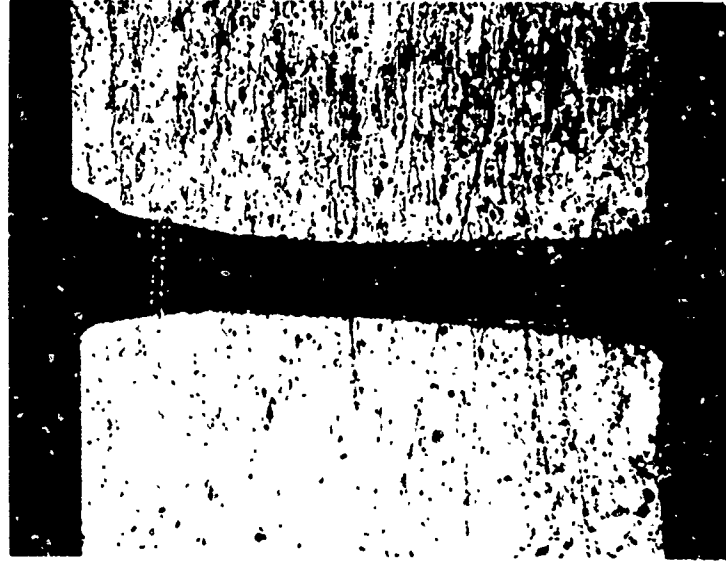
Figure 17—Effect of Speed on Cut Characteristics

Phase II laser cutting parameter optimization consisted of determining the optimum values for power level, speed, and gas pressure for each alloy and thickness, using the selected jet configuration and air as a gas. Figures 16, 17, and 18 show typical effects of variation in three parameters on cuts in 7075-T6. Based on these tests, as well as evaluation of samples by Lockheed-California, Lockheed-Georgia, Douglas, and Boeing, the following optimum cutting parameters were selected for both 2024-T3 and 7075-T aluminum alloys and used for the test phase of this program:

MATERIAL: 7075-T6
THICKNESS: 0.063 in

POWER: 3 kw
AIR PRESSURE: 150 psig

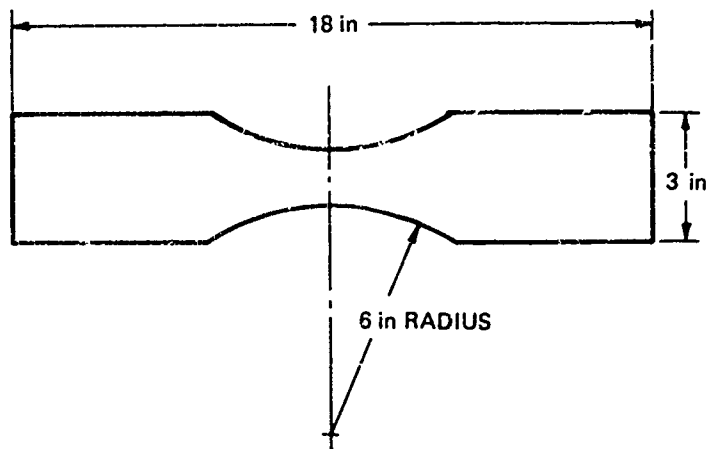
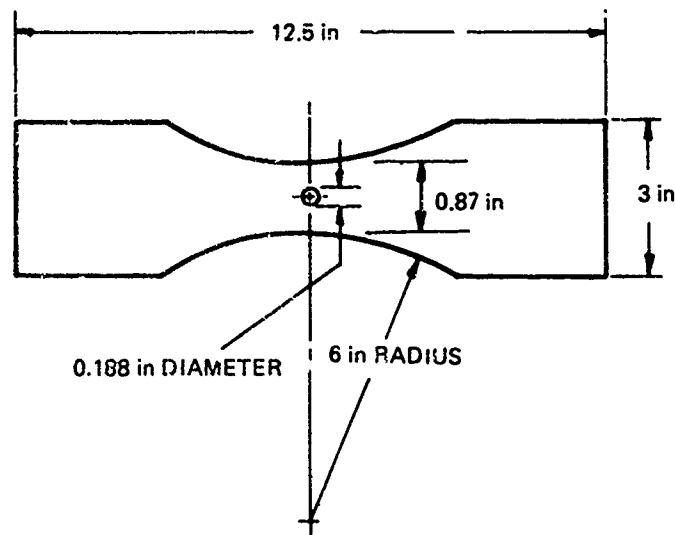
Figure 19—Geometry of Fatigue and Tensile Test Specimens

Tensile and tension-tension fatigue tests were conducted on specimens fabricated from 0.040- and 0.063-inch, 2024-T3, 7075-T6, and 7075-O aluminum heat treated to -T6 after laser cutting. All specimens for each thickness of each alloy were from a single lot of material. Specimen edges were produced by milling, blanking, and laser cutting plus a belt sanding operation to remove the burr on the flat surface only of blanked and laser-cut specimens. The cut surface was not altered. Figure 19 shows the smooth and hole-notched fatigue and static tensile test specimens.

GEOMETRY OF SMOOTH FATIGUE SPECIMEN

GEOMETRY OF NOTCHED FATIGUE SPECIMEN

GEOMETRY OF TENSILE TEST SPECIMEN

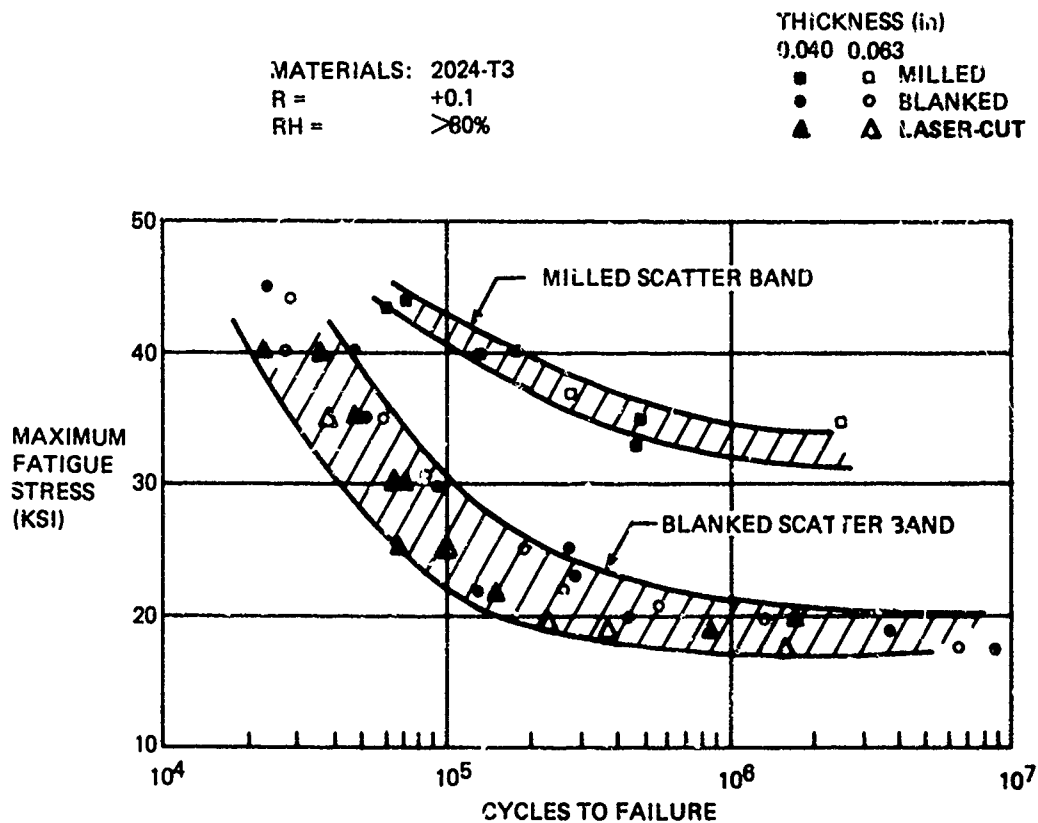
Figure 20—Results of Unnotched Fatigue Tests (2024-T3)

The results of fatigue tests on unnotched specimens are presented in Appendix A and figures 20 and 21. The data indicate that for both 0.040- and 0.063-inch 2024-T3 and 7075-T6 aluminum, fatigue properties of blanked and laser-cut specimens are similar. Both blanked and laser-cut specimens have fatigue properties lower than base line (milled specimens). The reason for the reduction in fatigue performance is attributed to stress risers in the case of blanked edges, since it is not a thermal process. In the case of the laser-cut edges, both a mechanical notch and thermal effect must be considered. The influence of the thermal effect is identified by looking at the test results for 0.063-inch 7075-O aluminum that was solution treated and aged to -T6 after laser cutting, thereby minimizing thermal overaging and diffusion of alloying elements at grain boundaries. The data indicate slightly better, but not necessarily significant, fatigue performance than specimens with an as-laser-cut edge, leading to the inference that the significant reason for reduction in fatigue strength exhibited by the laser-cut edge is due to the mechanical effects rather than metallurgical irregularities in the surface.
