AMMRC TR 78-14  
VOLUME 2

BRITTLE MATERIALS DESIGN,  
HIGH TEMPERATURE GAS TURBINE  
VOLUME 2  
CERAMIC TURBINE ROTOR TECHNOLOGY

12TH INTERIM REPORT FOR THE  
PERIOD JANUARY — SEPTEMBER 1977

FORD MOTOR COMPANY  
ENGINEERING AND RESEARCH STAFF  
DEARBORN, MICHIGAN 48121

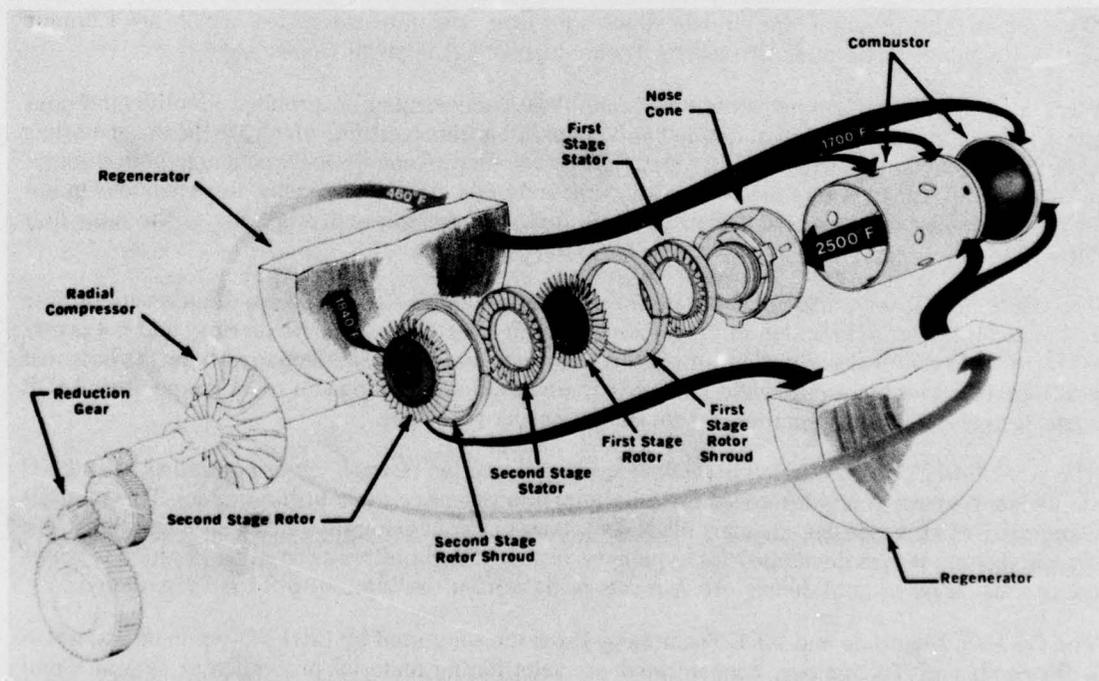
Figure 1.1 — Schematic View of the Vehicular Gas Turbine Engine Flowpath

The replacement of high cost nickel-chrome superalloys in gas turbines with low cost, higher temperature capability ceramics offers significant advances in efficiency, materials utilization and power per unit weight. The vehicular turbine project was organized to design and develop an entire ceramic hot flow path for a high temperature (2500°F) vehicular gas turbine engine (Figure 1.1).

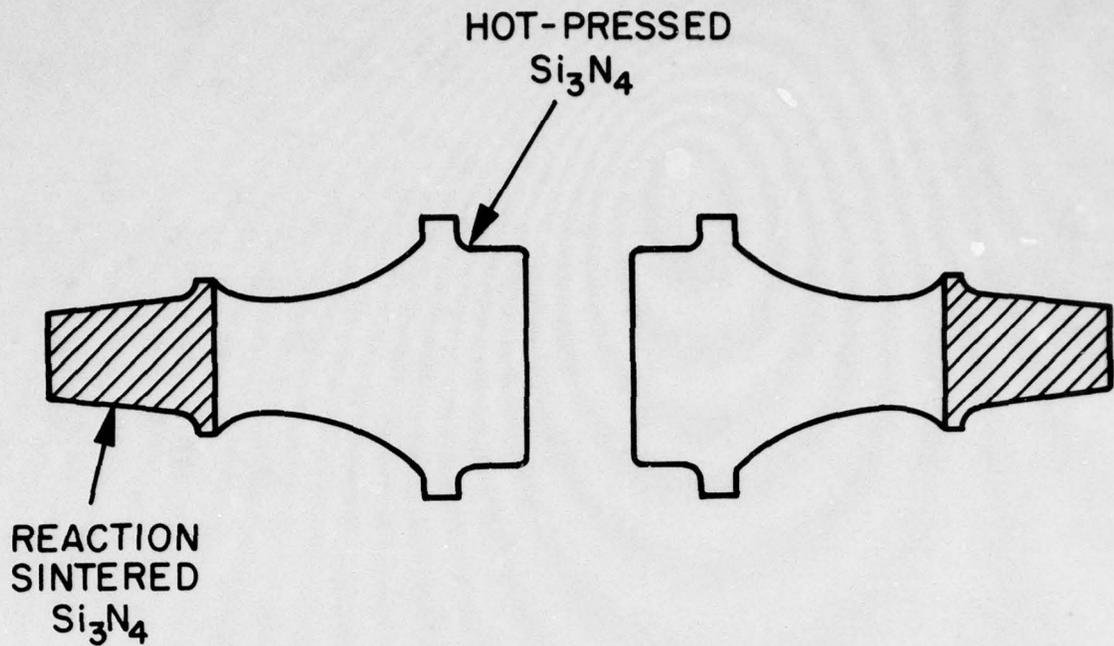
Figure 1.3 — Duo-Density Ceramic Turbine Rotor

The duo-density silicon nitride rotor concept utilizes reaction bonded silicon nitride for the complex shaped creep resistant blades and hot pressed silicon nitride for the high strength rotor hub. The blades are formed by injection molding a one piece blade ring consisting of all 36 blades and the blade ring rim. The green preform, made of silicon particles and an organic binder, is subsequently burned out, to remove the binder, and then heated in a nitrogen atmosphere to convert the silicon to silicon nitride. The silicon nitride blade ring, after encapsulation in a blade fill, is placed in a hot press. Silicon nitride powder is then hot pressed to form the hub while simultaneously hot press bonding the hub to the blade ring.

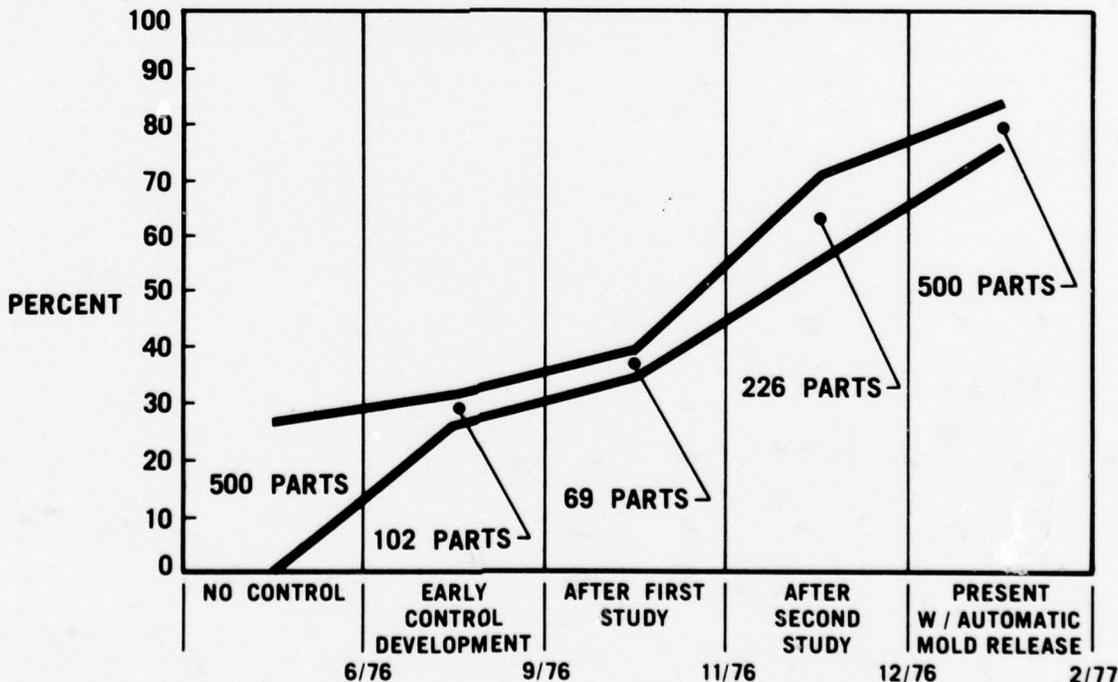
Figure 3.1 — Yield of Good As-molded Blade Rings Versus Process Development

The overall part quality was also improved as evidenced by increased yields after the burnout inspection and nitrided part inspection. The surface finish of the blade rings was noticeably improved at all stages of processing, following introduction of the automatic mold release system. An added benefit of better surface finish was improved ease of flaw detection during visual inspection.

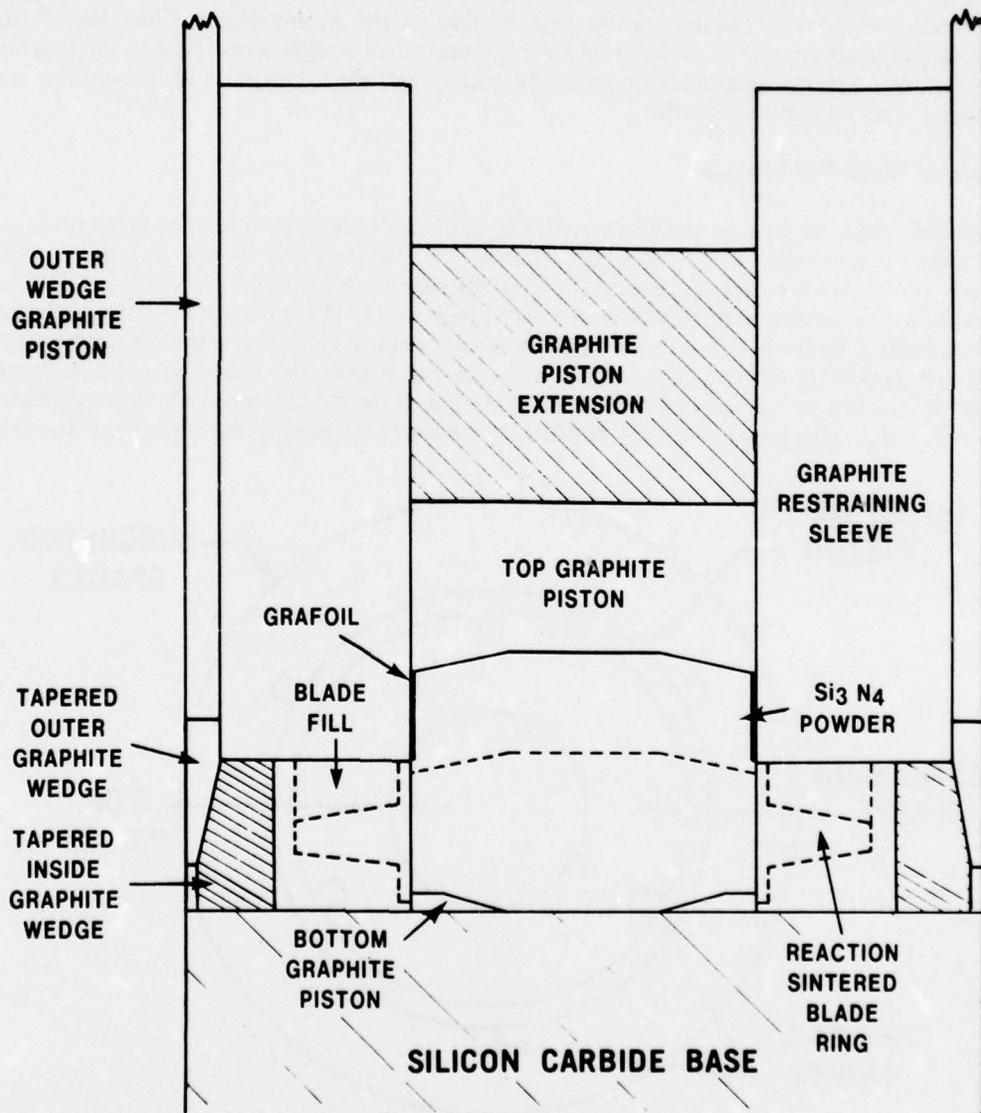
Figure 3.2 — Simplified Two-piece Configuration

The duo-density rotor concept utilizes the high strength of hot-pressed silicon nitride in the hub region where stresses are highest but temperatures are moderate and, therefore, creep resulting from the use of a magnesium densification additive is minimized. The process consists of hot pressing the hub, from silicon nitride powder, while simultaneously hot press bonding the hub to the reaction sintered silicon nitride blade ring. The primary fabrication approach, the simplified two piece design, was introduced in the first quarter of FY 77 and described in some detail in reference 11. Figure 3.2 shows the blade ring encapsulated in slip cast reaction sintered silicon nitride blade fill material which protects the blades from the high temperature/carbonatious atmosphere and supports the blade ring rim during hot pressing. A graphite wedge system was used to apply the radial restraining load to the outer diameter of the encapsulated blade ring. A 1000 pound wedge load was used to counter balance the 1000 psi central pressure which was held for three hours at temperatures of 1700 to 1775°C. The hub was hot pressed from silicon nitride powder with 3½ w/o magnesium oxide added before wet milling with tungsten carbide balls.

The major problem areas with this and earlier concepts were blade cracking and blade ring rim distortion/cracks on an inconsistent basis. Two changes to the process were made which resulted in a major improvement in quality and much more consistent results.

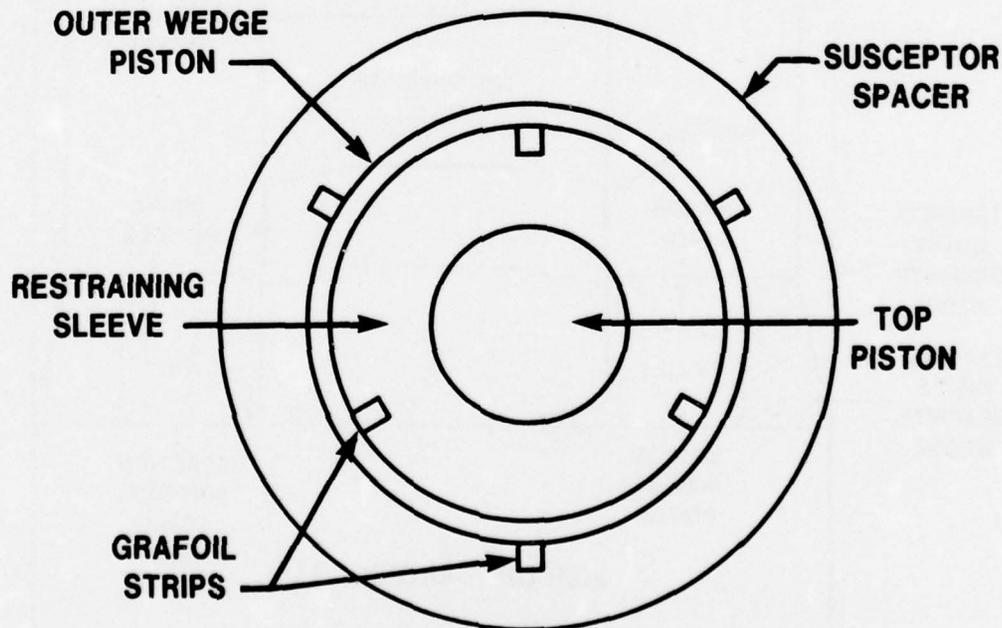
Figure 3.3 — Top View of Graphite Tooling

A set of new graphite tooling was carefully cleaned and hand polished and a normal hot pressing made. Inspection of the outer wedge graphite piston and mating graphite restraining sleeve and susceptor spacer, showed evidence of heavy rubbing which occurred during the run. This rubbing action must have been due to differential thermal expansion of the concentric graphite cylinders as a clearance existed when the parts were assembled in the cold condition. Such an interference condition reduced the wedge restraining load actually obtained at the wedges due to inconsistent friction drag on the sliding component. The radial clearances between the outer wedge piston and the inner sleeve and outer spacer were increased from 0.0015" to 0.022". In order to center the tooling over the blade filled blade ring six strips of 0.015" thick Grafoil were placed between the outer wedge loading cylinder and the mating cylinders as shown in Figure 3.3. The Grafoil strips were staggered in a circumferential direction to take advantage of the increased radial flexibility of the thin outer wedge loading cylinder when loaded at 3 points. The differential thermal expansion of the tooling then produced much lower radial loads and thereby minimized the drag friction on the sliding piston. Since this change was incorporated the shiny contact patterns on the inner and outer wedges were much more consistent and blade ring rim deformations/cracking were also more controlled. However blade cracking persisted until the second change was made.

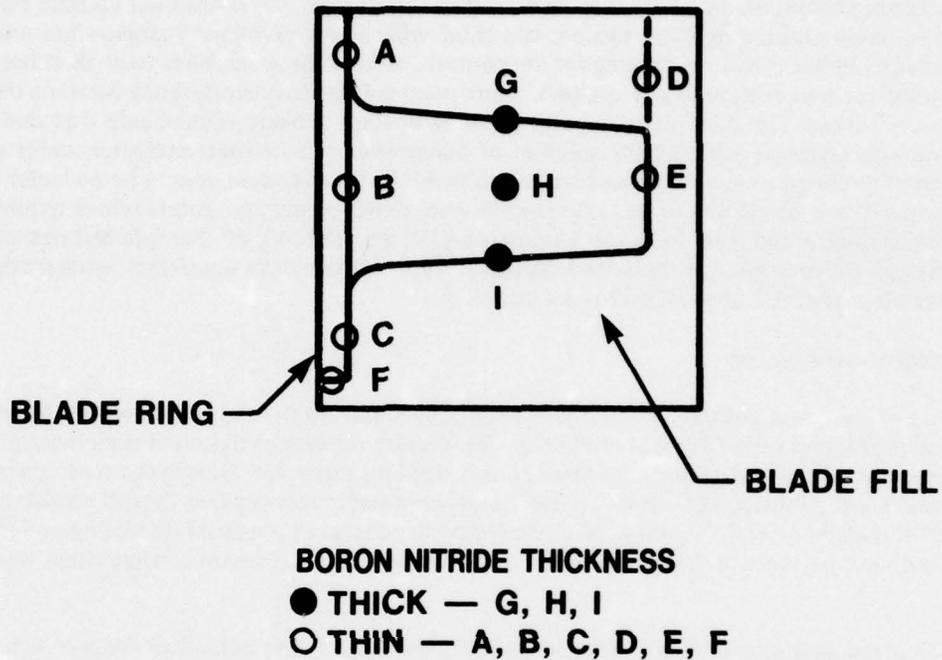
Figure 3.4 — Blade Filled Blade Ring Showing Boron Nitride Layers

removal of the blade fill impossible. A thicker coating of BN was desirable on the airfoils so that small motions of the blades were accommodated without resulting in cracking of the blades (Figure 3.4).

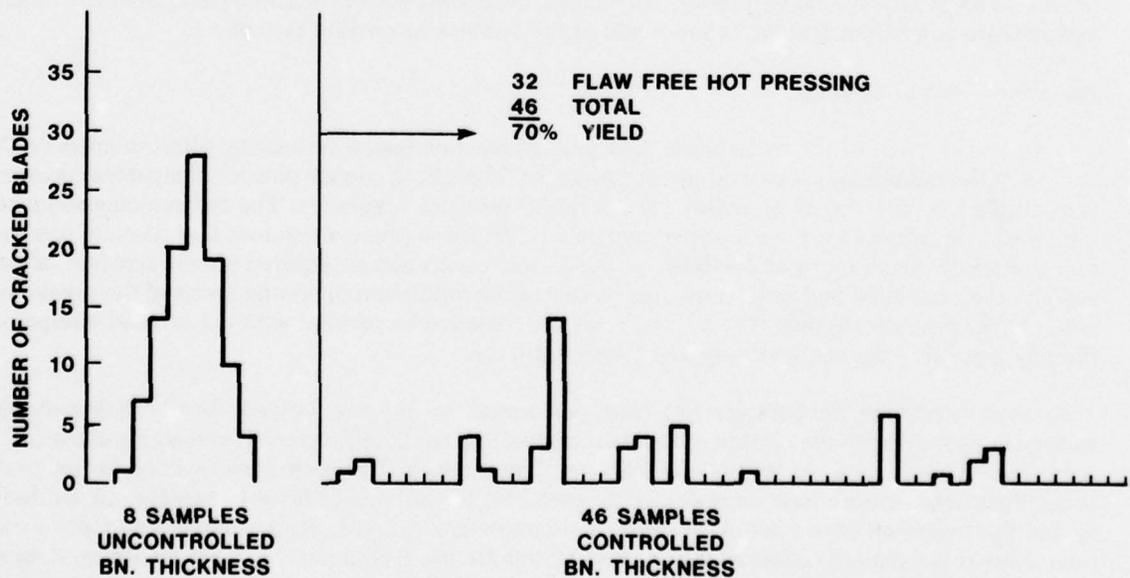
Figure 3.5 — Hot Press Induced Blade Cracks versus Boron Nitride Thickness

Forty-six simplified two piece duo-density turbine rotors were hot pressed with controlled BN thickness and the modified outer wedge loading cylinder design at standard conditions of 1000 psi, 1715°C for 3 hours with 3½ w/o magnesium oxide additive in the silicon nitride powder. As shown in Figure 3.5, 70% (32 out of 46) were free of flaws induced by hot pressing. This represented the most significant improvement in the yield of hot pressings to date.

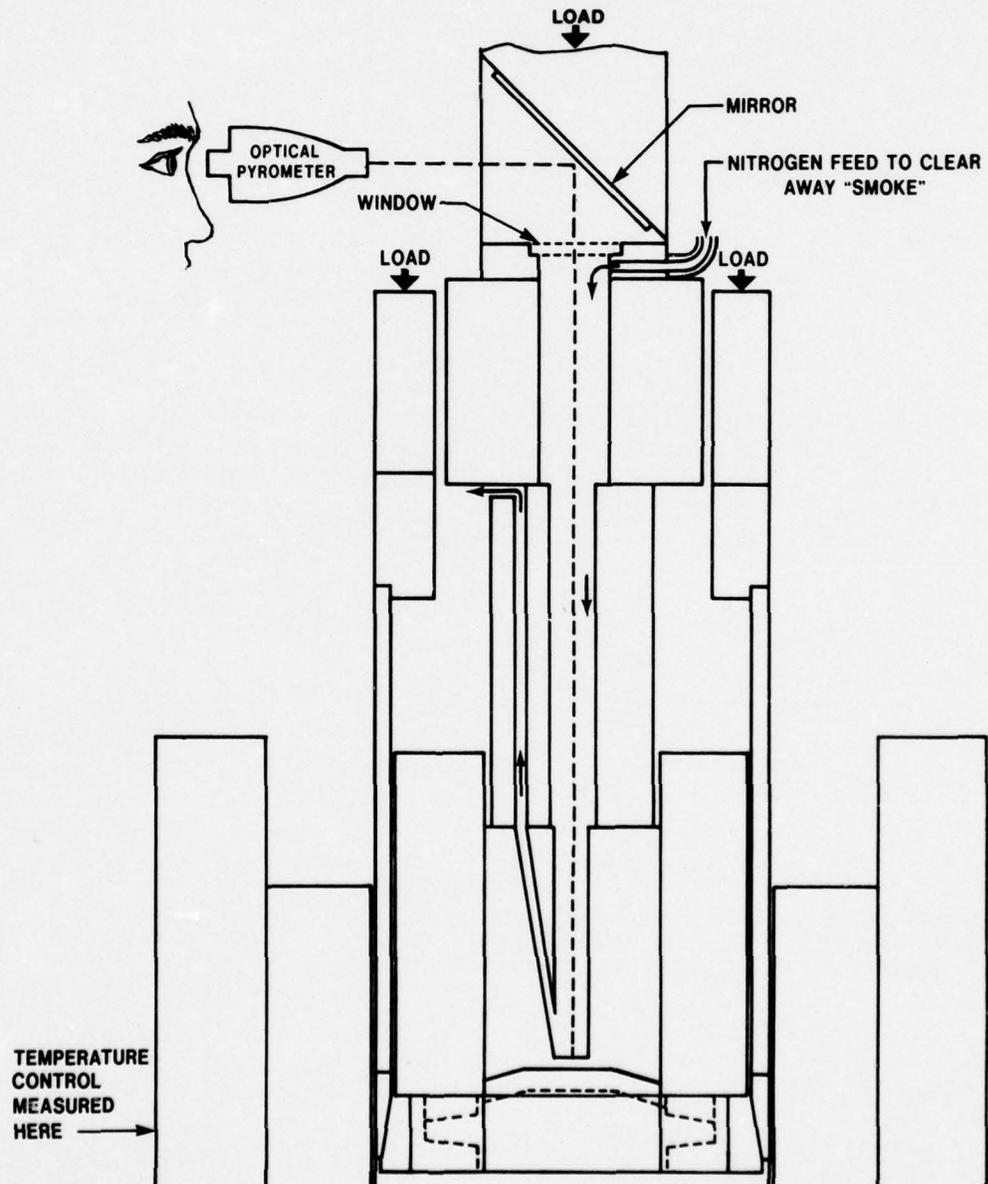
Figure 3.6 — Modification of Graphite Tooling for Inside Temperature Measurement

The standard graphite tooling was modified (*Figure 3.6*) so that optical pyrometer temperature measurements could be made at both the inside and outside of the furnace. The outside temperature was measured at the normal location while the inside temperature was measured 0.20 inches away from the hot pressed hub. Utilizing this system several hot press runs were made and the inside temperature was observed to be 1715°C while the outside temperature was maintained at the normal level of 1700°C. This system will be used to recheck the correlation of controlling temperature to inside temperature when future changes are made to the furnace or cooling system.

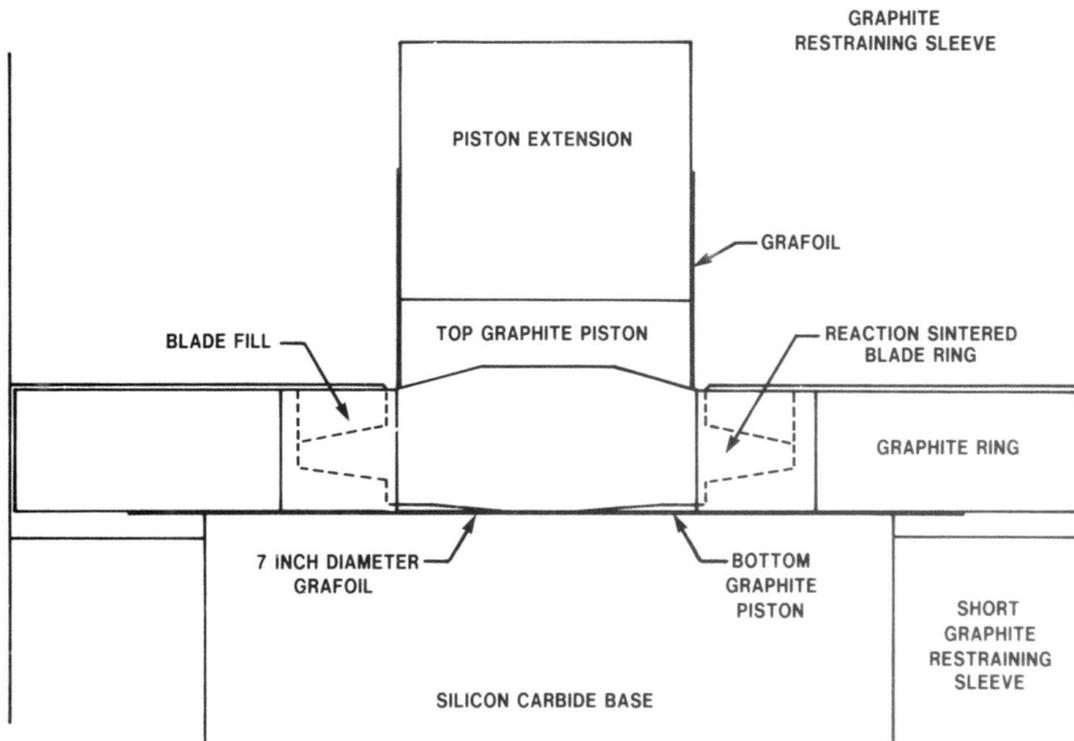
Figure 3.7 — Graphite Wedges Replaced by Ring

An alternate approach investigated to produce duo-density turbine rotors eliminated the graphite wedge system and attempted to supply the radial restraining load to the blade fill via a large graphite ring (Figure 3.7). Two fabrication trials were made using this concept. Both rotors exhibited large radial deformations of the blade ring rim indicating plastic flow of the reaction bonded silicon nitride in excess of 4%. Severe blade cracking in the leading edge fillet region was also observed on both rotors. Both of these problems were related to the larger coefficient of expansion of the graphite ring which expanded thermally more than the silicon nitride assembly.

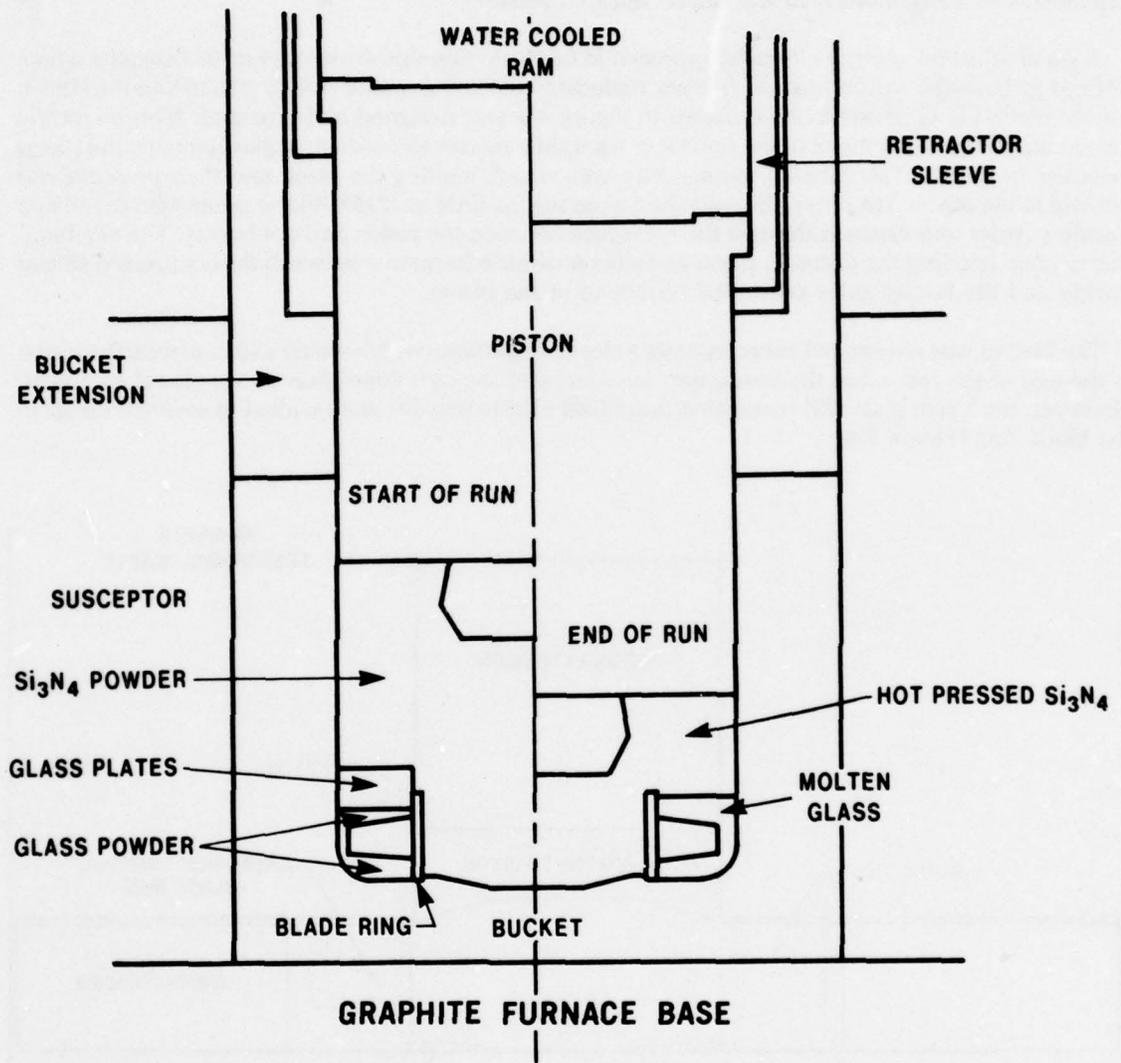
Figure 3.8 — Glass Restraining Concept

A small effort on another alternate approach to fabricate duo-density rotors was investigated which utilized glass as the restraining mechanism replacing both the graphite wedge system and the silicon nitride blade fill. Graphite tooling, shown in Figure 3.8, was designed and procured. A boron nitride coated blade ring was placed in the bottom of a graphite bucket and soda lime glass powder and plates installed as shown. The furnace temperature was raised, melting the glass, and then pressure was applied to the piston. However, the soda lime glass was so fluid at 1715°C that it permeated the silicon nitride powder and escaped through the clearance between the piston and the bucket. The combination of glass bonding the piston in place and silicon carbide formation between the hot pressed silicon nitride and the bucket sides prevented retraction of the piston.

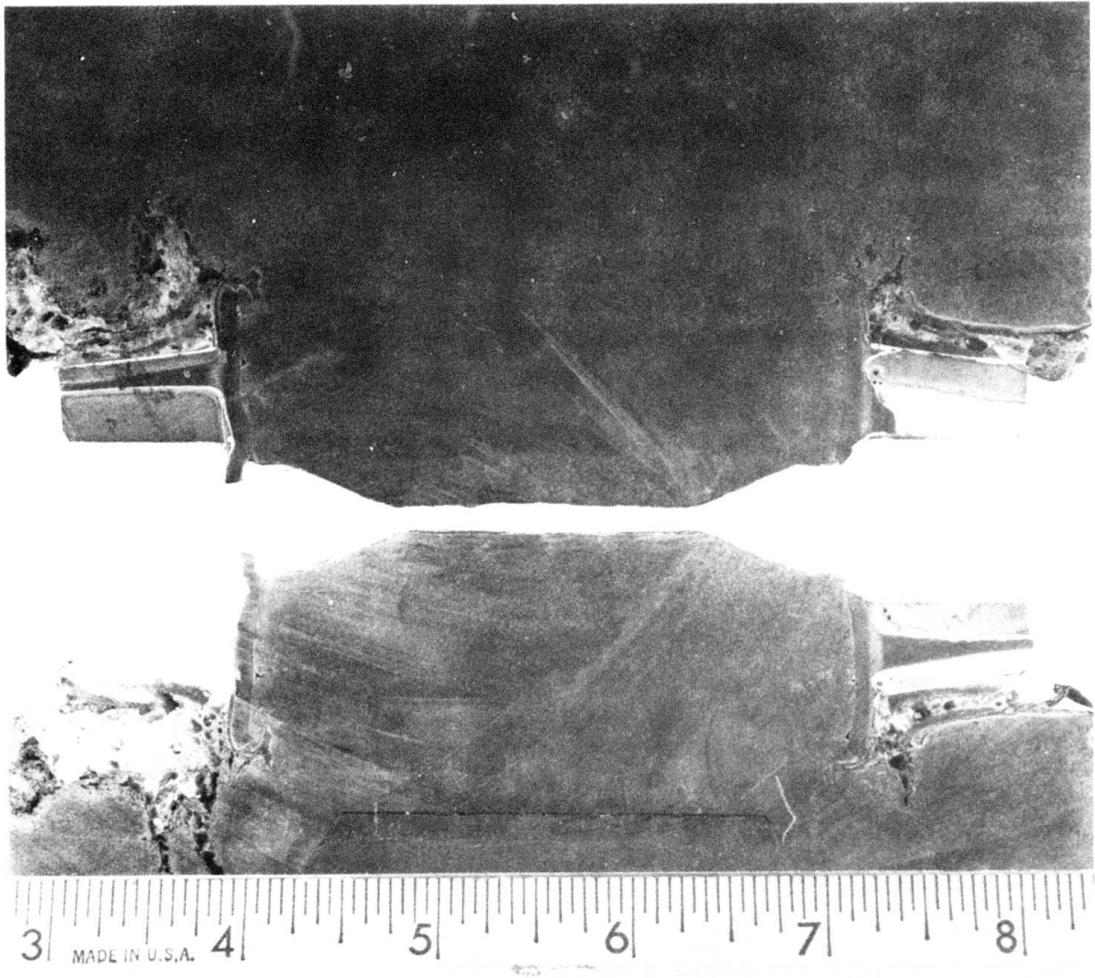
Figure 3.9 — Results of Second Glass Experimental Run

The bucket was redesigned to incorporate a sleeve of graphite which would slide out with the piston at the end of the run when the piston was retracted and the soda lime glass was replaced by Vycor. However, the Vycor glass still permeated the silicon nitride powder and resulted in severe damage to the blade ring (Figure 3.9).

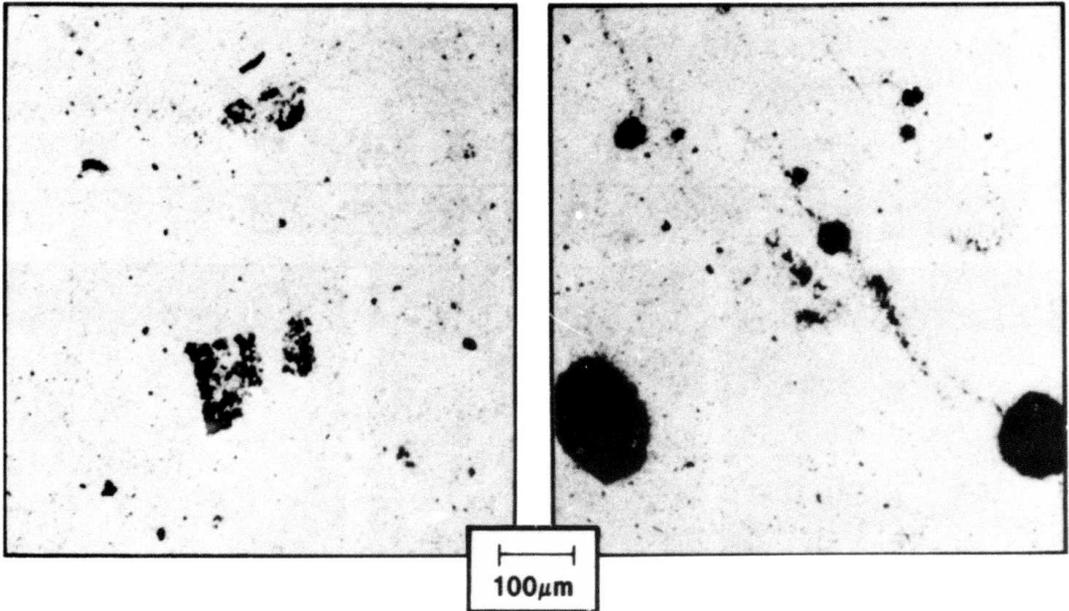
Figure 4.1 — Typical Molding Flaws in Injection Molded Test Bars

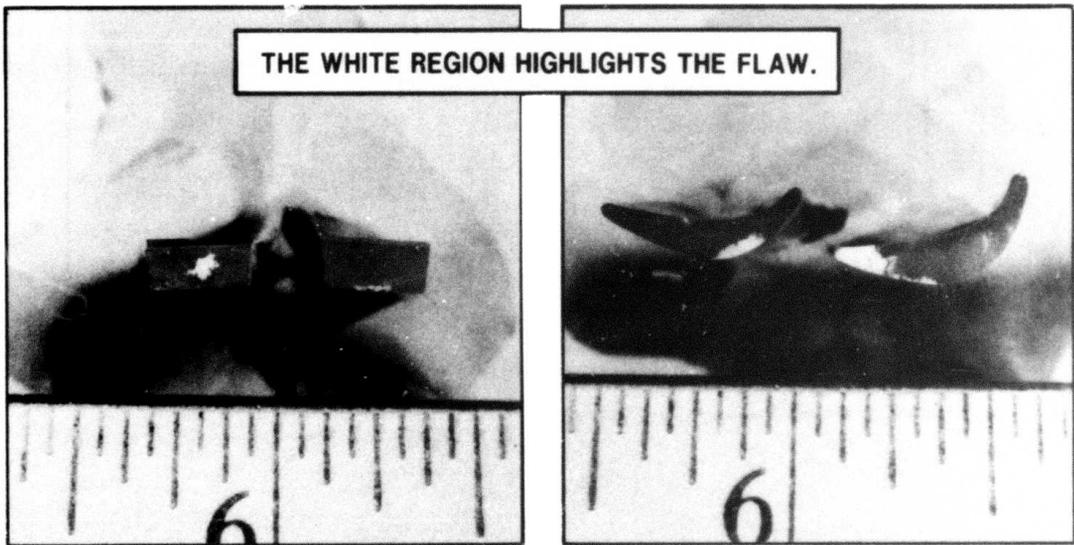
Figure 4.2 — Macroscopic Flaws in Test Bars and Rotor Blades

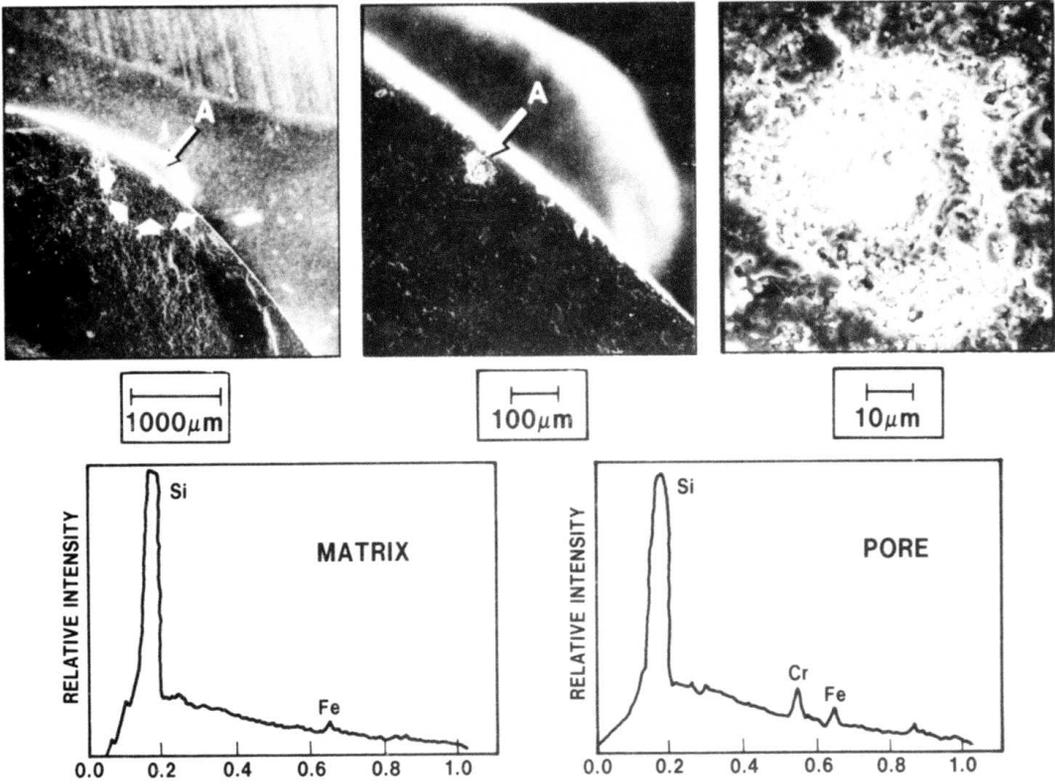
ARROW "A" DEFINES THE PORE

Figure 4.3 — Analysis of Pore from Rotor Blade 1773 #30

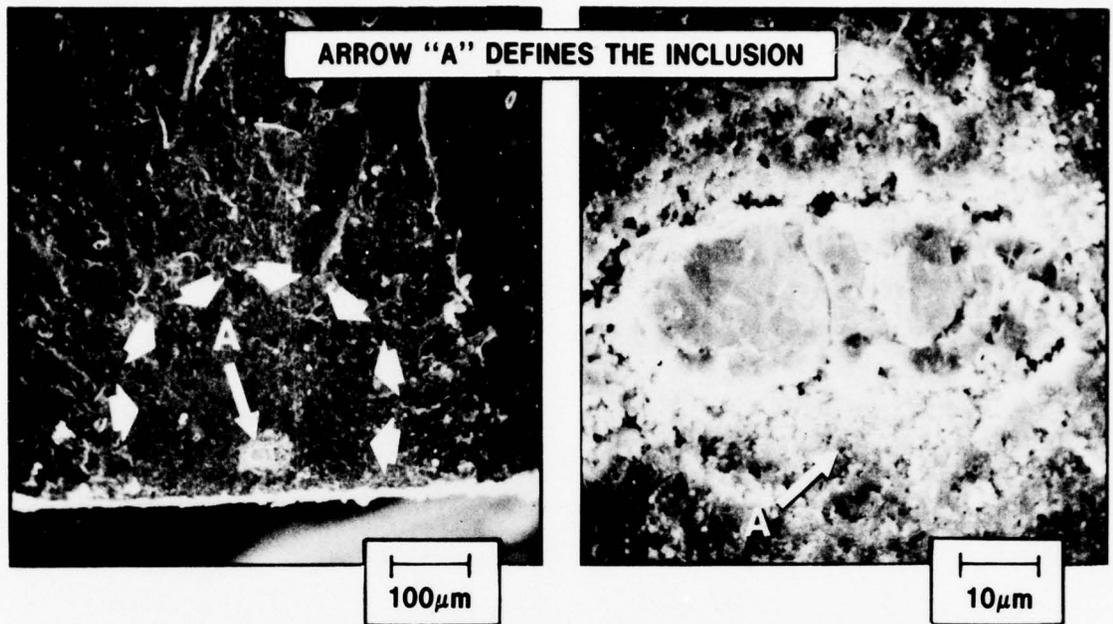
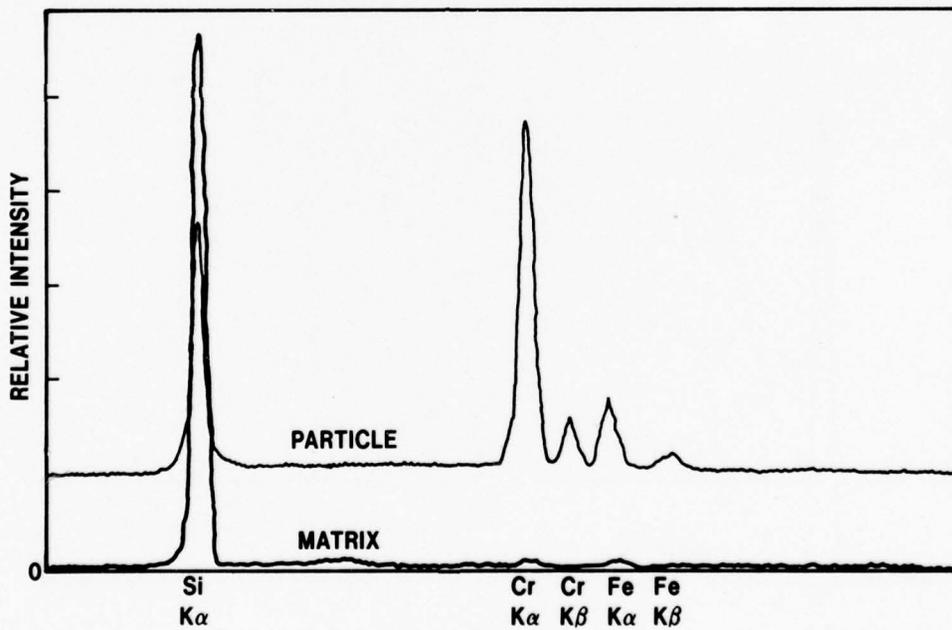
Figure 4.4 — Analysis of Inclusion from Sample B55 #6

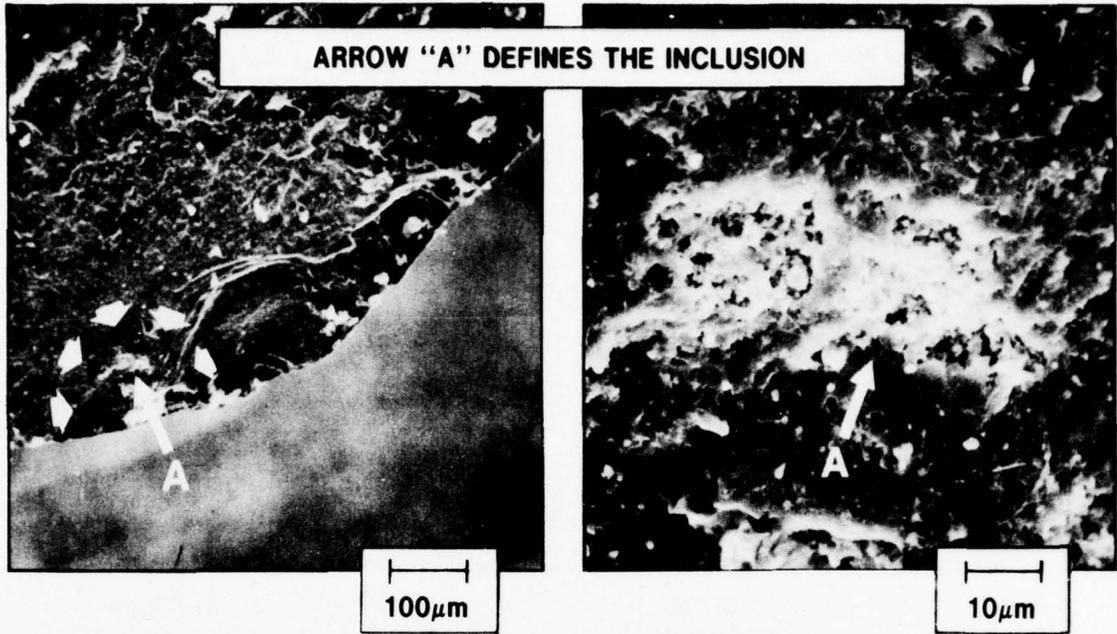
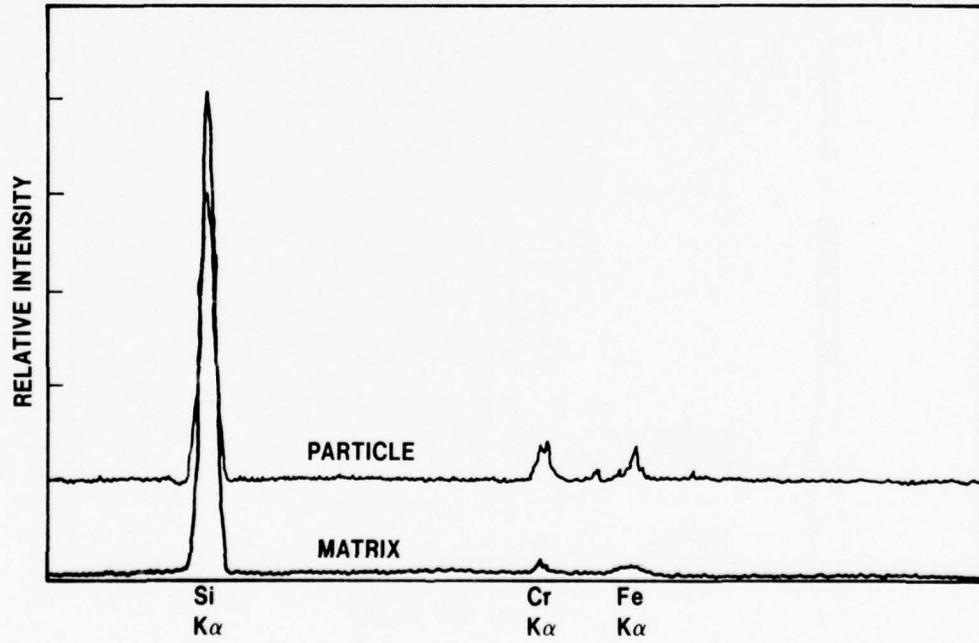
Figure 4.5 — Analysis of Inclusion from Sample B64 #18

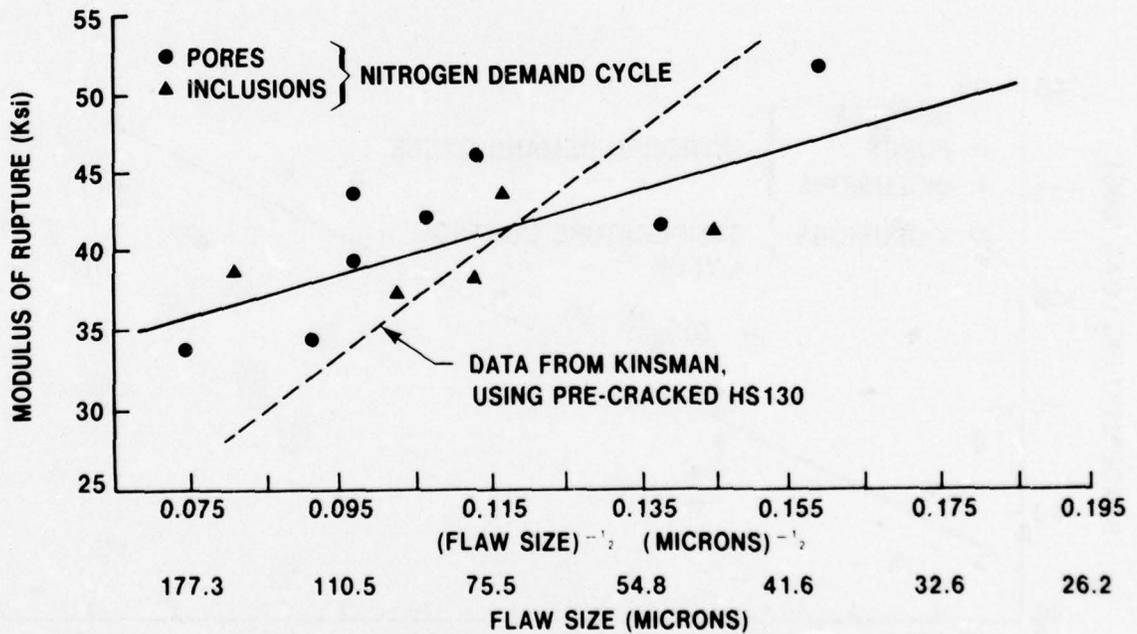
Figure 4.6 — Test Bar MOR versus Flaw Size

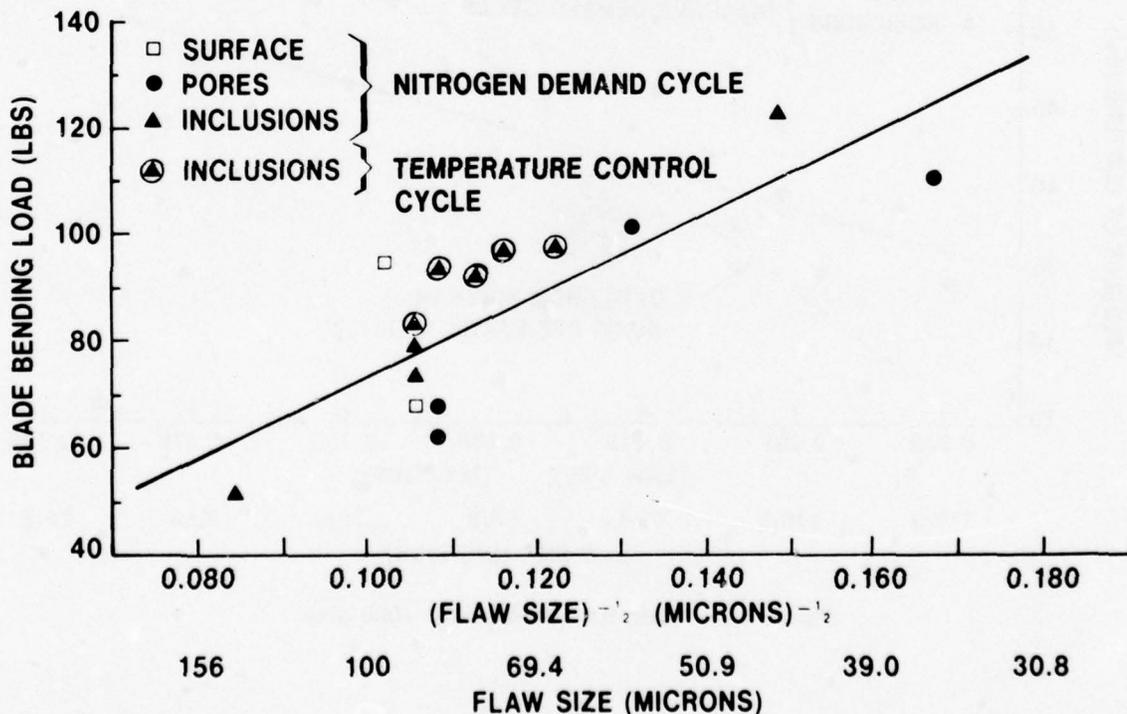
Figure 4.7 — Rotor Blade Bending Load versus Flaw Size

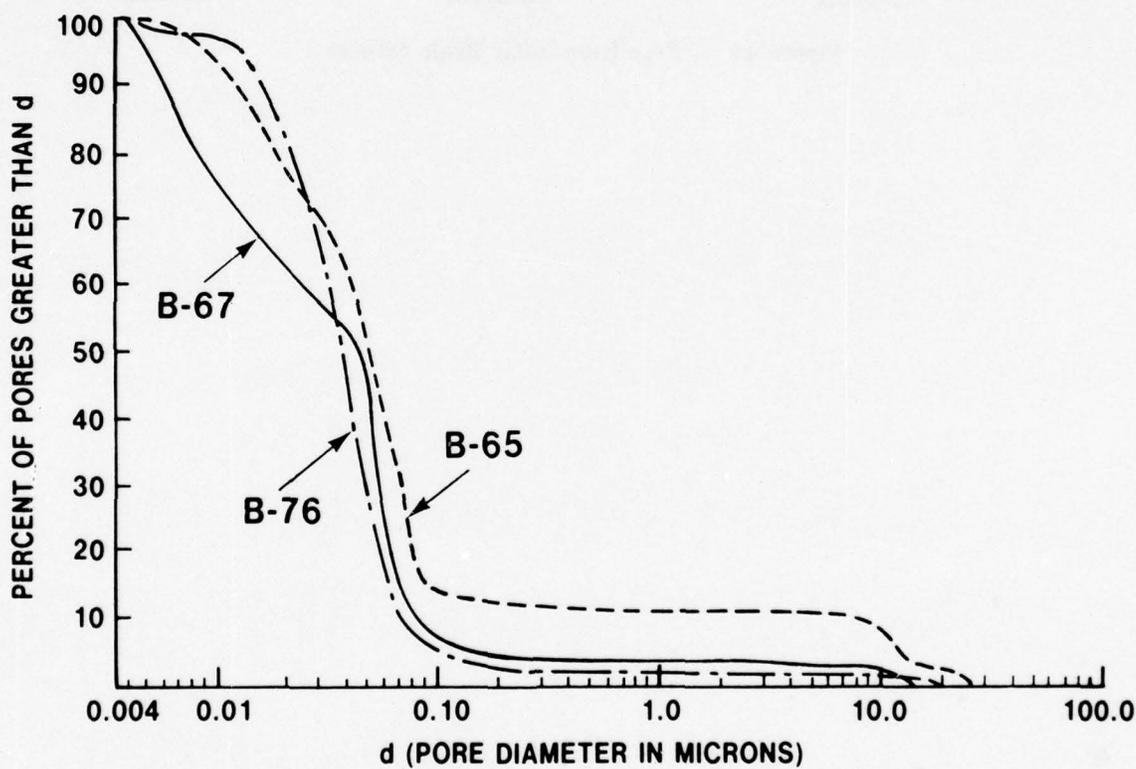
Figure 4.8 — Typical Pore Size Distributions for 2.7g/cc RBSN

The general pore size of Ford reaction bonded silicon nitride is quite uniform and fine (Figure 4.8) with the maximum pores being about 30 microns. The larger pores identified in this study could be the result of nitriding exotherms, molding flaws or pullout from inclusions.

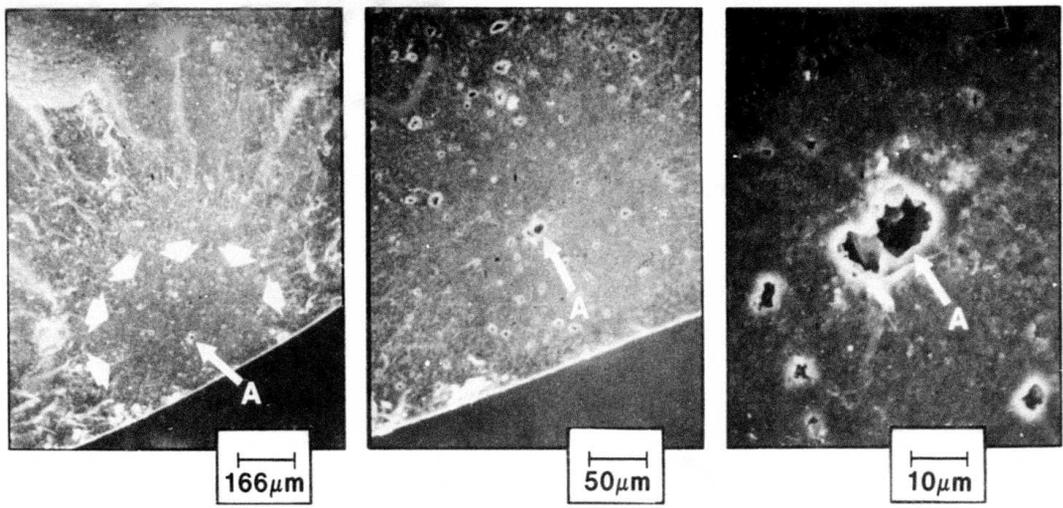
ARROW "A" DEFINES THE PORE

Figure 4.9 — Pore from Rotor Blade 1386 #3

The type of pores resulting from a nitriding exotherm (Figure 4.9) were found to be small, less than 40 microns (11), and were not typical of those considered in this investigation but were addressed previously (10, 11). Pores resulting from molding flaws (shown in Figure 4.1) were much larger, in the order of 75 to 150 microns, and were discussed in Section 4.1. Inclusions and large pores, due to pullout of inclusions, were shown to reduce the strength of reaction bonded silicon nitride as a function of their size. Reducing the contamination, in both the starting silicon powder and during in house processing, should result in a higher, more consistent strength material.

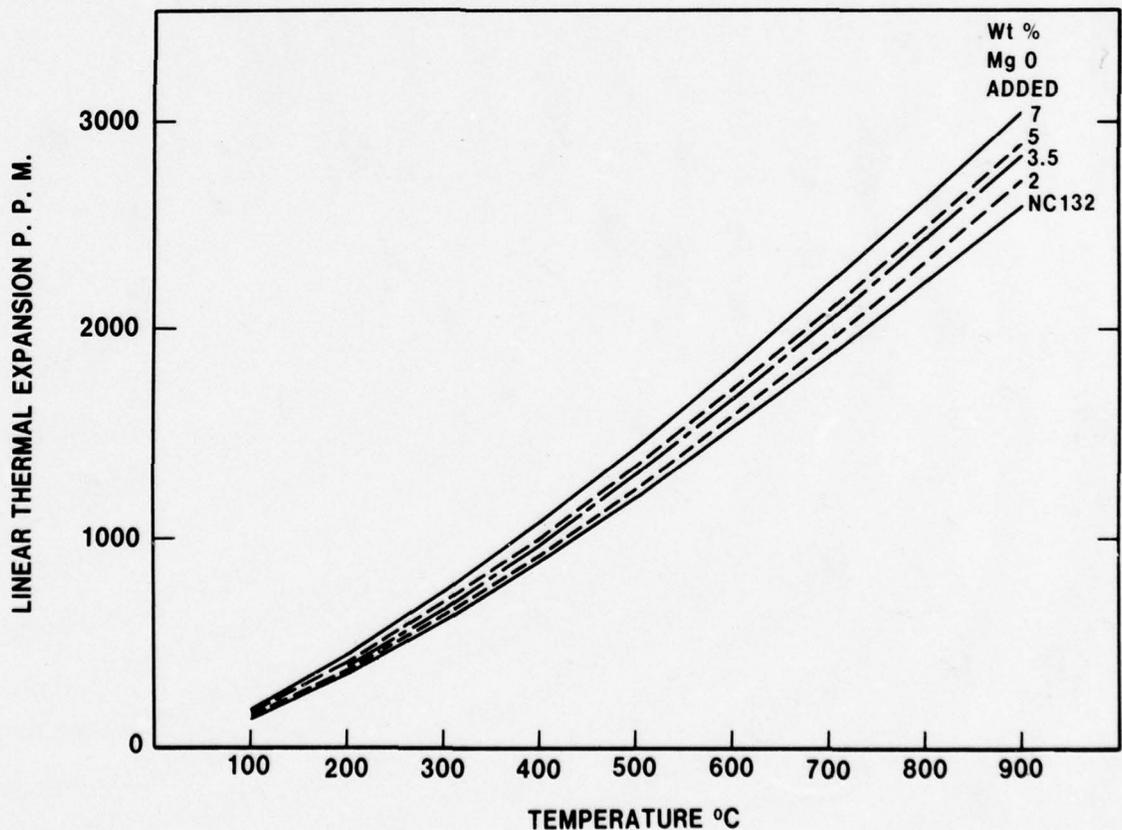
Figure 4.10 — Linear Thermal Expansion of HPSN

The MgO content was found to be the only significant variable affecting thermal expansion (Figure 4.10).

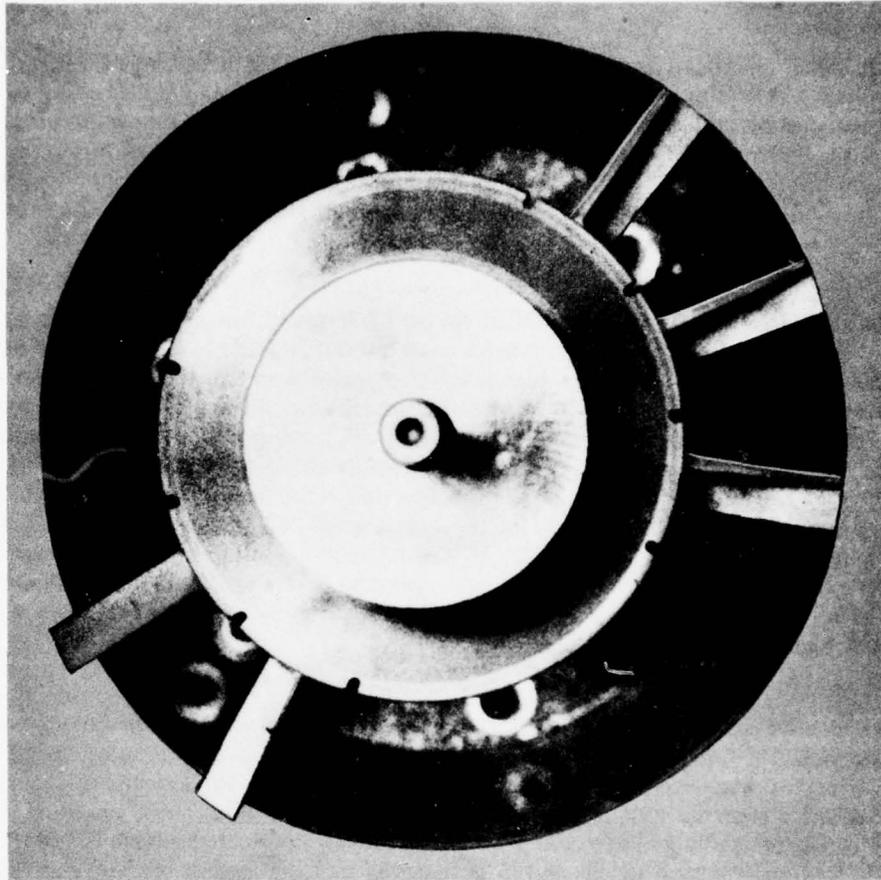
Figure 5.1 — Rotor 1197 Prior to Vacuum Spin Test

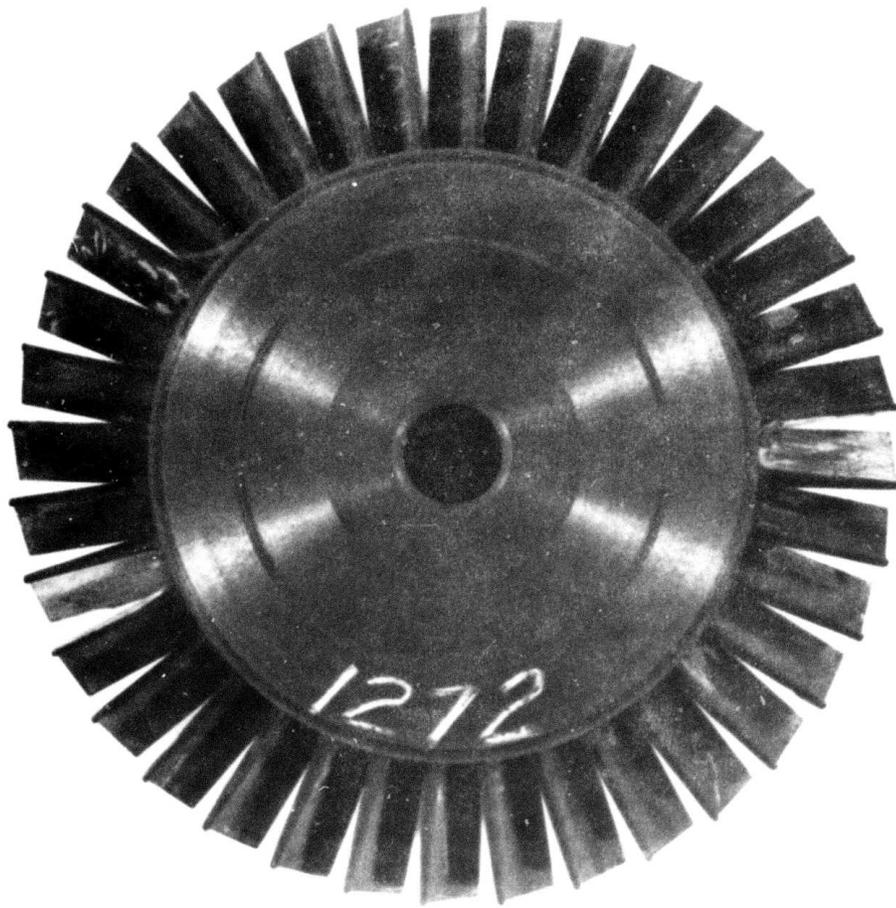
Figure 5.2 — Rotor 1272 Simple Tapered Disk

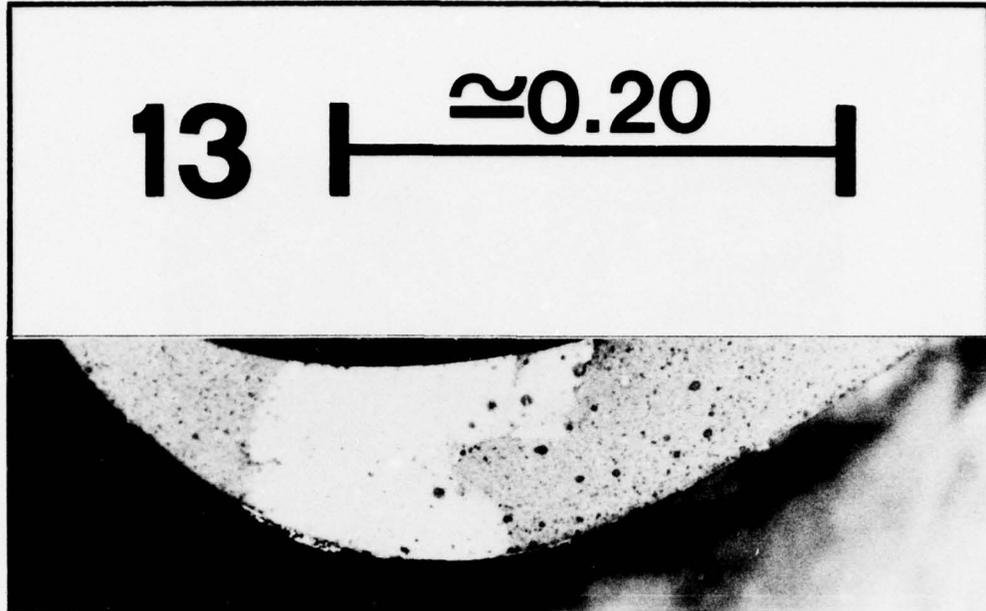
Figure 5.3 — Blade 13 of Rotor 1246 — 38,440 rpm Failure
