AMMRC TR 78-14  
VOLUME 2

BRITTLE MATERIALS DESIGN,  
HIGH TEMPERATURE GAS TURBINE  
VOLUME 2  
CERAMIC TURBINE ROTOR TECHNOLOGY

12TH INTERIM REPORT FOR THE  
PERIOD JANUARY — SEPTEMBER 1977

FORD MOTOR COMPANY  
ENGINEERING AND RESEARCH STAFF  
DEARBORN, MICHIGAN 48121

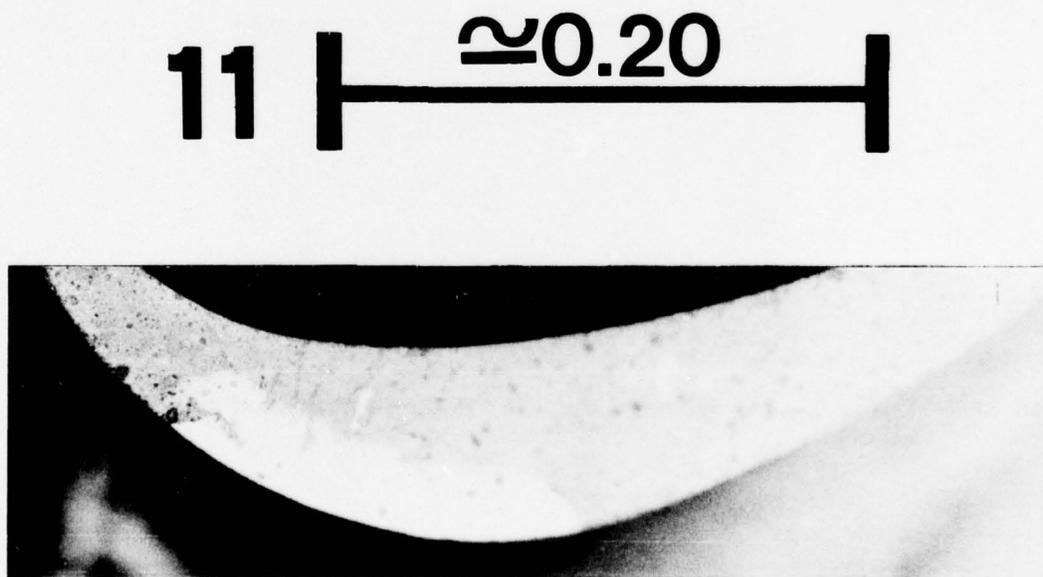
Figure 5.4 — Blade 11 of Rotor 1246 — 52,270 rpm Failure

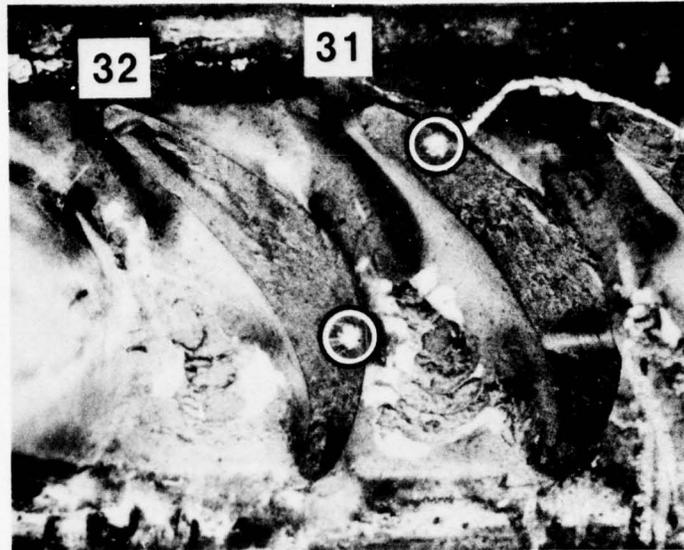
Figure 5.5 — Internal Flaws in Blade 31 (80,350 rpm) and 32 (81,020 rpm) of Rotor 1280

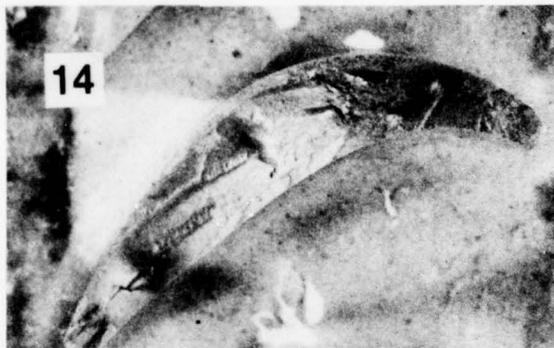
Figure 5.6 — Typical Fracture Surface of Unflawed Blades — Blade 14 of Rotor 1280 (95,700 rpm failure)

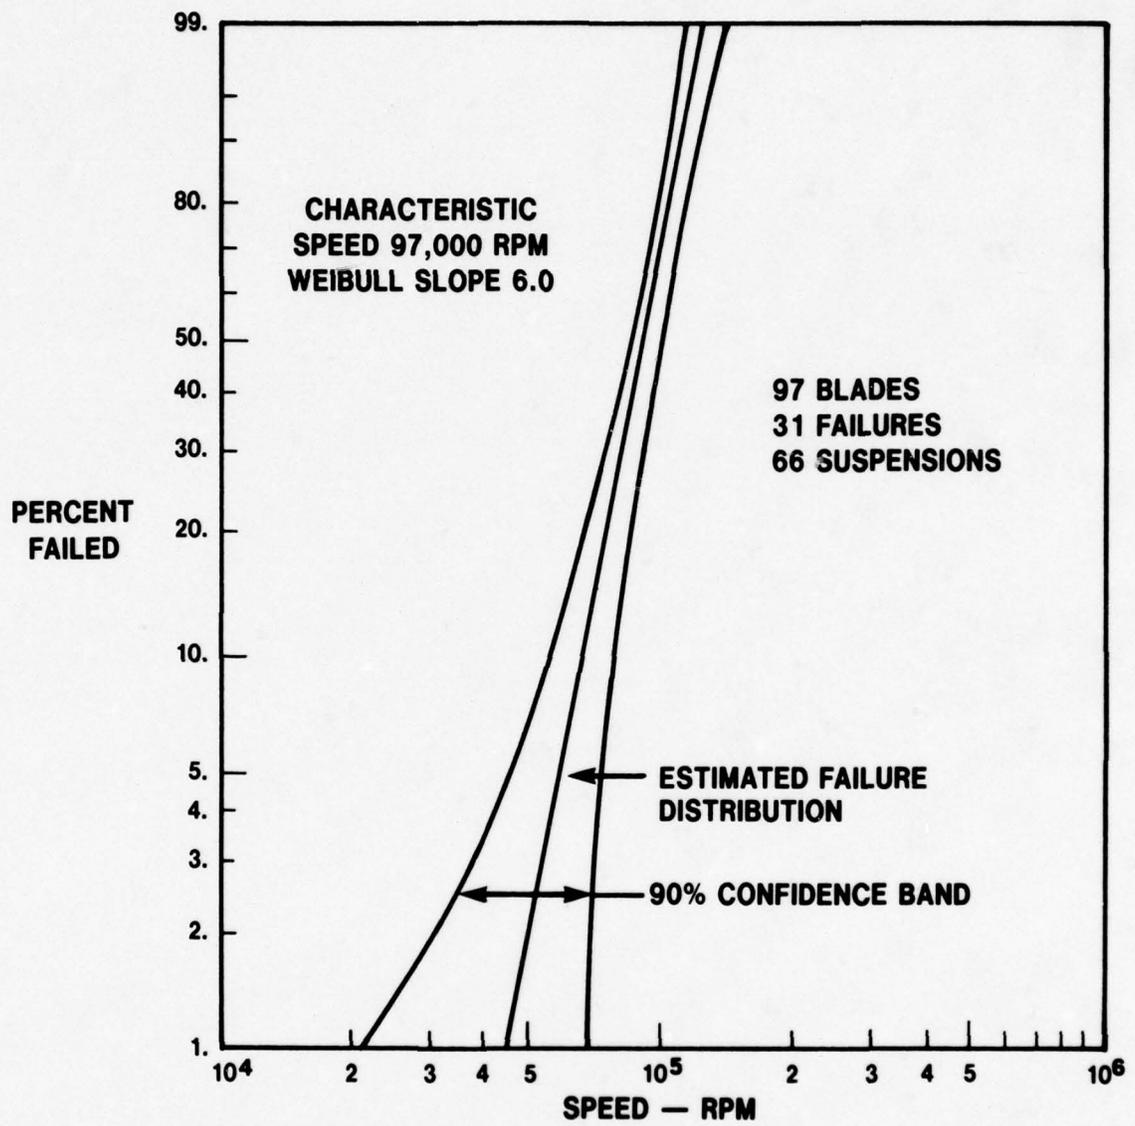
Figure 5.7 — Weibull Distribution of Combined Data from Rotors 1246, 1272, and 1280

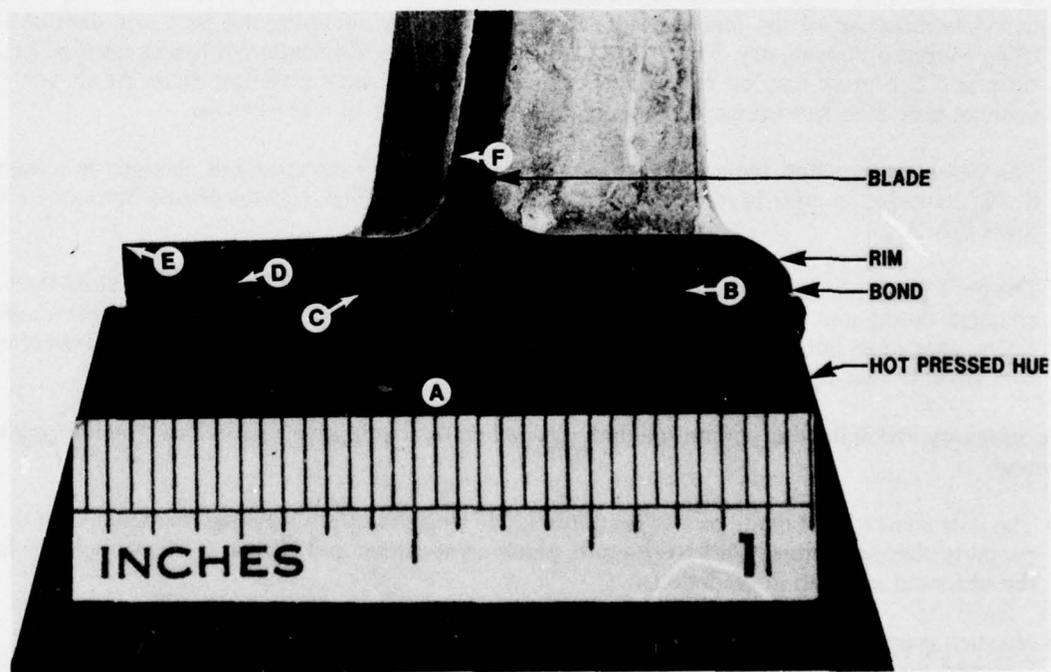
Figure 5.8 — Cross Section of Rotor 1182 Showing Color Gradients

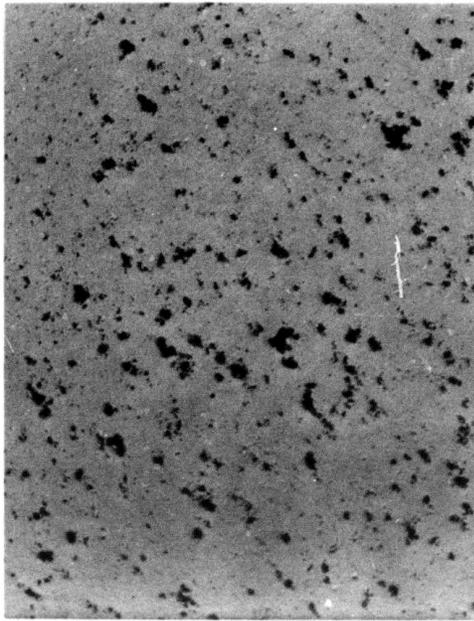
Figure 5.9a — Micrograph of Rotor 1182 Hub Region

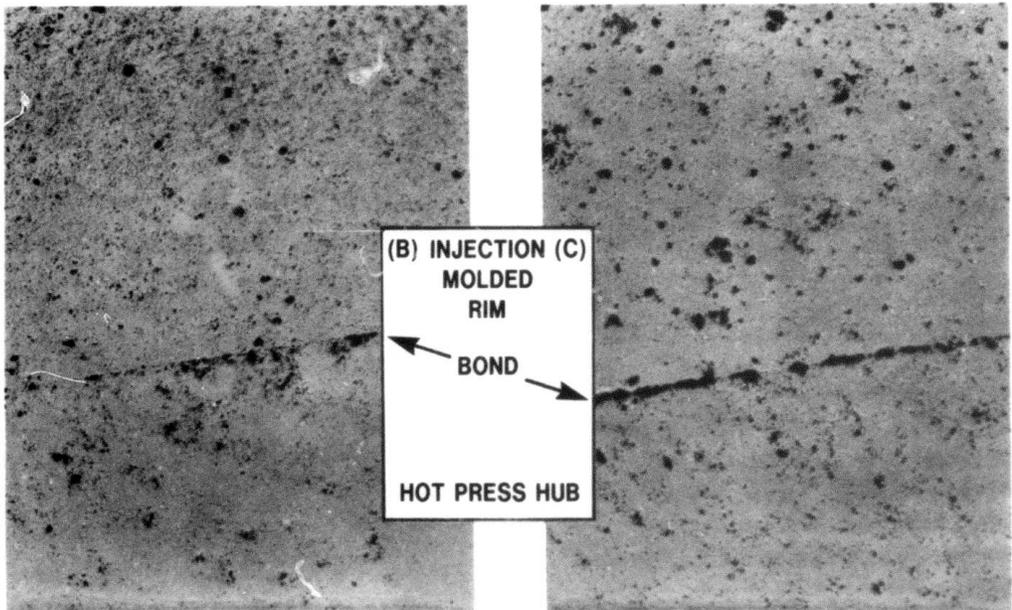
Figure 5.9b,c — Micrograph of Rotor 1182 Bond Region

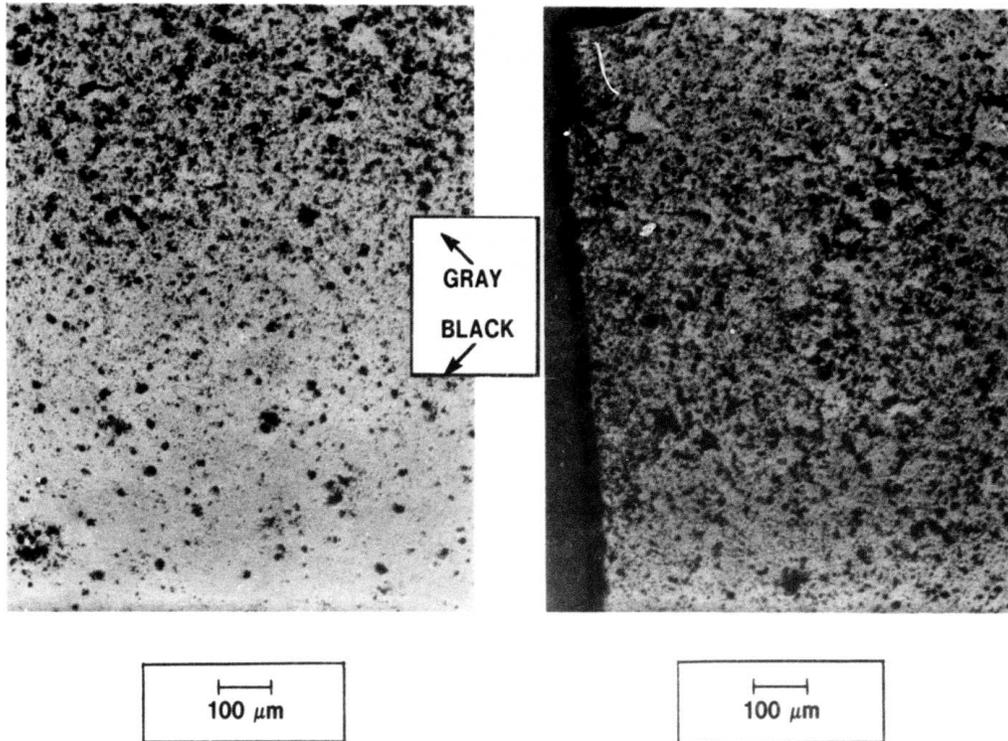
Figure 5.9d,e — Micrograph of Rotor 1182 Rim Region

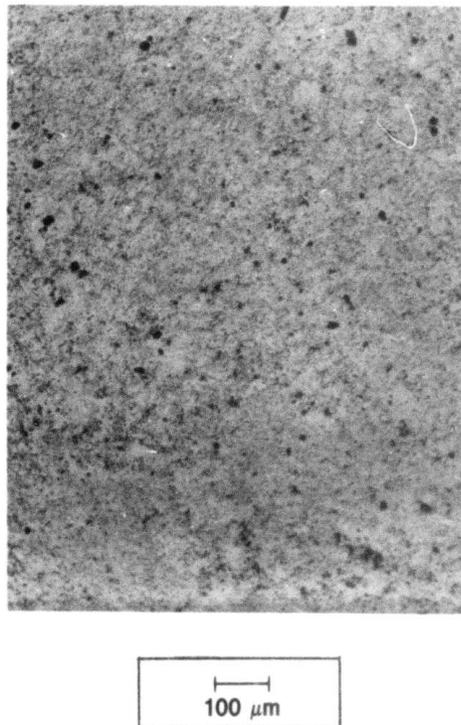
Figure 5.9f — Micrograph of Rotor 1182 Blade Region

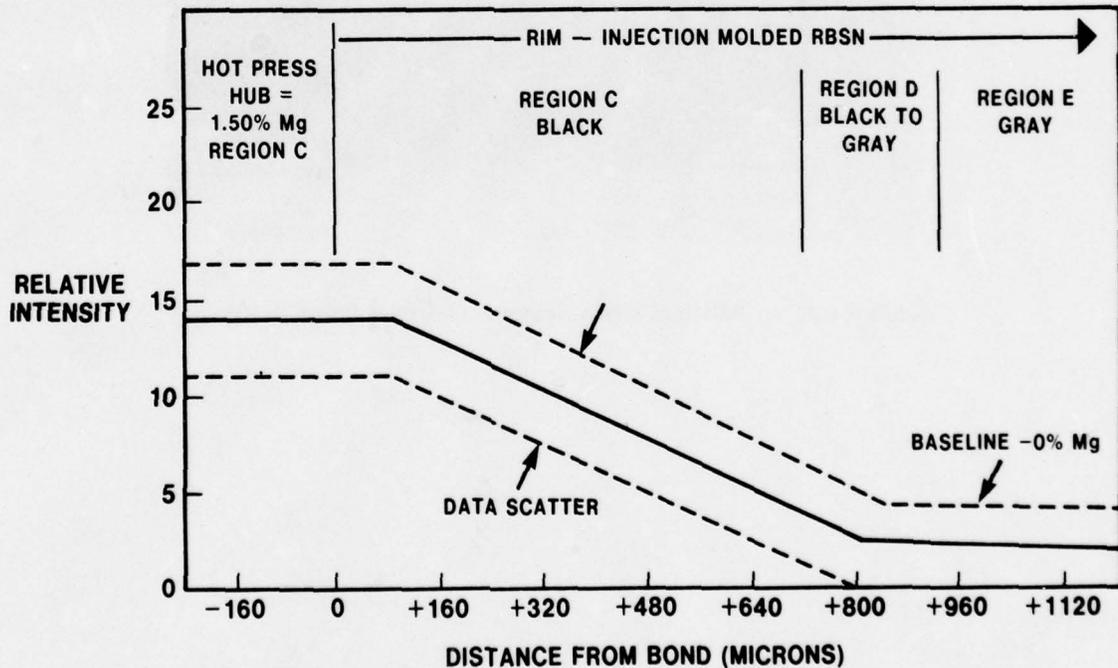
Figure 5.10 — Magnesium Concentration Across the Bond Joint of Rotor 1182

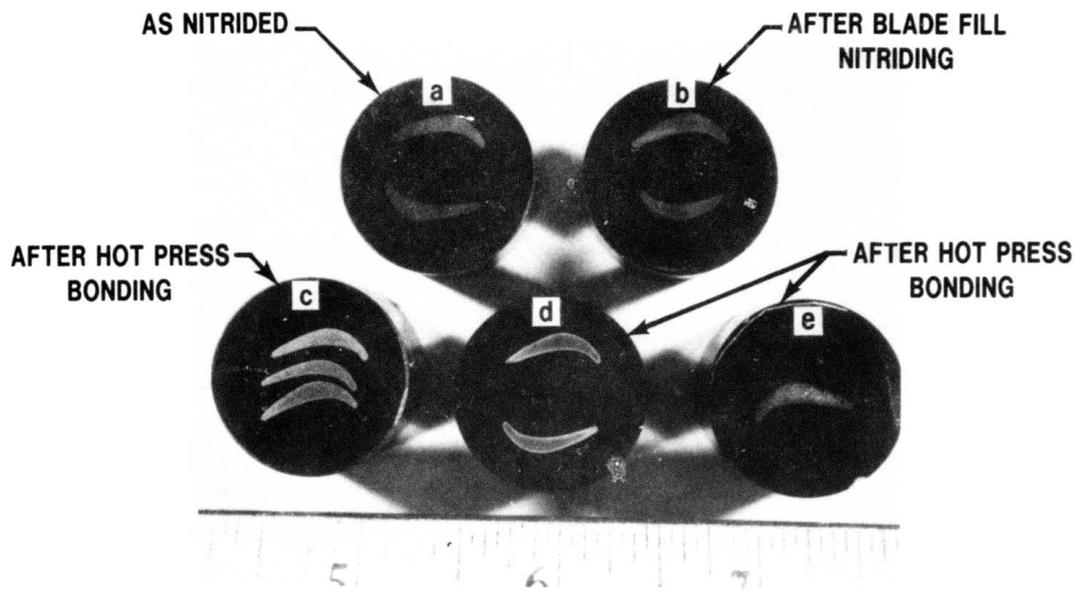
Figure 5.11 — Polished Cross Sections of RBSN Rotor Blades

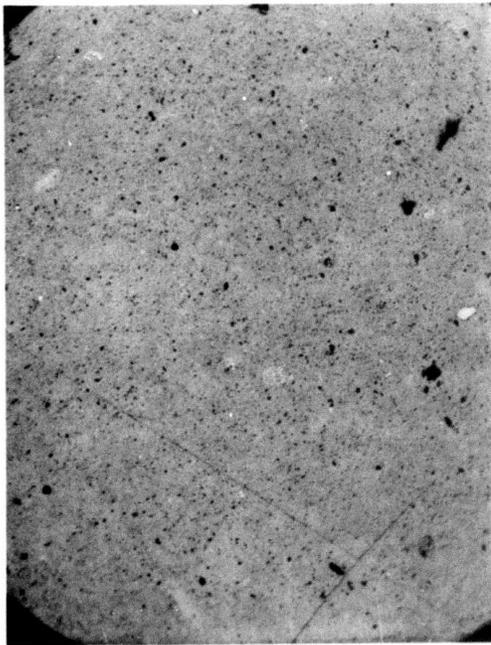
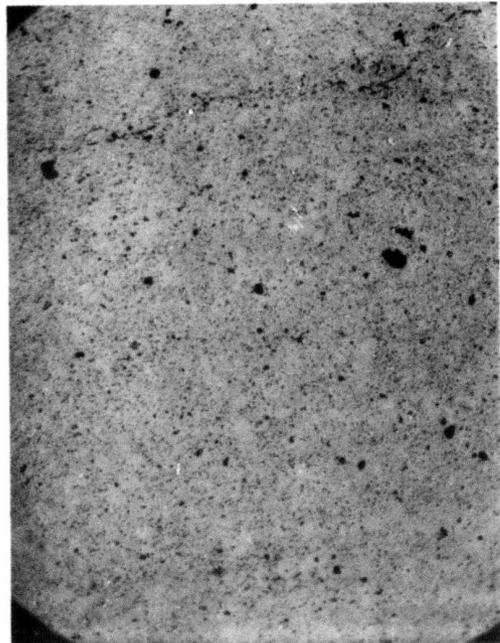
Figure 5.12a,b — Typical Microstructure of RBSN Rotor Blade Rings after:  
 a. Initial Nitriding b. Blade Fill Nitriding

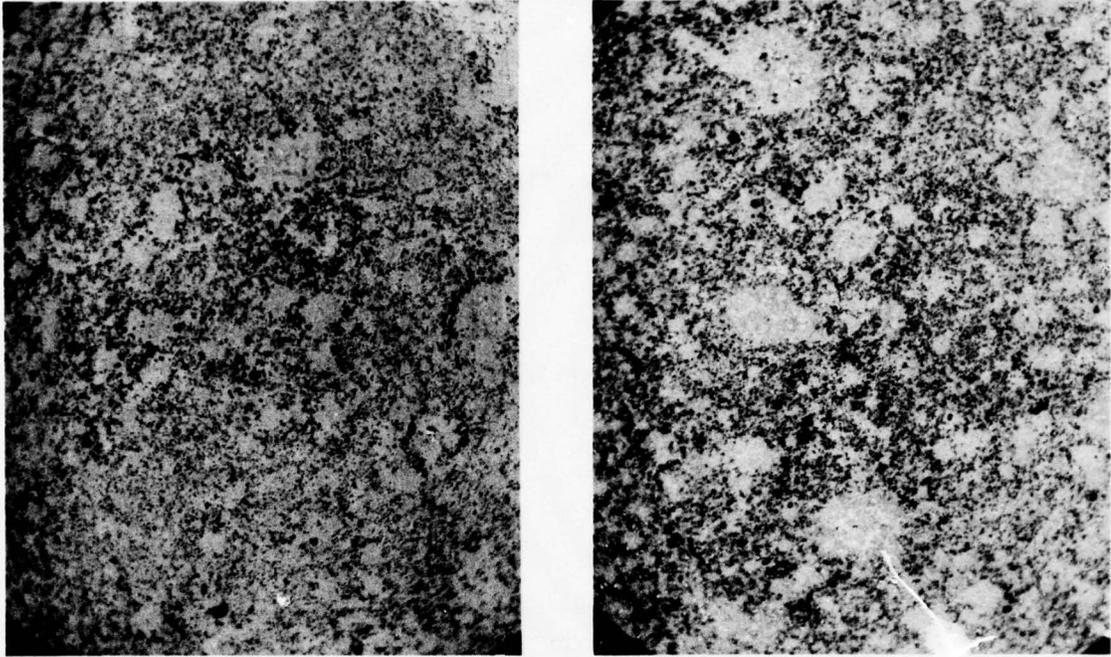
Figure 5.12c,d — Typical Microstructure of RBSN Rotor Blade Rings after:  
 c. Hot Press Bonding (1083) d. Hot Press Bonding (1263)

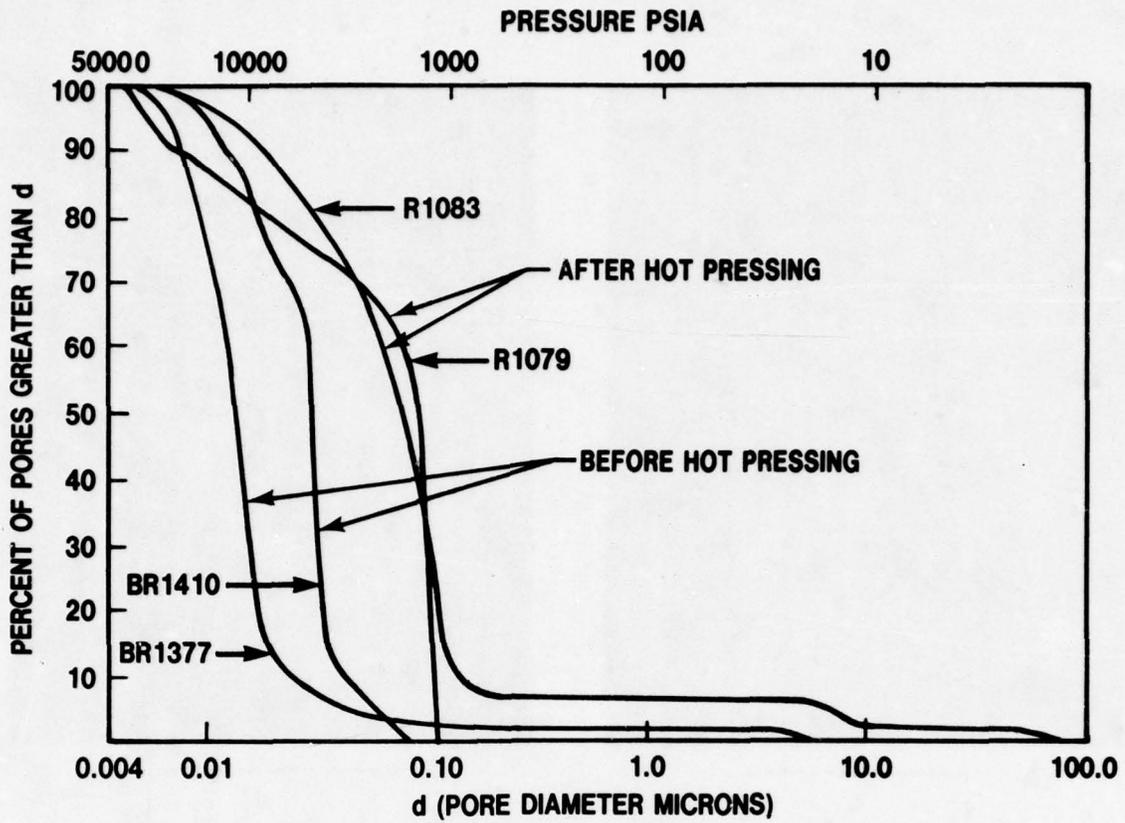
Figure 5.13 — Pore Size Distributions before and after Hot Press Bonding

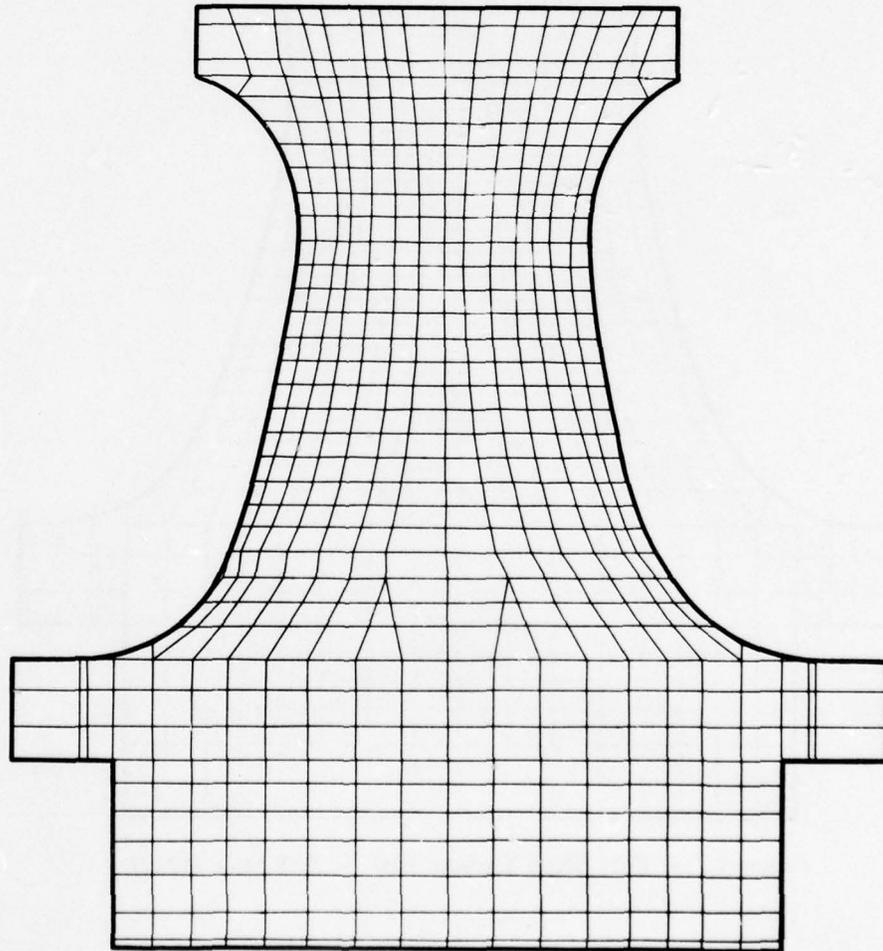
Figure 6.1 — First Stage Turbine Disk — 0.40 inch Throat

Disk redesigns studied were limited in scope so that any new disk configuration could be made from the existing hot pressing blank with minimal changes to the existing machining tools and so that existing blade tooling and rotor mounting hardware could be retained. Two disk contour modifications were investigated within these constraints. The first which is shown in Figure 6.1 has a throat thickness

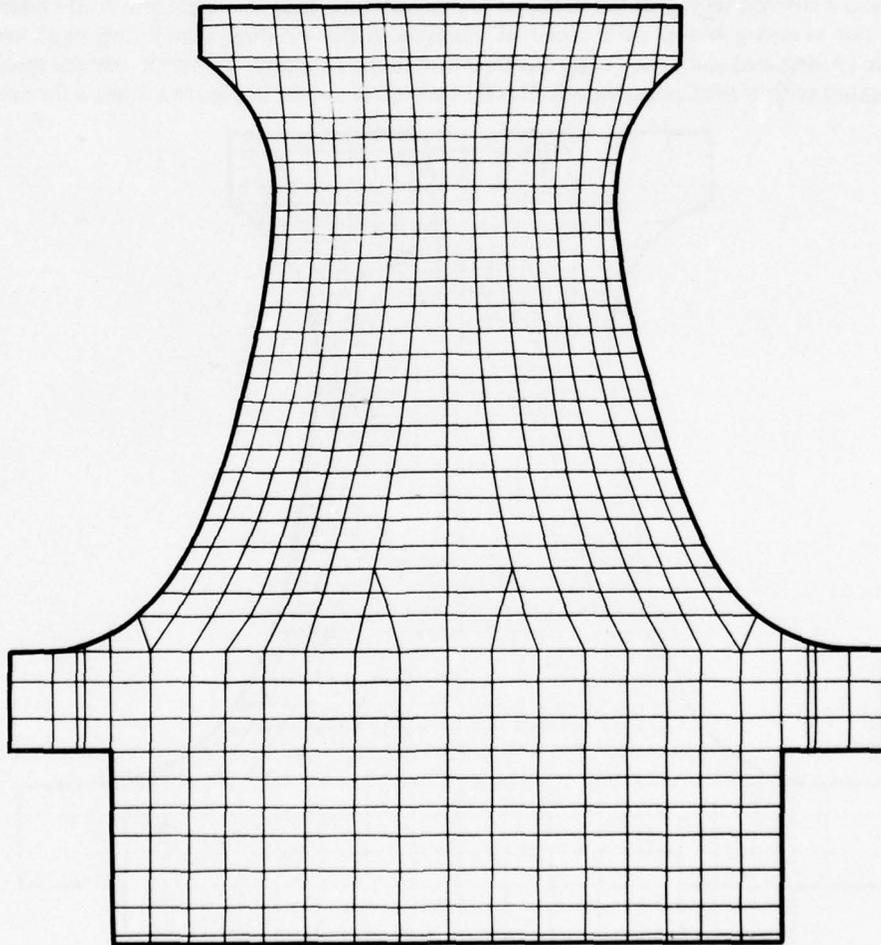
Figure 6.2 — First Stage Turbine Disk — 0.48 inch Throat

increased from .300 inch to .400 inch. The second with a throat thickness of .480 inch is shown in Figure 6.2. As will be shown later, both disk changes give a stress reduction in the throat without a significant increase in the stress levels in the disk bore.

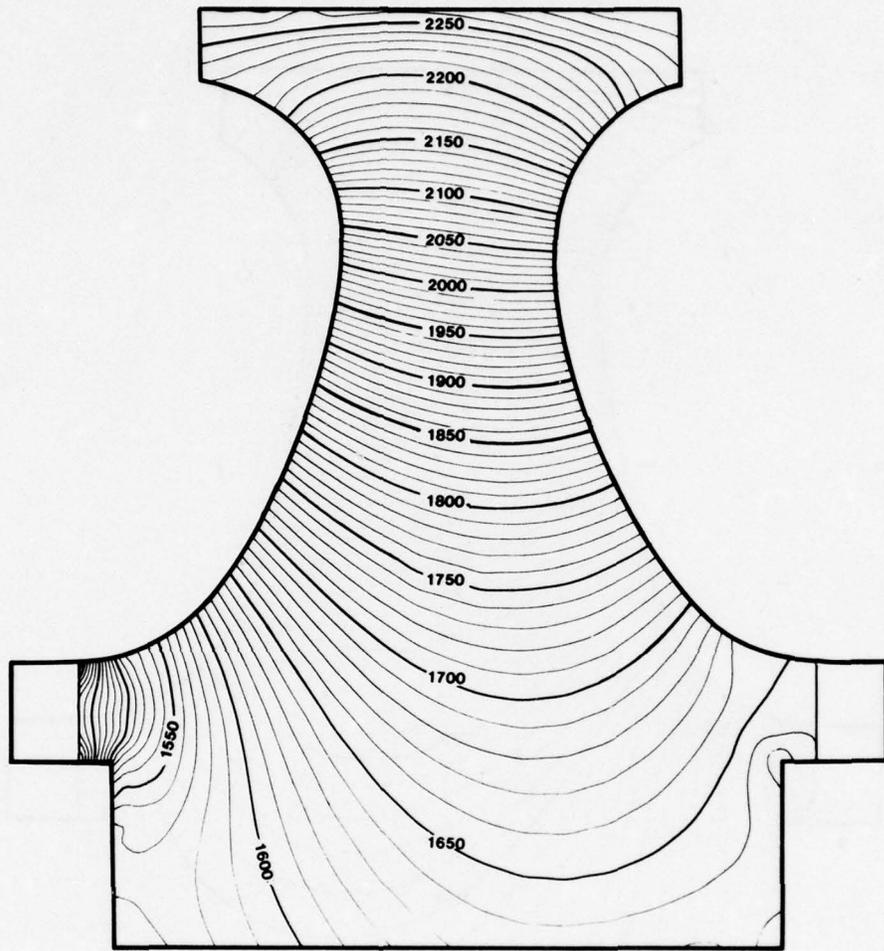
Figure 6.3 — First Stage Turbine Disk (0.30 inch Throat) Temperature ( $^{\circ}$ F) Contours for 2500 $^{\circ}$ F T.I.T. and 100% Speed

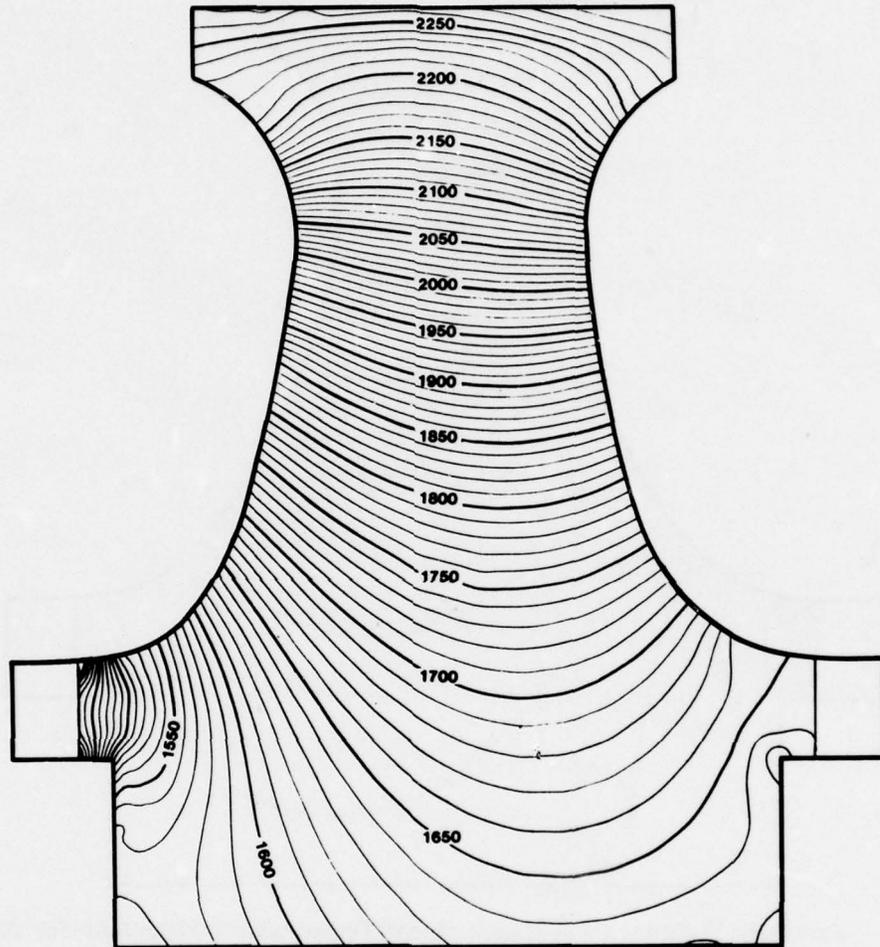
**Figure 6.4 — First Stage Turbine Disk (0.40 inch Throat) Temperature (°F) Contours for 2500°F T.I.T. and 100% Speed**

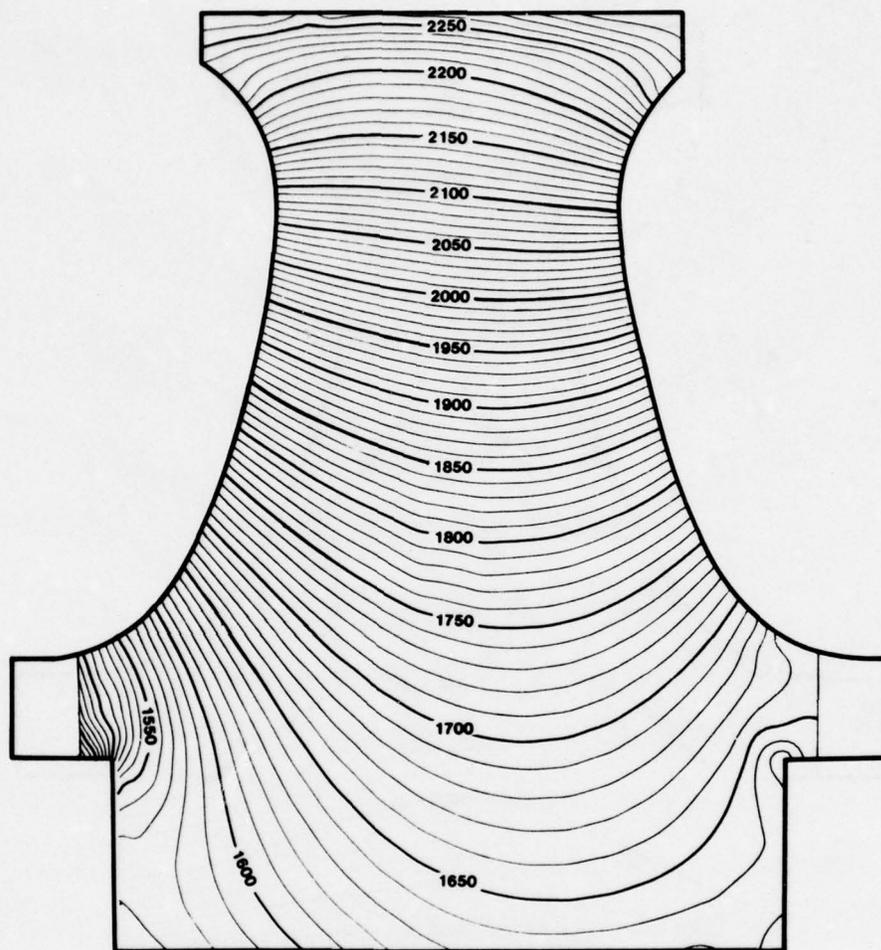
**Figure 6.5 — First Stage Turbine Disk (0.48 inch Throat) Temperature (°F) Contours for 2500°F T.I.T. and 100% Speed**

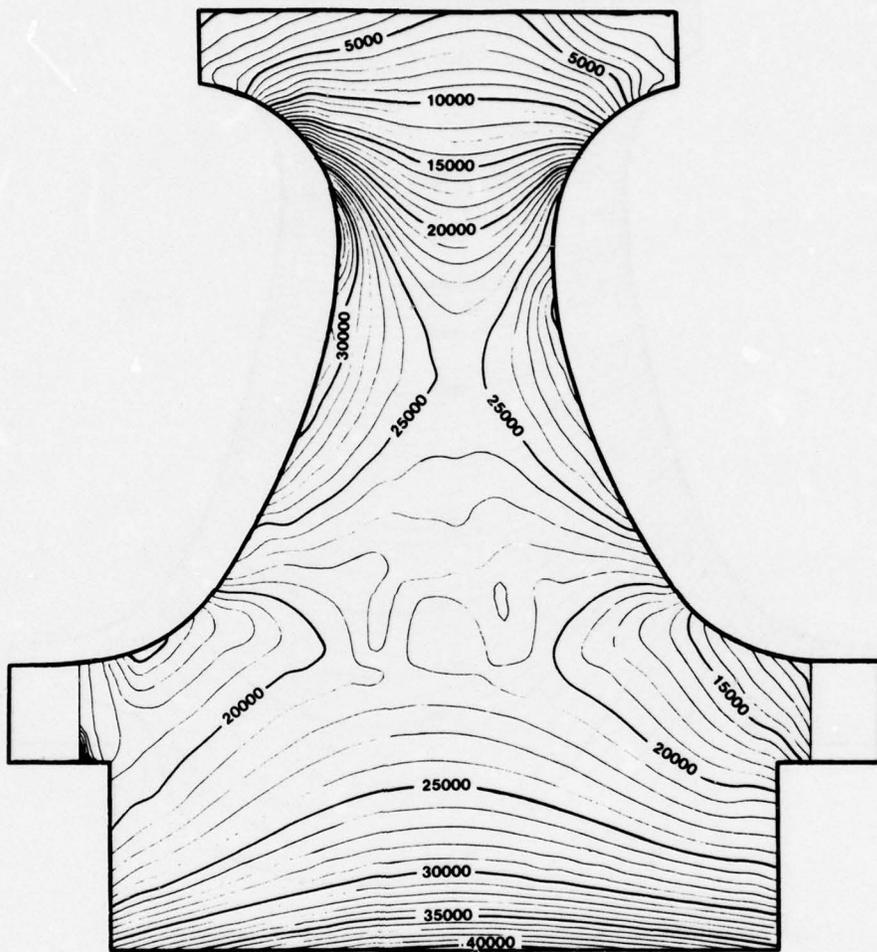
Figure 6.6 — Maximum Principle Tensile Stresses (Psi) for the First Stage Turbine Disk (0.30 inch Throat) at 2500°F T.I.T. and 100% Speed

The calculated maximum principle tensile stress contours for the original design and for the two modified designs at the full power loading (2500°F TIT and 100% speed) are shown in Figures 6.6, 6.7 and 6.8. A summary of maximum stress levels in the disk throat and bore areas for all three configurations is shown in Table 6.1.

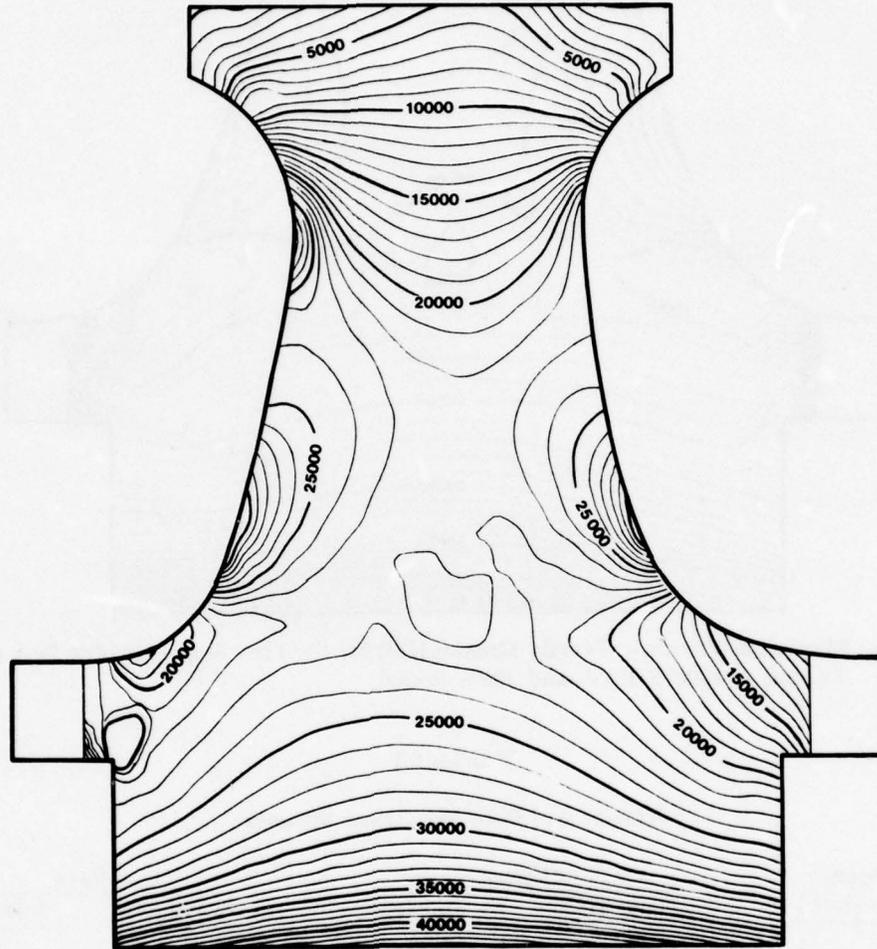
**Figure 6.7 — Maximum Principle Tensile Stresses (Psi) for the First Stage Turbine Disk (0.40 inch Throat) at 2500°F T.I.T. and 100% Speed**

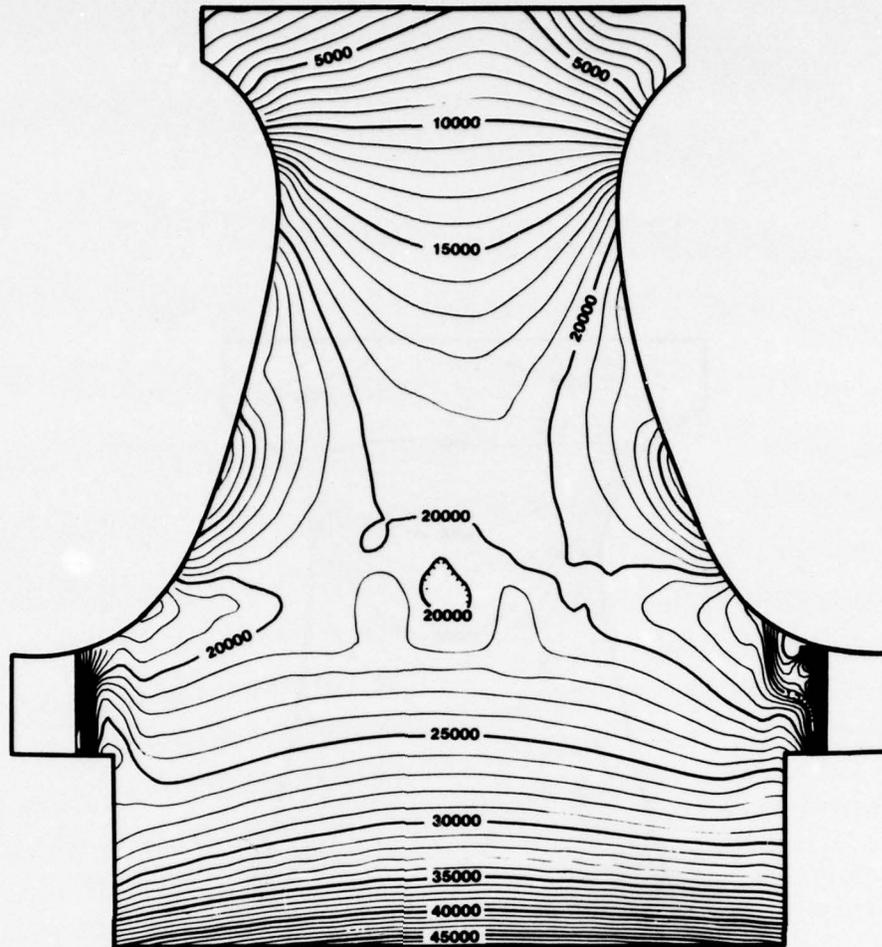
Figure 6.8 — Maximum Principle Tensile Stresses (Psi) for the First Stage Turbine Disk (0.48 inch Throat) at 2500°F T.I.T. and 100% Speed

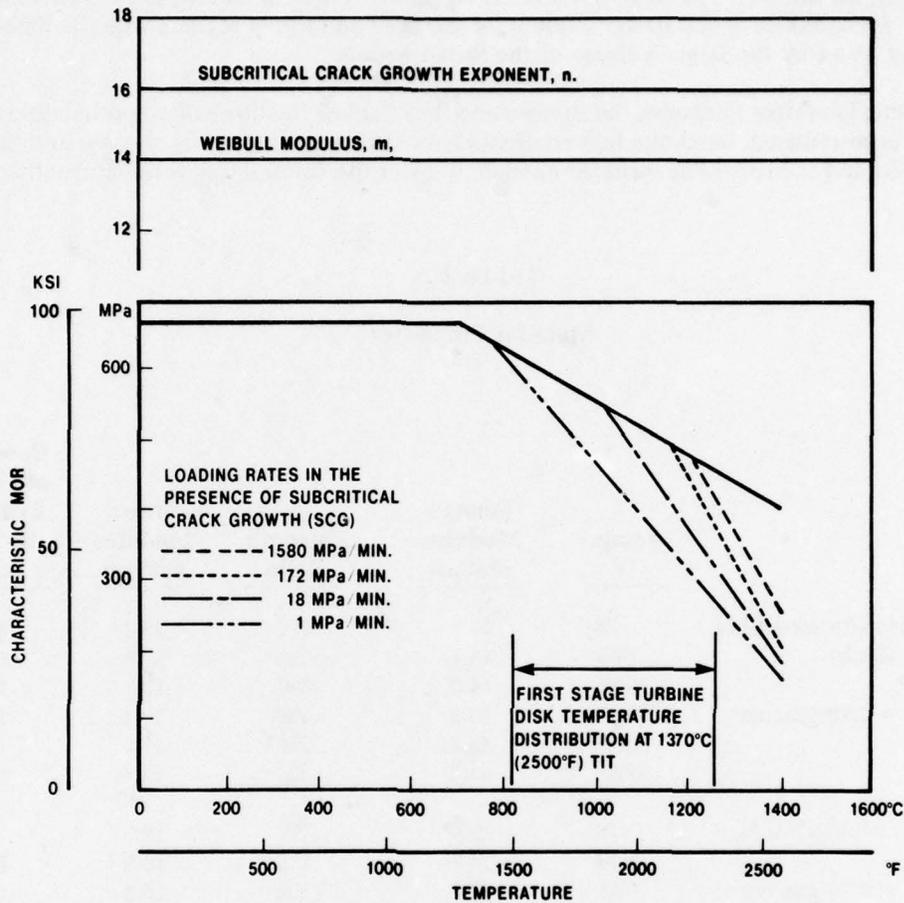
Figure 6.9 — Estimated Strength Characteristics of Rotor Hub Hot Pressed Silicon Nitride Used to Check Out Analytical Codes

rotor. Thus by trading off the reliabilities in these two regions, one can arrive at a rotor configuration that will be optimum from the standpoint of life considerations. This configuration will be different than that arrived at from the fast fracture point of view. Similarly as in the fast fracture approach an optimum configuration is defined as one for which the failure probabilities for the two regions are equalized at the time of failure. In this case this is represented by the .40 throat thickness which as seen from Table 6.3, gives the maximum probability of attaining the 25-hour life at full load.
