PTPT REPORT NO. 78-12
AFPEA PROJECT NO. 77-P7-55
LPN

6 PERFORMANCE EVALUATION OF A POLYETHYLENE FOAM SHIPPING
CONTAINER FOR THE F-16 EMERGENCY POWER UNIT HYDRAZINE FUEL TANK

HQ AFALD/PTP
AIR FORCE PACKAGING EVALUATION AGENCY
Wright-Patterson AFB OH 45433

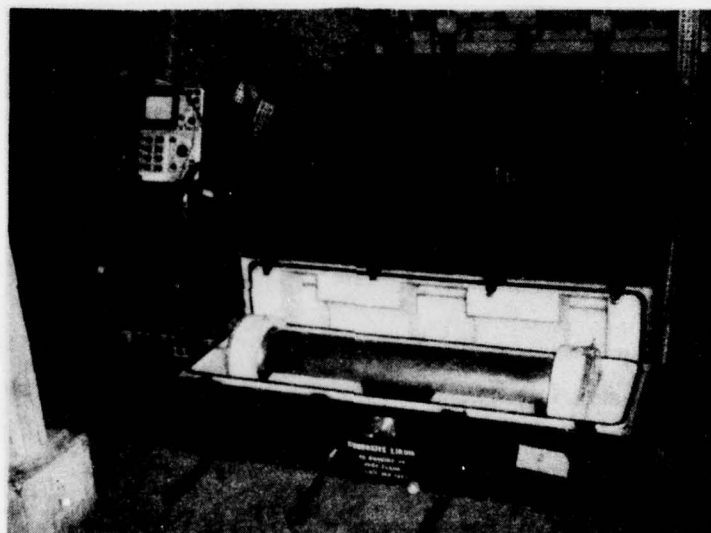
FIGURE 1. Opened container showing
internal cushioning configuration

The prototype container is fabricated from polyethylene of 2 lb. and 9 lb. density compatible with hydrazine (Figure 1). Polyethylene end caps (9 lb.), with plywood load spreaders, protect the quick-disconnect fittings on either end of the fuel tank (Figures 2 and 3). The fuel tank is nested in a saddle constructed of 2 lb. polyethylene material. The container walls are 2.25" thick, consisting of 3/8" polyethylene (9 lb.) on the outer surface, laminated to 1 7/8" polyethylene (2 lb.) on the inner surface. The container incorporated four retaining nylon straps with buckle-type securing devices.

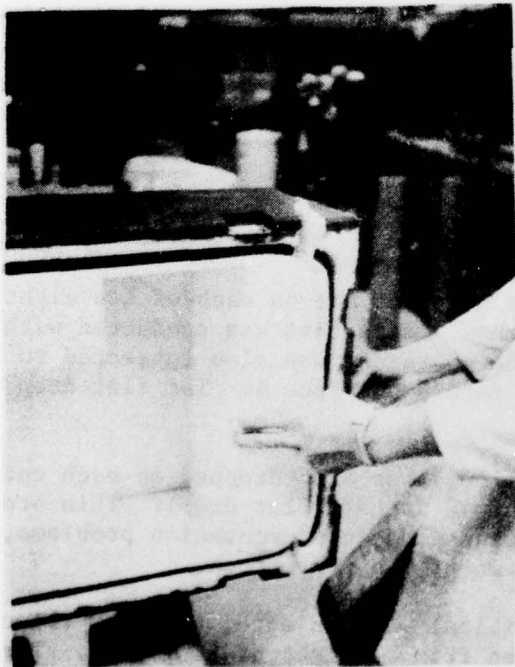
FIGURE 4.

The container was inspected after each series of drop tests. The container was damaged during the low temperature corner drop tests (Figures 4 and 5). The polyethylene material separated, damaging the gasket seal in two places. The separation was in the form of a material failure rather than that of a glue joint. The damage was attributed to the rigidity of the material at low temperature.

Container damage resulting from the 18" low temperature corner drops.

Low temperature drops (-40°F) from 18 inches resulted in significantly increased shock transmission as well as container damage.
