USARTL-TR-78-19

SUPERHARD TRANSPARENT COATINGS

Robert L. Fogarty, Richard S. Hassard, John Uram, Jr., Glenn E. Wintermute
Goodyear Aerospace Corporation
Arizona Division
Litchfield Park, Arizona 85340

Final Report for Period November 1975 - February 1977

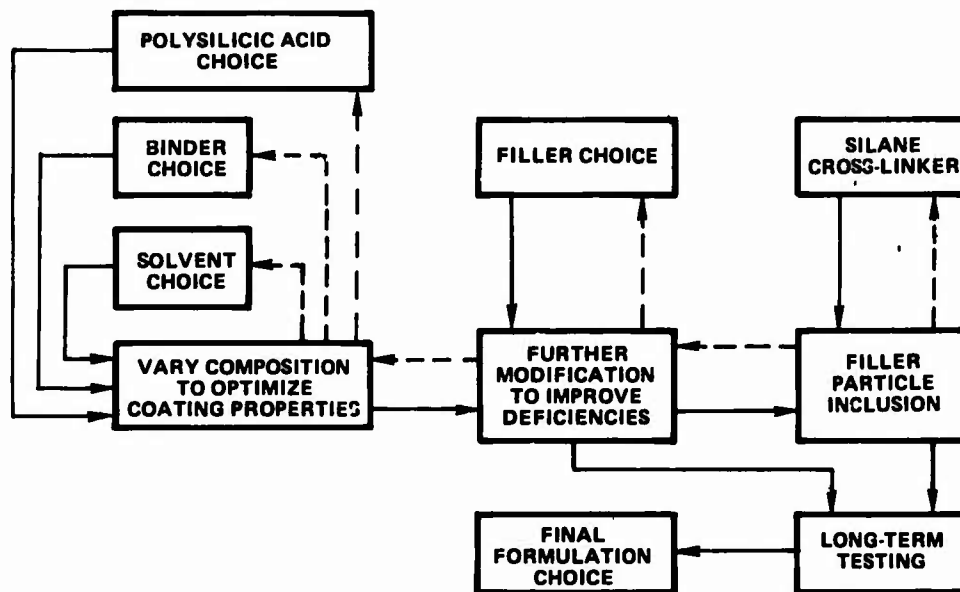
Figure 11. Coating Development Plan

The plan used to develop the final coating is shown in Figure 11.

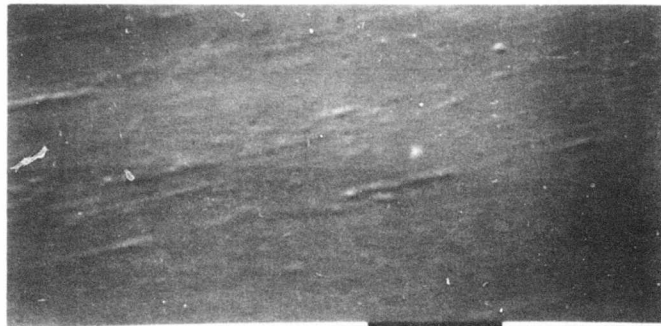
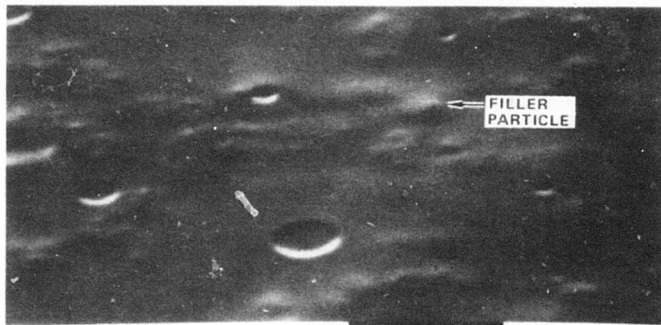
Figure 21. Electron Microphotographs of Filled and Unfilled Transparent Hard Coatings on Stretched Plex 55 Substrate (Black Marker Represents 4 Microns of Length)

Electron microphotographs of the three surfaces are shown in Figure 21. The No. 188 coating exhibits a finer irregularity, and has smaller imperfections than the filled coatings. It is interesting to note the relative sizes of the individual filler particles are in the submicron range, but the agglomerates tend to be larger despite refinement measures. The greater number of holes and/or pits in the filled materials may result in a lesser degree of hydrolytic stability than the unfilled material.

(A) NO. 188 FORMULATION (NO FILLER)

(B) NO. 210 FORMULATION (SiO₂ FILLER)

(C) NO. 214 FORMULATION Al₂O₃ FILLER
