6 TRANSPORTABILITY TEST OF
NAVY IRSKIT AMMUNITION RESTRAINT
SYSTEM IN 20-FOOT COMMERCIAL CONTAINERS,

14
REPORT NO. EVT-10-77

EVALUATION DIVISION
DARCOM AMMUNITION CENTER
SAVANNA, ILLINOIS

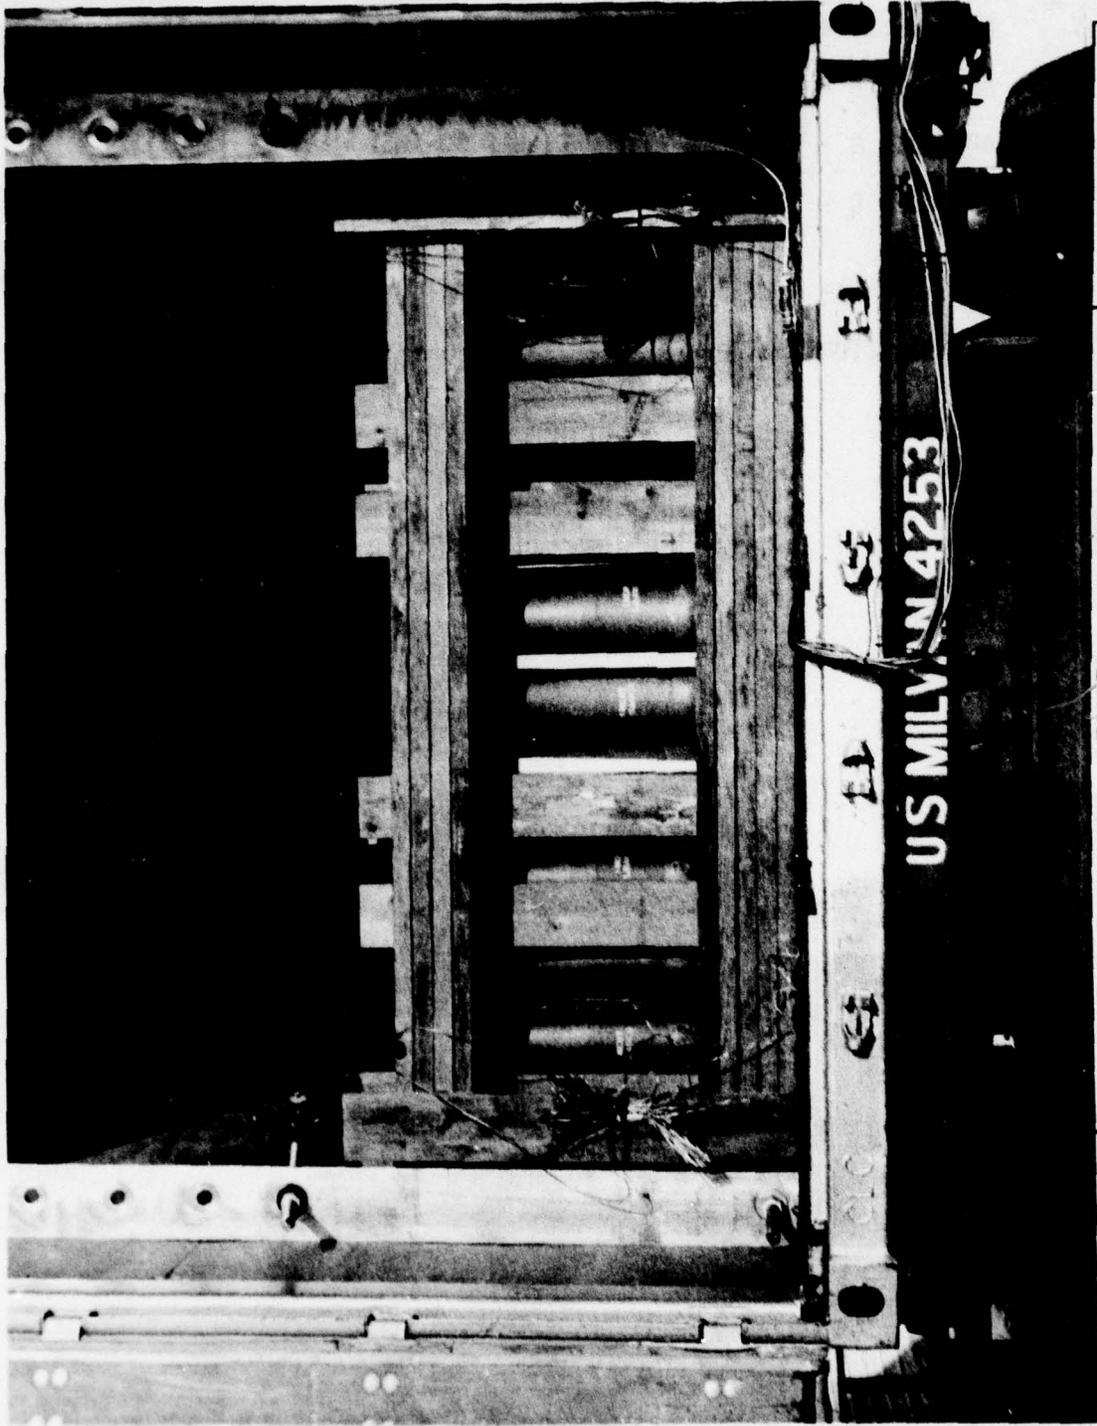
PHOTOGRAPH NO. 1

This photograph shows the inert 155MM SLP loaded-aluminum container with IRSKIT restraint system prior to commencement of the rail impact test.

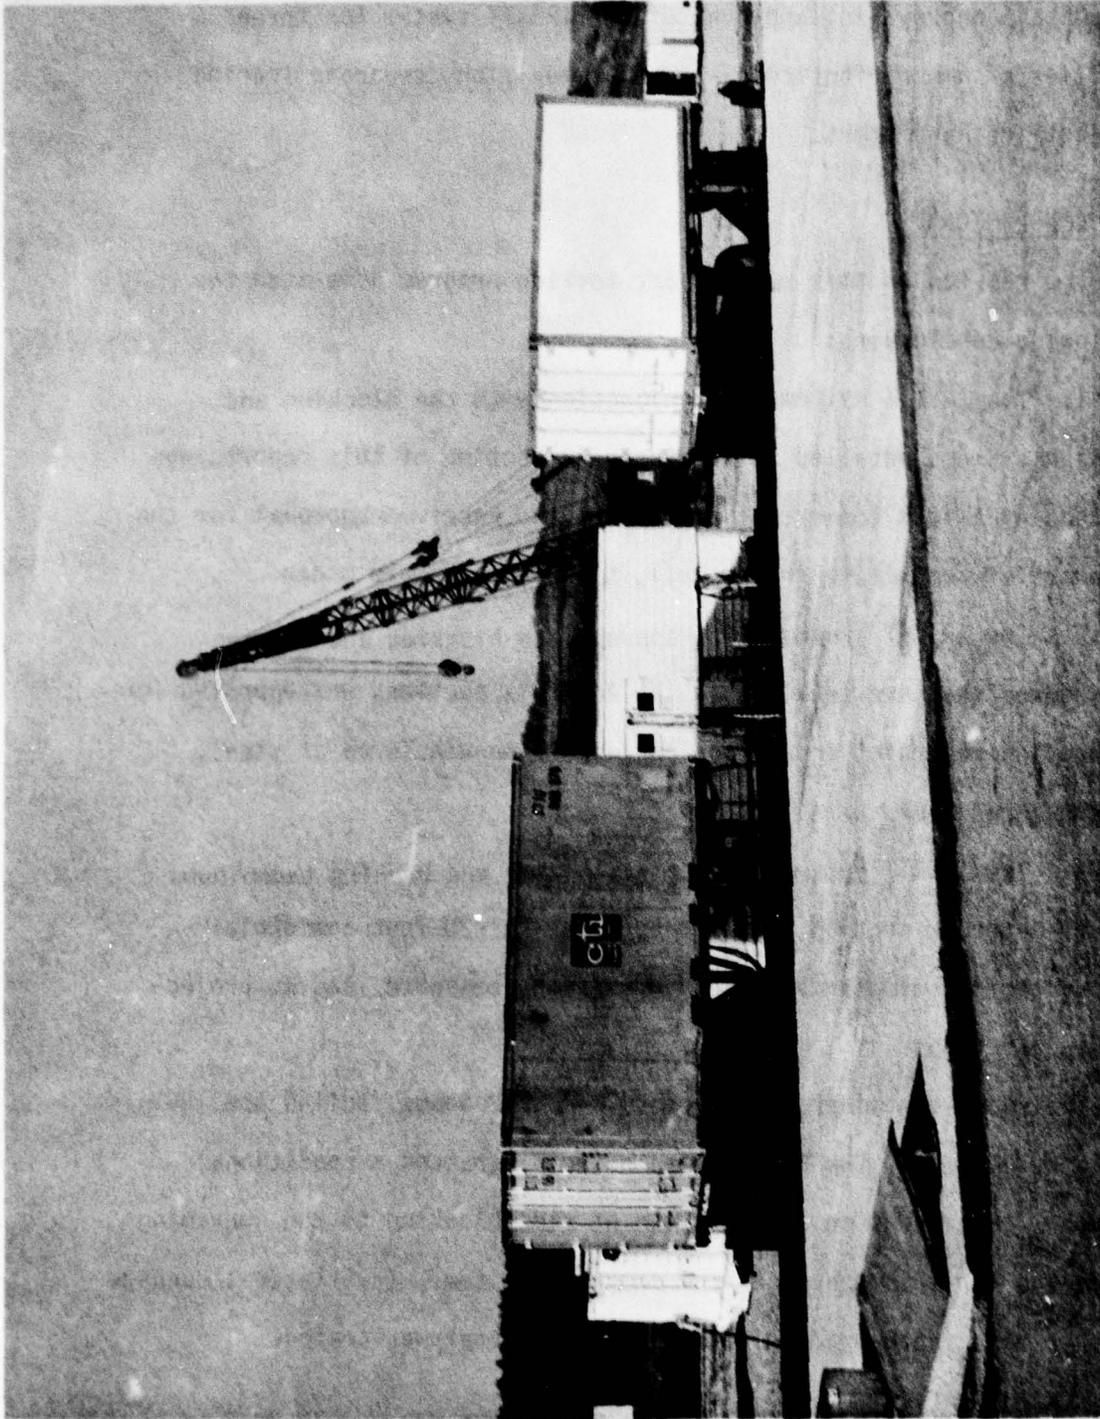
PHOTOGRAPH NO. 2

The aluminum container and the fiberglass reinforced plywood (FRP) container are shown in the trailer-on-flatcar (TOFC) mode prior to the rail impact test.

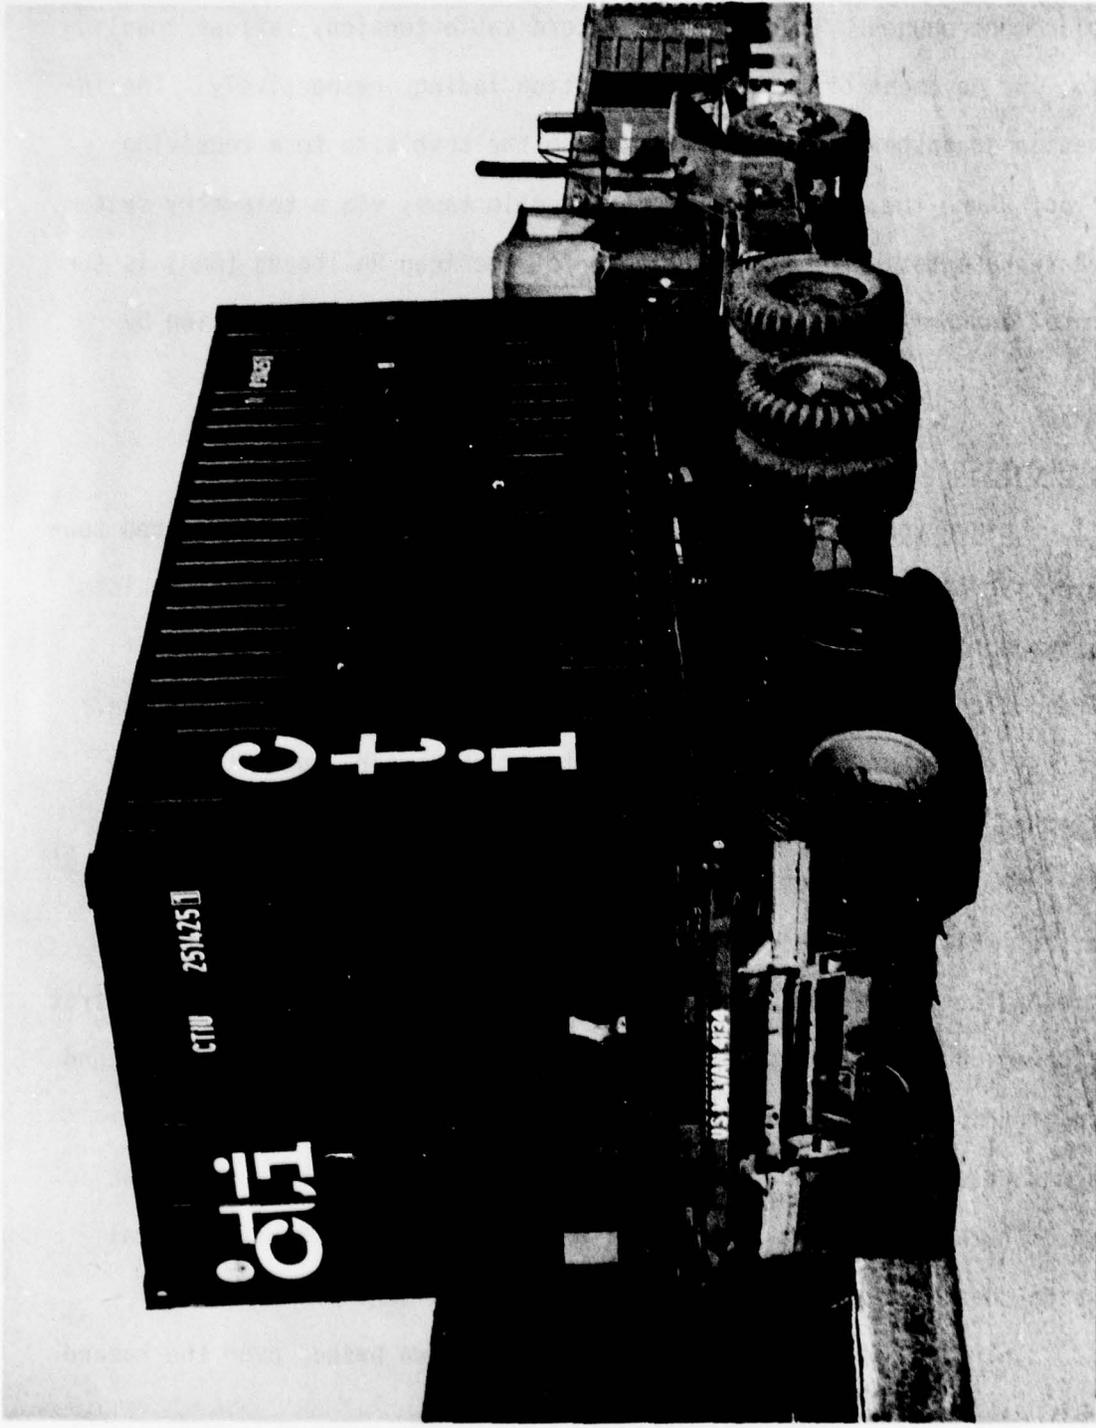
11-078-12660/DARCOM 71 DARCOM AMMUNITION CENTER - SAVANNA, ILLINOIS August 1977
PHOTOGRAPH NO. 3
The 20-foot steel container, with its inert MK92 bomb load, is mounted on its chassis, which is attached to a tactical tractor in advance of the road test.

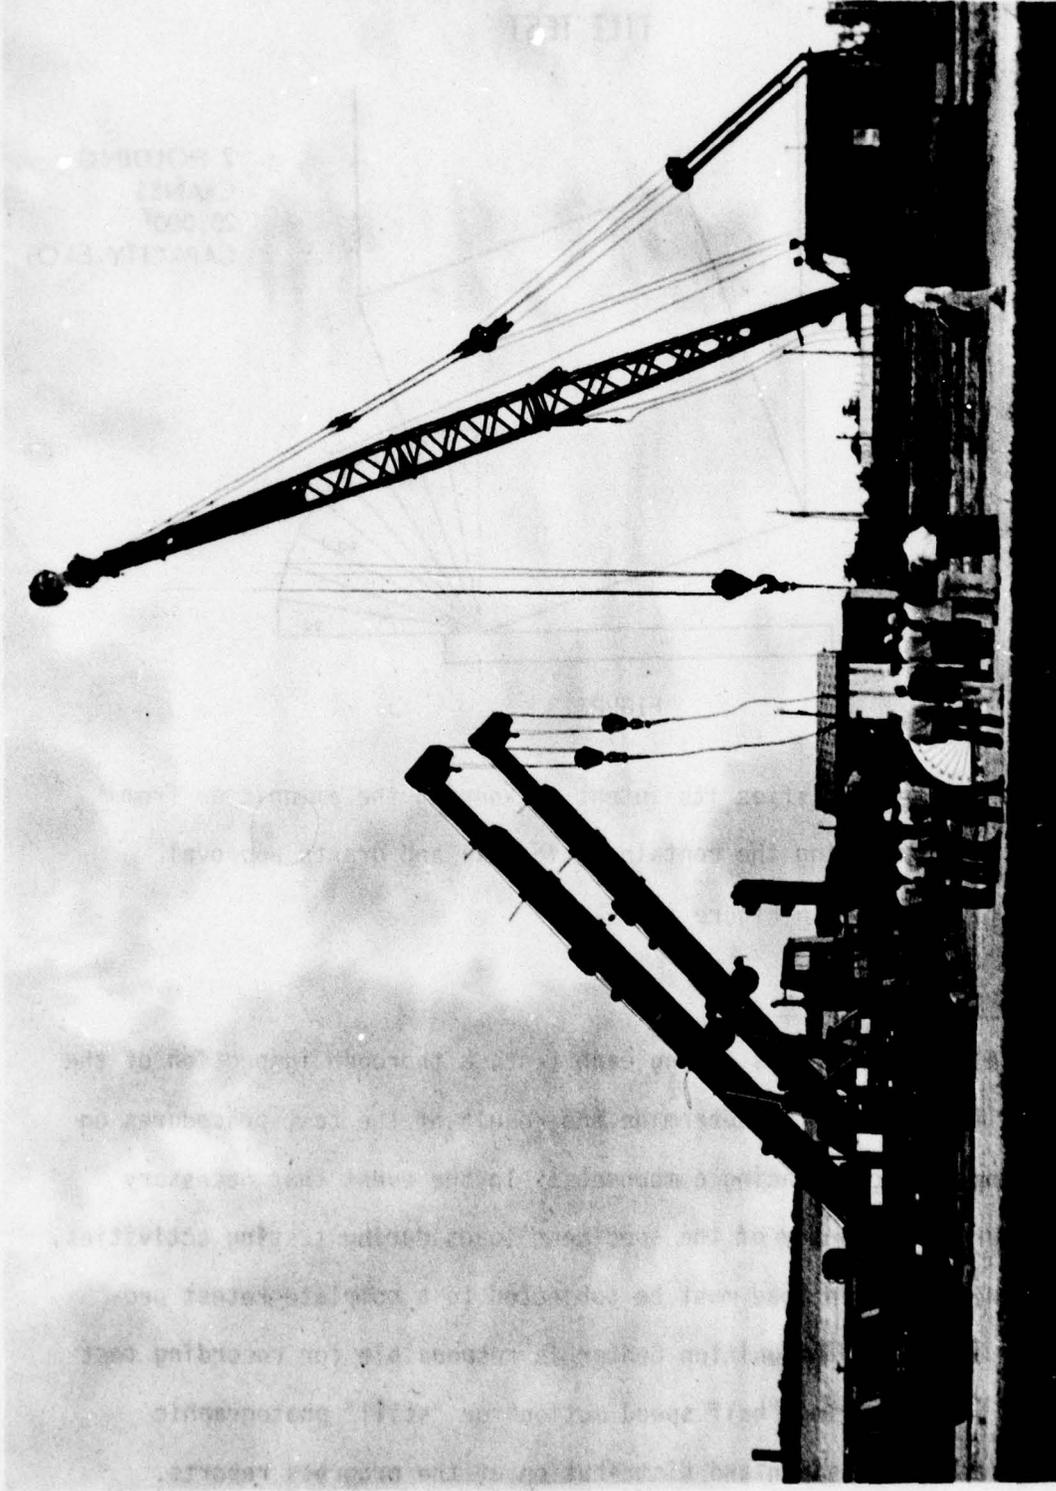
PHOTOGRAPH NO. 4

This photograph details the 80-degree tilt test setup. The crawler crane on the right provides the initial lift, while the two mobile cranes provide support originally and then support the container when the center of gravity shifts.

Tilt testing consists of pre-positioning mobile cranes at strategic lift points, securing cables and/or lifting beams to respective corners, and elevating the container for removal of the semi-tractor and chassis as required to position the container on ground level. Tilting of the container is accomplished by elevating one side of the container with one crane while two other cranes are utilized on the opposite side for control. The degree of tilt is determined through the use of a large protractor type measuring device. The container is tilted 80 degrees or until the angle between the ground and container wall is 10 degrees. See Photo No. 4.

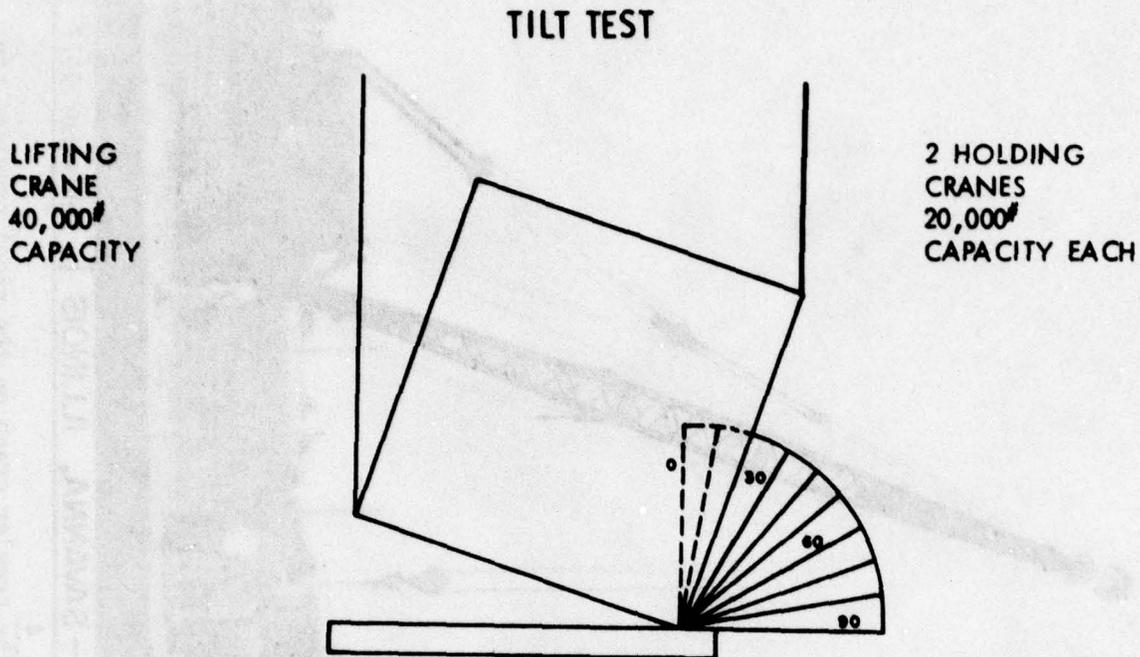
FIGURE 3

restraint system satisfies its intent of keeping the ammunition from permanently deflecting the container sidewall and grants approval accordingly. Refer to Figure 3.

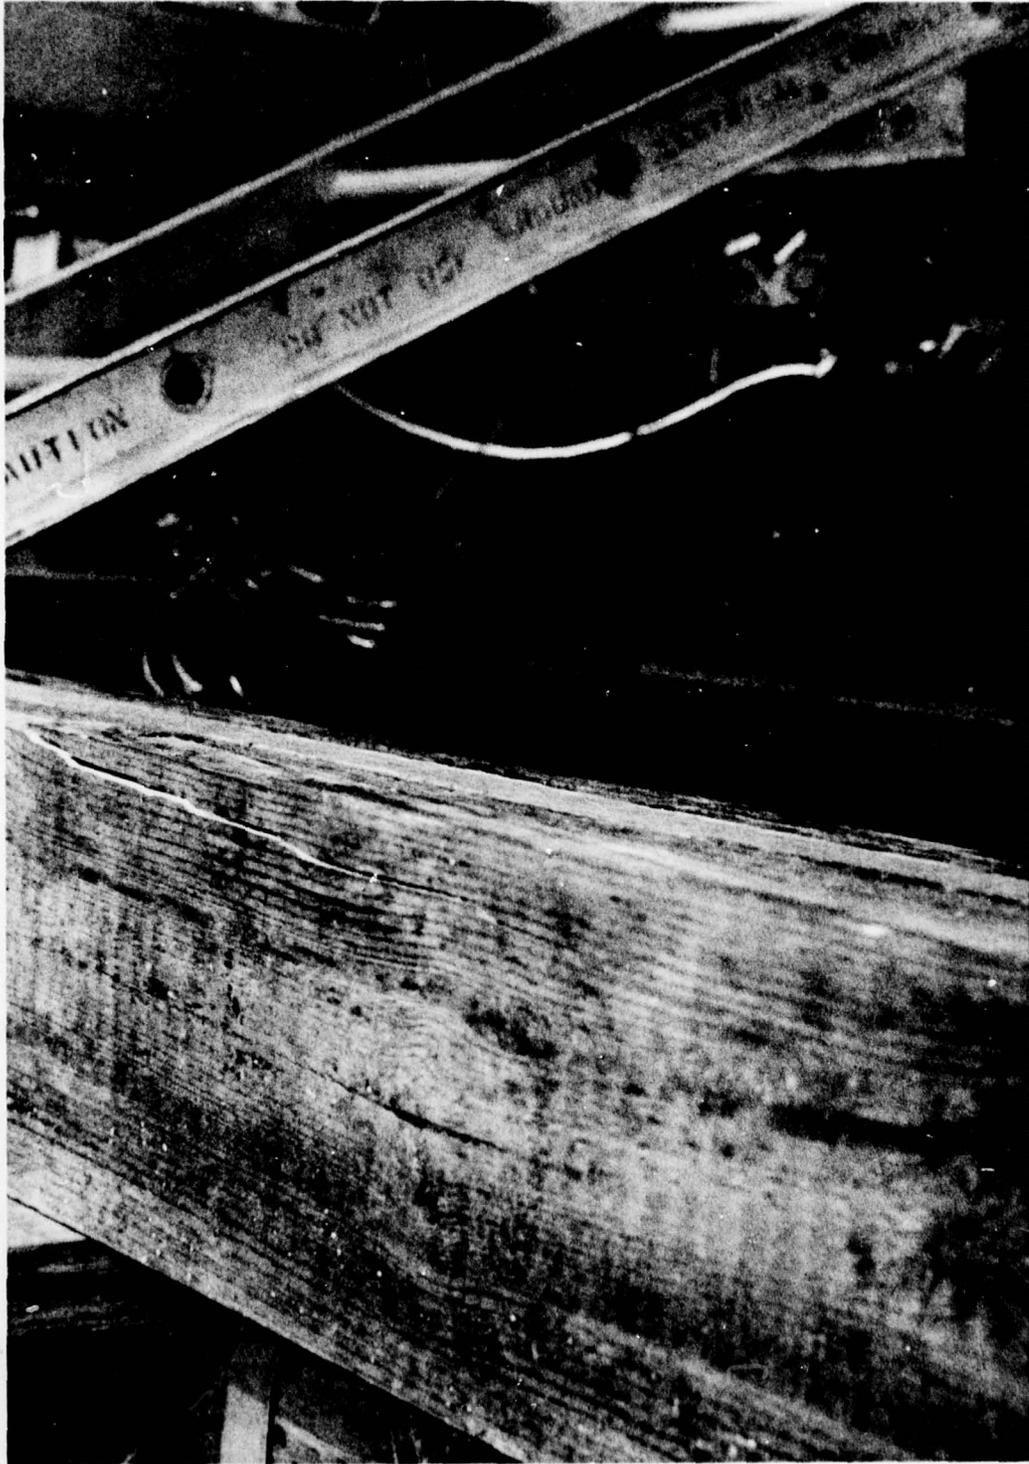
PHOTOGRAPH NO. 6

During the 8.72 MPH forward rail impact of the aluminum container, the rear bulkhead experienced a cracked top member due to the force exerted on it by the 155MM separate loading projectiles (SLP).

*Lost displacement gauge. Left lower jam nut loosened; top horizontal member of rear gate cracked (See PHOTO 6).

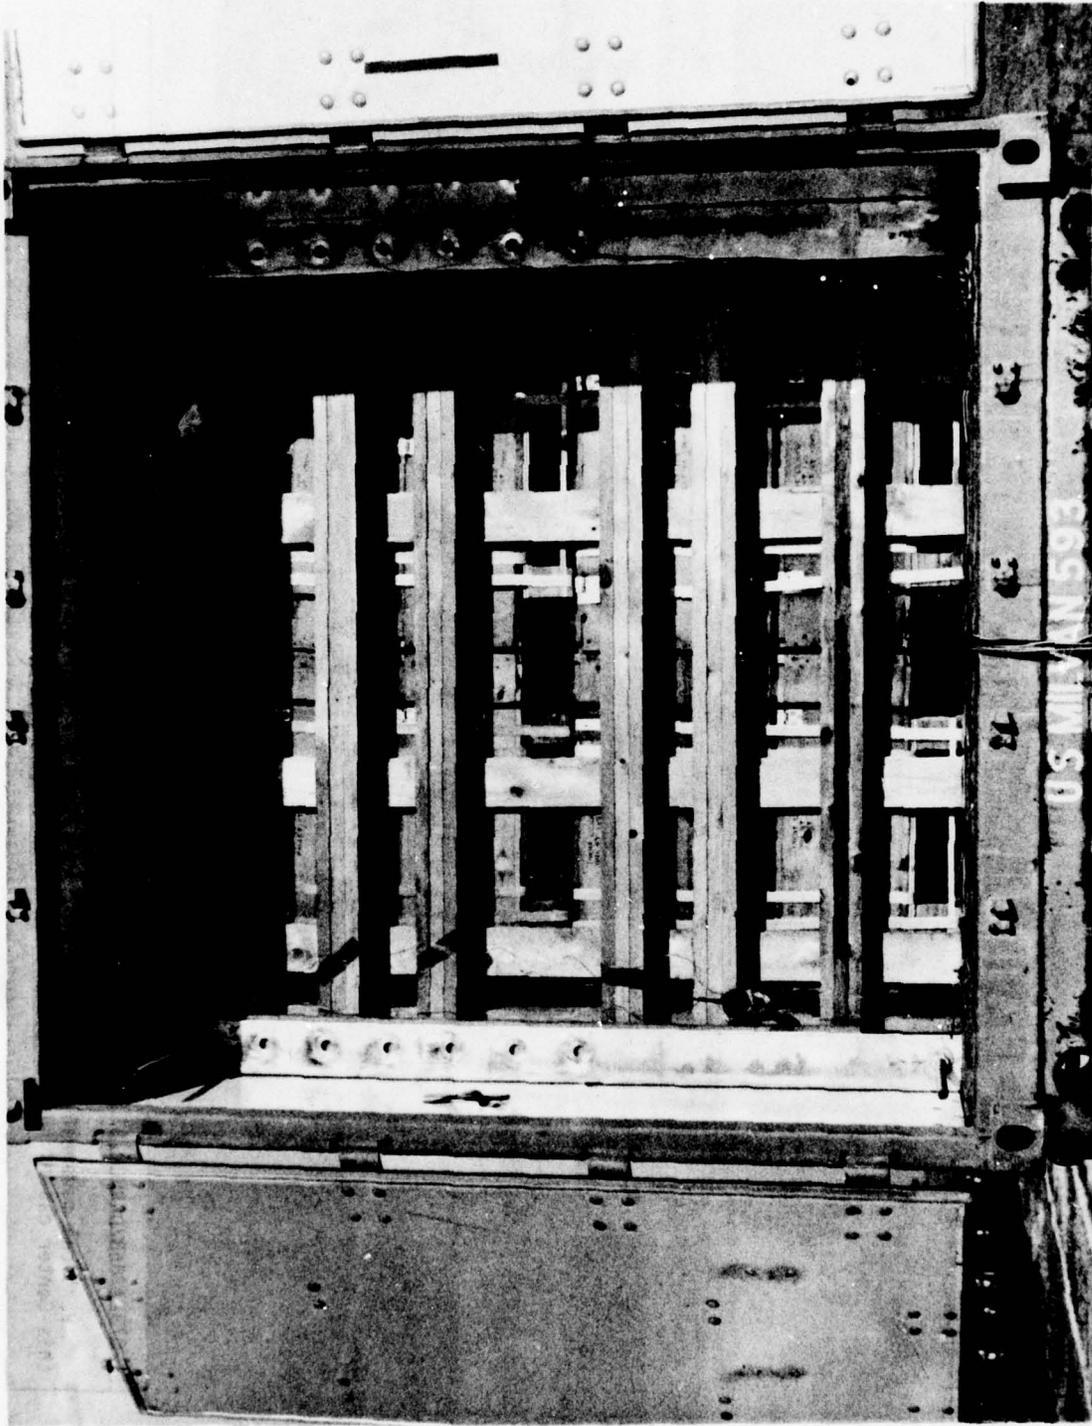
PHOTOGRAPH NO. 8

The FRP container with its payload of inert 105MM boxed ammunition presents a high profile and requires that the threaded rod assemblies be secured at the top of the rear vertical posts.

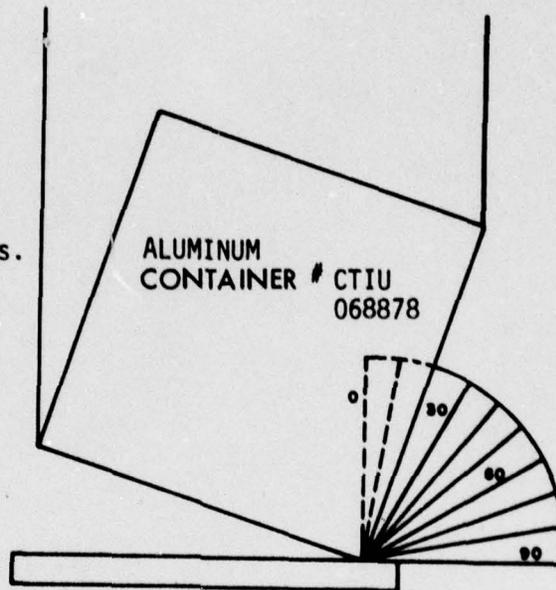
TILT TEST OF ALUMINUM CONTAINER LOADED
WITH 155MM SEPARATE LOADING PROJECTILES

Container Wt. 4,230 lbs.
Lading Wt. 35,200 lbs.
Inert-loaded 155MM
Separate Loading
Projectiles (SLP)

2 HOLDING
CRANES
20,000#
CAPACITY EACH

TILT DEGREE	SIDEWALL DEFLECTION (inches)	PHOTO NO.	REMARKS
0	0	12	Dunnage fully functional
10	.125		No change
20	.250		No change
32	.500		No change
40	.750		The side blocking on the right side of the SLP load lost contact with the right wall of the container.
51	1.000		Dunnage fully functional
60	1.063		No change
70	1.250	13	No change
80	1.500		No change
0	.688	14	No change
-20	.438		No change
-30	.125		No change - This container passed the Coast Guard 80-degree tilt test criteria.

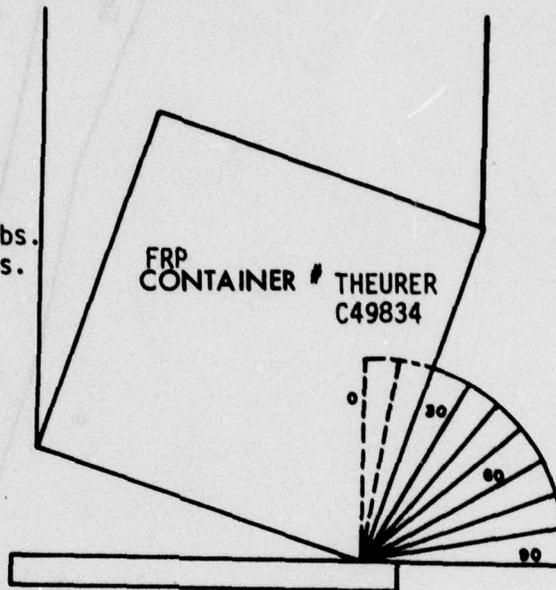
TILT TEST OF FRP CONTAINER LOADED WITH
105MM BOXED AMMUNITION

Container Wt. 4,350 lbs.
Lading Wt.. 40,940 lbs.
Inert-loaded 105MM
Ammunition

TILT DEGREE	SIDEWALL DEFLECTION (inches)	PHOTO NO.
0	0	15
10	.125	
20	.500	16
33	.875	
40	1.250	
55	1.750	17
60	1.875	
70	2.125	18
80	2.375	19

** This container passed the Coast Guard 80-degree Tilt Test criteria.

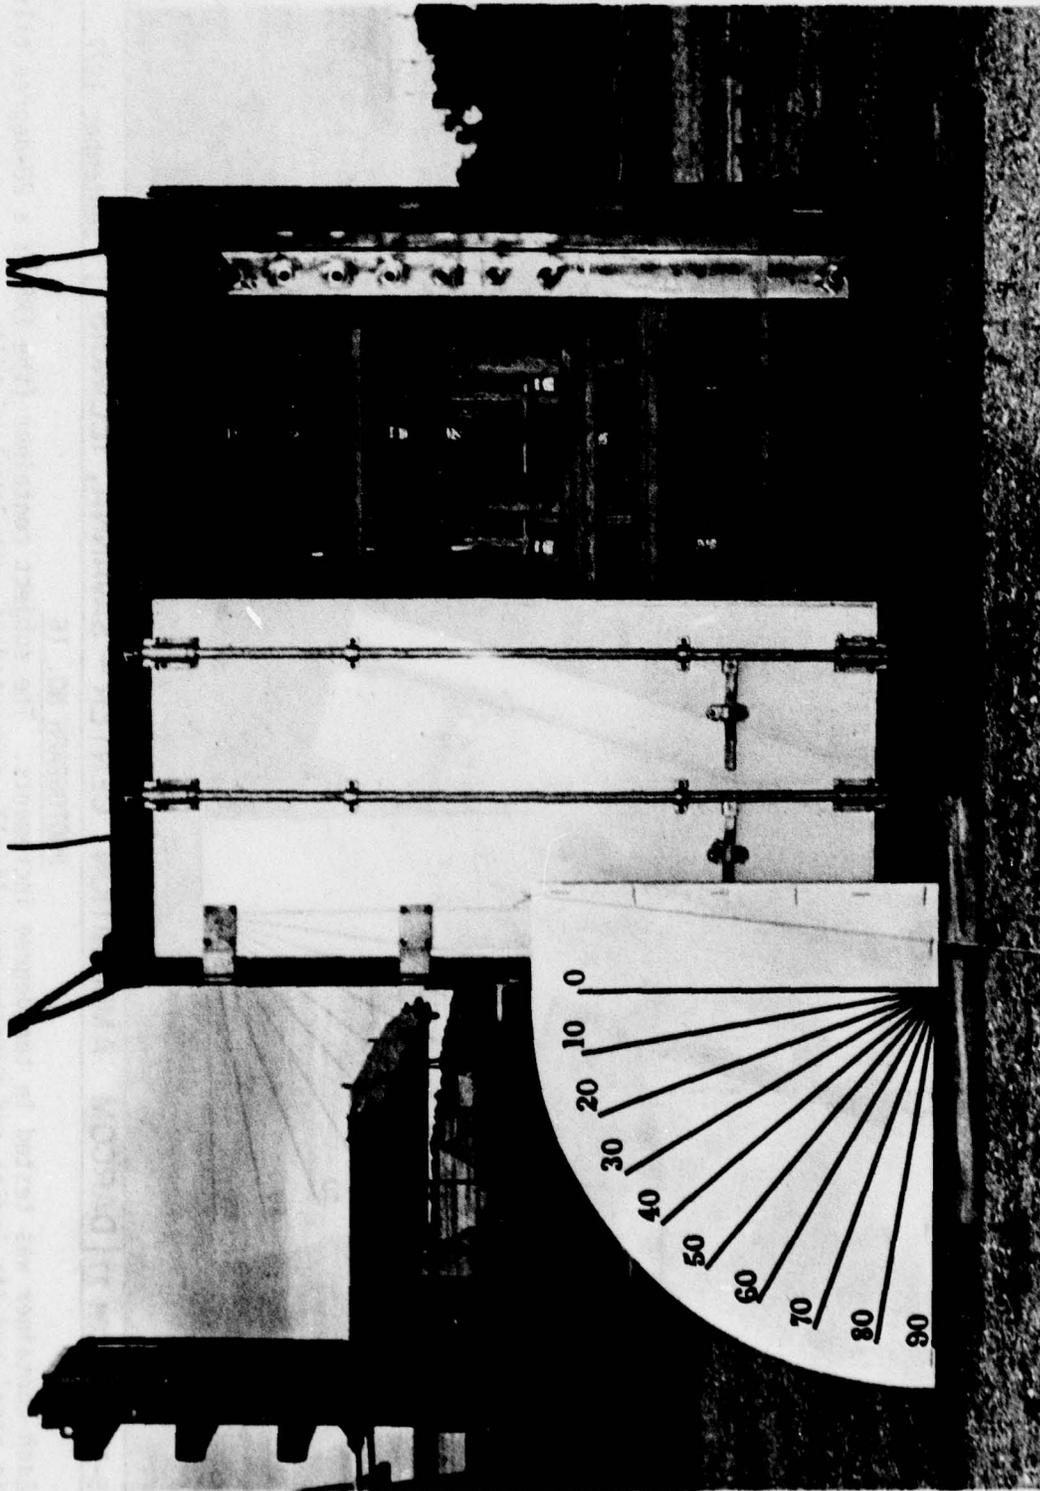
The fibreglass reinforced plywood (FRP) container, with its inert 105MM boxed ammunition load, is shown in its pre-tilt test condition.

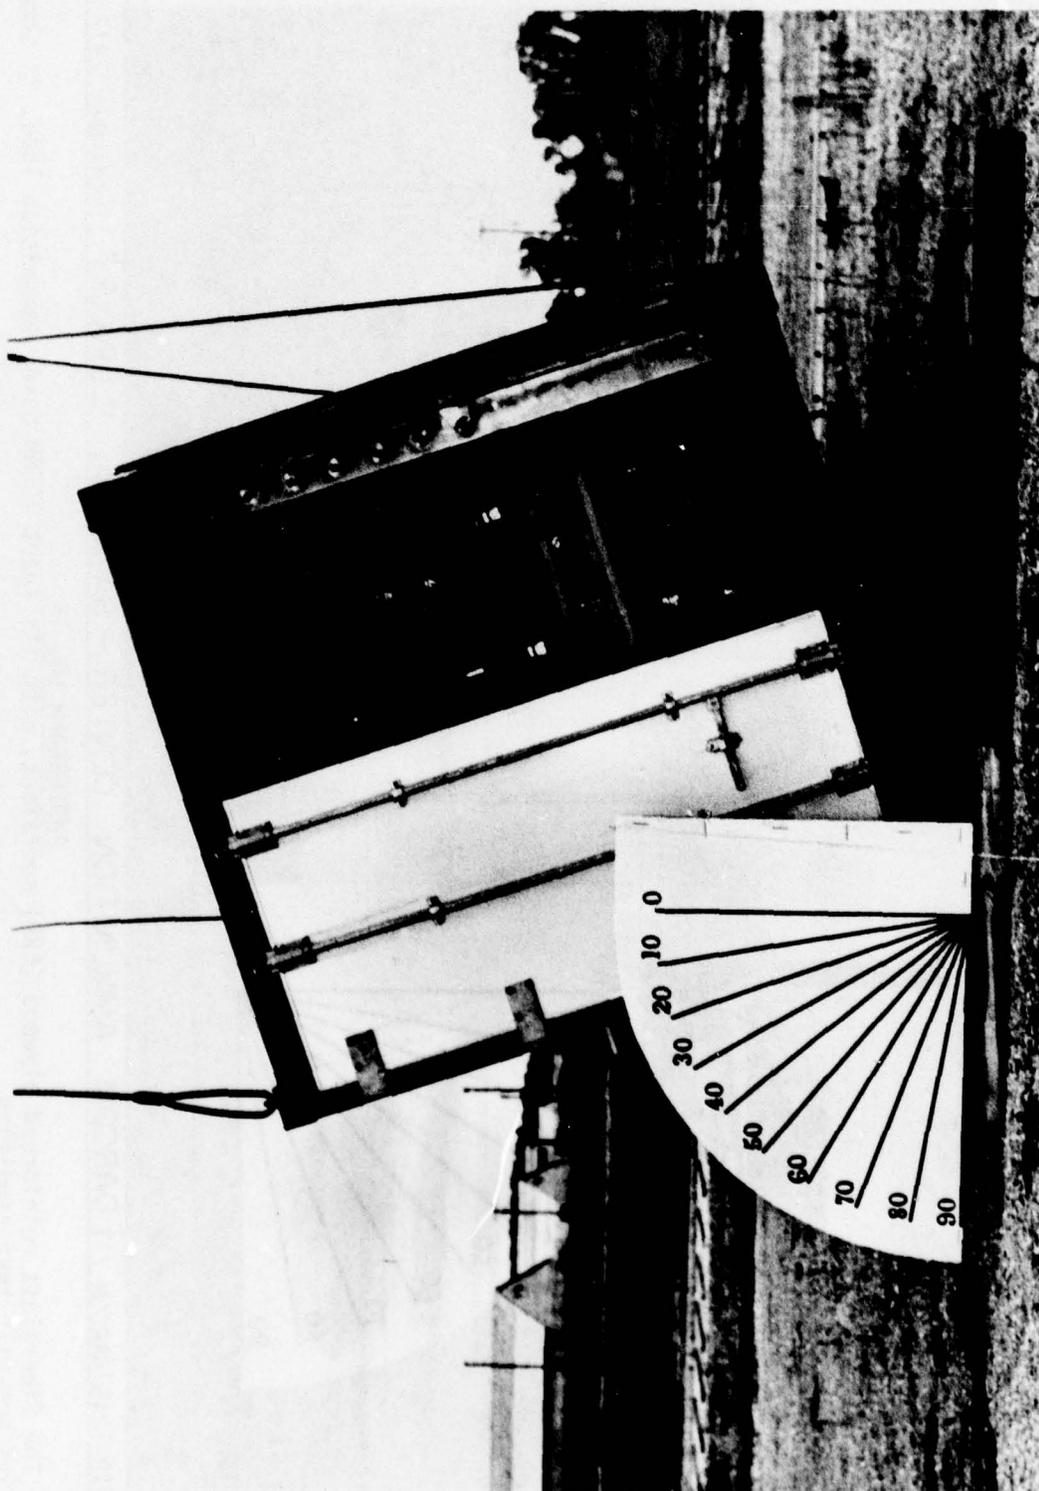
PHOTOGRAPH NO. 16
Each container was tested in ten-degree increments. The subject container (the FRP at a 20-degree tilt in this case) and its lading and dunnage are visually inspected at each level of tilt.

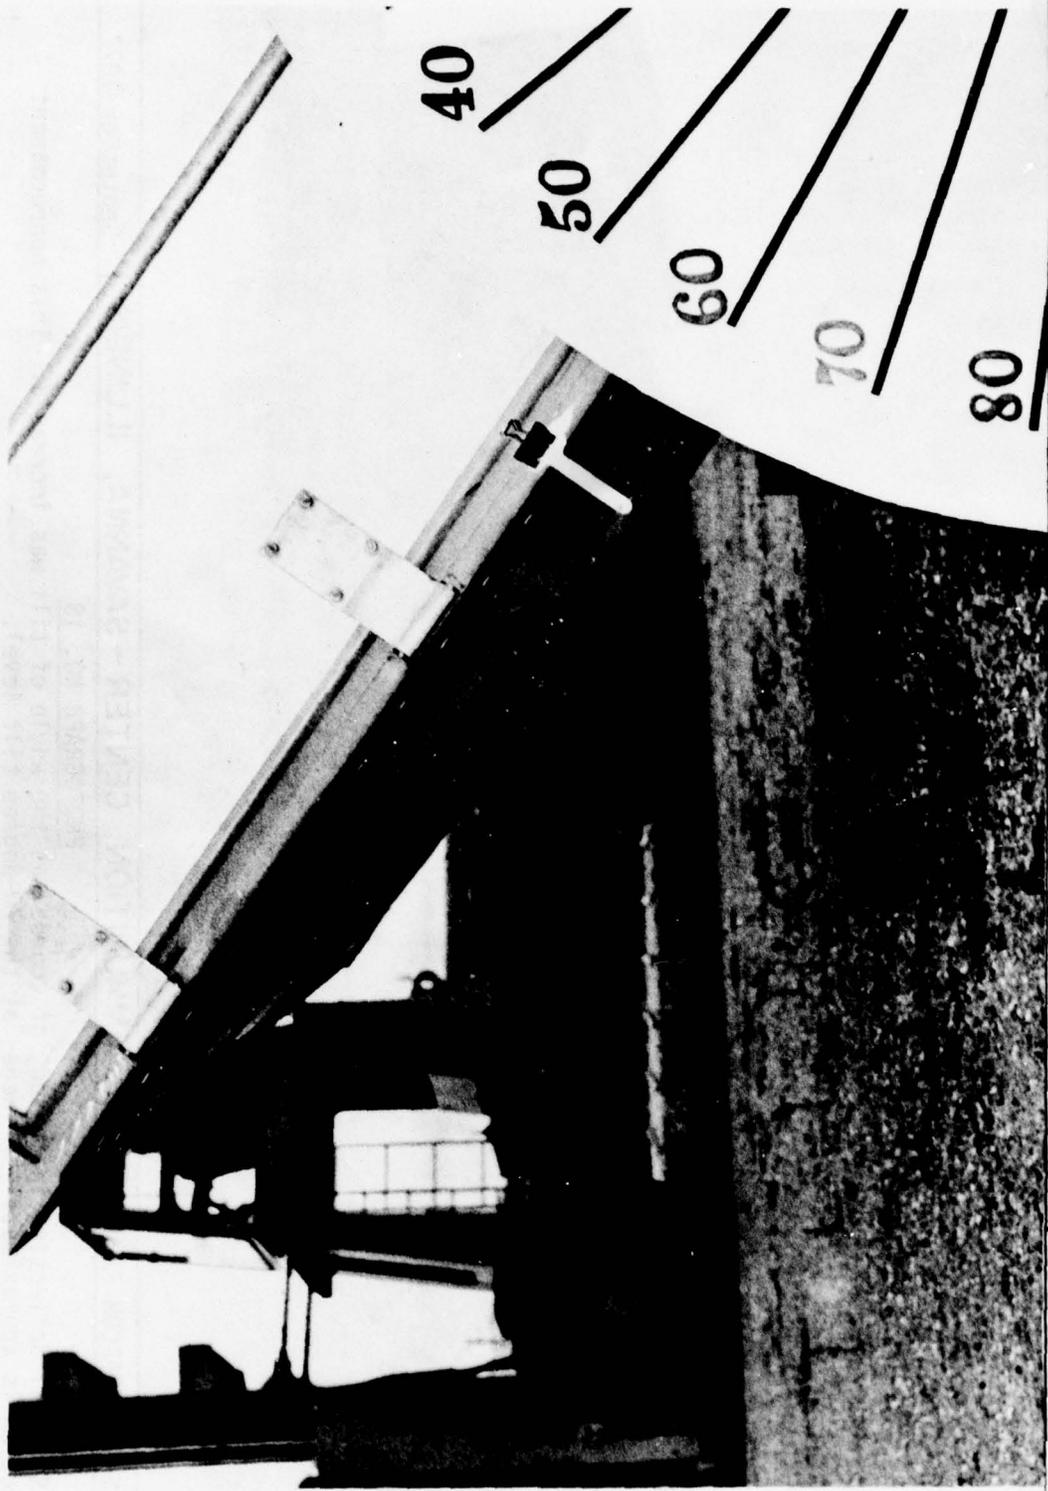
PHOTOGRAPH NO. 17

Slight bulging of the FRP container sidewall occurred at the 50-degree level due to contact with the side blocking.

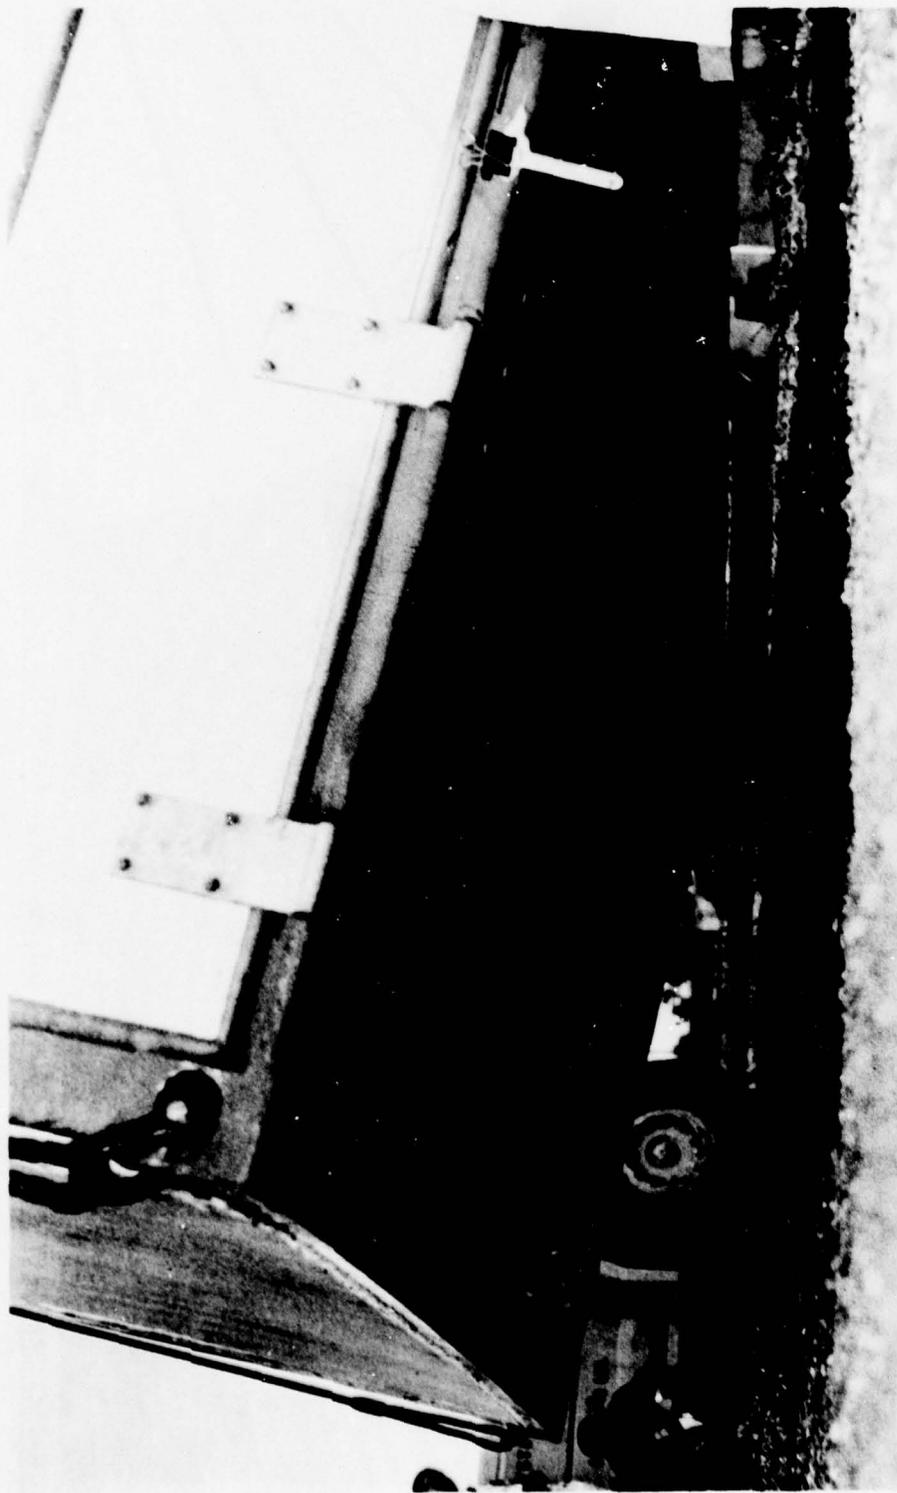
PHOTOGRAPH NO. 18

Sidewall deflection increased, of course, as the angle of tilt was increased. This nonpermanent deflection is approximately 2 inches at the 70-degree tilt level.

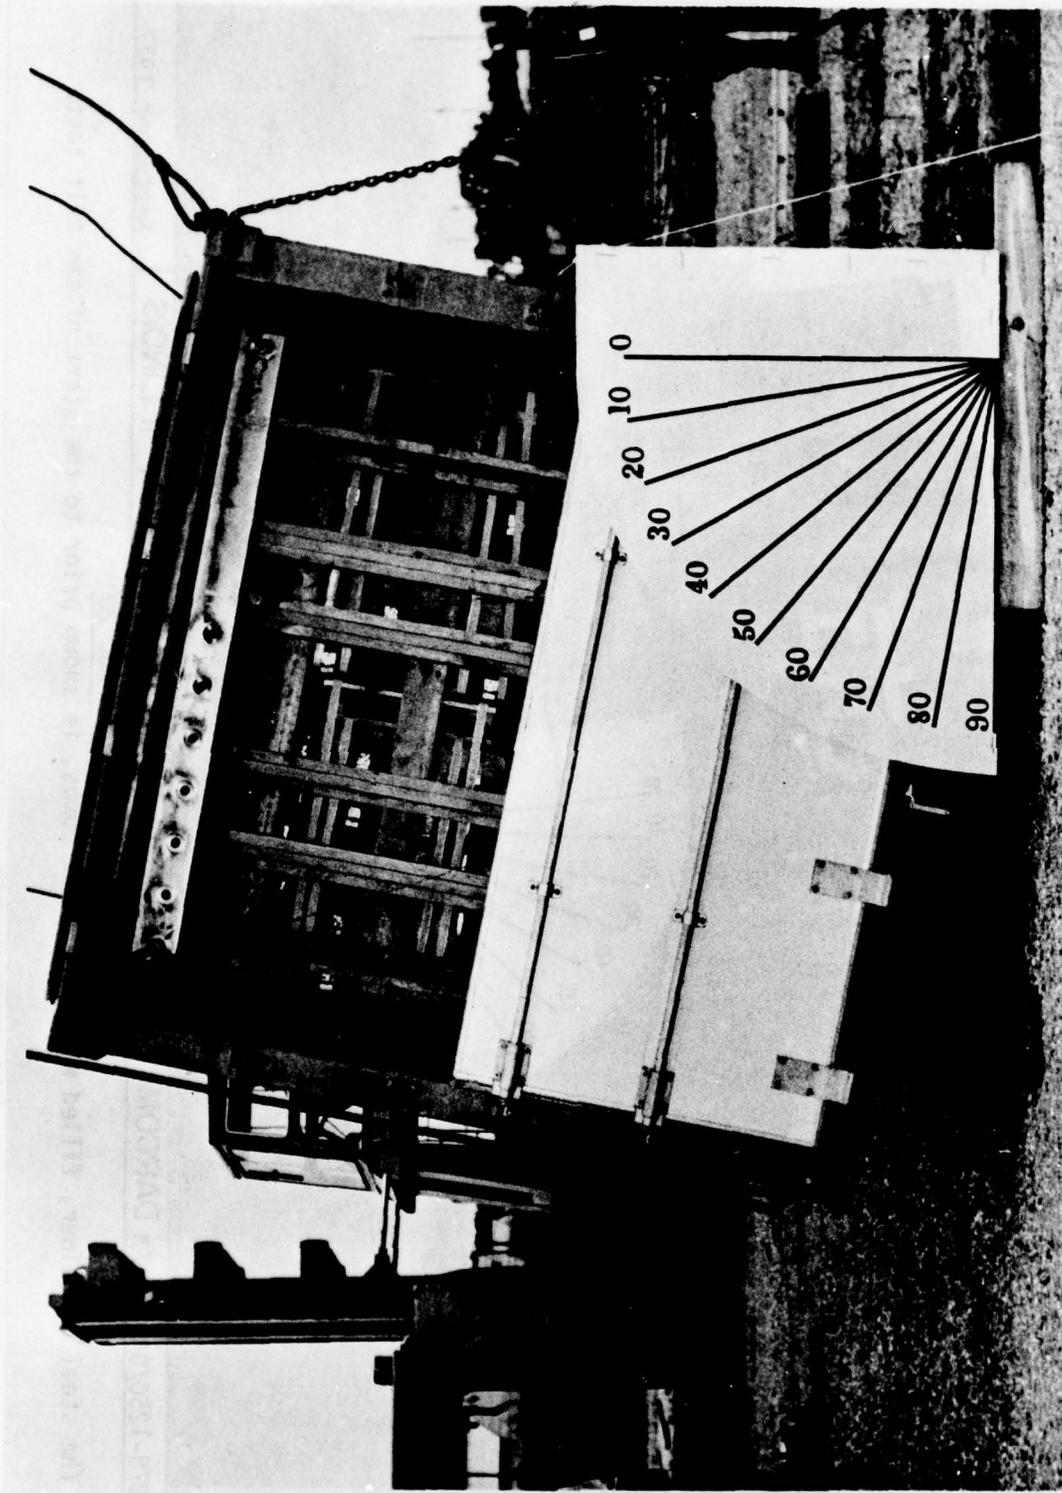
PHOTOGRAPH NO. 19

This photograph details the FRP 105MM ammunition load at the 80-degree maximum tilt. The container was returned to its original level position, where no permanent sidewall deflection was evident.

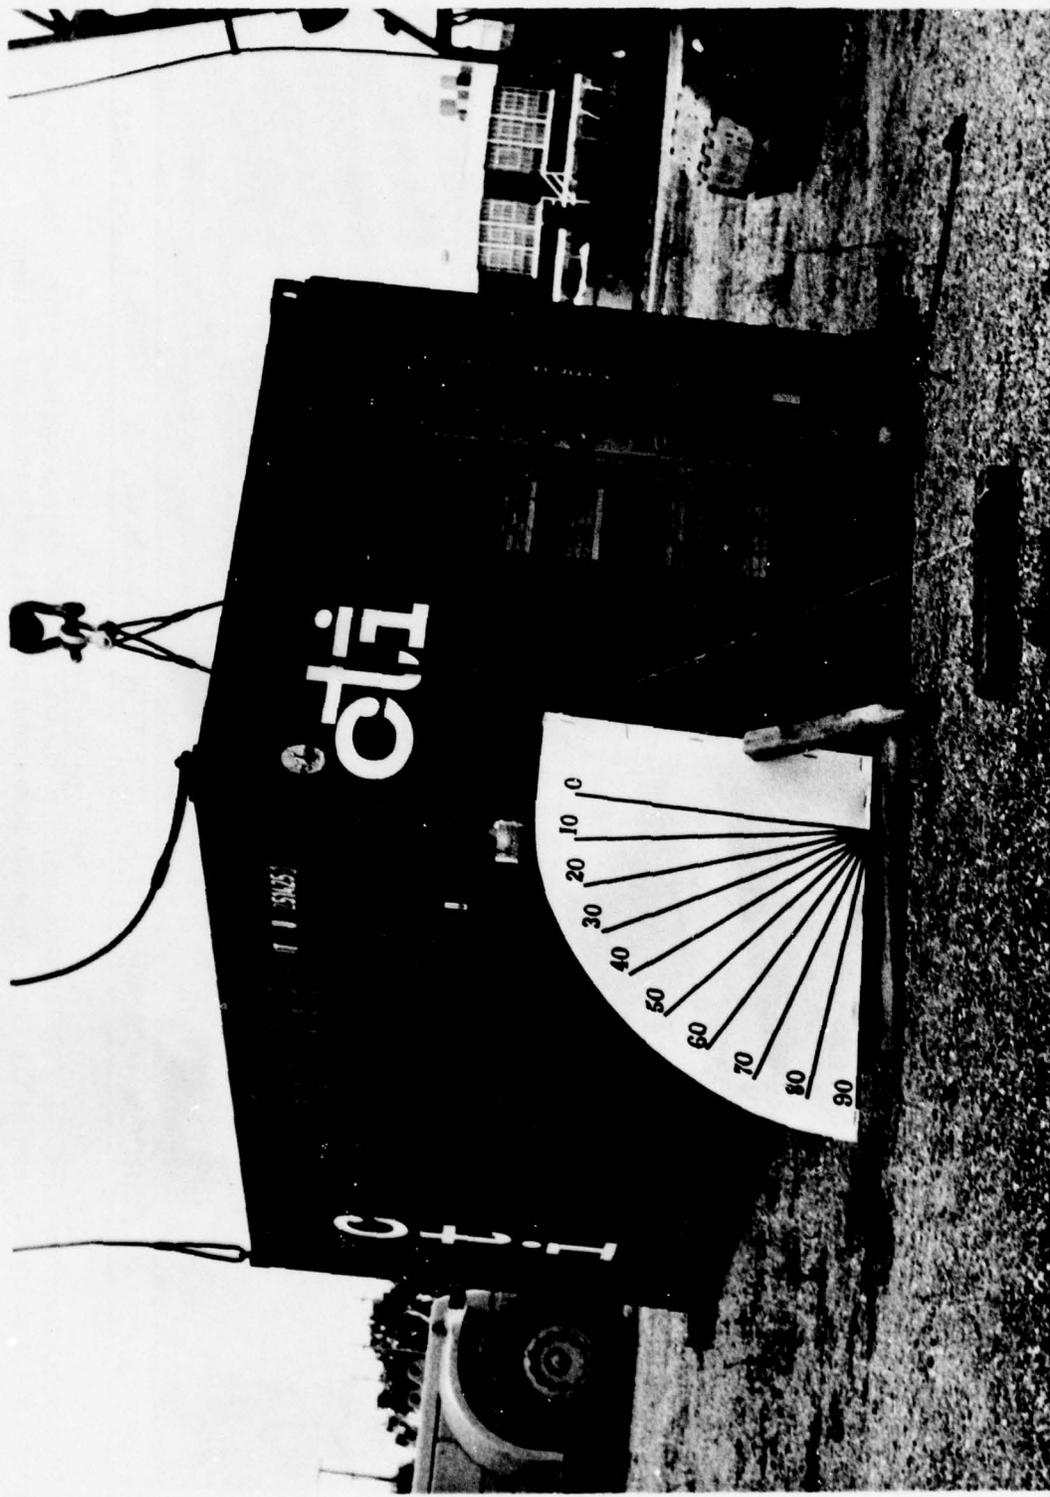
PHOTOGRAPH NO. 20
The steel container, filled with inert MK82 bombs, is shown prior to the start of the tilt test.

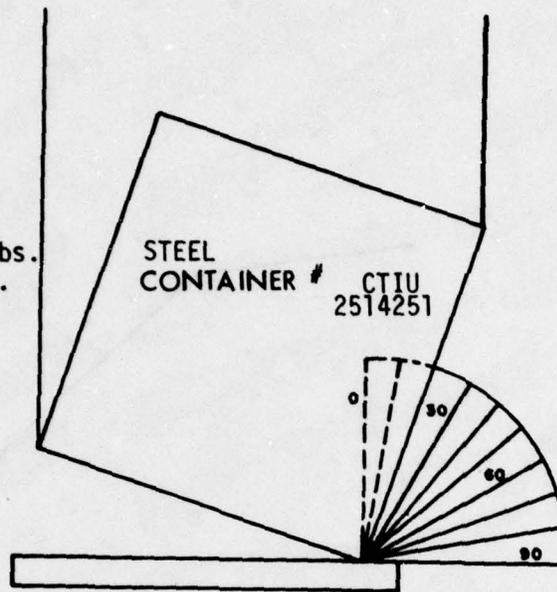
TILT TEST OF STEEL CONTAINER LOADED WITH MK82 BOMBS

TILT DEGREE	SIDEWALL DEFLECTION (inches)	PHOTO NO.	REMARKS
0	0	20	This dunnage system contained no side blocking to keep the load off of the container sidewall.
12	.188		The load contacted the sidewall.
20	.500		No change
30	.688		No change
40	1.188		No change
50	1.875		The lifting function shifted from the "lifting" crane to the two "holding" cranes.
60	3.250	21,22,23	The sidewall of the container began to permanently deform.
78	18.000 (approx.)	24,25, 26,27	The container sidewall failed, with the sidewall contacting the ground while the vertical wall post was 12 degrees off the ground. A resulting lading and dunnage displacement occurred.

The steel container, which contained MK82 bombs, failed the 80 degree tilt test. The Coast Guard official granted a conditional approval contingent on the addition of side blocking to the dunnaging procedure for this containerized ammunition item. This lateral dunnage had not been incorporated in the inert load that was tested.

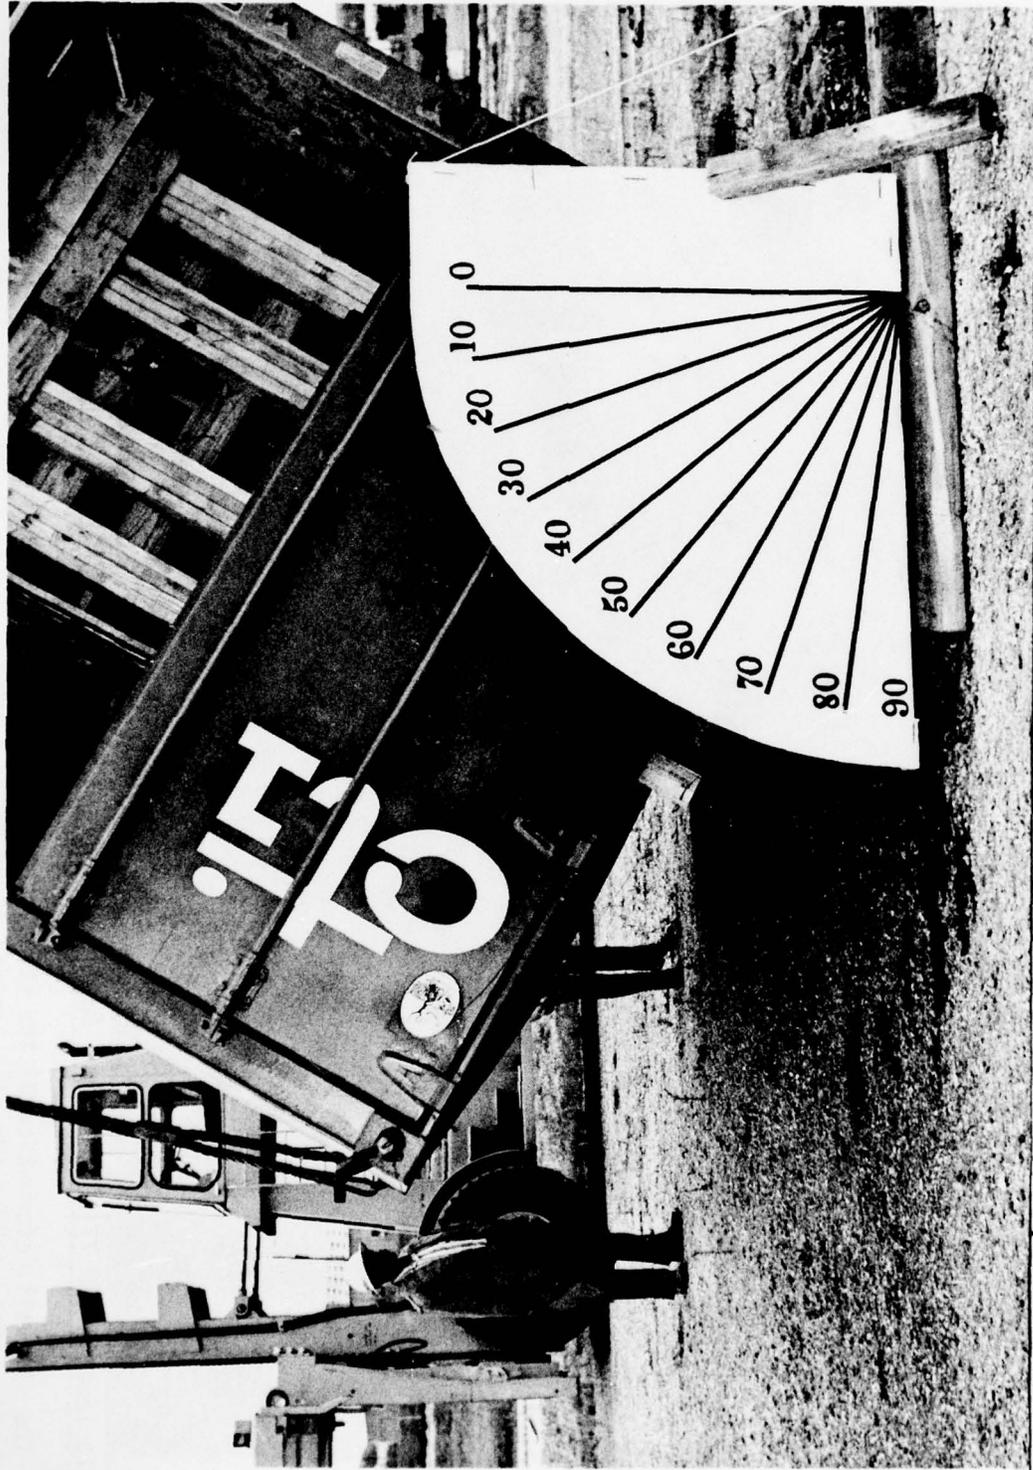
PHOTOGRAPH NO. 21

Sidewall deflection of the steel container, which did not contain side blocking, totaled over 3 inches at the 60-degree angle of tilt.
