6 TRANSPORTABILITY TEST OF
NAVY IRSKIT AMMUNITION RESTRAINT
SYSTEM IN 20-FOOT COMMERCIAL CONTAINERS,

14
REPORT NO. EVT-10-77

EVALUATION DIVISION
DARCOM AMMUNITION CENTER
SAVANNA, ILLINOIS

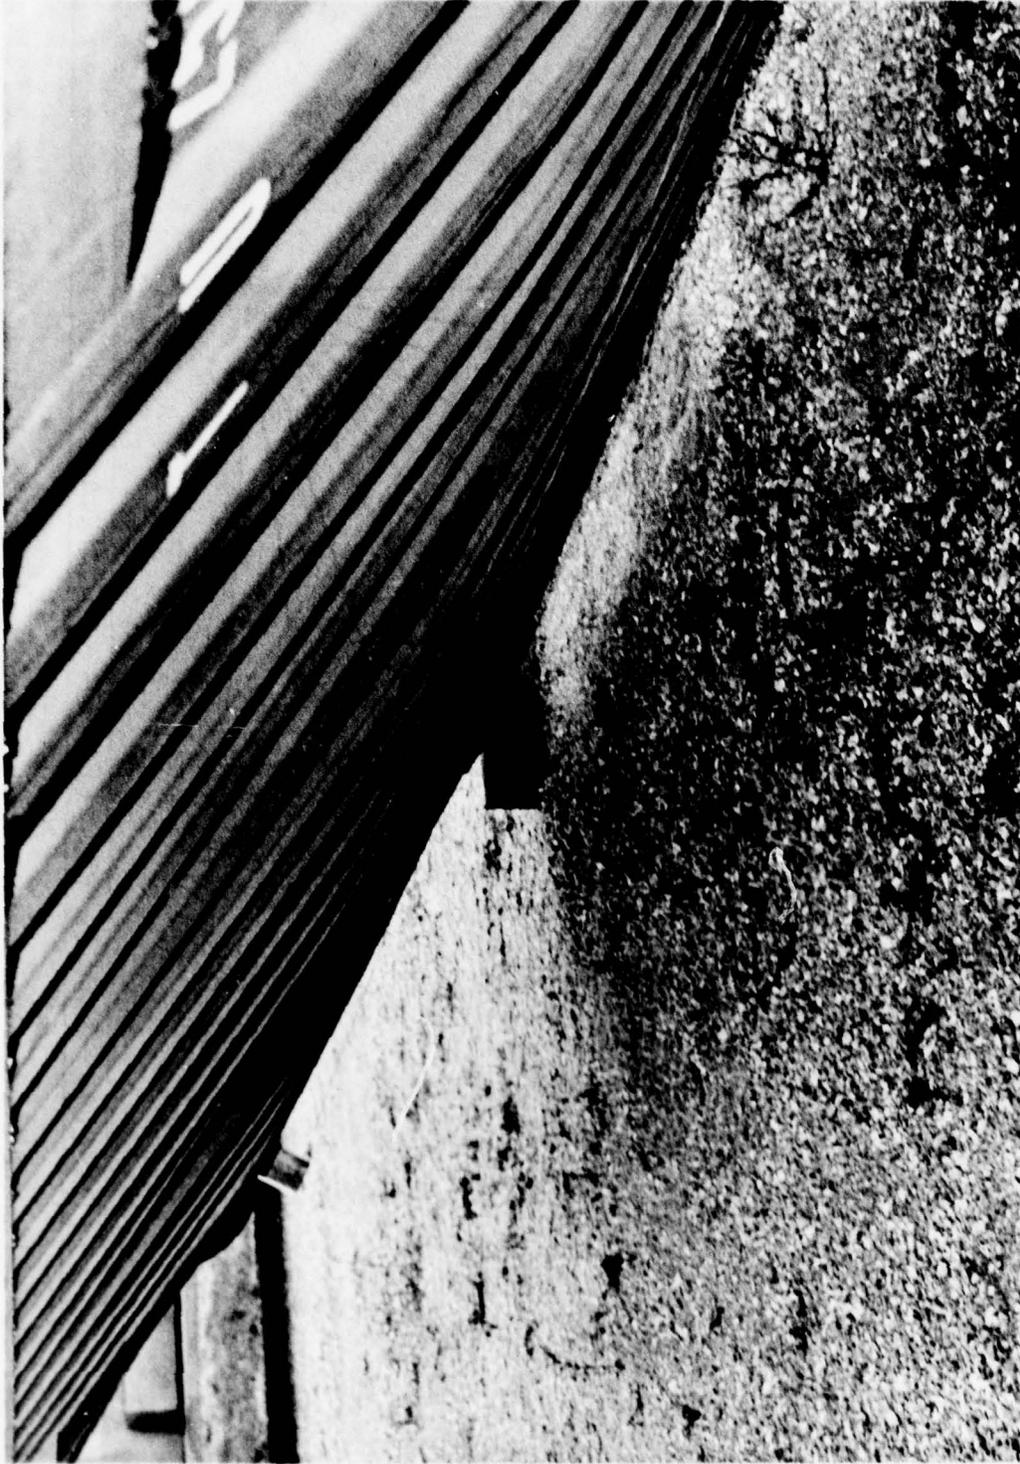
PHOTOGRAPH NO. 22

The sidewall deformation of the steel container at the 60-degree level of tilt was the first permanent deformation noted during the tilt testing program.

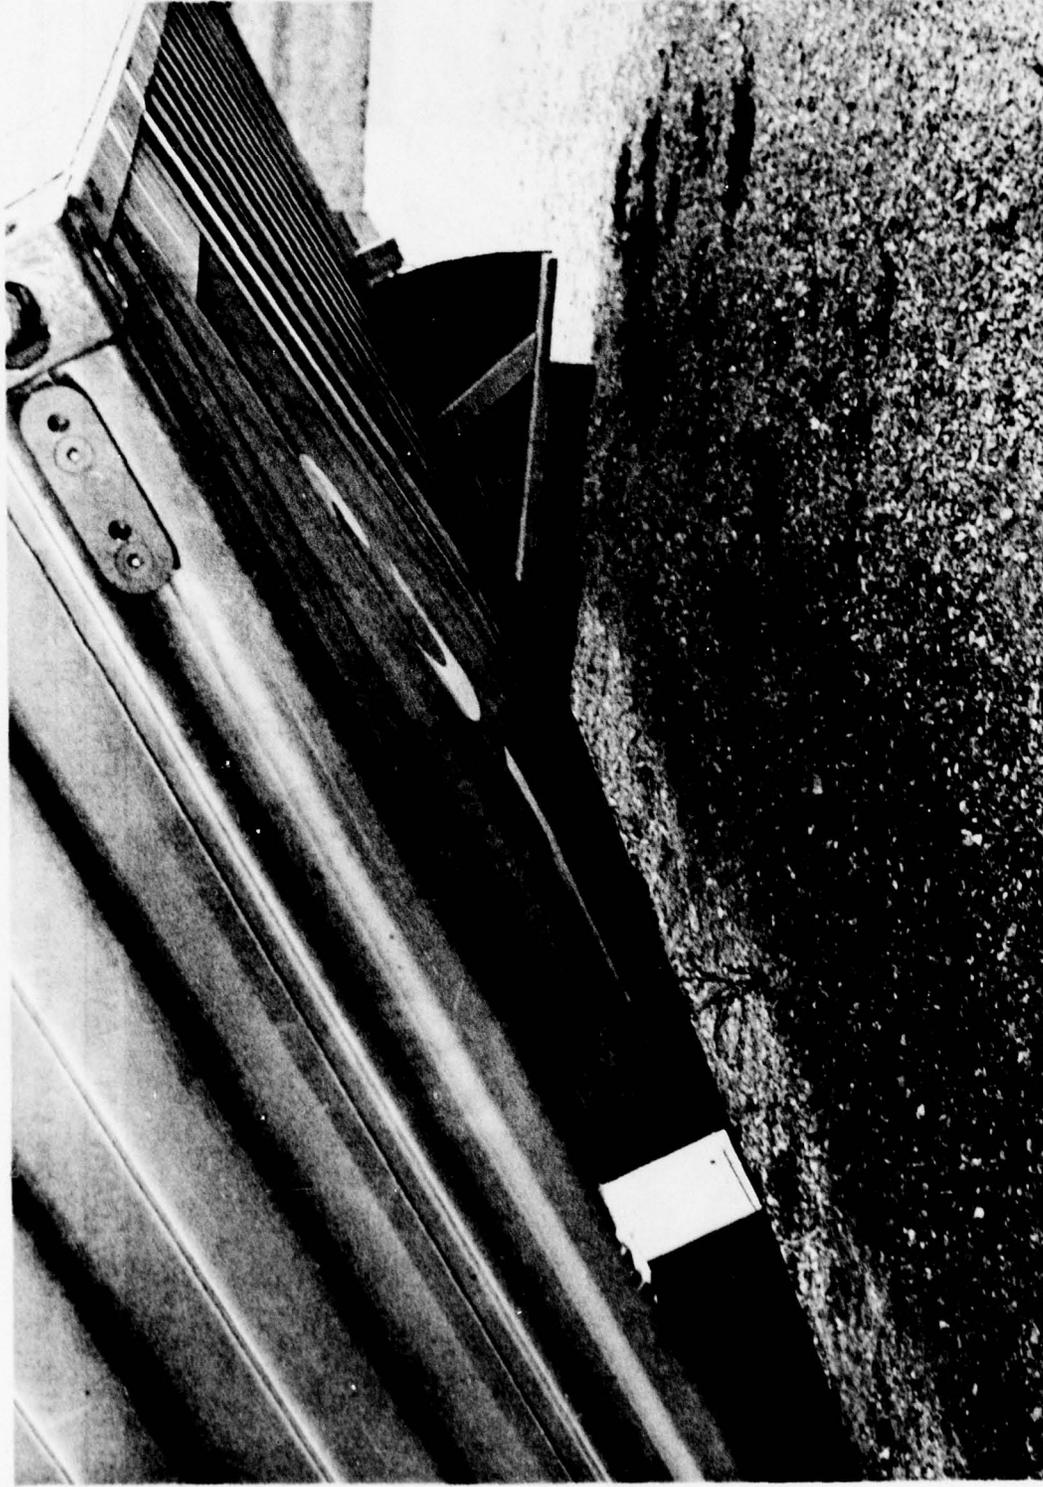
PHOTOGRAPH NO. 23

This photograph from the front of the steel container shows the permanent sidewall deformation from another angle.

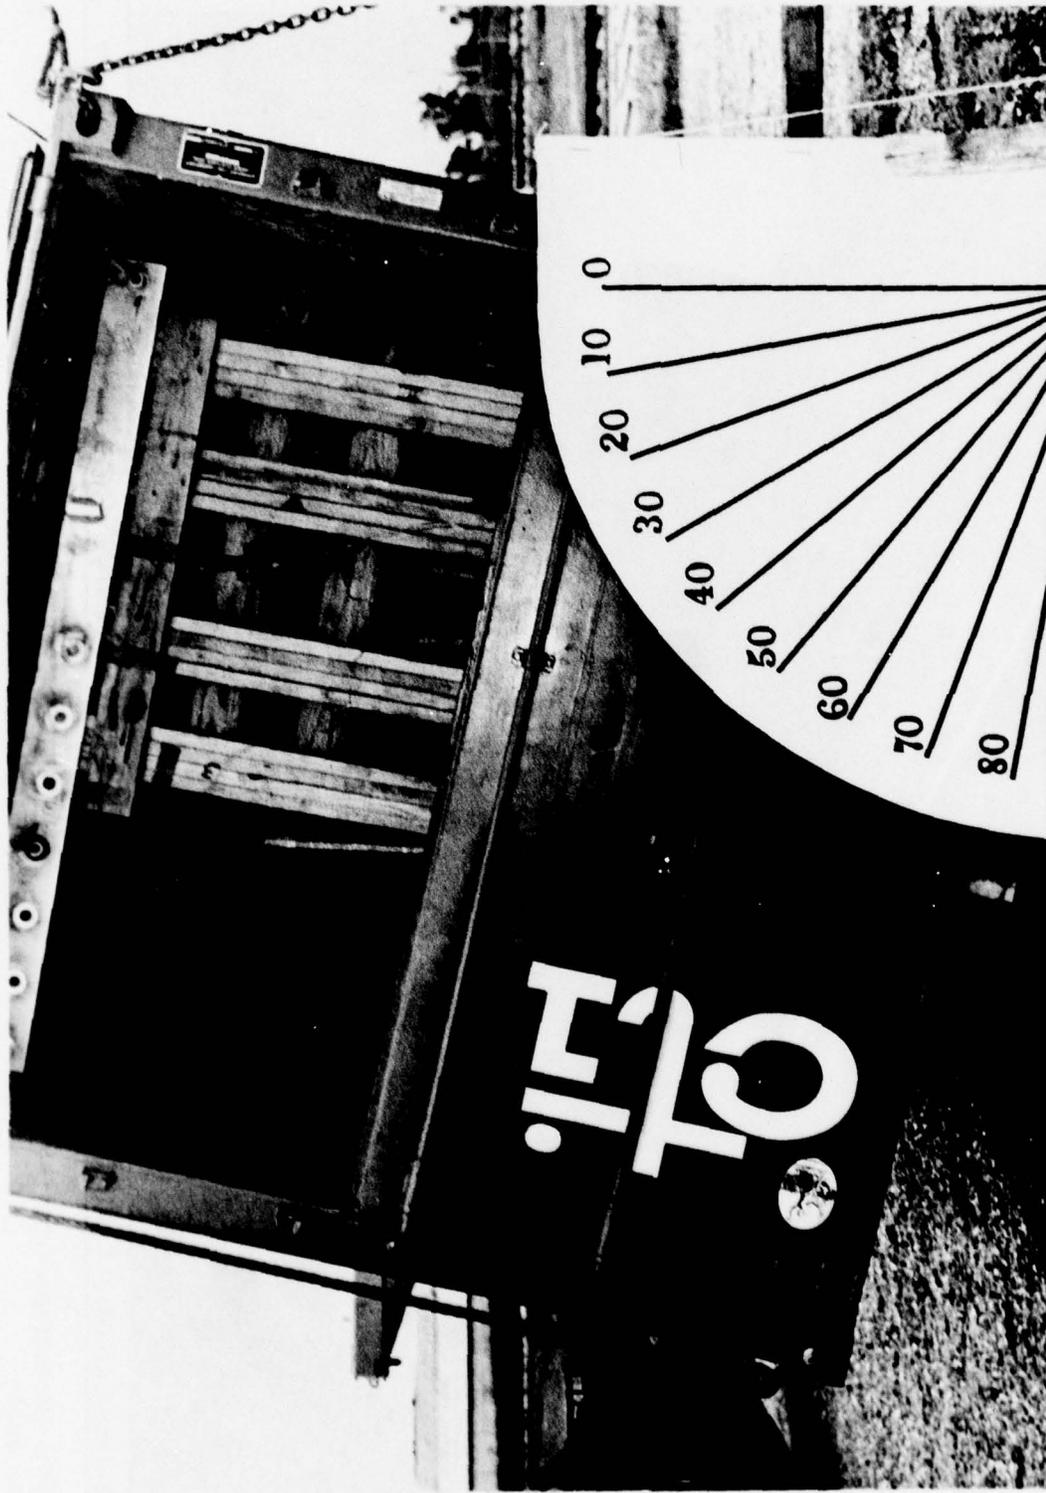
11-078-1254/DARCOM 77 | DARCOM AMMUNITION CENTER - SAVANNA, ILLINOIS | September 1977
PHOTOGRAPH NO. 24
The tilt testing of the steel container was halted at 78 degrees due to failure of the container sidewall.

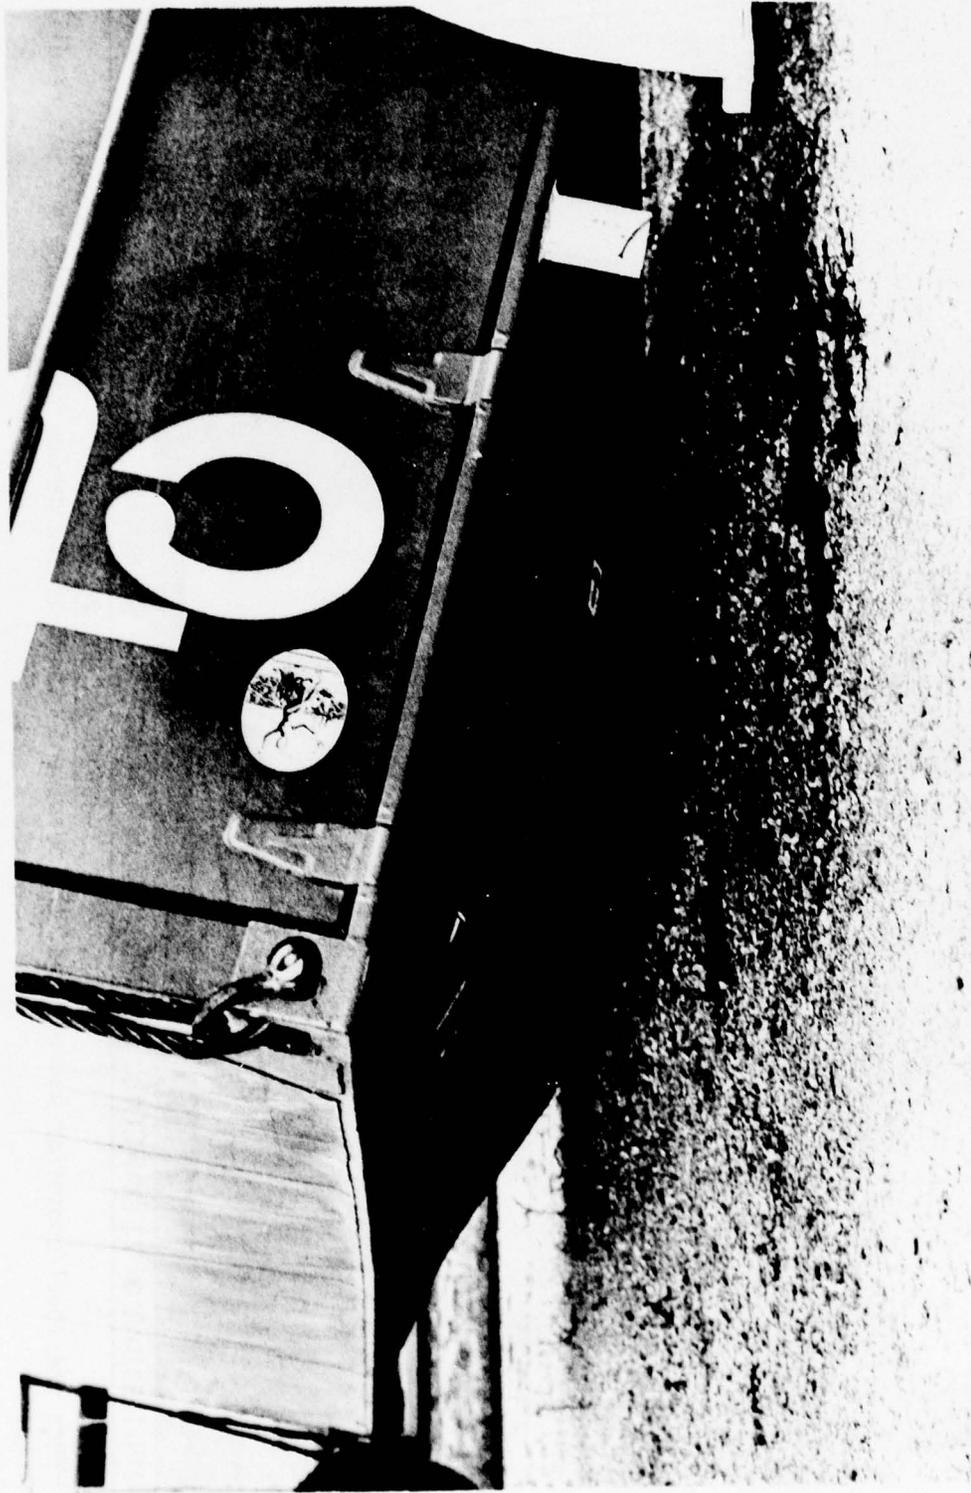
PHOTOGRAPH NO. 25

Side wall failure of the steel container, due to an absence of side blocking, was sufficiently severe to allow the sidewall to deflect in excess of 12 degrees from its original condition.

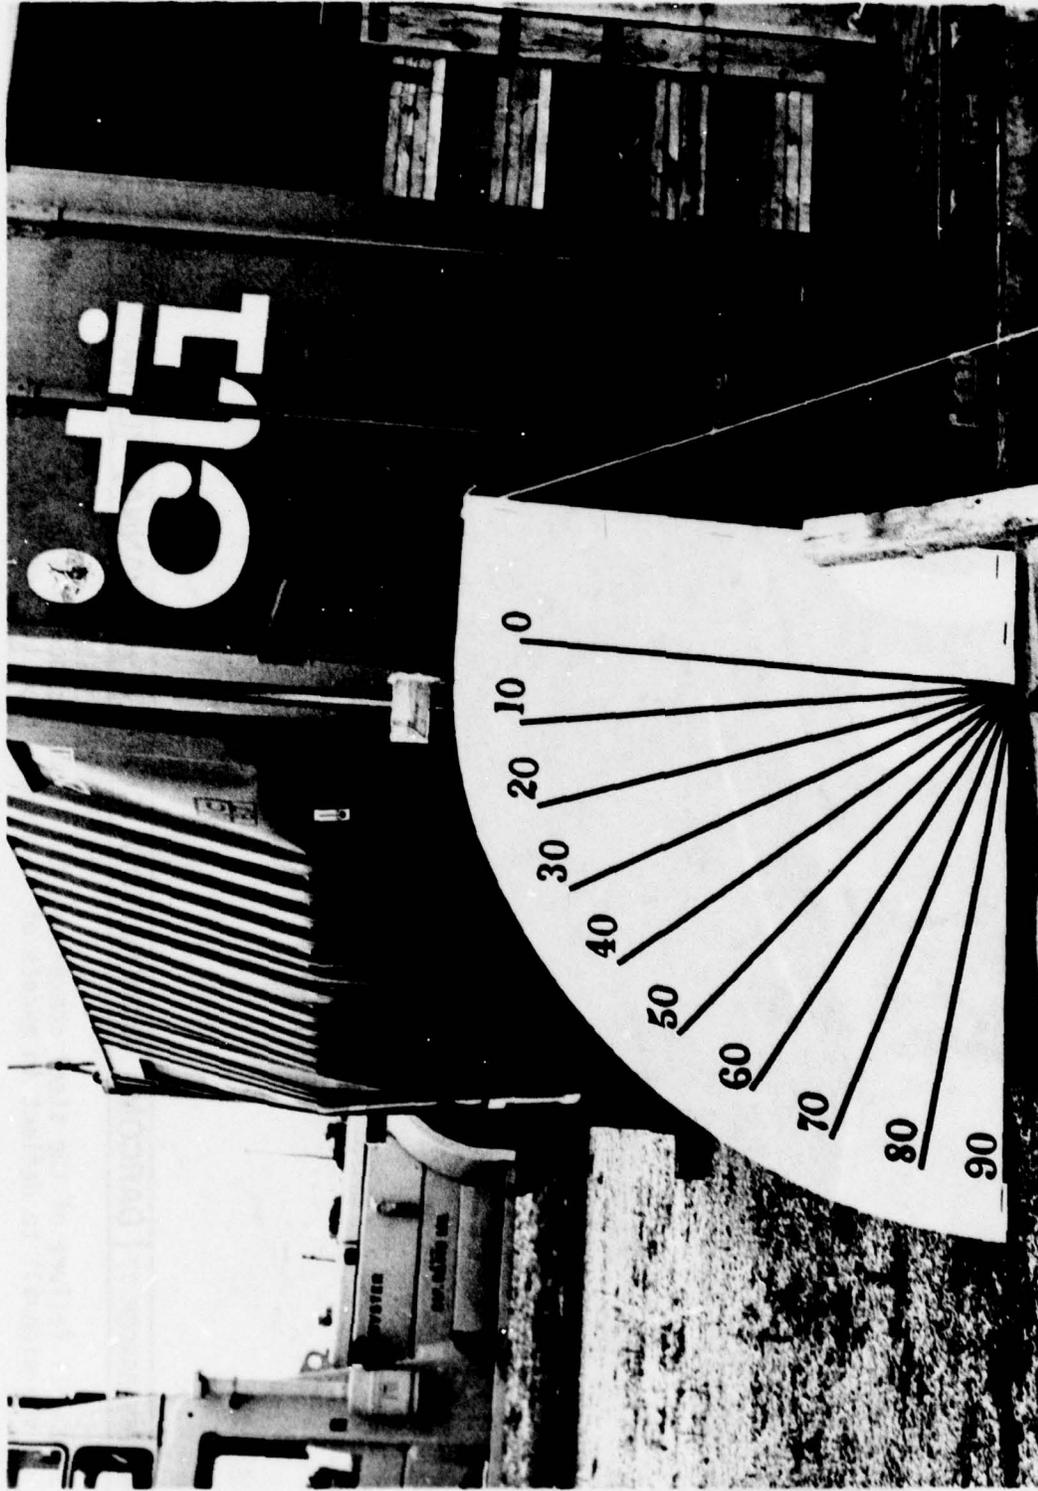
PHOTOGRAPH NO. 26

When the steel container was righted, the permanent nature of the damage to the container was readily apparent.

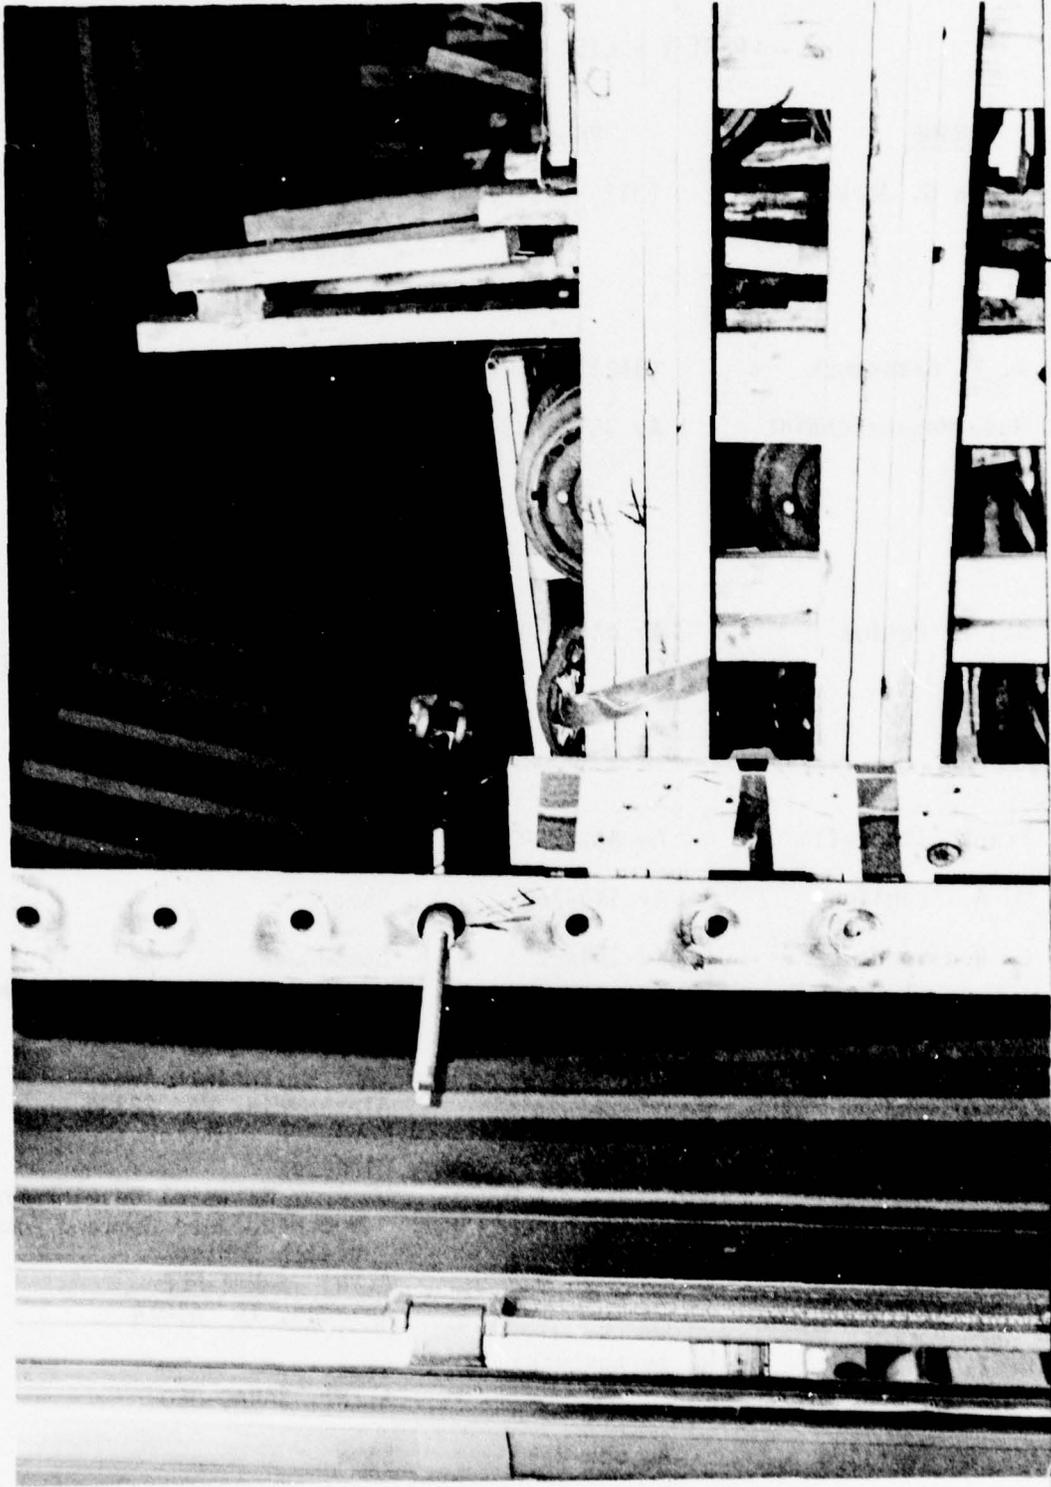
PHOTOGRAPH NO. 27

A post tilt test inspection of the steel container revealed displaced dunnage and inert Mk82 bombs. Direct contact of the bombs with the container sidewall caused sidewall localized loading and failure.

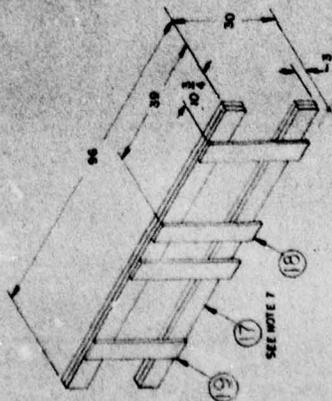
DETAIL J
REAR SIDE BLOCKING ASSEMBLY
(12 REQ'D)

THE LEFT HAND SIDE BLOCKING ASSEMBLY
IS SHOWN. A "RIGHT" AND A "LEFT" SIDE
BLOCKING ASSEMBLY IS REQUIRED.

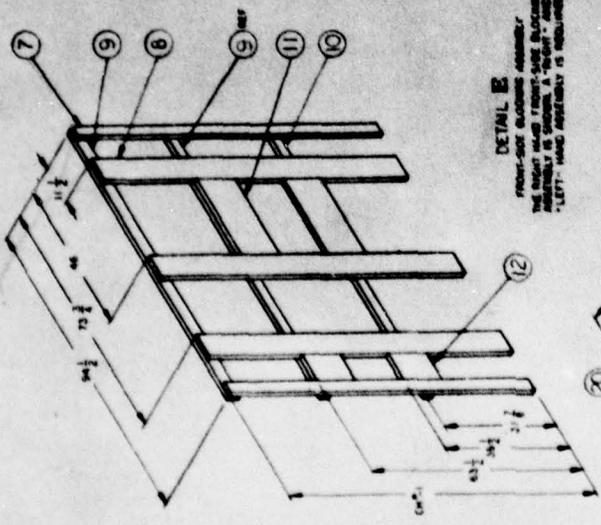
DETAIL E
FRONT-END BLOCKING ASSEMBLY
THE RIGHT HAND FRONT-SIDE BLOCKING ASSEMBLY IS SHOWN. A "LEFT" AND "RIGHT" HAND ASSEMBLY IS REQUIRED.

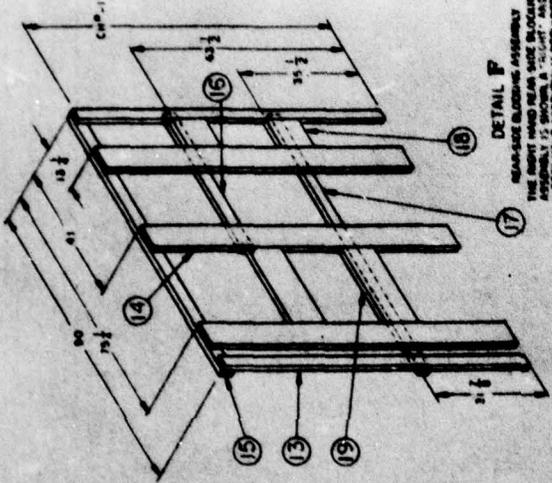
DETAIL F
REAR-END BLOCKING ASSEMBLY
THE RIGHT HAND REAR-SIDE BLOCKING ASSEMBLY IS SHOWN. A "LEFT" AND "RIGHT" HAND ASSEMBLY IS REQUIRED.
