**SKIN FRICTION DRAG DUE TO NUCLEAR DAMAGE**

The Boeing Aerospace Company  
P.O. Box 3999  
Seattle, Washington 98124

(9) Final Report, for Period February 1977 - September 1977,

CONTRACT No. DNA 001-77-C-0090

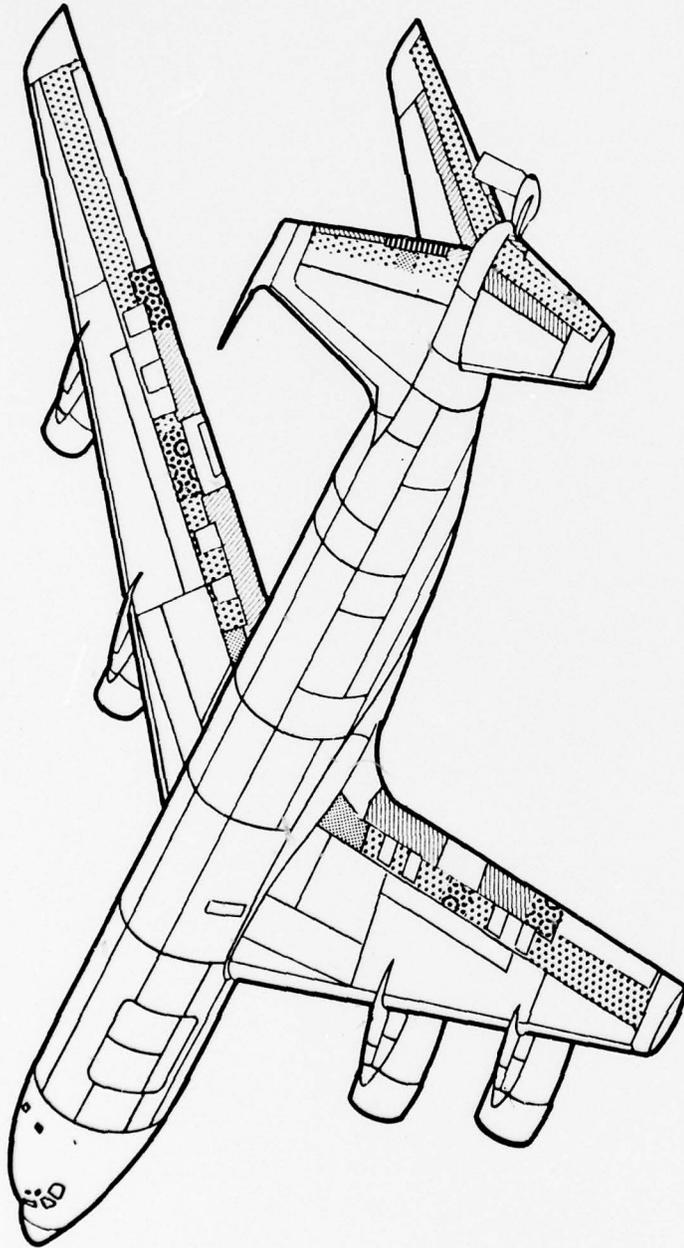
FIGURE 2-1

- ALUMINUM HONEYCOMB, 0.016" OUTER SKIN - 225 SQ. FT./8.7 SQ. FT. VERTICAL TAIL
- 0.018 BONDED ALUMINUM SKIN - 255 SQ. FT./83.9 SQ. FT. VERTICAL TAIL
- ALUMINUM HONEYCOMB, 0.010" OUTER SKIN - 7.0 SQ. FT.
- 0.020 BONDED ALUMINUM SKIN, - 33 SQ. FT./3.5 SQ.FT. VERTICAL TAIL
- ALUMINUM HONEYCOMB, 0.020" OUTER SKIN - 54.2 SQ.FT .

Thin Skin Panels on the KC-135

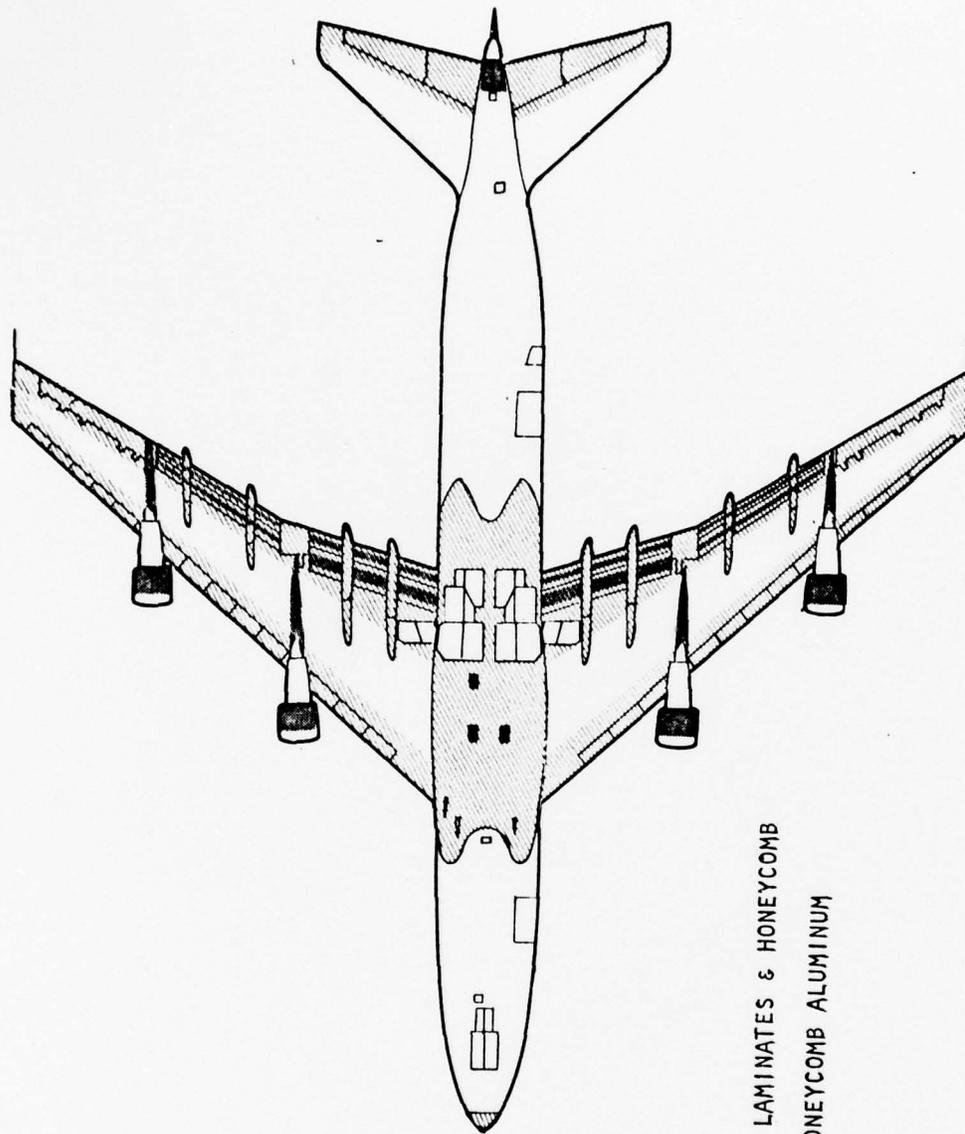
FIBERGLASS LAMINATES & HONEYCOMB  
BONDED & HONEYCOMB ALUMINUM

Thin Skin Panels on the 747

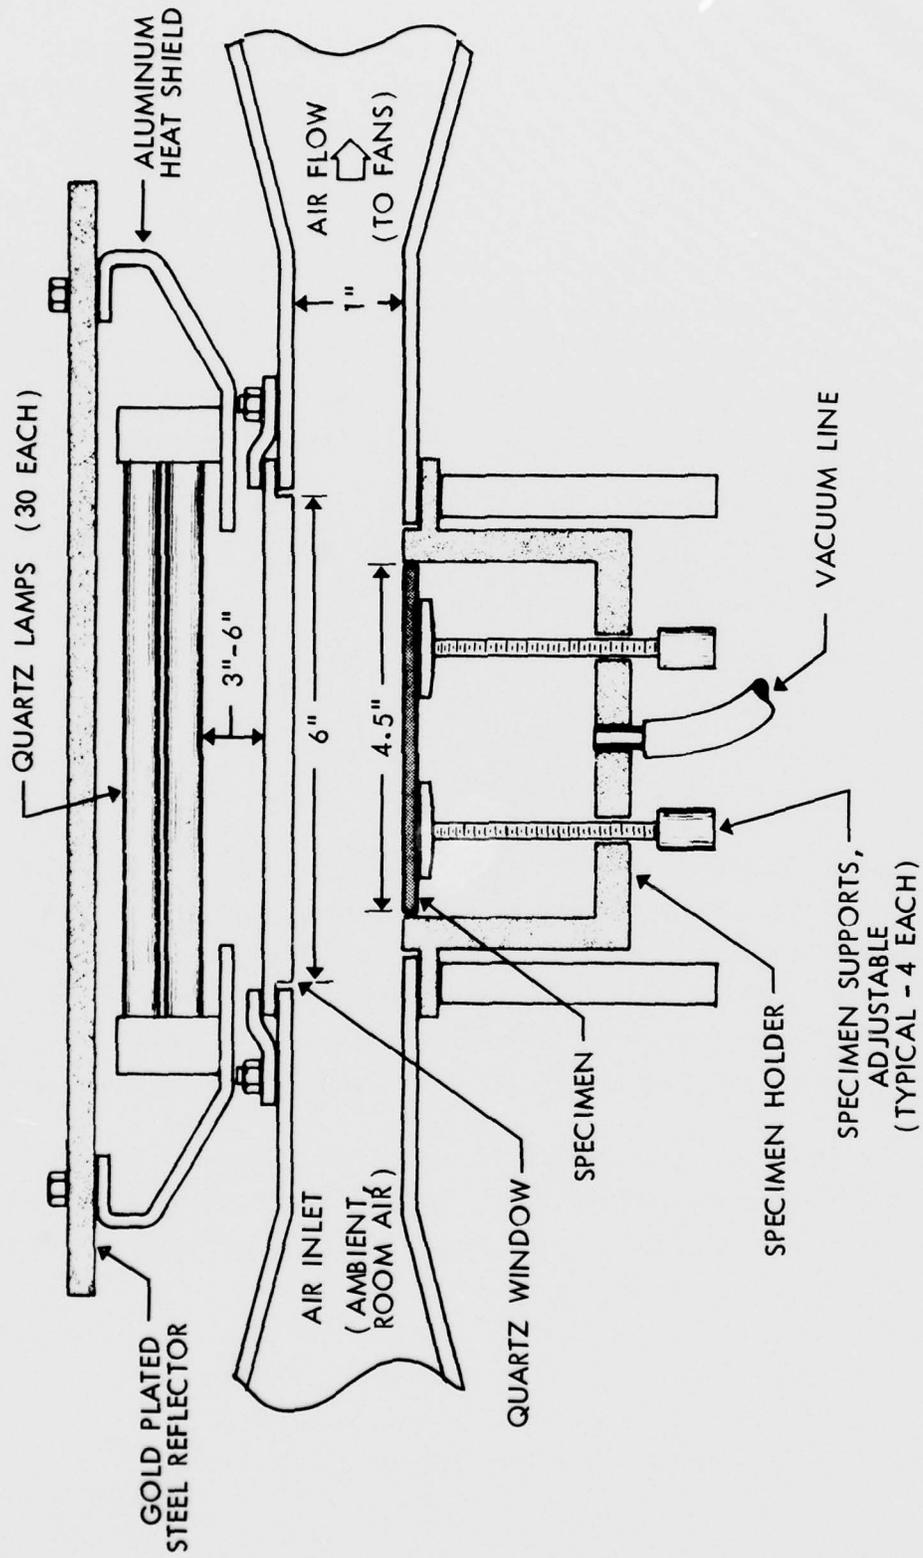
Figure 3-1 Plan View, AFML Quartz Lamp Bank - Wind Tunnel Facility

Studies of flux intensity over the specimen area show considerable nonuniformity. The center of the specimen face always has the highest flux, with lower, but not necessarily uniformly lower, fluxes toward the specimen edges. Toward the upper flux limit, the center area peak flux is approximately 30% higher than the lowest reading near the edge of the specimen. At lower peak fluxes the difference between the center (high) reading and the lowest edge reading decreases to a minimum of 15%. Appendix I contains several "maps" showing peak flux readings at various points over the specimen face area.

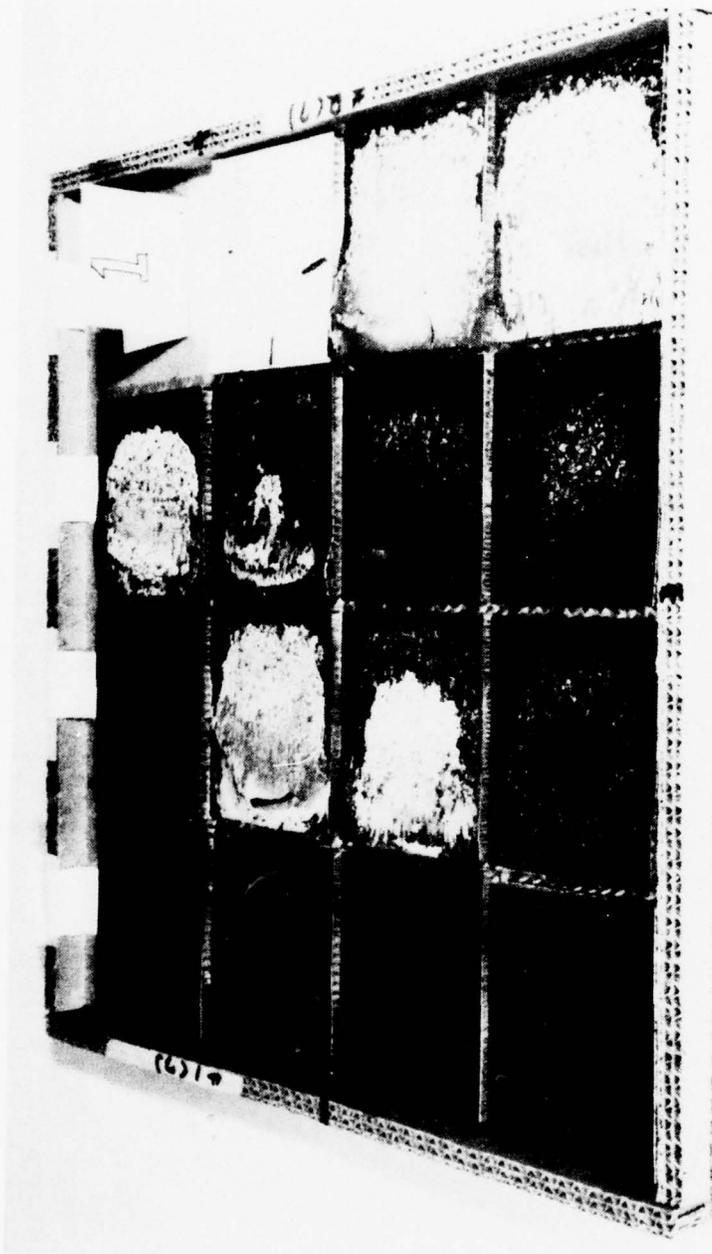
Figure 3-2 Specimens 1 and 2. Black enamel over thin aluminum. The wind flow was from right to left and the exposure increases going from bottom to top, then left to right. (Note: Specimen 1 -1 is back to front.)

The "standard" enamel system (MIL-P-23377 epoxy primer plus MIL-C-83286 polyurethane enamel) has a thermal degradation response and thermal capability essentially identical to the lacquer system (MIL-P-23377 plus MIL-L-81352) and the polysulfide primer/enamel (23-X series) coatings. The coating would first lose gloss; it would then form small blisters which would break open to produce a roughened surface and expose the yellow primer. Next the paint would burn completely off starting in the center of the specimen face and as exposure levels increased, progressing toward the edges of the specimen. This sequence is illustrated in Figures 3-2, 3-3 and part of 3-4.

The aluminum substrates demonstrated a quite consistent degradation pattern, i.e., the initial effect was warping and delamination of the face sheet which would typically start on the down stream edge. The degree of warpage and the amount (area) of delamination would increase as the exposure levels increased. Eventually an area of skin toward the downstream edge would disintegrate. Typically there was no evidence of liquefaction. Rather, the failure edges indicate a crystalline type failure. As aluminum face sheet thickness increased, the damage threshold and total thermal capability increased. (Figure 3-2, and Figure 3-4, specimen 25)

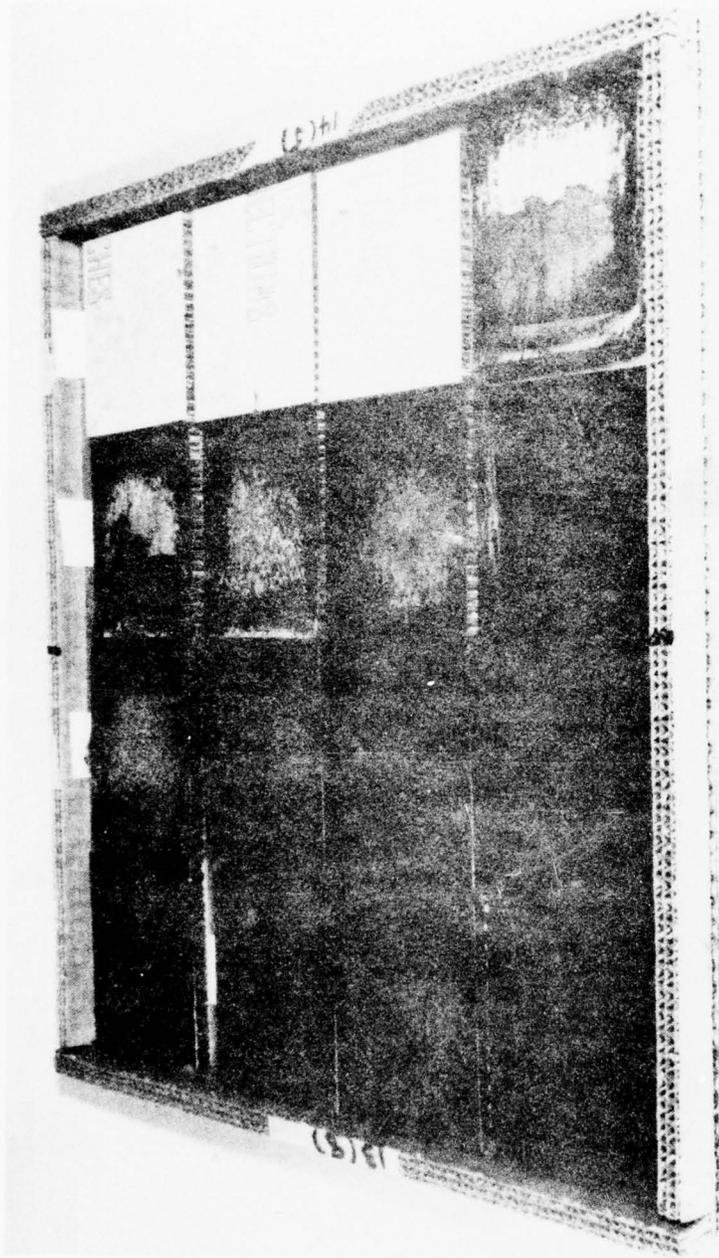
Figure 3-3 Specimens 13 and 14. Black enamel over E-fiberglass.  
(Sequence is bottom to top, left to right.)

The epoxy fiberglass substrates also demonstrated a consistent thermal degradation mode, i.e. the surface would char, char depth would increase, small areas of top ply delamination would appear, the downstream edge of the top ply would start to fray, then up to half of the first ply would disintegrate leaving some fibers still attached at one end. By this point the second ply was typically showing char and some delamination. Total thermal capability increased as total face thickness increased. There was very little difference between the 250<sup>0</sup>F and the 350<sup>0</sup>F cure epoxies either in threshold damage exposure level or in total thermal capability. (Figure 3-3, and Figure 3-6)

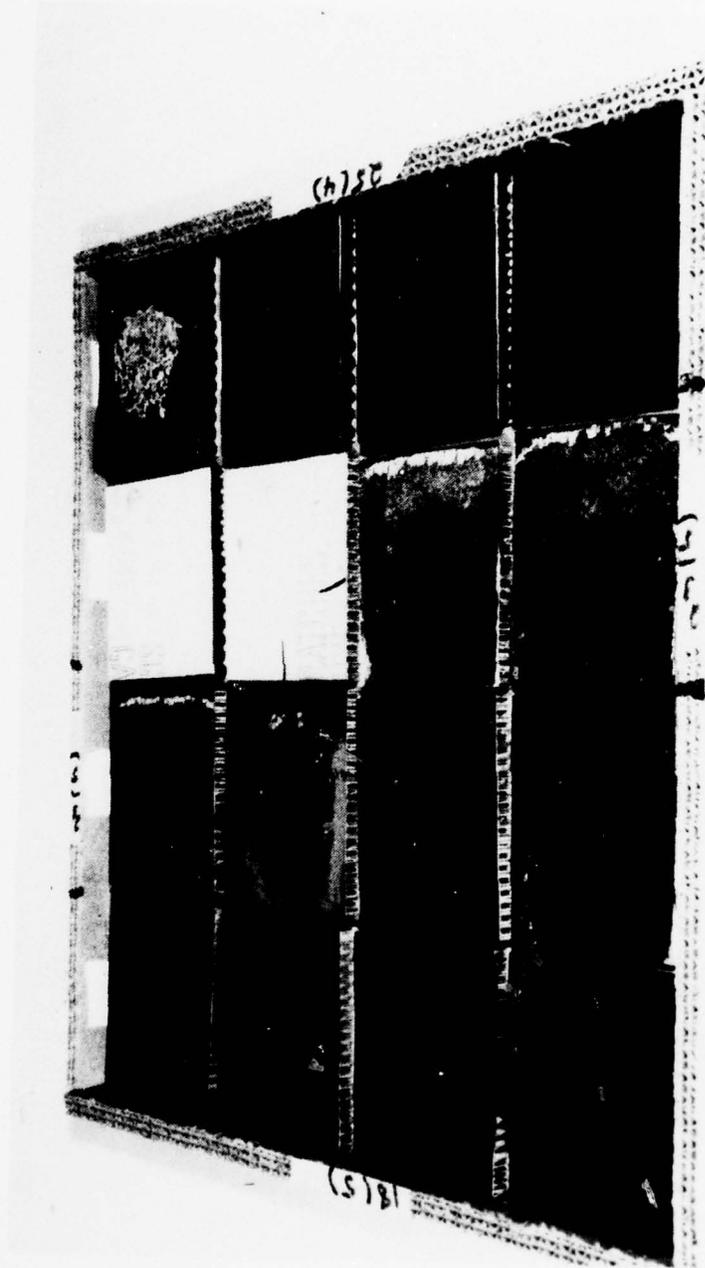
Figure 3-4 Specimens 18, 23 and 25. Numbers 18 and 23 are fiberglass with Astrocoat and enamel respectively, while 25 is a thick aluminum skin (40 mils) with enamel. (Sequence is bottom to top and then left to right.)

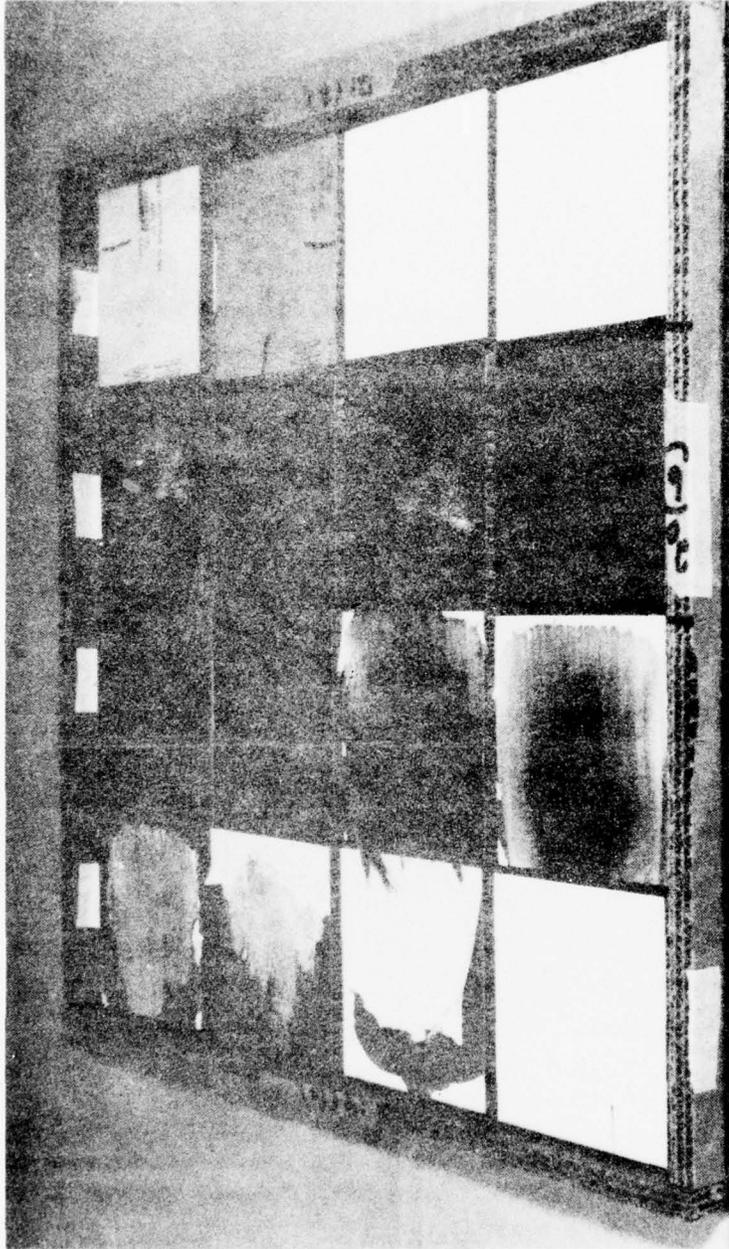
Figure 3-5 Specimen 19, 20 and 21. Fiberglass with Astrocoat and fluorocarbon coatings.  
(Sequence is bottom to top and then left to right.)

The high temperature resistant fluorcarbon coatings (20-X and 21-X) showed, as would be expected, a considerably higher thermal capability than the Astrocoat. The black over white system showed a surface flow quite comparable to the Astrocoat. However, throughout the ablation the surface stayed dark grey, i.e. significant amounts of the black carbon pigment remained mixed into the ablating surface. (Figure 3-5)

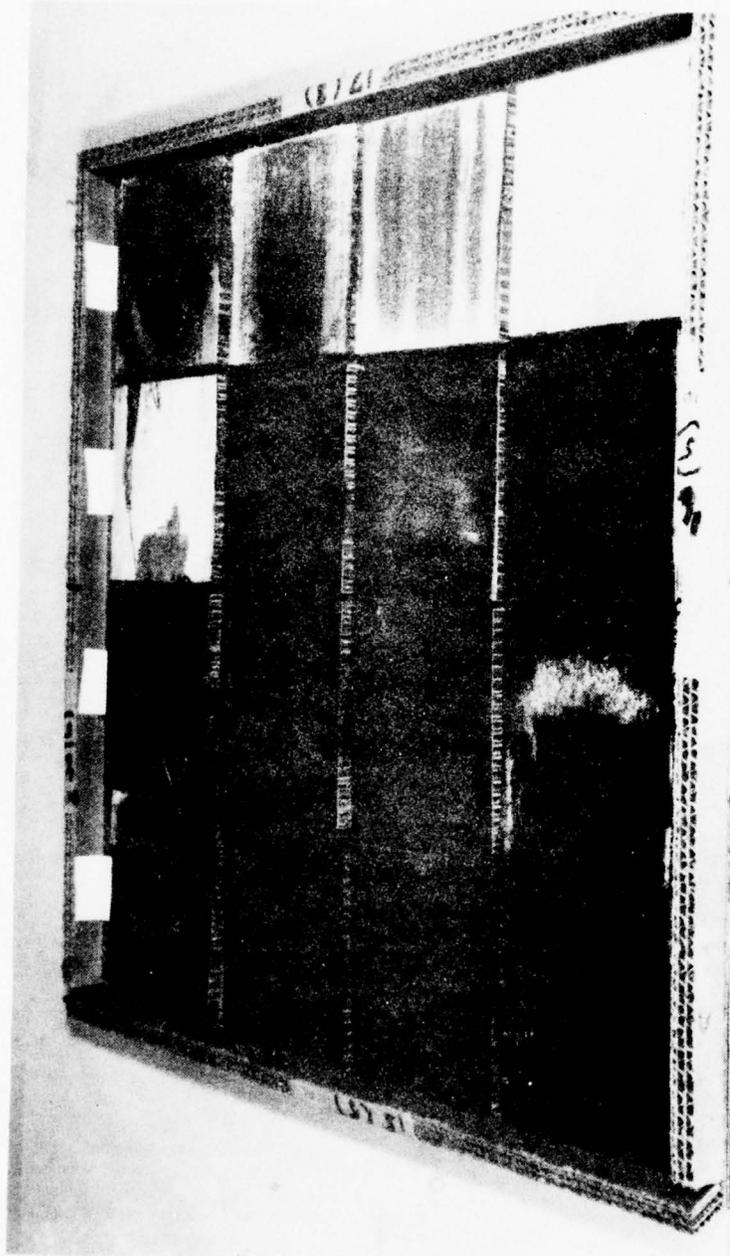
Figure 3-6 Specimens 15 and 16, enamel over fiberglass, and specimen 17, Astrocoat over fiberglass. (Sequence is bottom to top and then left to right.)

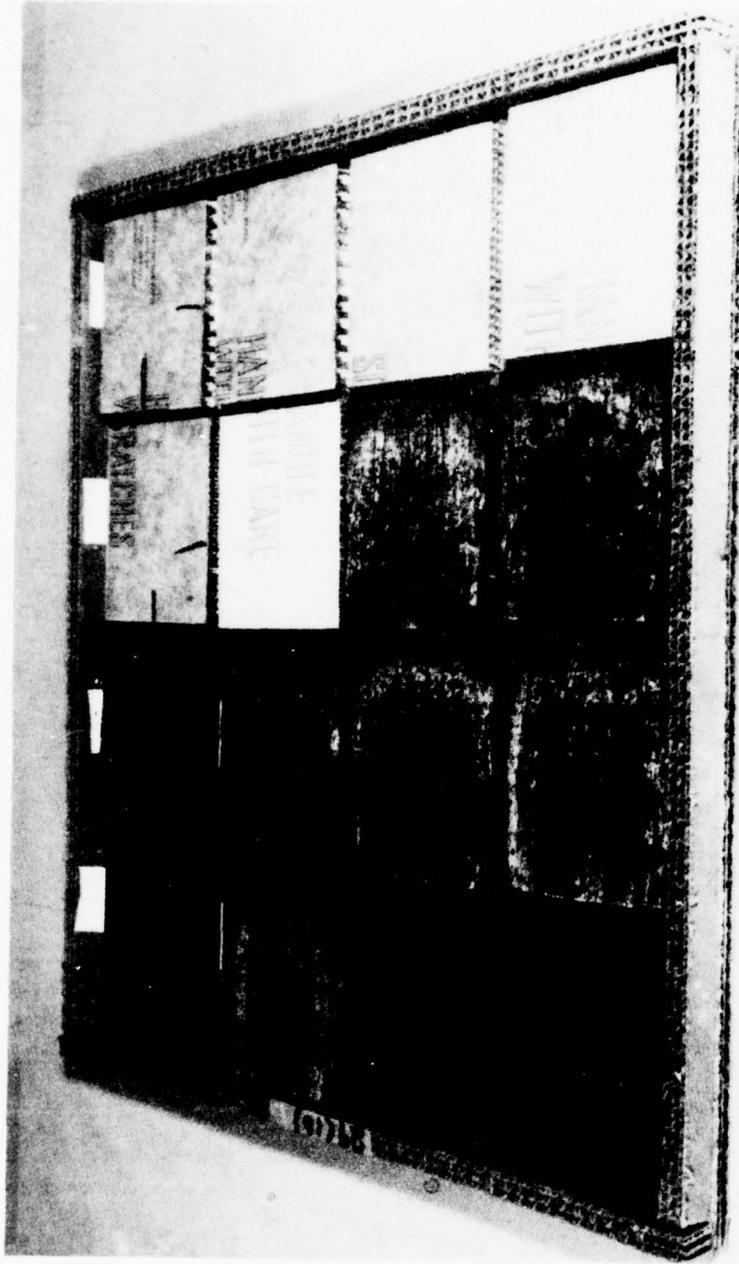
Figure 3-7 Specimen 29. Graphite epoxy with black enamel coating.  
(Sequence is bottom to top, and then left to right.)

The epoxy-graphite specimens (Series 29-X) quite rapidly lost epoxy and had major areas of delamination of the first ply. Beyond this point, however, there was little further degradation, i.e. the graphite, even where delaminated, largely resisted disintegration and thus tended to thermally shield the underlying ply. (Figure 3-7)

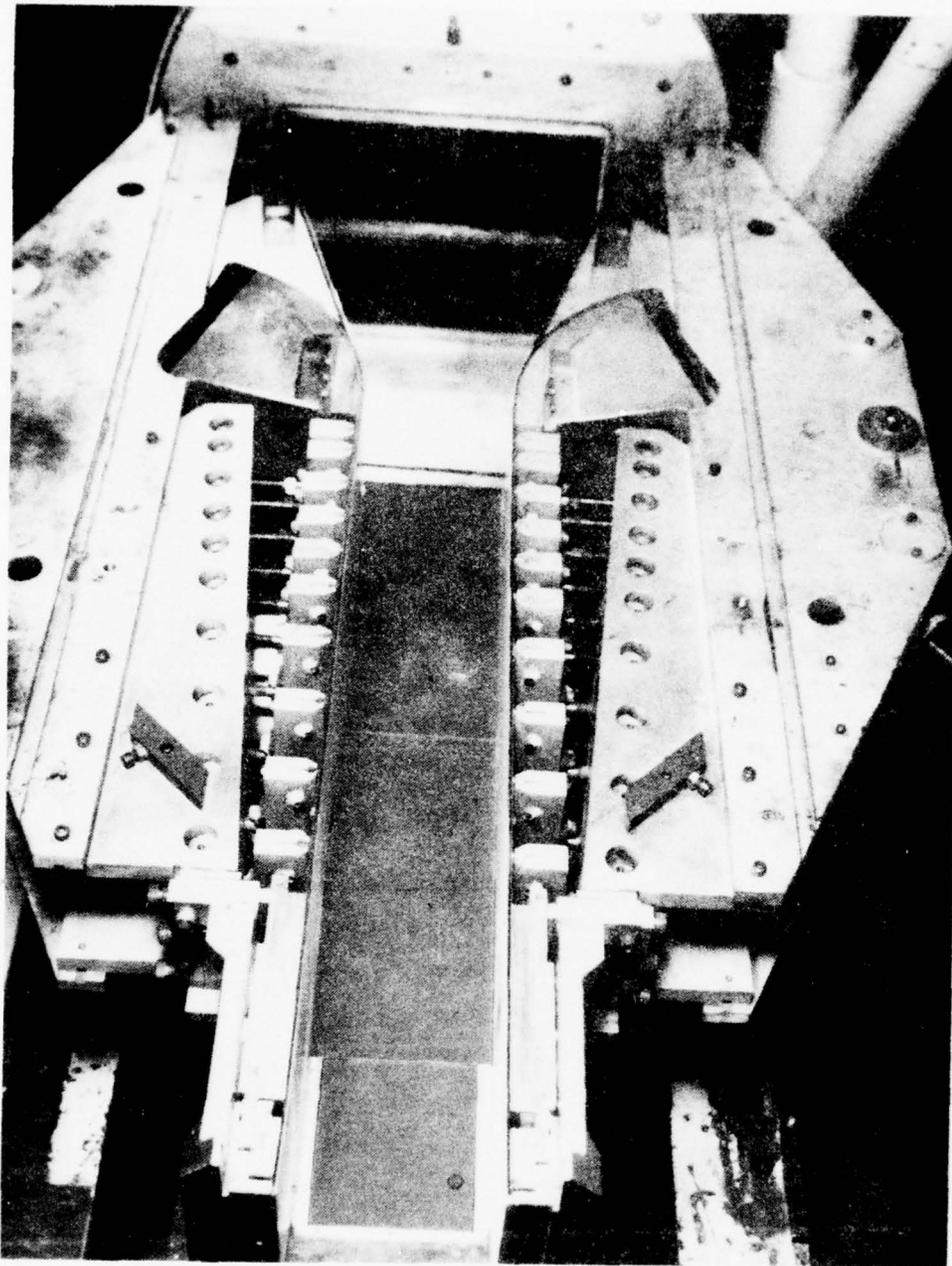
Figure 4-1 Top view of wind tunnel with sandpaper on floor.  
Test specimen at bottom of figure.

The tunnel selected for this study was the Boeing model supersonic wind tunnel, a one-tenth scale model of the 4 foot by 4 foot Boeing Supersonic Tunnel. The operating regime of the tunnel is adequate for the test conditions required and easily adaptable to different balance and probe configurations. It is a blowdown type tunnel capable of either subsonic or supersonic flow, with run times ranging from a few seconds to several minutes depending on run parameters. Maximum supply tank pressure is 10 atmospheres. Mach number is controlled by a variable diffuser for subsonic flow, and by changing the contour of the flexible side walls for supersonic flow (Fig. 4-1).

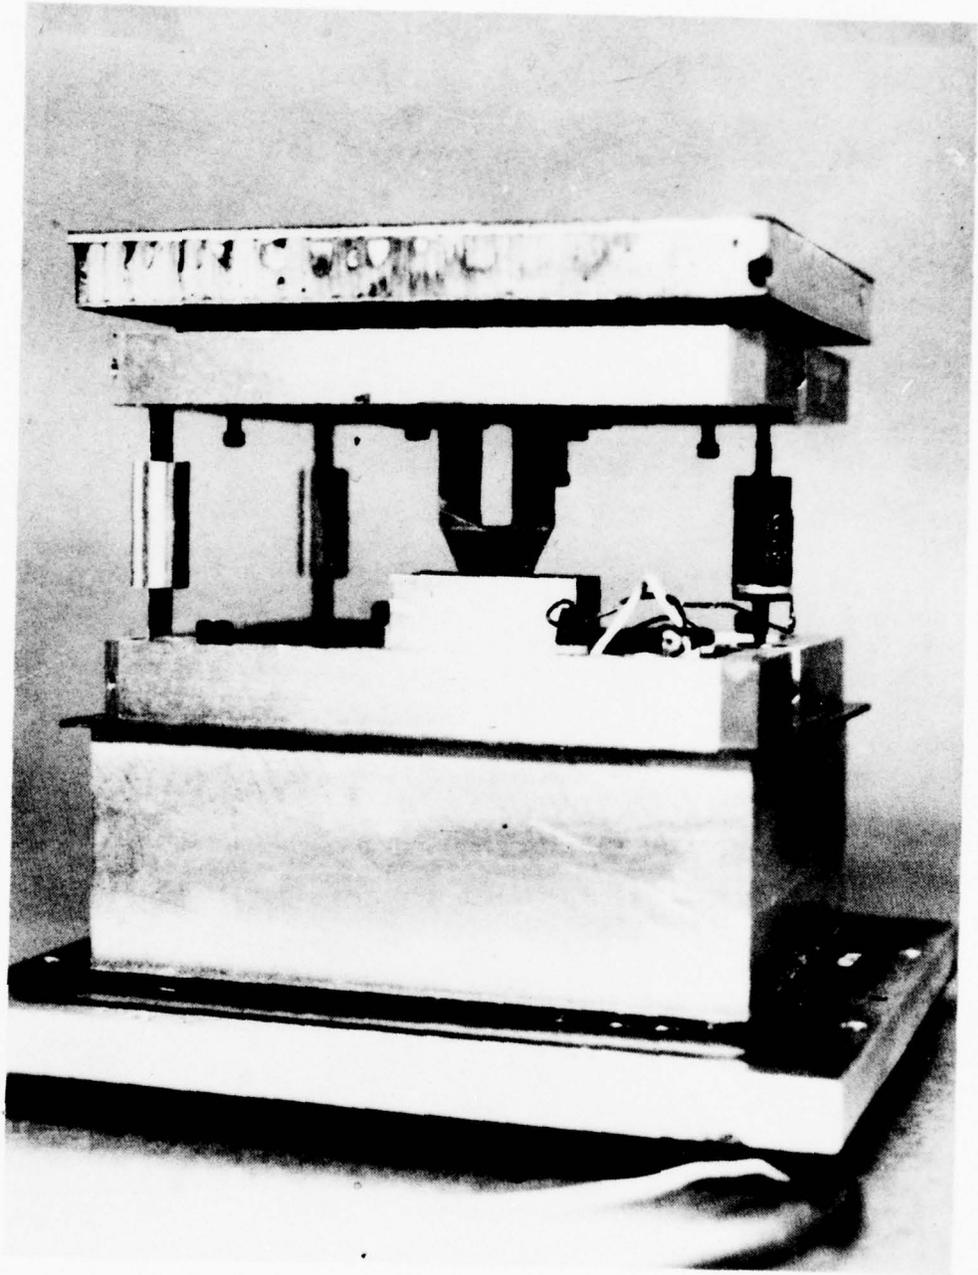
Figure 4-2 Specimen mounted on drag balance.  
Instrumented flexure is aft.

The balance is pictured in Figure 4-2. It consists of an aluminum plate, to which the sample is bolted, which is supported on three flexures. There are two flexures supporting the upstream side of the specimen, neither of which are instrumented. The simple flexure on the downstream side has strain gages attached for the direct drag measurements, and is interchangeable with two other instrumented flexures giving maximum drag levels of 0.25 lb., 1.0 lb, or 5.0 lb. depending on which flexure is installed. The assembly in the center of the balance is an oil filled dashpot designed to reduce vibrations

of the assembly during a run. The rubber O-ring on the base of the balance seals the balance pit and isolates the balance apparatus and tunnel test section from the atmosphere outside the tunnel.

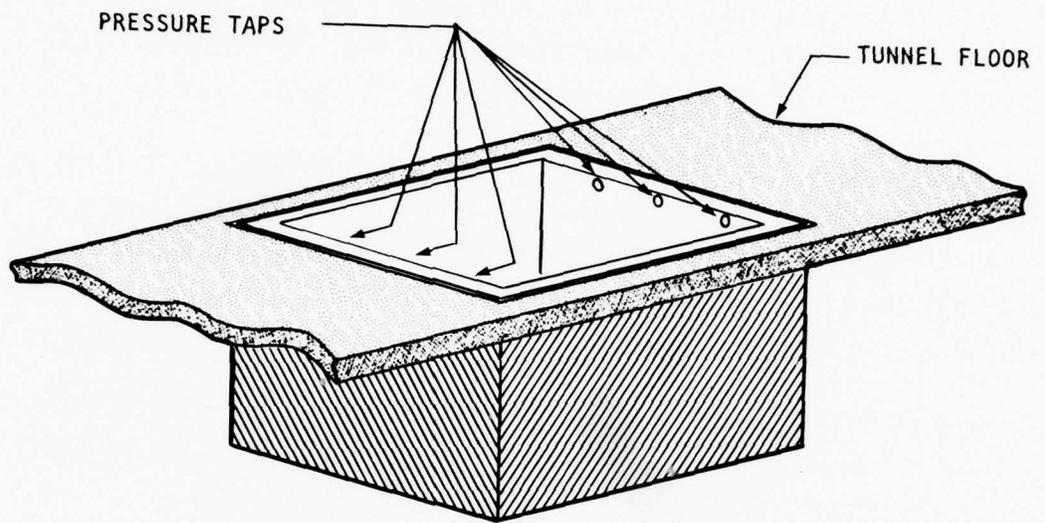
Figure 4-3 Pressure taps in balance box for drag correction factor

The pressure ports (Fig 4-3) can then be used to correct the balance data for any additional circulation due to tape "leaks" or turbulence due to the uncovered gaps on the sides of the specimen. These three  $\Delta p$ 's were averaged, multiplied by the end area of the sample and subtracted from the balance drag measurement to obtain corrected skin friction drag. Repeat runs with reference and production samples showed this method to be very reliable in providing consistent corrected data.

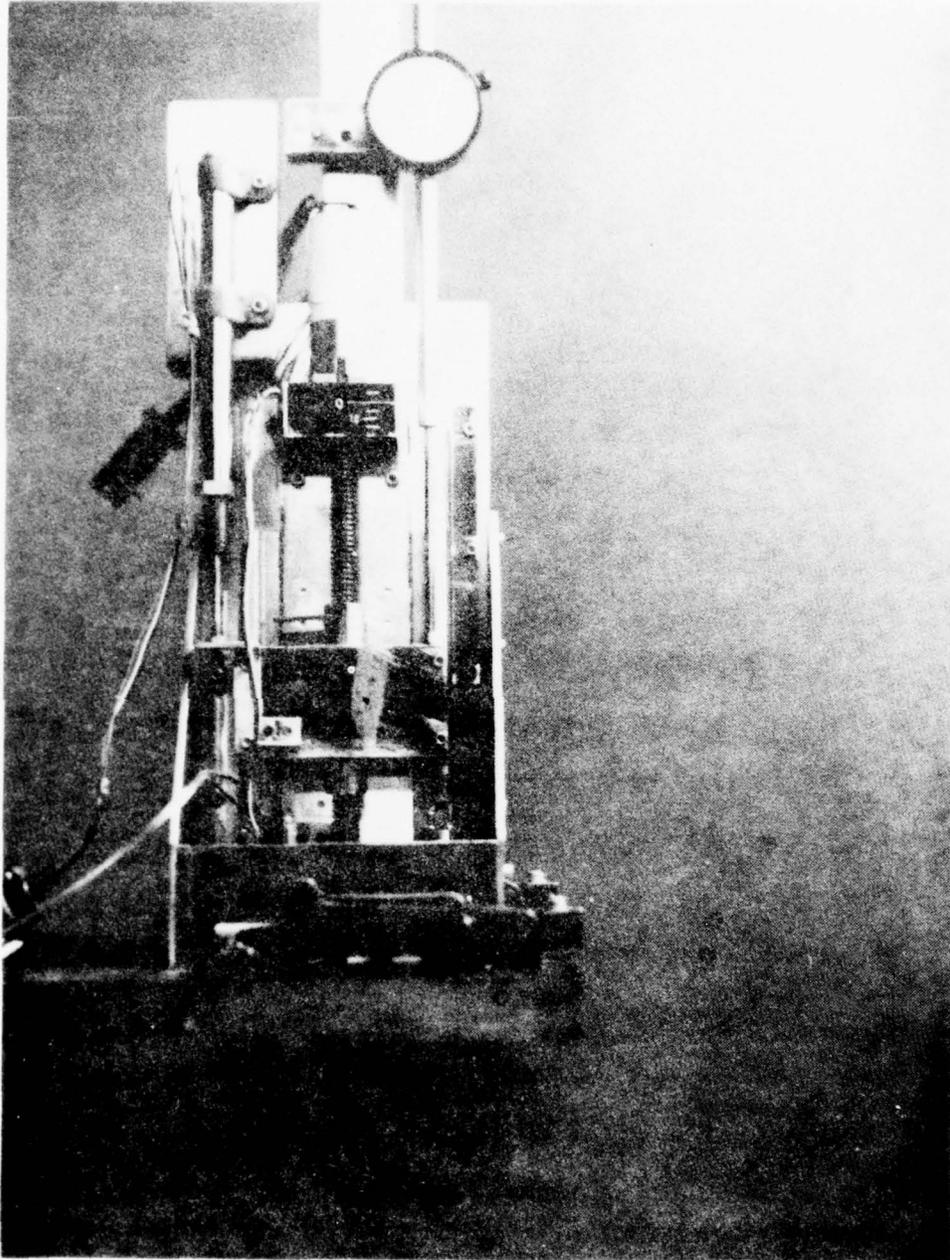
Figure 4-4 Boundary layer probe drive mechanism.

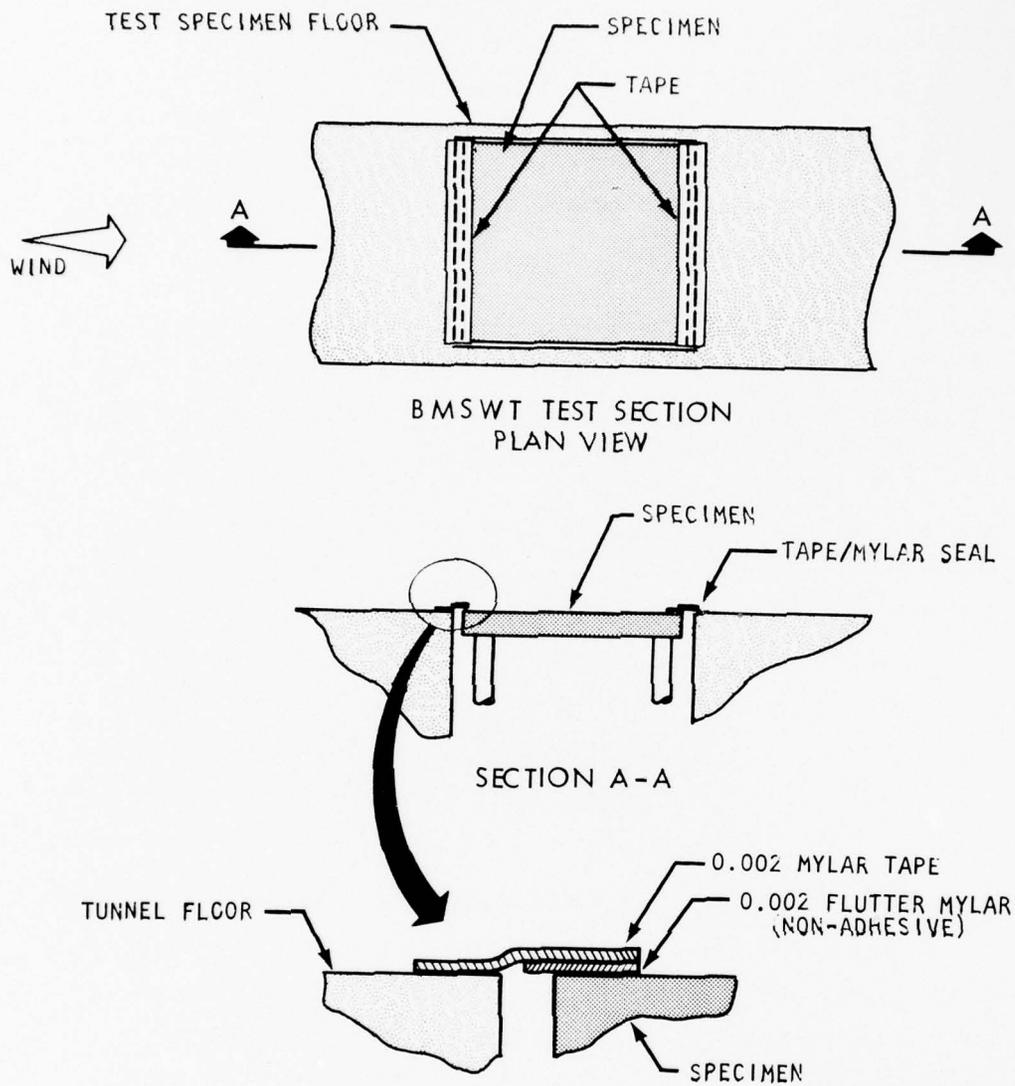
Figure 4-5 Leading/trailing edge gap seals

Initial runs showed large drag variations which were traced to mass flow circulation, into the balance pit at the trailing edge gap and out into the boundary layer at the leading edge gap, removing free stream momentum and increasing skin friction. This problem was solved by sealing the leading and trailing edge gaps. The most effective sealing method was strips of .002 flutter mylar covering the gaps and taped on the upstream sides (Fig. 4-5). Balance interference was insignificant and the durability of the strips was sufficient for the test conditions. The mylar strips were cut so that they were long enough to cover the gaps and not be drawn into them, but not so long that they would flap in the airstream and increase drag levels.

The trailing edge tape showed a consistent drag reduction of approximately 40% to 50%, and the leading edge tape showed no change. This indicates the direction of circulation around the specimen, as the tape could not be as effective stopping flow out of the cavity as it would be stopping flow in. Leading edge tape (attached to the tunnel floor) was used throughout the test program to compensate for the surface area of the trailing edge tapes (attached to the test specimens).

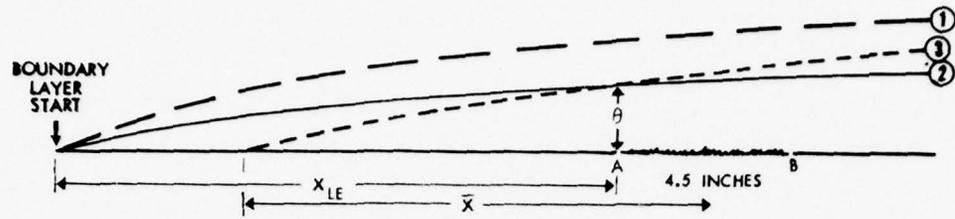
Figure 4-6 Growth of momentum thickness

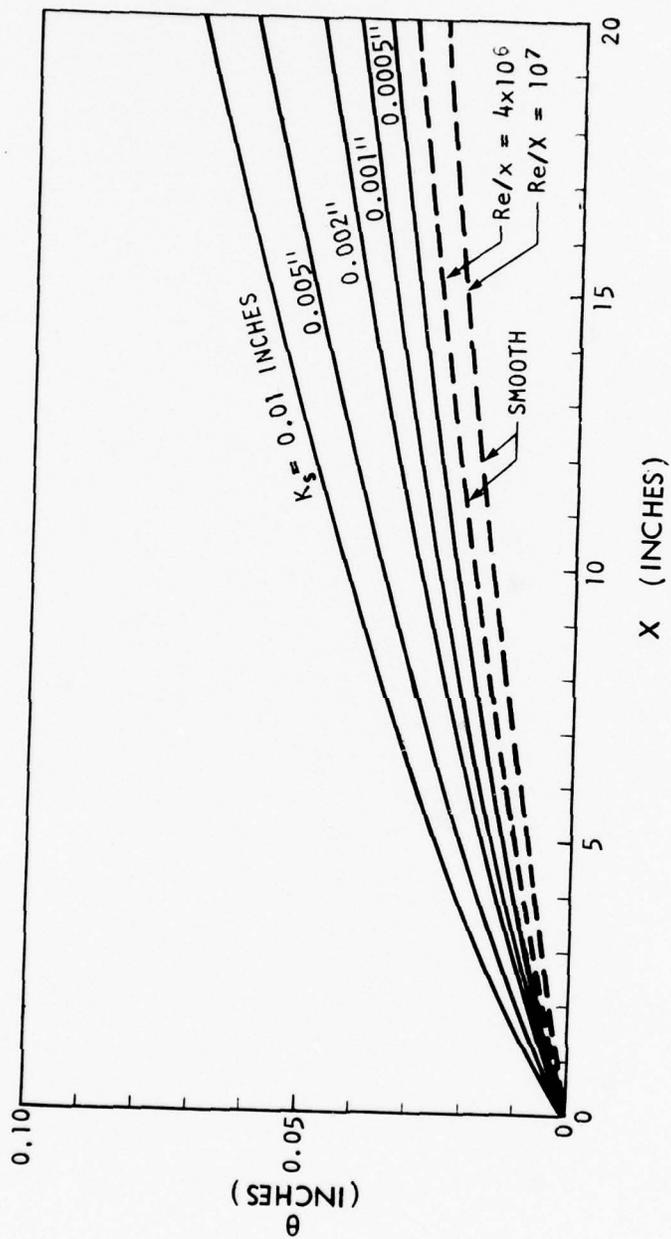
Figure 4-7 Effect of upstream roughness on momentum thickness

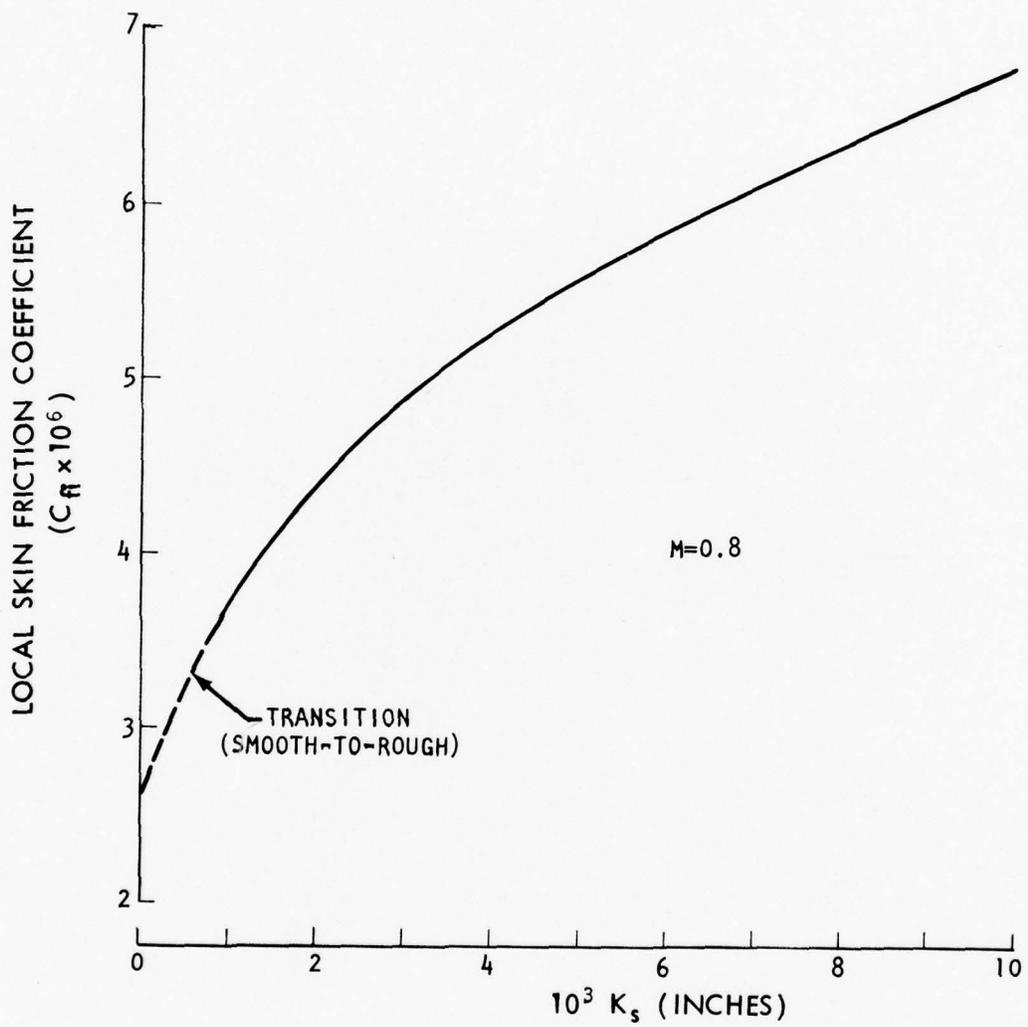
Figure 4-8 Roughness height versus skin friction, based on Schlichting formula and Boeing wind tunnel

If this analysis method is valid Figure 4-8 may then be used to give the value of  $k_s$  corresponding to the drag on a rough plate for given flow conditions.

The method used to validate this procedure is described below, but, essentially with measured skin friction, sandpaper of known roughness was used, to obtain data points for correlation with curves such as Figure 4-8.

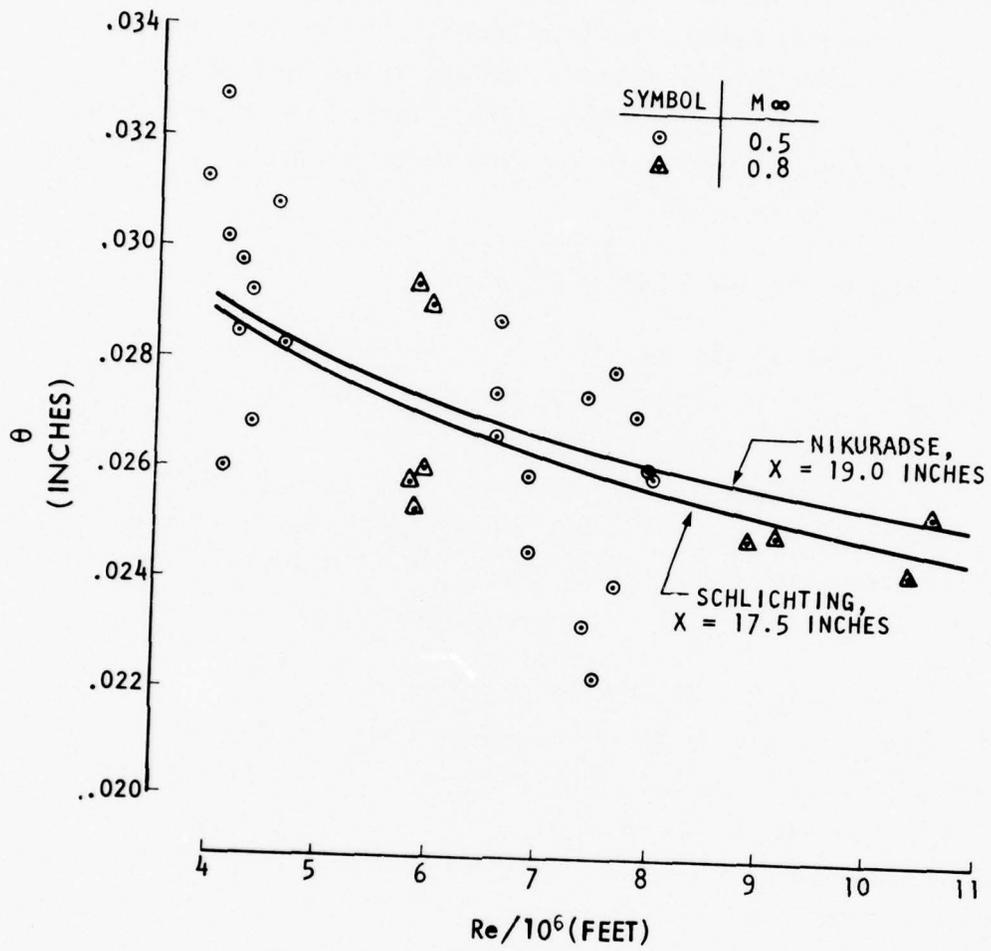
Figure 4-9 Smooth plate boundary layer momentum thickness at leading edge of test specimen

These values of momentum thickness were next used to derive a nominal starting point for the turbulent boundary layer, since it was clear that it was not starting exactly at the trip strip. To do this we used the Schlichting relation (based on a logarithmic velocity profile).

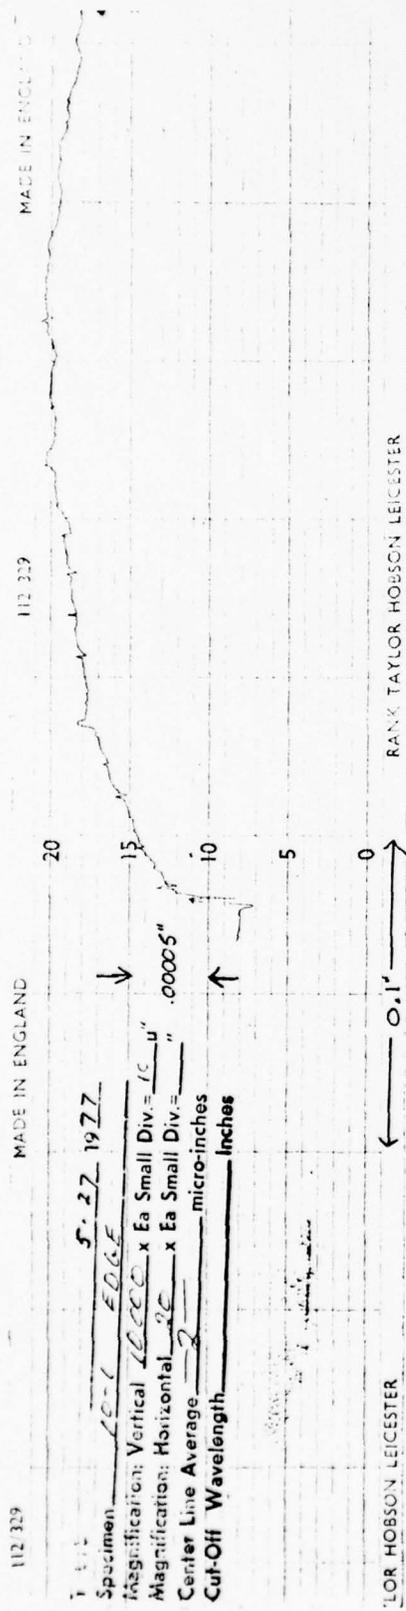
FIGURE 4-11 (a) PROFILE OF SMOOTH ENAMELLED SURFACE (SPECIMEN 10-1)

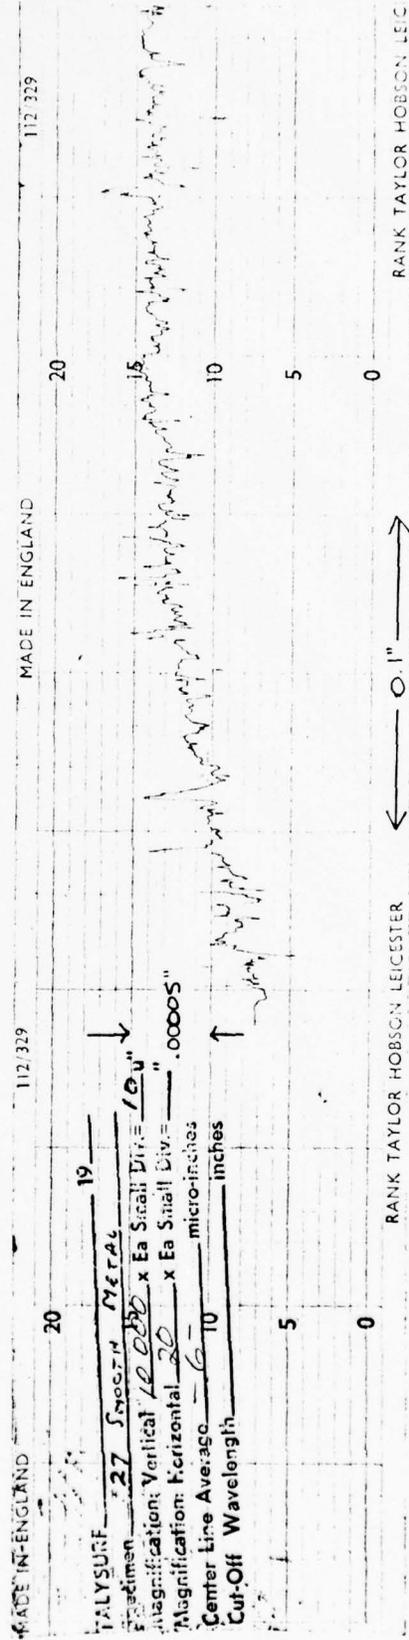
FIGURE 4-11 (b) PROFILE OF SMOOTH ALUMINUM SKIN (SPECIMEN 27)

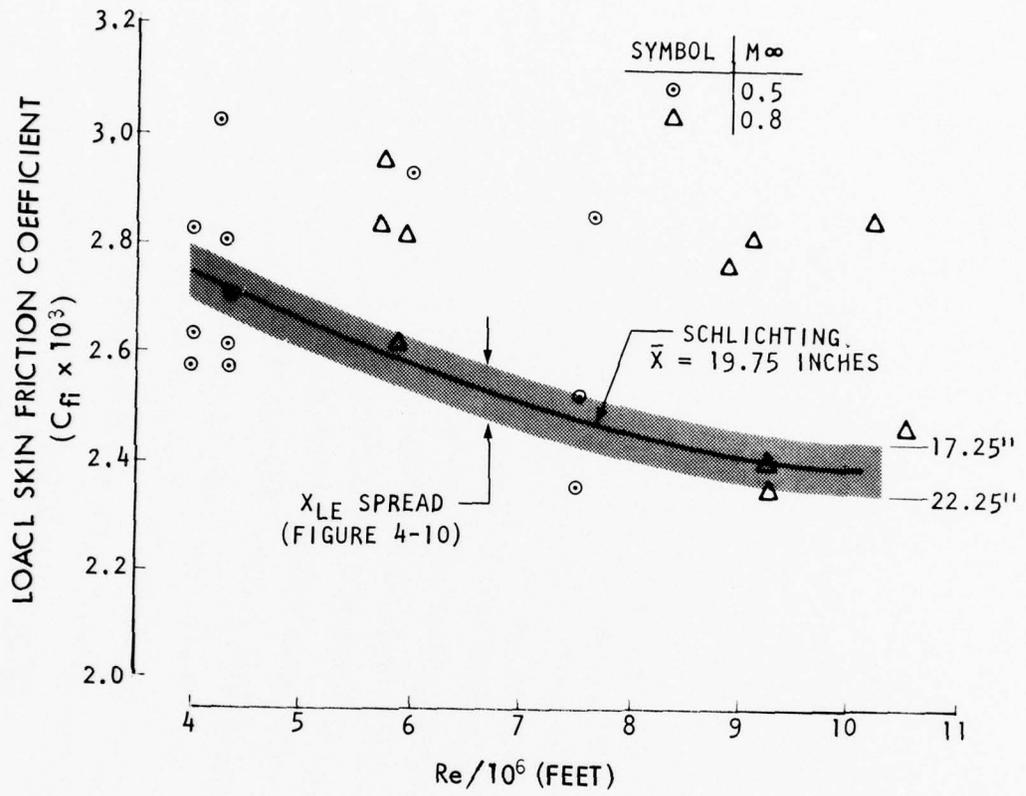
Figure 4-12 Smooth plate, local skin friction coefficient
