**SKIN FRICTION DRAG DUE TO NUCLEAR DAMAGE**

The Boeing Aerospace Company  
P.O. Box 3999  
Seattle, Washington 98124

(9) Final Report, for Period February 1977 - September 1977,

CONTRACT No. DNA 001-77-C-0090

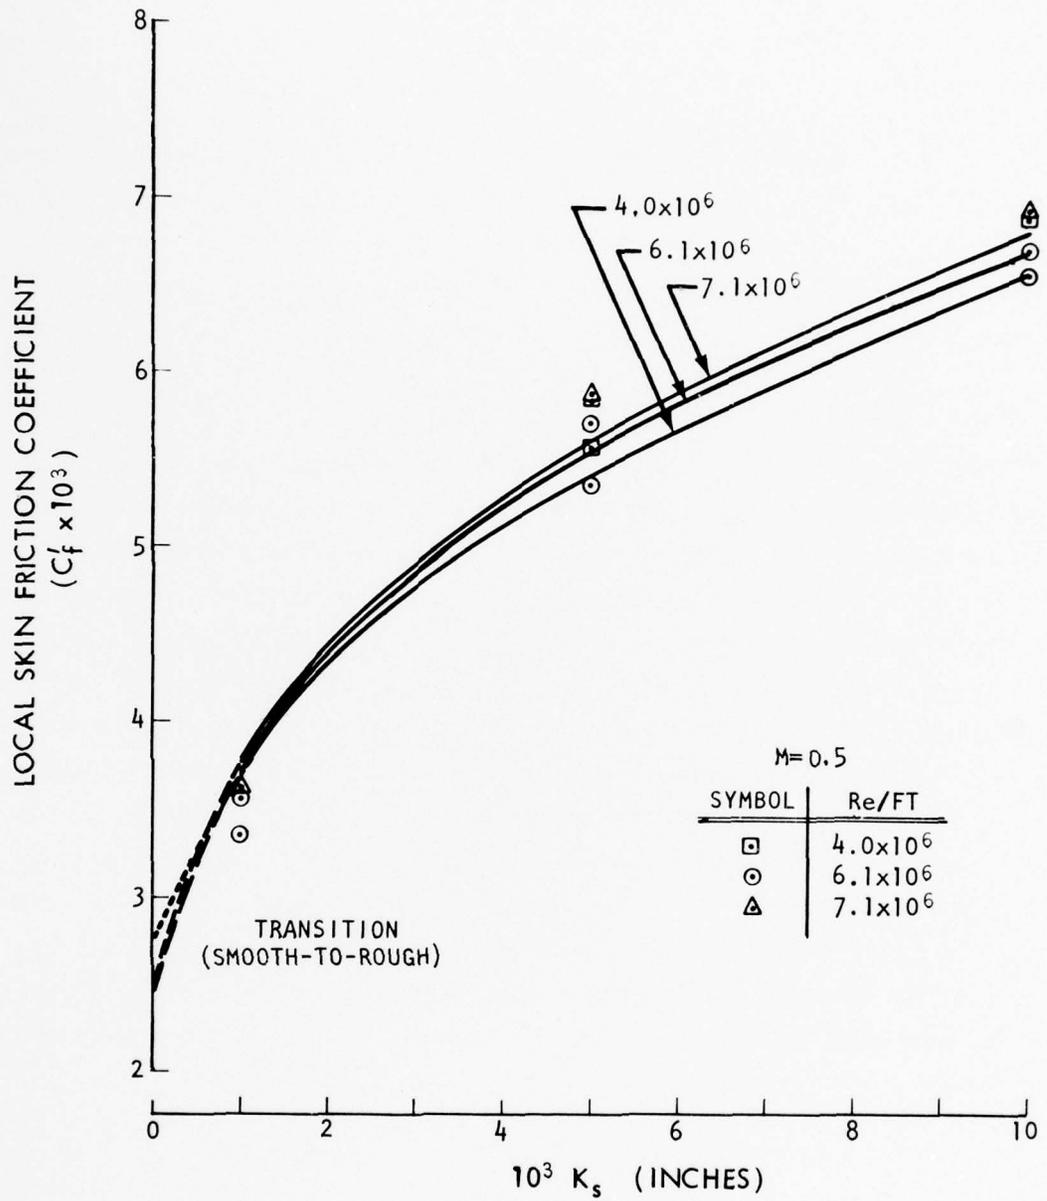
Figure 4-13 Effect of roughness on incompressible skin friction

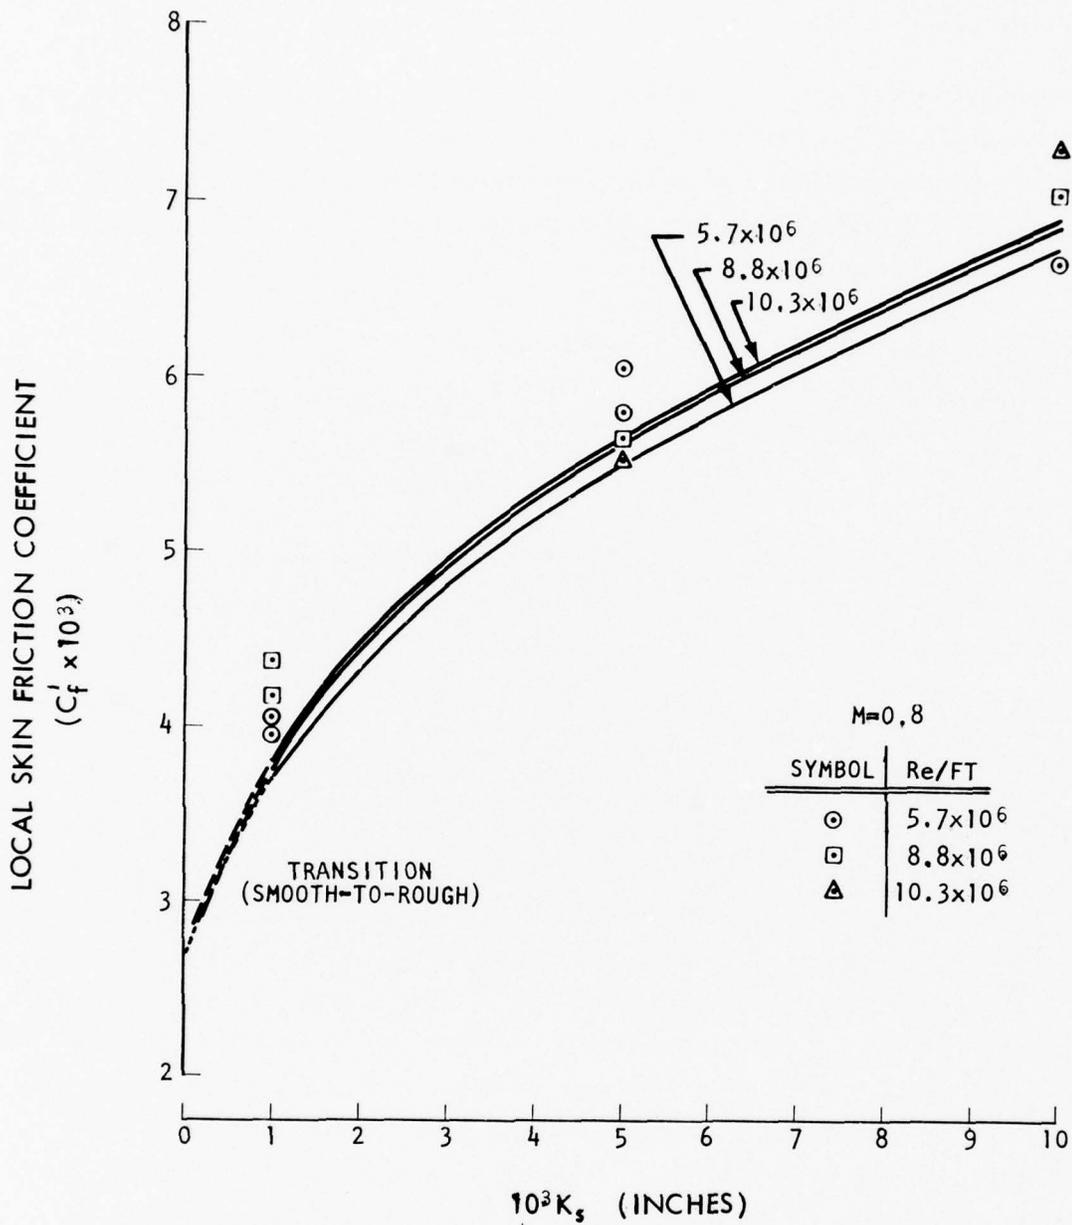
Figure 4-14 Effect of roughness on incompressible skin friction

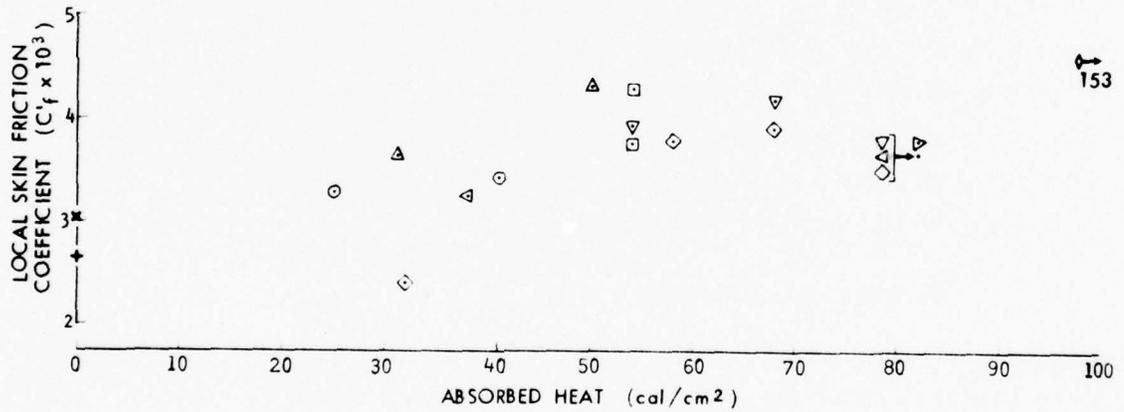
Figure 5-1. Absorbed heat versus local skin friction coefficient for aluminum skin samples.

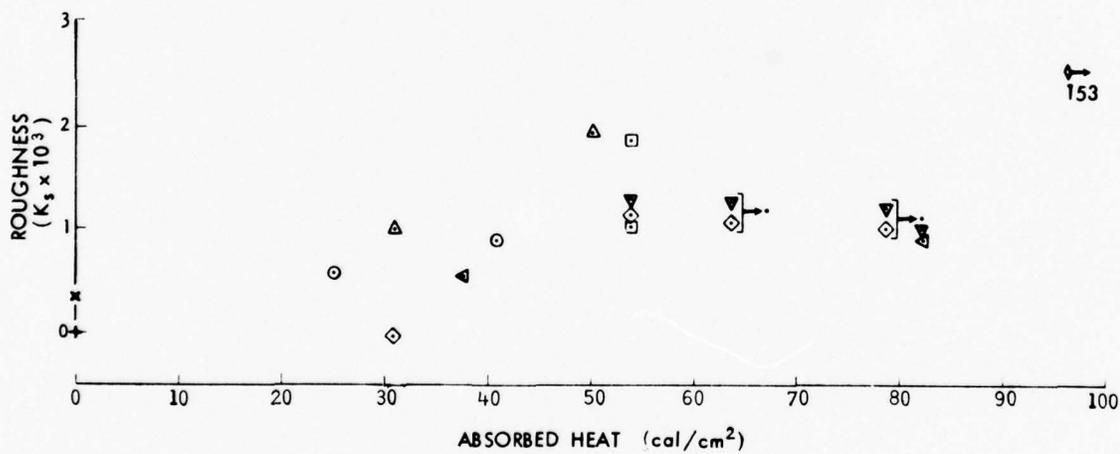
Figure 5-2. Equivalent sand roughness for aluminum skin samples.

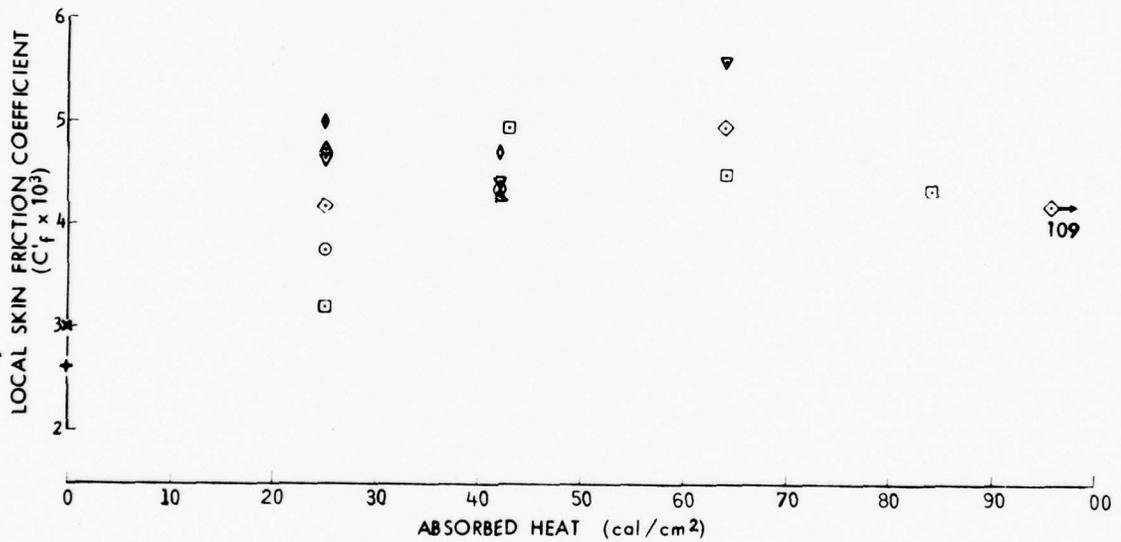
Figure 5-3. Absorbed heat versus local skin friction coefficient for fiberglass/enamel samples.

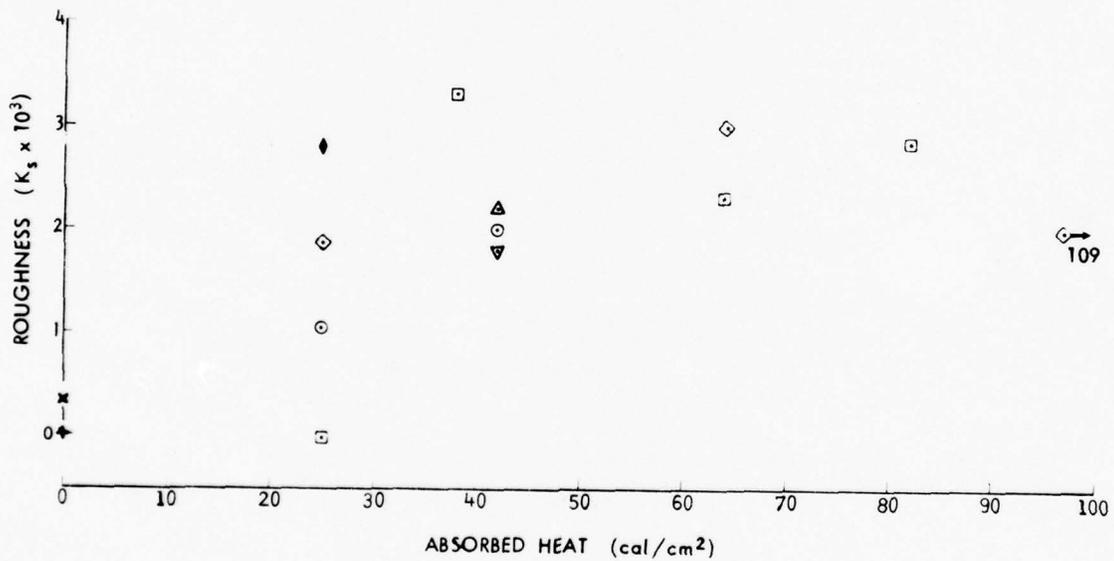
Figure 5-4 Absorbed heat versus equivalent sand roughness for fiberglass/enamel skin samples.

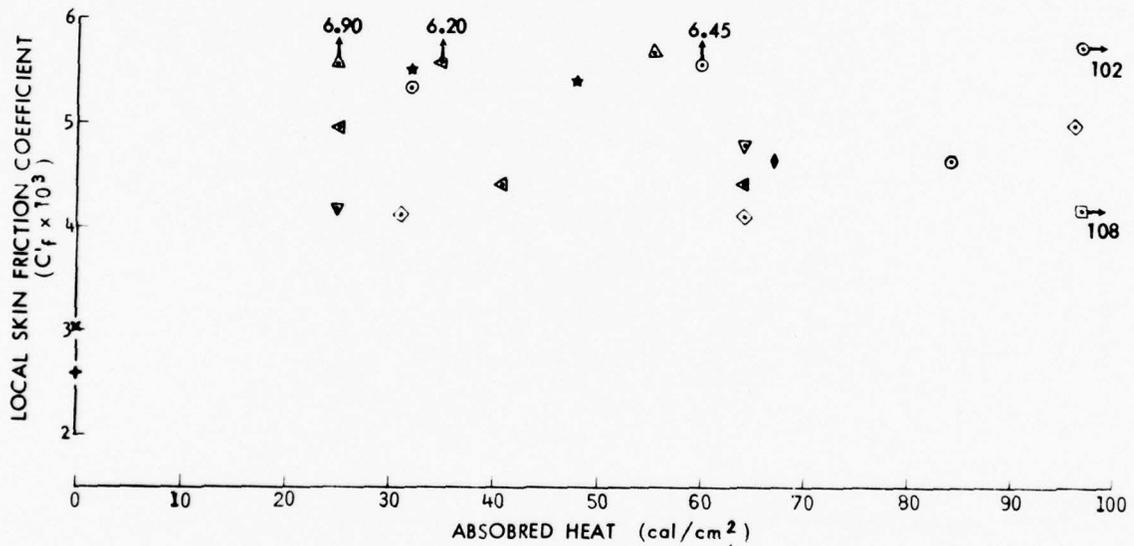
Figure 5-5. Absorbed heat versus local skin friction coefficient for fiberglass/thick coating and graphite skin samples.

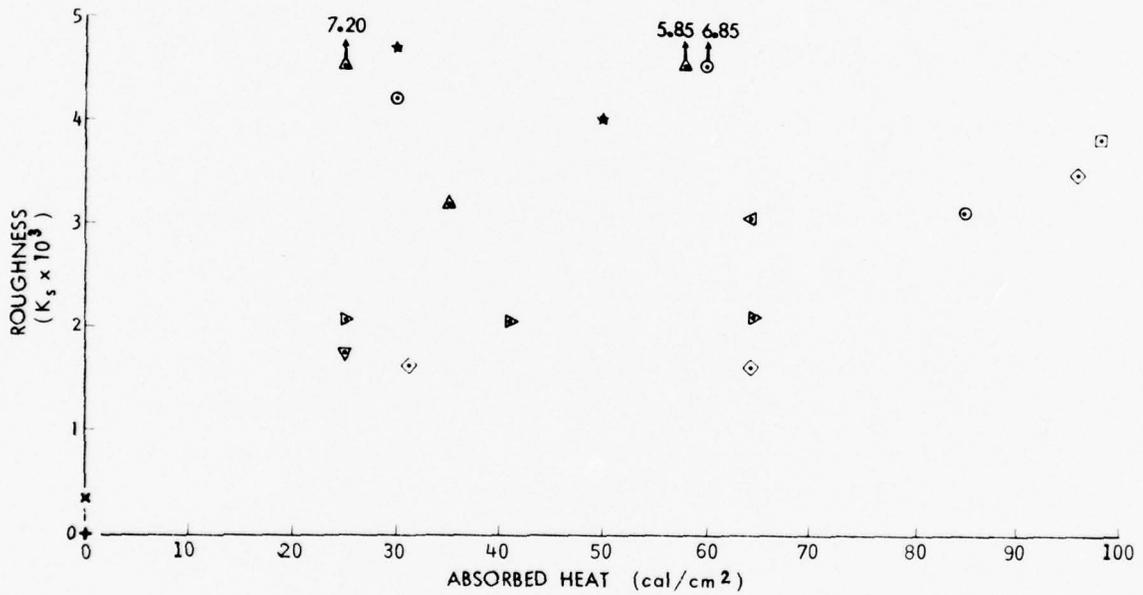
Figure 5-6. Absorbed heat versus equivalent sand roughness for fiberglass/thick coatings and graphite.

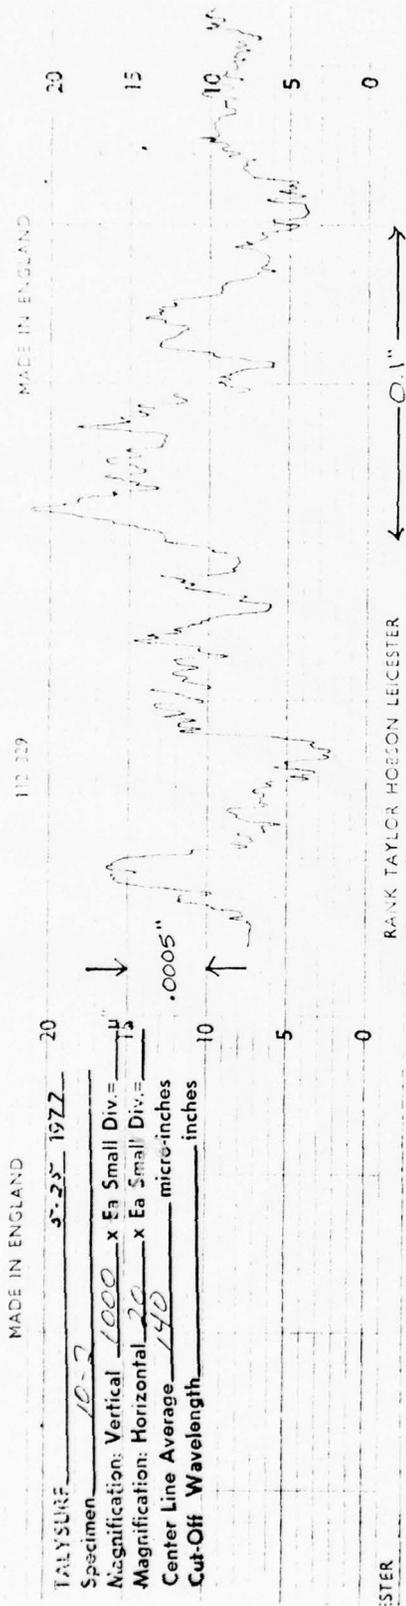
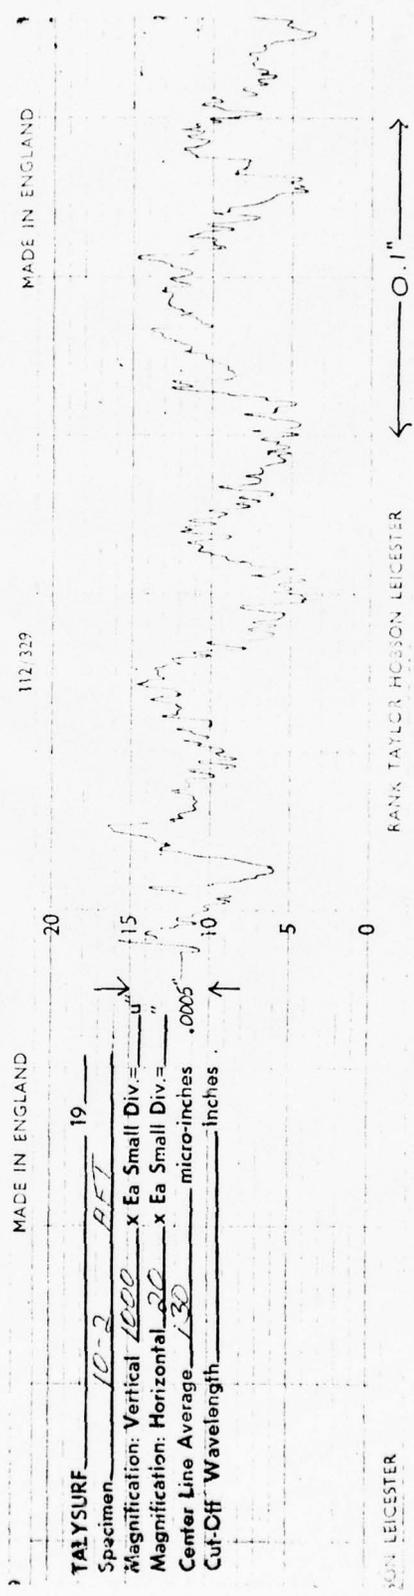
FIGURE 5-7 PROFILE OF EXPOSED ALUMINUM/ENAMEL SURFACE. SPECIMEN 10-2

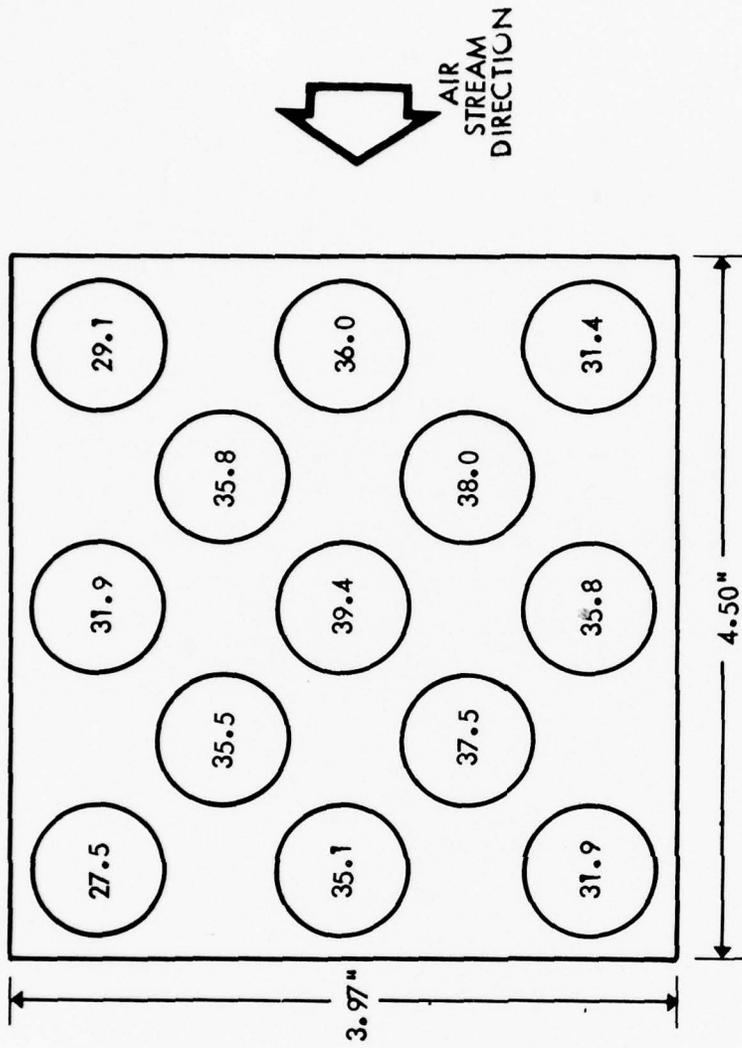
Figure A1-1 Cal/cm<sup>2</sup> - sec peak after four second exposure looking at the sample surface (Face).

Examination of exposed specimens indicated that there might be some non-uniformity of irradiation over the specimen face. Because of this concern, peak flux readings were taken at thirteen different locations over the specimen area. Figures I-I through I-V are "maps" showing peak flux vs. location for five different levels of irradiation. Flux meter size and locations are to scale. The center of the specimen face always has the highest flux, with lower, but not necessarily uniformly lower, fluxes toward the specimen edges. Toward the upper flux limit the center area peak flux is approximately 30% higher than the lowest reading near the edge of the specimen. At lower peak fluxes the difference between the center (high) reading and the lowest edge reading decreases to a minimum of 15%. We have been advised that there is some concern that the absolute value of these measurements may not be correct, but a final determination of the correct flux measurement has not been made.

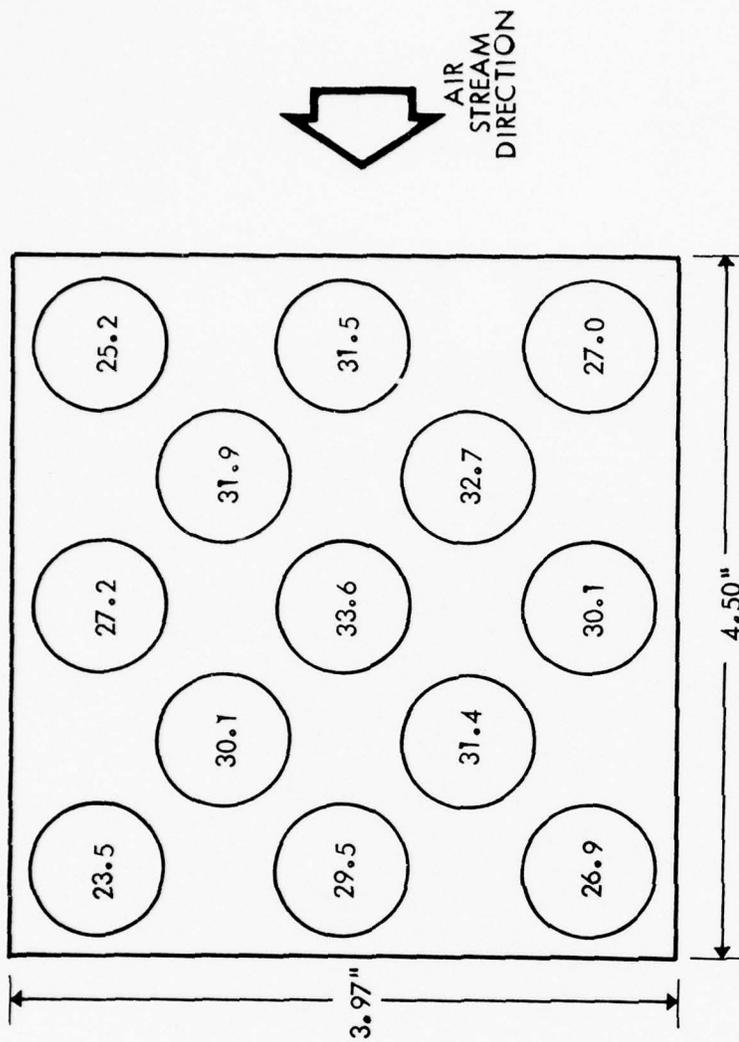
DATE: 4-5-77  
 CENTER PEAK: 33.6 cal/cm<sup>2</sup>-sec  
 AVERAGE PEAK: 28.5 cal/cm<sup>2</sup>-sec  
 DISTANCE: 4"  
 MAXIMUM VARIATION: 30%  
 (CENTER = 100%)

Figure A1-2 Cal/cm<sup>2</sup>-sec peak after four second exposure looking at the sample surface (Face).

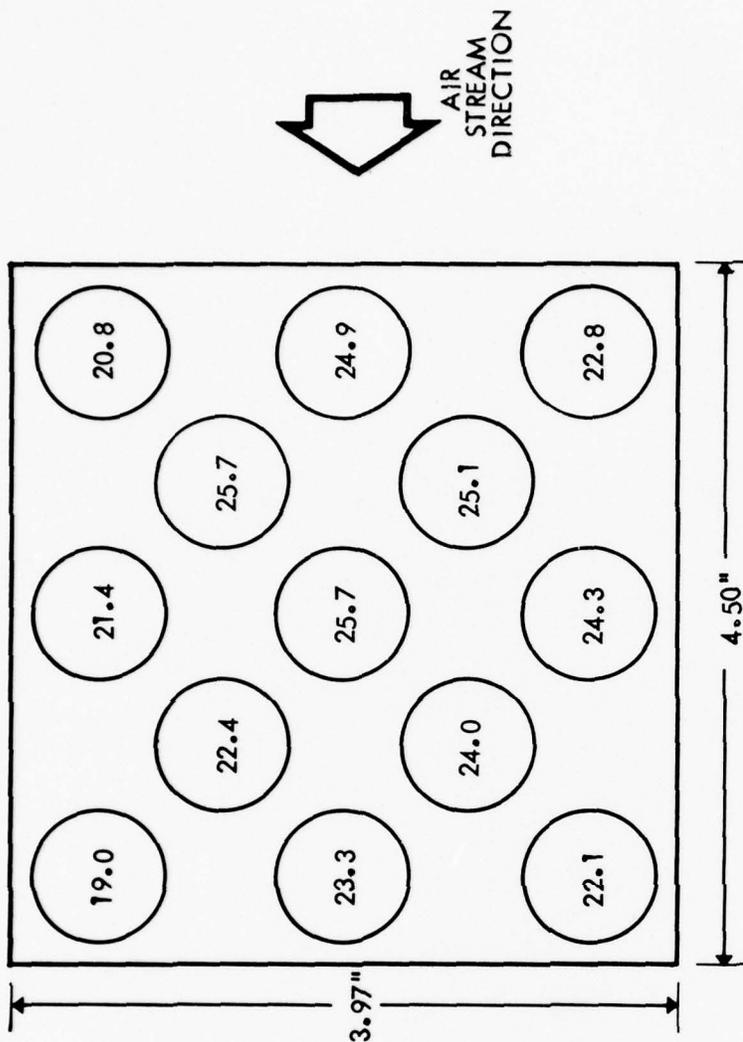
Figure A1-3 Cal/cm<sup>2</sup>-sec peak after four second exposure looking at the sample surface (Face).

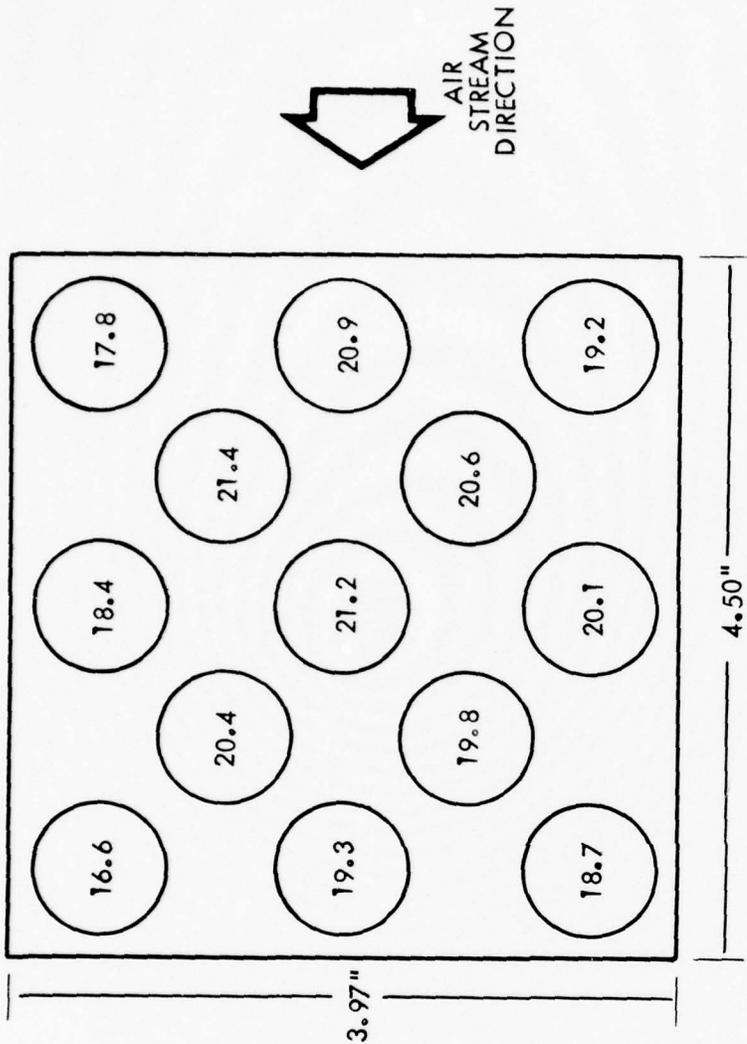
Figure A1-4 Cal/cm<sup>2</sup>-sec peak after four second exposure looking at the sample surface (Face).

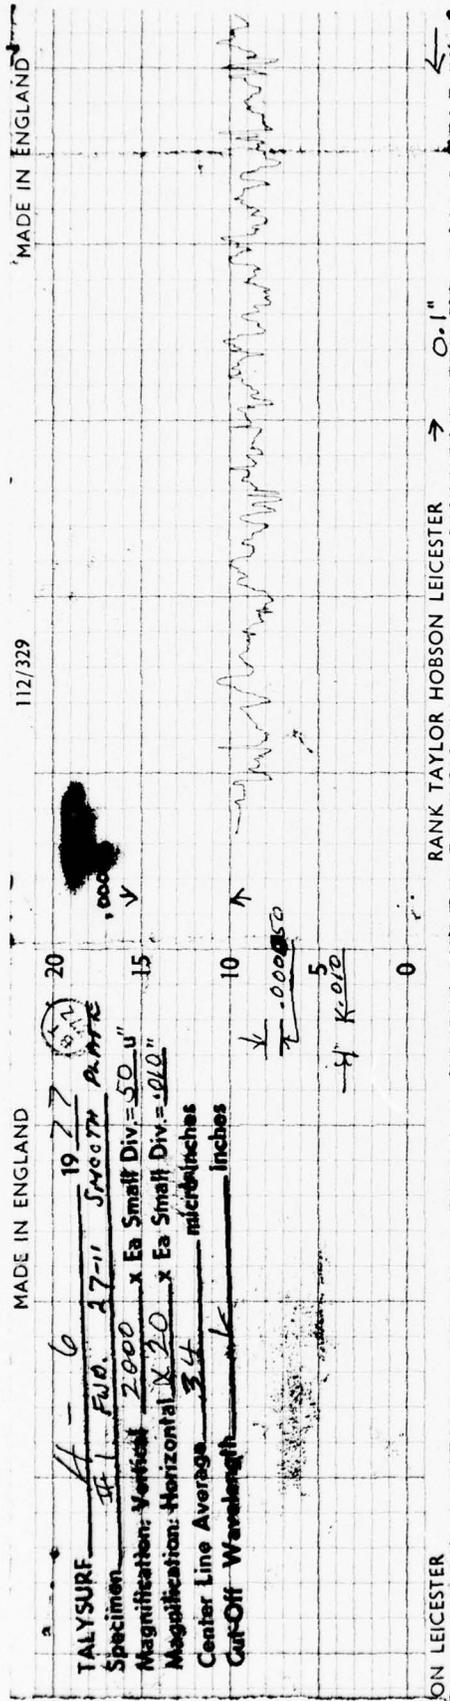
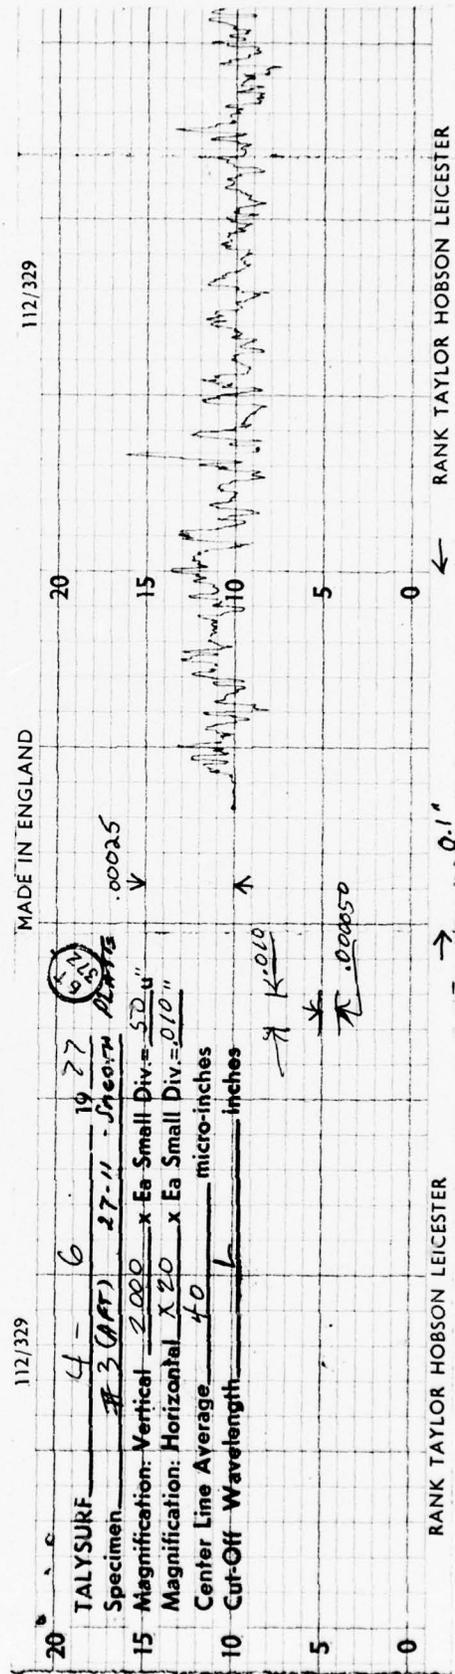
Fig. A4-1 Specimen 27-11. Smooth Polished Aluminum Test Plate (63 mils thick)

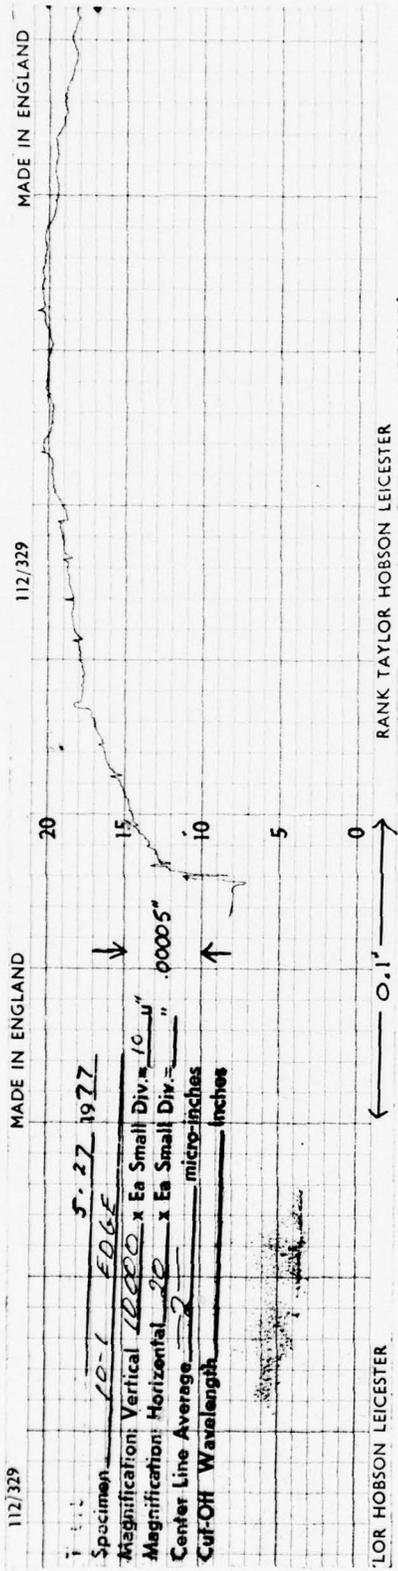
Fig. A4-2 (a) Specimen 10-1. Profile of Smooth Enamel Over 32 mil Aluminum Skin

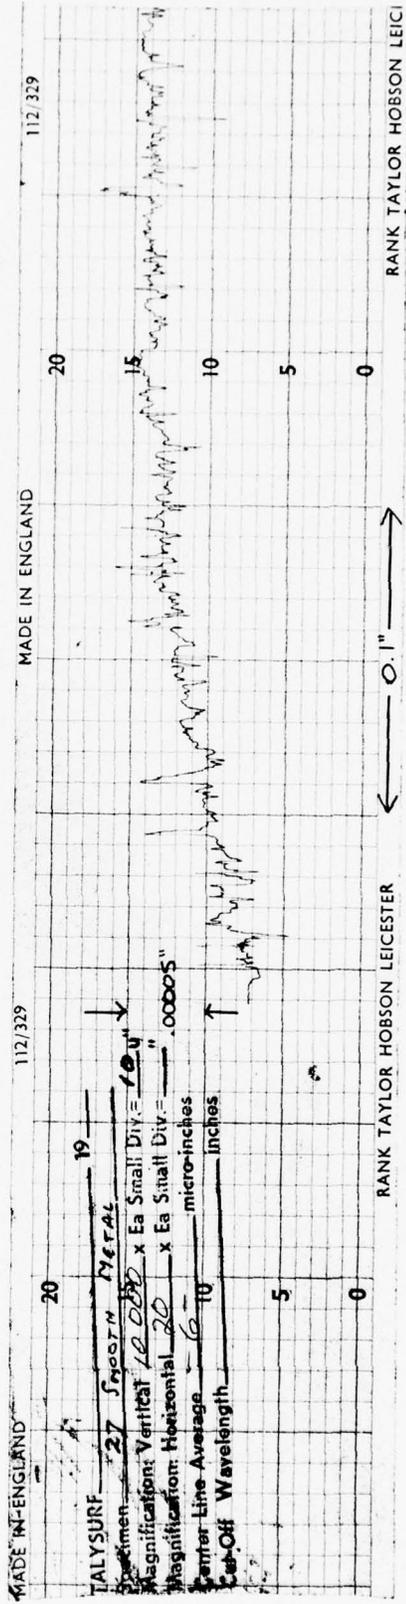
Fig. A4-2 (b) Specimen 27. Smooth Unpolished Aluminum Plate (63 mils)

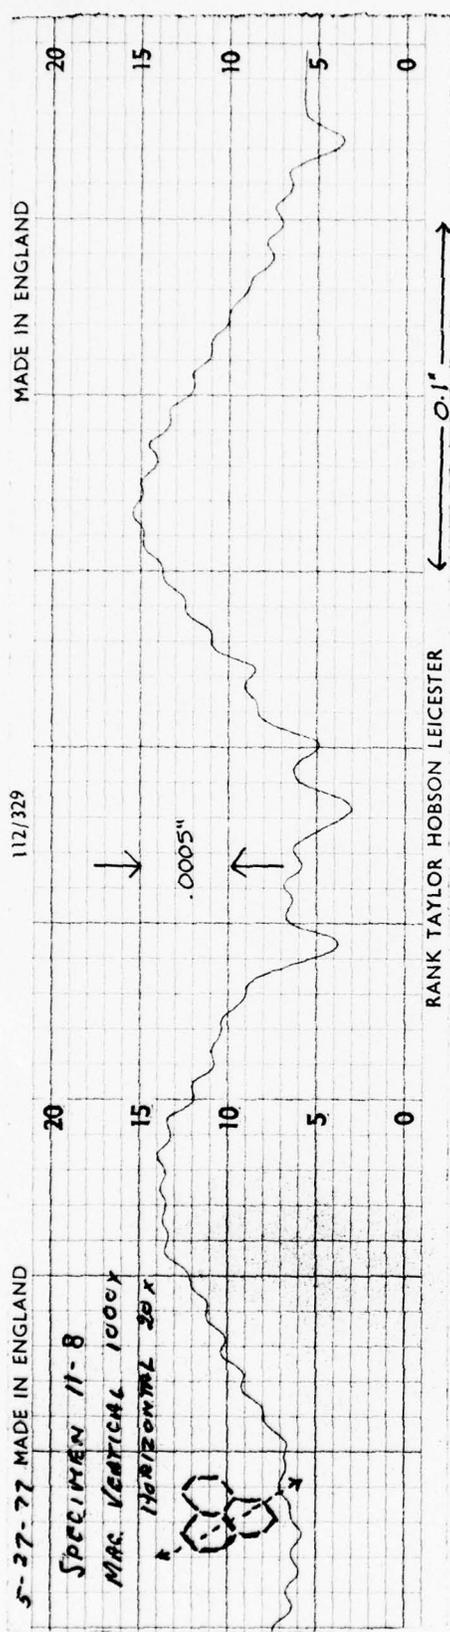
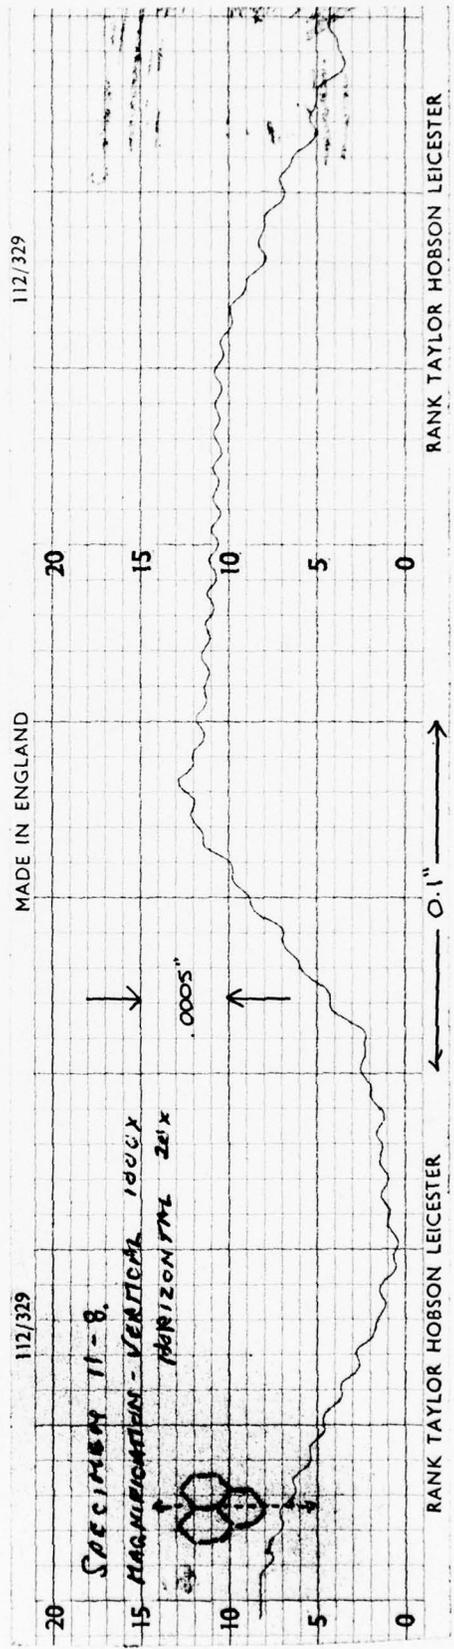
Fig. A4-3 Specimen 11-8. Unexposed Enamel over 13.5 mil Fiberglass Skin. Profile Traverses in directions indicated with respect to honeycomb core.

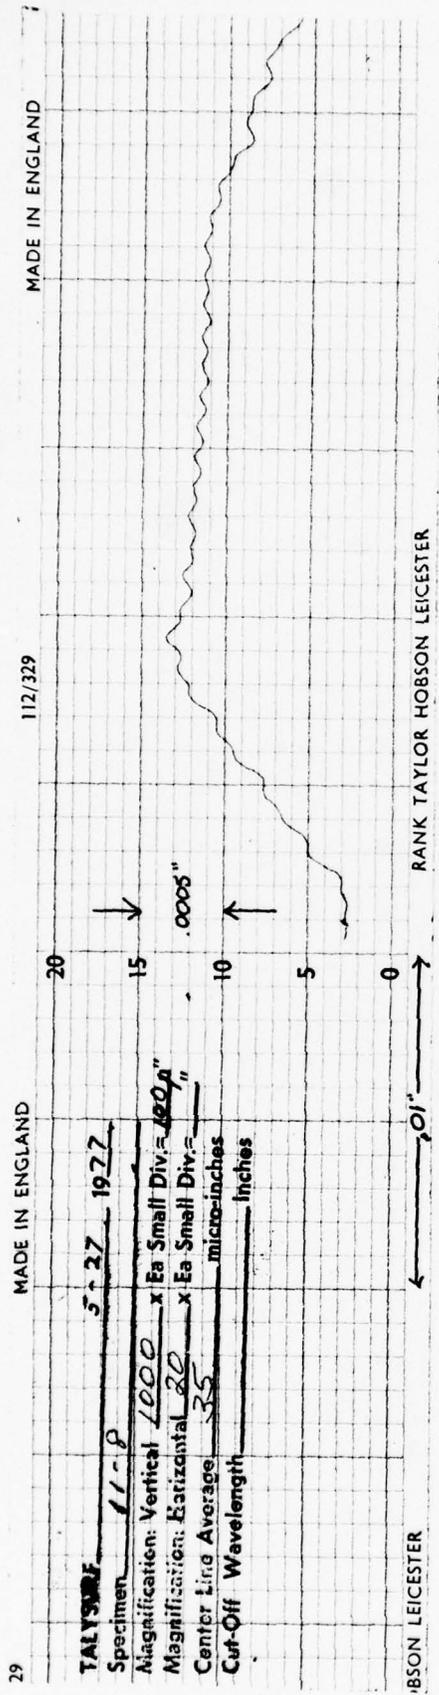
Fig. A4-4 (a) Specimen 11-8. (As in A4-3) Traverse was in an arbitrary direction.

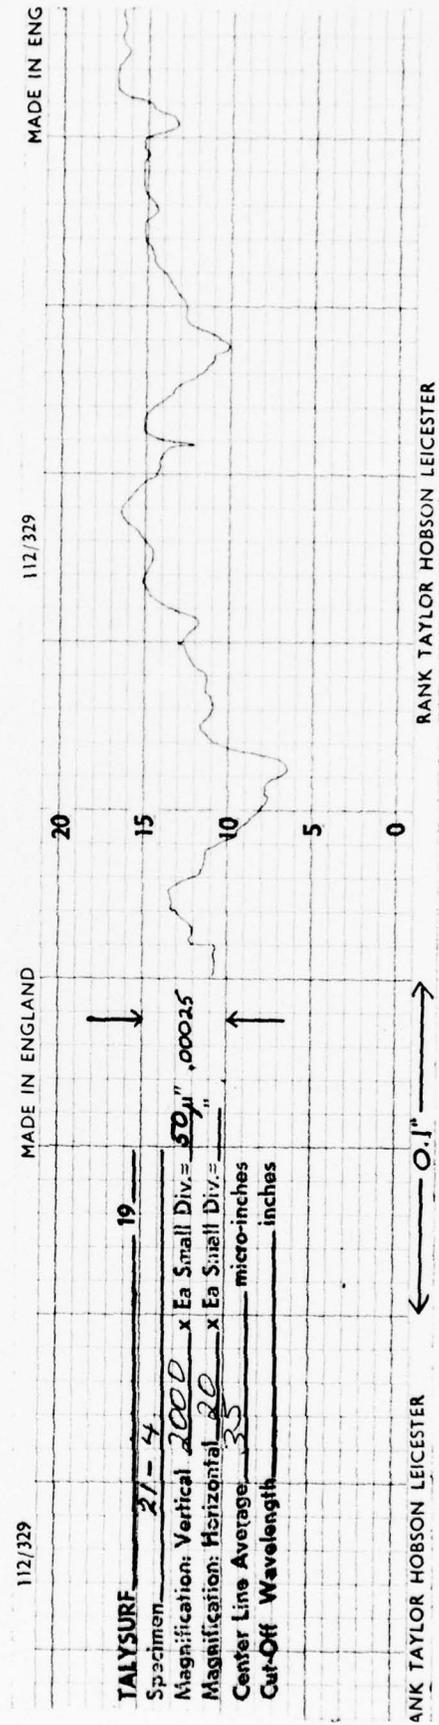
Fig. A4-4 (b) Specimen 21-4. Unexposed fluorocarbon (15 mil) over 30 mil fiberglass skin. Honeycomb is identical to 4 (a).

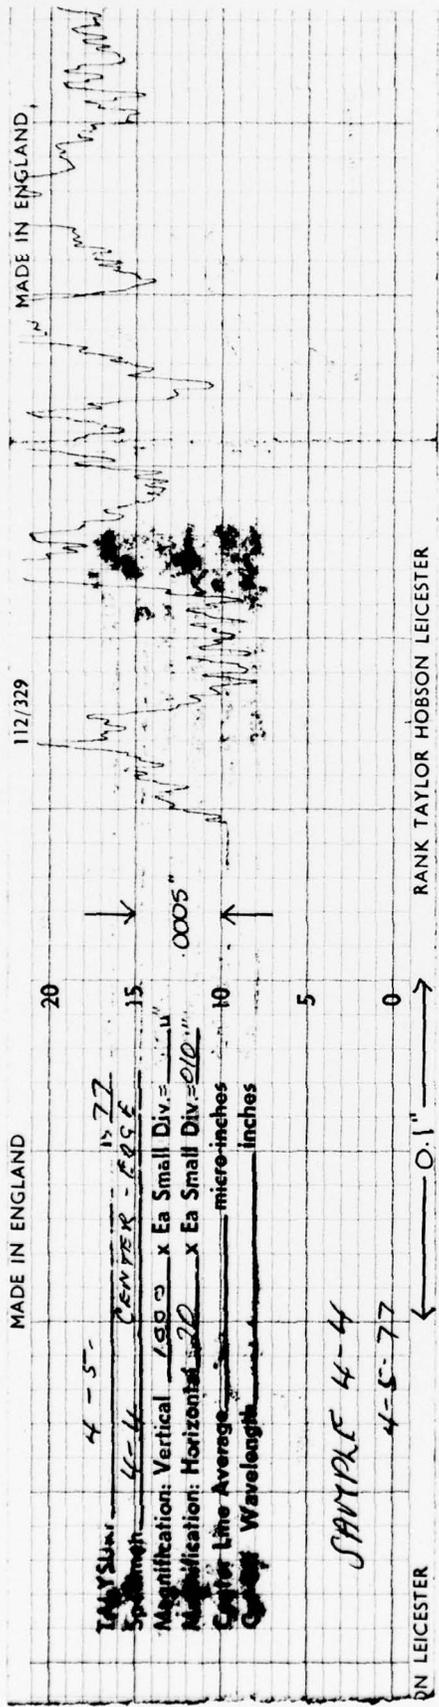
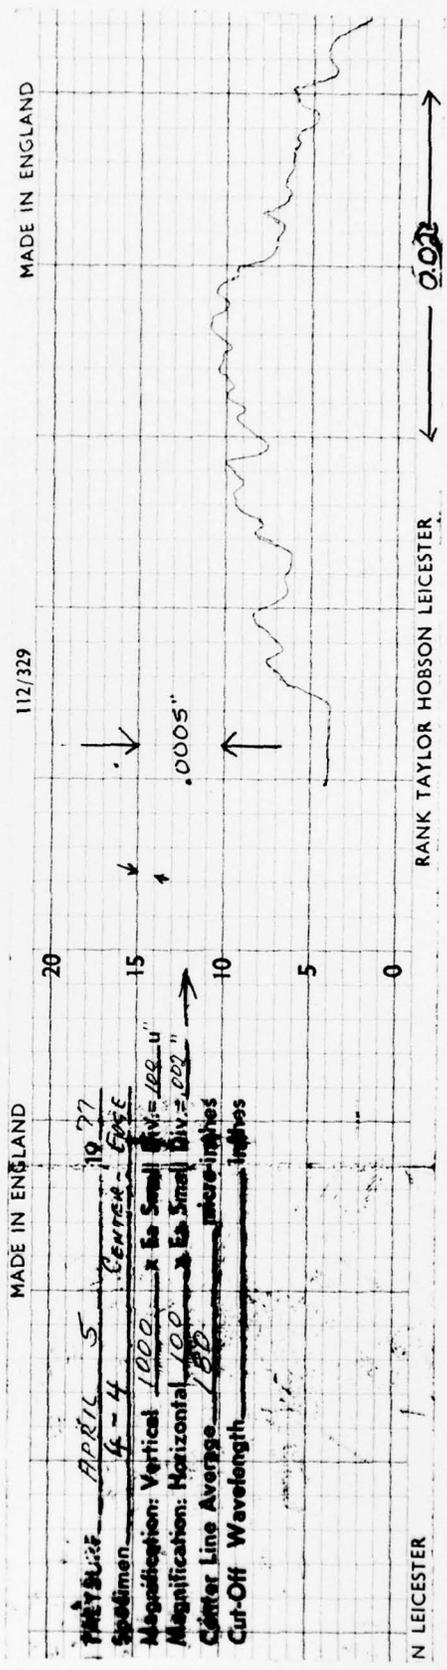
Fig. A4-5. Specimen 4-4 at edge. Exposed enamel (52 cal/cm<sup>2</sup>) over 25 mil aluminum skin. Note difference in horizontal scale.

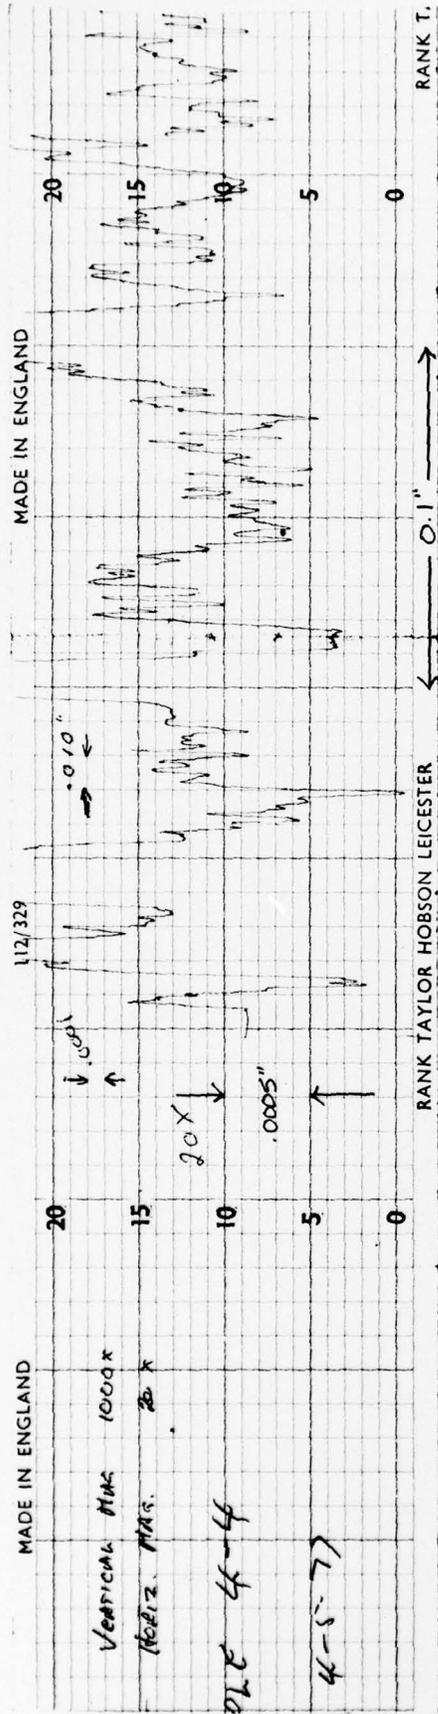
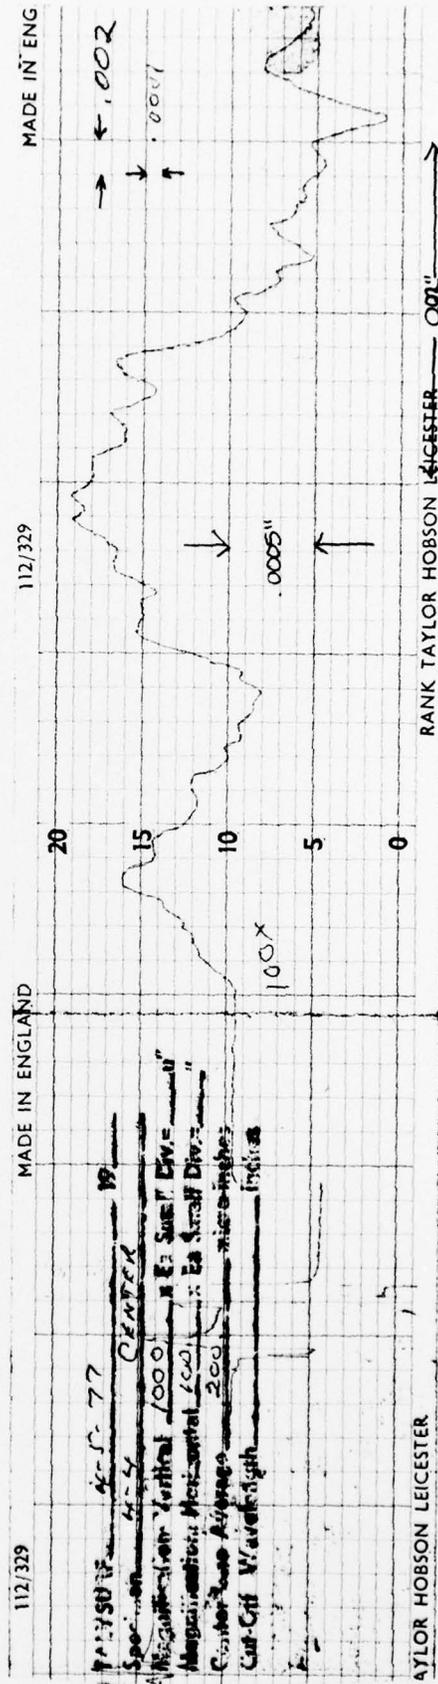
Fig. A4-6 Same as -5, but profile taken in center.

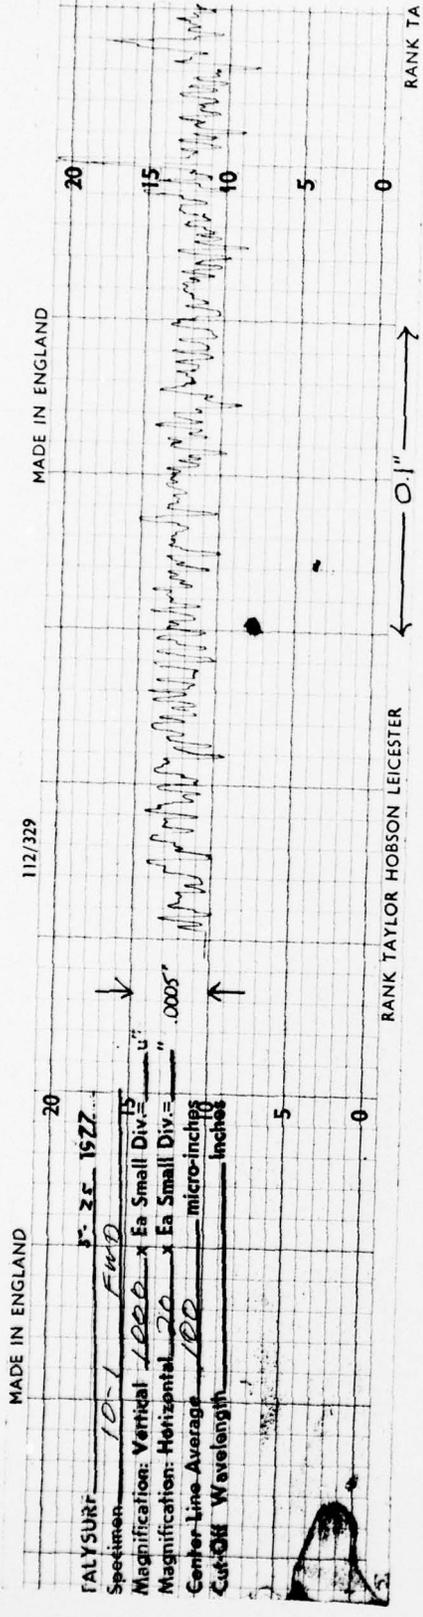
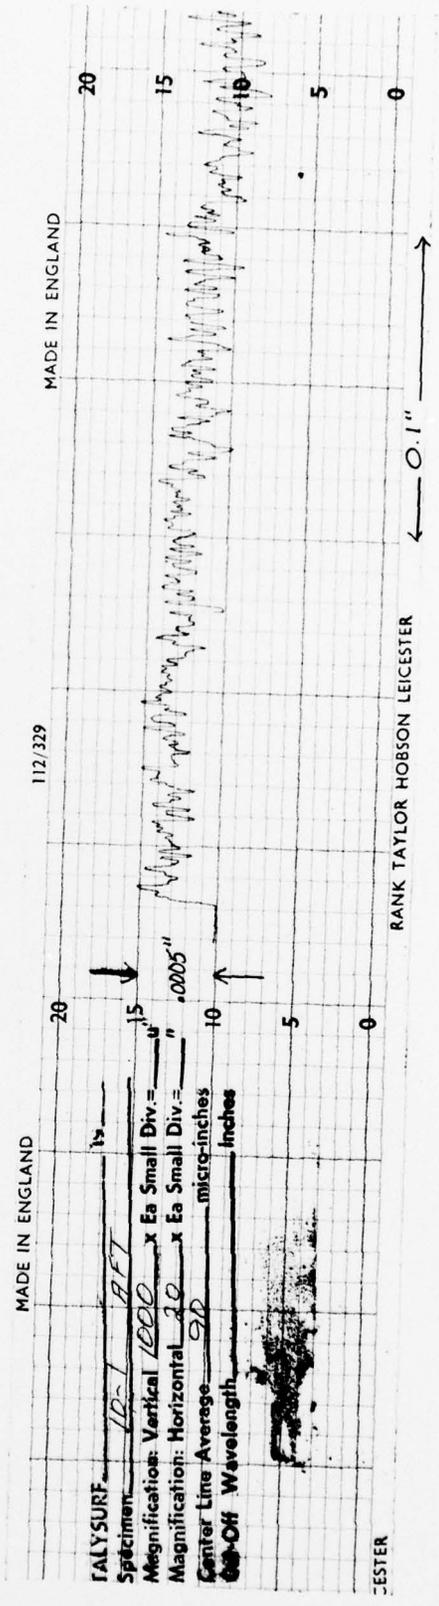
Fig A4-7. Specimen 10-1. Exposed enamel (31 cal/cm<sup>2</sup>) over 32 mil aluminum skin.

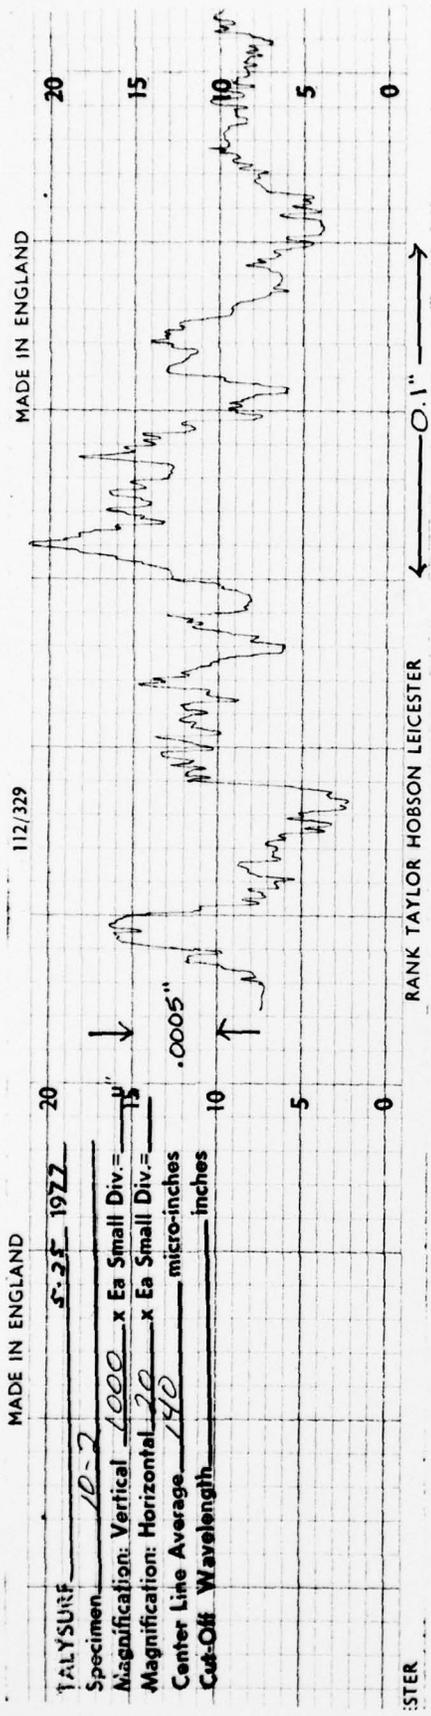
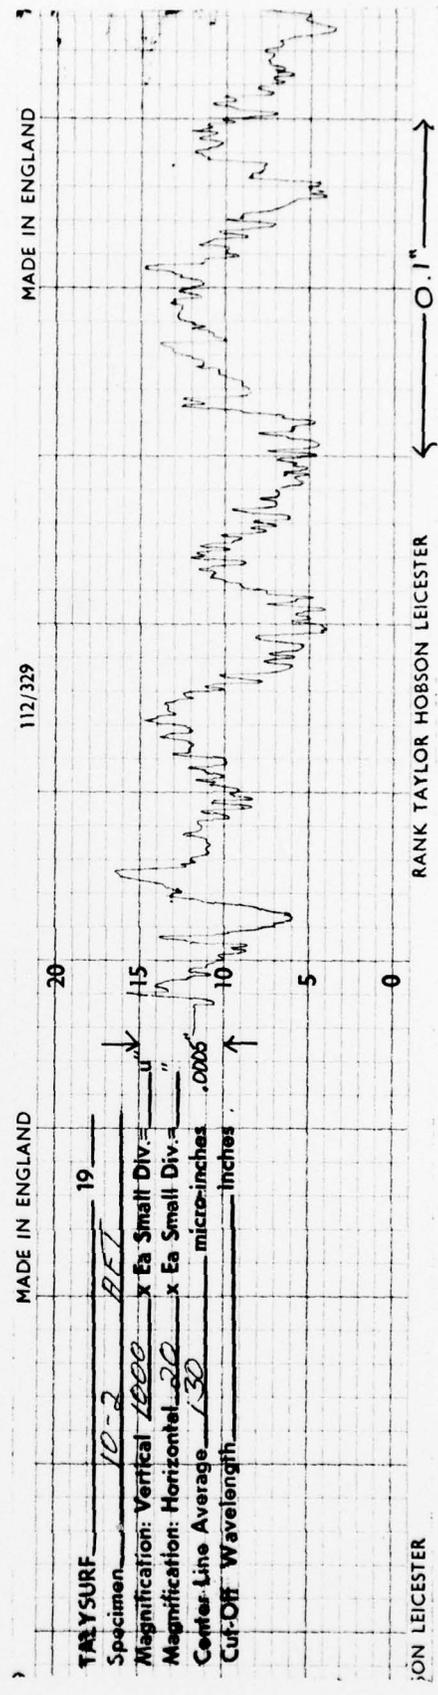
Fig. A4-8. Specimen 10-2. Fluence 54 cal/cm<sup>2</sup>.
