**SKIN FRICTION DRAG DUE TO NUCLEAR DAMAGE**

The Boeing Aerospace Company  
P.O. Box 3999  
Seattle, Washington 98124

(9) Final Report, for Period February 1977 - September 1977,

CONTRACT No. DNA 001-77-C-0090

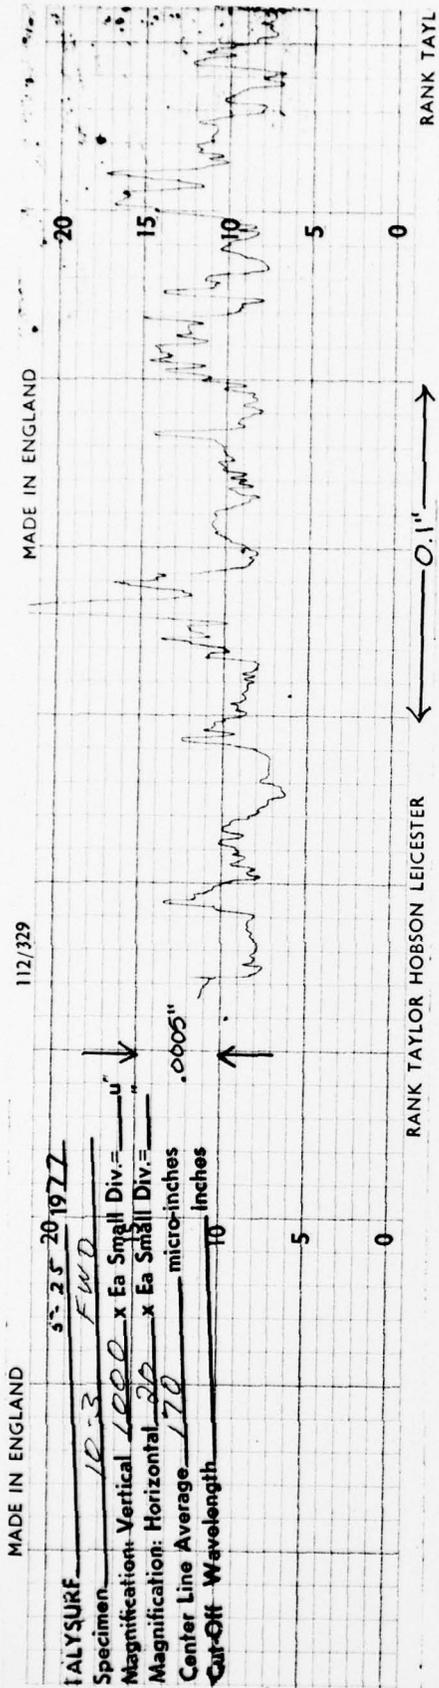
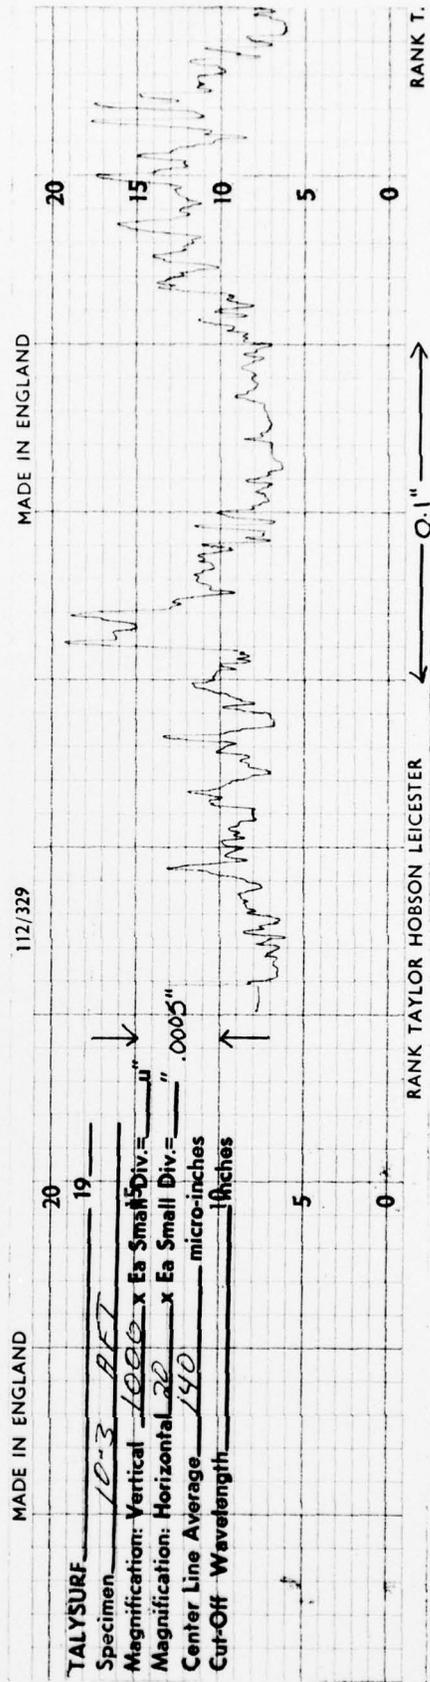
Fig. A4-9. Specimen 10-3. Fluence 67 cal/cm<sup>2</sup>.

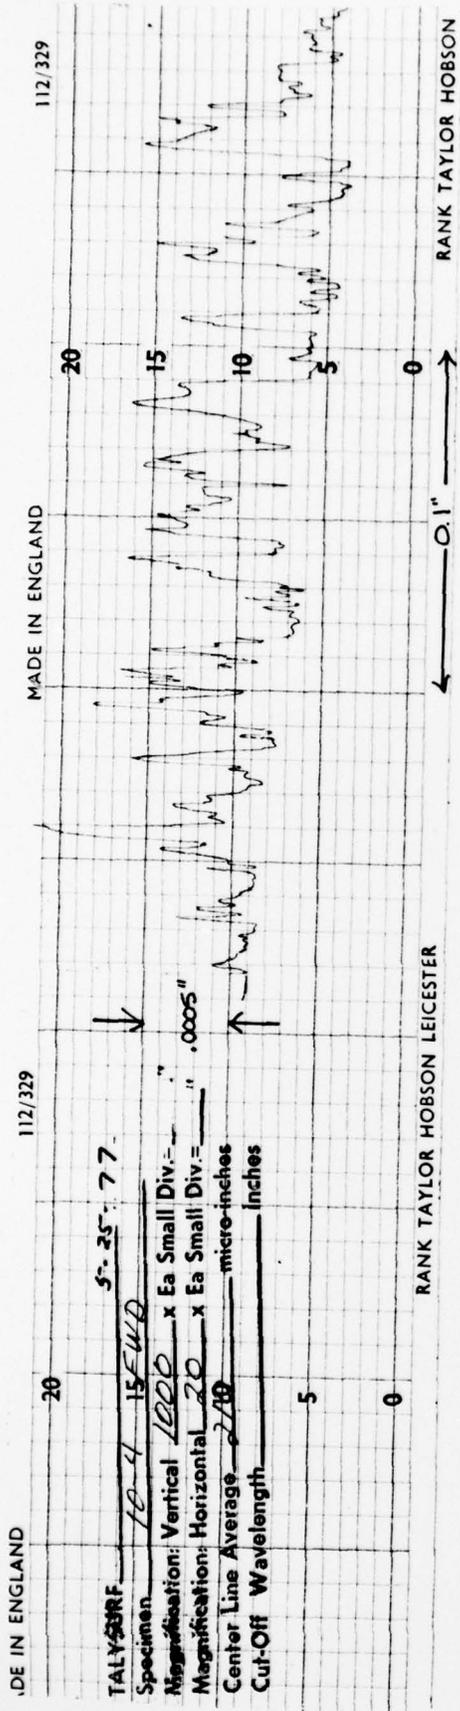
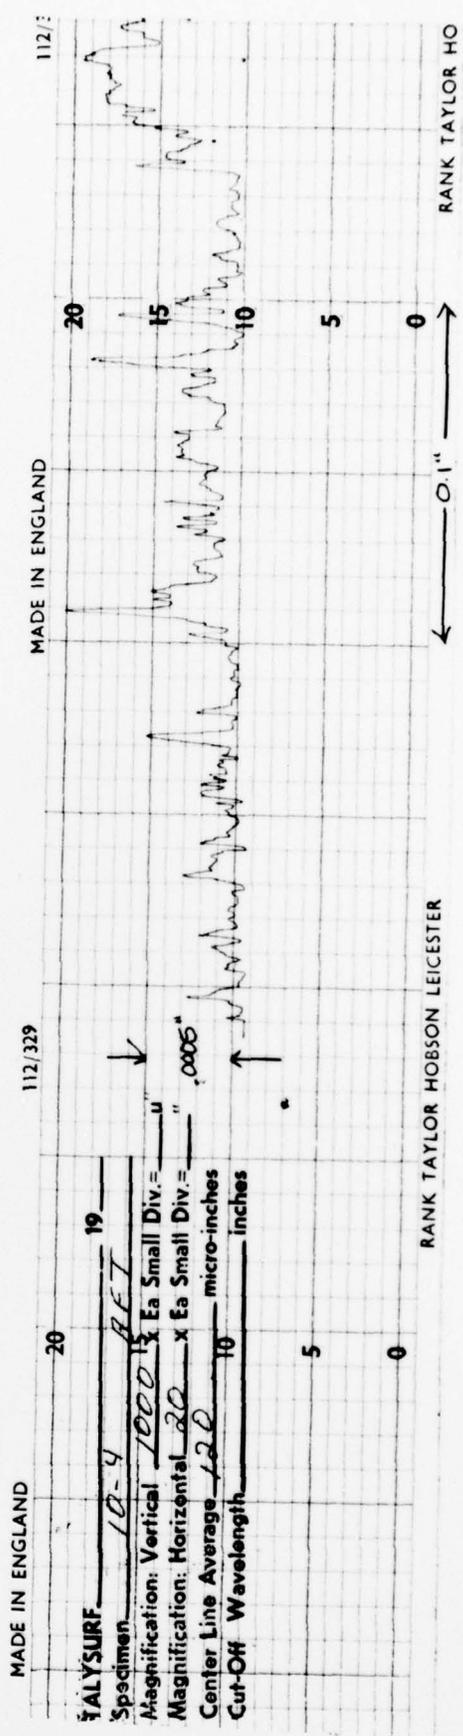
Fig. A4-10 Specimen 10-4. Fluence 82 cal/cm<sup>2</sup>.

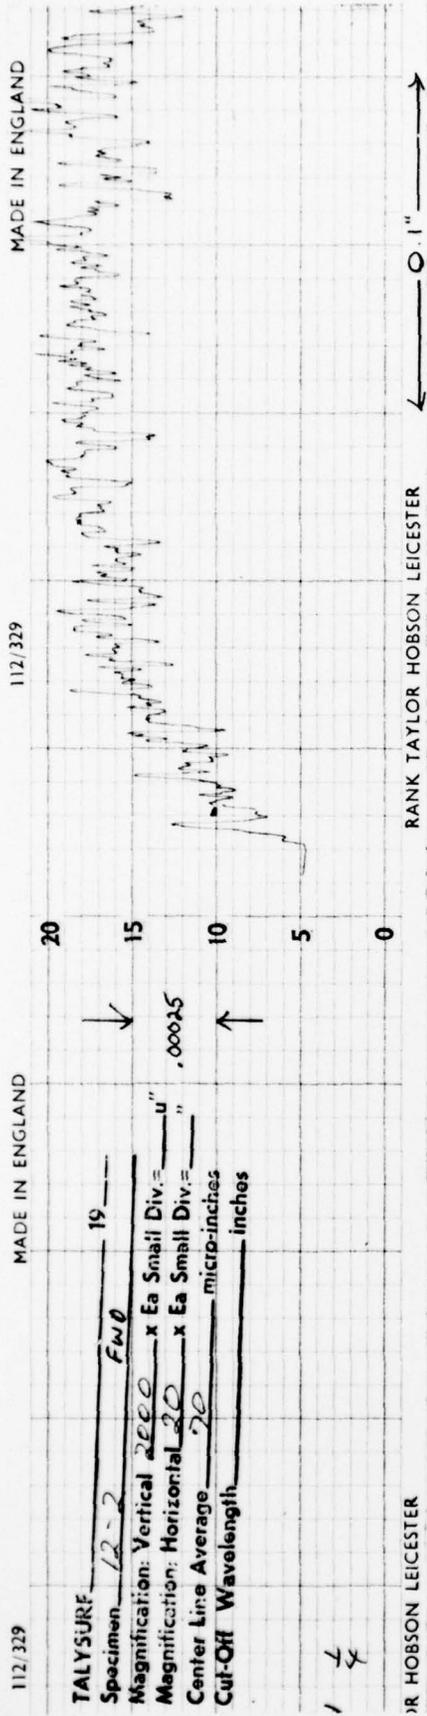
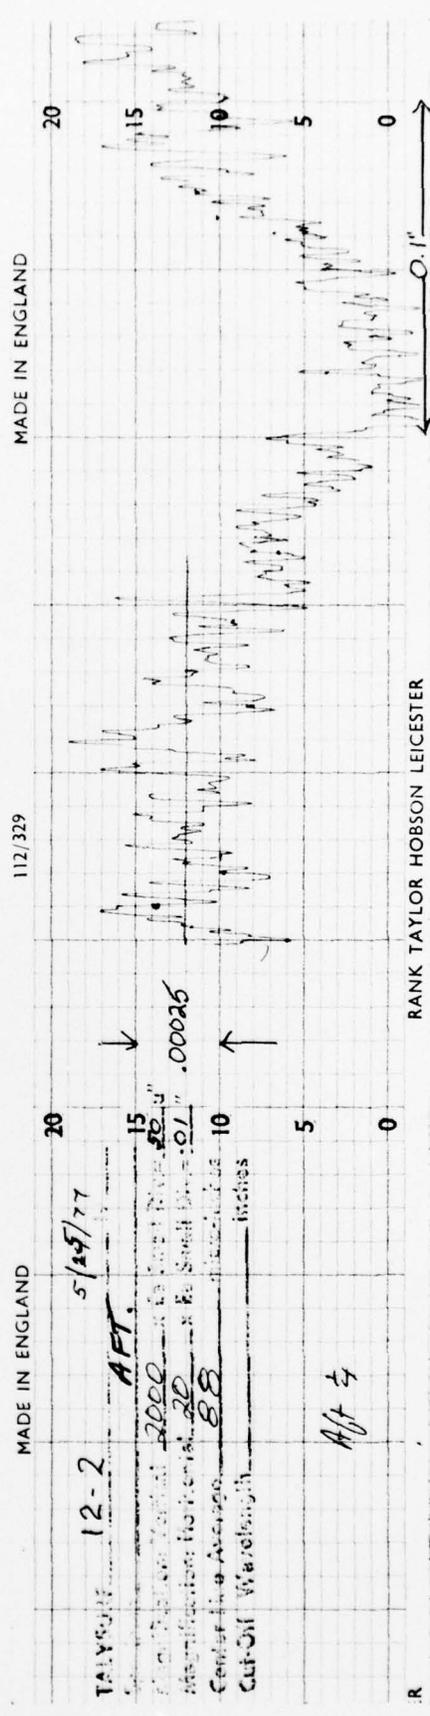
Fig. A4-11 Specimen 12-2. Exposed enamel (25 cal/cm<sup>2</sup>) over 20 mil fiberglass skin.

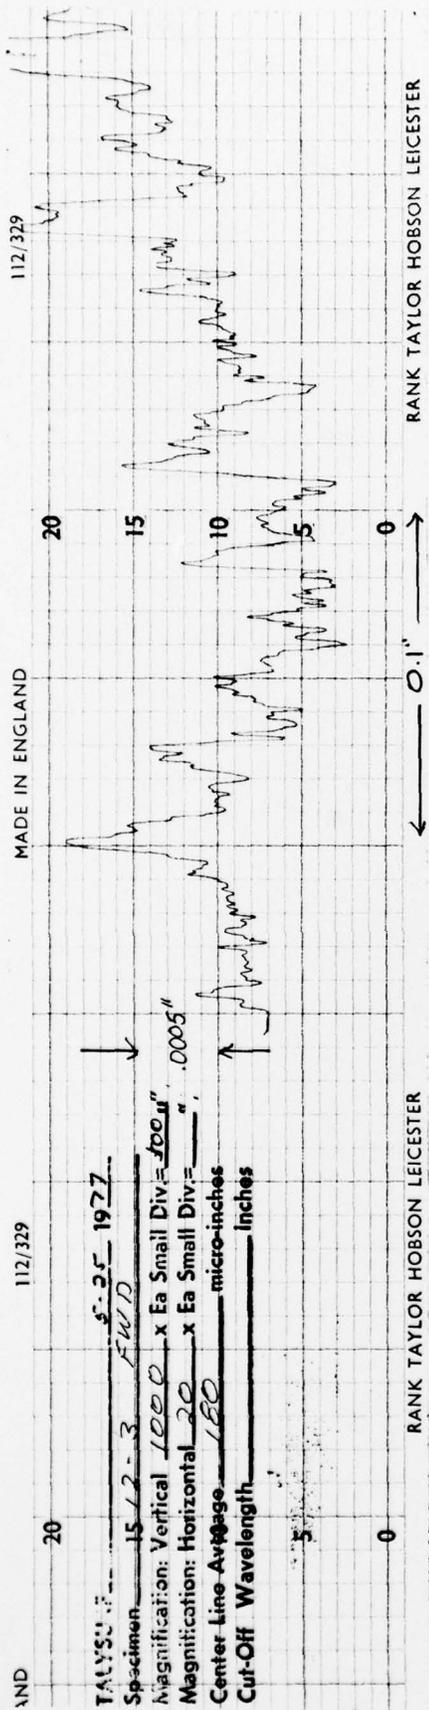
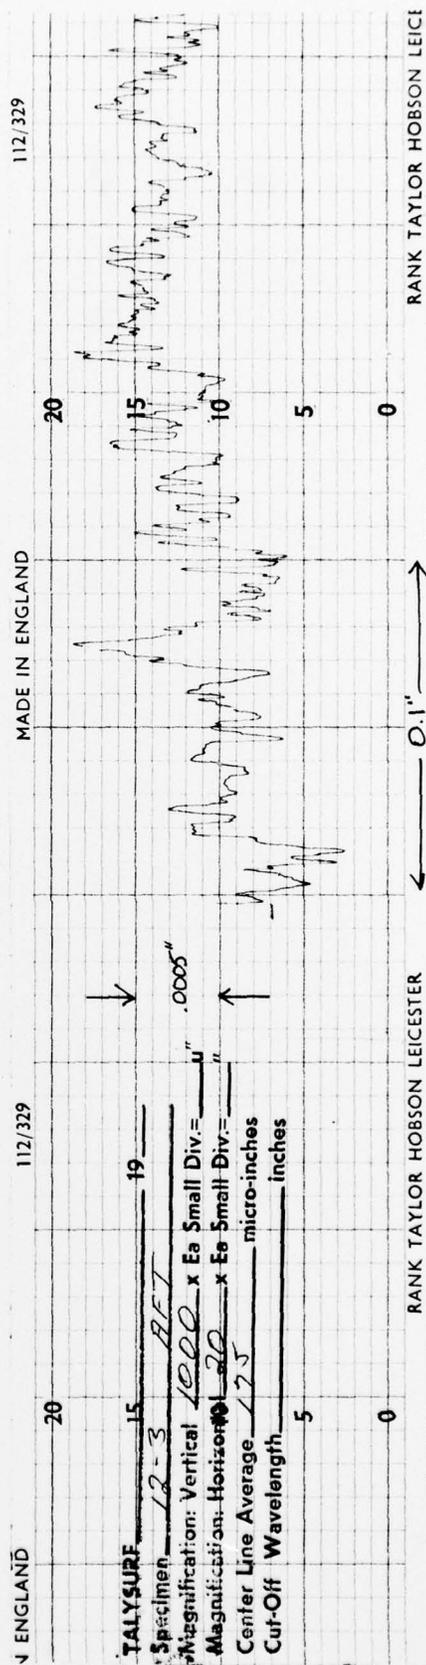
Fig. A4-12 Specimen 12-3 Fluence 38 cal/cm<sup>2</sup>.

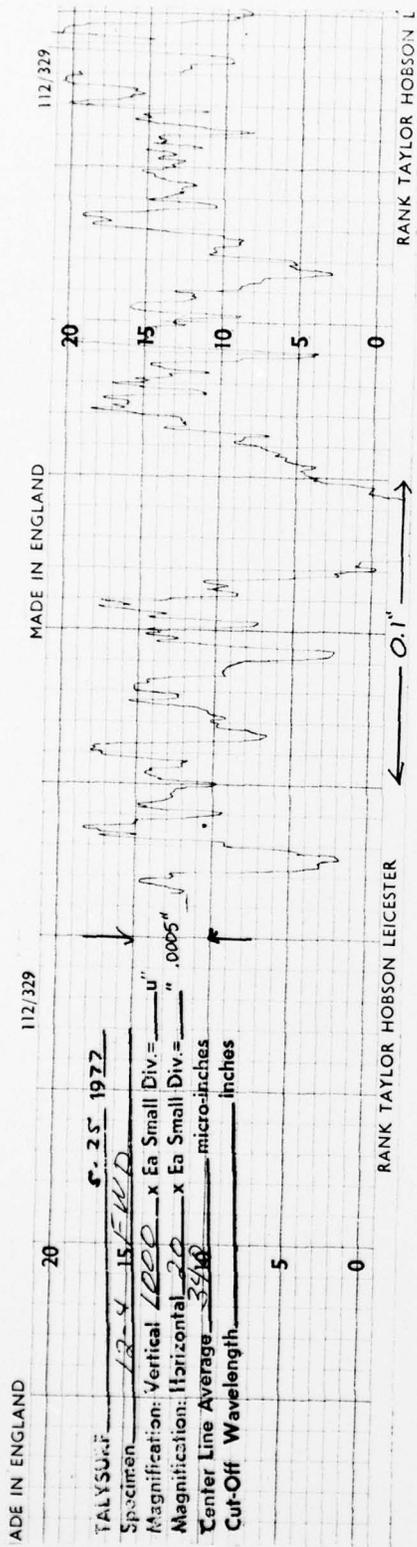
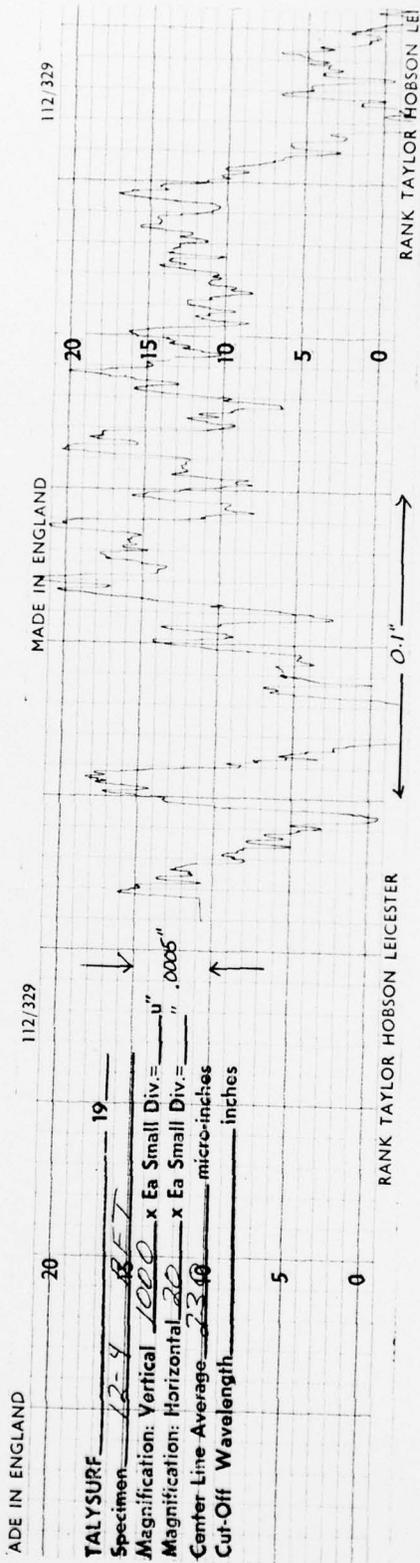
Fig. A4-13 Specimen 12-4. Fluence 64 cal/cm<sup>2</sup>.

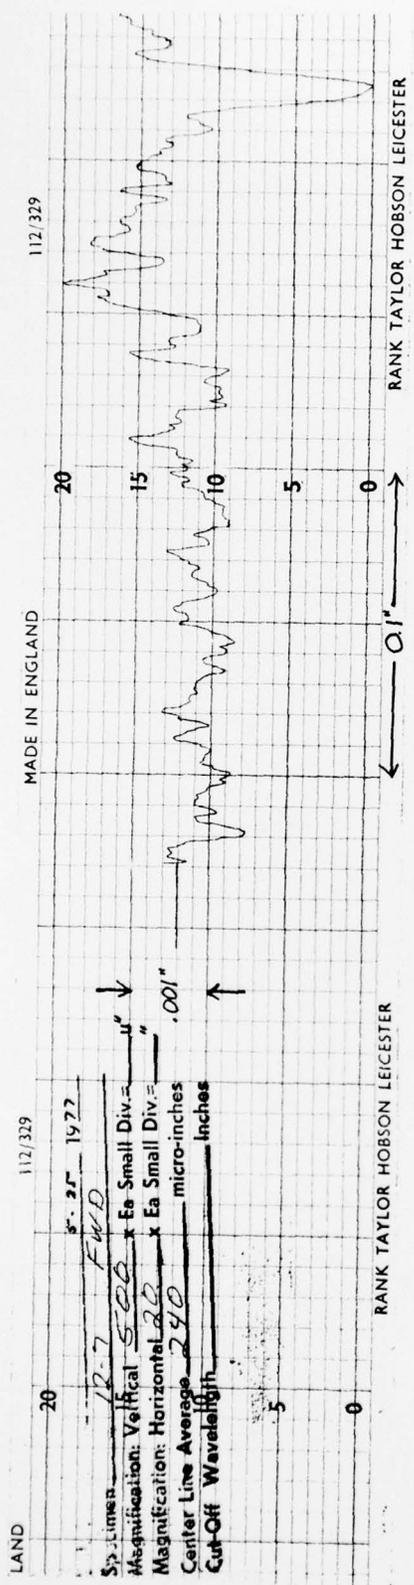
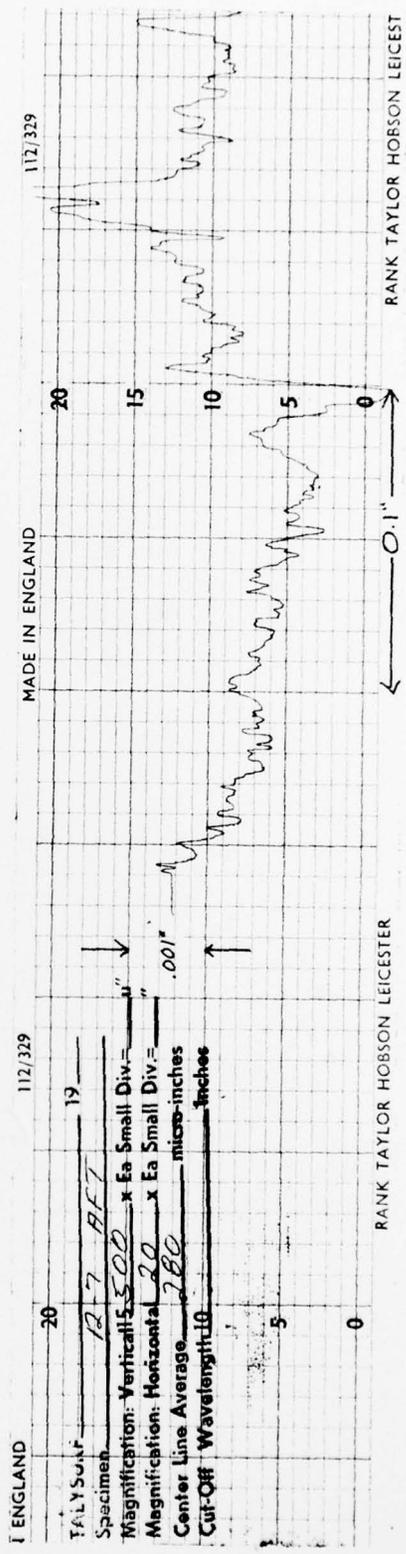
Fig. A4-14 Specimen 12-7. Fluence 82 cal/cm<sup>2</sup>.

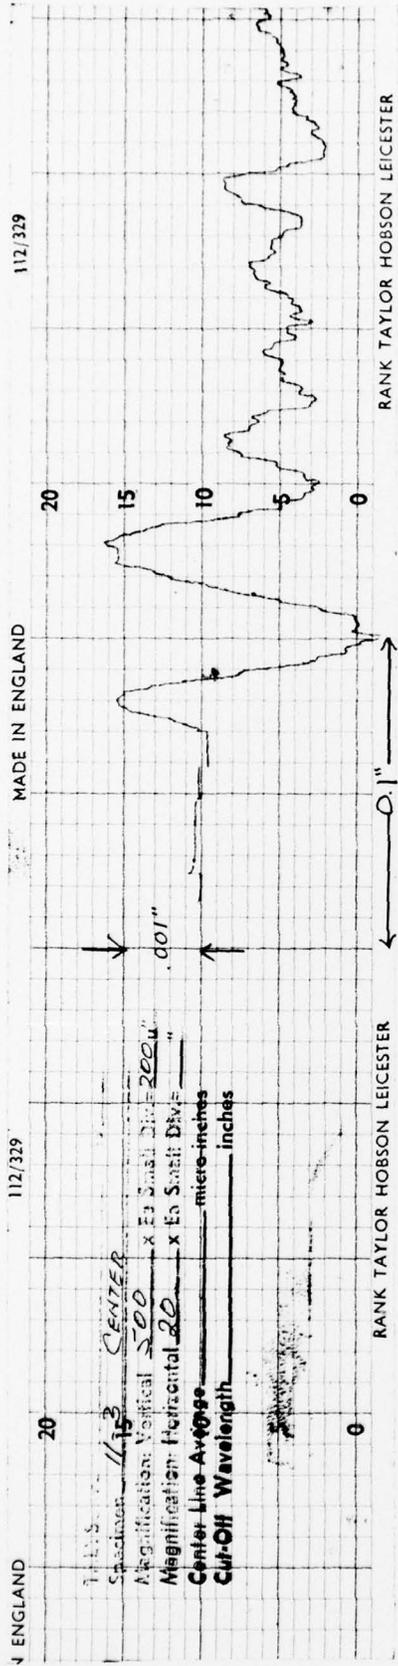
Fig. A4-15 (a) Specimen 11-3. Exposed enamel (25 cal/cm) over 13.5 mil fiberglass skin. Profile is in area of pinpoint blistering.

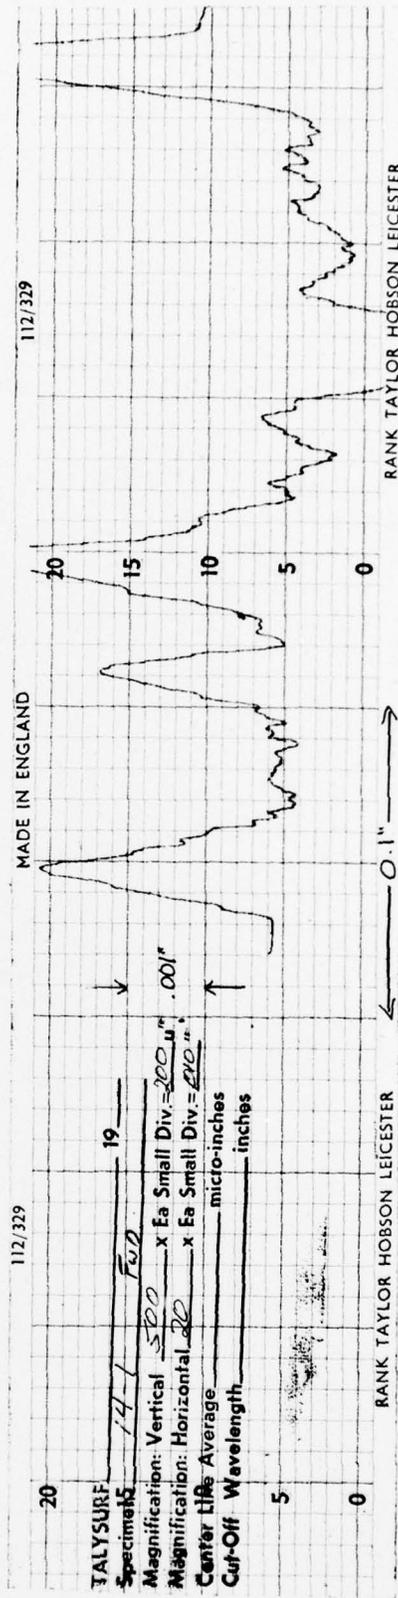
Fig. A4-15 (b) Specimen 14-1. Exposed enamel over 13.5 mil fiberglass skin. Profile is in area of pinpoint blistering.

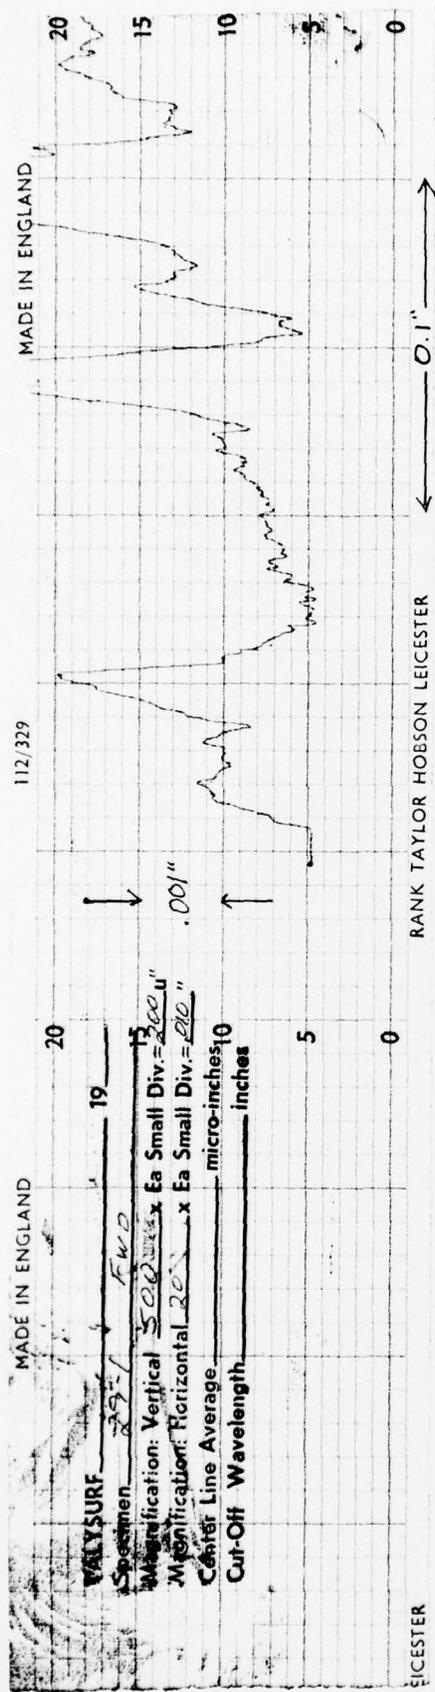
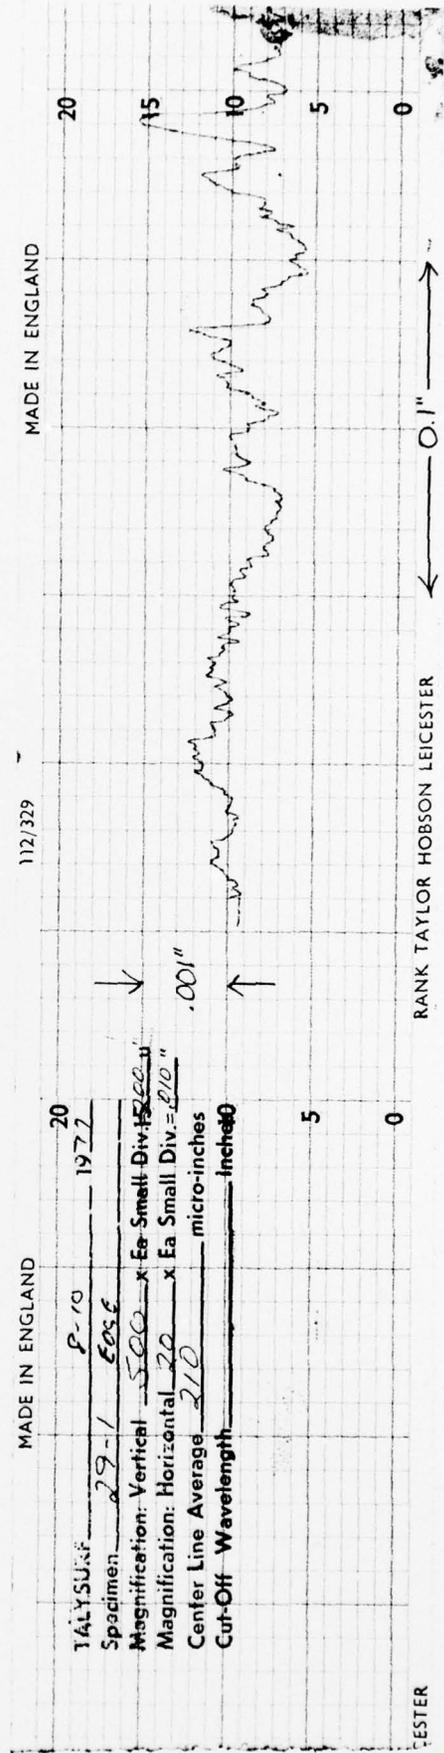
Fig. A4-16 Specimen 29-1. Exposed enamel (31 cal/cm<sup>2</sup>) over 20 mil graphite skin. Upper profile is in area of pin-point blistering.
