# WATERPROOFING STRAIN GAGES FOR LOW AMBIENT TEMPERATURES

Donald E. Garfield and Bryan G. McLain

September 1978

COLD REGIONS RESEARCH AND ENGINEERING LABORATORY  
U.S. ARMY CORPS OF ENGINEERS  
HANOVER, NEW HAMPSHIRE

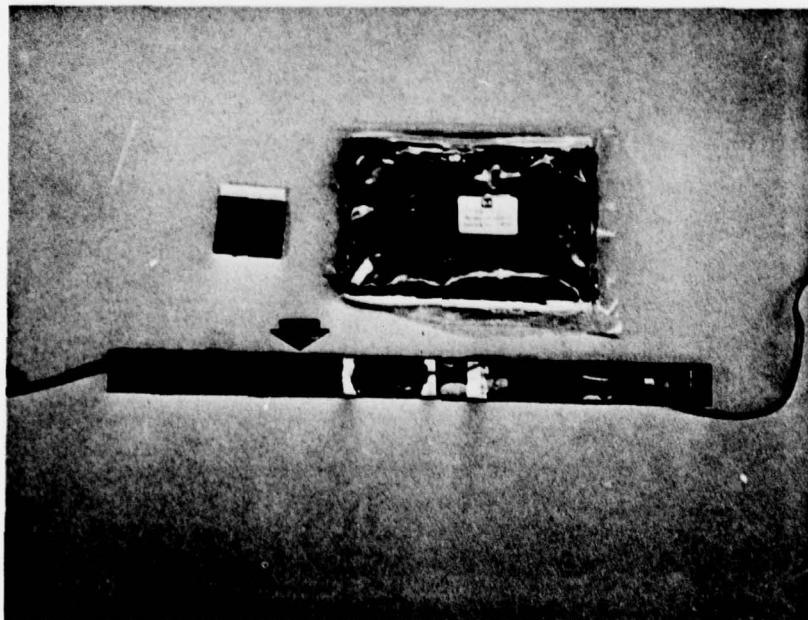
*Figure 10. Barrier E installation.*

Barrier E, another BLH Electronics product, is a soft Butyl rubber with a patch of unfabricated Neoprene rubber for mechanical protection. The patch was cut to size, allowing a  $\frac{1}{4}$ -in. border around the gage and  $\frac{1}{2}$  in. beyond the terminals at the lead end. The patch was then applied to the specimen and pressed firmly with the fingers. The Neoprene was pulled back slightly at the lead exit end and the Butyl rubber kneaded around and under the lead wires. Then the Neoprene jacket was replaced and pressed firmly to exclude all air bubbles. This was by far the easiest waterproofing coating to apply and required no curing.

Barrier E is simple to apply since it consists of only a rubber patch. Extra care must be taken to knead the soft rubber around the lead wires, which may be difficult in confined areas. The rubber patch remains pliable at low temperatures and will not cause significant localized reinforcement in the specimen.
