POTAMOLGY INVESTIGATIONS

Report 21-5

USE OF PLASTIC FILTER CLOTH IN
REVTMENT CONSTRUCTION

B. J. Littlejohn

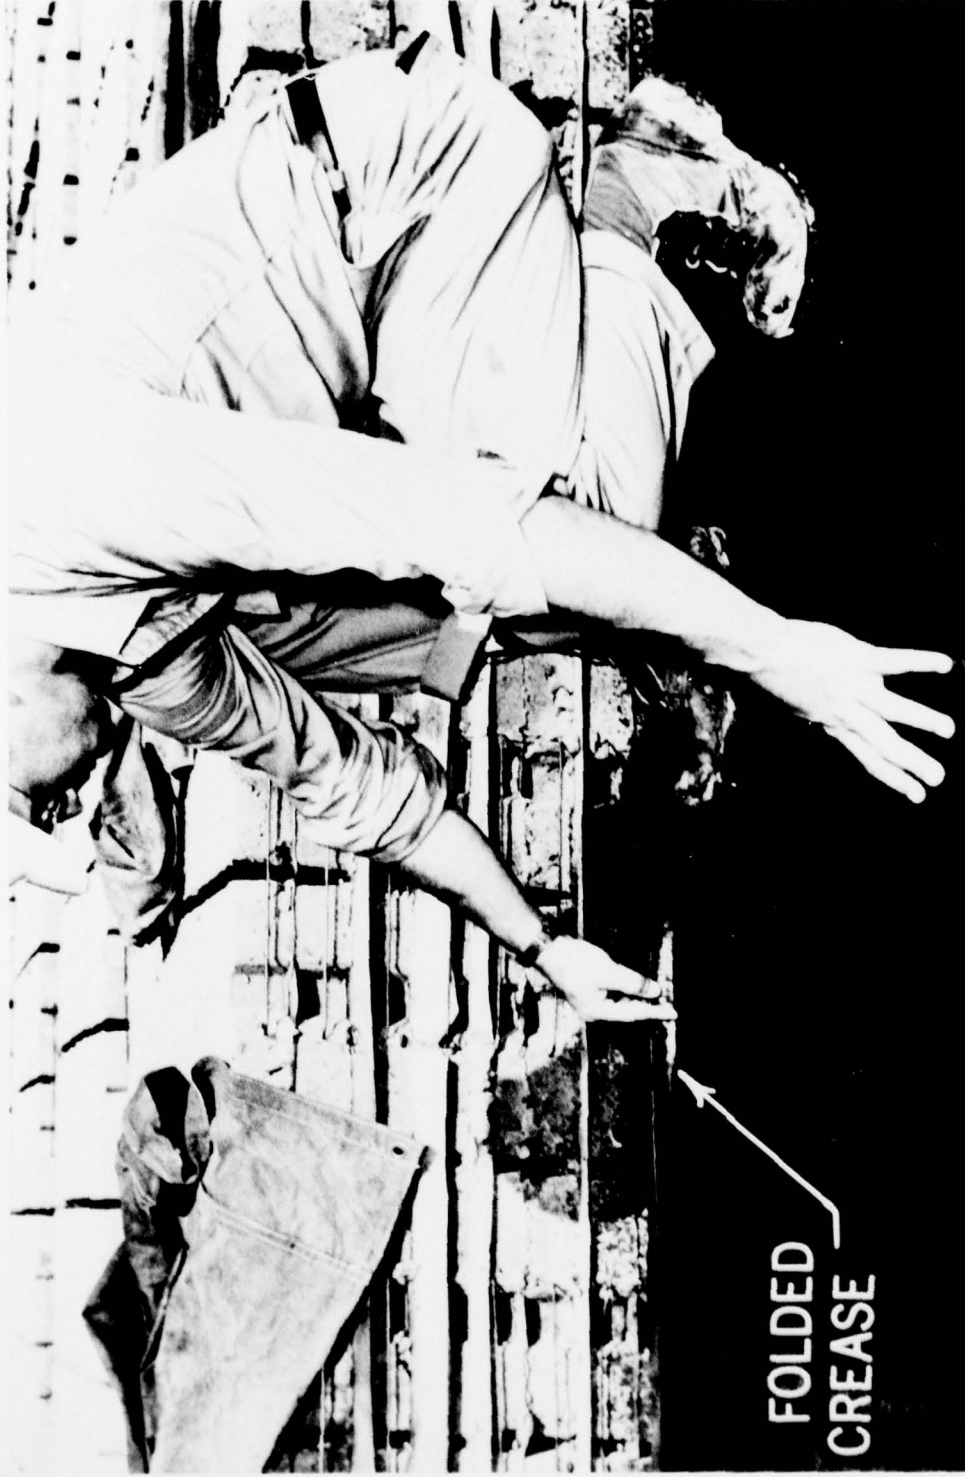
Photo No. 4

A folded crease parallel to the raised seam was inadvertently left in the cloth during the manufacturing process. This reduced the effective width of the cloth strip.

18. Upon unrolling the cloth with the polyethylene cord sewn in, there was a crease in the cloth parallel to the cord which could not be eliminated without delaying the casting operations (Photo 4). This reduced the effective width of the cloth as much as two inches in some

places and allowed the cloth to extend only one inch at these locations rather than the desired two inches on each side of a square. In placing the forms on the filter cloth, care was exercised to position the forms so that an equal width of cloth protruded on each side. Even the rolls with the folded seams sewn into the cloth had some creasing, but to a lesser extent.

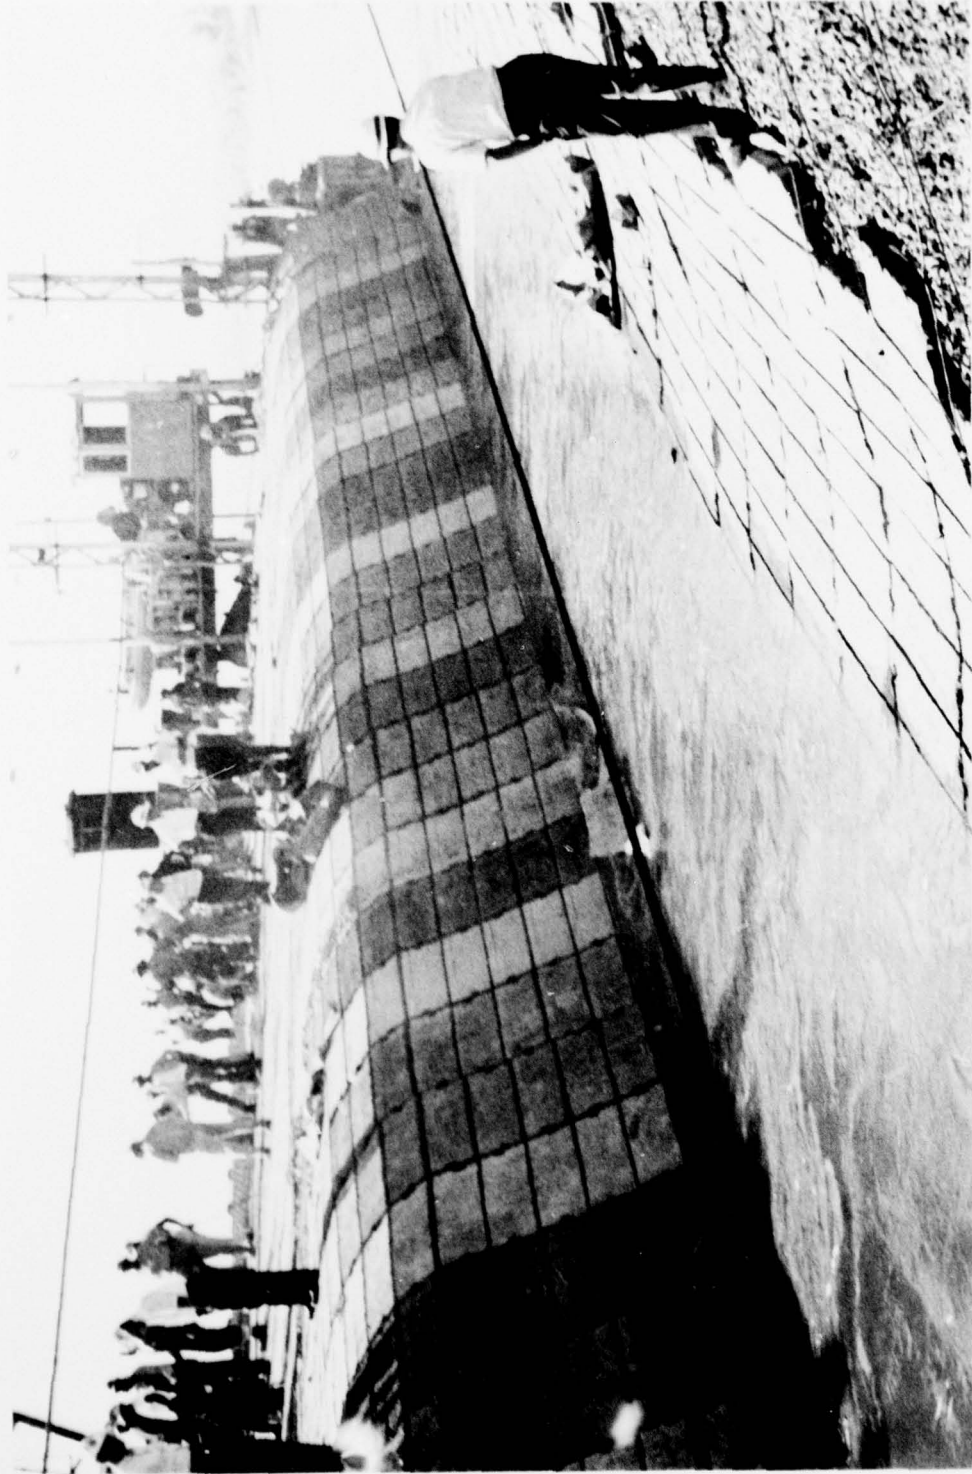
Photo No. 8

A full mattress consisting of the experimental squares with filter cloth being launched from the sinking plant.

25. Each launch was closely observed as it moved down the mat deck and into the water to determine whether the filter cloth was still attached to the bottom of the mattress squares (Photo 8). The cloth on seven squares was pulled loose from the concrete mattress to such extent that it would be of little or no value as erosion control.

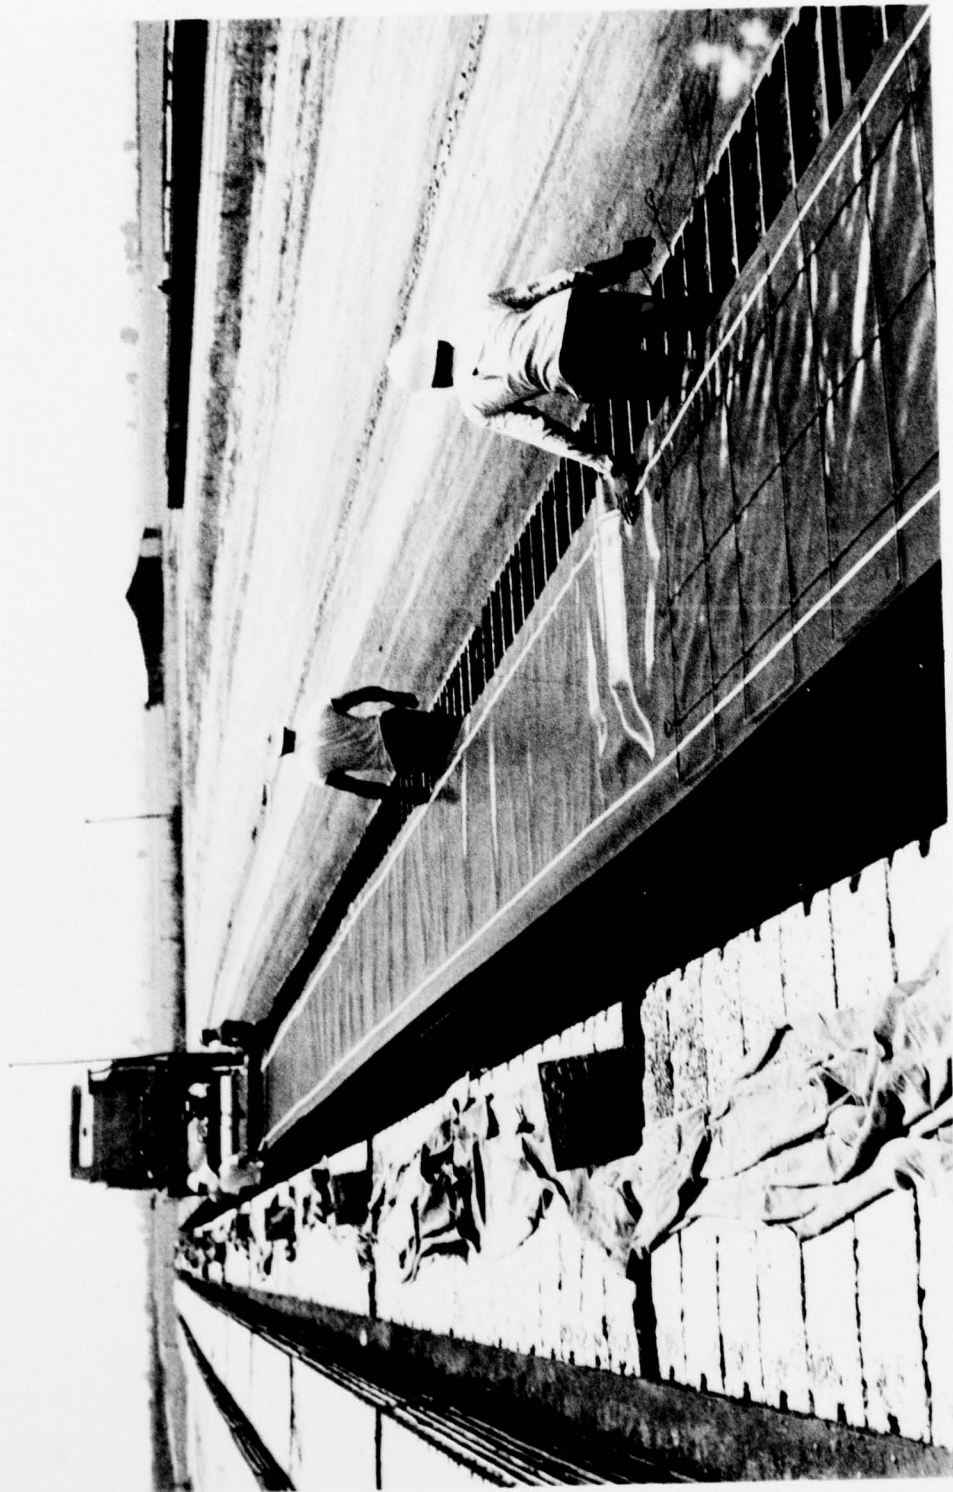
Photo No. 9

Filter cloth with 1/4-inch cords sewn on top as a bonding device. Note that the cloth strips lie flat with no folds or creases present.

28. After being advised of the failures in the bonding devices used in the first experiment, Carthage Mills, Incorporated, furnished two samples with a cord sewn directly on top of the cloth. They had continued attempts to develop a more satisfactory bonding device even before the first experiment was conducted. This type of bonding device had a major advantage over the two previously used in allowing the cloth to extend the full two inches beyond the edge of the mattress on each side since the entire 50-inch width of the cloth laid flat with no folds or creases (Photos 9 and 10). Both samples of cloth had a 1/4-inch diameter cord sewn on top, but one was polyethylene and the other cotton. These were located six inches from and parallel to the two longitudinal edges, the same as for the previously used seams.

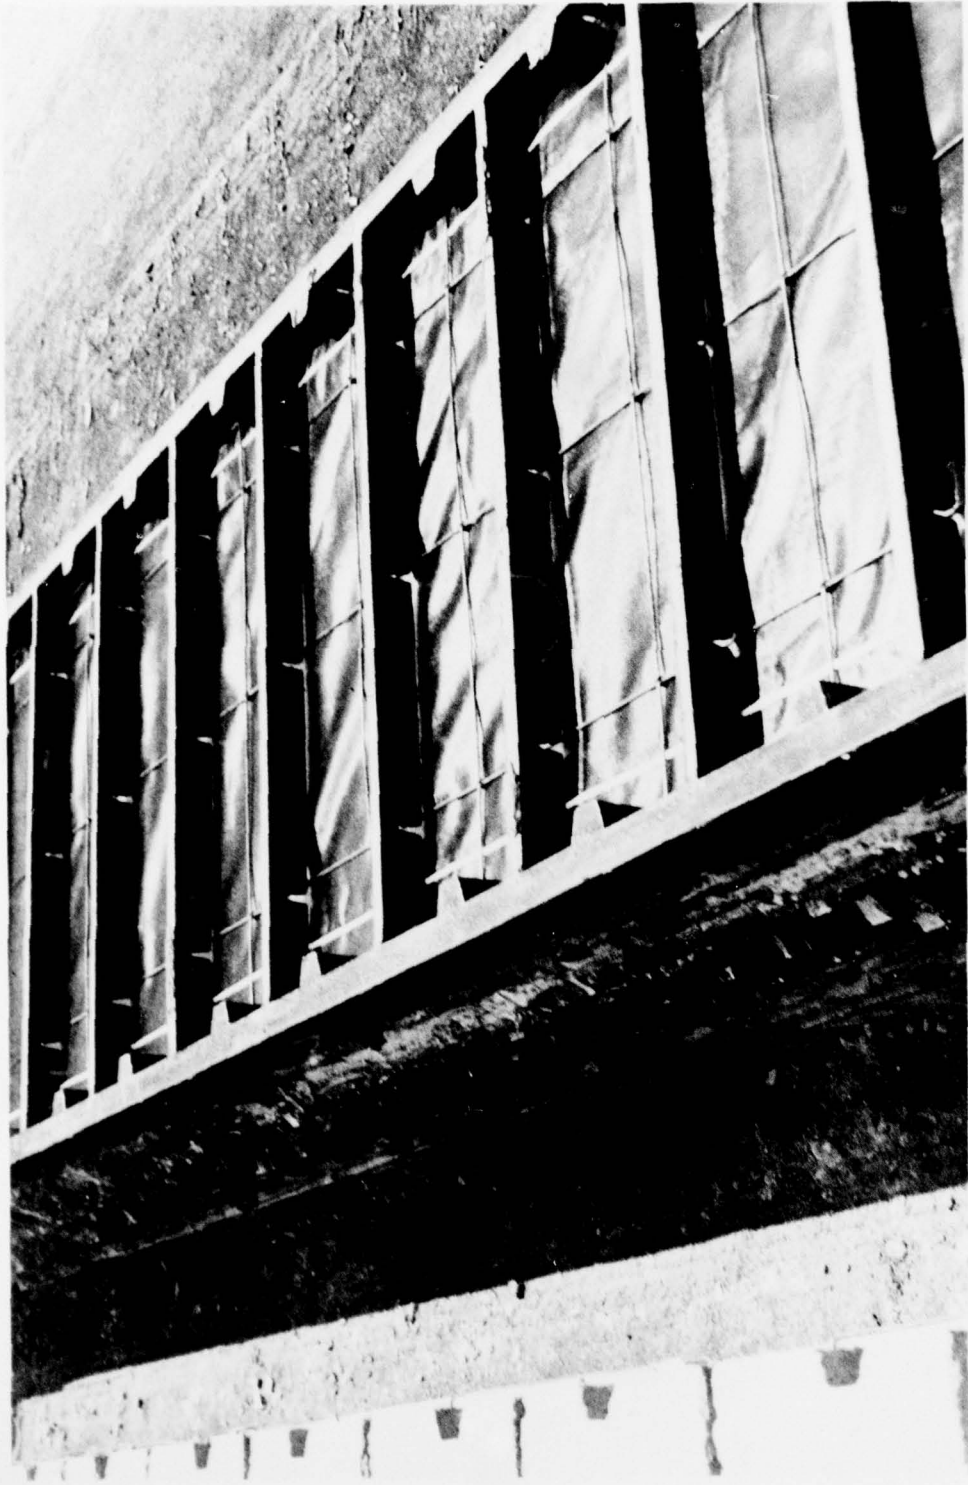
Photo No. 10

Mattress forms in place on the filter cloth with 1/4-inch cord in preparation for placing concrete.

29. The experimental mattress squares were cast at Cates Casting Field, Tennessee, on 20-22 May 1969, in conjunction with the standard mattress casting contract which was modified to incorporate the casting of 48 squares of mattress with the filter cloth bonded to the bottom side. The casting procedure was the same as that used in Experiment No. 1. Of the 48 test squares, 24 were cast using the polyethylene cord and 24 were cast using the cotton cord. The corners of the test squares were painted with red or black paint for easy identification of the two types of cord during the handling, assembling, and sinking operations.
