# U. S. ARMY ELECTRONICS COMMAND

6) POLARIZATION/MULTIPATH STUDY,  
August 1971 through June 1972,

Navigation and Landing Technical Area  
387 890 Avionics Laboratory

ABSTRACT

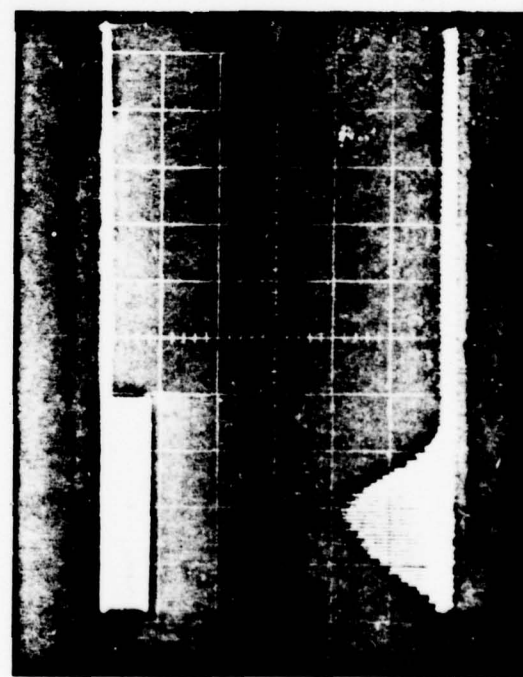
FIGURE 5a.

Illustrations 4, 5, and 5a are actual scope photographs of data obtained during the preliminary Red Bank tests. In each photo, the scope was calibrated against a precision Ku band attenuator in order that the relative difference in amplitude in decibels between the direct and the reflected signals could be determined. The photos, therefore, show the following data: difference in amplitude between the direct and reflected beams on the bottom trace of each photo (beam envelope trace where the first envelope is always the direct beam) and whether or not the receiver actually tracked or locked on to the reflected beam (vertical expansion of top trace coincidental with bottom beam envelope trace). The top photos of Figures 4, 5, and 5a illustrate vertical polarization; the bottom photos illustrate horizontal polarization.

5 Nov 71

IDENTICAL HV POLARIZED ANTENNAS

To summarize, the data shows the horizontally polarized reflected beam to be weaker than vertically polarized reflected beam: 5.7 dB to greater than 9 dB down for horizontal polarization versus 1.3 to 5.9 dB down for vertical polarization. The data also shows the receiver locking to or tracking the vertically polarized reflected beam whereas it did not track the horizontally polarized reflected beam in the examples noted here. (Figure 6 summarizes the data further.)

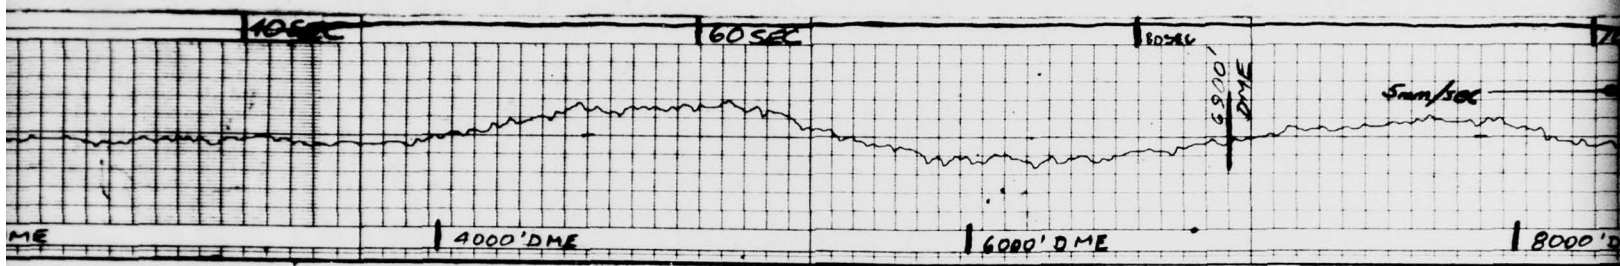
FIGURE 2. 36

Figure 2 presents actual chart recorder data taken in the aircraft during actual approaches. The top two strips are approaches with horizontal polarization, the bottom two strips are approaches with vertical polarization. The course deviation indicator (pilots indicator) tolerances are exactly as shown on the chart recordings, i.e.,  $\pm 1$ -degree deviation for full scale needle or recorder pen deflection. It should be noted, however, that when the needle goes full scale on a multipath beam, this can represent an error much greater than 1 degree.

PILOT UNABLE TO REGAIN LOCALIZER BECAUSE OF PREVIOUS FALSE GUIDANCE

FULL SCALE FLY RIGHT  
LOCKUP ON MULTIPATH BEAM  
DURING FLY LEFT INTERCEPT

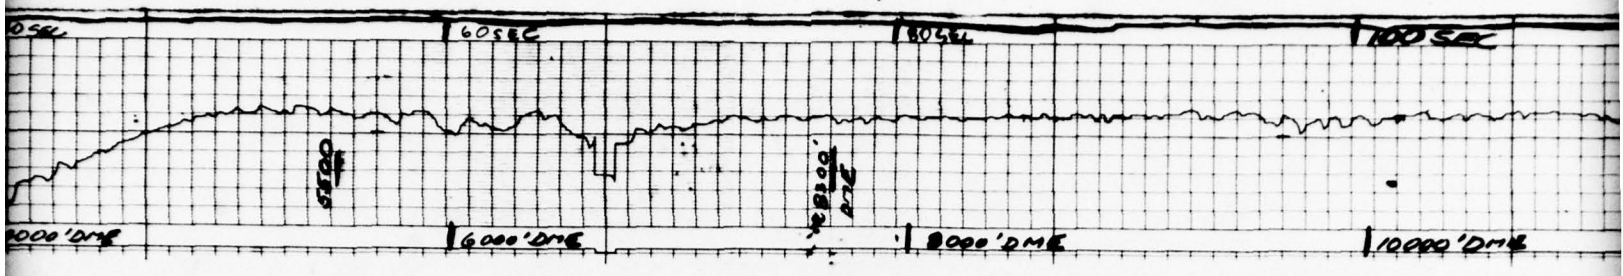
FIGURE 4.

Referring to the bottom two strips of Figures 4 and 5, the courses are seen to be rough and erratic with peak-to-peak course deviations of more than 2 degrees appearing throughout the approaches. As expected, the deviations become more erratic as the aircraft approaches within 1 mile of touchdown. Looking at the top two strips of Figures 4 and 5 (horizontal polarization), no course degradation due to multipath can be found.

**VERTICAL VS HORIZONTAL POLARIZATION  
FLIGHT TEST DATA  
2 APR, 27 APR 72, LAKEHURST NAS  
CIRCLE CHARLIE TEST SITE**

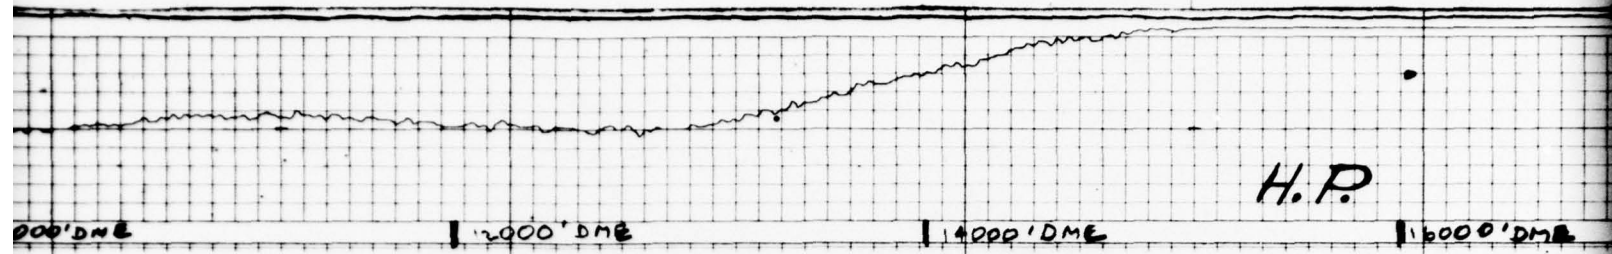
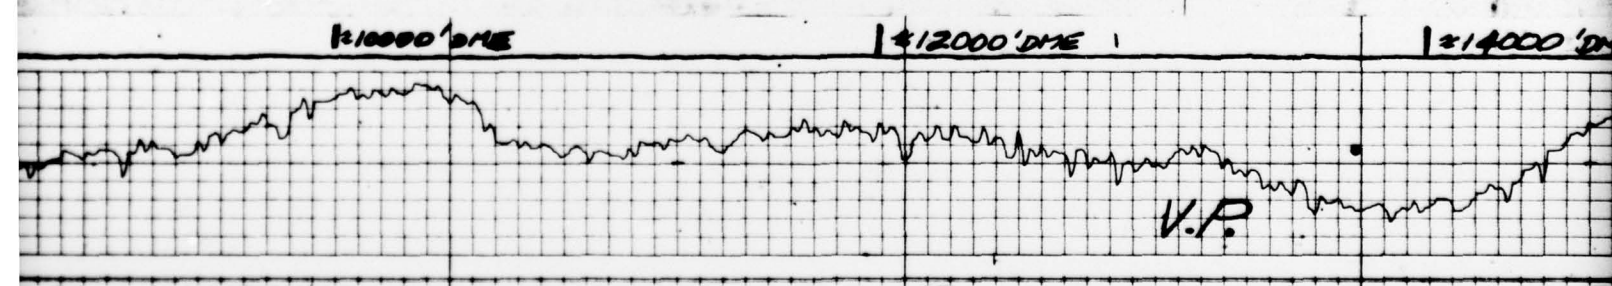
FIGURE 5. 57

# VERTICAL VS HORIZONTAL POLARIZATION FLIGHT TEST DATA
