FAA-RD-77-70

**6** FLIGHT TESTS OF A LOW-COST  
OMEGA NAVIGATION RECEIVER.

**9** FINAL REPORT.

**U. S. DEPARTMENT OF TRANSPORTATION  
FEDERAL AVIATION ADMINISTRATION**

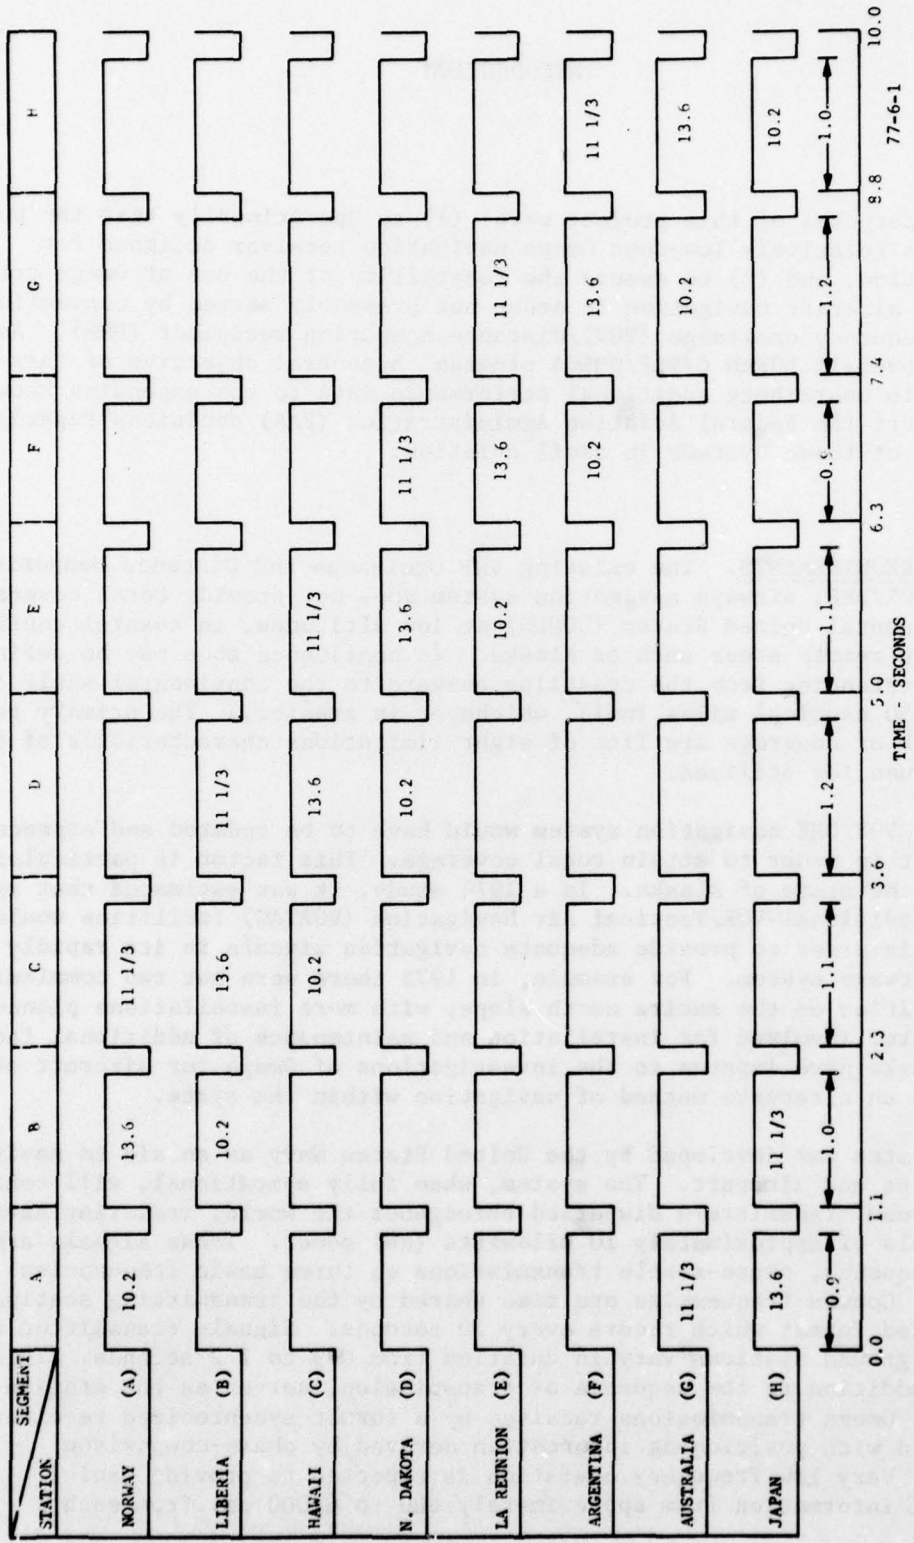
FIGURE 1. BASIC OMEGA TRANSMISSION FORMAT

NOTES: TRANSMISSION FREQUENCIES (kHz) ARE NOTED WITHIN THE SEGMENTS ASSIGNED.  
 BLANK SEGMENTS ARE RESERVED FOR UNIQUE FREQUENCY ASSIGNMENTS.

The Omega system was developed by the United States Navy as an aid to navigation for ships and aircraft. The system, when fully operational, will consist of eight ground transmitters dispersed throughout the world, radiating navigational signals of approximately 10 kilowatts (kW) power. These signals are very low frequency, phase-stable transmissions on three basic frequencies (figure 1). Common frequencies are time shared by the transmitting stations in a specified format which recurs every 10 seconds. Signals transmitted by the various ground stations vary in duration from 0.9 to 1.2 seconds. This factor, in addition to the sequence of transmission, serves as the station identifier. Omega transmissions received by a format-synchronized receiver, are processed with positioning information derived by phase-comparison techniques. Very low frequency operation is expected to provide useful navigational information from approximately 600 to 6,000 nmi from each transmitter.

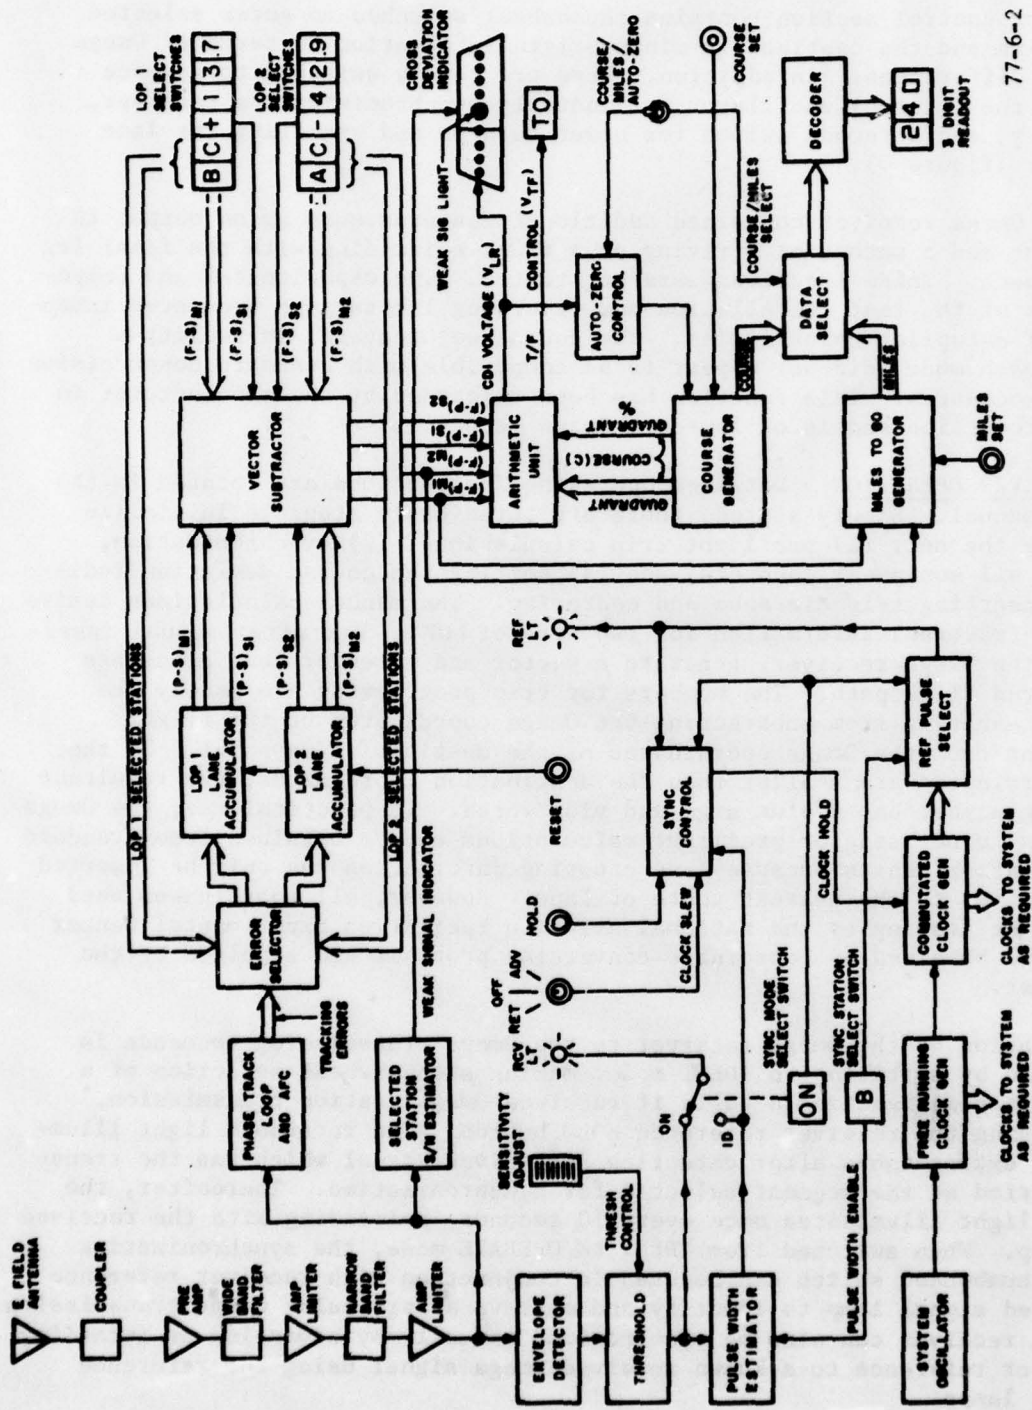
FIGURE 2. MARK III FUNCTIONAL DIAGRAM

The signal tracking section consists of a phase detector, weak-signal detector, and storage registers for phase data. The phase of each 10.2 kHz received signal is compared by the phase detector to an internally generated 10.2 kHz reference signal. The resulting phase data are stored at the end of each reception until 10 seconds later when the station transmits again. This enables the phase detector circuit to be time multiplexed and thus permits tracking of signals received from all Omega transmitting stations with one phase detector. As the weak-signal detector compares the internal Omega time-frame signal and the 10.2 kHz received signal, it generates signal-to-noise data (S/N) which is thresholded to produce an indication on the weak-signal lamp if the S/N ratio is too low.

The lane accumulator, data generator, and readout generator consist of two 12-bit, up/down accumulators (one for each station-pair selected) and a vector subtractor. These circuits process destination-minus-origin Omega coordinate information (thumbwheel switch inserted) and present position-minus-origin data (from the accumulators) to produce destination-minus-present position data as a sign-plus-magnitude for each line of position (LOP) chosen. These data are fed into the arithmetic unit and the miles-to-go generator. The arithmetic unit produces the error voltage for the course deviation meter and the TO/FROM flag control voltage. The miles-to-go generator supplies the distance information to the indicator. The course generator supplies

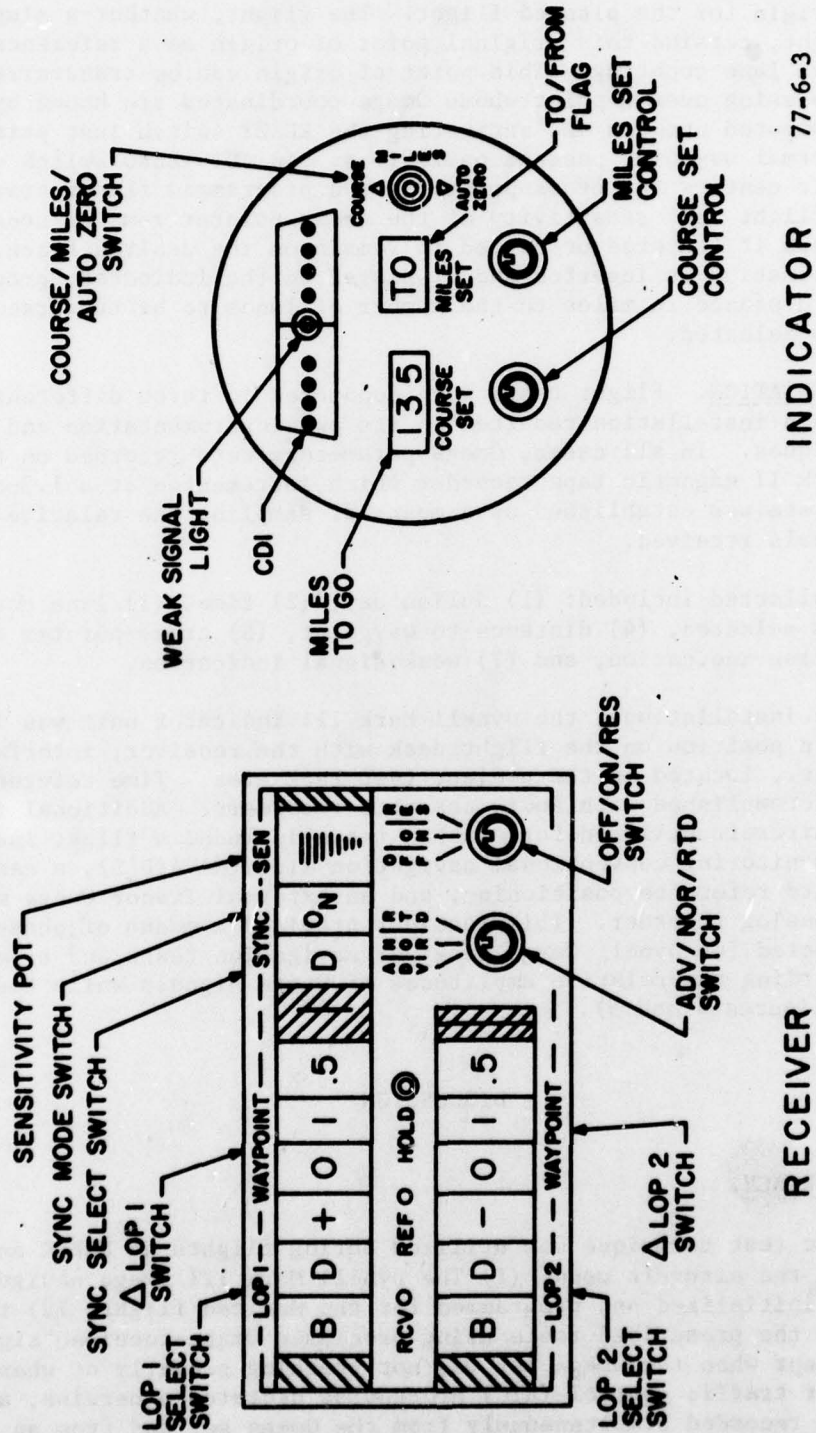
FIGURE 3. MARK III OMEGA CONTROLS AND INDICATORS

Synchronization of the Omega receiver to the Omega transmission sequence is accomplished by switching to IDENT mode, making a thumbwheel selection of a segment letter designating a valid if received Omega station transmission, and depressing the receiver reference HOLD button. The reference light illuminates and extinguishes after detecting a received signal which has the transmission period at the segment selected for synchronization. Thereafter, the reference light illuminates once every 10 seconds, coinciding with the received signal lamp. When switched from IDENT to OPERATE mode, the synchronization selector thumbwheel switch can be used in conjunction with receiver reference and received signal lamp to identify and observe a particular Omega transmission. The Dynell receiver can also be synchronized manually by advancing or retarding the receiver reference to a known received Omega signal using the reference and signal lamps.

The RESET switch zeros the lane accumulator within the receiver and establishes a point of origin for the planned flight. The flight, whether a single or multileg flight, retains this original point of origin as a reference for all internal Omega lane counting. This point of origin can be transferred in flight when passing over a point whose Omega coordinates are known by inserting the proper computed numbers and activating the RESET switch just prior to performing normal waypoint passage operations. An AUTO-ZERO switch on the indicator unit centers the cross-pointer for a programmed flight track. For a given flight leg, sensitivity of the cross-pointer remains constant, and the pilot keeps it centered or nulled to remain on the desired track. Trip distance information is inserted and displayed on the indicator, properly scaling trip distance in miles to the number of lanes to be traversed for the pair of LOP's selected.

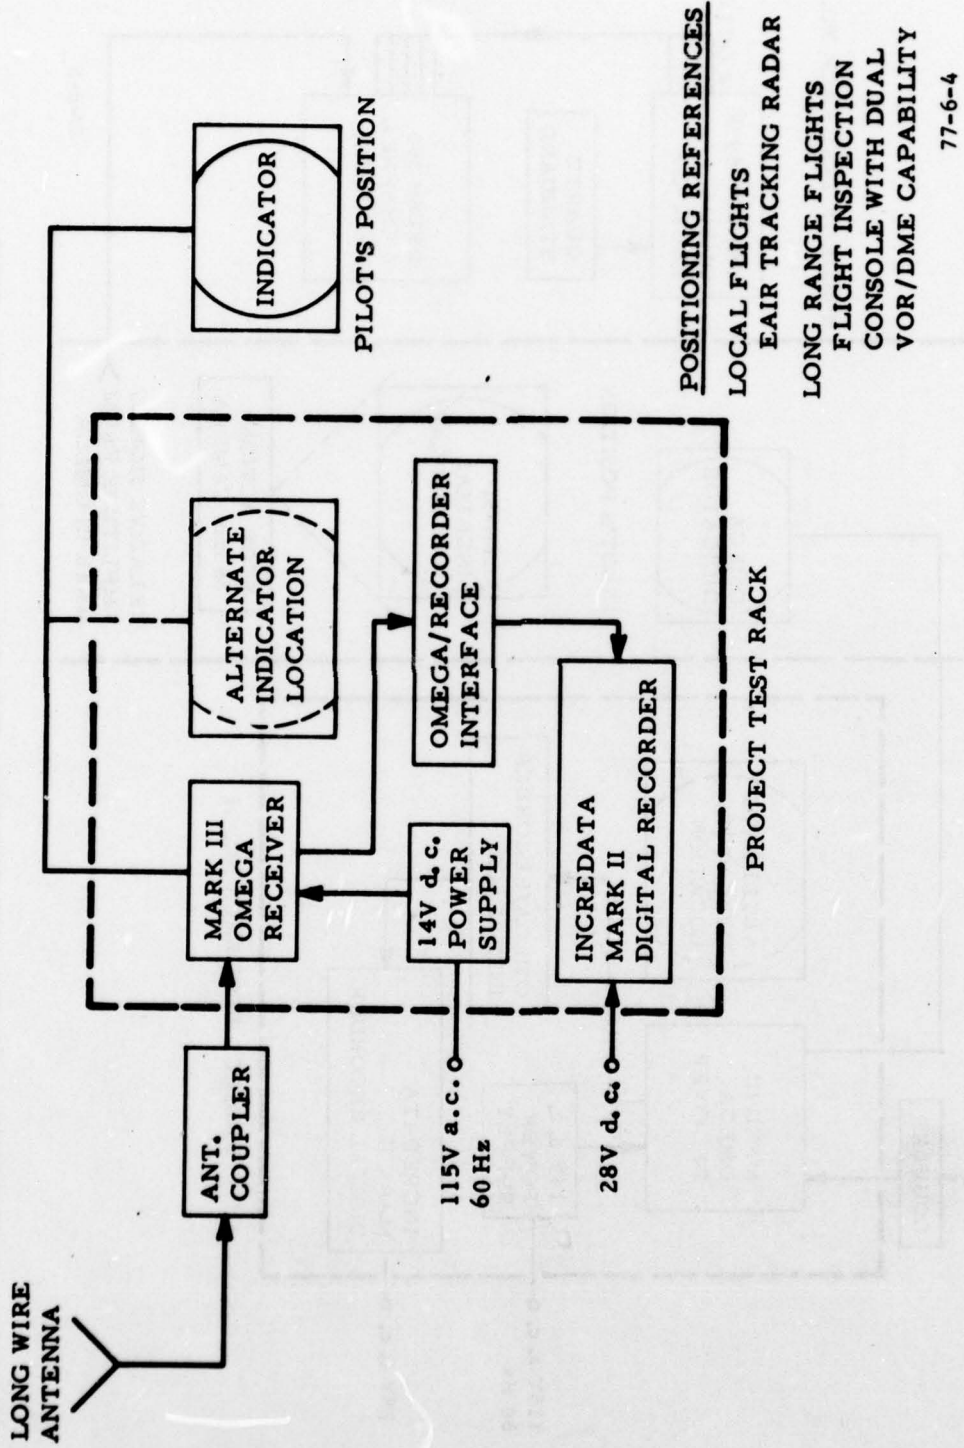
FIGURE 4. AEROCOMMANDER/DC-6 OMEGA TEST INSTALLATION

The same basic test technique was utilized during flights at NAFEC and Alaska, regardless of the aircraft used: (1) The Dynell Mark III Omega navigation receiver was initialized and programmed for the desired flight, (2) the aircraft flew the prescribed route using processed Omega-received signals for guidance, except when the Omega set was not tracking properly or when flight safety and air traffic control (ATC) procedures dictated otherwise, and (3) data were recorded simultaneously from the Omega set and from an acceptable position-reference system and compared.

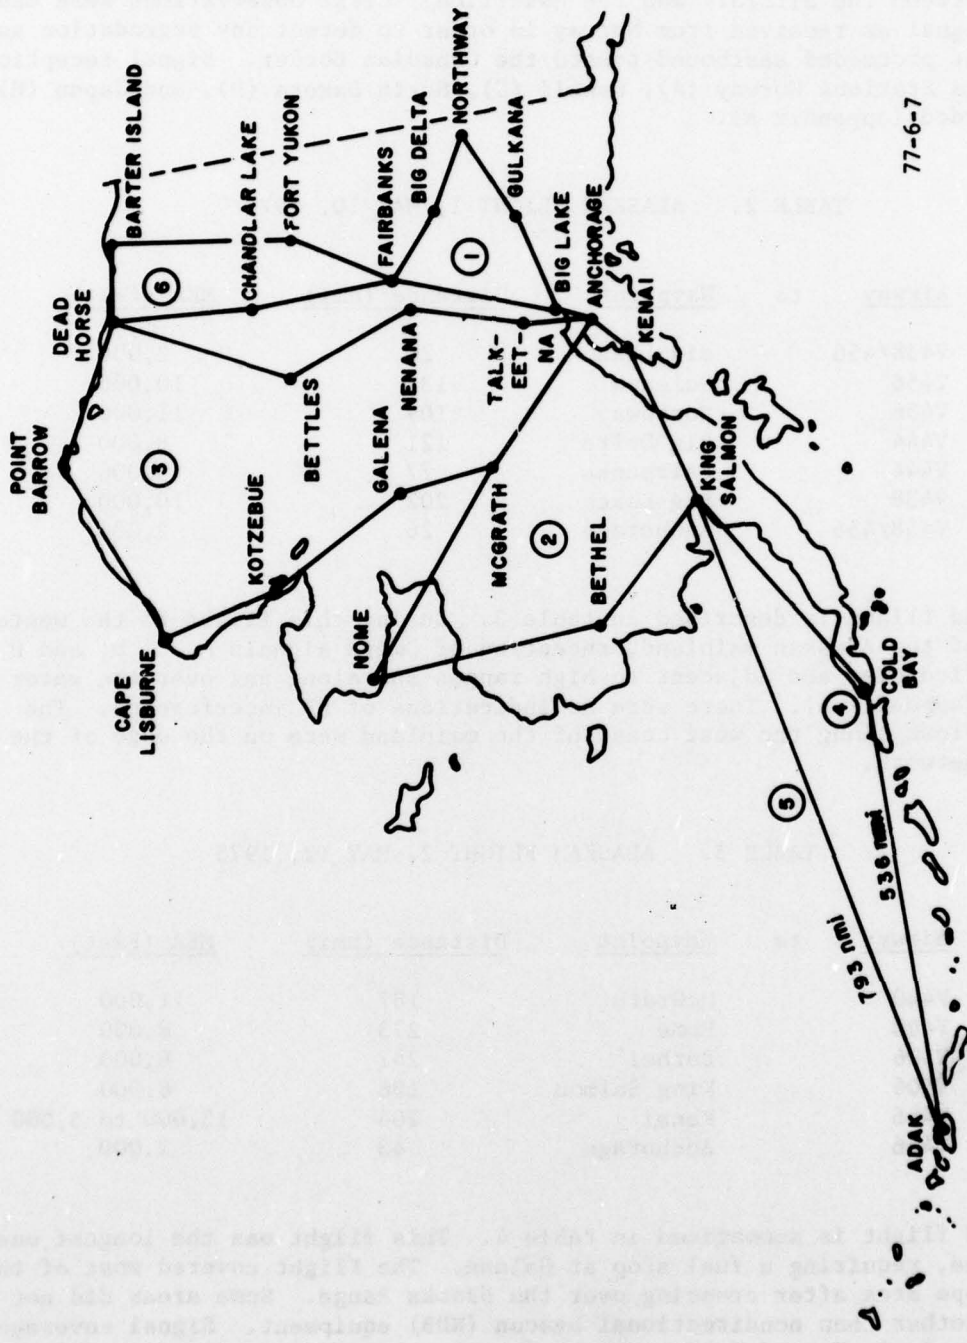
FIGURE 7. ALASKAN FLIGHT ROUTES

All flights originated and terminated at Anchorage except for flights 5 and 5A. They were flown on standard air routes at published minimum enroute altitudes (MEA's) and at groundspeeds of approximately 300 knots. All flights were accomplished during daylight hours, commencing at approximately 10:00 a.m. local time. Anchorage time in May was Greenwich mean time (GMT) minus 9 hours. The six test flight routes are depicted in figure 7.

The initial relatively short flight (table 2) in the southeast central portion of the state demonstrated operation and signal reception over various types of terrain. The legs from Northway to Fairbanks were flown in a valley with high ranges between the aircraft and the coastline. Close observations were made of the signal as received from Norway in order to detect any degradation as the flight proceeded eastbound toward the Canadian Border. Signal reception from Omega Stations Norway (A), Hawaii (C), North Dakota (D), and Japan (H) was recorded (appendix A).

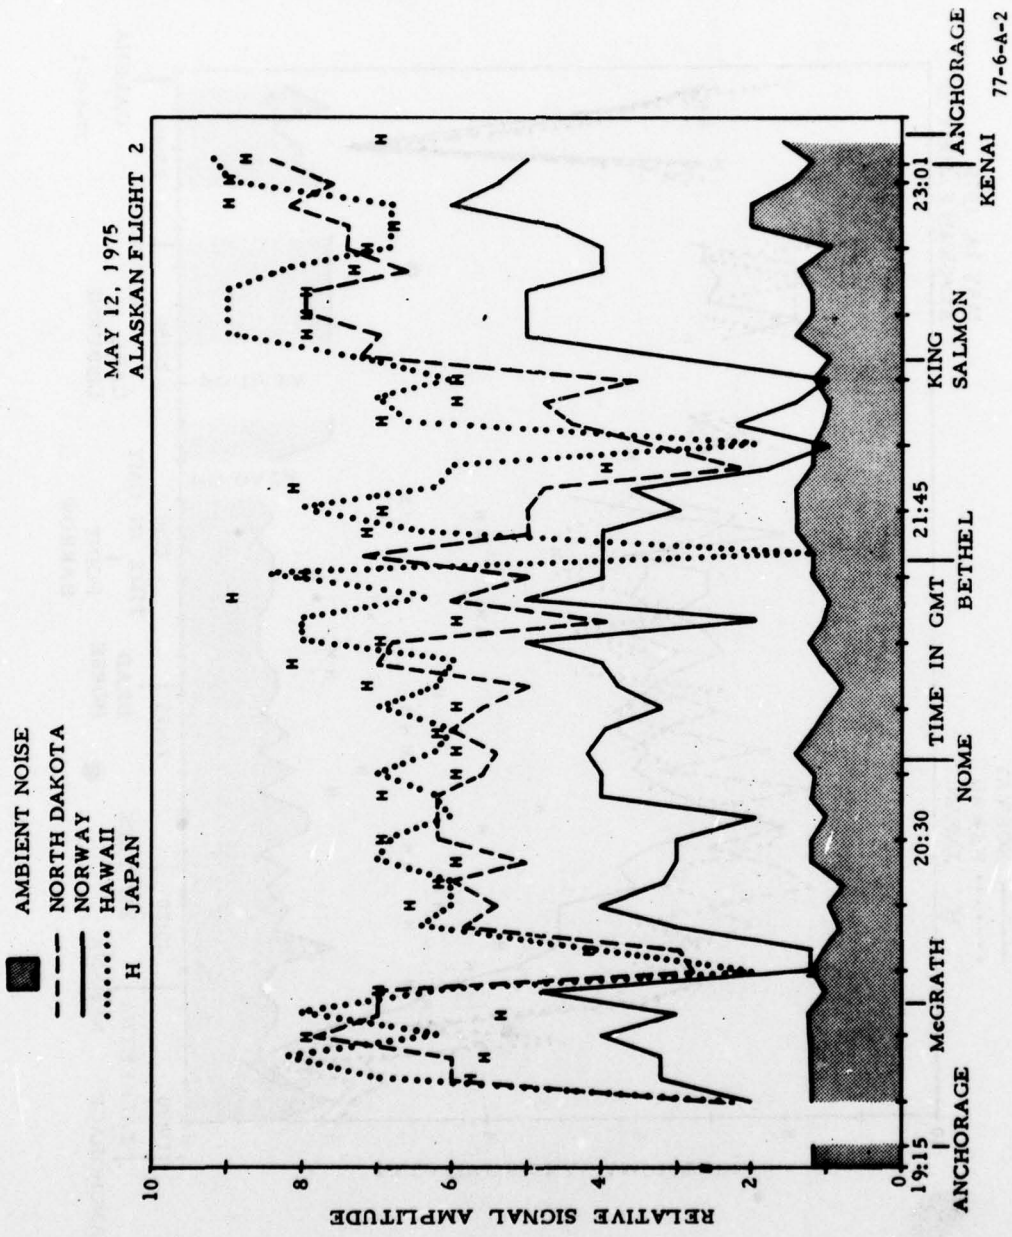
MAY 13, 1975  
ALASKAN FLIGHT 3

These plots represent uncalibrated relative signal levels recorded during Alaskan flights. The shaded areas are ambient noise levels measured during segments of the Omega transmission format which were not being utilized for Omega transmissions. Alaskan flight 1 illustrates the degradation of the signal from Norway as the aircraft proceeded eastward to Northway and noted improvement as the aircraft turned northwest towards Fairbanks. Flight 2 and 4 encountered severe weather conditions with resultant noise and signal dropout on several occasions. During flight 3, extremely heavy snow showers encountered between Kotzebue and Galena resulted in loss of usable signals for a brief period of time. During flight 5A, just prior to project power interruption, a total signal loss occurred during flight through clear weather. The reason for this loss has not been determined, but was not related to the power outage which occurred after the Omega receiver had reacquired navigation signals.

■ AMBIENT NOISE  
 - - - NORTH DAKOTA  
 - - - NORWAY  
 ..... HAWAII  
 H JAPAN

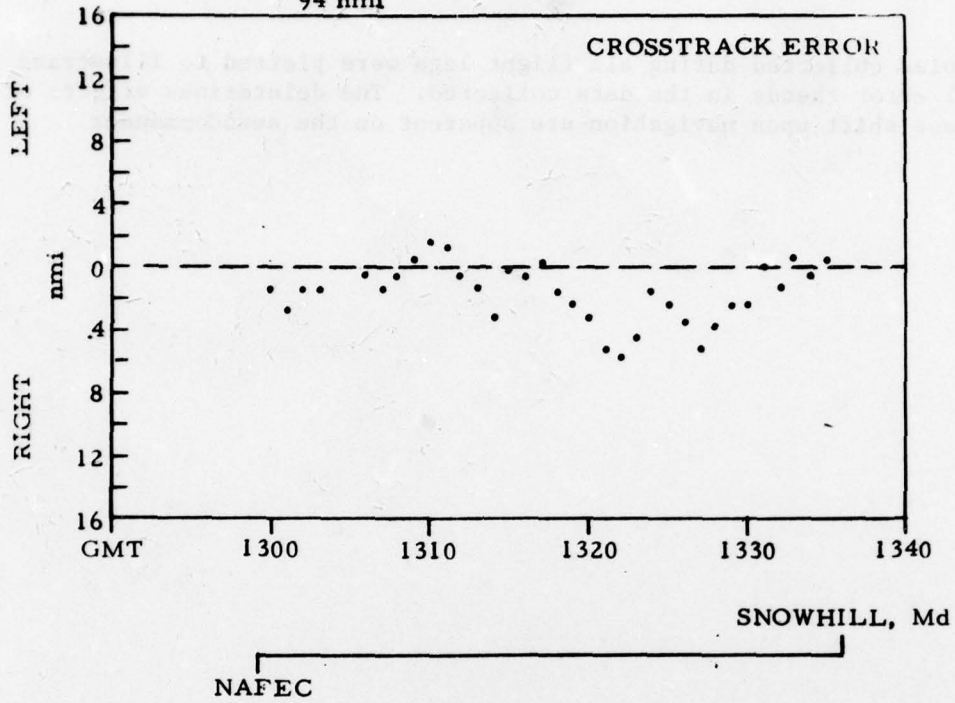
OCTOBER 23, 1974  
AEROCOMMANDER FLIGHT 2  
376 nmi TOTAL

Random samples collected during all flight legs were plotted to illustrate any overall error trends in the data collected. The deleterious effects of diurnal phase shift upon navigation are apparent on the AeroCommander flight 2.
