SECTION 32 PROGRAM.
STREAMBANK EROSION CONTROL
EVALUATION AND DEMONSTRATION
WORK UNIT 4-RESEARCH ON SOIL STABILITY
AND IDENTIFICATION OF CAUSES OF
STREAMBANK EROSION.
EVALUATION OF SPRAY-ON STABILIZERS FOR
BANK PROTECTION,

Investigation Report I

SECTION 32 PROGRAM
STREAMBANK EROSION CONTROL EVALUATION AND DEMONSTRATION
WORK UNIT 4 - RESEARCH ON SOIL STABILITY AND
IDENTIFICATION OF CAUSES OF STREAMBANK EROSION

EVALUATION OF SPRAY-ON STABILIZERS FOR BANK PROTECTION

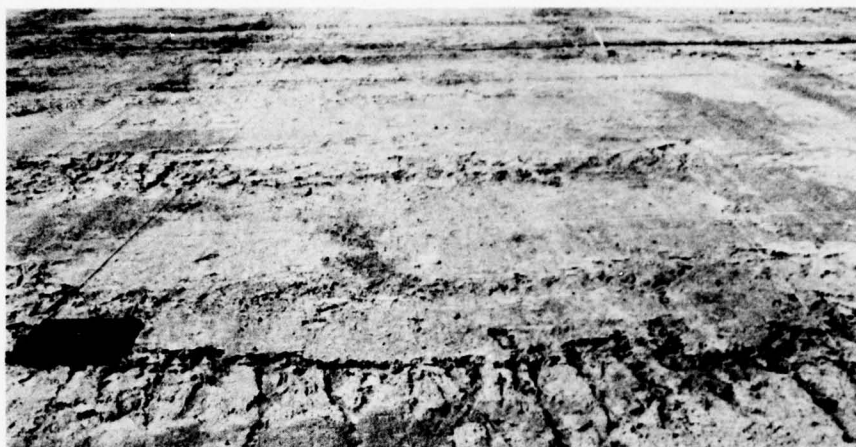
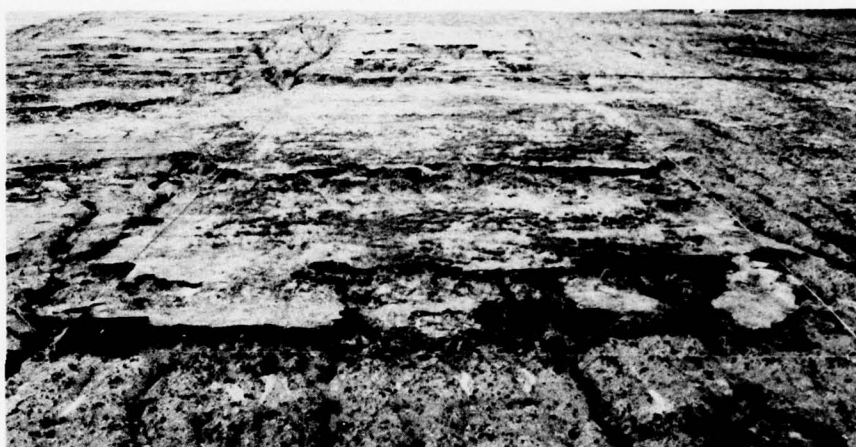
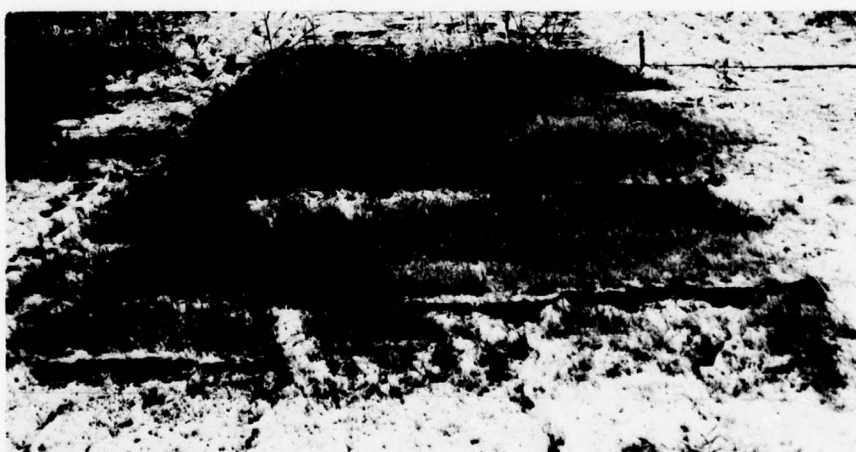
Figure 8. Application of Aerospray-70 at rate of 0.122 l/m^2 (130 gal/acre) on the slope (Section F₂)

8. Aerospray-70 was applied on the slope at rates of 0.122 and 0.183 ℓ/m^2 (130 and 195 gal/acre). The two plots are shown in Figures 8 and 9, respectively. Examination of the photographs taken on 11 May reveal that rills of 10 to 20 cm (4 to 8 in.) had formed outside the test plots. Sloughing was apparent in both plots, but no rills had formed in the plots. The 11 May photographs also reveal that plant emergence is greater in the plot having the lighter application. This deficiency was only temporary as noted in photographs taken on 22 June. At this time, plant emergence and growth rate were approximately equal in both plots. These sections appeared to be equally effective in controlling erosion.

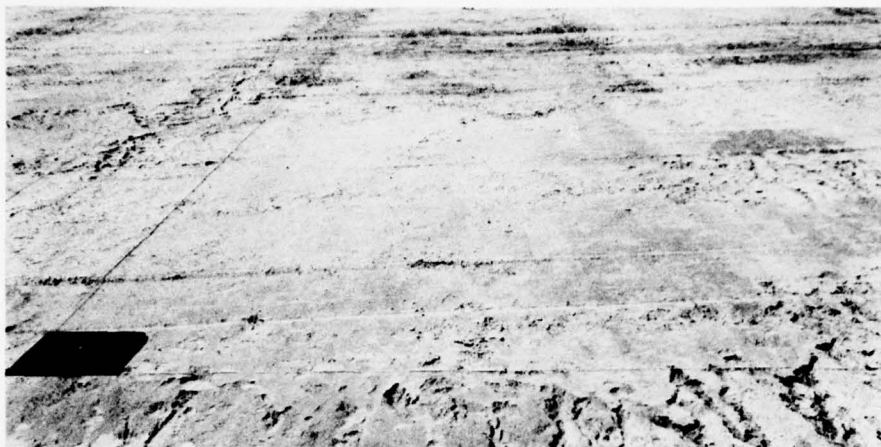
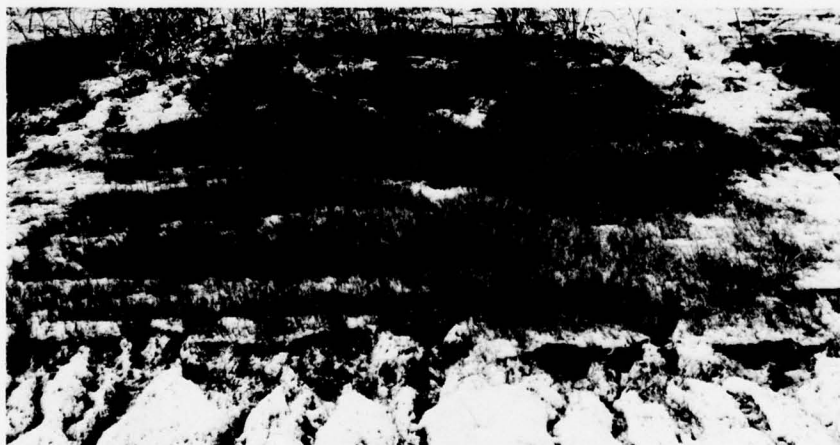
Figure 9. Application of Aerospray-70 at rate of 0.183 l/m^2 (195 gal/acre) on the slope (Section G₂)

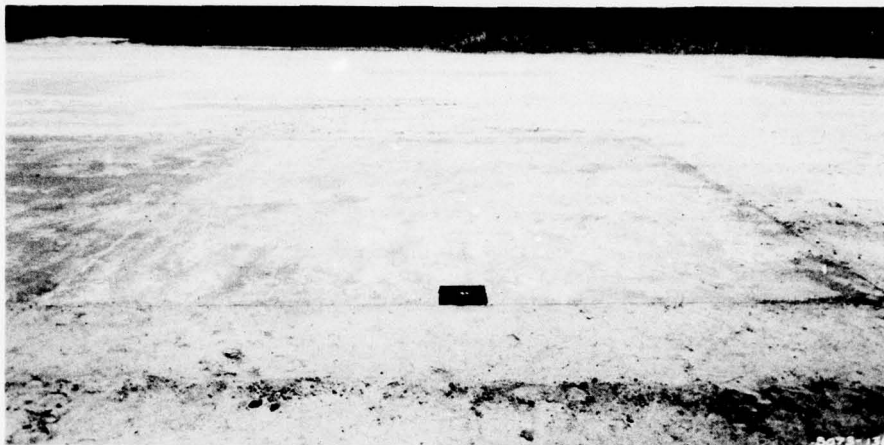
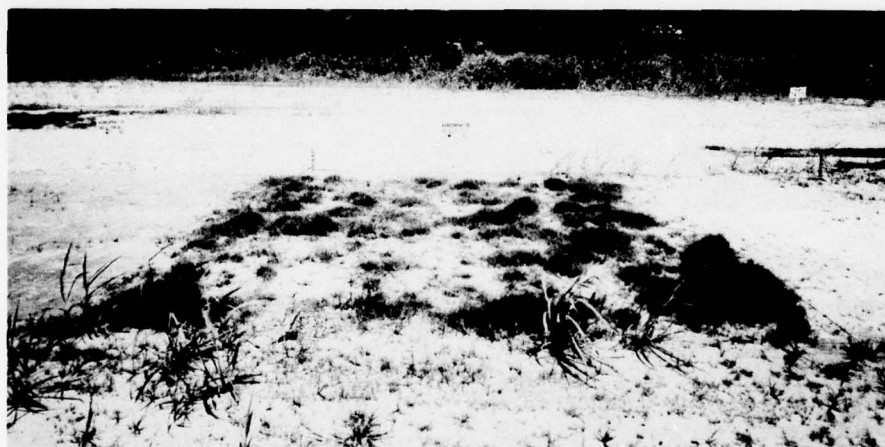
Figure 10. Application Aerospray-70 at rate of 0.122 l/m^2 (130 gal/acre) on the flat area (Section B₃)

9. Plant emergence and growth rate using Aerospray-70 at 0.122 ℓ/m^2 (130 gal/acre) in the flat area were poor (Figure 10) but better than in the control plot. Plant emergence and growth rate were poorer for all plots on the flat area than for those located on the slope. This may be due to the difference in nutrients in the soil. No other conclusions could be drawn.

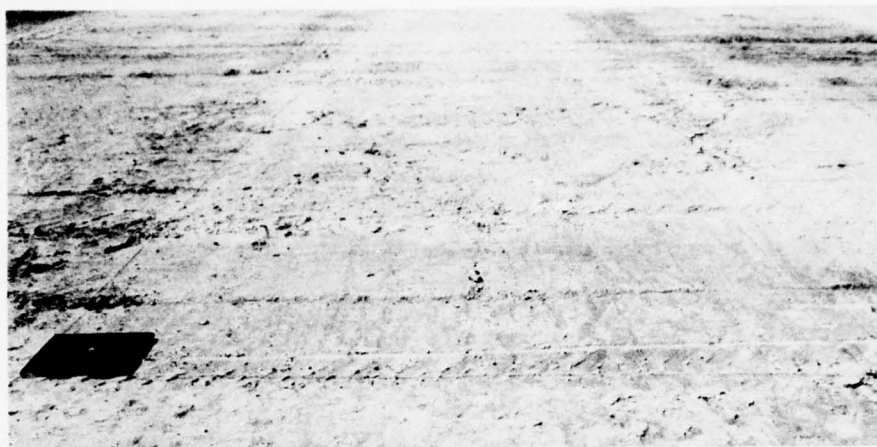
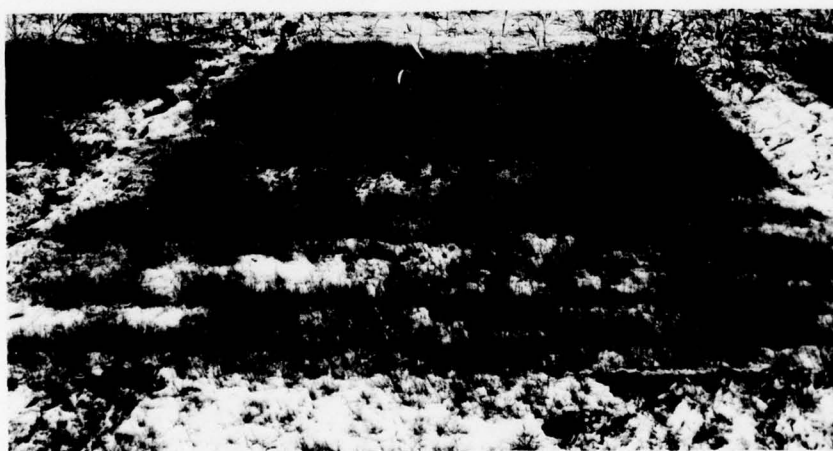
Figure 11. Application of Soil Seal at rate of 0.041 l/m^2 (45 gal/acre) on the slope (Section H₂)

10. Soil Seal was applied at rates of 0.041 and 0.061 ℓ/m^2 (45.0 and 67.5 gal/acre). The two plots on the slope are shown in Figures 11 and 12, respectively. Plant emergence was good but slow. Once the plants had emerged, growth rate was good. The growth rate was greater in the plot having the greater application rate. In the flat area, the plot stabilized with Soil Seal (Figure 13) had very poor plant emergence and plant growth. Soil Seal appears to be a very effective stabilizer. Very little erosion took place within the plot while the area outside the plots was badly eroded.

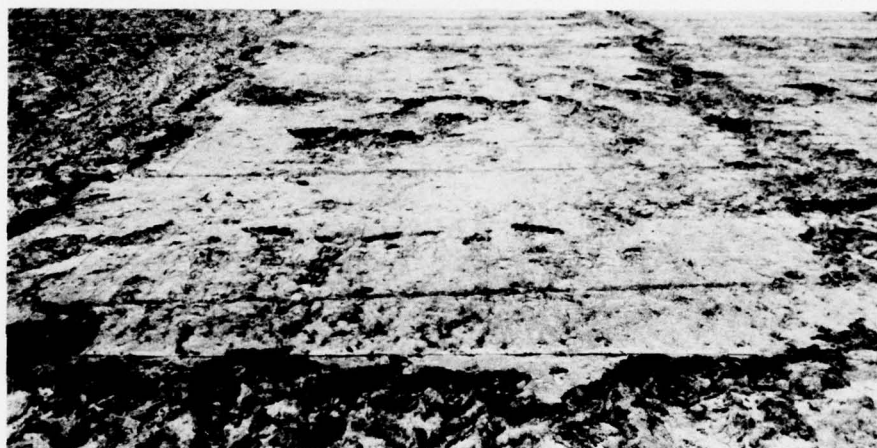
Figure 12. Application of Soil Seal at rate of 0.061 l/m^2 (67.5 gal/acre) on the slope (Section I₂)

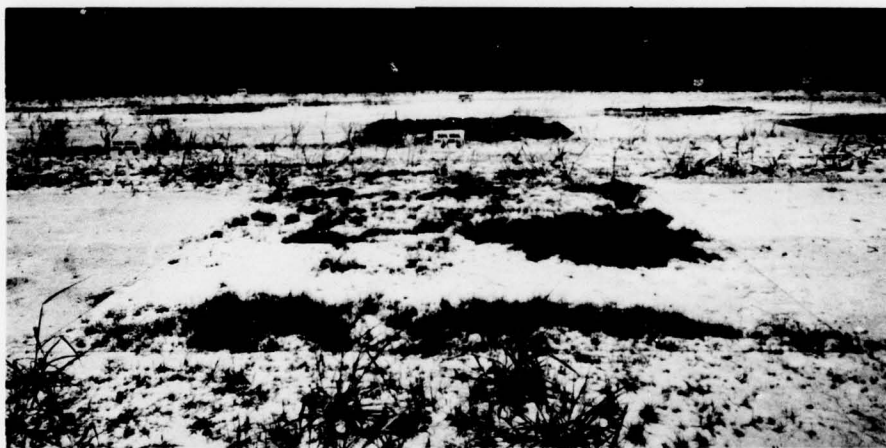
Figure 13. Application Soil Seal at rate of
 0.041 l/m^2 (45 gal/acre) on the flat area (Section C₃)

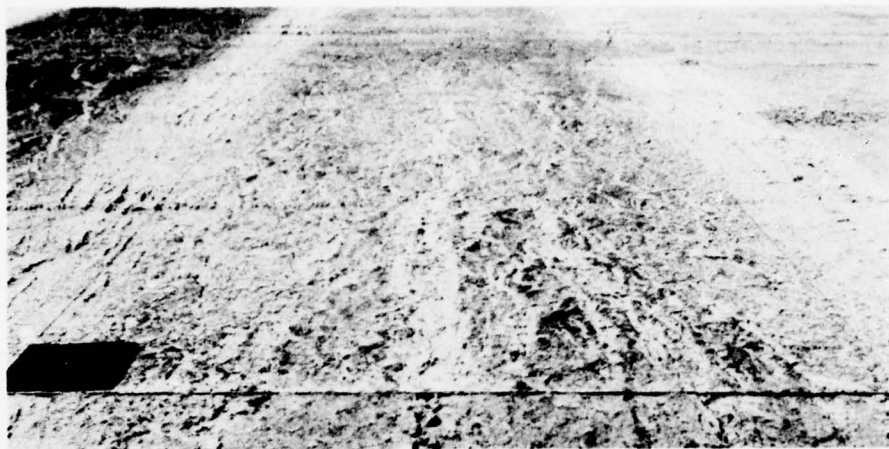
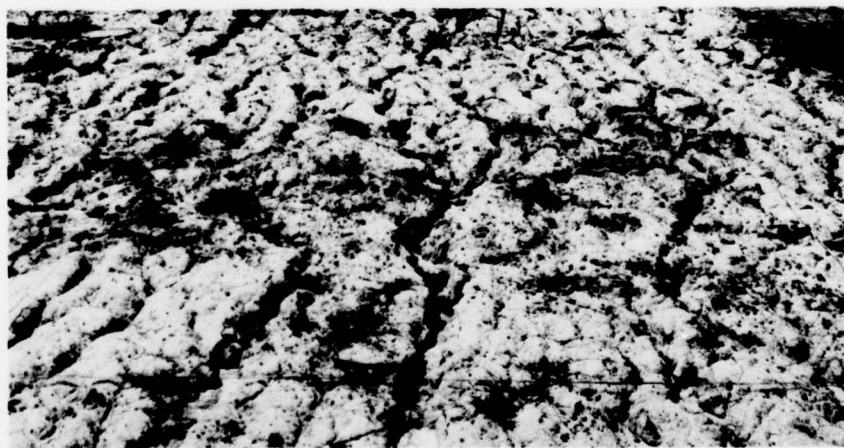
Figure 14. Application of Nerozin at rate of 0.297 l/m^2 (320 gal/acre) on the slope (Section J₂)

11. Nerozin was applied at the recommended rate of 0.297 l/m^2 (320 gal/acre) and also at 1-1/2 times that rate or 0.448 l/m^2 (490 gal/acre). Figures 14 and 15 show these plots as they appeared throughout the observation period. Neither plot on the slope was effective in maintaining stability of the soil particles to allow vegetation to be established. This may be due in part to the small quantity of the undiluted material recommended to cover the test plot. Also little or no benefit was realized when the recommended application rate was increased by 1-1/2 times. Total uniform coverage of the plot was difficult to achieve at these application rates. Photographs taken on 11 May reveal 10- to 20-cm (4- to 8-in.) rills and very little established vegetation in either plot. Very few Bermuda grass seeds germinated in the Nerozin plot on the flat (Figure 16). Most of the vegetation shown in Figure 16 is volunteer vegetation.

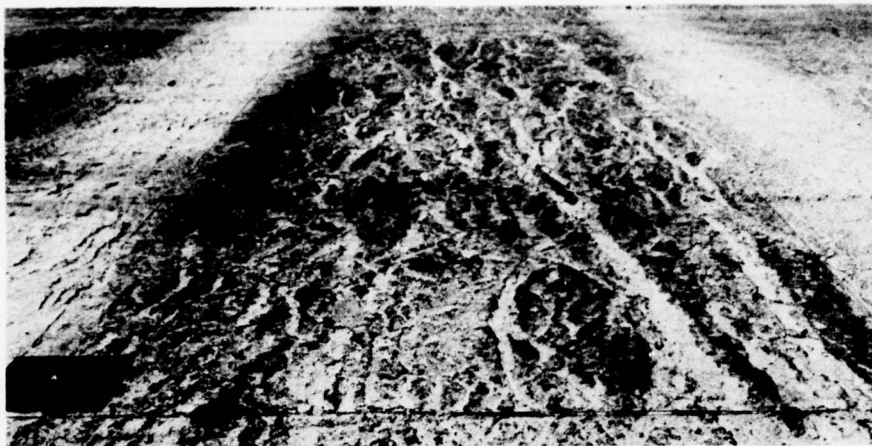
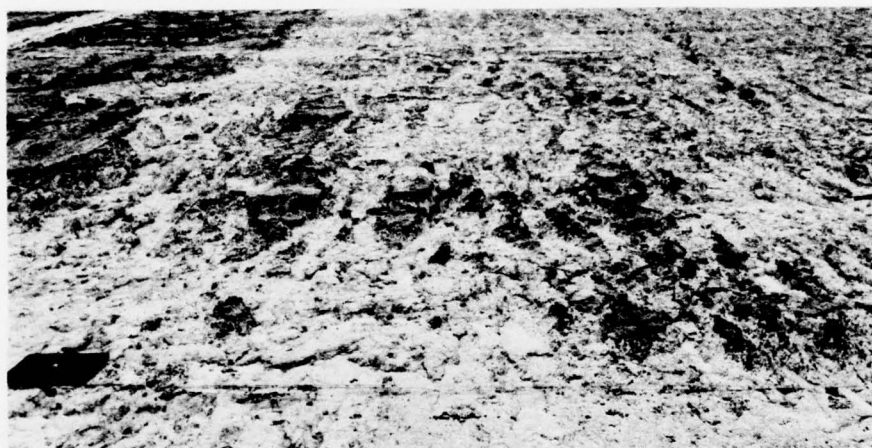
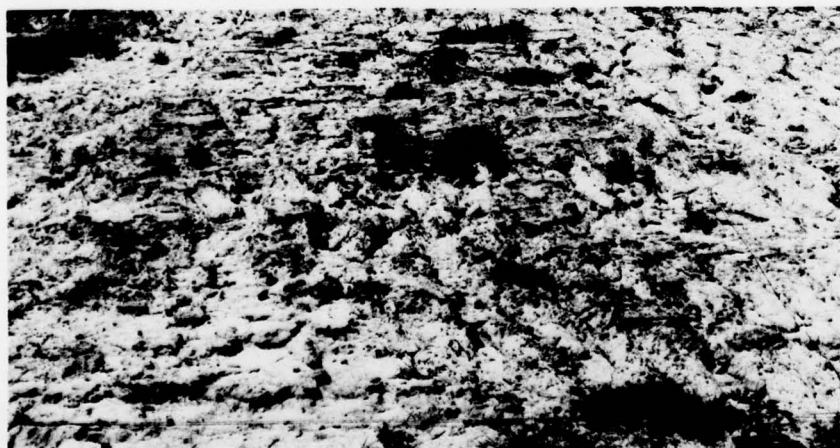
Figure 15. Application of Nerozin at rate of 0.448 g/m^2 (480 gal/acre) on the slope (Section K₂)

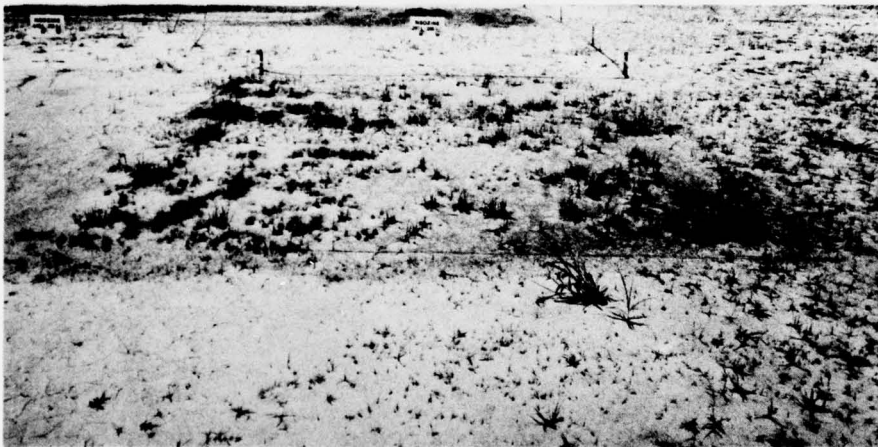
Figure 16. Application of Nerozin at rate of 0.297 l/m^2 (320 gal/acre) on the flat area (Section E₃)

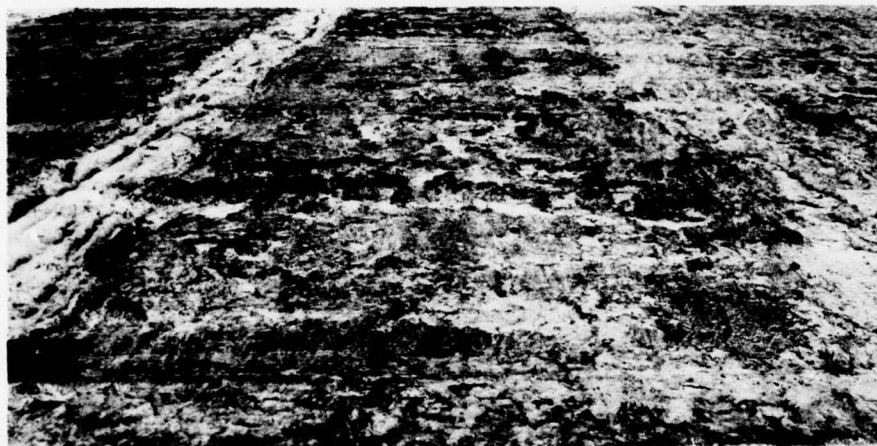
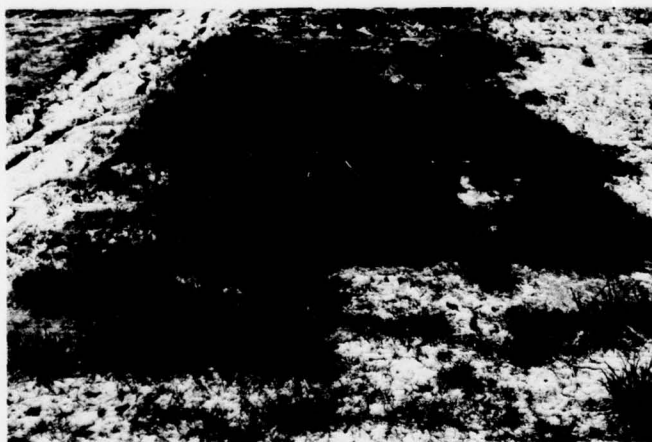
Figure 17. Application of Penepime at rate of 0.896 l/m^2 (958 gal/acre) on the slope (Section L_2)

12. Peneprime was applied at rates of 0.896 and 1.344 l/m^2 (958 and 1437 gal/acre). The two plots on the slope are shown in Figures 17 and 18, respectively. Plant emergence was slow in both plots and lighter in the plot having the heavier application rate. This light emergence also took place in the plot located in the flat area (Figure 19). This may be due to the hard crust formed by the heavy application of the undiluted material. Plants that did emerge appeared to have a fair growth rate. Erosion in the form of sloughing took place in both plots on the slope but appeared to be greater in the plot having the heavier application (1.344 l/m^2 (1437 gal/acre)).

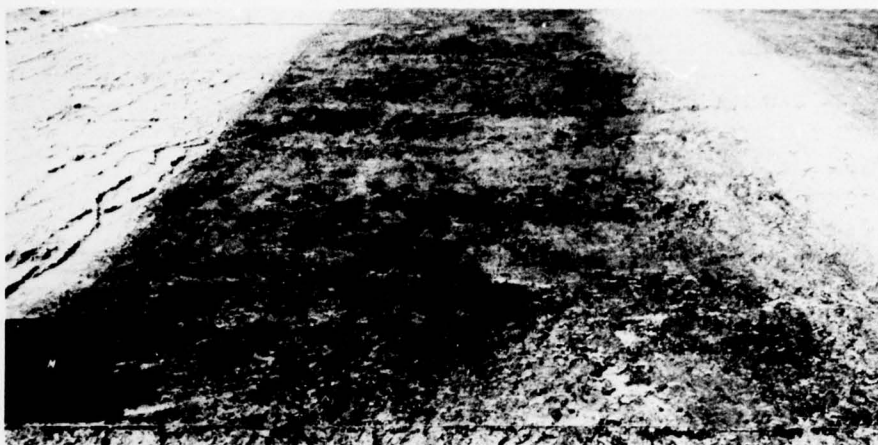
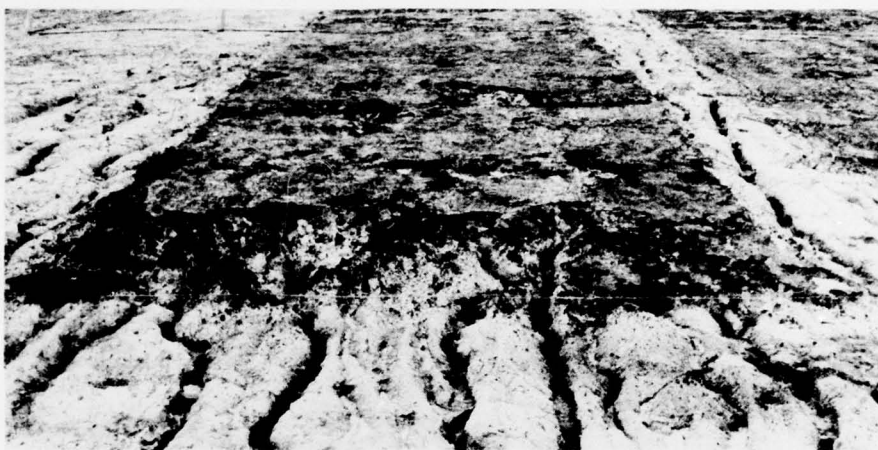
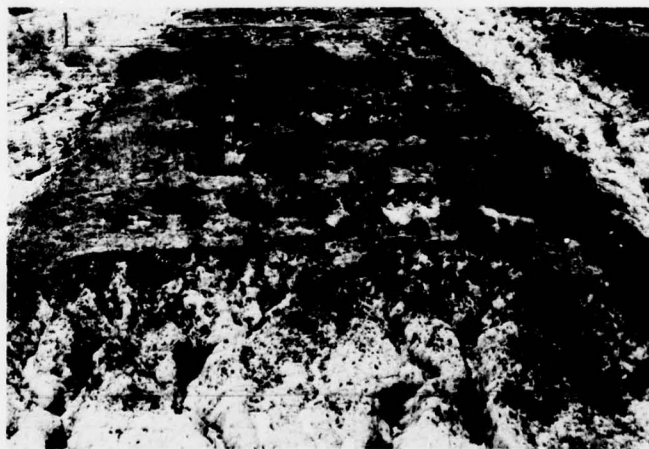
Figure 18. Application of Peneprime at rate of 1.344 l/m^2 (1437 gal/acre) on the slope (Section M₂)

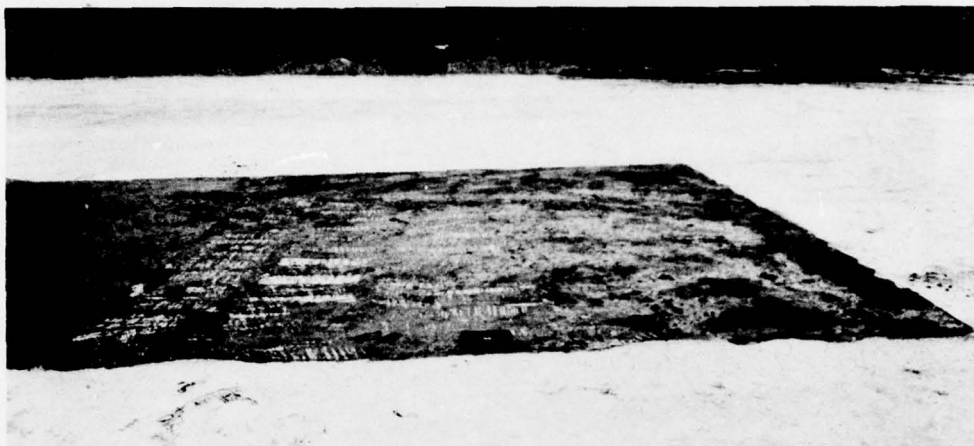
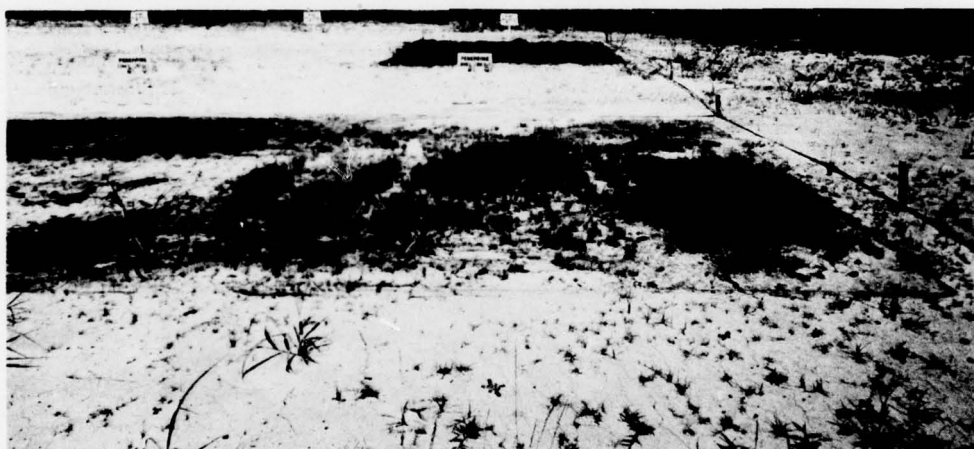
Figure 19. Application of Penepime at rate of 0.896 l/m^2 (958 gal/acre) on the flat area (Section D₃)

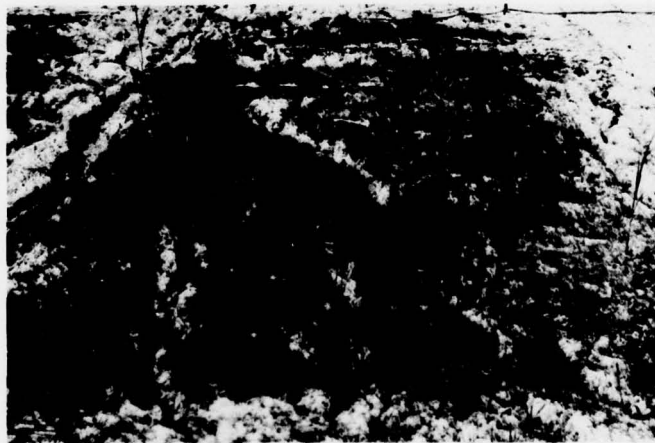
Figure 20. Application of DLR at rate of
 0.041 l/m^2 (45 gal/acre) on the slope (Section N₂)

13. DLR was applied at rates of 0.041 and 0.061 l/m^2 (45.0 and 67.5 gal/acre). Figures 20 and 21, respectively, show these plots

during the observation period. Plant emergence and growth rate were good in all plots including the plots in the flat area (Figure 22). Plots on the slope sustained a high degree of erosion. Rills of 15 to 20 cm (6 to 8 in.) formed in the plots, and sloughing was very evident.

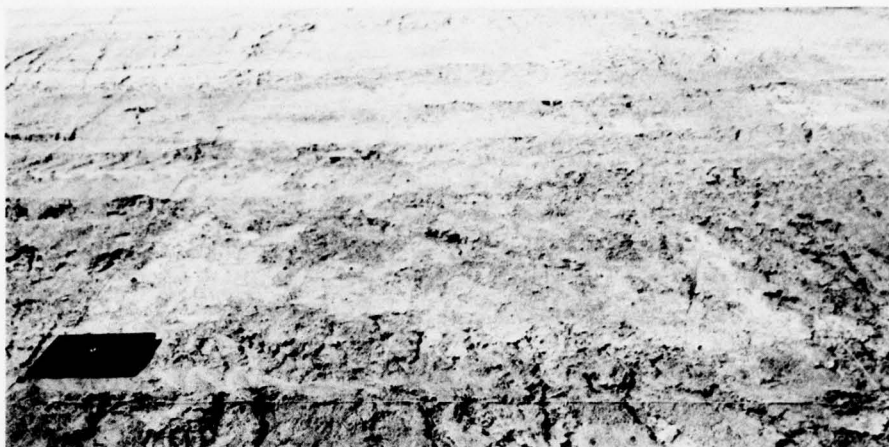
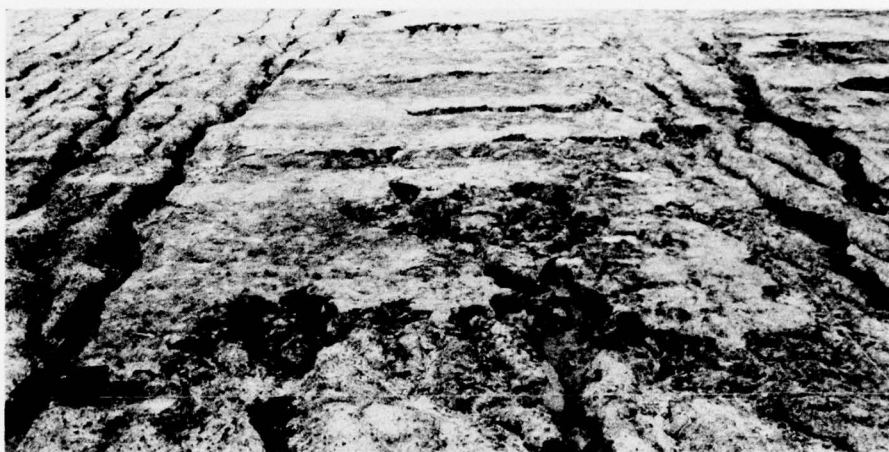
Figure 21. Application of DLR at rate of 0.061 l/m^2 (67.5 gal/acre) on the slope (Section 0₂)

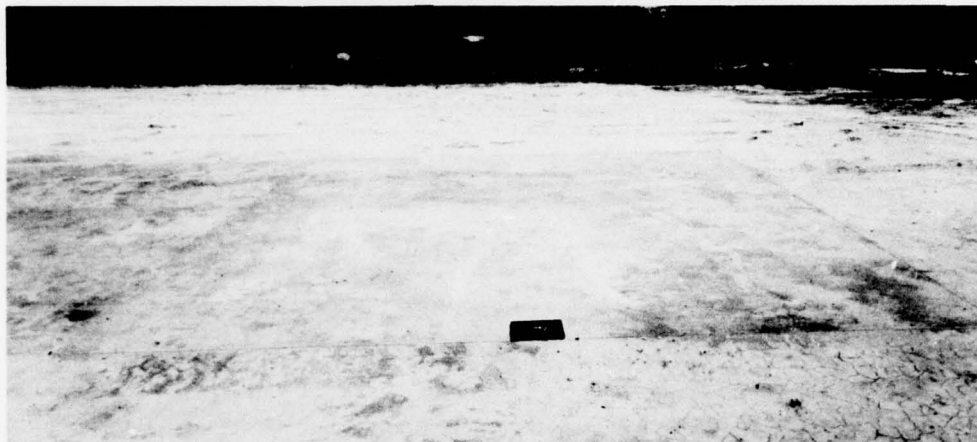
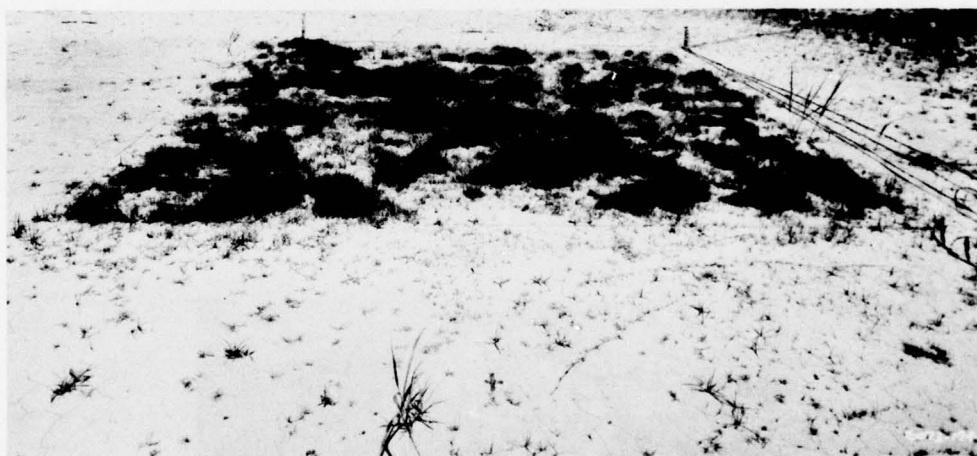
Figure 22. Application of DLR at rate of
 0.041 l/m^2 (45 gal/acre) on the flat area (Section Q₃)

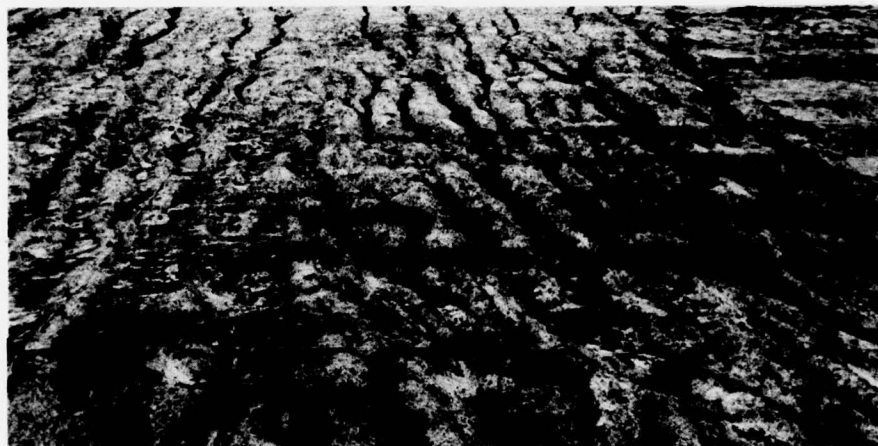
Figure 23. Control plot on the slope (Section P)

14. The control plot on the slope (Figure 23) indicates the results of seeding without using a stabilizer. Very little vegetation has been established in the plot, and rills of 15 to 20 cm (6 to 8 in.) were evident.
