THE DESIGN AND DEVELOPMENT OF A
WHEEL MOUNTED AIRCRAFT TIRE INFLATION INDICATOR.

TECHNICAL DOCUMENTARY REPORT NO. ASD-TDR-65-1

11 MARCH 1966

(Prepared under Contract No. AF33(657)-12491
by U. S. Gauge, A Div. of AMETEK, Inc., Sellersville, Pa.)

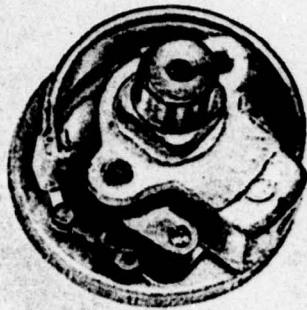
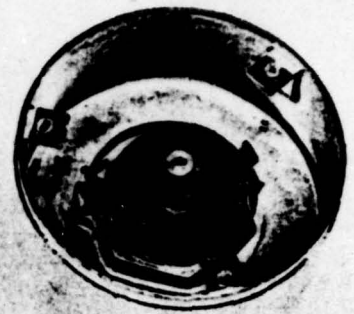
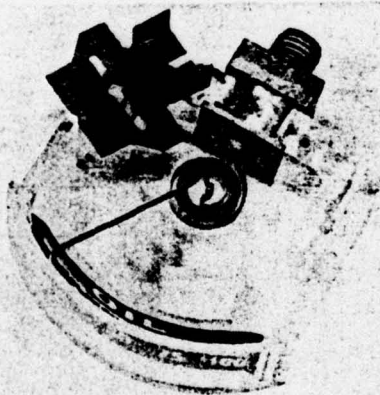
Photographs of the specimens are shown in Figure 1.

(2) Specimen 2 - This specimen resisted deformation due to shock but indicated a need for additional structural support for the acceleration loads. It was felt that with some increase in the strength of the bearing support, the shifts could be eliminated. The oscillation under vibration was isolated to a narrow frequency band and would probably have no adverse effect on the performance under static conditions.

(3) Specimen 3 - The large diameter center support provided support for all coils urged against it by the g forces. The strength of each coil was sufficient to support without deformation of all the coils being forced onto it. The large resonances noted under vibration indicate a need for viscous damping or better balance of the pointer. The damping could be introduced by the use of silicone grease between the coils. The balance could be achieved by the use of a center pivot around which the pointer and its balance would be pivoted.

(4) Specimen 4 - This specimen was permanently damaged on the first test due to the insufficient strength of the case material. As it was very similar in construction to specimen 3, it was felt no additional information could be obtained by its repair and continued testing.

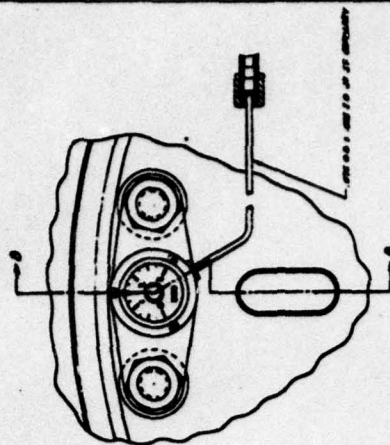
DESIGN II

(c) Design III (Figure 3) - The charging stem on this design extends through the center of the gauge internals and is, therefore, limited to particular internal design in which the pointer rotates around the periphery of the dial.

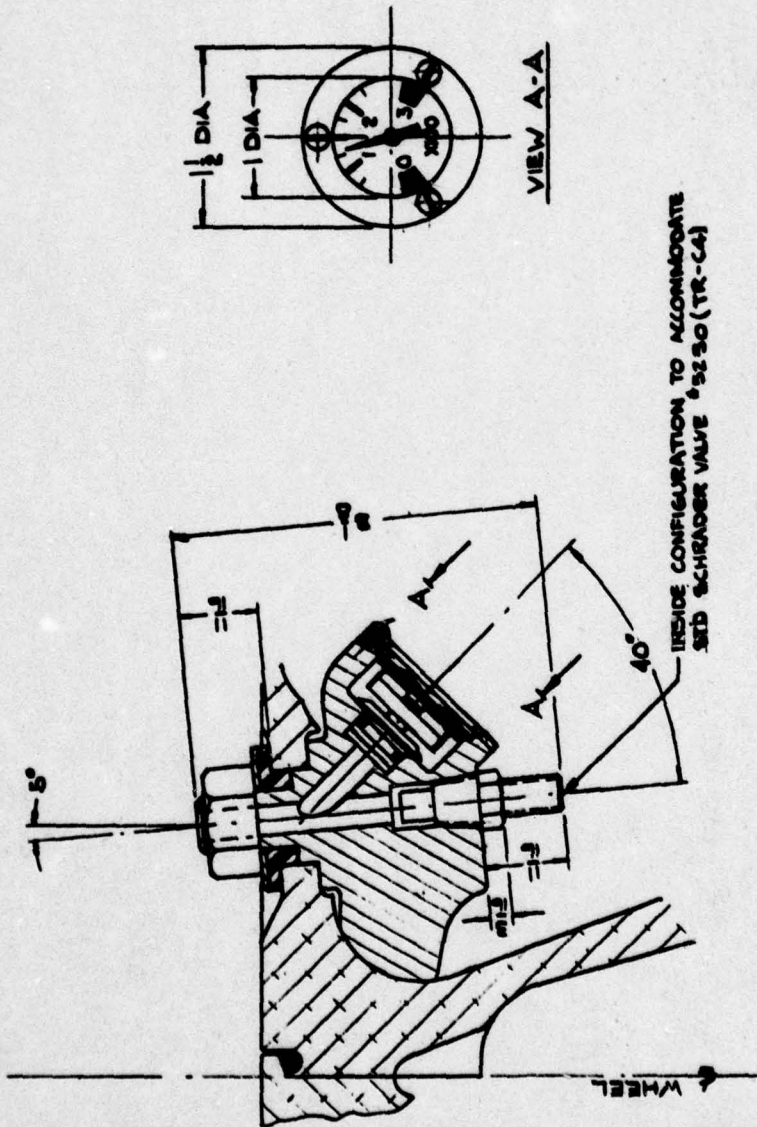
Fig. 4

IRISIDE CONFIGURATION TO ACCOMMODATE
STD SCHRAEDER VALVE 63250 (TR-CA)

(1) Pressure is inducted to the gauge by means of a stainless steel capillary connecting to the valve stem and the pressure port of the gauge. The valve stem end is equipped with a swivel nut which, when attached, depresses the tire valve and creates a pneumatic seal.

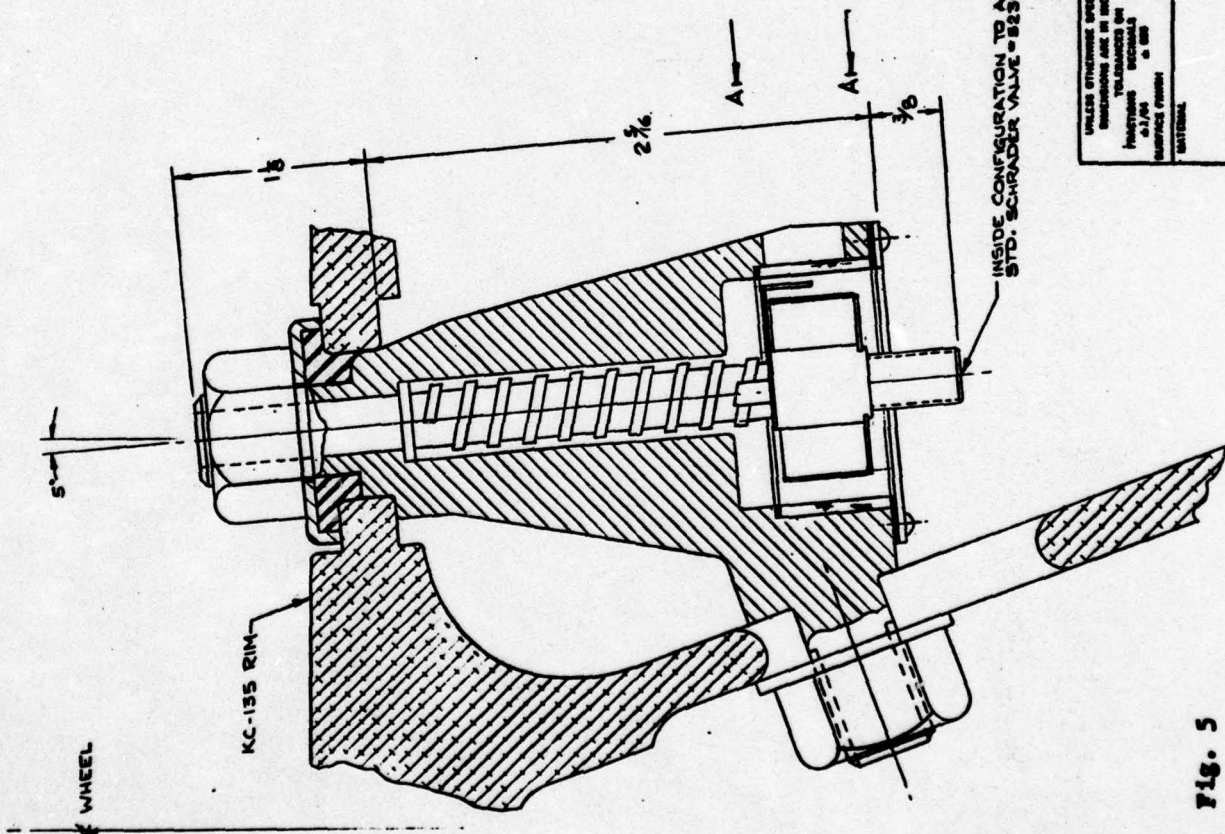
Fig. 5

(f) Design VI (Figure 5) - This design employs a helical Bourdon tube. The tube is approximately 2" long and is silver soldered into the internal connection. The output motion is transmitted through a bracket which indicates the pressure on the outer periphery of a cup shaped dial. A small clearance is maintained between the helix and the center post. The outer end of the socket is fitted with the standard filling valve which extends through the center of the lens. Mounting and installation are identical to Design II. The angular output is about 120°, limiting the scale length and readability.

(b) Helical Bourdon Tube - The same comments concerning angular travel, rigidity, and mass apply to the helical Bourdon element. A helical Bourdon delivering 230° of travel for rated pressure with a margin for overpressure takes the form of a long thin cylinder, which occupies several times the volume of the spiral. Designs VI and VII were proposed to illustrate some possibilities for the use of such an element (Figures 5 and 6).

2. Housings and Mounting - The housing designs shown on drawings SK-9426, (Figures 3 and 4), SK-9426-A (Figures 5 and 6), and SK-9426-B (Figure 7) are not intended for illustration of internal mechanism.

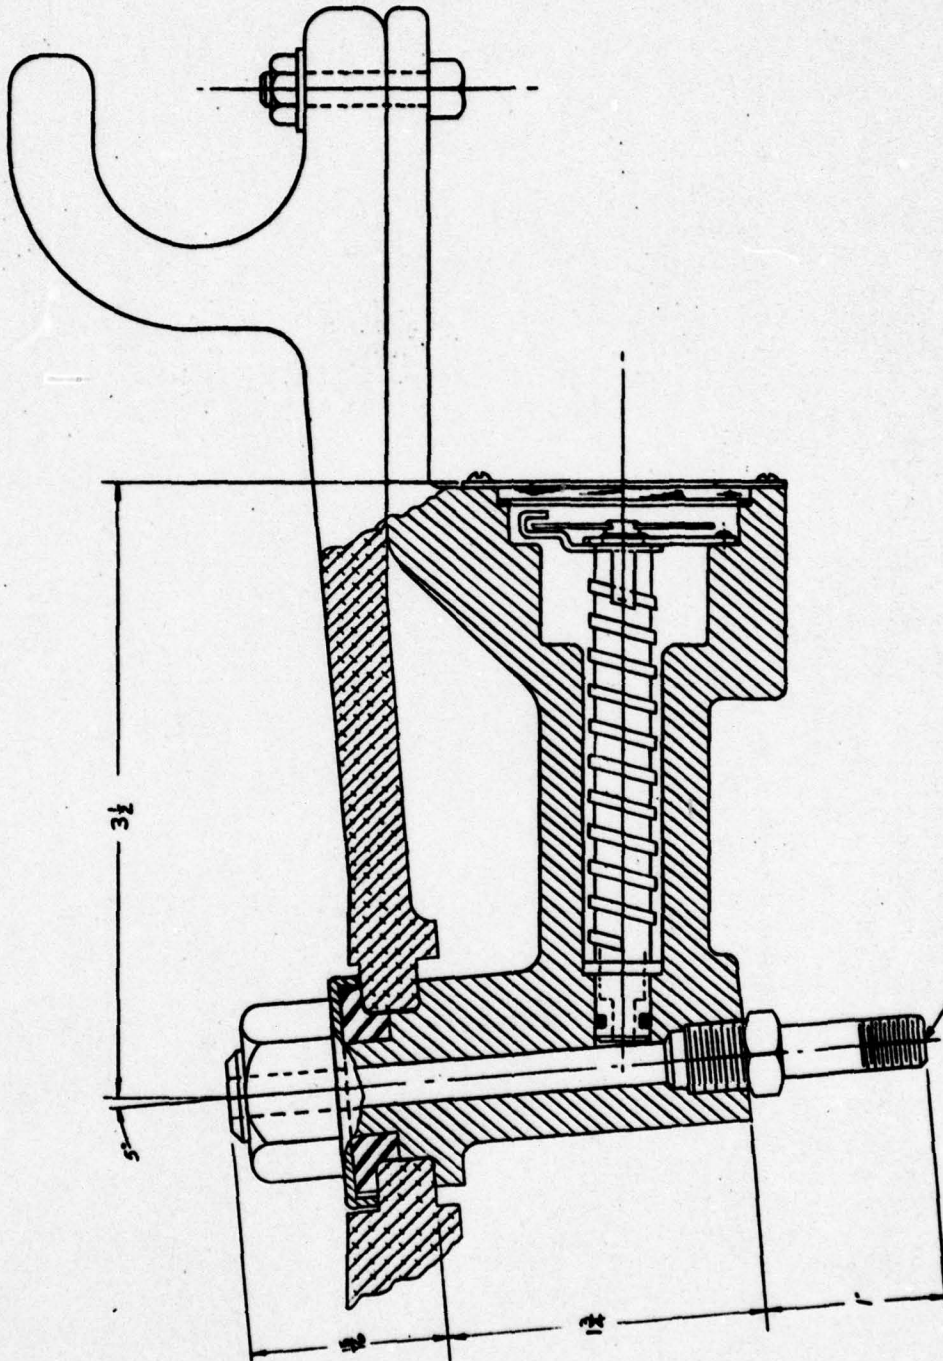
Fig. 6

INSIDE CONFIGURATION TO
ACCOMMODATE SCHLUDER VALVE
#8330 (TR. 2A)

2. Housing - The basic housing design which was selected by the USAF Project Engineer is shown in Figure 6. This drawing illustrates general outline features only. The final configuration, size, etc., was dependent upon further development of the gauge internals and review of the method of mounting to the wheel rim. Reference is made to Figure 17 of this report for the final housing definition and outline dimension. This drawing illustrates a complete tire inflation indicator with the helical Bourdon gauge installed. The spiral Bourdon design is completely interchangeable except that the gross weight retaining ring markings would be reversed. The housing material of the Phase II prototype was aluminum. Final material specifications will depend on the wheel rim material (aluminum or magnesium).

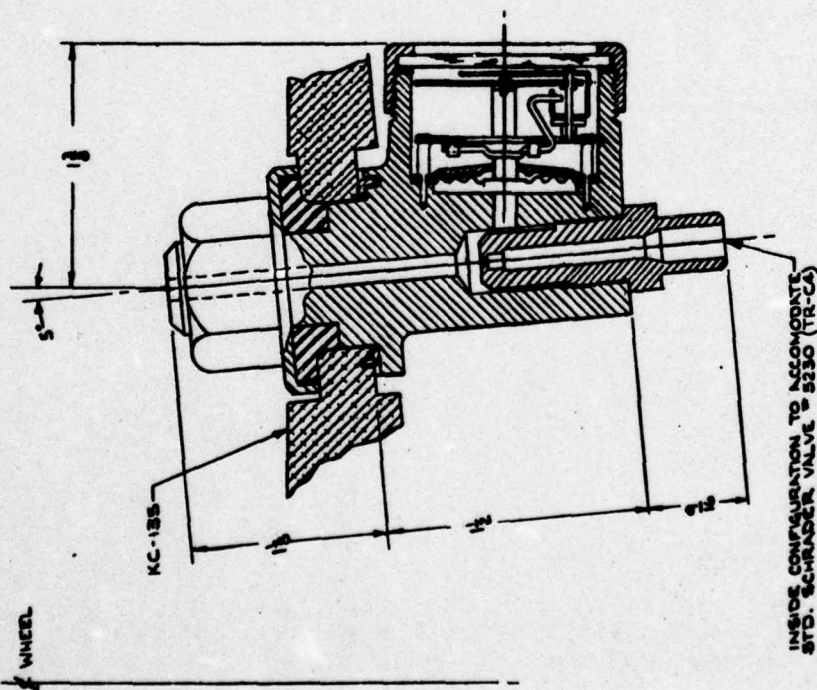
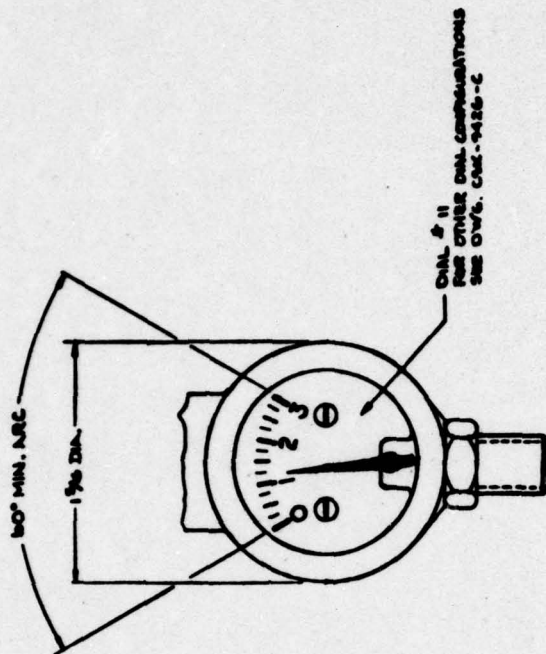
Fig. 7

(1) The prime mover is a single corrugated diaphragm plate (approximately .875 diameter) fastened into the housing, driving an extremely light wire rocker arm which in turn drives the pointer pivoted on a wire staff. The mechanism is kept coupled by a spring of sufficient strength to maintain mechanism coupling under most conditions while not contributing significantly to the friction of the mechanism. The scale angle is limited to about 75° in order to obtain a reasonable degree of linearity. Taking advantage of the non-linear effects over larger pointer angles would permit a scale compression between 175 psi and 300 psi resulting in better readability in the operating zone. Overpressure protection is achieved by supporting the diaphragm element with a heavy plate formed to match its corrugations.

U.S. GAGE A DIVISION OF JAMES W. HARRIS, INC. MILWAUKEE, WISCONSIN		DATE 5-23-66	
HOUSING & MOUNTING DESIGN OF DIAPHRAGM GAUGE USAF TIME GAUGE		DRAWING NO. 6349	
DESIGNED BY J. D. Palmer		DATE 1/2/66	
CHECKED BY S. D. W.		DATE 7-1-66	
APPROVED BY [Signature]		DATE [Blank]	
TITLE HOUSING & MOUNTING DESIGN OF DIAPHRAGM GAUGE USAF TIME GAUGE		SCALE 2:1	
PART NO. CSK-9426-B		QUANTITY 1

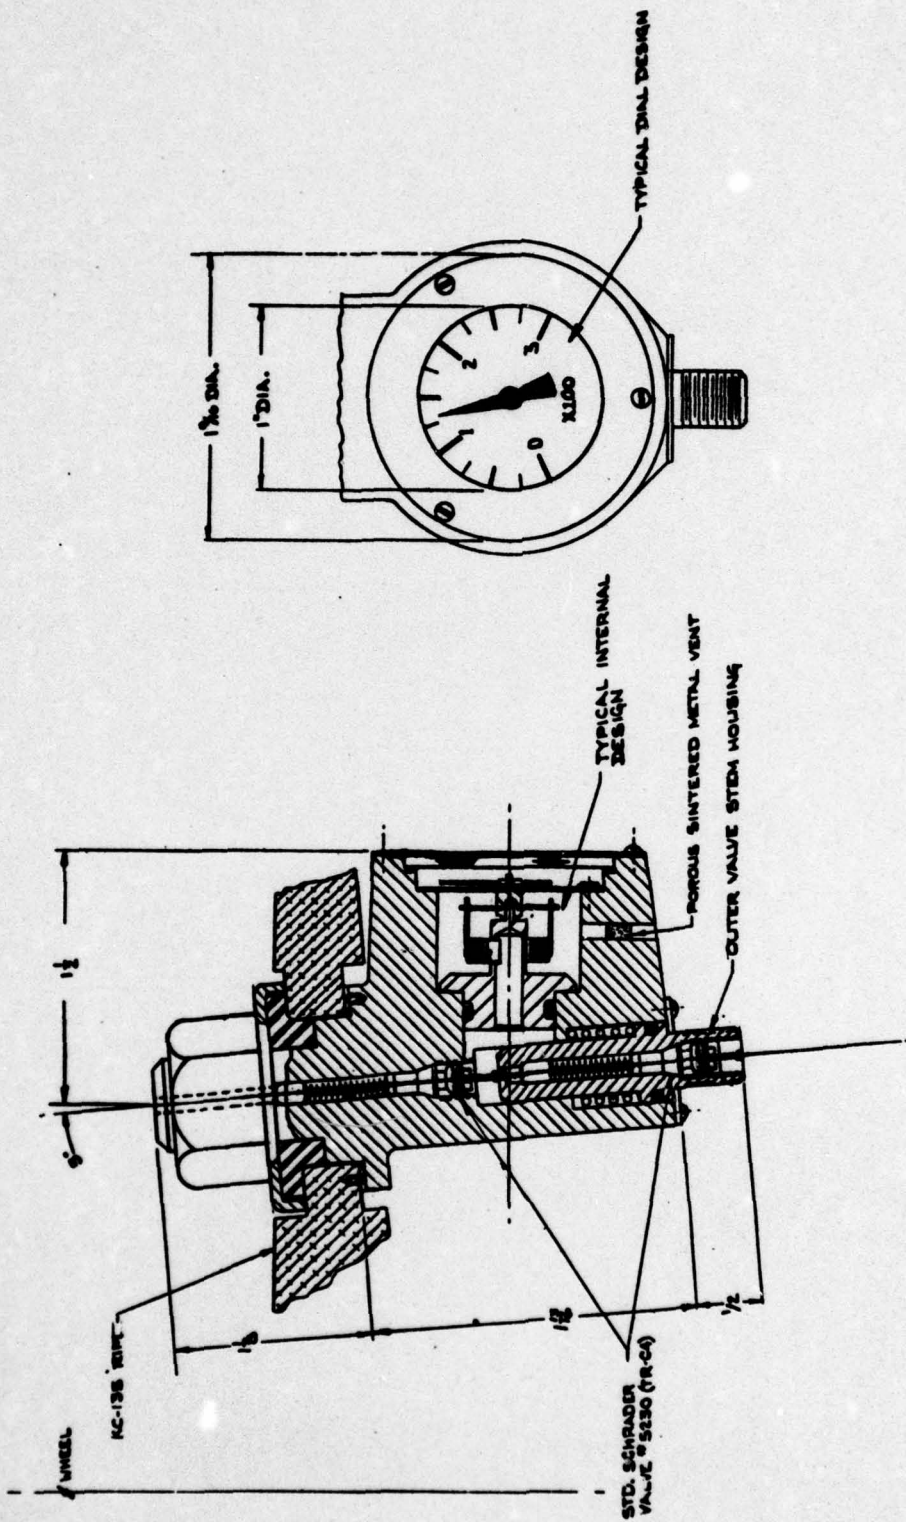
Fig. 9

(1) This design provides a fail safe gauge device without the need for a pressure sealed gauge housing. This is accomplished by providing a "piggyback" valve assembly which isolates the gauge from the tire. During ground inspection, it would be necessary to depress the outer valve stem housing which actuates the inner valve core, thereby opening the gauge to the tire pressure. During this inspection check the outer valve core would retain the pressure in the tire. The gauge would then be exhausted by depressing the pin of the outer valve core.

(3) Due to the isolation of the gauge from the tire pressure, the need for the gauge Bourdon tube to withstand the over-pressure encountered during landing of the aircraft is eliminated. Furthermore, in the event of a gauge failure, the tire pressure will not be lost.

U. S. GAGE A DIVISION OF AMERICAN GAGE CO. 1000 W. 10TH ST., MILWAUKEE, WIS.	
FAIL SAFE GAUGE SYSTEM "A"	
FOR USE IN TIRE GAUGE	
ORDER NO. 61300	PART NO. C
MODEL 2:1	
DRAWING NO. CSK-9426-D	
SHEET 1

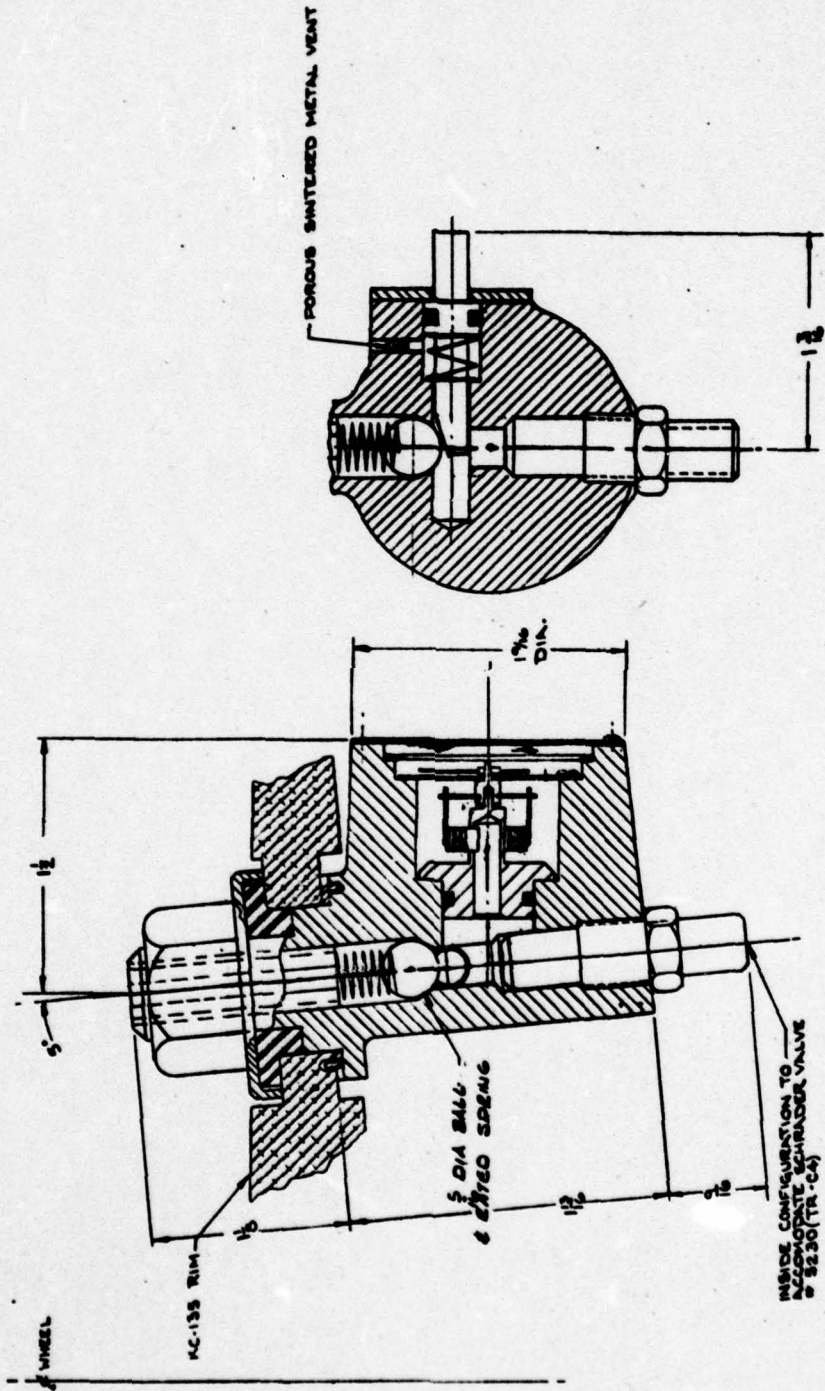
Fig. 10

(1) This fail safe arrangement is similar to that defined in Design (a) above, except that the tire pressure is isolated from the gauge by a spring loaded valve ball. The spring force is sufficient to support the ball check during periods of radial acceleration of 3000 g's.

(2) In order to inflate the tire, it is necessary to depress the plunger in the side of the gauge which unseats the ball check. While holding the plunger in the depressed position, the gauge will read the tire pressure. Upon release of the plunger the com-

U.S. GAUGE A DIVISION OF AMERICA'S SMALL BUSINESS ENTERPRISE		DATE 6-18-64	
DESIGN V.H. SA		REV. 1	
PROJECT C. J. FULMER		DATE 6-18-64	
DESIGNED BY E.D.W.		DATE 6-18-64	
USED BY TEST LAB		DATE 6-18-64	
TEST LAB SINTERED		DATE 6-18-64	
UNLESS OTHERWISE SPECIFIED DIMENSIONS ARE IN INCHES TOLERANCES ON DIMENSIONS .015" .010" .005" .002" .001"		FOR USE OF TYPE GAUGE DATE CONT. NO. 61349 C	
FAILURE GAUGE SYSTEM "B"		SCALE 2:1	
CSK-9A26-D		SHEET 2

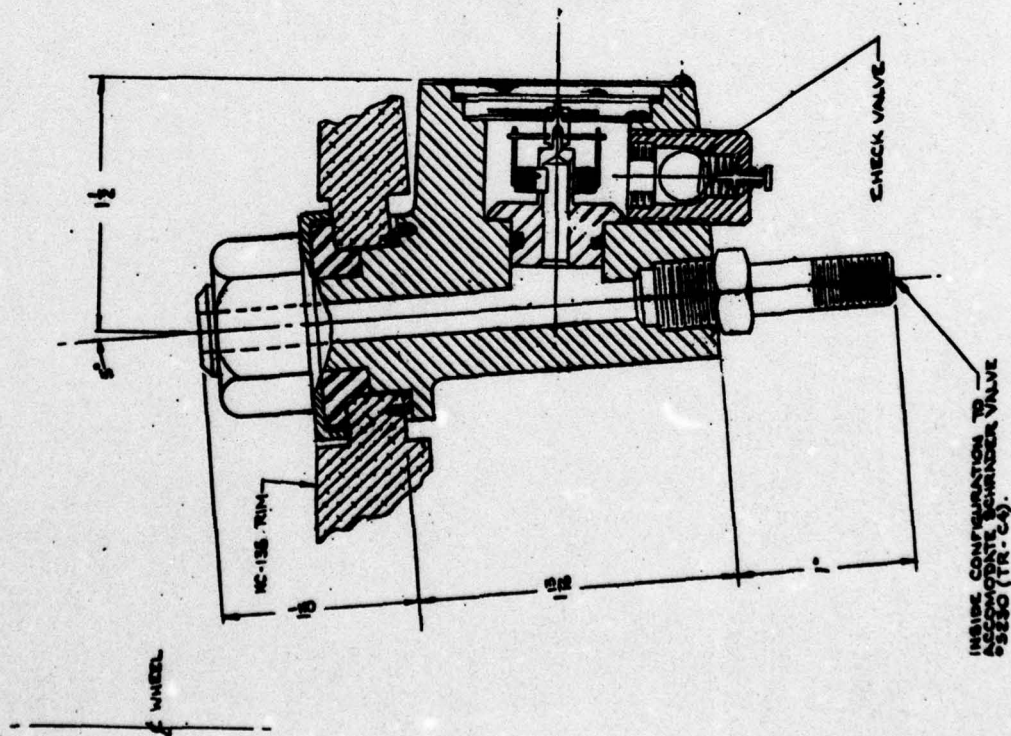
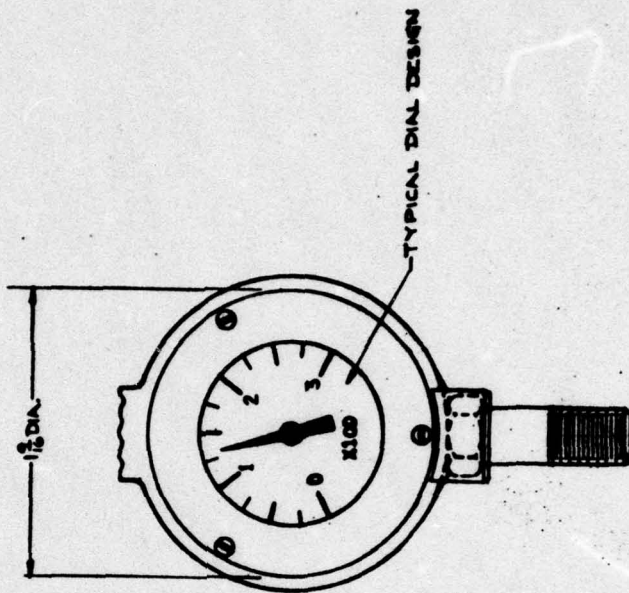
Fig. 11

(1) This design protects the tire from loss of air should the gauge develop a leak. The clearance between the ball and its housing is designed to make the ball act as a check valve when flow rates exceed a predetermined level. This level of flow will be sufficiently low to assure that the total loss of air over any period of flight will be insufficient to cause tire under-inflation. Under normal conditions the spring urges the ball to maintain a vent from the gauge. A leaking gauge can be detected by the low reading which will be obtained. To verify whether the low reading is due to under-inflation of the tire or to a gauge leak, the vent pin in the housing is depressed. If the reading increases, a gauge leak exists.

U.S. GOVERNMENT PRINTING OFFICE WASHINGTON, D. C. 20540		U.S. GOVERNMENT PRINTING OFFICE WASHINGTON, D. C. 20540	
TITLE FAIL SAFE GAUGE SYSTEM C		FOR U.S. AIR FORCE	
PROJECT NO. 61309		DRAWING NO. 61309-9426-D	
SHEET NO. 2:1		SHEET NO. 2:1	
DATE 6-11-62		DATE 6-11-62	
DESIGNED BY J. PALMER		CHECKED BY J. PALMER	
DRAWN BY J. PALMER		APPROVED BY J. PALMER	
MATERIAL ALUMINUM		FINISH ANODIZED	
WEIGHT 0.100		VOLUME 0.100	
PART NO. 61309-9426-D		PART NO. 61309-9426-D

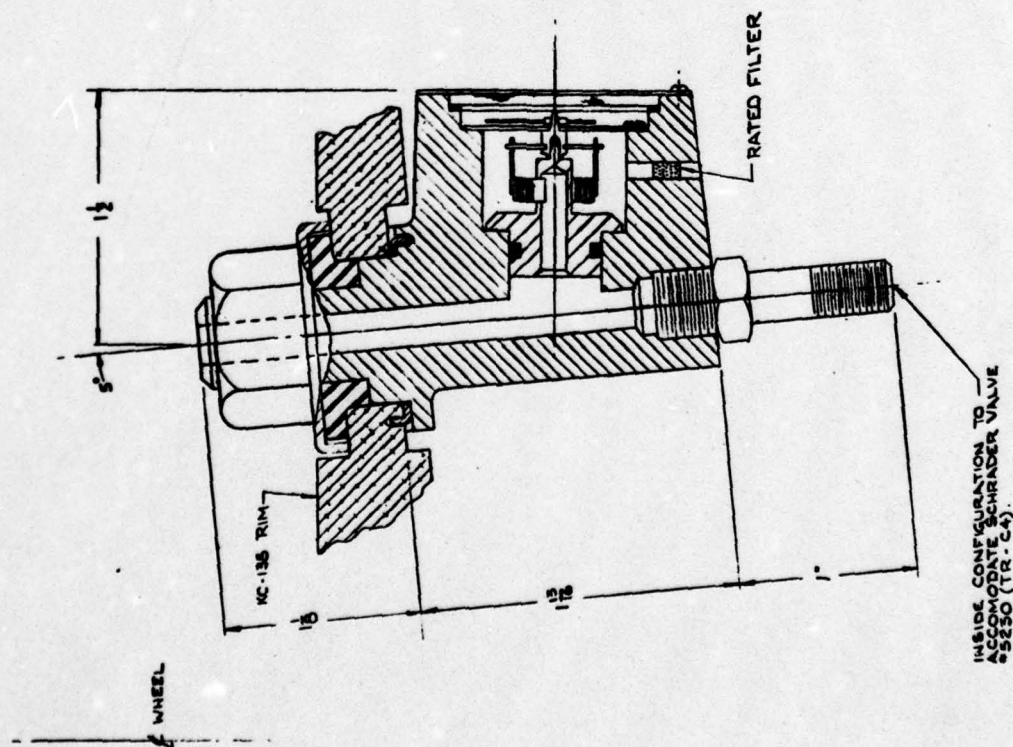
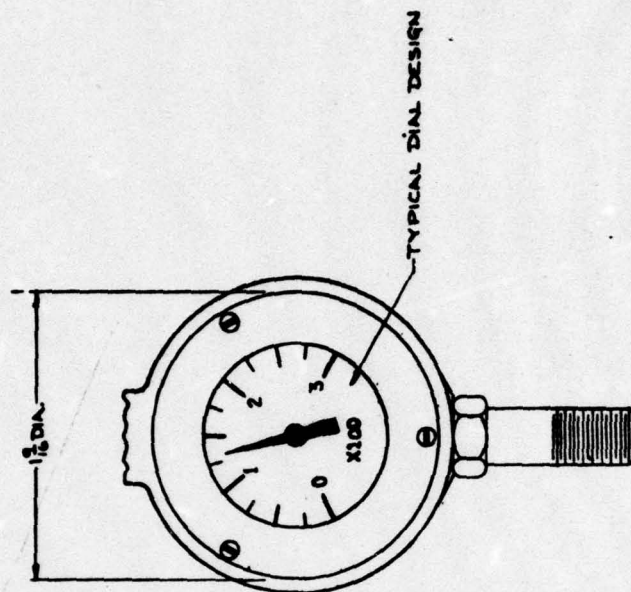
Fig. 12

(1) This design is similar to Design (c) except that a check valve is not used. The case vent is sized to assure that should a leak develop in the gauge, the flow rate will be sufficiently low to prevent excessive under-inflation for the period of flight. A leak in the gauge will result in a low indication of tire pressure due to a build up of pressure in the gauge housing. If there is a gauge leak and the vent becomes plugged, the gauge will eventually read zero (0) although the tire inflation will remain at safe values.

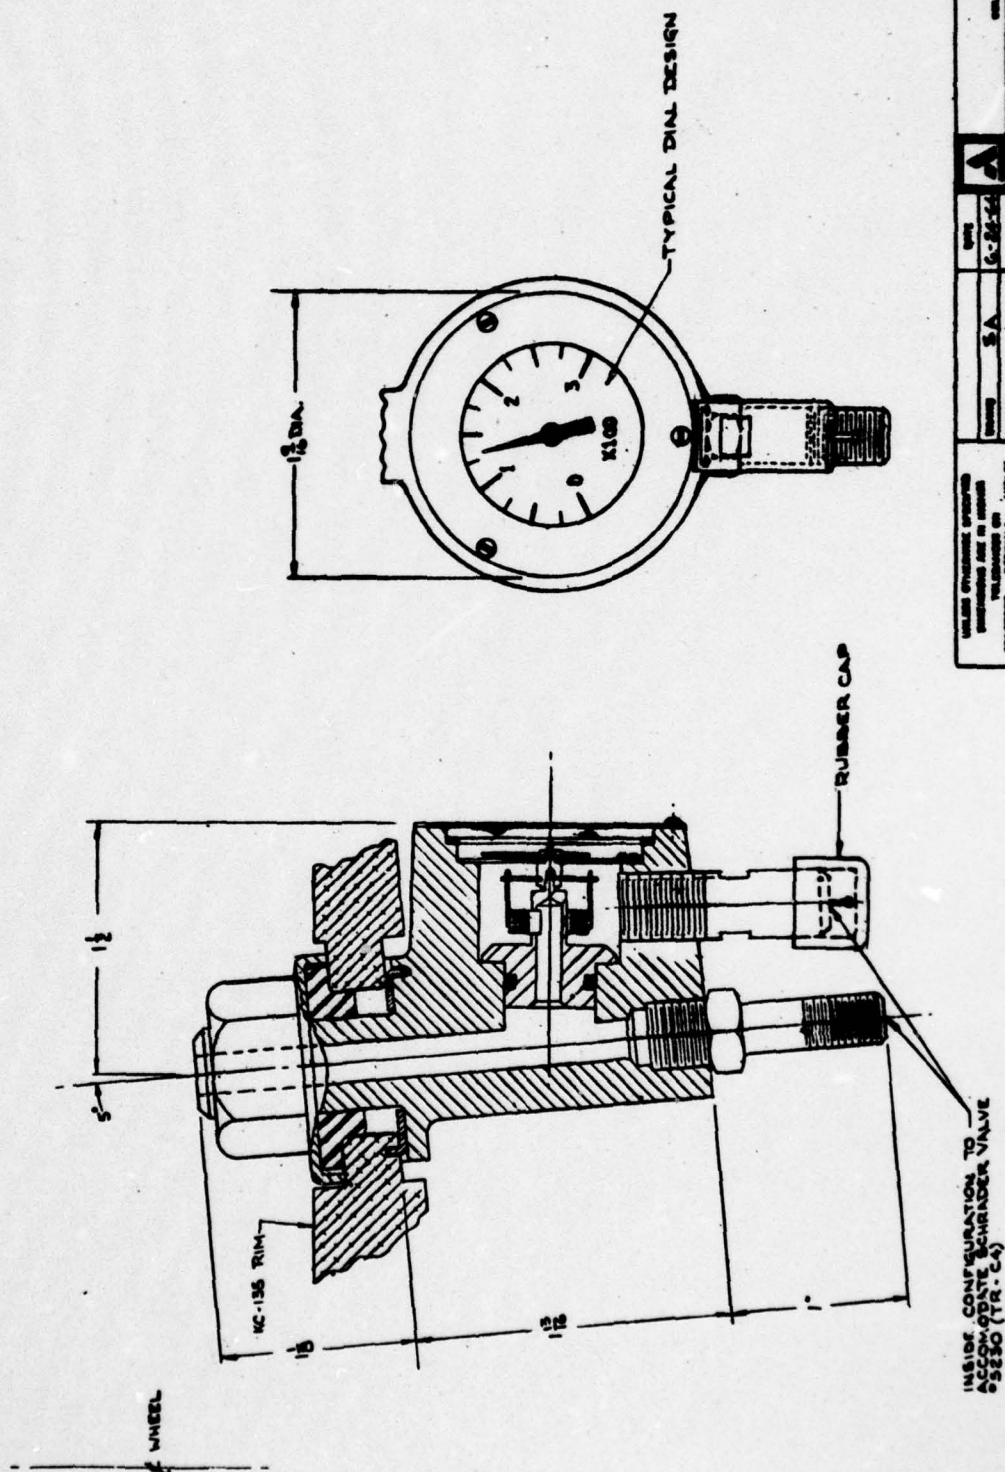
Fig. 13

(1) This design is similar to Design (c) above, except the case vent valve is normally closed. This seals the gauge housing and provides complete protection against dust and moisture. The sealed construction does make the gauge subject to pressure errors due to ambient temperature changes. These errors are on the order of ± 3 psi, depending on whether the temperature is above or below the temperature at which the gauge was last vented. For the most accurate indication of tire pressure, the case should be vented by pushing the vent valve open, prior to taking the reading.

(2) The sealed gauge housing provides a self-temperature compensating effect since the change in spring modulus of the Bourdon tube causes an error which is partially offset by the change in air pressure within the sealed case.

(3) If a low gauge reading exists, the cause of the low reading may be under-inflation of the tire or a leak in the pressure gauge. By use of the vent valve, the actual cause can be determined if the low pressure condition is a result of tire pressure loss, the gauge reading will not change when the vent valve is depressed; however, if the gauge reading increases when the valve is despressed, a leak in the gauge would be indicated.

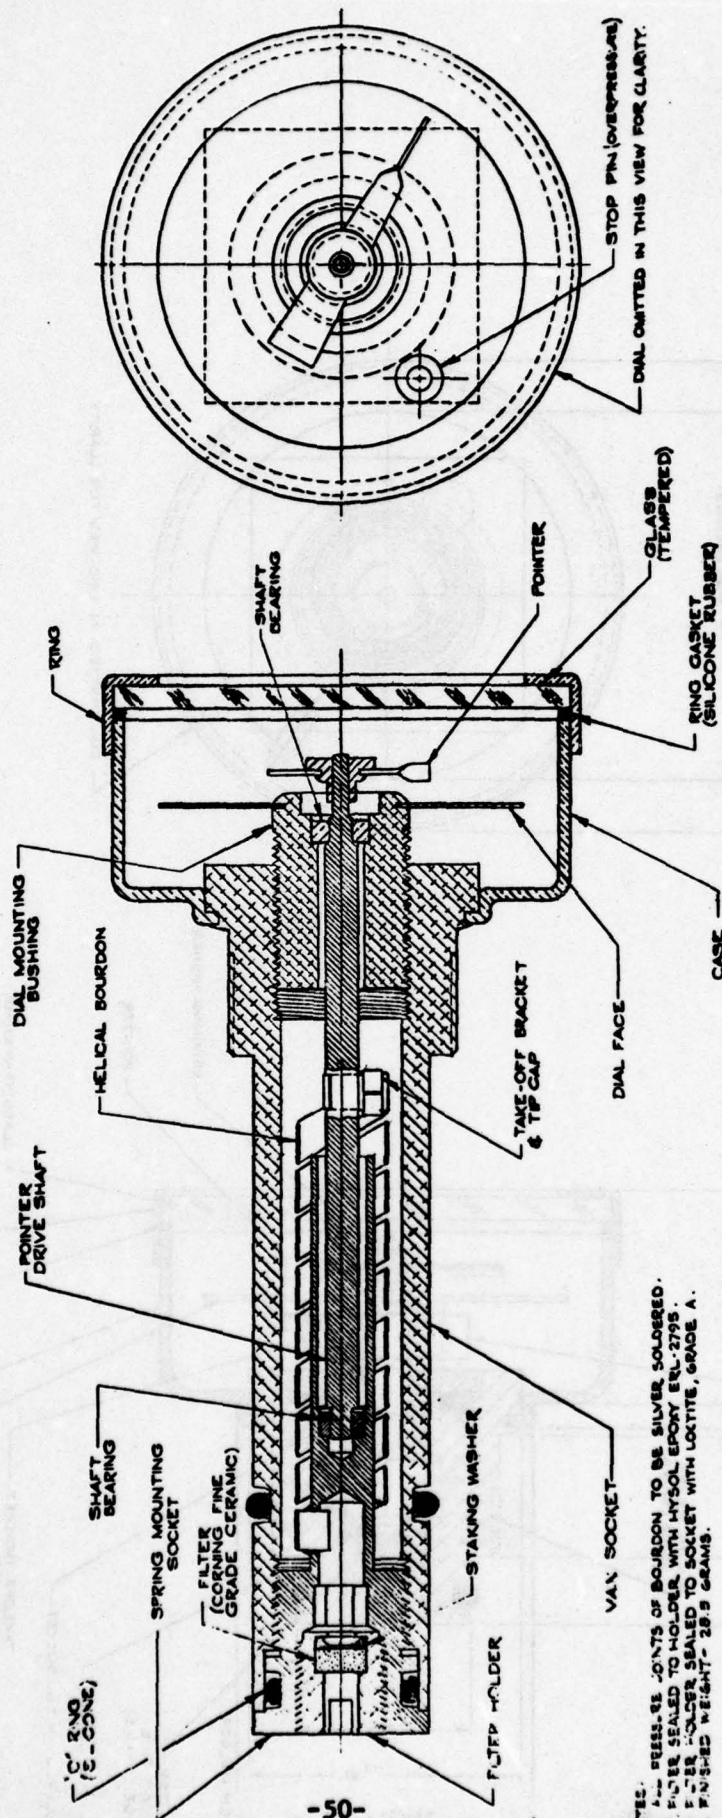
Fig. 19

- NOTES:
1. ALL PRESSURE JOINTS OF BOURDON TO BE SILVER SOLDERED.
 2. FILTER SEALED TO HOLDER WITH HYDROLYTIC EPOXY RESIN-2795.
 3. FILTER HOLDER SEALED TO SOCKET WITH LOCTITE, GRADE A.
 4. FINISHED WEIGHT - 28.5 GRAMS.

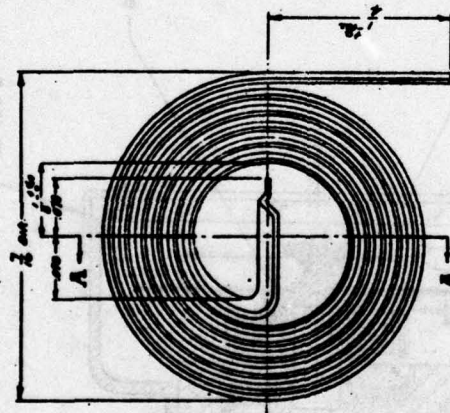
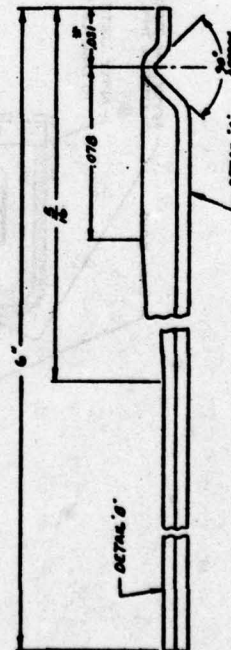
NOTE:
 BLEND DETAIL "A" WITH DETAIL "B" AS SHOWN.
 THE SECTION DEFINED BY THIS DIMENSION SHALL BE CROWNED TO
 APPROX. .005 TO EFFECT A SEAL AGAINST JOURNAL FLAT (JOURNAL
 DETAIL OF DEVELOPED LENGTH
 SCALE 20:1

- NOTES:
1. NUMBER OF ACTIVE COILS - 5 1/2
 2. OUTSIDE DIAMETER - 2 1/2 INCH AND PER INCH
 3. COILS PER INCH - 10 COILS PER INCH
 4. NO FRICTION IN COILS IS PERMISSIBLE
 5. SPRING MUST BE CAPABLE OF A RESILIENCE OF 1 INCH
 6. THE .005 SECTION OF THE SPRING MUST BE APPROX. 1/2 INCH
 7. NO SPRING ARE PERMITTED OVER THE SPRING COILS SPRING EXCEPT
 8. AT THE SPRING SHALL BE CAPABLE OF A RESILIENCE OF 1 INCH
 9. SPRING SHALL BE CAPABLE OF A RESILIENCE OF 1 INCH
 10. SPRING SHALL BE CAPABLE OF A RESILIENCE OF 1 INCH
 11. APPROVED SOURCE FOR RAW MATERIAL -

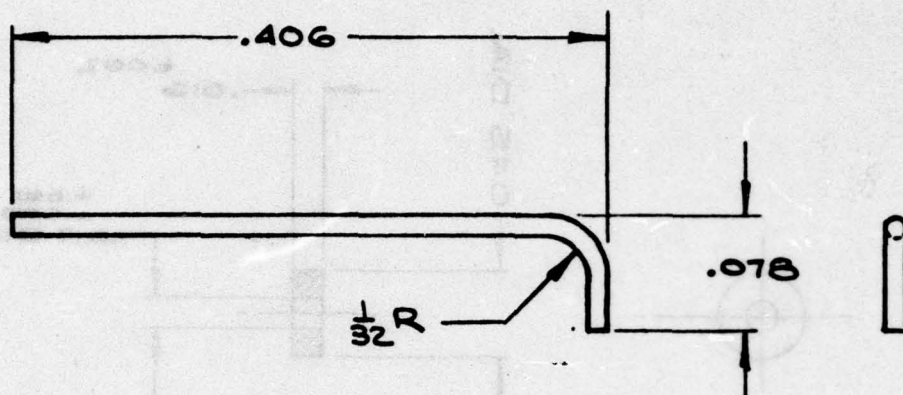
1. MATERIAL: .014 DIA. MUSIC WIRE
2. SPECIFICATION: MS-210-11

U. S. GAUGE A DIVISION OF AMETEK, INC. SELLERSVILLE, PENNSYLVANIA	
CHECKED			
APPROVED			
USED ON AW1026 BCO1		DRAWING TITLE POINTER DRIVE U.S.A.F TIRE INFLATION INDICATOR	
NEXT ASS'Y BNN-3009			
SUPERSEDES ASK-9444-BH			
UNLESS OTHERWISE SPECIFIED DIMENSIONS ARE IN INCHES TOLERANCES ON FRACTIONS DECIMALS ANGLES ± 1/64 ± .005 ± 1° SURFACE FINISH AA MAX.		CODE IDENT. NO. 61349 SIZE A DWG. NO. AH-5269	
		SCALE B/1 RAW WT/M SHEET

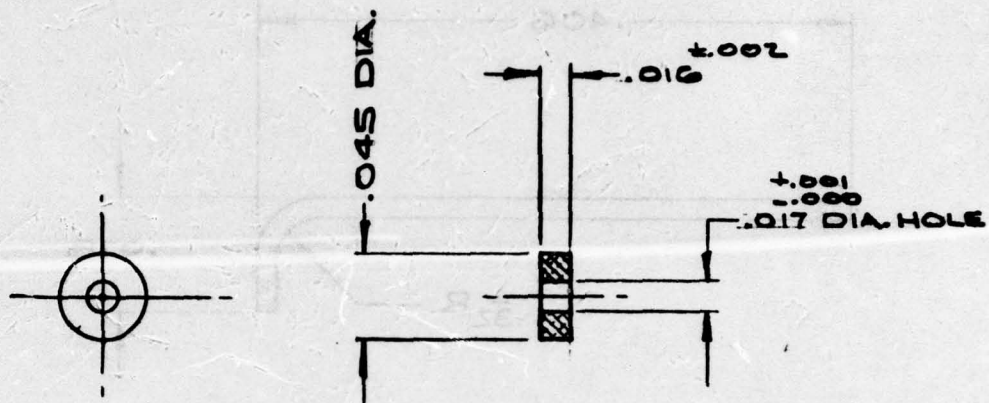
1. MATERIAL: ^{±.002} .016 THK ALUM. STRIP 2024-T4
2. SPECIFICATION: MS-200-1
3. FINISH: #36 CLEAR ANODIZE

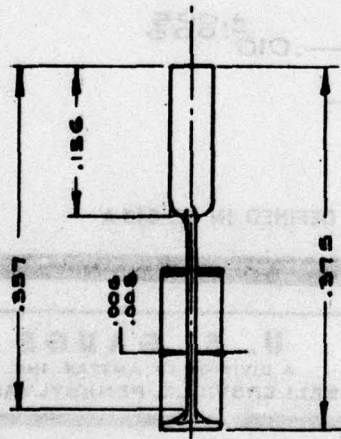
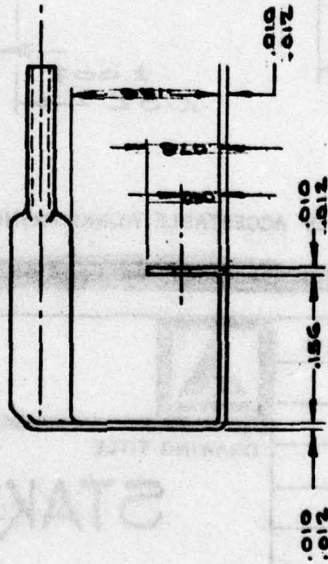
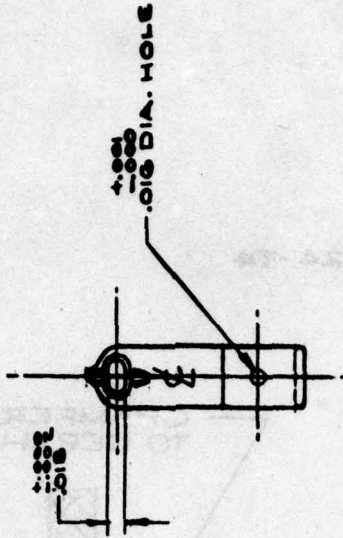
UNLESS OTHERWISE SPECIFIED DIMENSIONS ARE IN INCHES FRACTIONS DECIMALS ON ANGLES 1/16 1/32 3/64 1/2 1"		DATE 7-12-65	U. S. GAUGE A DIVISION OF AMERICAN COLLEENAVILLE, PENNSYLVANIA	
SURFACE FINISH AS SUP.		DESIGN R. R.	DRAWING TITLE POINTER EXTENSION	
MATERIAL .040 O.D. X .008 WALL ST. STEEL TUBING TYPE 316		TRACES	USAFT TIRE INFLATION INDICATOR	
SPECIFICATION MS-211-106		CHECKED	TYPE IDENT. NO. 61300	DATE B
TREATMENT PASSIVATE		APPROVED	SCALE 1/16" = 1"	1/16" = 1"
FINISH		USED ON AV1026 BC01 NEXT ASST AP-201-A SUPERSEDES A-347-944-20	BHI-5272

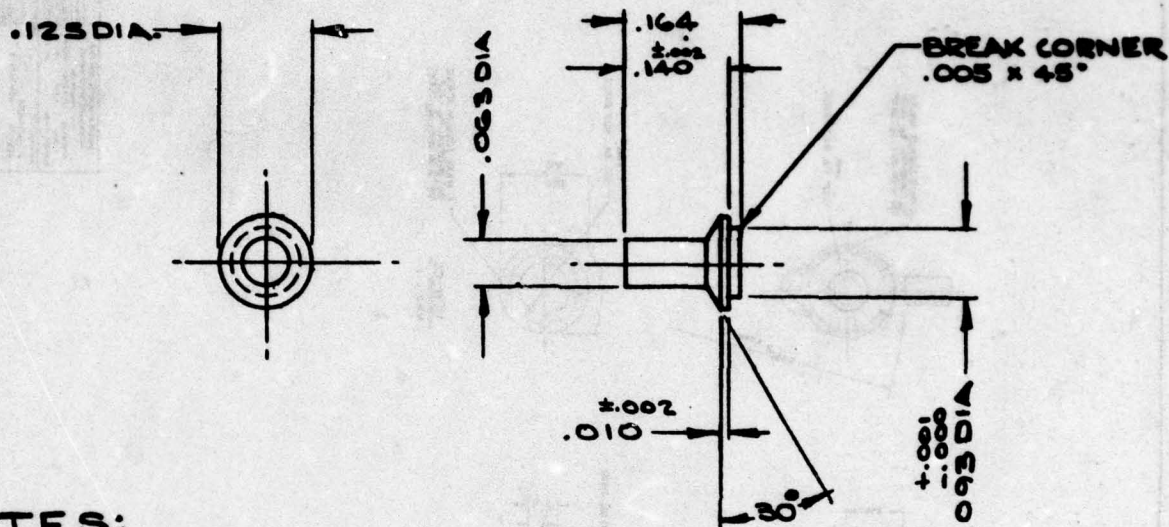
1. MATERIAL: $\frac{1}{8}$ DIA. ALUM. ROD 2024-T4
2. SPECIFICATION: MS-200-B
3. FINISH: 66 CLEAR ANODIZE

U. S. GAUGE A DIVISION OF AMETEX, INC. SELLERSVILLE, PENNSYLVANIA		RETAINER PLATE	
DRAWING TITLE U.S.A.F. TIRE INFLATION INDICATOR		CODE IDENT. NO. 61349	SIZE A
DATE 8-11-65		DWG. NO. AH-5277	
DRAWN C.BROOKS		SCALE 2/1	
TRACED		RAW WT / IN 2.9	
CHECKED		SHEET	
APPROVED			
USED ON CNN-3005			
NEXT ASS'Y CNN-3005			
SUPERSEDES ASK-9444-AQ			
UNLESS OTHERWISE SPECIFIED DIMENSIONS ARE IN INCHES		SPECIFICATION MS-200-20	
FRACTIONS DECIMALS ANGLES $\pm 1/64$ $\pm .005$ $\pm 1^\circ$		TREATMENT	
SURFACE FINISH 1" WIDE .032 THK. ALUM. STRIP 5052-H32		FINISH ANODIZE

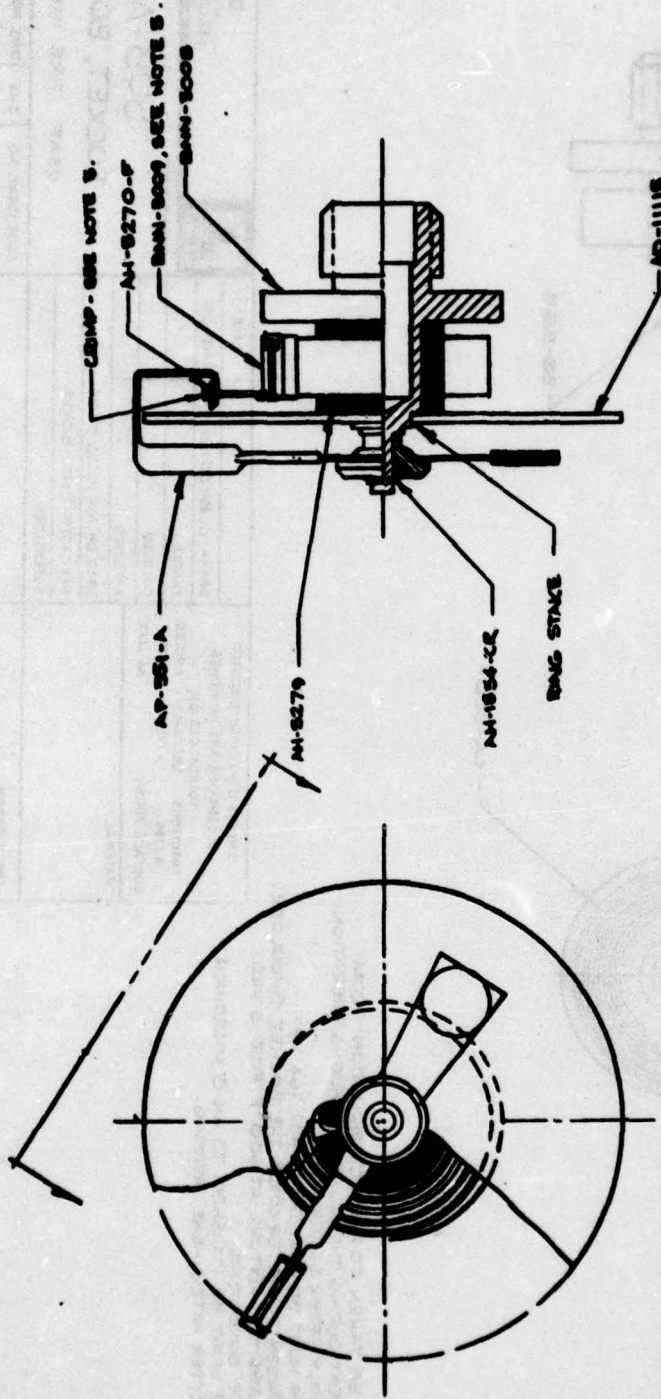
1. APPLY LIGHT FILM OF DRY MOLYKOTE PRIOR TO ASS'Y OF POINTER TO SHAFT.
2. TEST FOR SMOOTHNESS OF POINTER ACTION PRIOR TO ASS'Y OF AN-8270-F.
3. AFTER ASS'Y OF AN-8270-F, COMP WIRE AS SHOWN, WHILE COMPING, THE BOURDON MUST NOT BE FLEXED SO AS TO CAUSE PRELOAD ON THE POINTER.
4. APPLY 150 PSI PRESSURE AND ROTATE DIAL TO INDICATE 150 PSI.
5. ADJUST TAKEOFF BRACKET TO ACHIEVE 0 ± 500 PSI TEST POINTS. COMP BRACKET AND APPLY HYDOL EPOXY. CURE EPOXY AT 180°F FOR 1 HOUR.

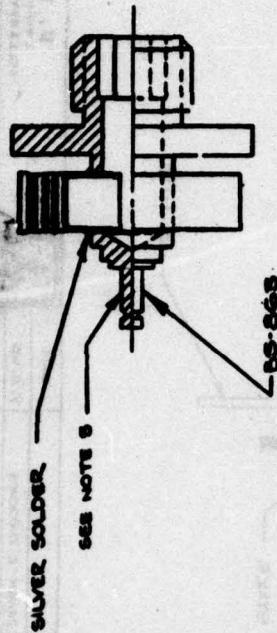
- NOTES:
1. CARE MUST BE TAKEN TO PROTECT BOURDON FROM EXCESSIVE HEAT DURING THE SILVER SOLDERING OPERATION.
 2. CLEAN ASSEMBLY AFTER SOLDERING.
 3. THE BOURDON MUST BE FLAT TO WITHIN $1/64$ MAX. RUNOUT BETWEEN THE OUTER COIL & THE SOCKET SHOULDER.
 4. HEAT TREAT ASS'Y IN FIXTURE AT 600°F FOR 8 HRS. AFTER SILVER SOLDERING.
 5. THIS SURFACE MUST BE POLISHED TO AN 8 MICRON INCH FINISH OR BETTER AFTER HEAT TREATING.

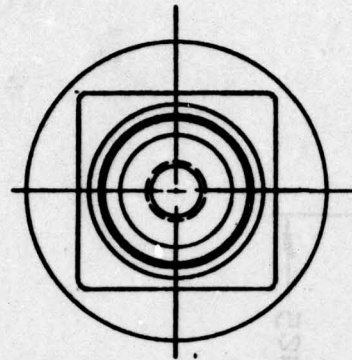
- NOTES:
1. APPLY LOCKTITE GRADE 'A' TO CASE PRIOR TO STAKING
 2. T-ESSE SURFACES ARE FOR PRESSURE SEALING. CARE MUST BE TAKEN NOT TO DISTORT MARK DURING THE STAKING OPERATION.

UNLESS OTHERWISE SPECIFIED DIMENSIONS ARE IN INCHES FRACTIONS DECIMALS ANGLES 3/16 0.1875 31° SURFACE FINISH AS MAN		DRAWN C. BROOKS		DATE 9-7-65		U. S. GAUGE A DIVISION OF BETHLEHEM STEEL CO. BELLERSVILLE, PENNSYLVANIA	
MATERIAL		TRACED				DRAWING TITLE ASSEMBLY-CASE & MAIN SOCKET	
		CHECKED				USAF TIRE INFLATION INDICATOR	
		APPROVED				CODE IDENT. NO. 61340	
SPECIFICATION		USED ON AM/1026 BCO1			SIZE B		IND. NO. BNN-3010
TREATMENT		NEXT ASST AM/1026 BCO1			SCALE		SHEET
FINISH		SUPERSEDES
