4. TITLE (and Subtitle) PROTOTYPE GATE VIBRATION TESTS, BARKLEY DAM, CUMBERLAND RIVER, KENTUCKY		5. TYPE OF REPORT & PERIOD COVERED Final report
7. AUTHOR(s) E. Dale Hart John E. Hite, Jr.		8. CONTRACT OR GRANT NUMBER(s)

20. ABSTRACT (Continue on reverse side if necessary and identify by block number)  This report presents data obtained during prototype tests concerned with the vibration of the 50- by 55-ft spillway tainter gates at Barkley Dam. The gates vibrate during flow passage in which the gate lip is submerged by high tailwater.  Field tests were conducted on two of the gates during high tailwater. Three pressure transducers were placed near the lip of the gate. In addition (Continued)

PROTOTYPE GATE VIBRATION TESTS, BARKLEY DAM  
CUMBERLAND RIVER, KENTUCKY

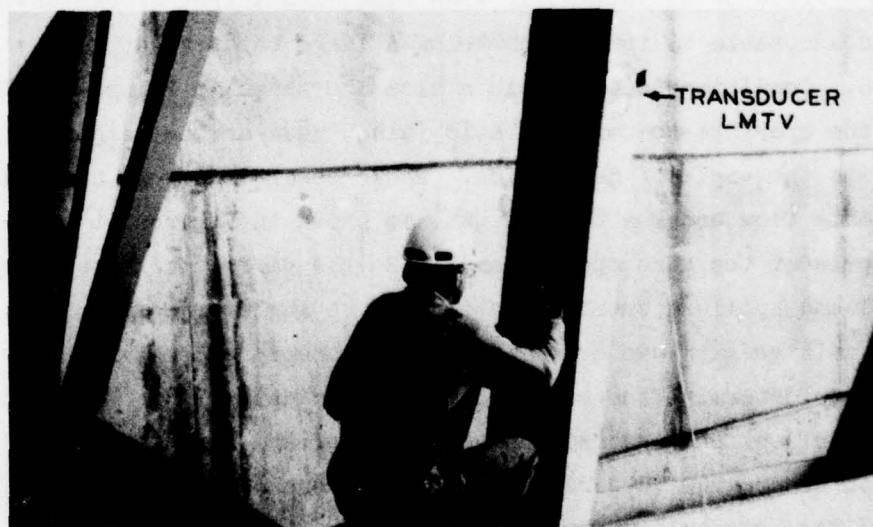
Figure 9. Support member LMTV "ring" test

designated transducer LMTV (Table 1 and Plate 2) and left on the vertical member for the remaining gate 3 tests. To determine the natural frequency of this member, a "ring" test was conducted by tapping it with the plastic handle of a screwdriver (Figure 9) and recording the results for subsequent computations.

34. A "ring" test was conducted by tapping the member LMTV with the handle of a screwdriver as shown in Figure 9. The recorded response is shown in Plate 10. Also shown in the lower left plot is the FFT of this ring test response. Note the first spike at approximately 30 Hz. The lower right plot shows the frequency of response of LMTV during test 10 (also presented in Table 3), again within the area of the calculated natural frequency of the member. Consideration should be given to some form of bracing to alter the natural frequency of this and any other observed oscillating members.

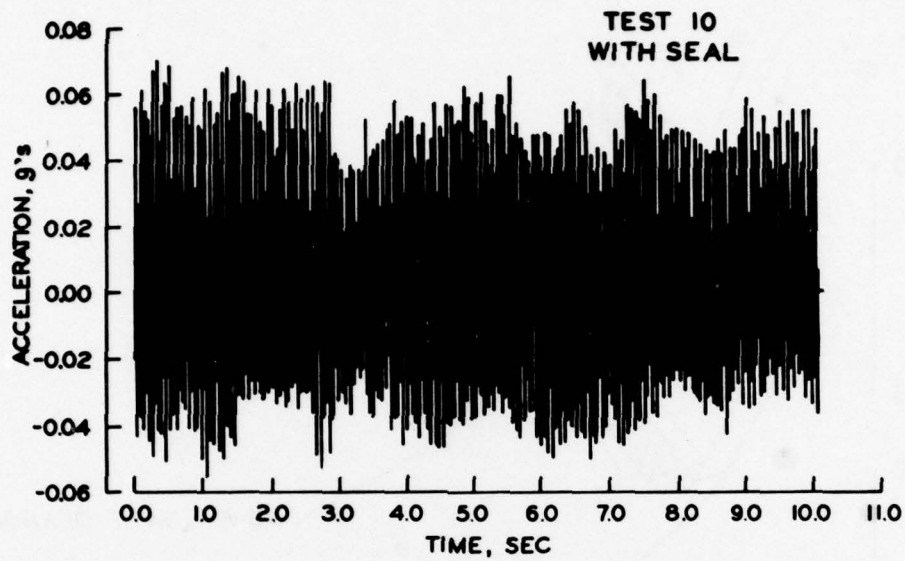
GATE ACCELERATION INTENSITY  
TRANSDUCER CMP  
GATE 3, GATE OPENING 4.2 FT

24. The effect of seal removal is further illustrated by results from the time series analysis of the magnetic tape data. Plate 4 presents a comparison of accelerations for identical conditions except for seal removal. These data are from transducer CMP which was mounted in the gate center near the skin plate (Plate 2) and responded to movement tangent to the skin plate thereby representing gate movement in the
