# PRIMARY ADHESIVELY BONDED STRUCTURE TECHNOLOGY (PABST)

## Tooling, Fabrication and QA Report

TECHNICAL REPORT AFFDL-TR-79-3154

Final Report: February 1975 - June 1979

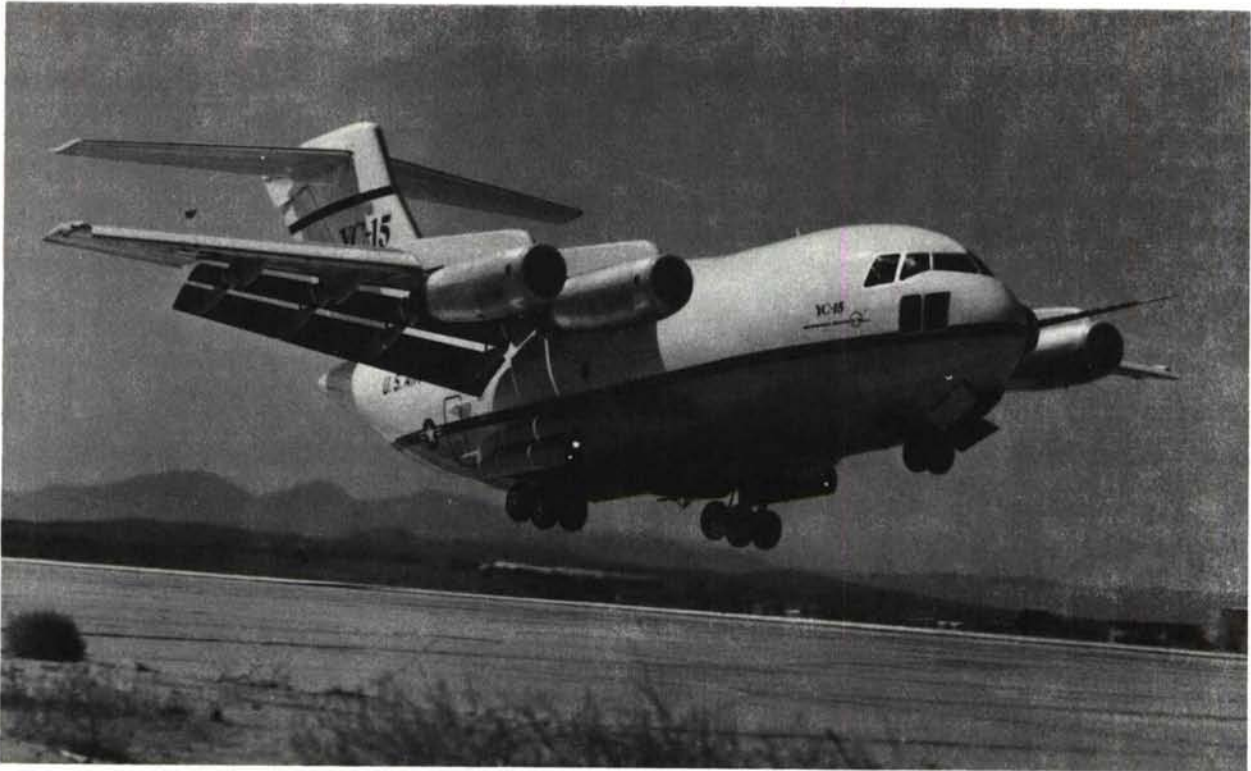
FIGURE 1. DOUGLAS AMST CANDIDATE – WIDE-BODY TRANSPORT (YC-15)

On 18 February 1975, the Air Force awarded the \$18.4 million PABST contract to the Douglas Aircraft Company. This is a multidiscipline program, the primary objective of which is to achieve significant improvement in cost, weight, integrity, and durability of primary fuselage structure applicable to the AMST (Figure 1) and other wide-body transports through (1) the development and validation - ultimately by full-scale test - of adhesively bonded structure technology, and (2) the prompt and complete transfer of the knowledge and data obtained to the aerospace community. Implicit in the primary objective was the need to demonstrate manufacturing capability to produce large bonded fuselage structure and to verify that applications of adhesive bonding to primary structures can achieve the goals of a 20 percent cost saving and a concurrent 15 percent weight reduction when compared with existing fabrication techniques and conventional riveted structures.

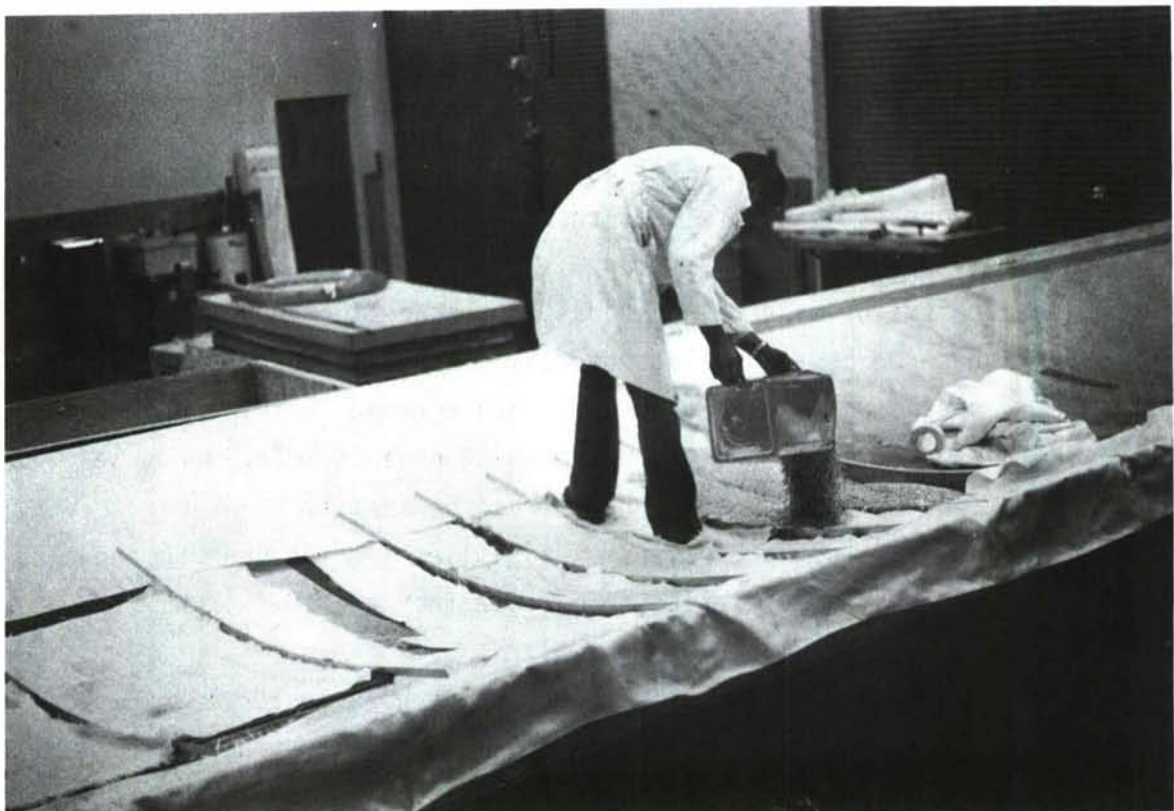
FIGURE 21. APPLICATION OF HOLLOW ALUMINUM BEADS TO THE FEMALE BOND TOOL

The next major problem involved the use of 1/4 inch hollow aluminum beads, Figure 21, to cover the inside of the skin up to the height of the shear tees (about two inches) in an attempt to simplify the bagging operation and reduce the likelihood of a bag failure due to puncturing by a sharp cornered detail. Occasionally in practice, the "beads" locked up solid in the vacuum bag and actually prevented the uniform transmission of the autoclave pressure to the bonding surfaces, as shown in the upper view of Figure 22.

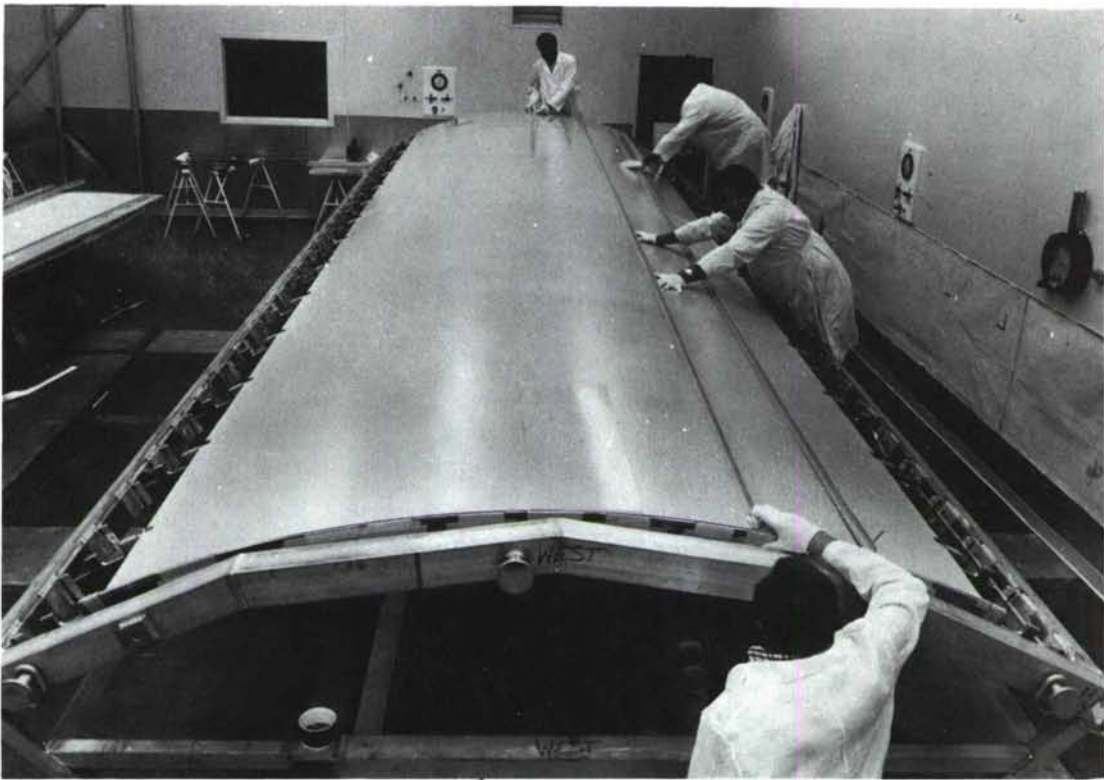
FIGURE 34-a. MALE BOND TOOL – SKIN AND EXTERNAL LONGERON

The PABST male tool, Figure 34, consisted essentially of a stiff picture frame around the periphery with a series of transverse contour boards at each frame station to locate and support the shear tees on the inside of the assembly. Autoclave pressure was transmitted across the bag on each side of the bonded assembly, so that the skin was free to deflect until it rested on the stiffeners. This tool was much less expensive to build than the female tool. This dual bag tool is the easiest of all bonding tools to use reliably because the skins are accessible from both sides for inspection of fit. The PABST experiences with the male tool were encouraging as the bond quality improved significantly in comparison with female tool bonds in terms of markedly improved verifilms and a reduction in voids and porosity as shown in Figure 35.

The male tool effectively bonded the external longerons on the lower panels of the FSDC which was impossible using the female tool. The male tool is easily cost-justified for production with some bagging improvements required. However, the use of nylon sheet for the internal bag, as on PABST, raised two problems. The first was the large labor effort in laying up the bag carefully to prevent it from being punctured. The second problem, especially on the early panels, was bridging caused by the excessive use of bleeder material to pack the corners which resulted in aesthetically unacceptable mark-off at the stiffeners on the outside of the panels.

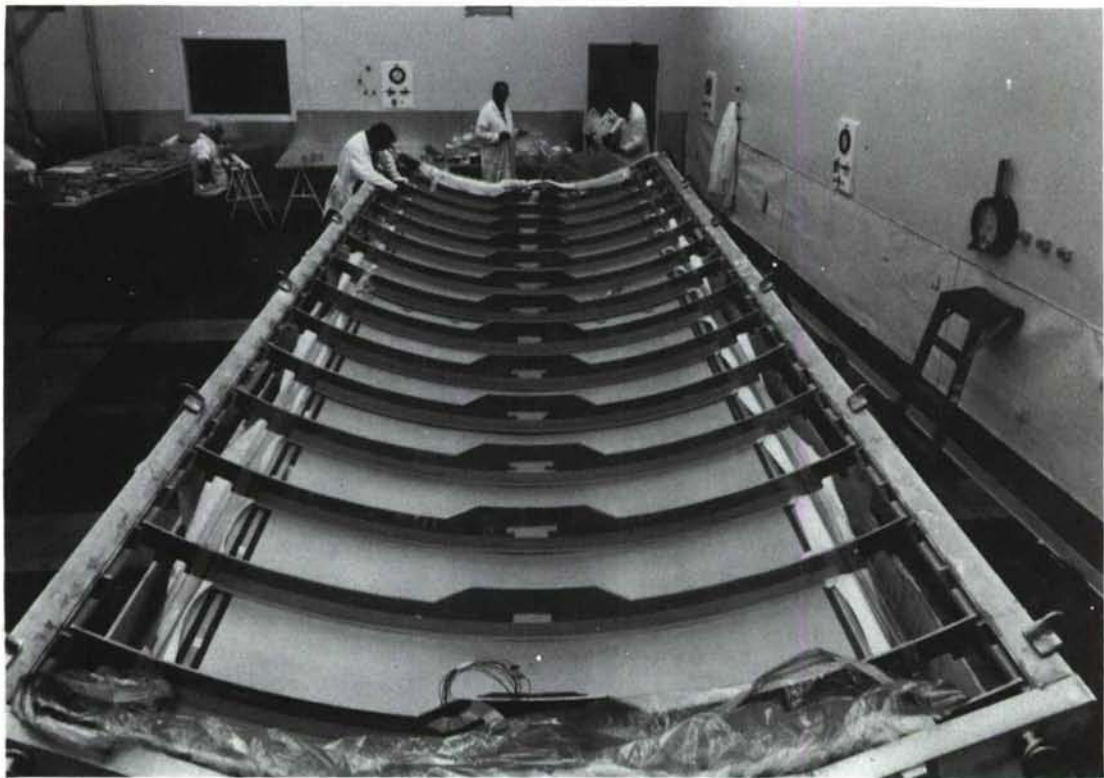
FIGURE 34-b. MALE BOND TOOL – INTERNAL CONTOUR BOARDS

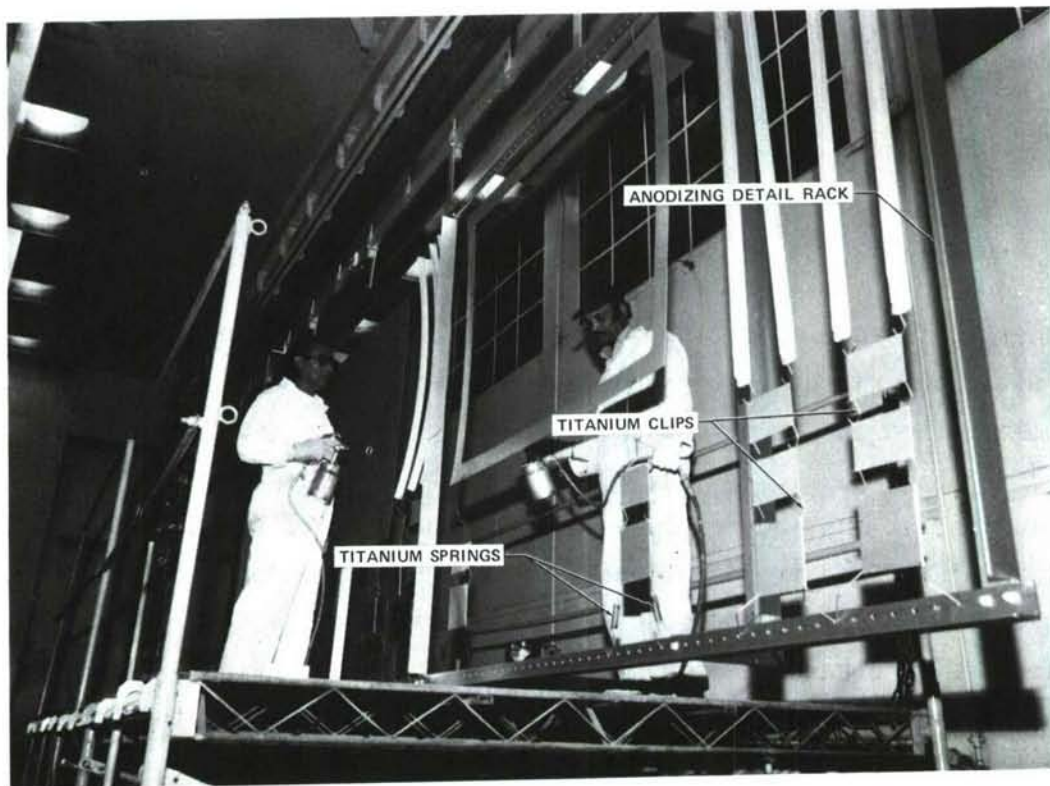
FIGURE 43. TYPICAL PRIMER APPLICATION FOR PABST PANELS

During the program, techniques for application and control of the primer and priming operation were developed, Figure 43. It was discovered that the chosen primer's characteristics are such that standard "paint spraying" techniques had to be altered to obtain the desired results. Spraying equipment, Figure 44, was required to agitate and recirculate the primer continuously during the application operation since the chromates included

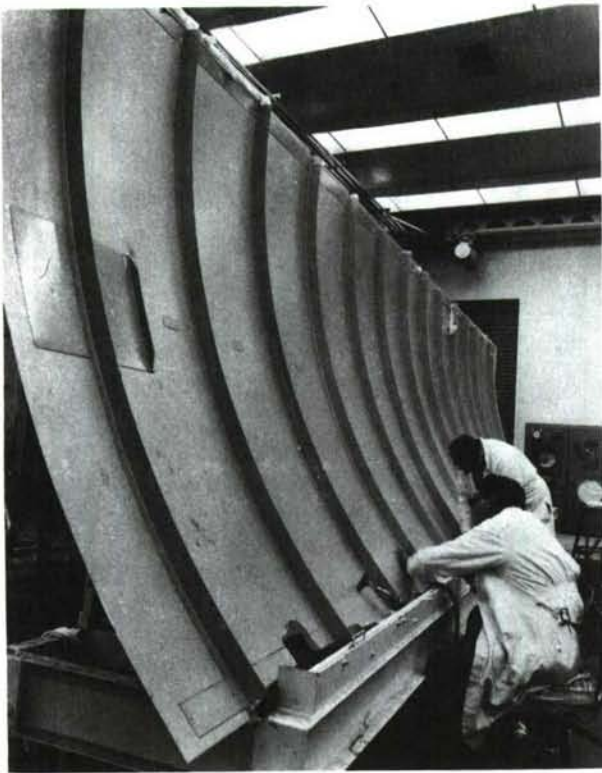
FIGURE 46. GRINDING ADHESIVE FLASH FROM PANELS
