*Environmental analysis of the Upper Susitna River Basin using Landsat imagery*

CRREL Report 80-4

Environmental analysis of the Upper Susitna River Basin using Landsat imagery

Prepared for DIRECTORATE OF CIVIL WORKS OFFICE, CHIEF OF ENGINEERS

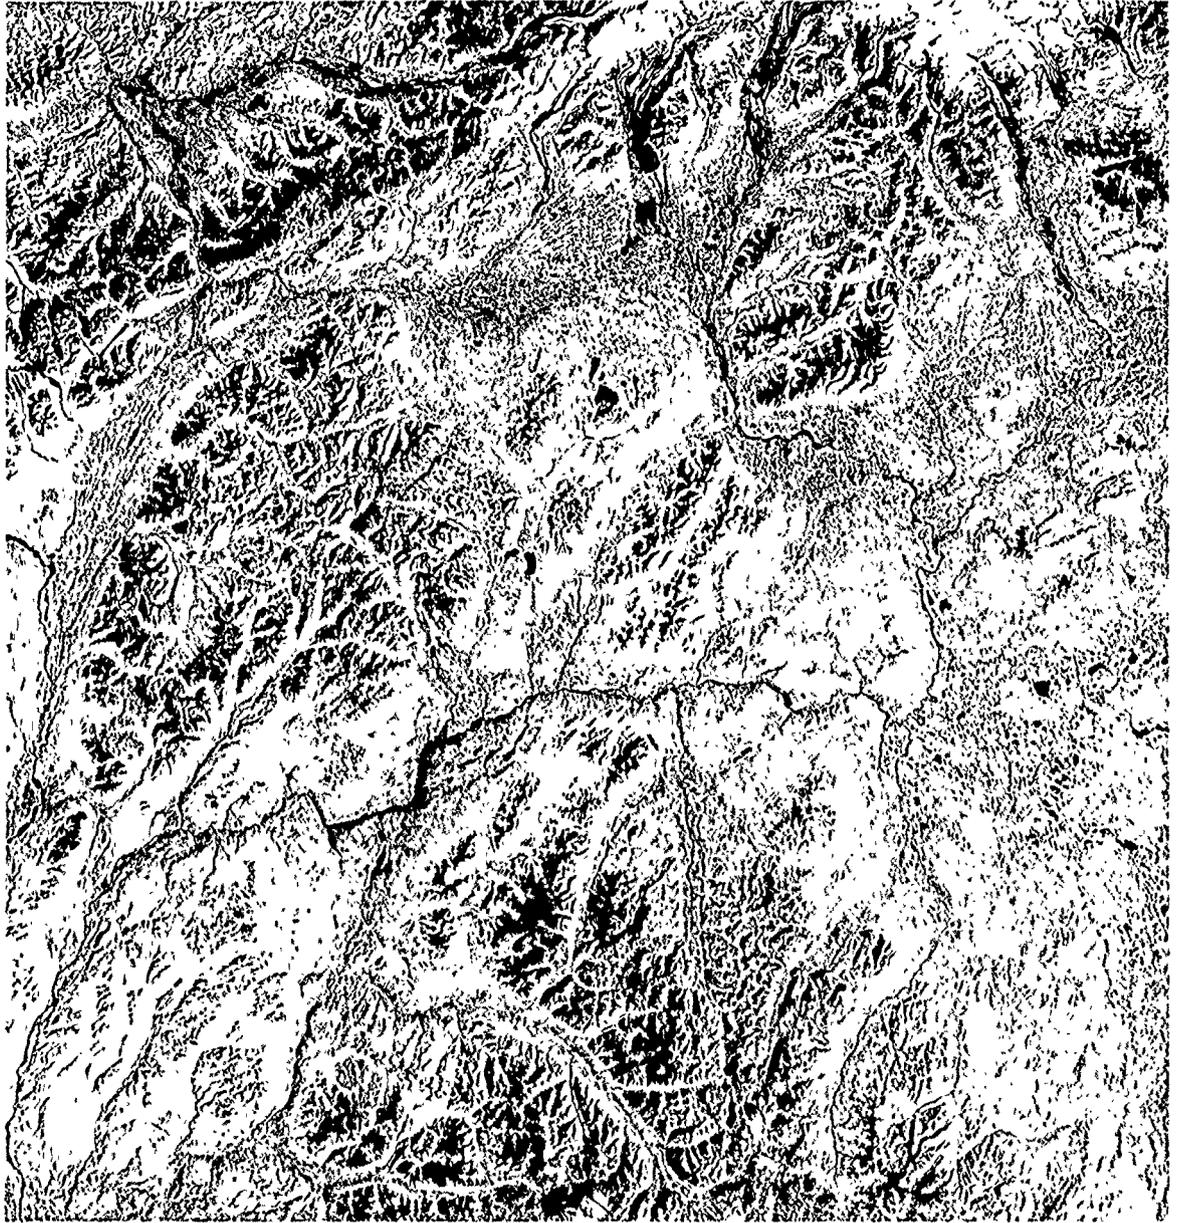
a. Band 4.

Figure 4. Single band EDIES images of scene 5470-19560.

*b. Band 5.*

c. Band 6.

*d. Band 7.*

Band 5 images provided information not obtainable from band 7 images and vice-versa. Band 7 always showed the water-filled portion of stream beds, which was not always possible with the band 5. The contrast between land and water on the band 5 image was not always sufficient to differentiate the shoreline. This contrast was usually more apparent on band 7. Consequently, both band 5 and 7 images were used during the mapping.

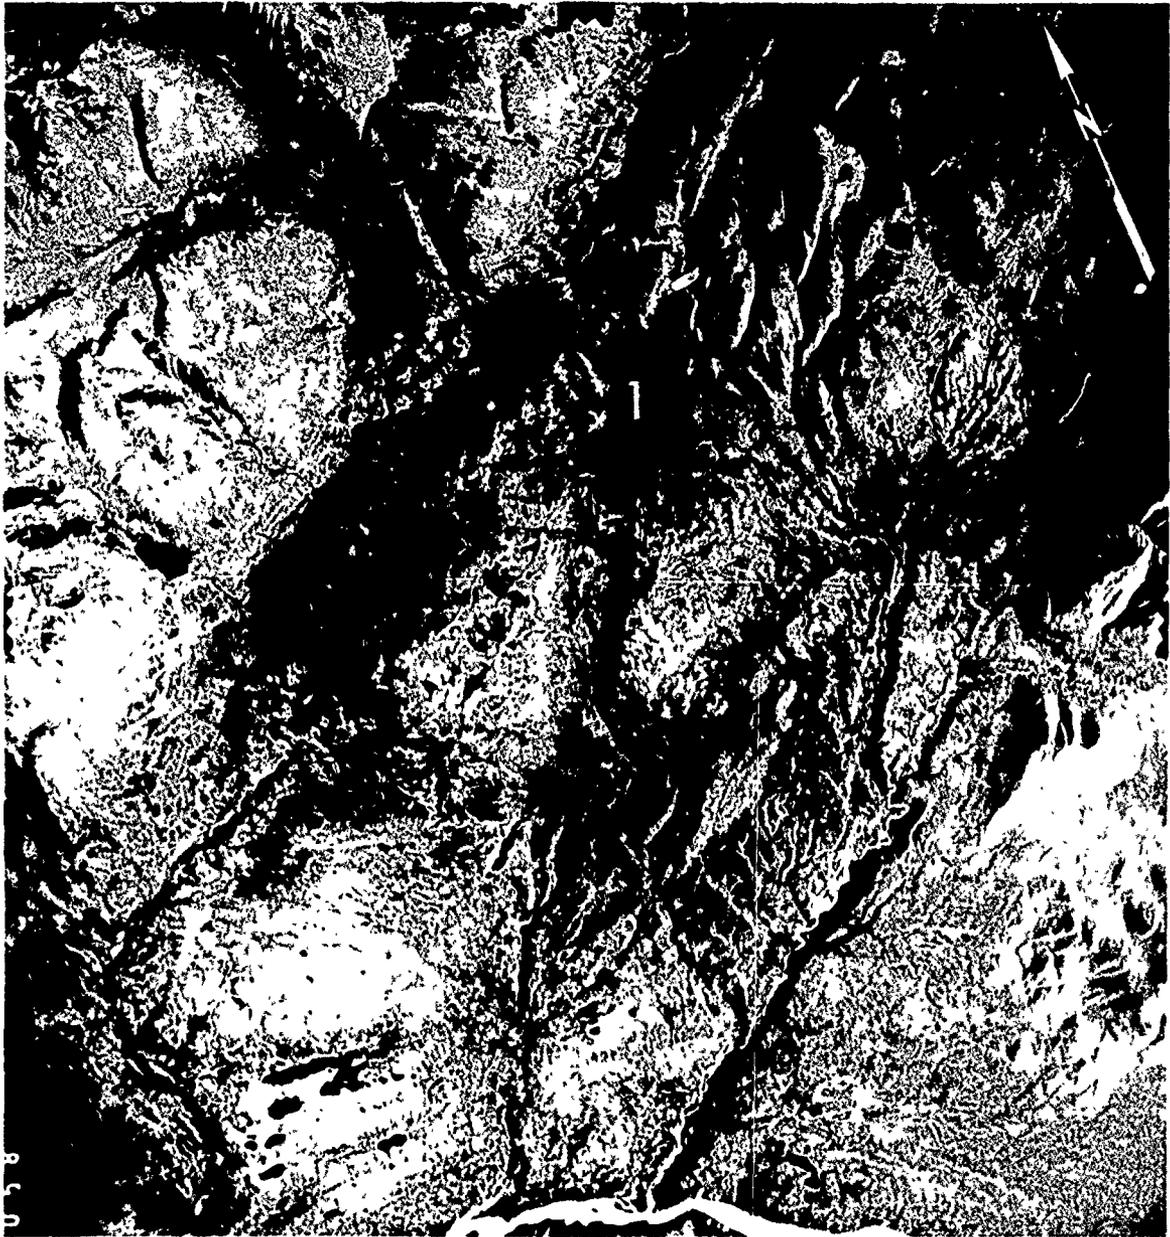
*Figure 9. Big Lake (1) and surrounding area, taken on 28 July 1977 during NASA mission 364; scale, 1:160,000.*

I compared the distribution of lakes mapped from the Landsat imagery to that on the NASA aerial photographs and the Healy topographic map. NASA photograph 16-054 (Fig. 9) shows the lakes in the Big Lake (1) area of the basin. Most of the lakes shown can also be seen on the Landsat EDIES image (Figs. 3 and 4d). NASA photograph 16-060 (Fig. 5) shows the area around the confluence of the Maclaren and Susitna rivers. Many of the lakes are so small that their shape could not be mapped accurately but are easily observed on the Landsat scene. Frequently, the shape of the lakes is not as well-defined on the Landsat image as on the NASA photographs because of the difference in resolution between the photographs and the imagery.

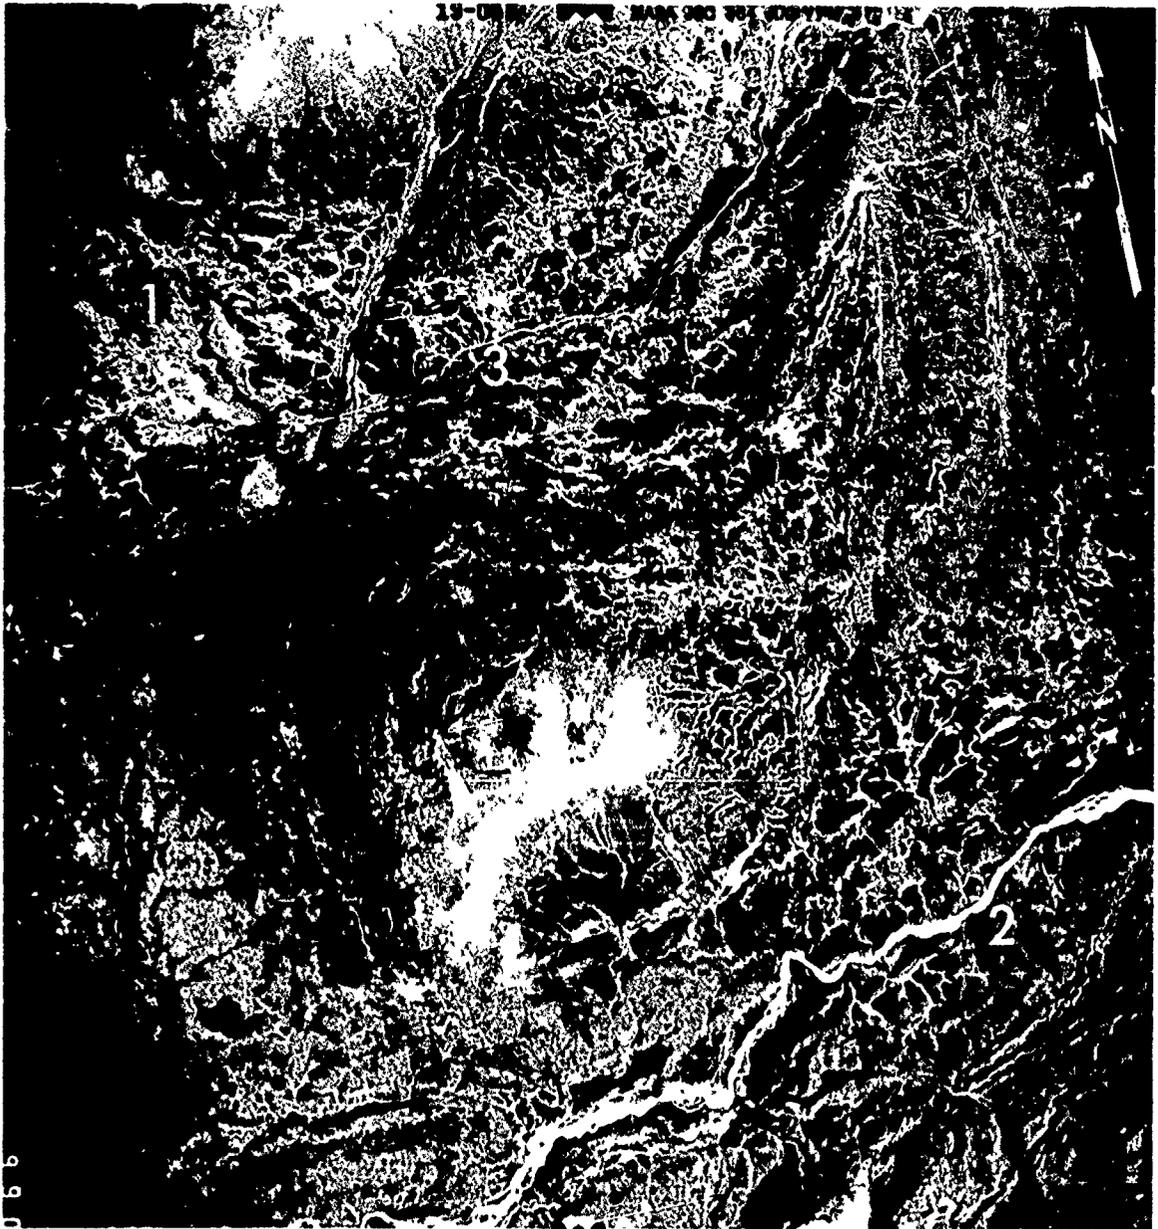
Figure 13. Clearwater Creek (1), Maclaren River (2), and Denali Highway (3); taken on 29 July 1977 during NASA mission 364; scale 1:160,000.

NASA photographs Figure 11, NASA photograph 16-036, Figure 12, NASA photograph 19-058, and Figure 13, NASA photograph 19-056.

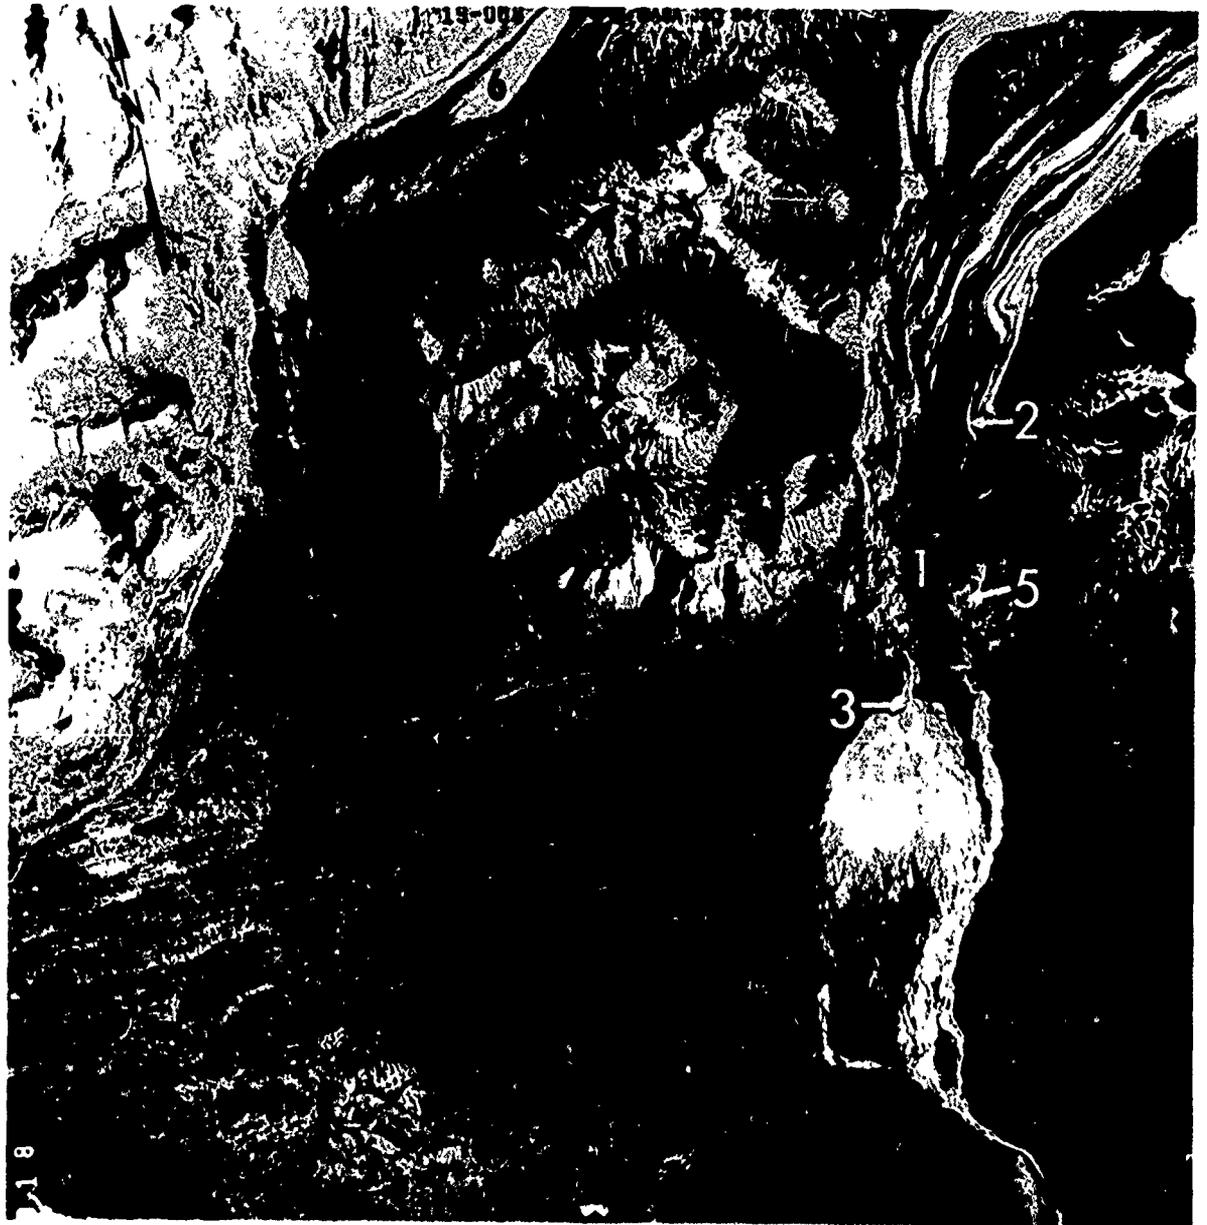
Fig. 3. Terminus of the West Fork Glacier (4), exposed ice (2), meltwater streams (3), debris at terminus (1), surface water (5), Nenana Glacier (6); taken on 29 July 1977 during NASA mission 364; scale 1:160,000.

age (Fig. 3) and NASA photograph 19-008 (Fig. 14). Surface water (5) on the surface of the terminus is also apparent on both, however, small-scale roughness is apparent only on the NASA photograph.

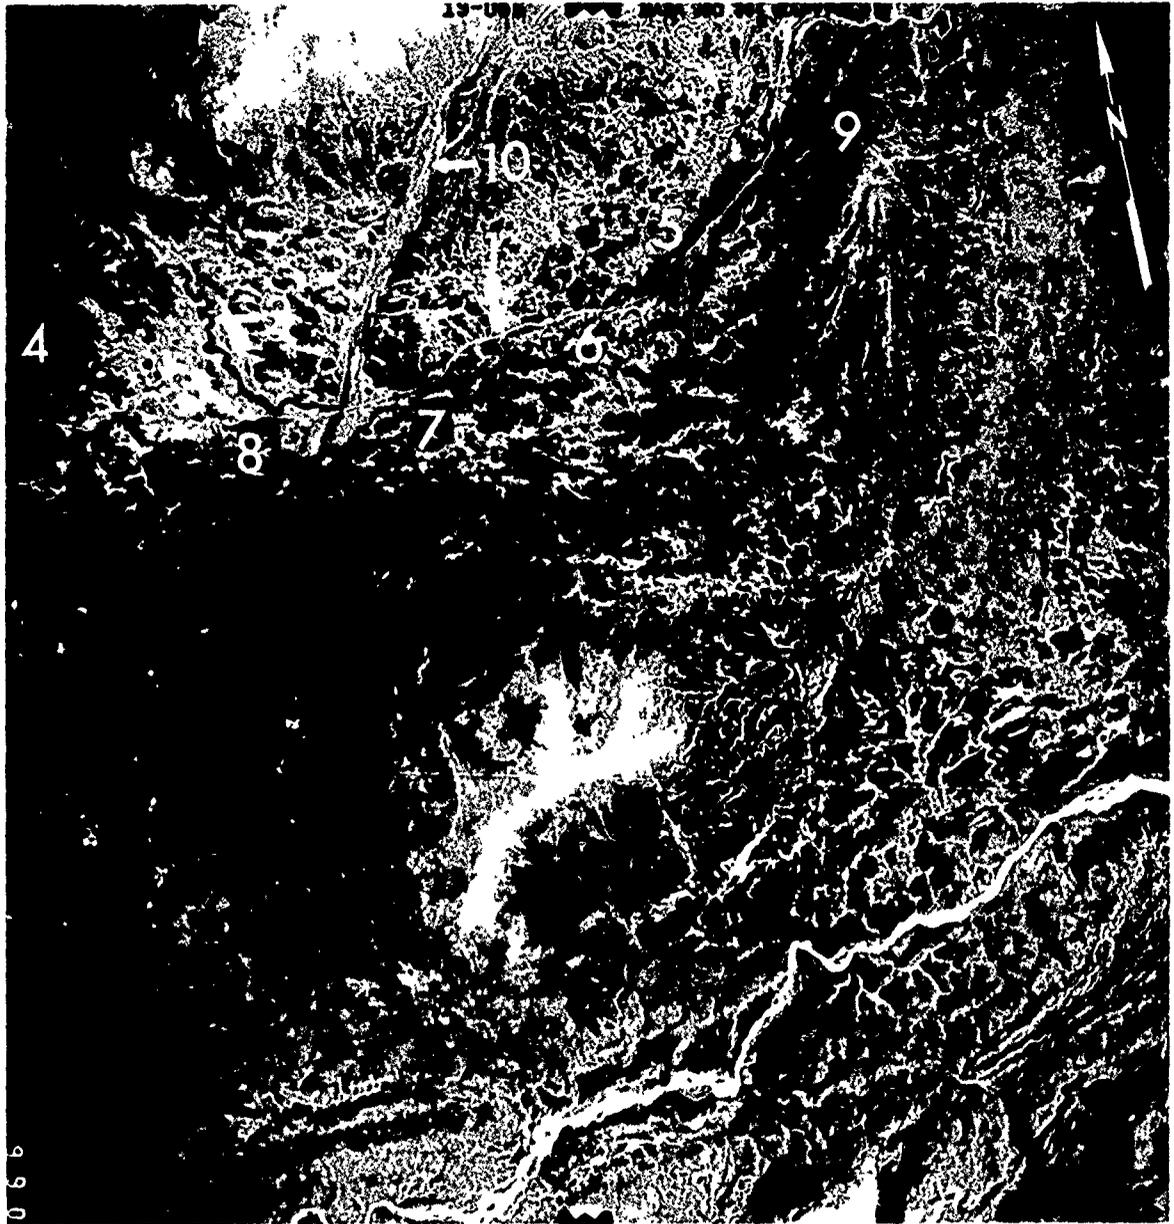
Figure 24. Aerial photograph showing region near Denali Highway (1) and Clearwater Creek (2). The surficial materials at location 3 in map unit ag consist of till overlain by a thin cover of loess with minor amounts of glaciofluvial and fluvial gravels and sands. At location 4 in map unit ag materials are also mainly till interspersed with sands and gravels. At locations 5, 6 and 7 mapped as unit fl<sub>1</sub>, deposits are complex, varying from largely till with a thin loess blanket (6), glaciofluvial sands and gravels in old stream channels and eskers interspersed with till (5), and till and glaciofluvial sands and gravels in moraine ridges with swales and kettles (7). Surficial deposits at location 8 in map unit fl<sub>2</sub> are similarly complex materials in kames, eskers and end and ground moraines. Location 9 in map unit fl<sub>2</sub> consists of mostly till deposited as lateral and ground moraines. Loess may thinly cover some till and glaciofluvial deposits throughout the region. Some geomorphic features evident on the photo include arcuate end and lateral moraines near and below (5), abandoned stream channels below (4) and near (3), and esker below (3) upon which the Denali Highway is located, and the old river channel occupied by an undersized stream (Little Clearwater Creek, 10). Photo taken on 29 July 1977 during NASA mission 364, scale 1:160,000.

than those described by the mapping units of the Landsat-derived map. In part, this was expected; however, because till and materials with similar properties were not recognizable on Landsat imagery, the imagery may be inappropriate for mapping complex glacial deposits in this or similar regions.
