4. TITLE (and Subtitle) An Investigation Into the Susceptibility of Tantalum and Vanadium to Slow Strain-Rate Embrittlement Due to Oxygen, Nitrogen and Carbon	5. TYPE OF REPORT & PERIOD COVERED Final Report 4/1/79-6/30/80

SLOW STRAIN-RATE EMBRITTLEMENT IN TANTALUM DUE TO OXYGEN AND SELECTED  
EXPERIMENTS IN THE VANADIUM-OXYGEN AND TANTALUM-NITROGEN SYSTEMS

An Investigation Into the Susceptibility  
of Tantalum and Vanadium to Slow Strain-  
Rate Embrittlement due to Oxygen,  
Nitrogen and Carbon.

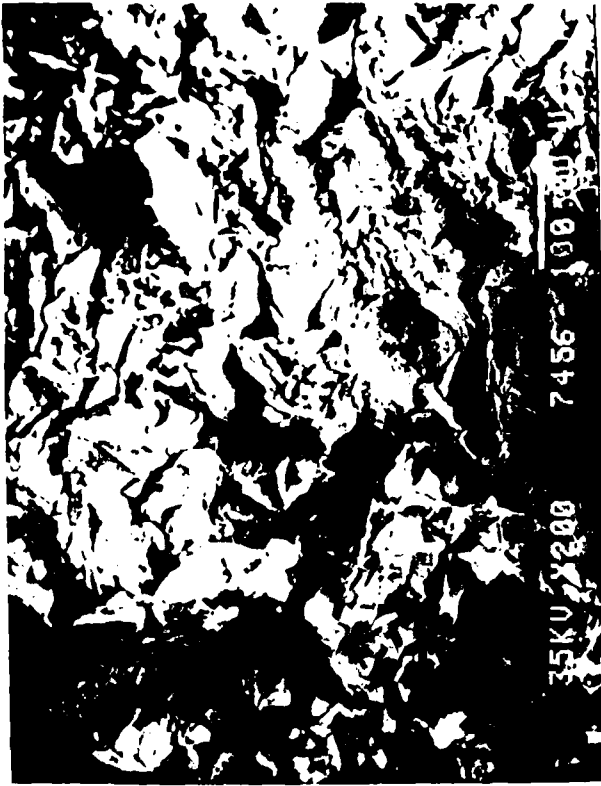
Figure 8. Fractograph of a 1.30 atomic % O alloy tested at 1013K showing high temperature ductility.

The third type of fracture observed is characteristic of the high temperature return to ductility (1000-1300K). These fractures do not show the microvoids typical of low temperature ductility. Instead, there is a fibrous appearance to the fracture surface which at high magnification shows grain boundary sliding and shearing. The surfaces still show facets of grain boundaries, but these appear to have deformed and slipped over one another rather than separating with clean crisp facets.

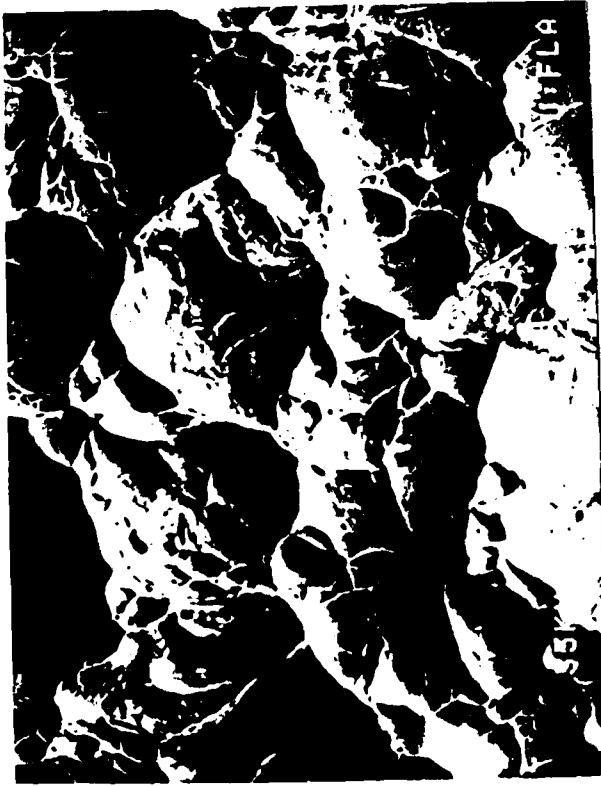
Figure 6. Fractograph of a 1.30 atomic % O alloy at 450K showing partial embrittlement.

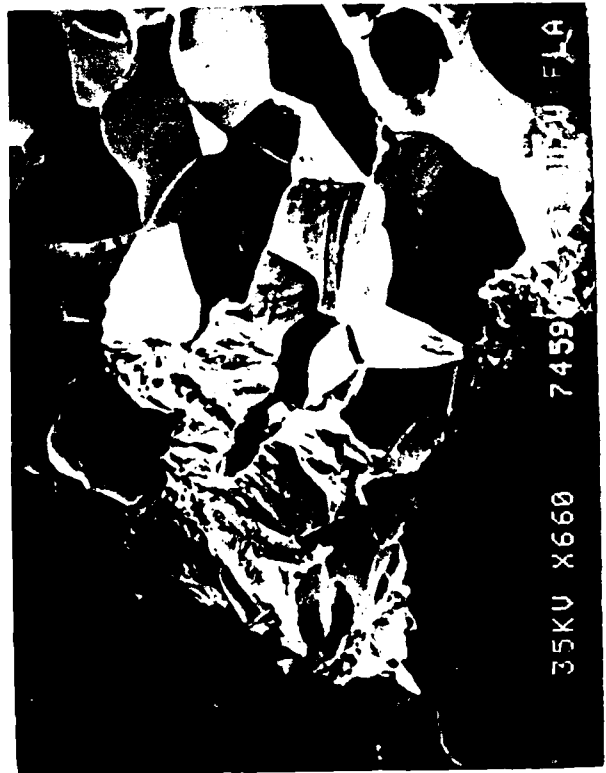
Figure 7. Fractograph of a 1.30 atomic % O alloy at 690K showing the intergranular fracture mode of brittle specimens.

The brittle intergranular fractures within the ductility minimum have very little or no transgranular component. This is observed both in samples tested on the low temperature side of the ductility minimum where fracture is internally nucleated and in samples tested at higher temperatures where there is surface cracking and the failure is externally nucleated. This is in contrast to the fracture morphology observed in

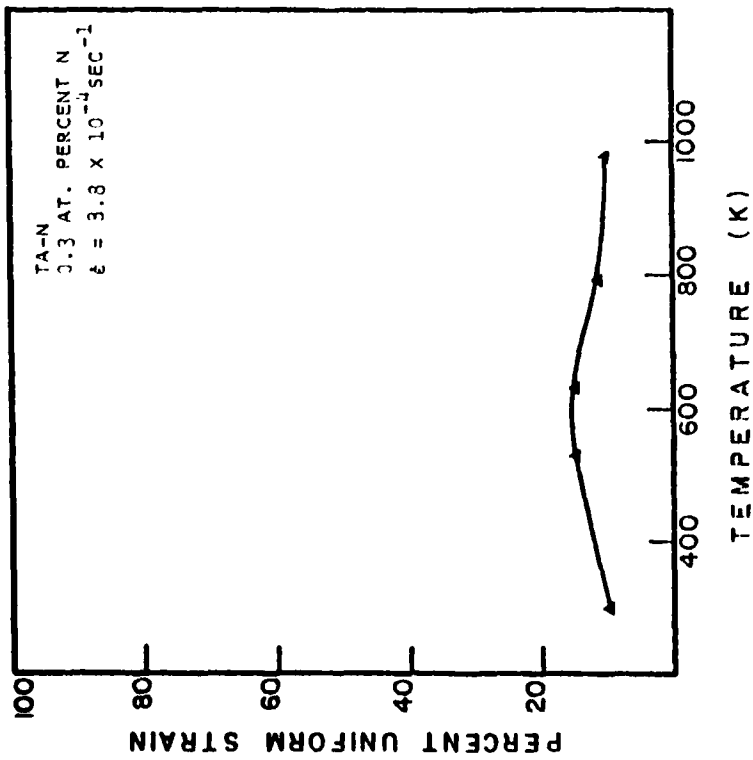
Figure 14. Plot of the uniform strain as a function of temperature for a Ta 0.3 atomic % N alloy.

Figure 14 shows the uniform elongation as a function of temperature for the 0.3 atomic percent nitrogen alloy. Uniform elongation rather than reduction in area is plotted because these samples failed in a chisel point. This is due to the very few grains making up the entire

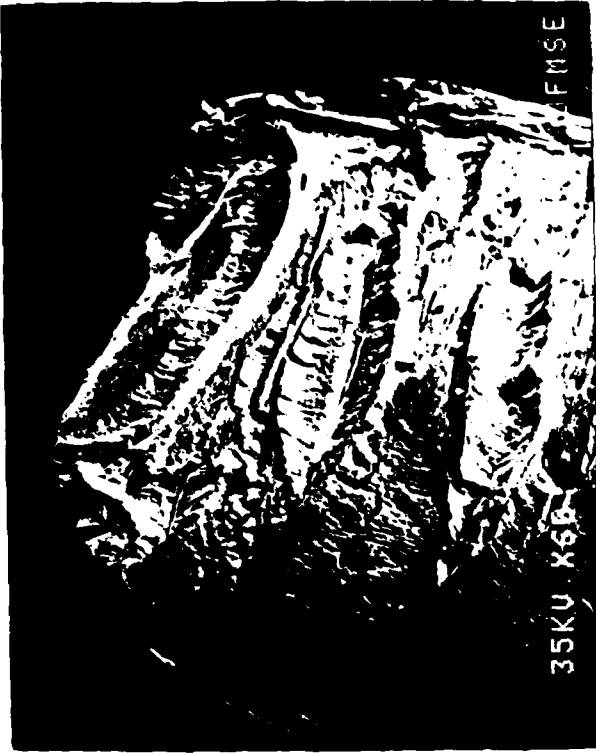
Figure 20. Scanning electron micrograph of the fracture surface of a Ta 0.3 atomic % N alloy tested at 973K.

the lower temperature samples. As the temperature is increased, we see initially a more ductile fracture, then plastic flow lessens until superficial cracking is evident at 798K.

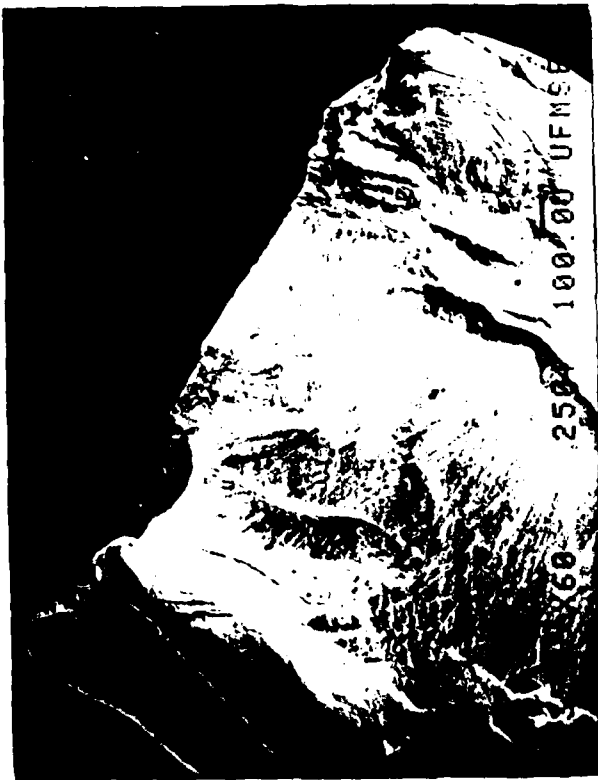
Figure 18. Scanning electron micrograph of the fracture surface of a Ta 0.3 atomic % N alloy tested at 300K.

The fracture surfaces show some very interesting features characteristic of the near single crystal character of the cross-sections. In all cases failure was caused by the pulling down of the specimen into a chisel point. Slip bands showing a duplex slip system can be seen in
