NRL Memorandum Report 4321

High-Voltage Lifetime Function of the PZT Ceramic/Gas Insulator Interface in Underwater Sound Transducers

L. P. BROWDER

October 1, 1980

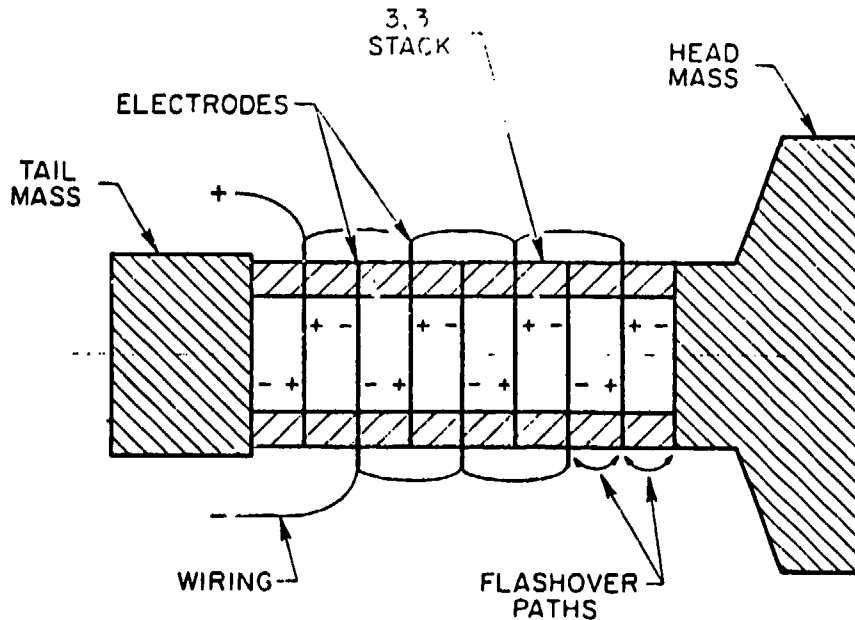
The purpose of the tests reported here was to demonstrate the time-dependent factors associated with electrical failure of sonar transducers. The simplified transducer drawing of Fig. 1 shows the surface flashover paths where failure normally happens. The voltage endurance function developed by these measurements describes the dependence of dielectric strength on the time of exposure to high voltage. The first step in the process was to measure the breakdown voltage by increasing the drive voltage across ceramic piece-parts at a rate of about 100 V/sec. After this, a specific lower drive voltage was applied to a new test specimen and the time to the failure event was measured. The second step was repeated using various drive voltage levels until the endurance function curve was completed. The failure event was clearly indicated by electrical arcing between the test specimen electrodes. Arcing in a sonar transducer permanently reduces the dielectric strength and qualifies as a unit failure.

Fig. 1 - Surface flashover paths in 3,3 mode sonar transducers

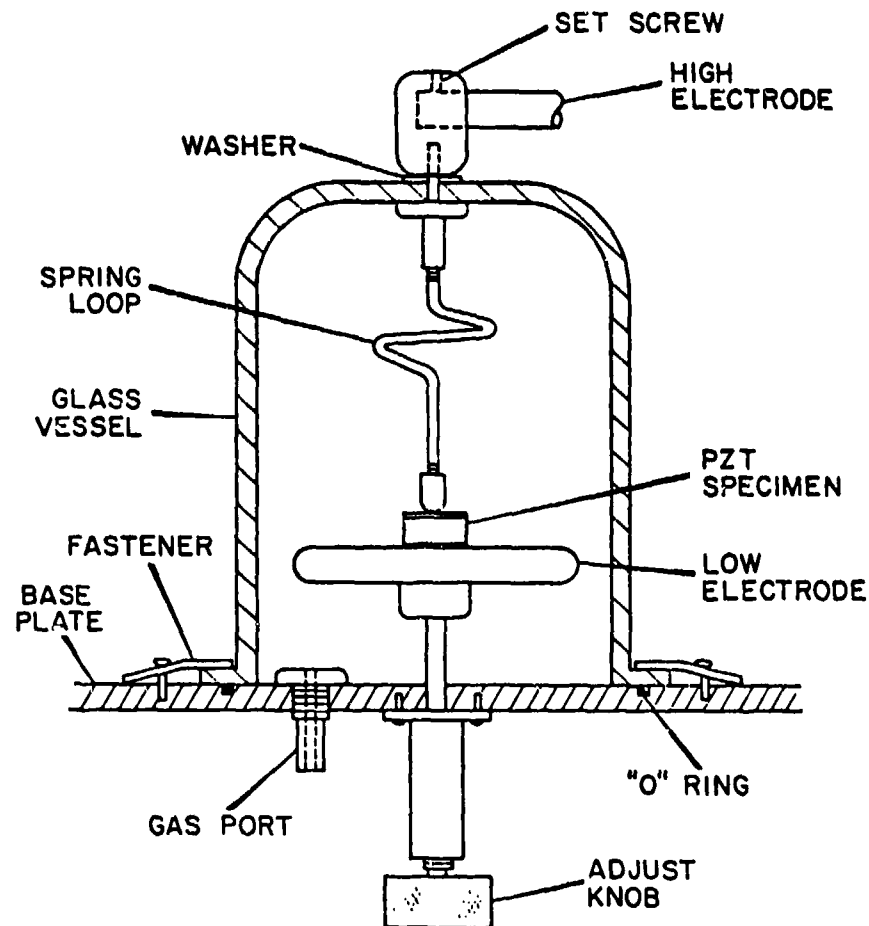
Figure 2 shows the high-voltage test cell and mounting of the PZT test specimen. The 2000-ml glass chamber was sealed with O-rings so that a vacuum could be pulled before back-filling with gas. The spring loop provided pressure contact to the test specimen electrodes, thus avoiding the need to make solder connections. To avoid external corona, all electrical leads associated with the high-voltage terminal were made as large as practical with edges rounded; for instance, the main lead was of 1.27-cm (0.5-in.) diam copper tubing.

Fig. 2 - Sketch of high-voltage test cell

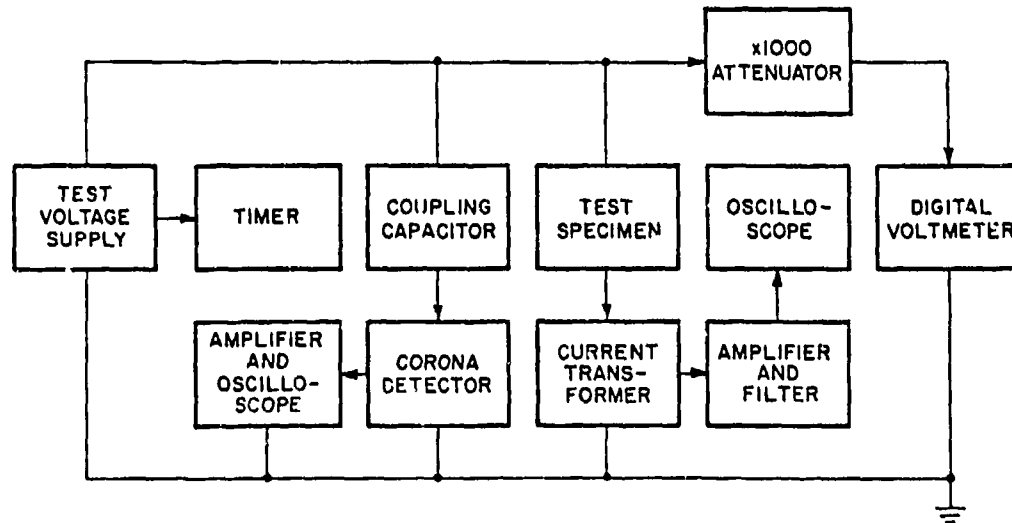
A block diagram of the test system is shown in Fig. 3. This was a partial discharge test equipment (J.G. Biddle Co. System No. 662045-01) that used ASTM Standard Method D1868-73 to measure corona [6]. The $\times 1000$ attenuator probe and digital voltmeter were added to improve the measurement of test voltage readout and were calibrated using instruments with accuracy traceable to NBS. The current transformer with amplifier and oscilloscope was used to measure the electrical current waveform associated with the test specimen. A timer was instrumented with the system to record time-to-failure. For the purpose of safety, all high-voltage equipment was enclosed in a steel cabinet with interlock switches to disconnect power when the access door was open.

Fig. 3 - Test system block diagram

The electrical current pulses at the peaks of the drive voltage are detected using a current transformer and instrumentation as shown in Fig. 3. The current waveforms of Figs. 7(a) and 7(b) illustrate changes in the pulses from the test start to near failure. Low-frequency components of the 60-Hz current were removed using a 300-Hz high-pass filter. The driving voltage waveform is shown in Fig. 7(c).

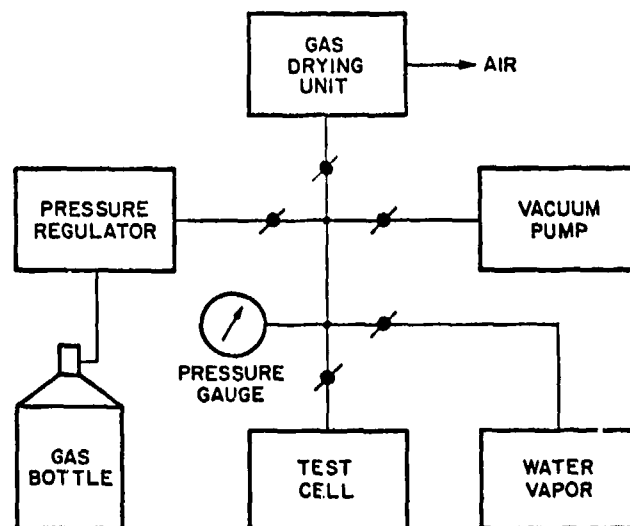
A diagram of the gas system is shown in Fig. 4. The vacuum pump evacuated the test cell and interconnecting tubing. Insulator gas was introduced from the gas bottle via the pressure regulator. Gas pressure in the test cell was monitored by a calibrated Wallace and Tiernan model FA160410 precision gauge. When a test was complete, the vacuum pump removed the used gas by venting it outside and replacing it with air through the gas drying unit. For tests requiring a wet gas, water vapor at the correct partial pressure was introduced into the evacuated test cell; then the fill was completed using dry gas.

Fig. 4 - Block diagram of gas system

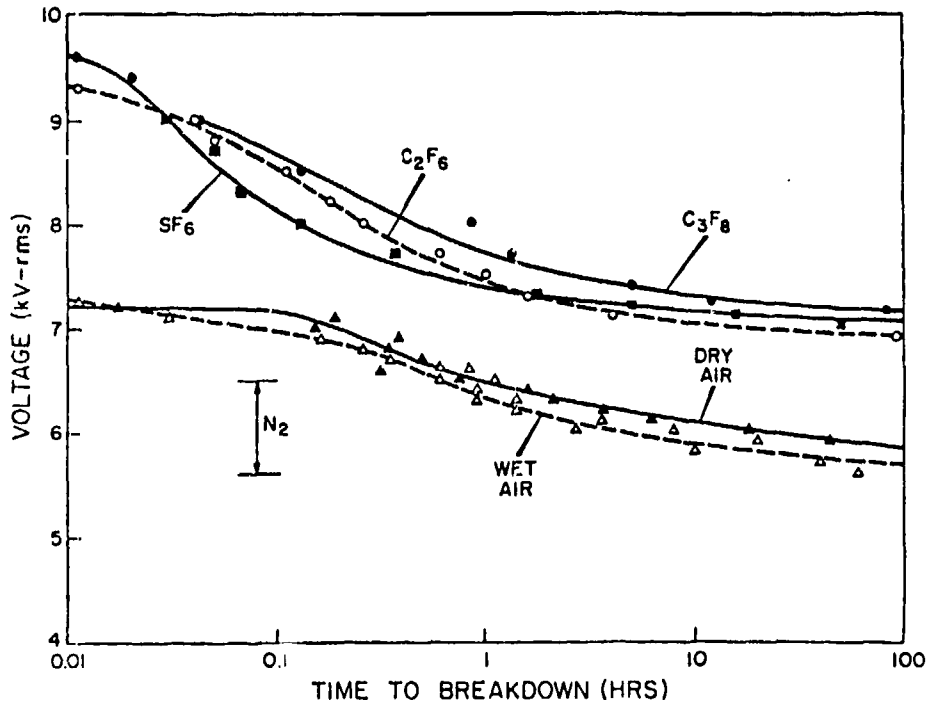
The curves of Fig. 5 show the endurance function of 0.635-cm (0.25-in.) thickness PZT in the various insulator gases. The time axis is the length of time to the failure event at the different voltage exposure levels. Each of the functions has three regions of interest: 1) the higher voltage area that is the maximum short-term withstand capability, 2) an intermediate area in which a time-dependent failure mechanism operates, and 3) a lower-voltage area that is usable for long-term operation.

Fig. 5 - Voltage endurance functions for 0.635-cm thickness PZT ceramic in various insulator gases

The time axis may be interpreted as the cumulative exposure time to high voltage. This effect was demonstrated using several tests that were stopped before failure and a 1-hour rest given before the test was completed. In all cases, the cumulative time of voltage exposure for the interrupted tests was nearly the same as for uninterrupted tests.

The main implications of the endurance functions of Fig. 5 that apply to sonar transducer design are:

- The long-term voltage level withstand capability of SF_6 , C_2F_6 , and C_3F_8 gases is approximately 20% greater than with dry air. This compares to short-term test indications that the difference was 60-70% greater [5].
- The intermediate failure mechanism progresses approximately two times faster in SF_6 than in C_2F_6 or C_3F_8 . This failure mechanism progresses more slowly in dry air than with any of these three gases.
- Nitrogen gas did not yield a clear-cut endurance function but gave upper and lower failure limits as indicated. Failure was by arcing through the gas instead of on the PZT ceramic surface.

Both Figs. 5 and 6 give an indication of changes to the curves resulting from the presence of water vapor in air. There is a scattering of the data points and lowering of the curve by a few percent. Although complete curves were not obtained, results for water vapor in SF_6 gas were similar. This is evidence that water vapor in the insulator gas may cause some reduction of the reliability of transducers, but the margin of difference is small.

The intermediate time-dependent area on the curves of Figs. 5 and 6 may be fitted to this function, but the quantity V_e is replaced by V_a , which is a voltage level asymptote to the curve where t is large. The flattening of the curves in the area with small values of t is due to a different breakdown mechanism and is neglected because it is not significant for transducer lifetime analysis.

The endurance function curves with each of the gases shown in Fig. 5 may be computed from the mathematical expression

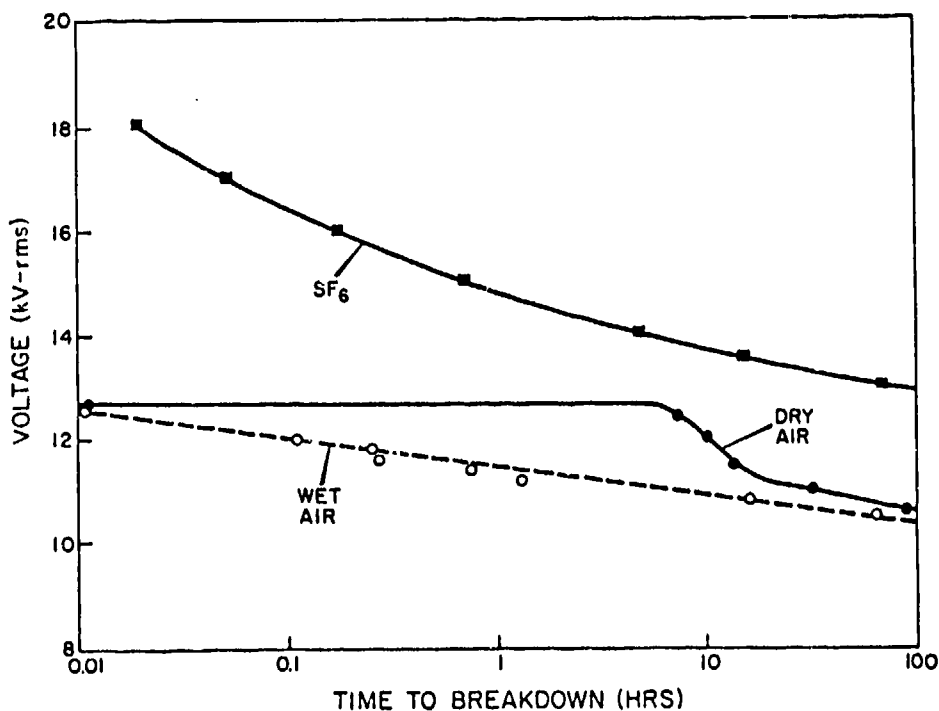
The effect on the endurance function of increasing the PZT ceramic thickness to 1.27 cm (0.5 in.) is shown in Fig. 6 for the gases SF_6 , dry air, and wet air. The features of the curves of Fig. 6 are similar to those of Fig. 5, and doubling the ceramic thickness also approximately doubles the failure voltage level. The curve shapes also indicate that thick ceramic discs will have greater endurance to over-voltage transients than will thin discs.

Fig. 6 - Voltage endurance functions for 1.27-cm thickness PZT ceramic in air and SF₆ gases

The curve in Fig. 6 for SF₆ may be expressed as:

$$t = .001 [(V/11)-1]^{-6.5}. \quad (5)$$

The data for dry air and wet air in Fig. 6 are not complete enough to evaluate the function, particularly the value for V_a .

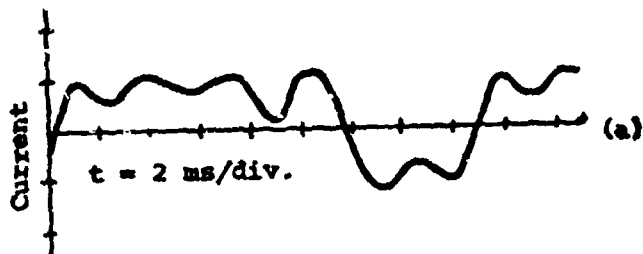
(a) Current waveform early in test

- The current pulse occurs roughly on the peak of the drive voltage waveform.
- The current flow is probably a surface phenomena because the various insulator gases change the endurance function.
- The pulse progressively increases in amplitude as the ceramic proceeds to breakdown.
- The magnitude of the current pulse is sufficiently large to dissipate 0.5 W and may be localized to *hot spots* on the ceramic surface.
- The current pulse that builds up to failure occurs on the driving voltage peak that is in series aiding the ceramic polarity.
- The predominant frequency component introduced by the pulses on the current waveform is the sixth harmonic (360 Hz) of the driving voltage.
- There is a specific minimum driving voltage at which the current pulses have their inception; for instance with 0.635-cm (0.25-in.) thickness ceramic in dry air, the inception voltage is between 3 and 4 kV.

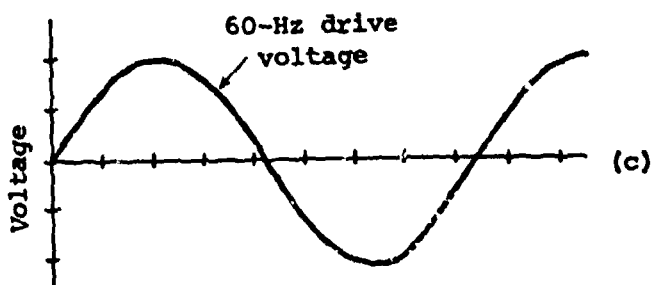
(c) Test driving voltage waveform
