NTIAC 74-1

PROCEEDINGS OF THE 1973 SYMPOSIUM ON NONDESTRUCTIVE TESTING OF TIRES

Sponsored by
ARMY MATERIALS AND MECHANICS RESEARCH CENTER
Watertown, Massachusetts 02172

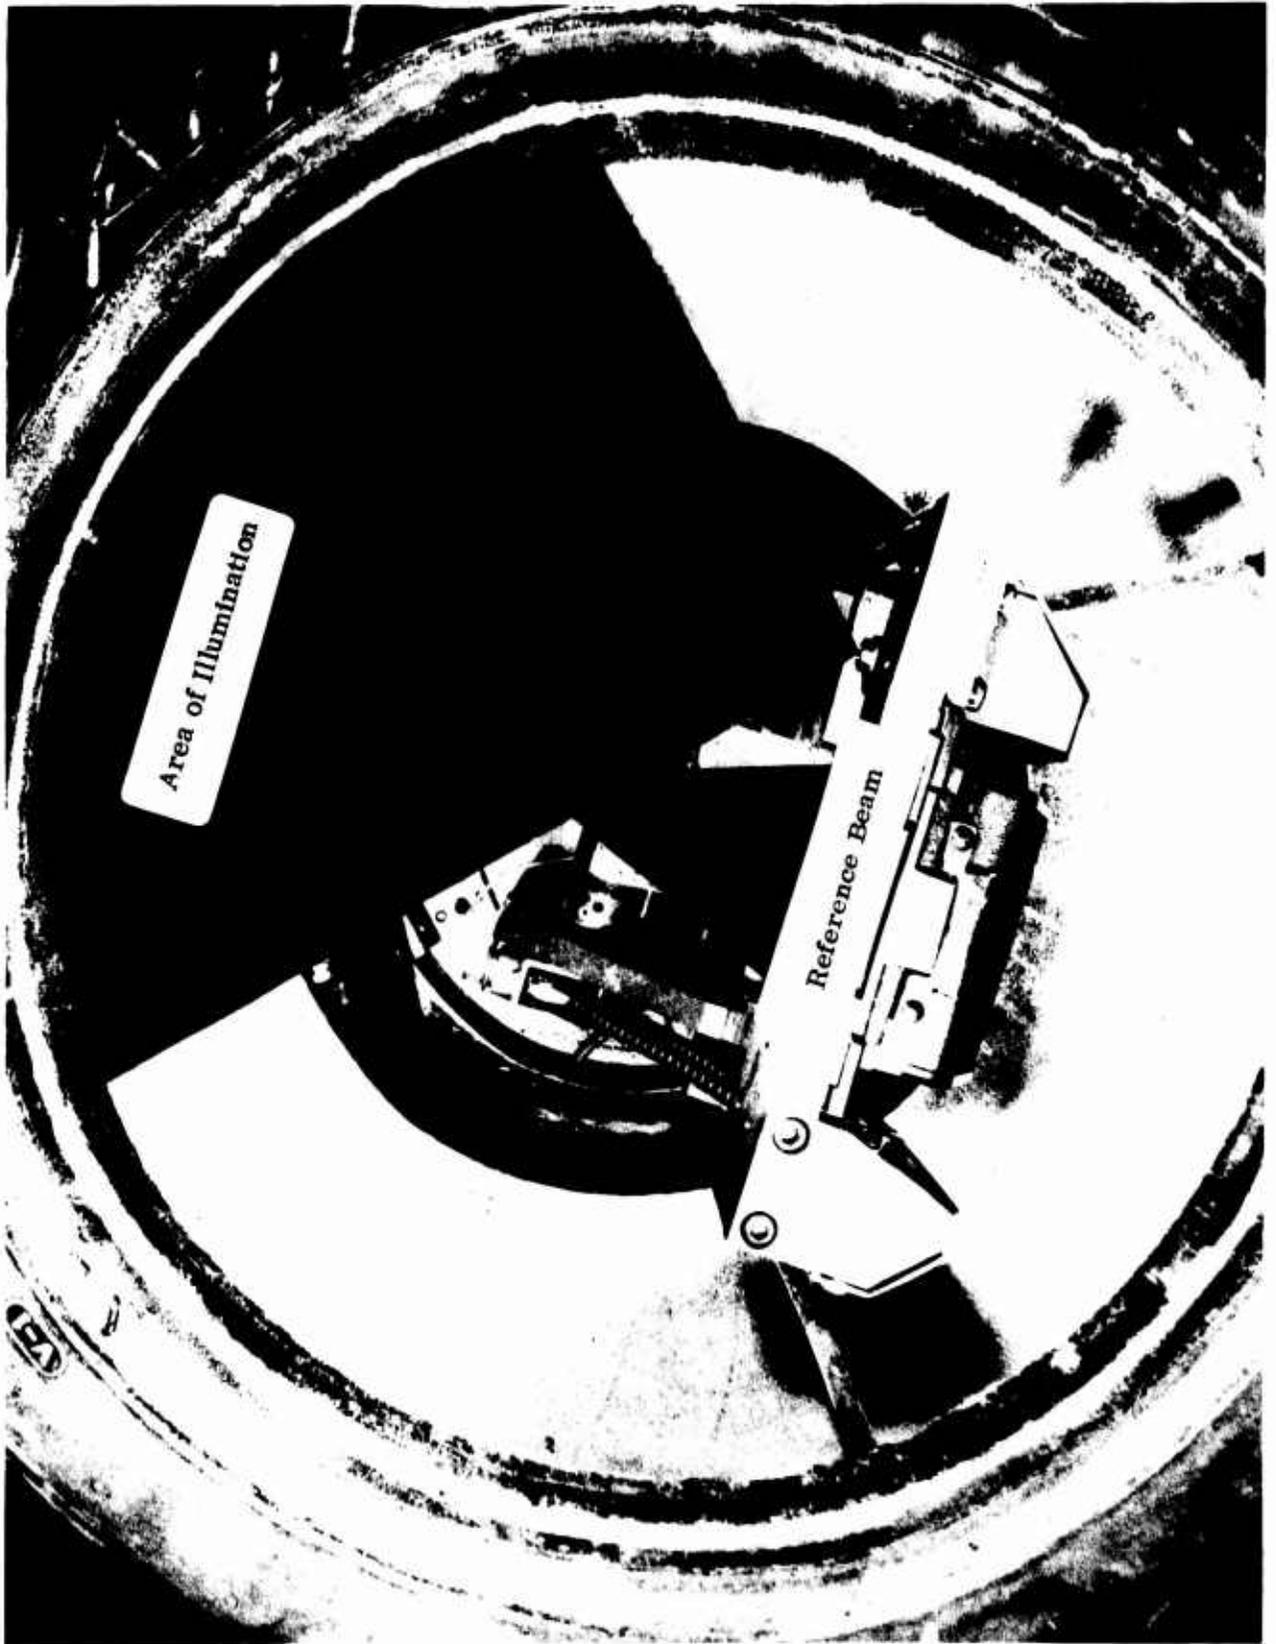
FIGURE 2d
OVERALL VIEW OF OPTICS PACKAGE SHOWING SPREAD TIRE

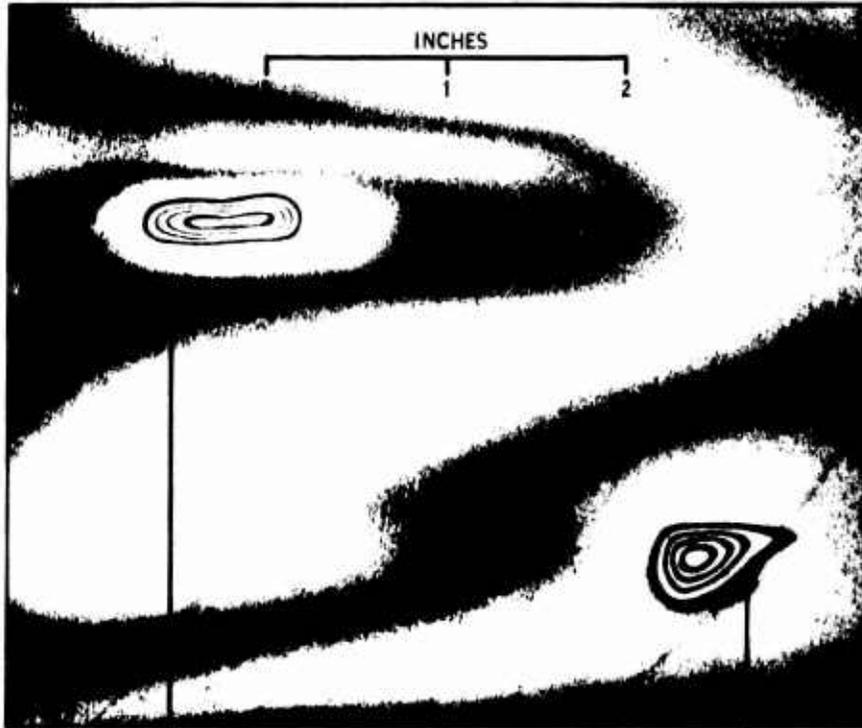
Characteristics of these fringe patterns plus the known vacuum level and tire type leads to the prediction that we are seeing a tread and shoulder separation. A view of the tire, cut open at the location determined from the hologram, is shown in Figure 4. The tread (TS) and shoulder (SS) separations are indicated by the arrows.

FIGURE 3
FRINGE PATTERN WITH
IRREGULARITIES AS SEEN
THROUGH THE HOLOGRAM

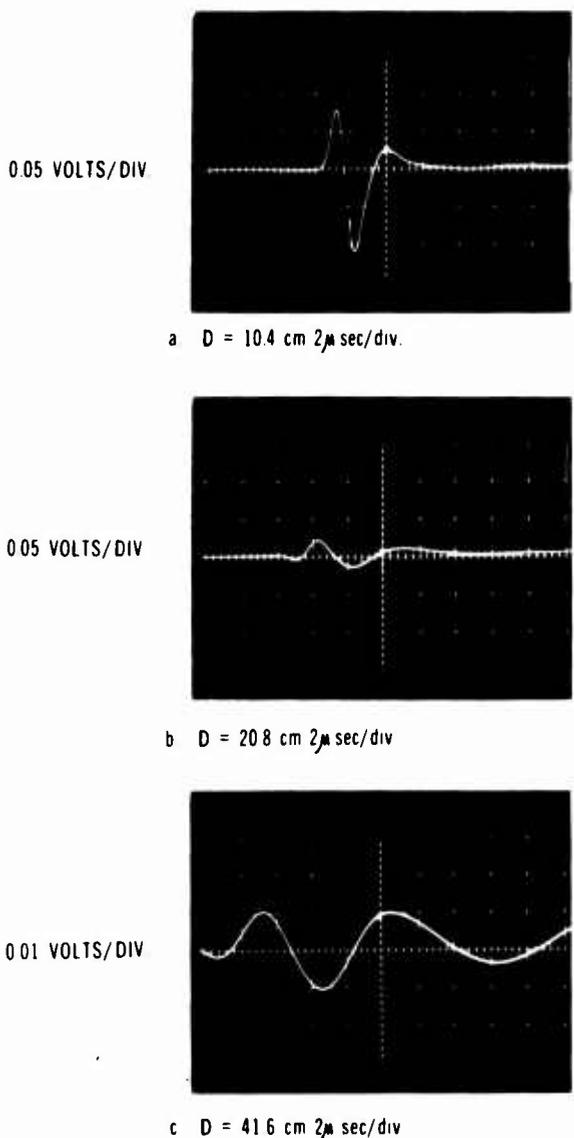
FIGURE 3
ACOUSTIC PULSE DISPERSION IN RUBBER
 (received signal after propagating distance 'D'
 through natural, filled vulcanized rubber)

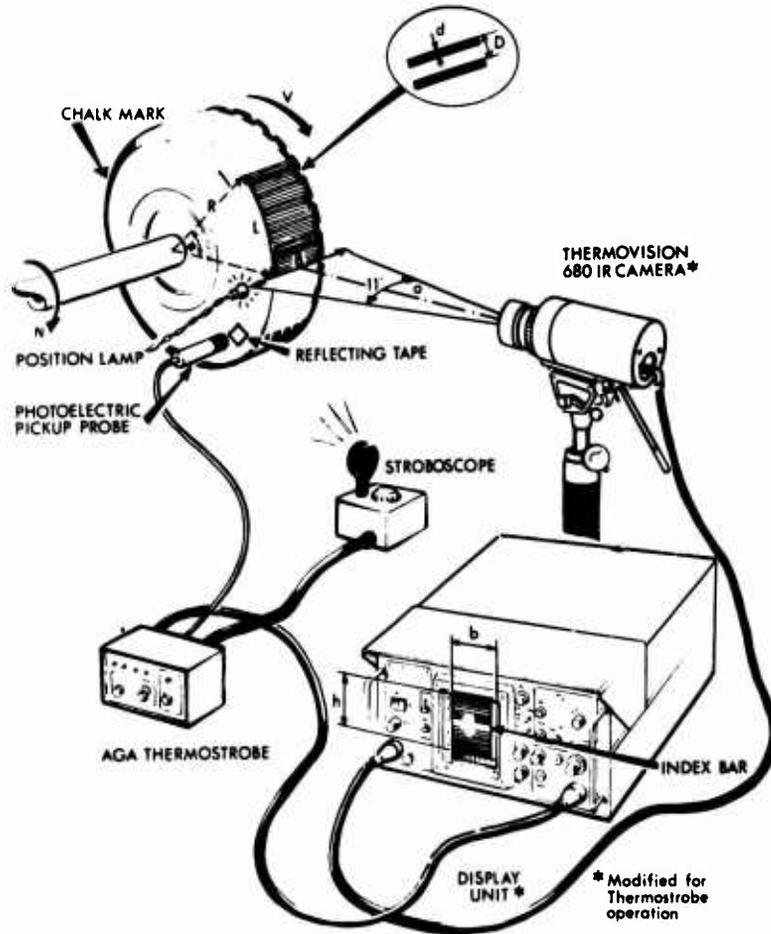
FIGURE 2
DIAGRAM OF THE THERMOVISION SYSTEM ADAPTER FOR STOPPED-MOTION VIEWING
OF A TIRE UNDER DYNAMIC TEST CONDITIONS

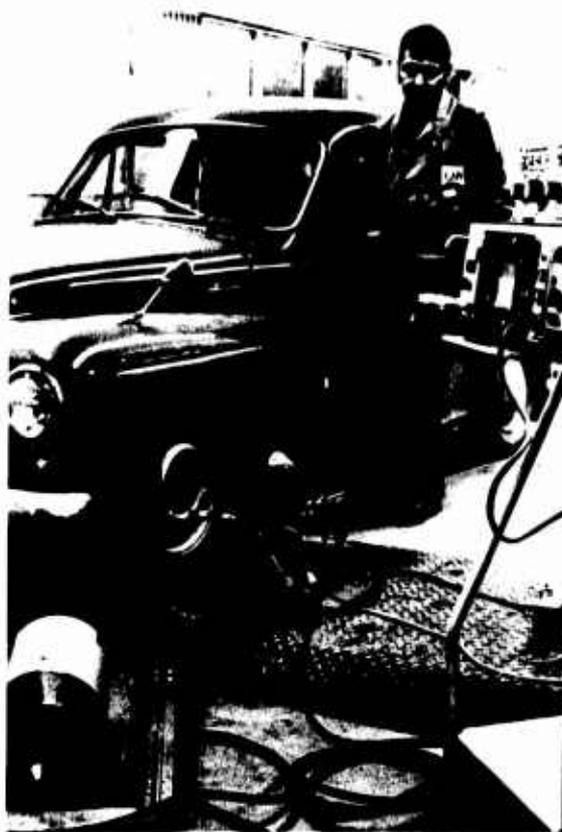
FIGURE 4
ACTUAL SETUP AT A SWEDISH AUTOMOBILE INSPECTION STATION, WHERE THE THERMAL IMAGES OF RETREADED TIRES WERE INVESTIGATED

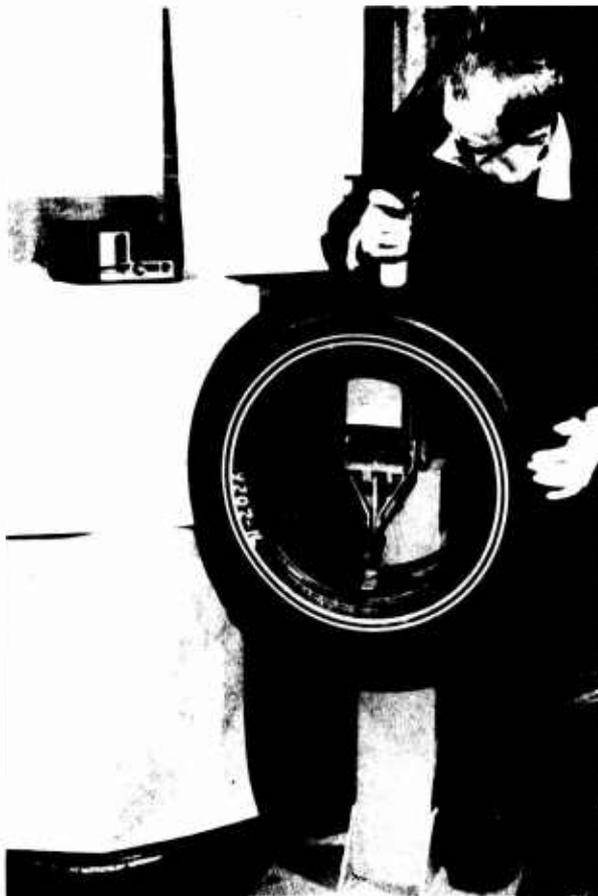
FIGURE 21

We have equipped our passenger tire retread plants with variable inductance transducer systems (Figure 21) to measure the thickness of the tire carcass after the buffing operation. This system is limited to comparatively small thicknesses but has enabled us to retread fiberglass belted tires without buffing into the belt. The operation of the system is simple enough that the retread laborer can use it with little instruction. This system is used as a process control and not to inspect outgoing finished products. However, the buff limits have been established by our Retread and Repair Development Department after extensive testing against the original DOT compliance standards for retreaded tires.

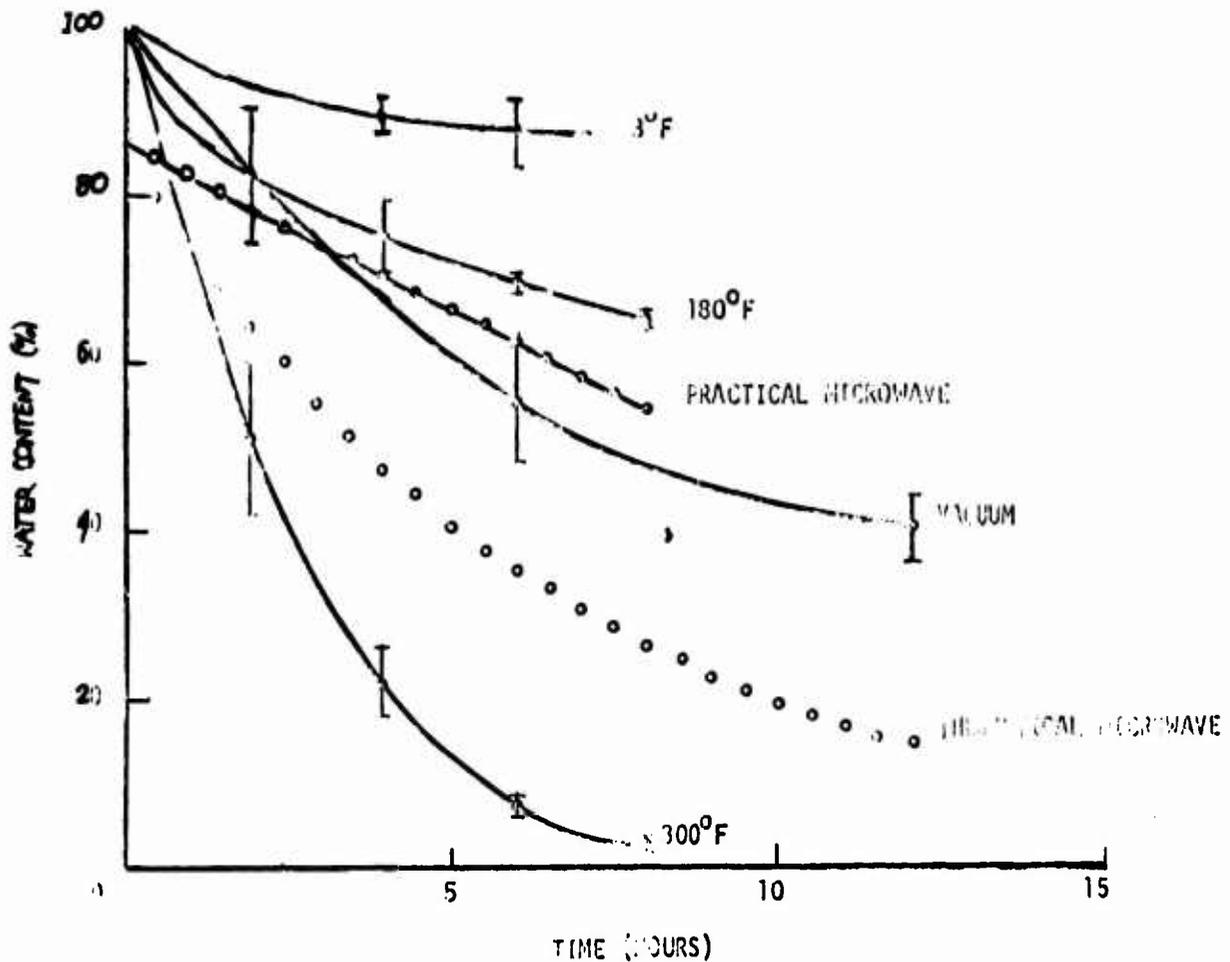
FIGURE 10
COMPARISON OF DRYING METHODS

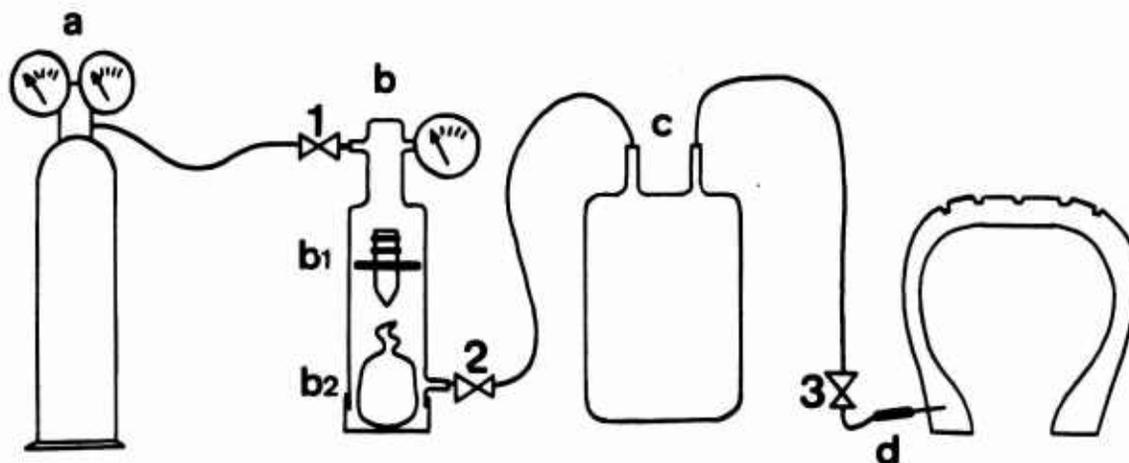
1. A nitrogen tank equipped with a pressure-reducer and a manometer.
2. A mixing unit with a pneumatic hammer in which the xenon ampoule is introduced and broken.
3. A tank of tracer gas (nitrogen + xenon-133) which can contain about 3 liters of gas under a maximum pressure of 8 Atmospheres.
4. 1 or 2 needles.

FIGURE 2
INJECTION DEVICE

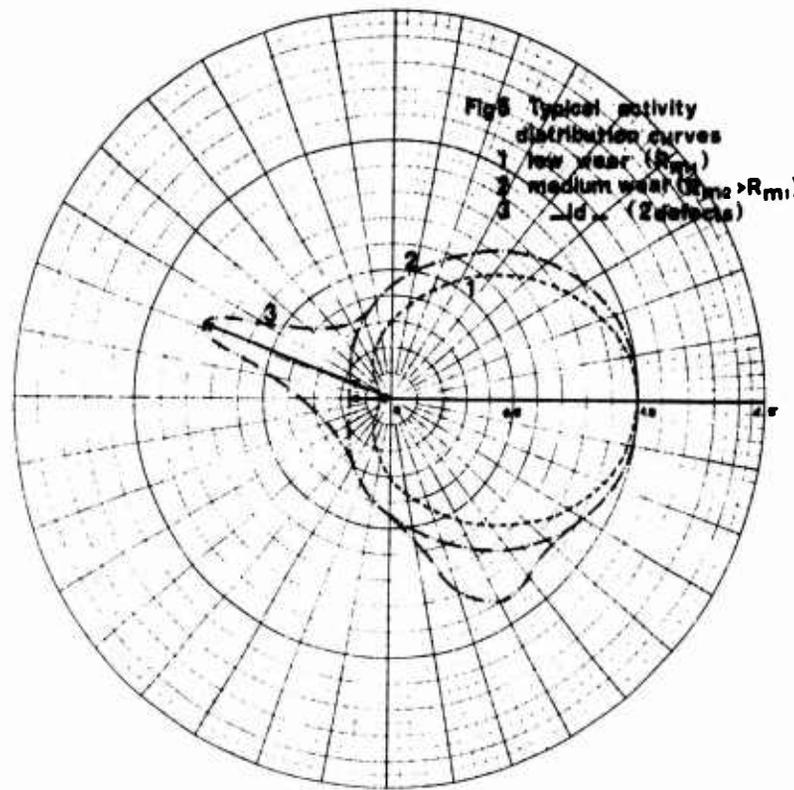
FIGURE 5
TYPICAL ACTIVITY DISTRIBUTION CURVES

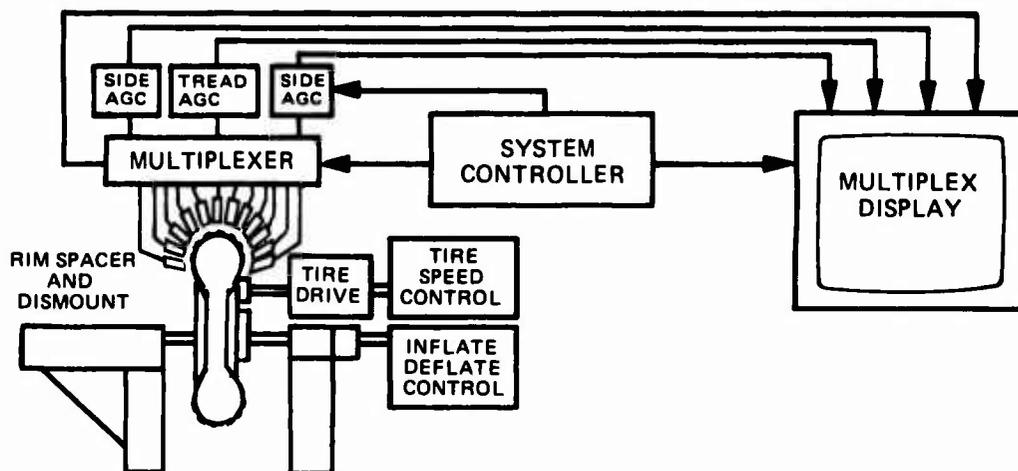
**SLIDE 11
CASING FLAW INSPECTION**

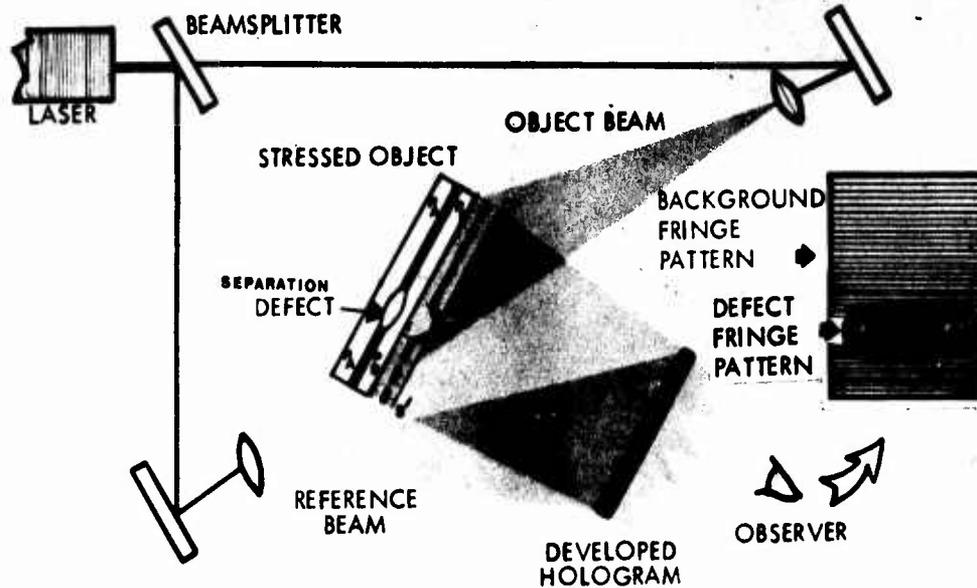
FIGURE 6
HOLOGRAPHIC INTERFEROMETRY WITH
BACKGROUND AND DEFECT FRINGE
PATTERN SHOWN

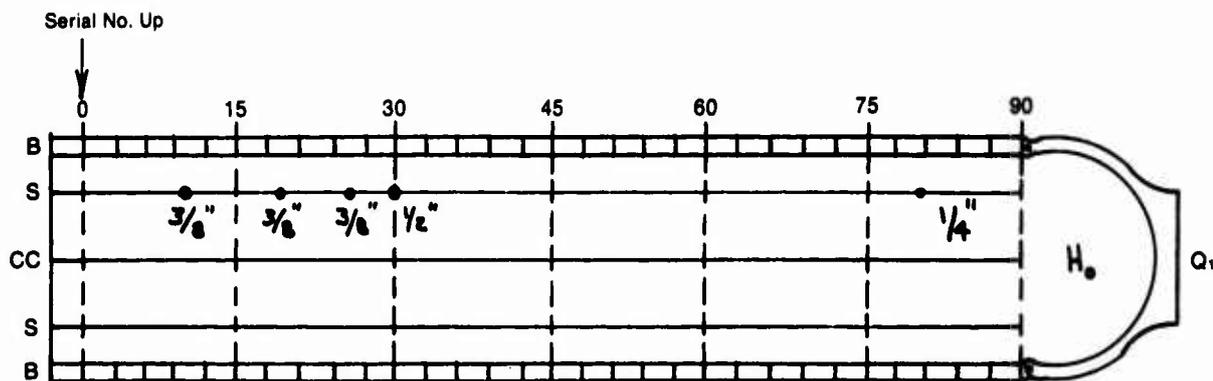
FIGURE 13A. QUADRANT ONE, NO MILEAGE – TIRE EXAMPLE NO. 1

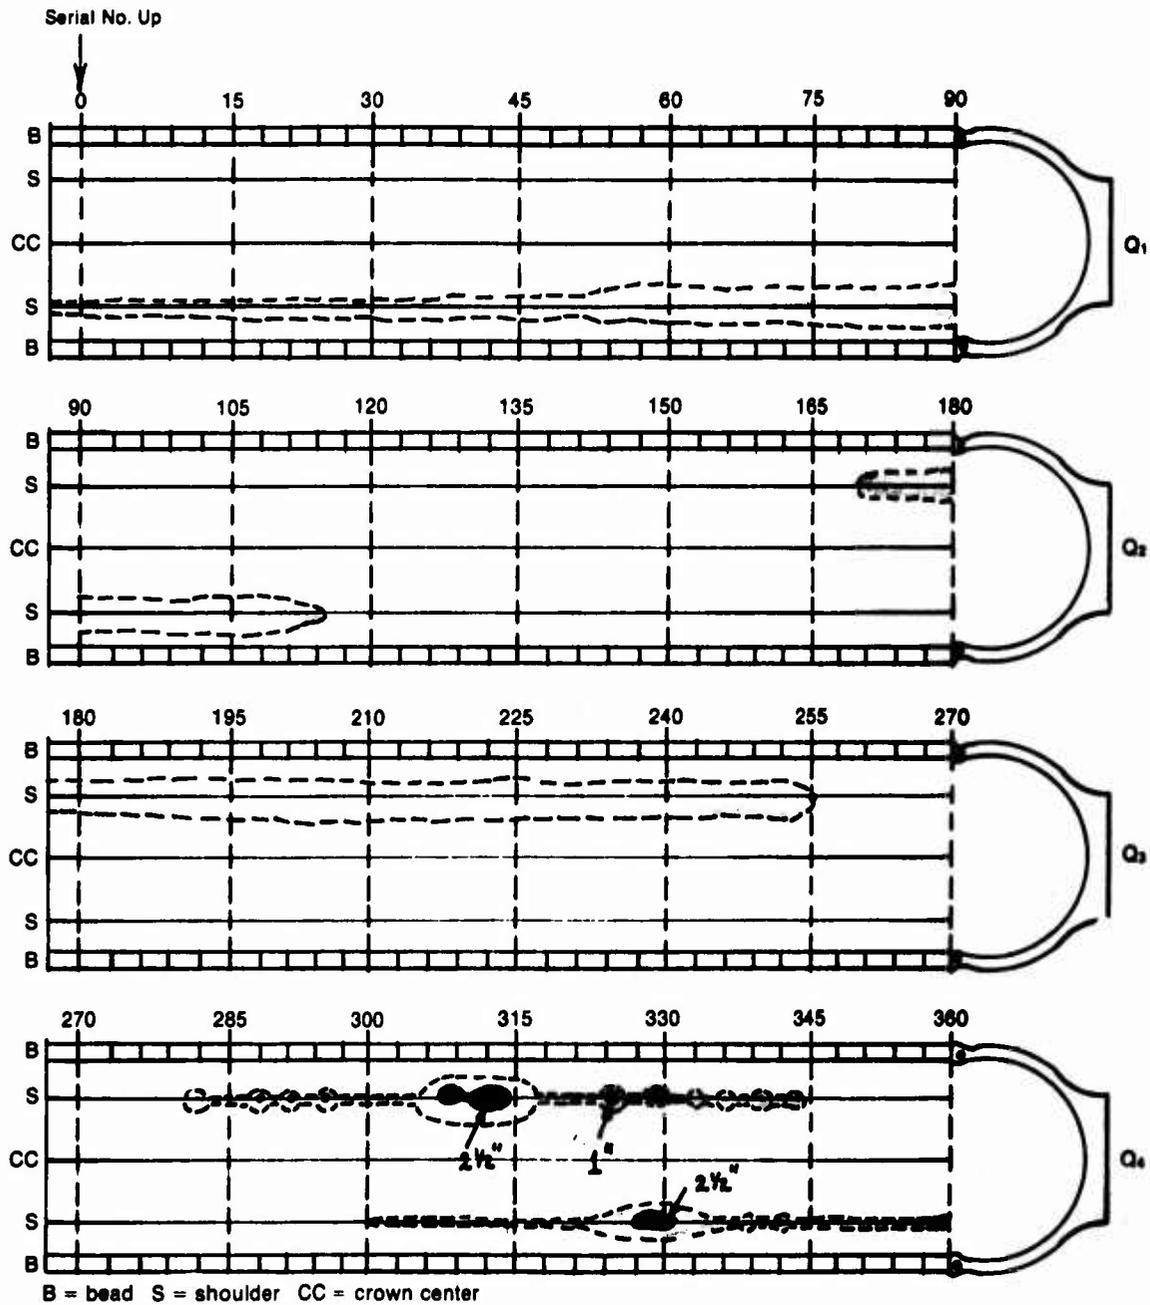
FIGURE 15A
CHART OF TIRE NO. III BEFORE AND AFTER AN INDOOR TEST WHEEL RUN OF 5595 MILES
WHEREUPON THE TIRE WAS REMOVED DUE TO FAILURE

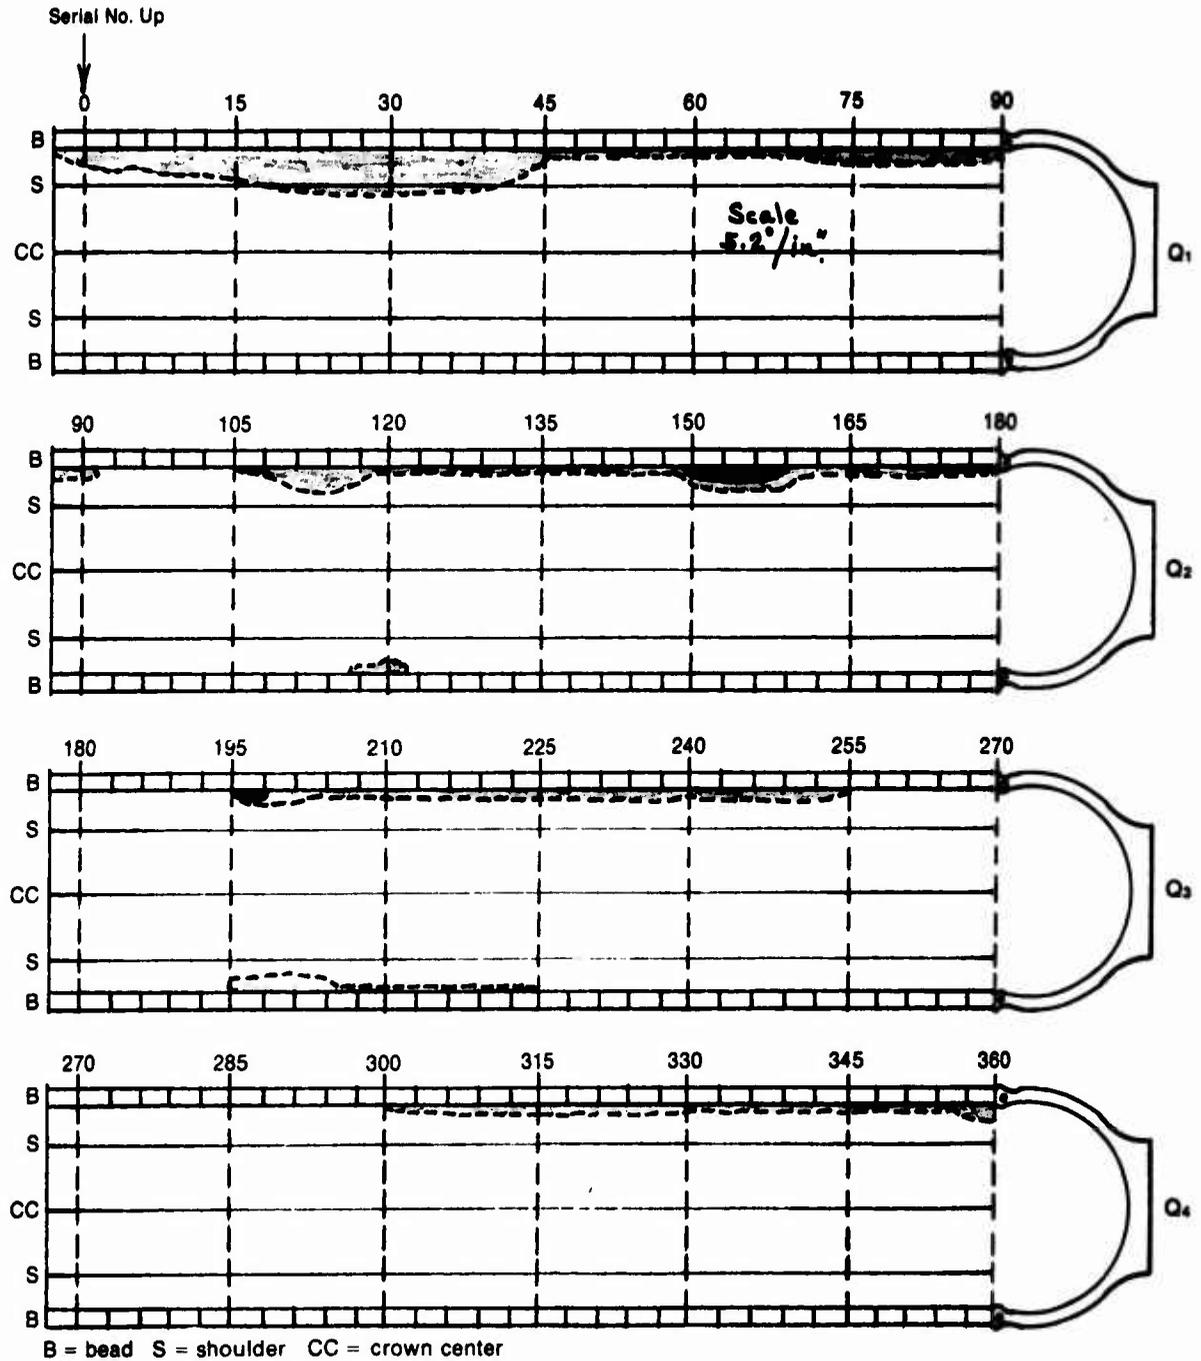
it failed at 29,900 miles, due to extensive separation at the flipper or turnup edge, as shown in the chart H₁. Control tires of similar size and construction, which do not exhibit separation at the turnup or other types of separations, have performed excellently under similar road conditions.

FIGURE 17
CHART OF SEPARATIONS IN TIRE EXAMPLE NO. V

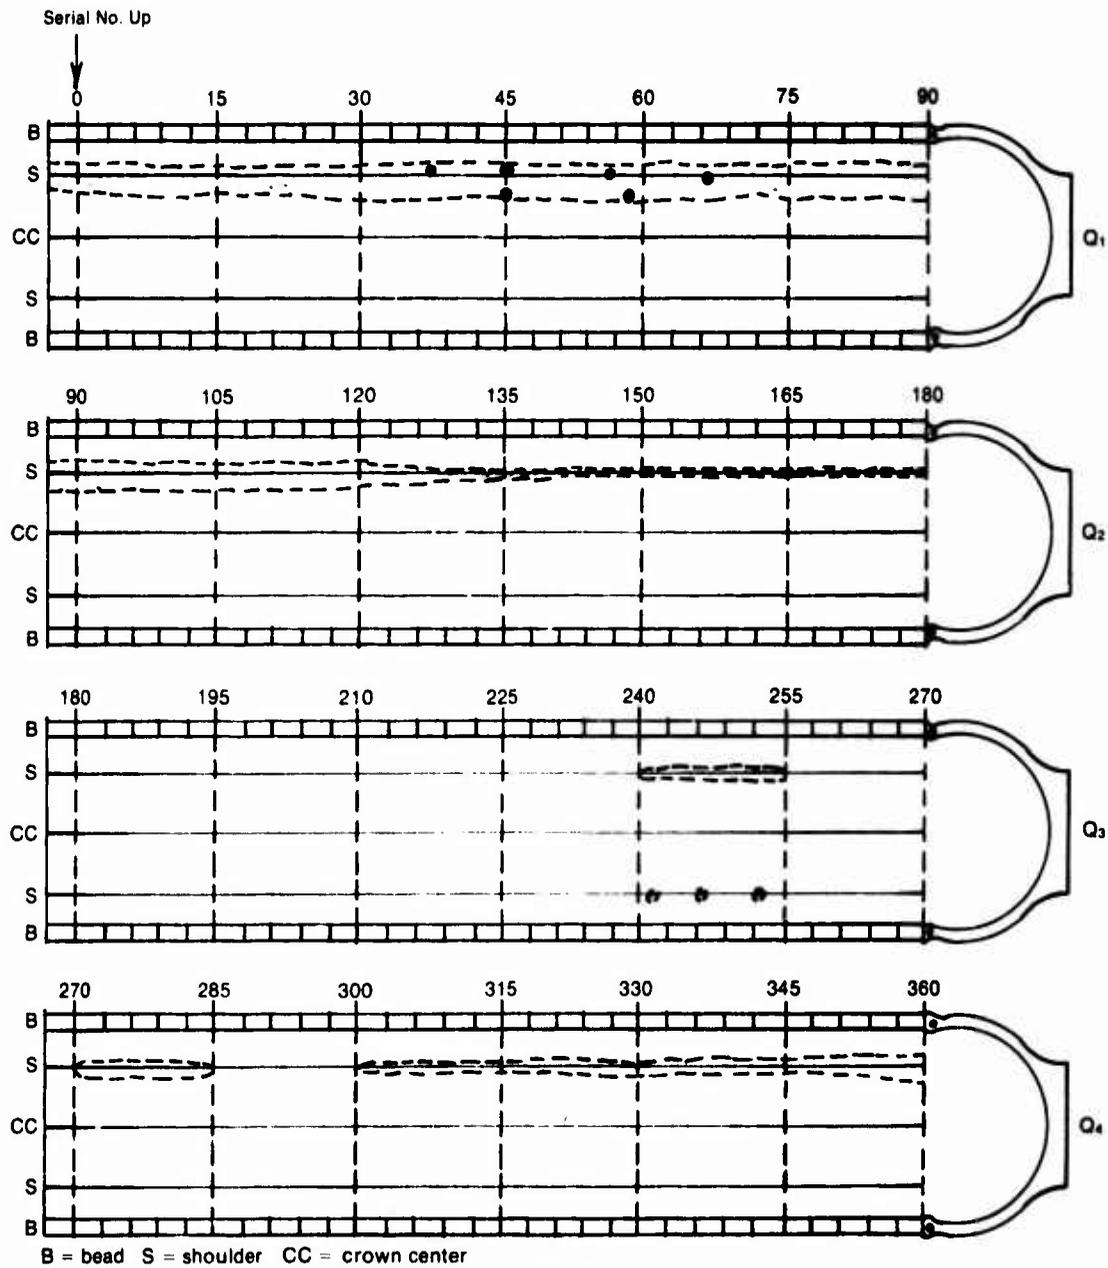
which was $(5/8 \pm 1/8)$ inches in diameter. Four are on the outer belt edge and two are on an adjacent belt edge. Separations A, B, and C noted in H_0 by the black dots, are indicated in the failed region shown in Figure 18B. When the tire was removed, the upper belt edges were extensively separated, as shown in the chart. Whenever a cluster of separations are observed, especially when the average diameter is in the vicinity of $1/2$ inch, premature failure is almost certain.

FIGURE 18A
CHART OF SEPARATIONS IN TIRE EXAMPLE NO. VI

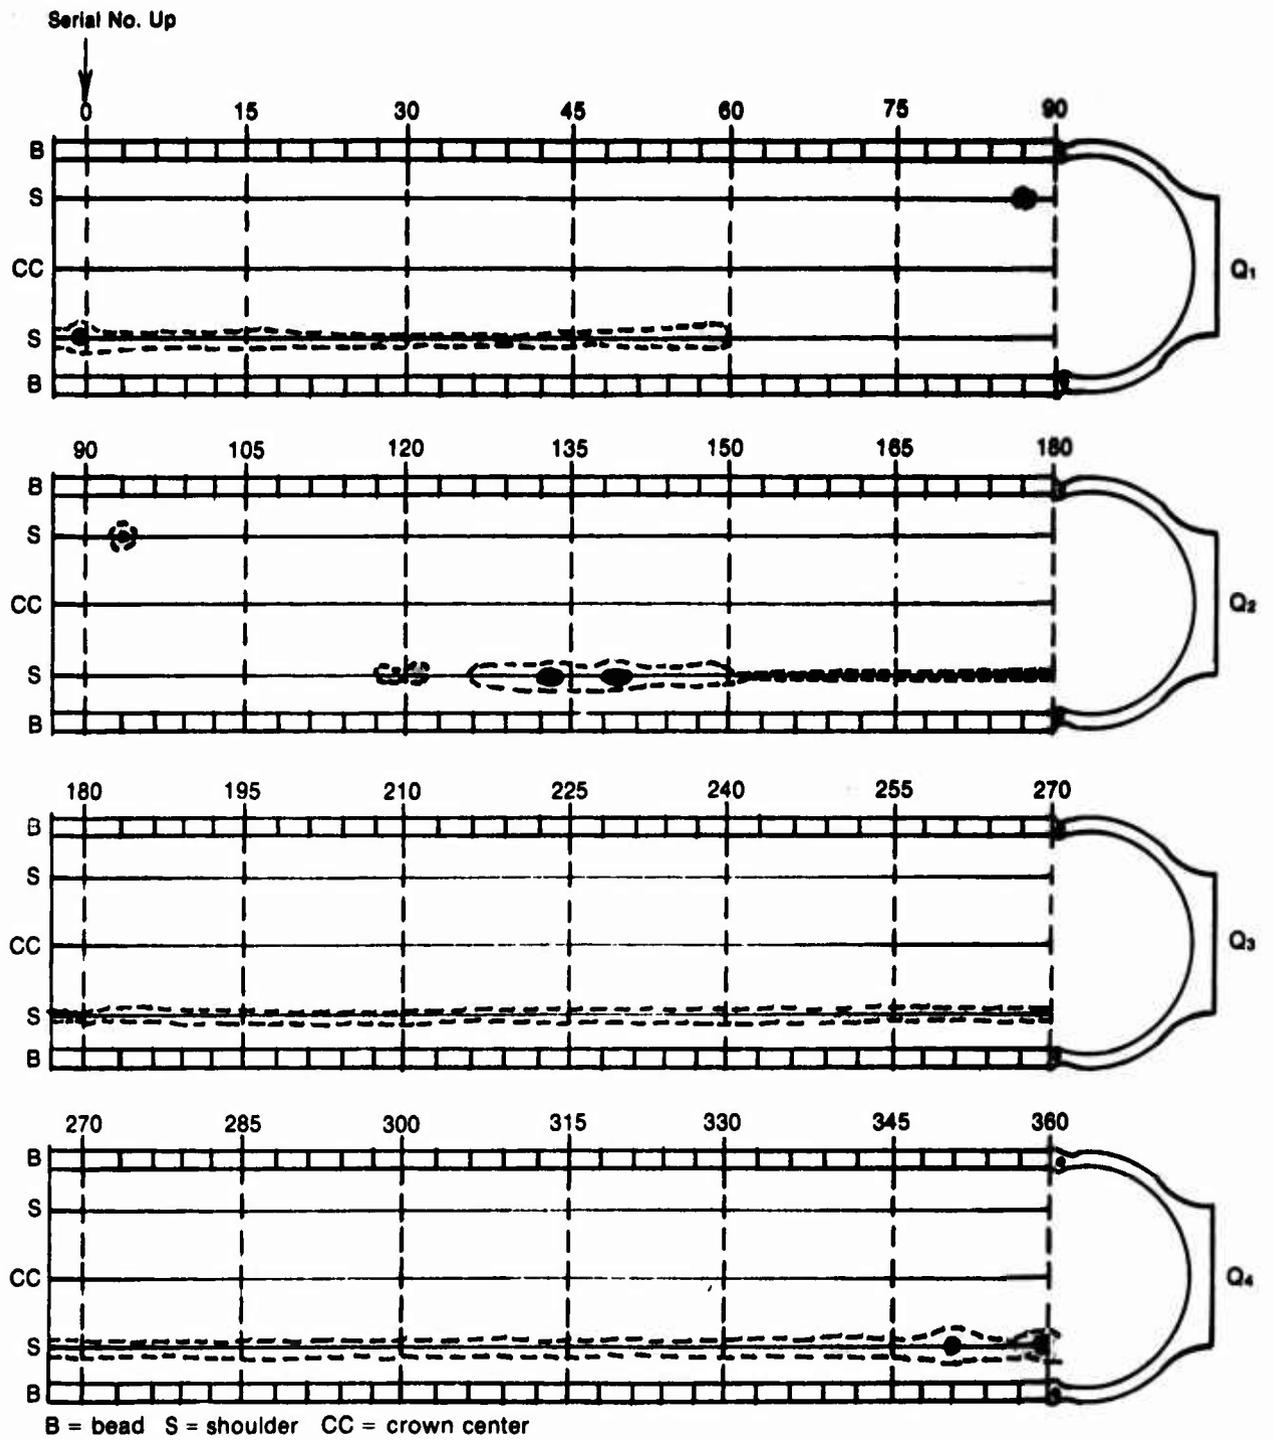
The tire was near failure when dismounted and yet one must not lose sight of the fact that it ran for nearly 100,000 miles. This carcass should obviously not be recapped. However, this example points out that tires containing separations can survive as long as the defects are not overly large or clustered together. On the other hand this tire could have failed at any time within the last 20,000 or 30,000 miles had it experienced a steering axle position or any form of overload. The opening of the belt edges in all probability started at the original $3/4$ inch diameter positions. Had even smaller separations been clustered more the probability of a premature tire removal would have been high.

FIGURE 19
 CHART OF SEPARATIONS IN TIRE EXAMPLE NO. VII

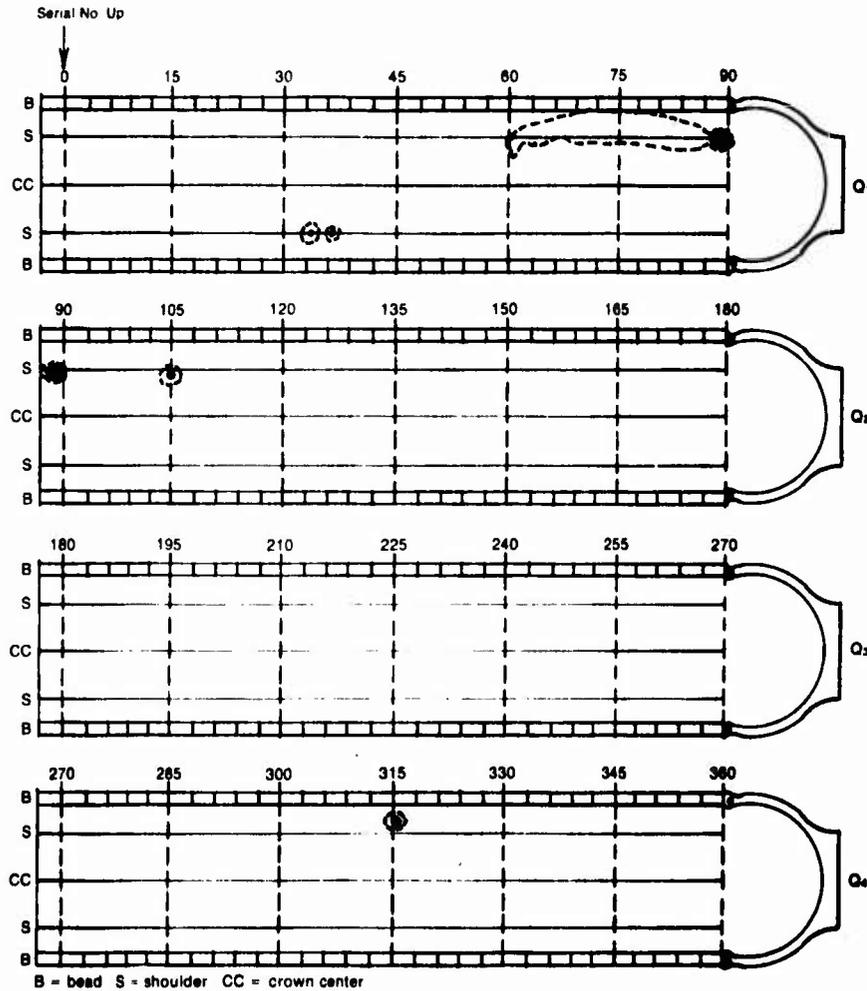
FIGURE 21
CHART OF SEPARATIONS IN TIRE EXAMPLE VIII

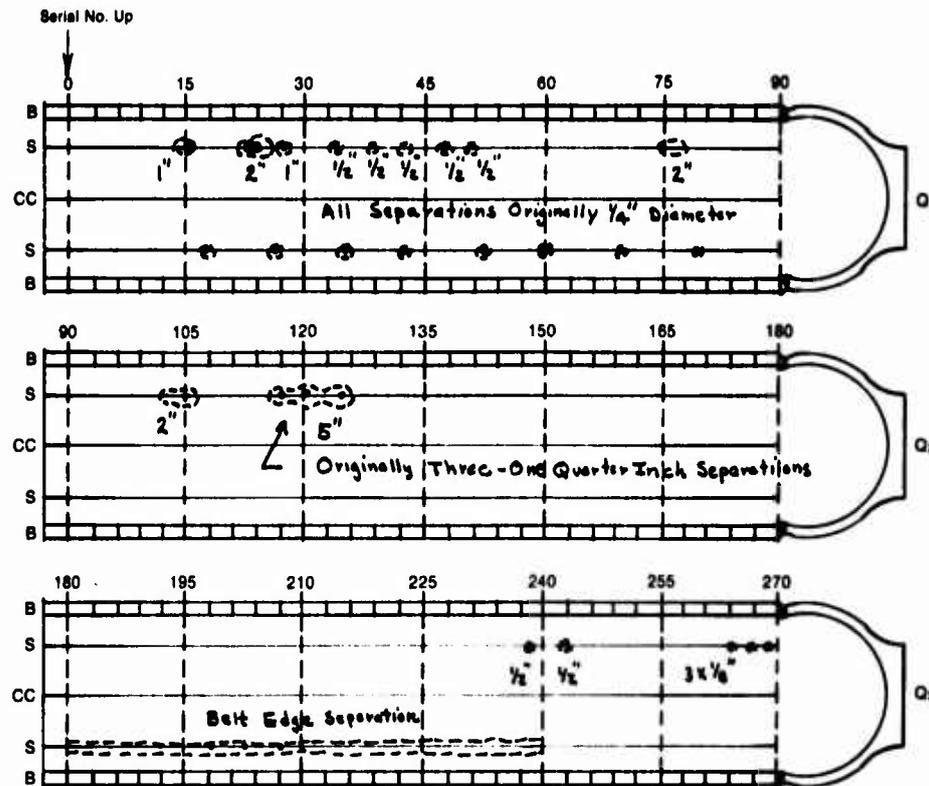
original $1/4$ inch separations which grew to an average of $(1/2 \pm 1/8)$ inch. This region is just beginning to get weak. Note that three $1/4$ inch ones at $120^\circ \pm 3^\circ$, which were more closely clustered, brought about a five inch separation on the upper stabilizer ply edge and the three very small ones at 198° , 203° and 208° brought about a 60° mild opening of the belt edge between 180° and 240° . Despite remaining tread depth, this tire could fail prior to total run out. The tire should obviously not be recapped.

FIGURE 23
CHART OF SEPARATIONS IN TIRE EXAMPLE IX

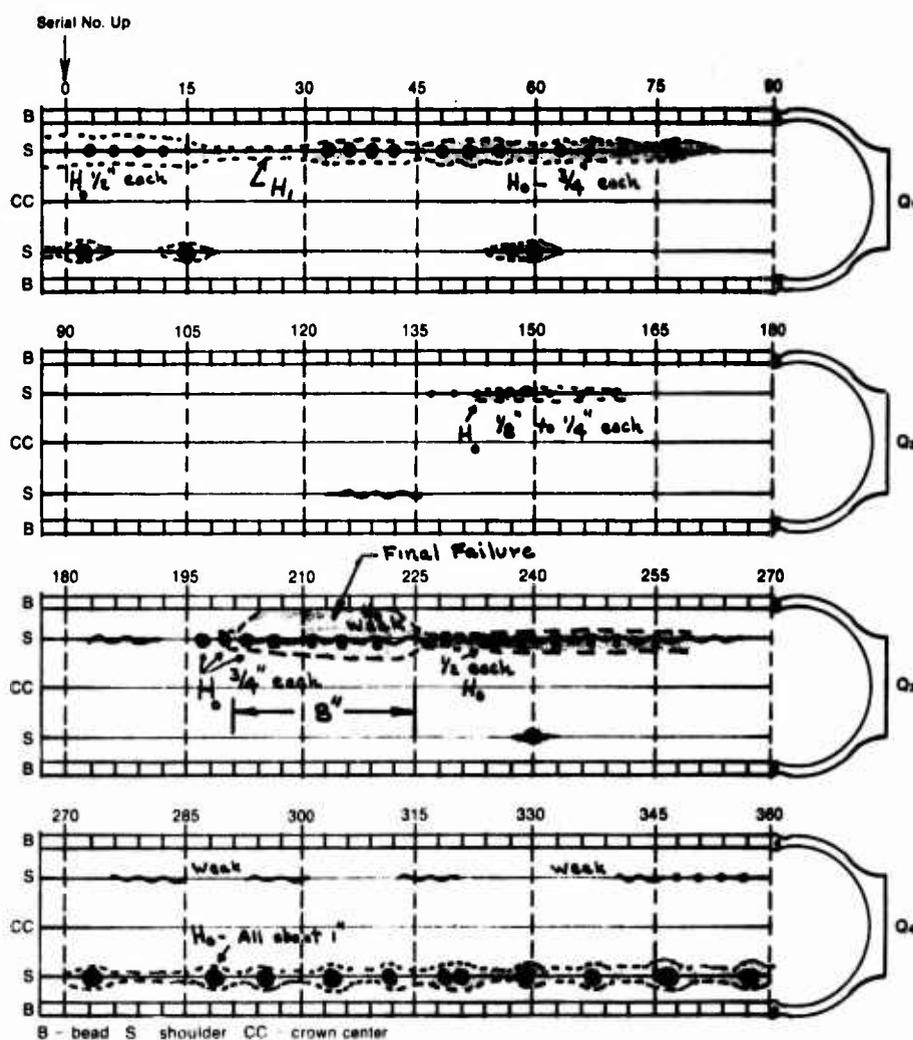
extensive separation existed in addition outside of the immediately failed region. It was quite evident in H_0 that this tire would experience an early failure. It is rather surprising that it lasted up to at least half of its expected drum life. We note, however, that the multiple-circular type separations along the belt edge with the gate barriers mentioned above and noted in Figure 31, do not lead to failure as quickly as the completely open edge observed at H_0 in example IX. When the belt edge is completely open over an inch wide and extends for a few inches the failure appears to take place very quickly. In case of multiple-circular separations in the ½ inch to 1 inch diameter category where reasonably good adhesion exists between separations, it appears to take a little longer to reach failure since more mileage is required to open up the extended edge.

FIGURE 31A
 CHART OF H_0 AND H_1 FOR EXAMPLE XII WITH ORIGINAL SEPARATION IN BLACK
 AND FINAL SEPARATION IN GRAY WITH DASHED OUTLINE

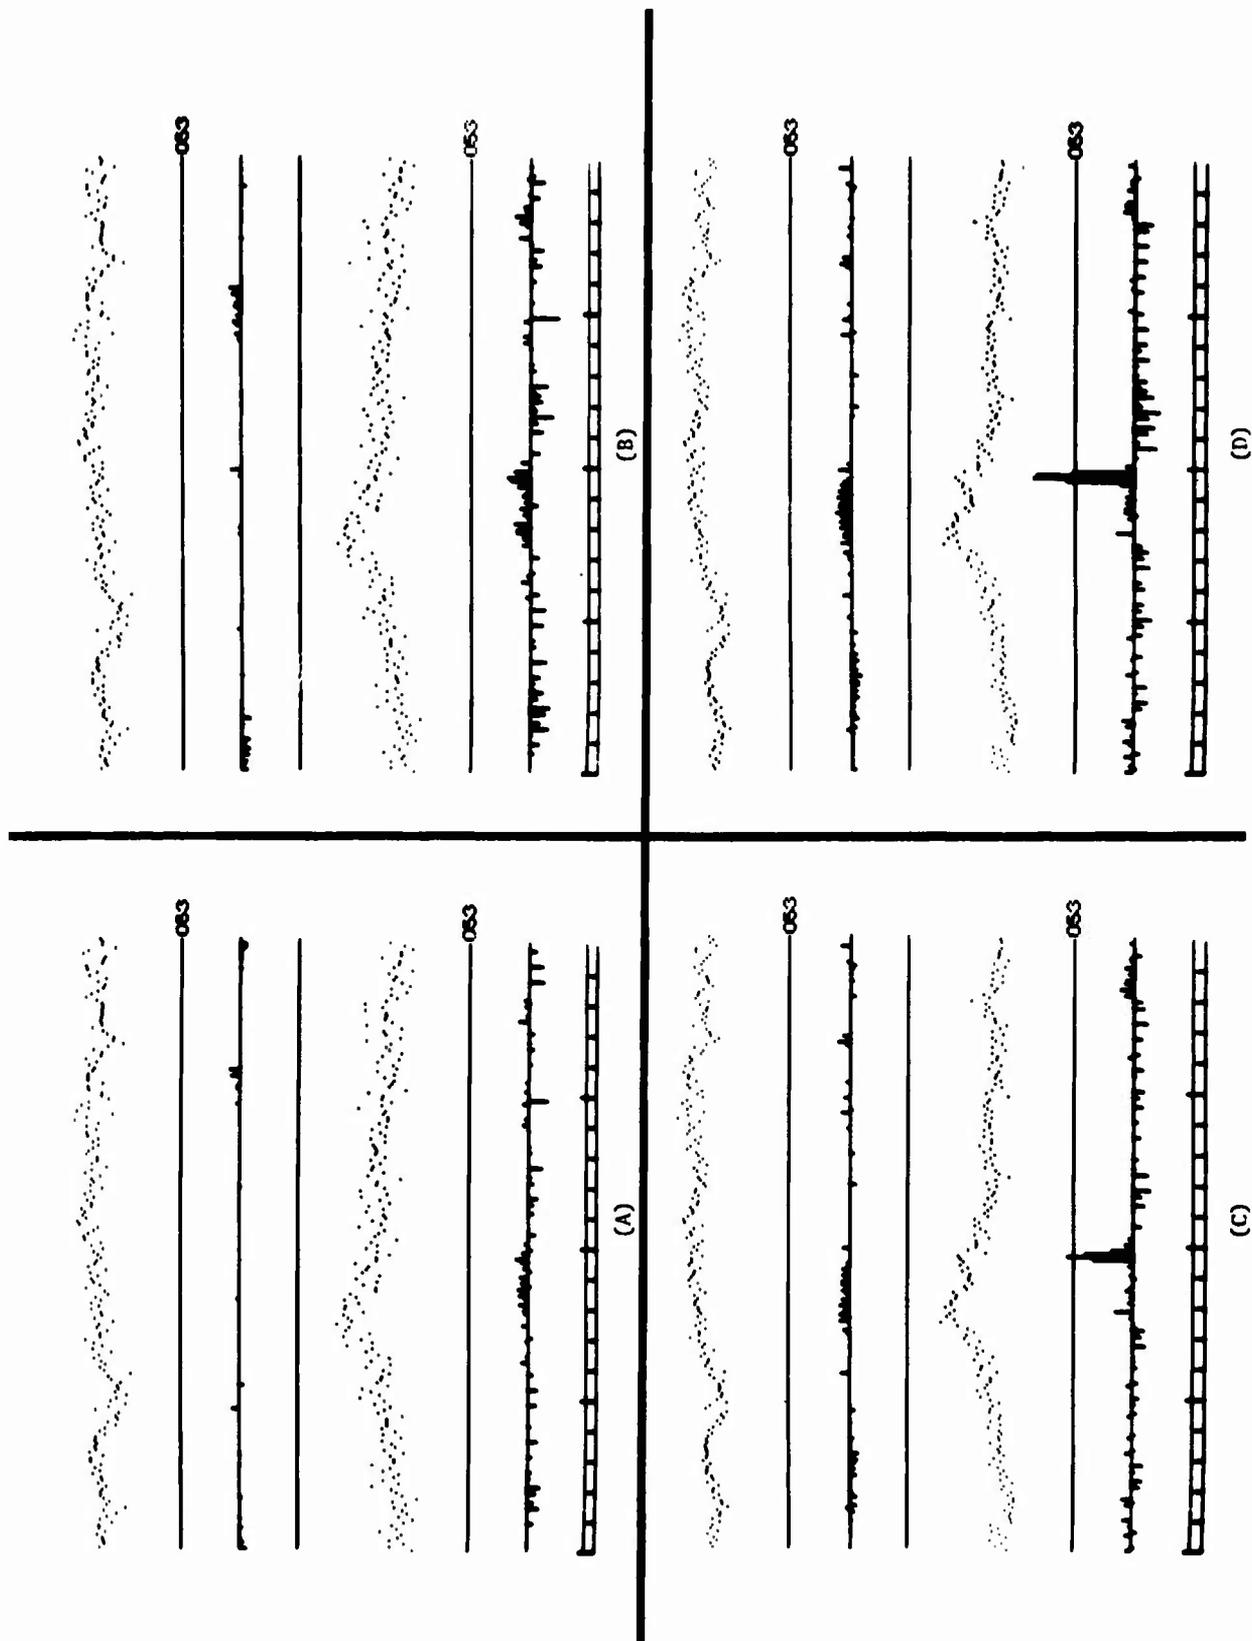
FIGURE 6

Figures 6, 7 and 8 present application data for three (3) different tires tested on the TFD. Each figure contains four (4) photographs of the cathode ray tube display screen taken on a sequential time basis. The photographs show data associated with the front radiometer in the upper half of the picture, and rear radiometer data in the lower half. These data include the display of the current scan, and the cumulative difference curve with its upper and lower control limits.

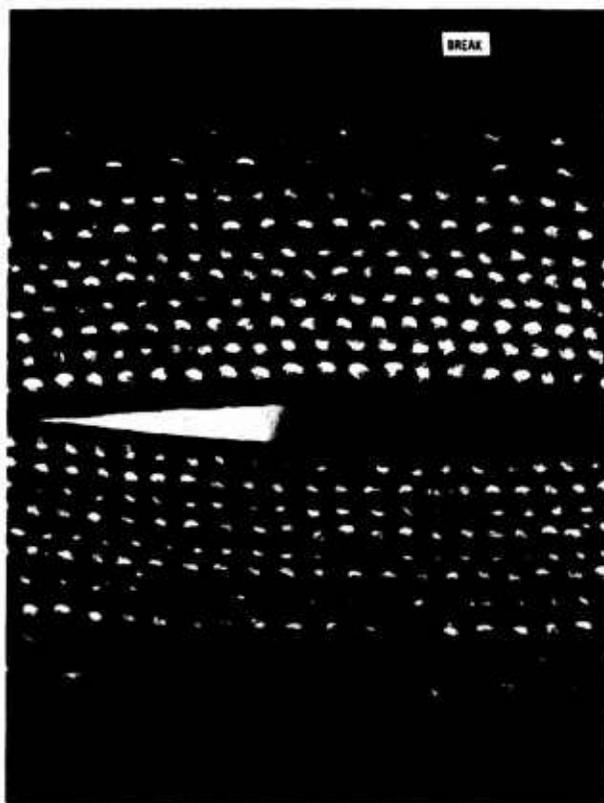
FIGURE 5
CROSS SECTION OF A BREAK DETECTED
IN THE PLY OF A TIRE

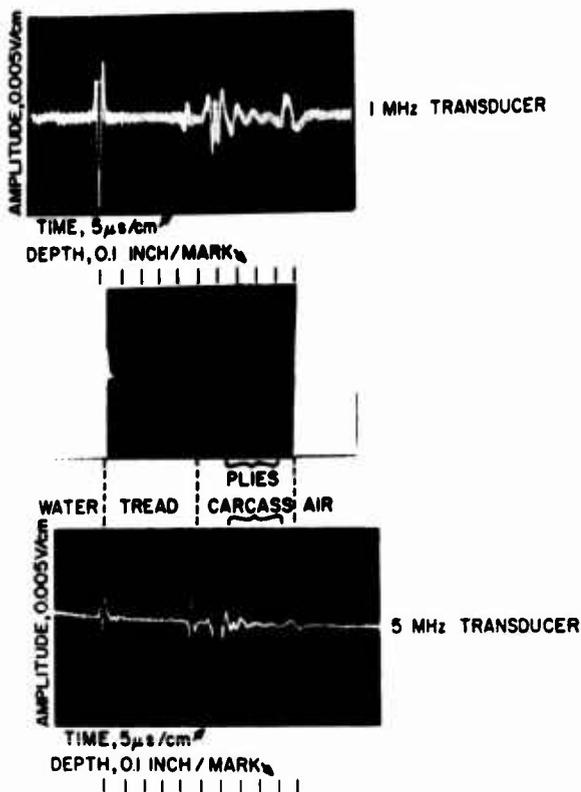
Figure 10. Reflection signal matched to tread structure of belted tire section.
