NTIAC 74-1

PROCEEDINGS OF THE 1973 SYMPOSIUM ON NONDESTRUCTIVE TESTING OF TIRES

Sponsored by
ARMY MATERIALS AND MECHANICS RESEARCH CENTER
Watertown, Massachusetts 02172

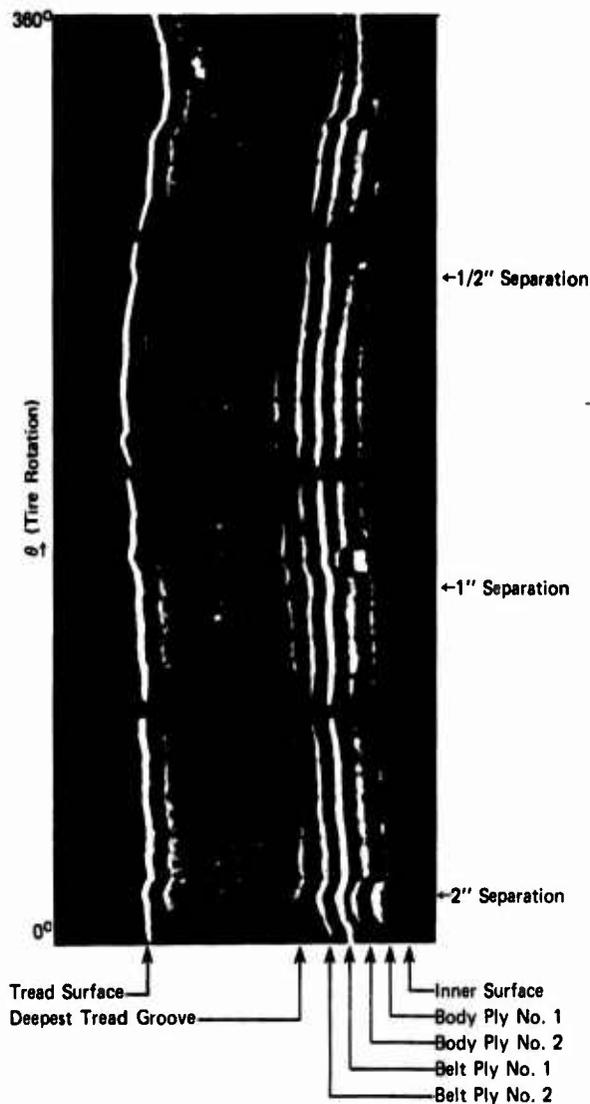
The B-scan display technique provides a very sensitive means for detecting any such perturbations of the normally present echo patterns. Figure 11 illustrates the technique with scan data taken on a programmed-defect tire having separations approximately 1/2", 1", and 2" in diameter, deliberately introduced between the belt and the body plies. The reflection amplitude signal is used to intensity modulate the beam of an oscilloscope, which is then displaced vertically in synchronism with mechanical scanning produced by rotating the tire relative to the fixed transducer. The image display shown was produced in four sections by recording the face

Figure 11. Single-channel B-scan display.

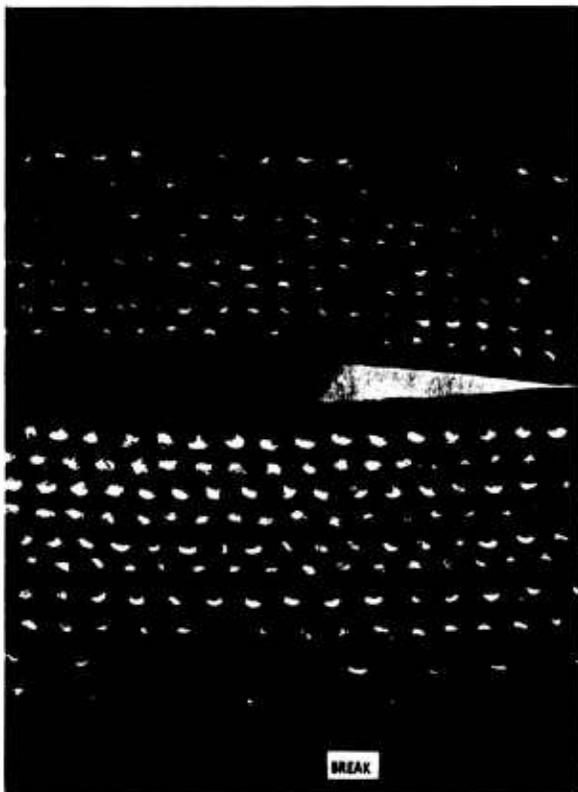
Figure 5. Cross section of break detected.

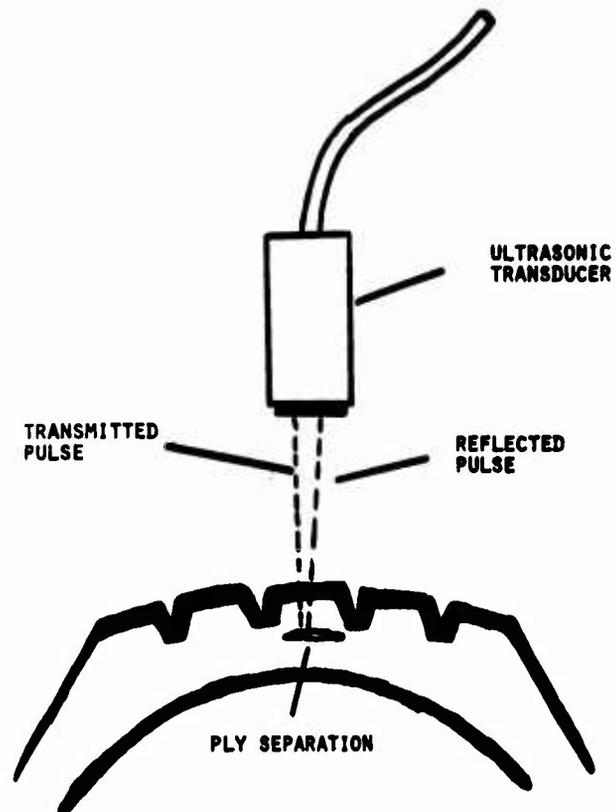
Figure 1. Pulse echo method of ultrasonic tire inspection.

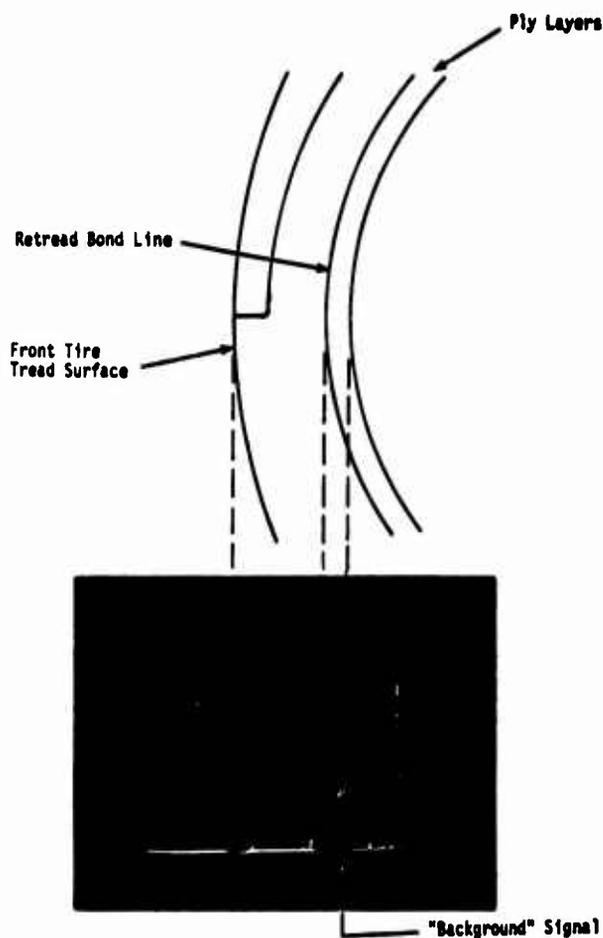
The various tire interfaces that produce signals on the scope and their corresponding background signals are shown in Figure 2. Figure 3 illustrates the various scope displays that can be encountered while inspecting tires using ultrasonics. The normal condition implies that the tire is basically sound, with no ply separation

Figure 2. Schematic of tire interfaces.

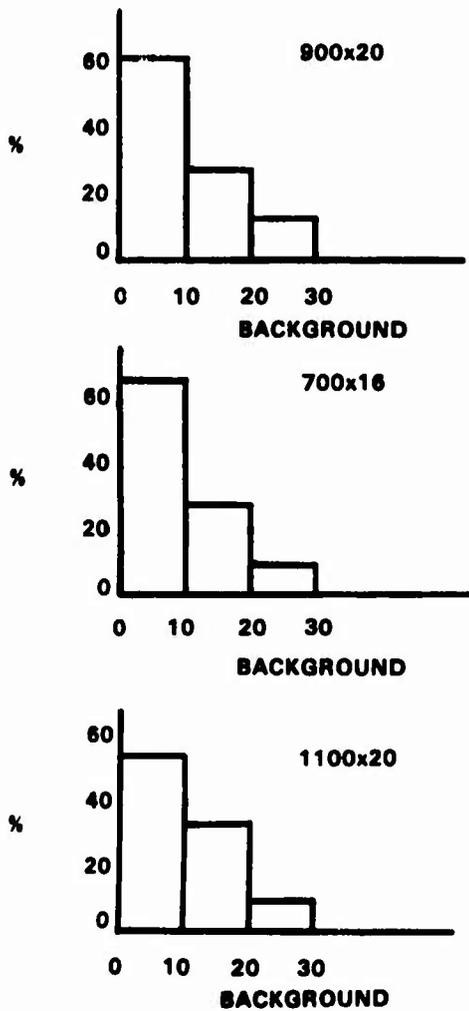
Figure 4. Percentage of total population versus ultrasonic background reading after test.

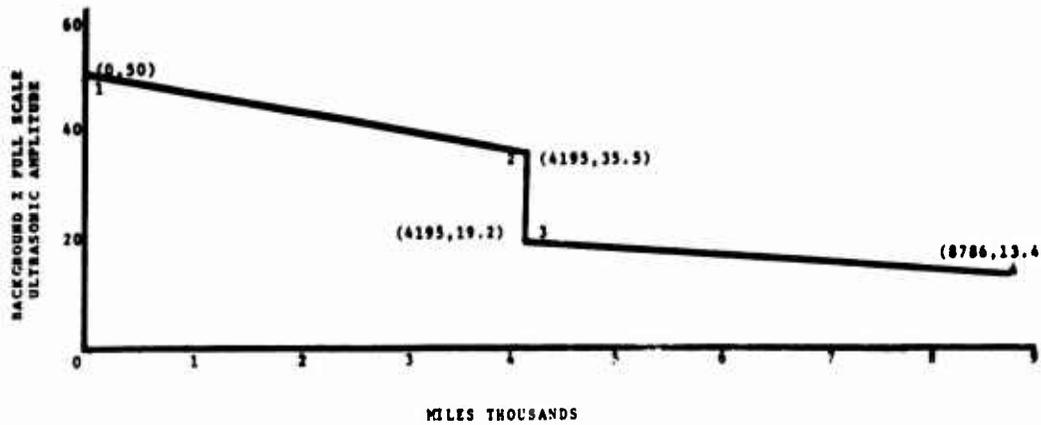
A life cycle curve or "map" for the 1100 x 20 tires is shown in Figure 6. This map illustrates the degradation which occurs in tires as they run to failure. The points were obtained by plotting average background readings versus average mileage. Segment 1-2 represents the degradation which occurs in new tires as they are run to failure or wearout. Segment 3-4 represents the degradation occurring in

Figure 6. 1100 x 20 tires average background reading versus average mileage.

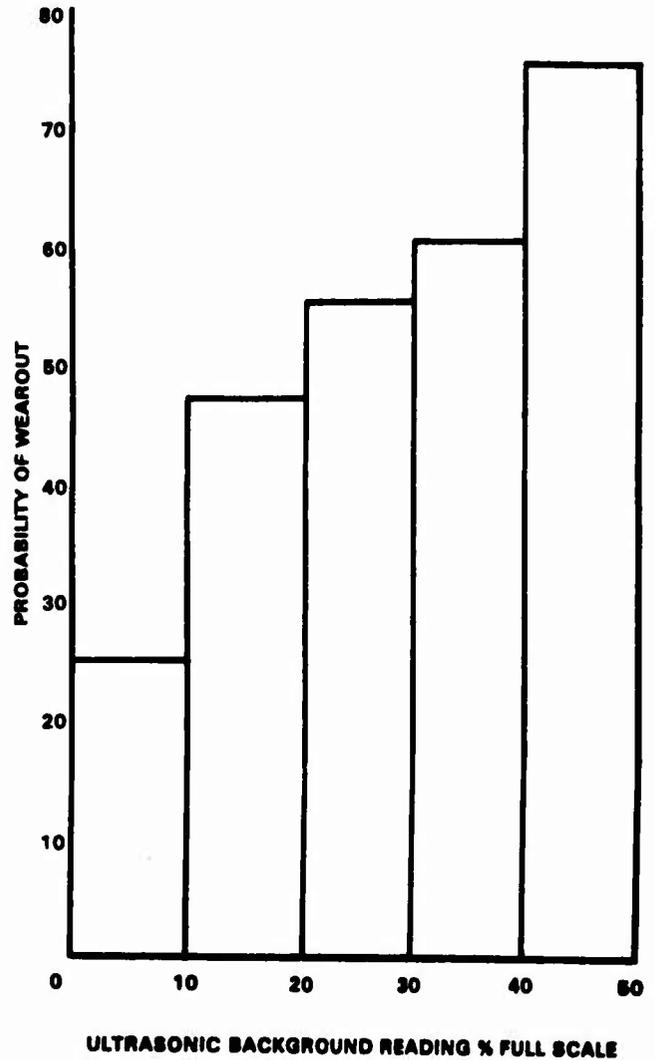
Figure 7. Probability of wearout versus ultrasonic background reading.

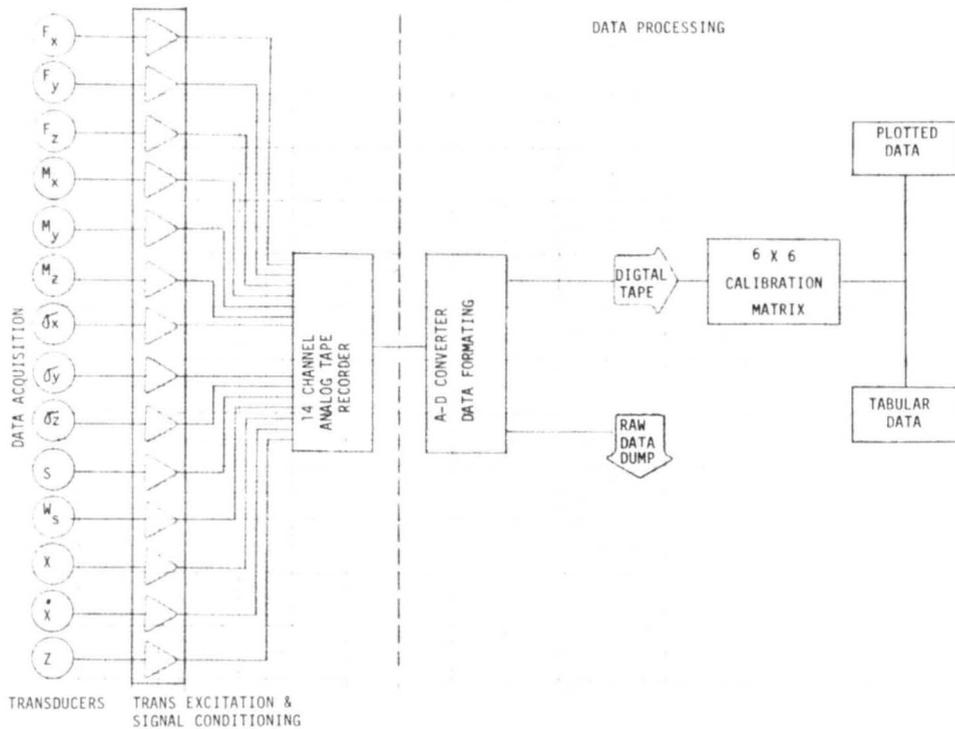
FIGURE 2
TIRE FORCE MACHINE DATA ACQUISITION AND PROCESSING

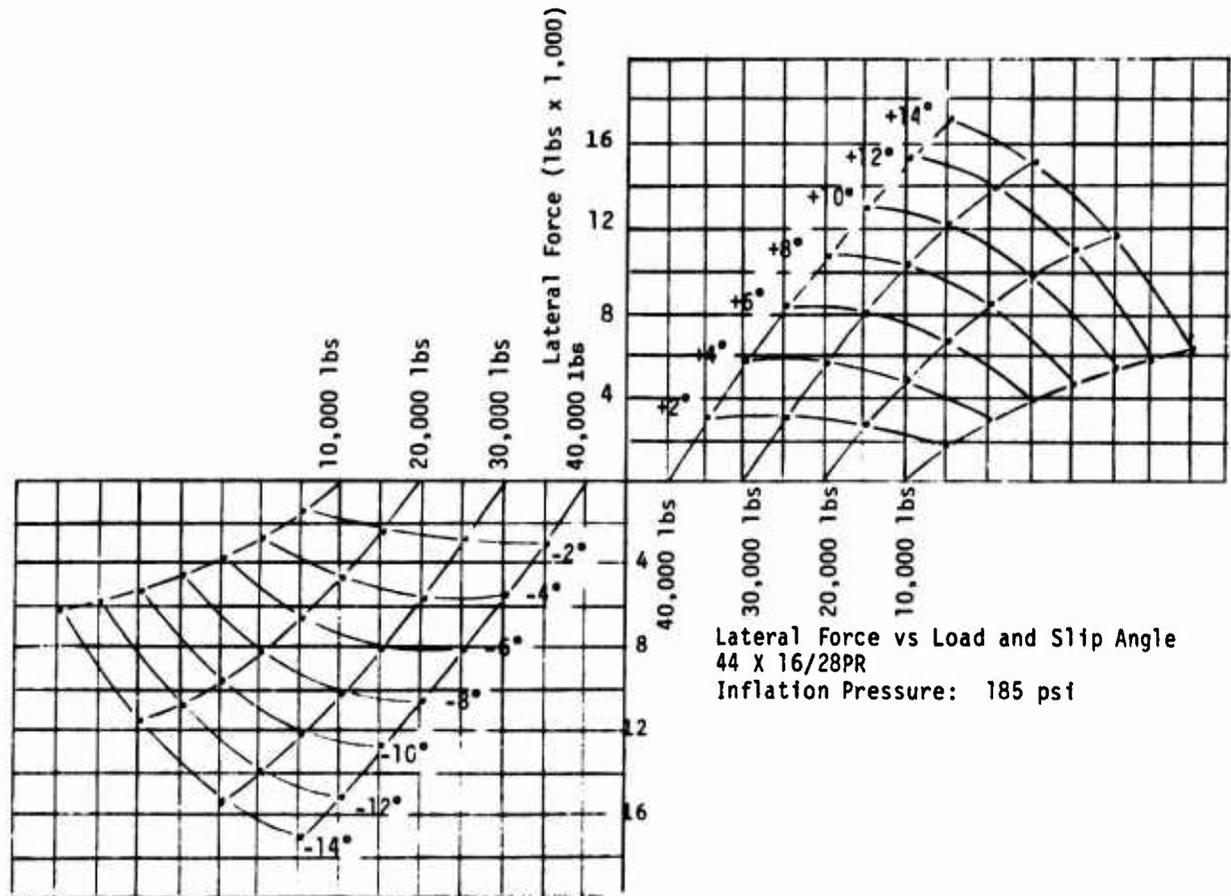
FIGURE 13 AIRCRAFT TIRE LATERAL FORCE CARPET PLOT

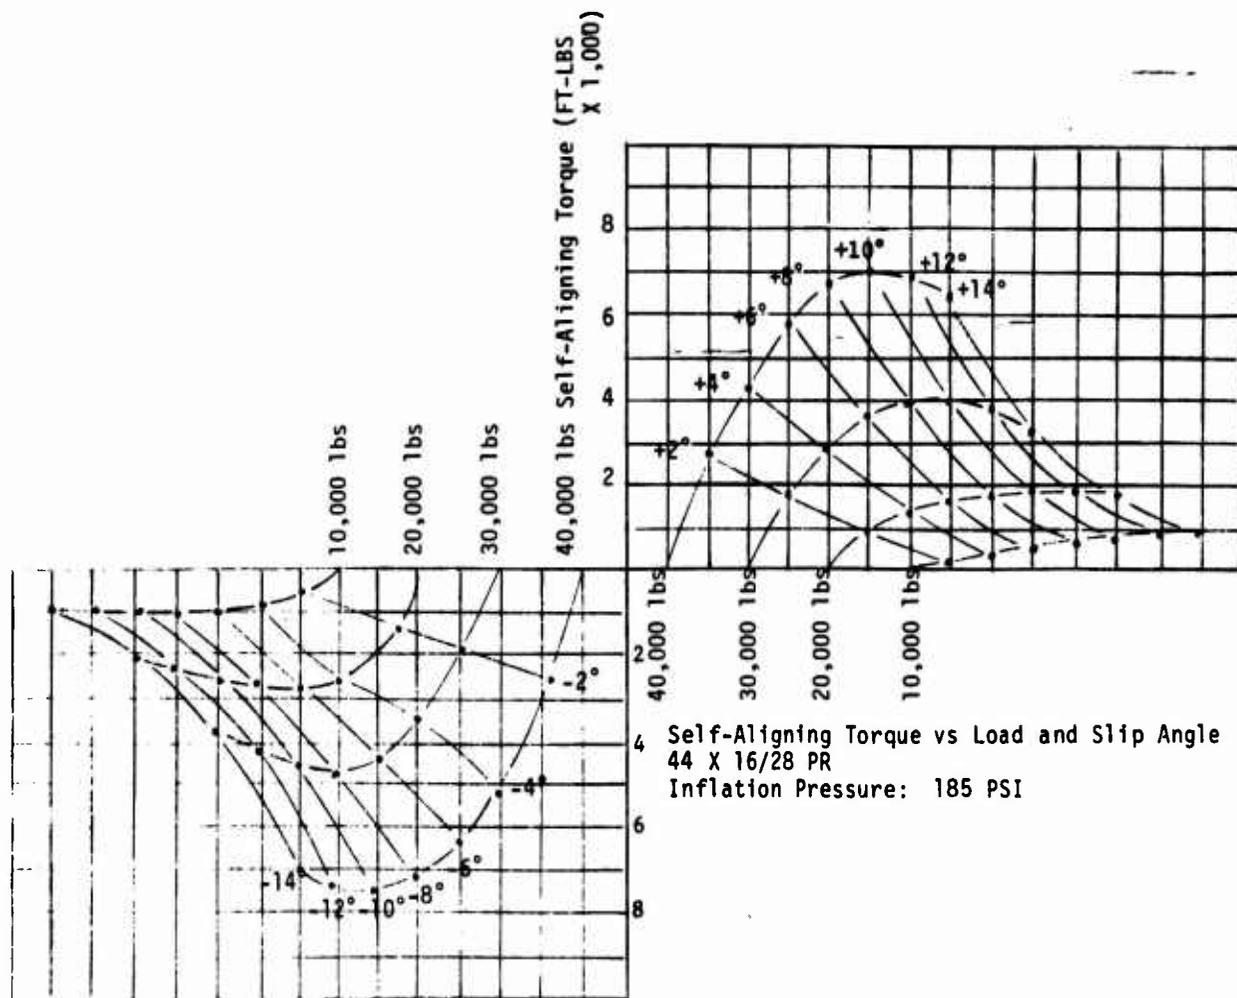
FIGURE 14 AIRCRAFT TIRE SELF-ALIGNING TORQUE CARPET PLOT

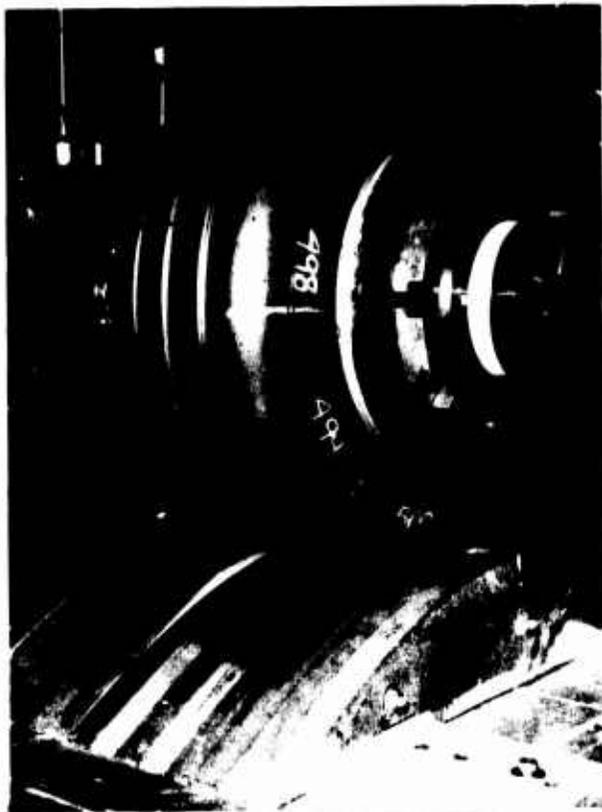
FIGURE 16 MEASURING STRESS
NORMAL TO TIRE TREAD AND CARCASS

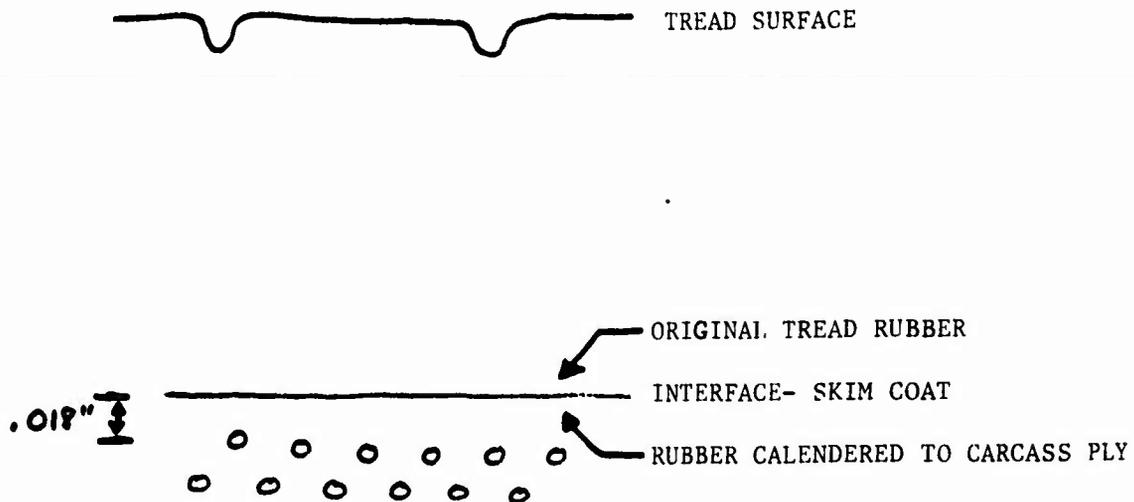
FIGURE 10 LOCATION OF SKIM COAT INTERFACE

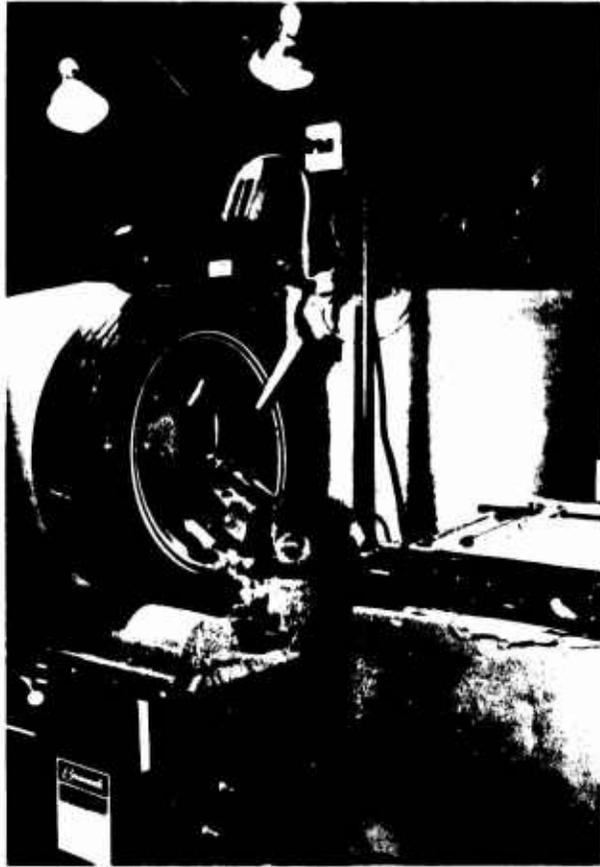
FIGURE 1
AN AUTOMATIC TIRE INSPECTION MACHINE WITH
A BEAD-INSPECTION ADAPTER (BIA) ATTACHED
TO THE SPREADER ARM

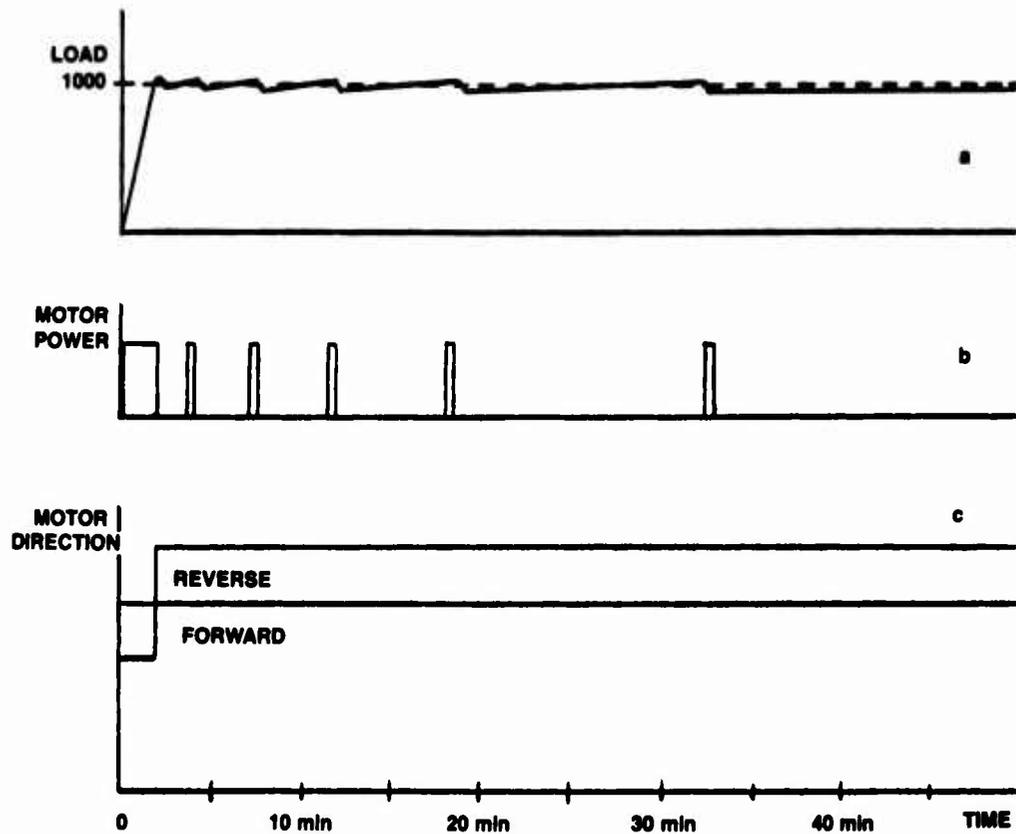
FIGURE 16
TYPICAL REGULATION PATTERN WITH
UNI-DIRECTIONAL LOAD CONTROL (SEE TEXT)

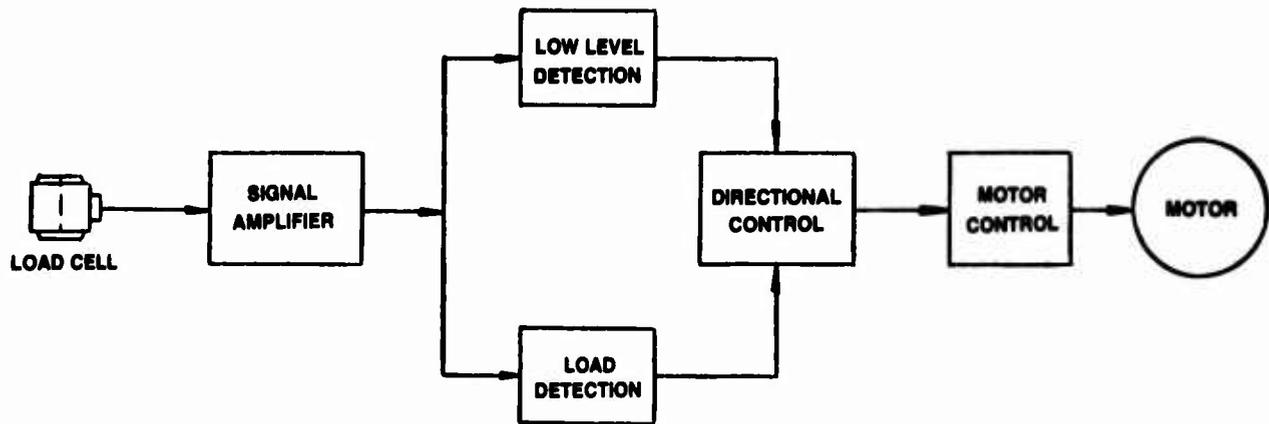
FIGURE 17
FUNCTIONAL BLOCK DIAGRAM

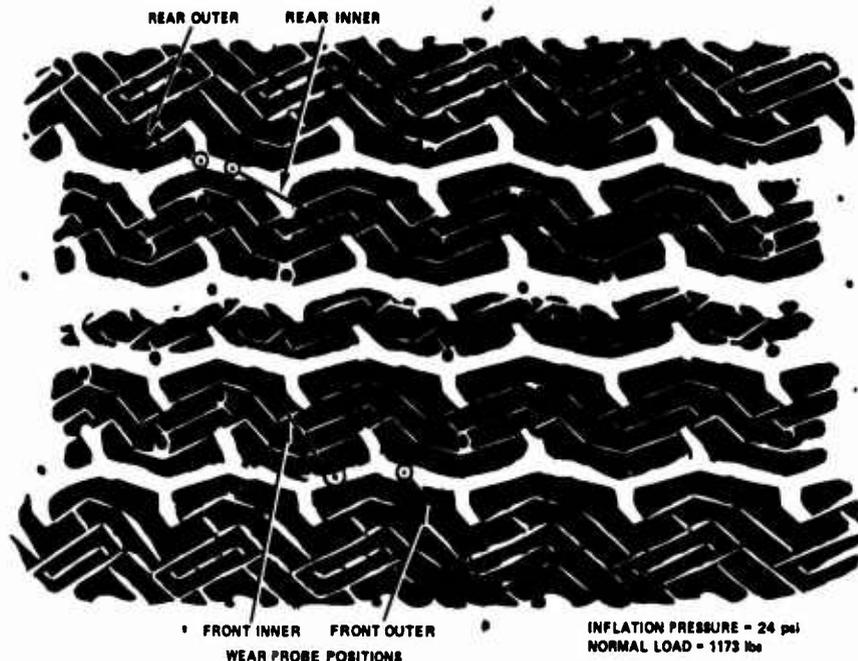
FIGURE 5 FOOTPRINT - DUNLOP HIGH MILEAGE RADIAL - #7-1-48

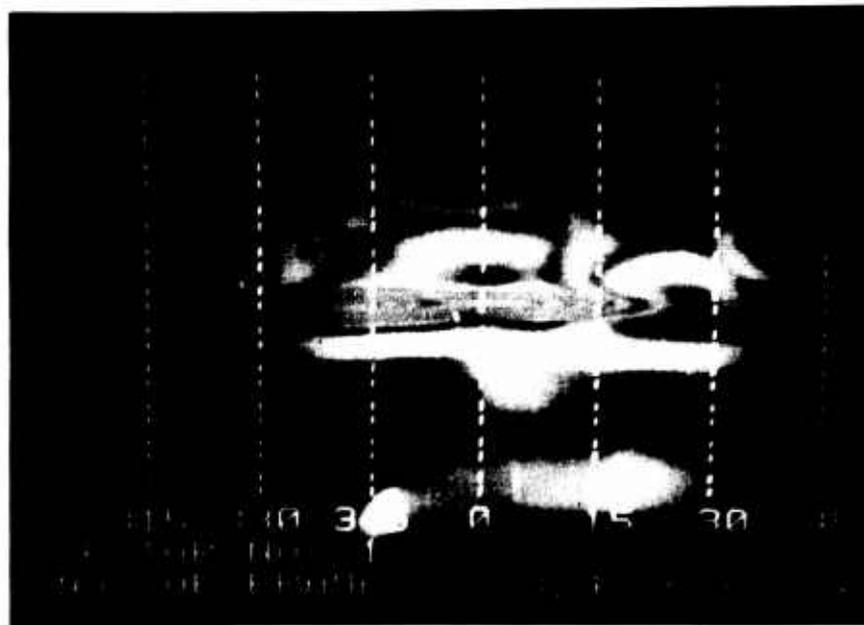
FIGURE 2
VIDEO MONITOR DISPLAY OF FRINGE PATTERN WITH SUPERIMPOSED GRID LINES

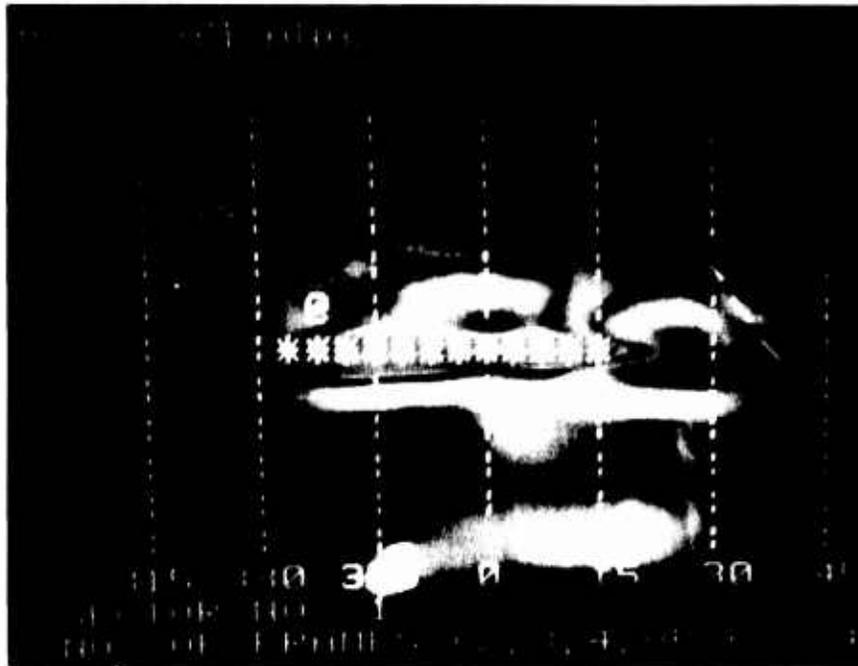
FIGURE 3
THE HOLOGRAM IMAGE CAN BE ANALYZED BY
TYPING SPECIAL DEFECT SYMBOLS ON THE VIDEO MONITOR.

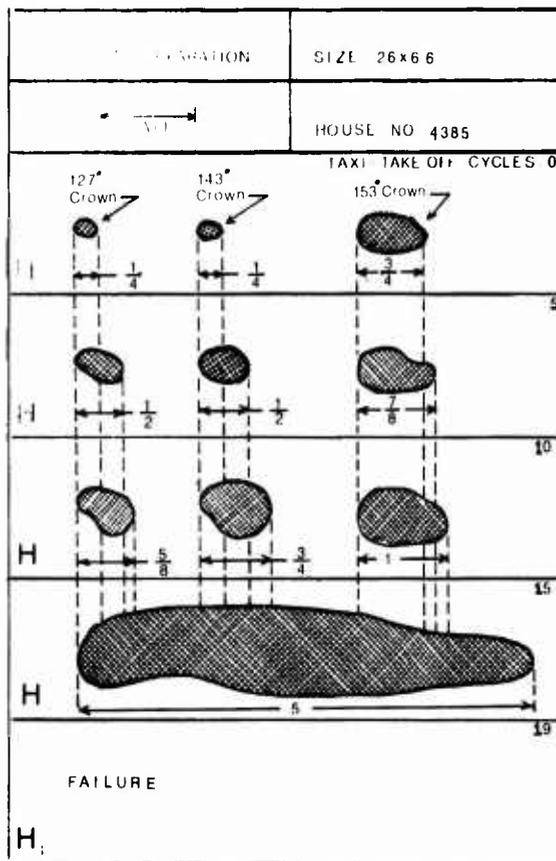
FIGURE 16
U.S. Navy Tire No. 1 – Indoor Test Wheel

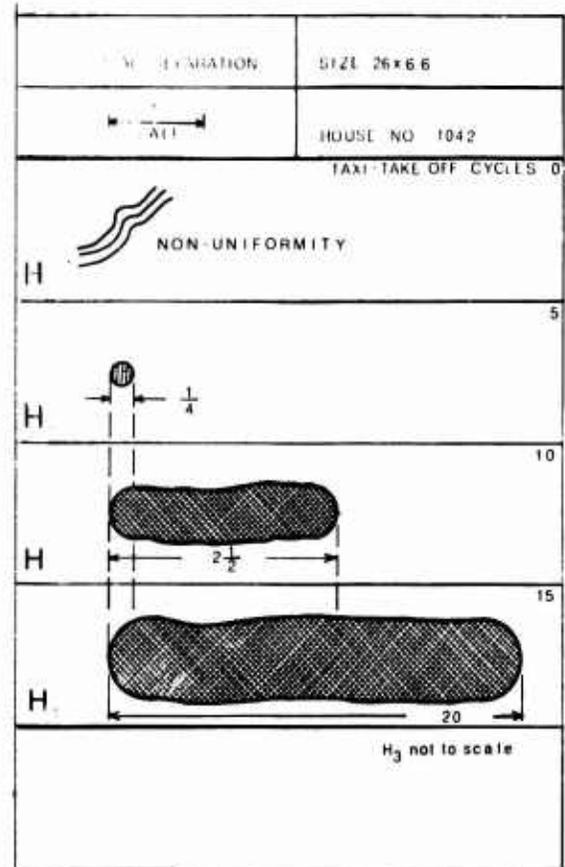
FIGURE 20
U.S. Navy Tire No. 1042 - Indoor Test Wheel
Propagation Pattern

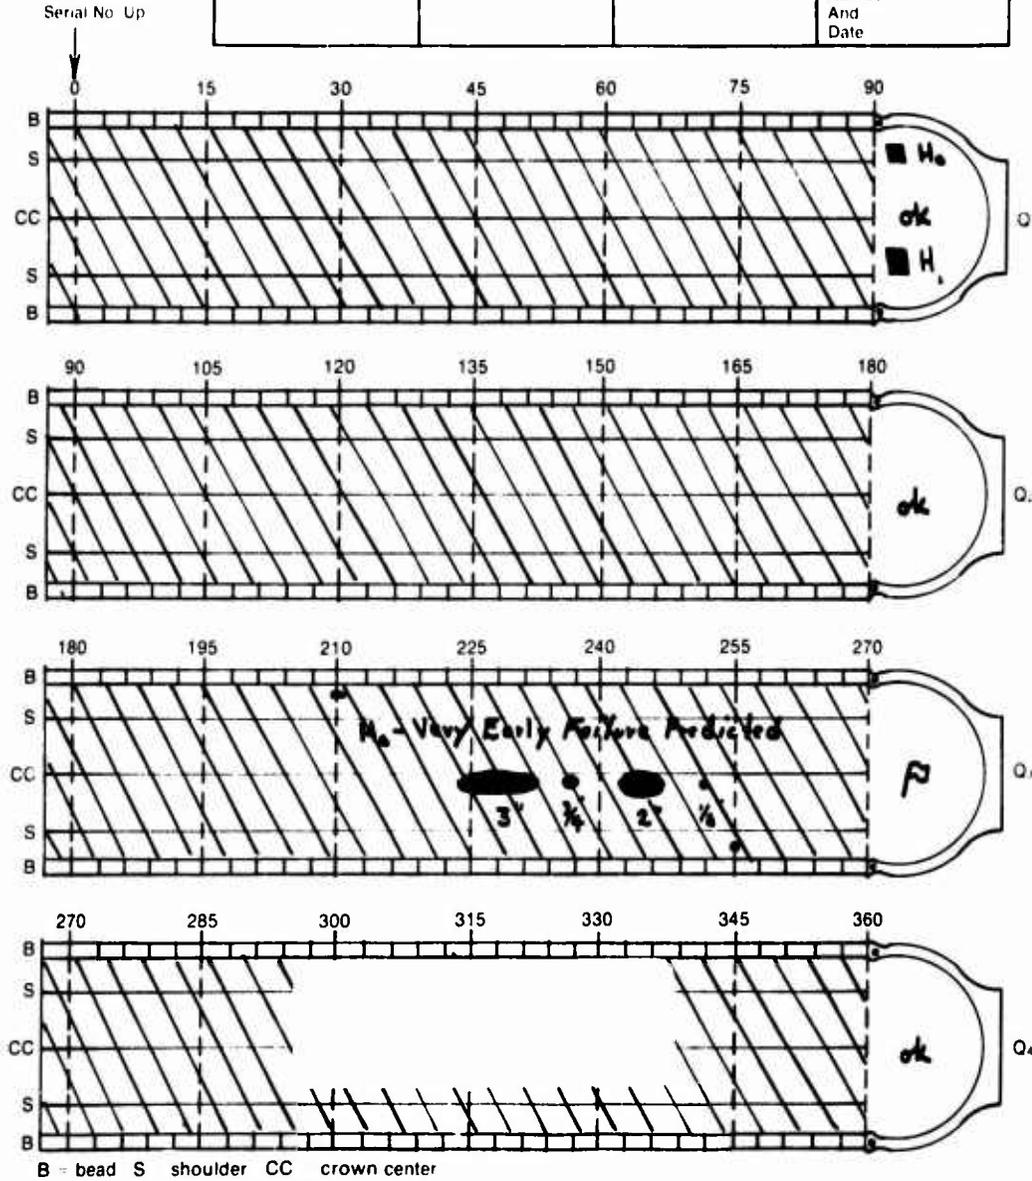
FIGURE 21
U.S. Navy Tire No. 5 - Early Failure

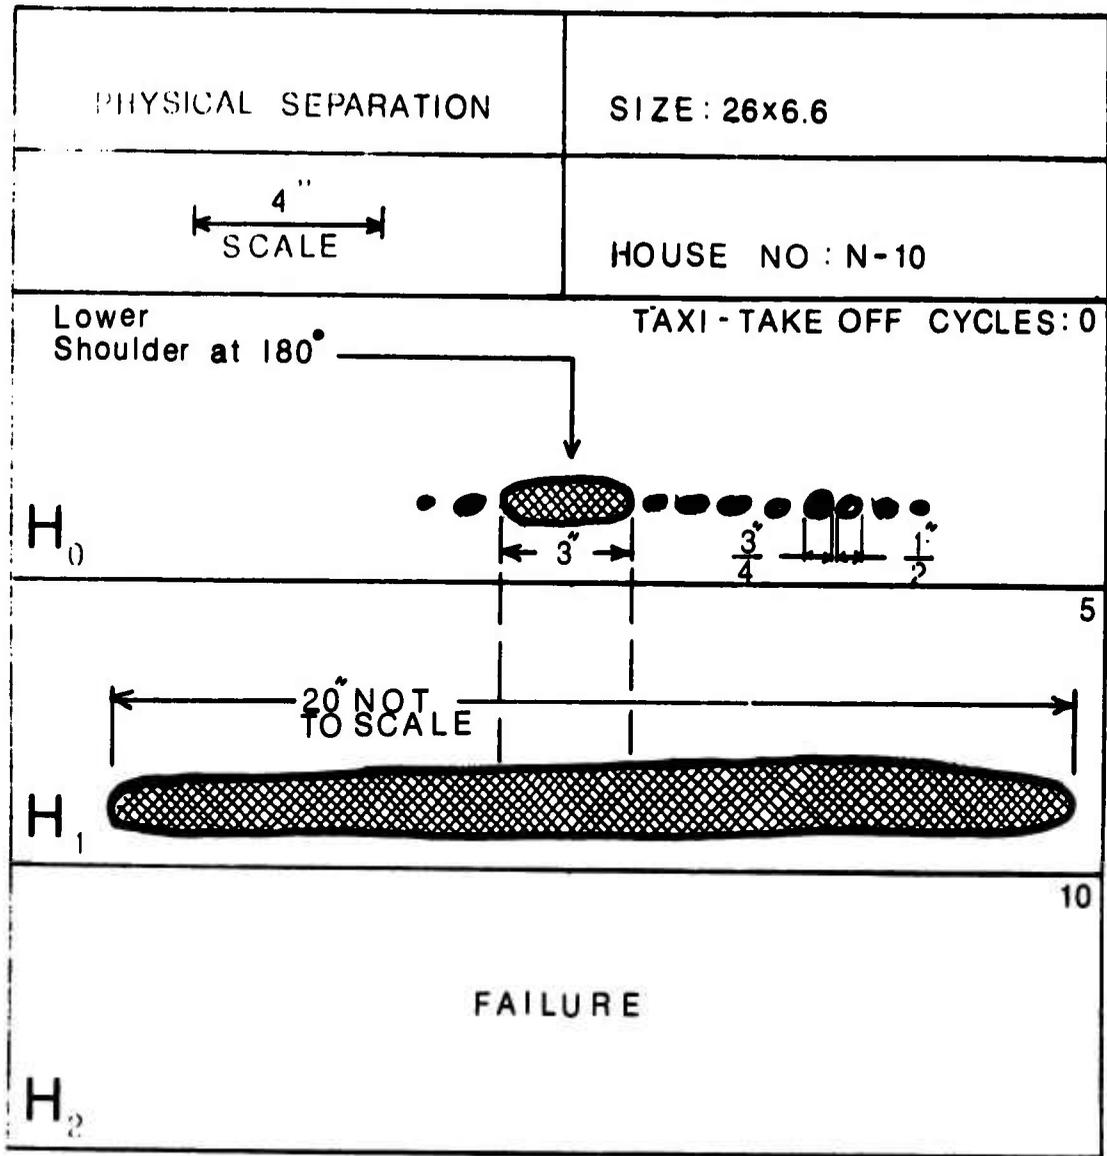
FIGURE 22.a.
U.S. Navy Tire No. 7 - Indoor Test Wheel

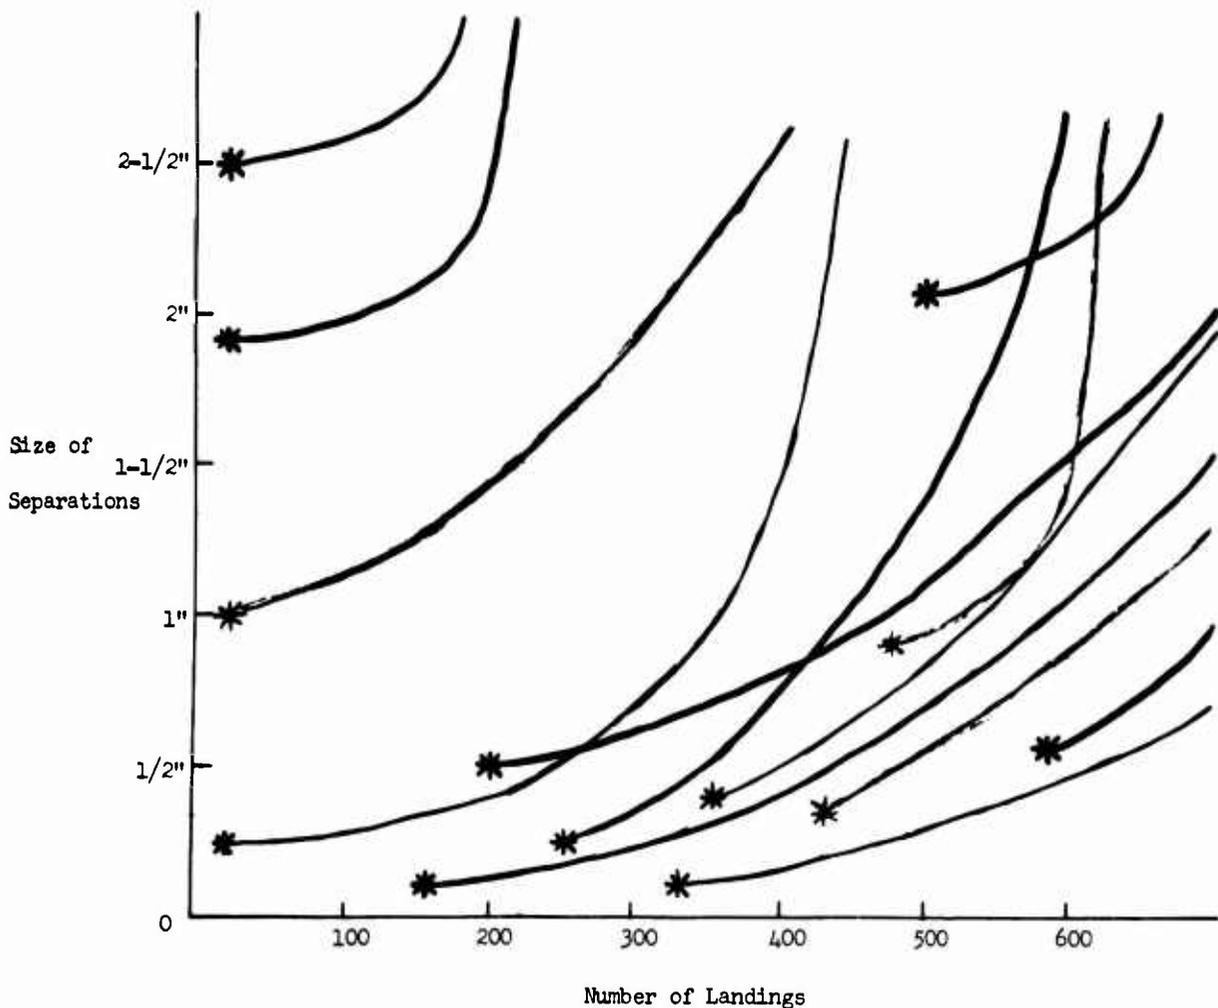
FIGURE 29
General Separation Propagation Behavior As a Function of the Number of Landings

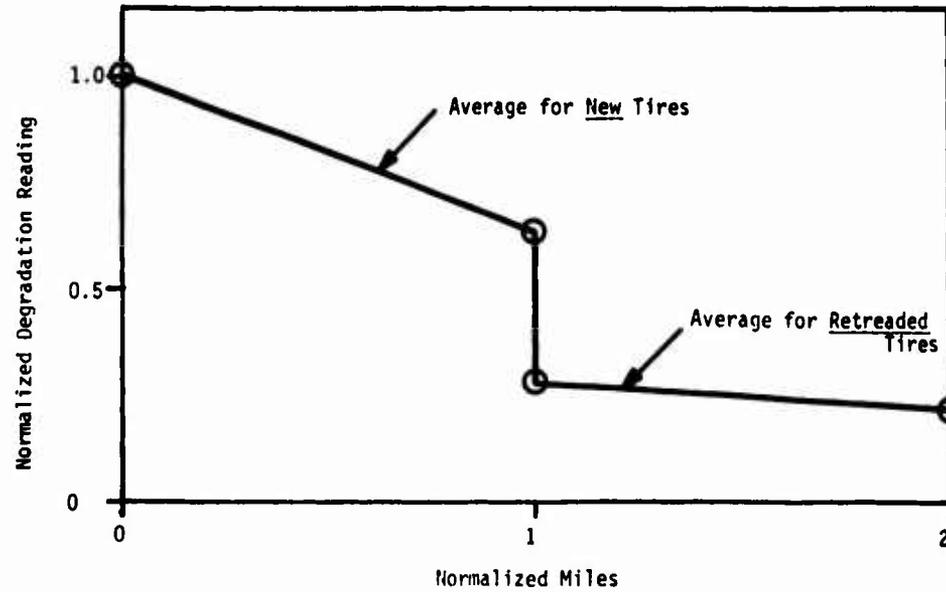
FIGURE 2
POPULATION DEGRADATION READINGS

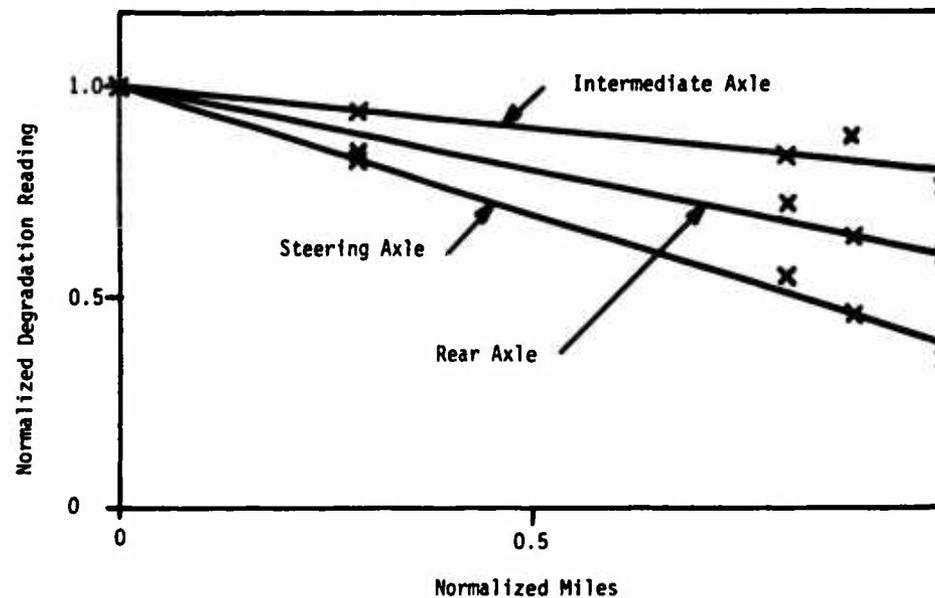
FIGURE 3
ON-VEHICLE DEGRADATION READINGS

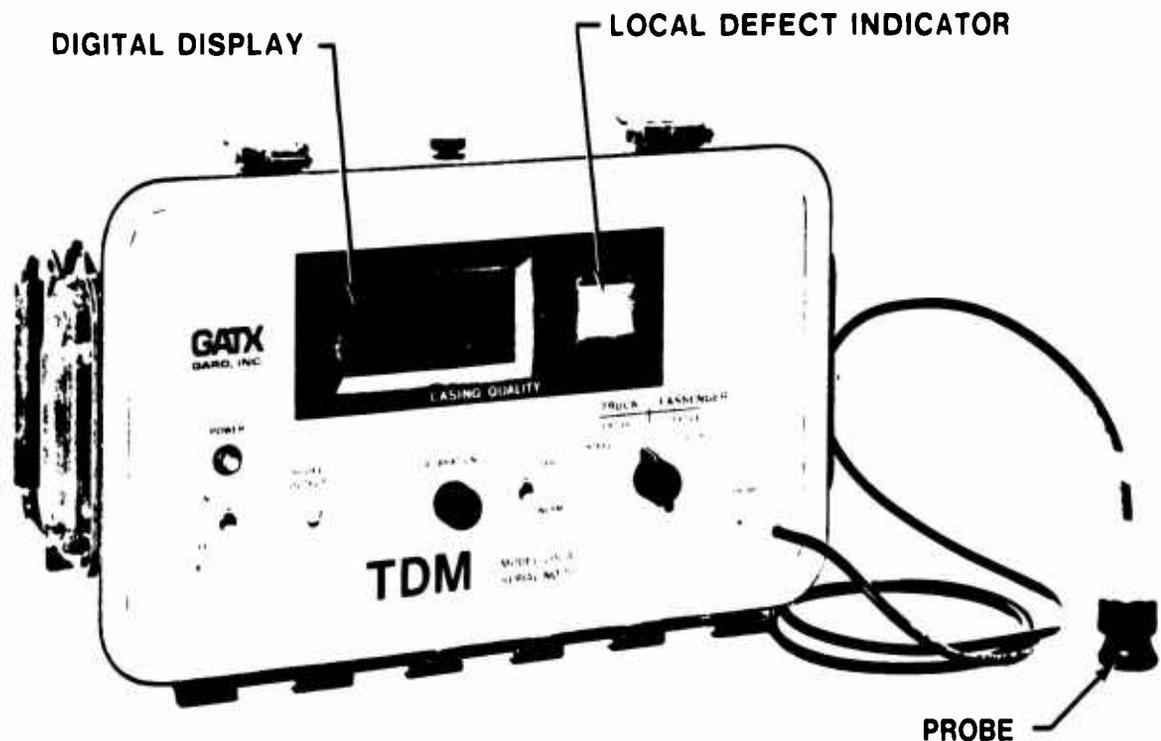
FIGURE 4
TIRE DEGRADATION MONITOR
