TECHNICAL REPORT EL-81-3

# EVALUATION OF UNDERDRAINAGE TECHNIQUES FOR THE DENSIFICATION OF FINE-GRAINED DREDGED MATERIAL

David P. Hammer

Geotechnical Laboratory  
U. S. Army Engineer Waterways Experiment Station  
P. O. Box 631, Vicksburg, Miss. 39180

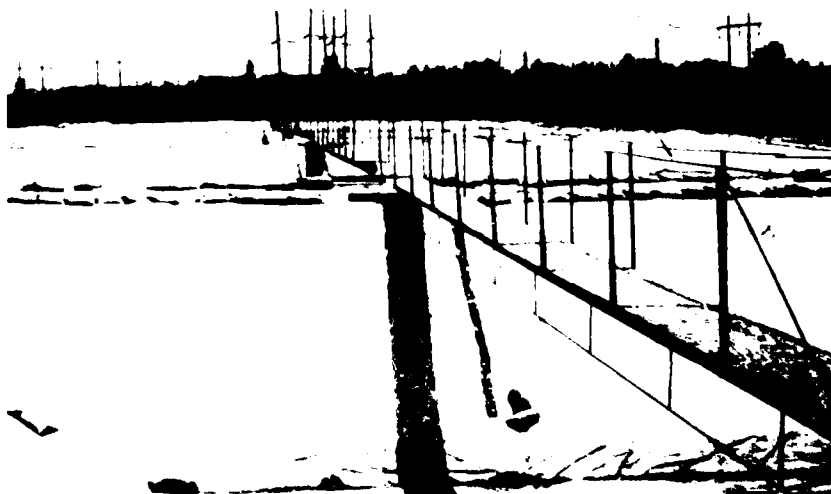
Figure 25. Access bridges, in place across test sections.

54. After the impervious liner was in place, access bridges fabricated on site were moved by a crane into place across the test section (Figure 25).

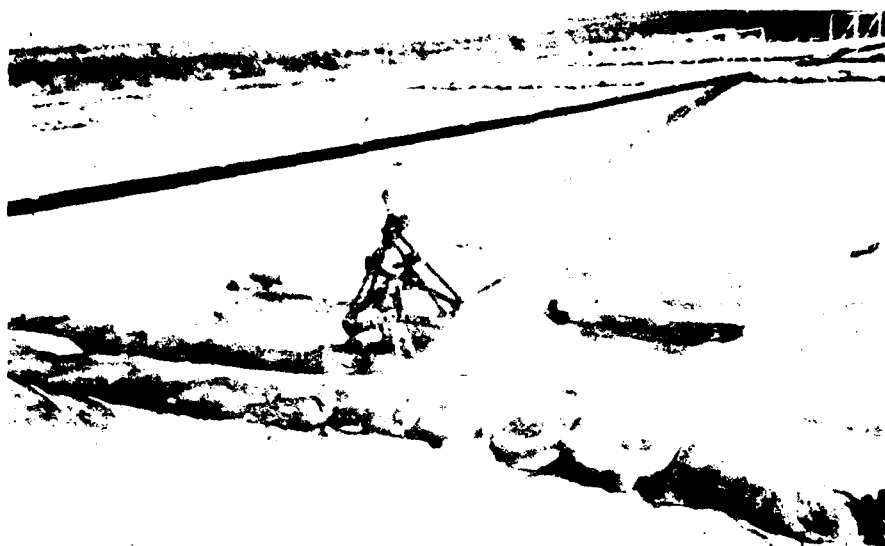
Figure 26. Placement of drainage material in test section 1

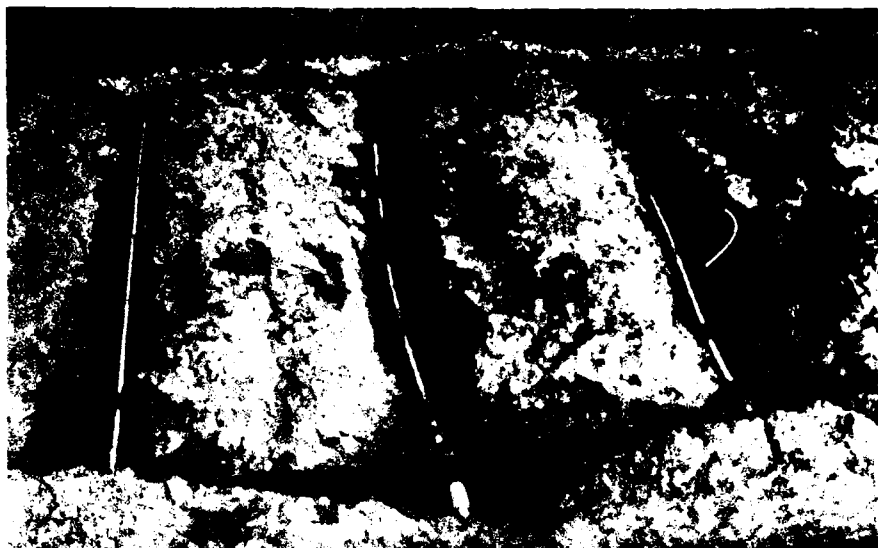
Figure 27. Slotted collector pipe in trenches  
(test section 2)

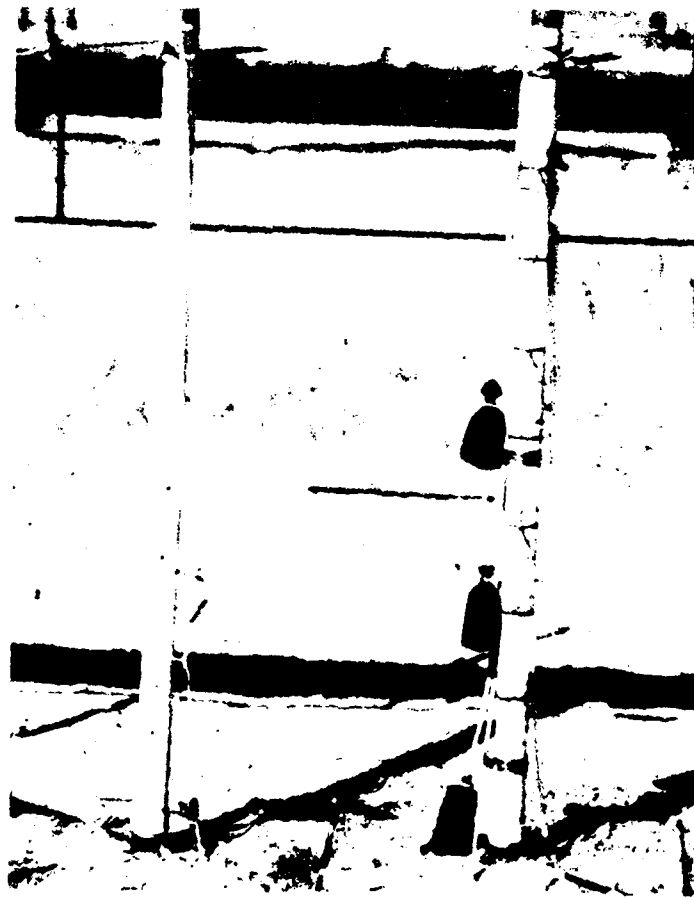
Figure 31. Piezometers in place on a settlement plate riser and on an instrument stand

61. One settlement plate to measure settlement of the under-drainage layer and foundation was installed in each test section. A typical in place settlement plate with riser is shown in Figure 31 (on left). As previously mentioned, these devices, which were carefully plumbed and leveled, also served to support the WES transducer piezometers. A hole was cut in the side of the bridge for the riser pipe and strapping was carefully placed around the riser to help hold it in place, but not bind it. Zero settlement reference elevations for these devices are given in the following tabulation.

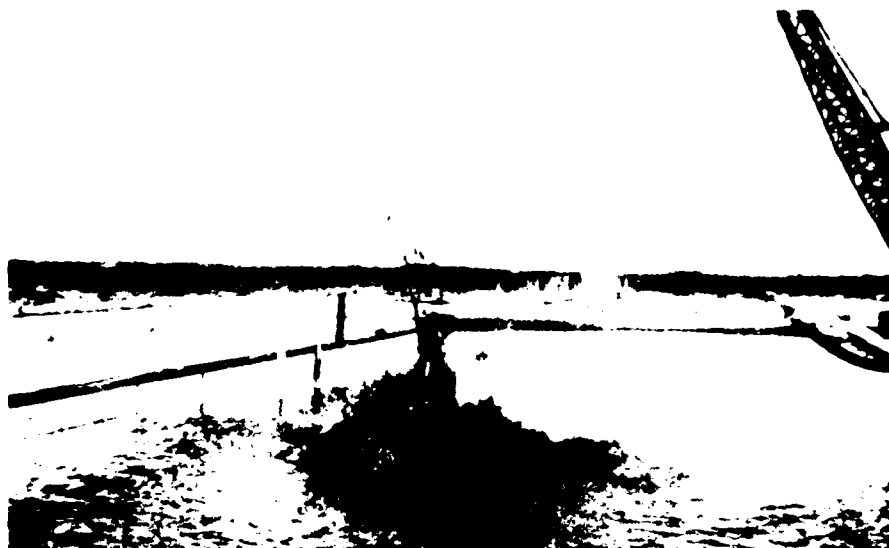
Figure 40. Dredge discharge with dredge operating at maximum rpm

Dredging was then resumed with the dredge operating at approximately one-half of its maximum rpm (Figure 39). After about another 2 ft of slurry had been deposited, the dredge was allowed to operate at its maximum rpm (Figure 40).
