TECHNICAL REPORT

No. 12573

FORMATION AND FAILURE OF ELASTOMER NETWORKS VIA THERMAL, MECHANICAL AND SURFACE CHARACTERIZATION

by DAVID W. DWIGHT, J. E. McGRATH & R. M. YANG

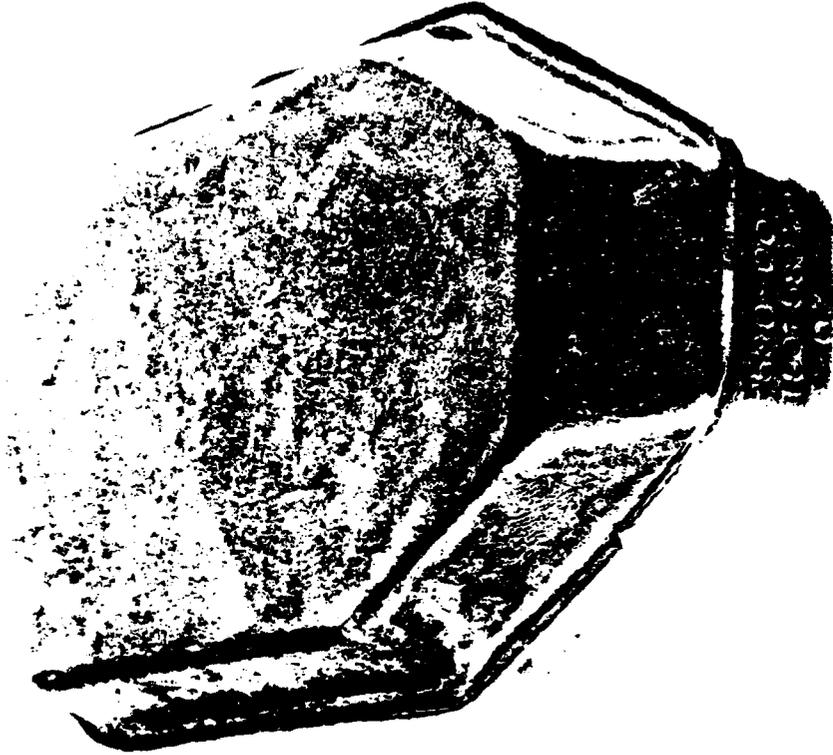
Figure 1. A: preservice pad; B: the general feature of paved course pads, small chunk detached at 1500 miles of service, but abrasive wear was the dominant mechanism.

one pad in each case (a to d) are shown in Figures 1 and 2. The failure mode between test courses is visually different. Rubber wear seems to be the main mechanism of service weight loss on pavement. Chunk failure dominated in cross-country course and the gravel course pads show both types of failure.

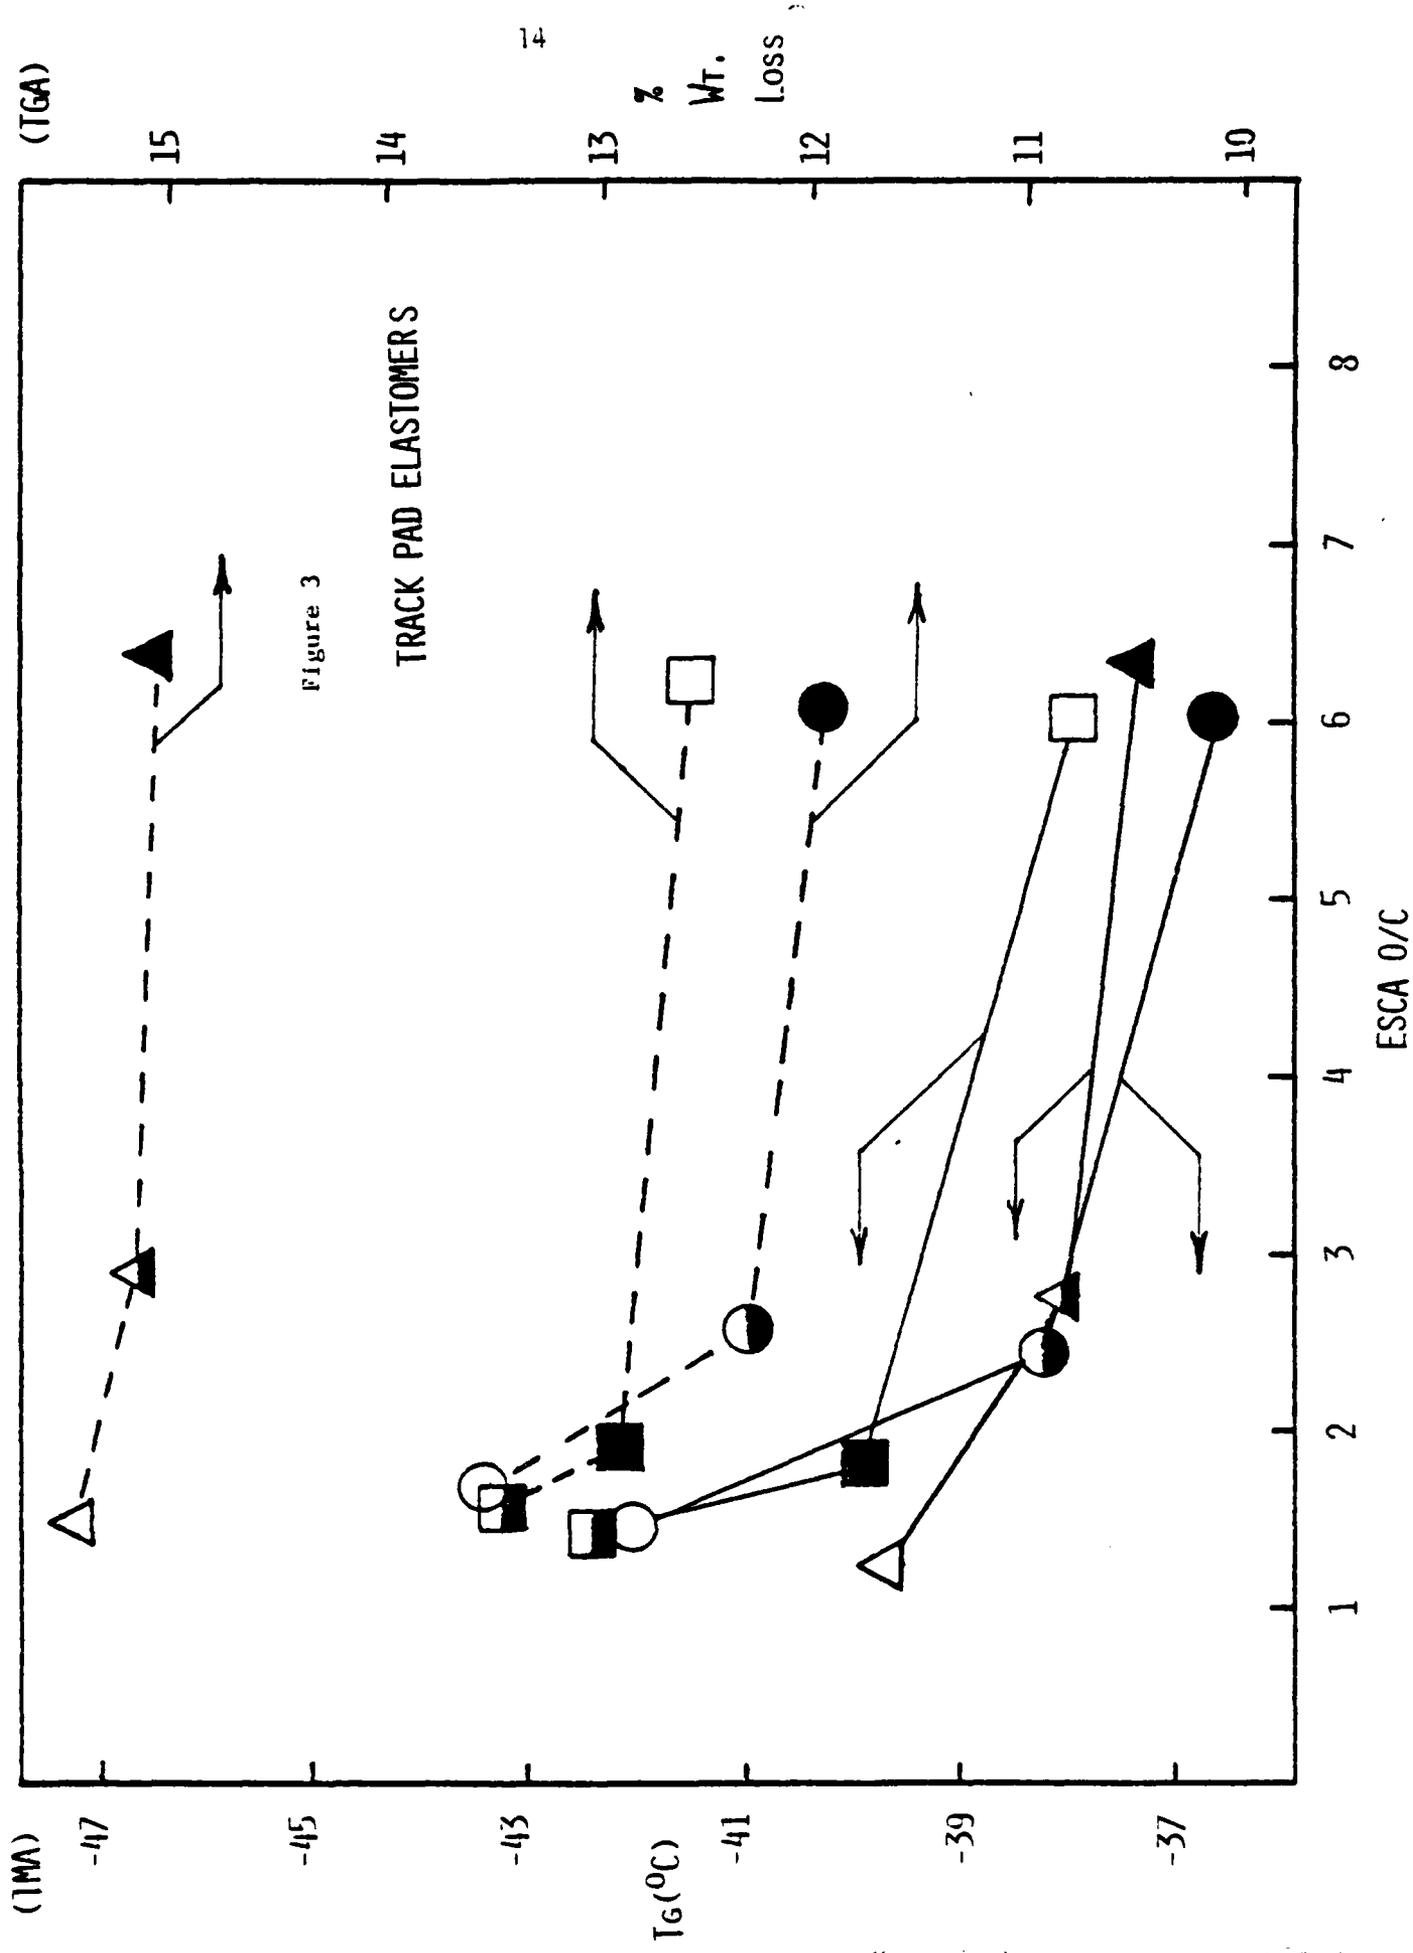
differently from FS and GS pads. Thus it seems certain that oxidation plays a role in restricting molecular mobility. In comparison with the TGA % weight loss at 400°C of these pads, another correlation is observed. Higher volatile contents were also found in the pads of lower glass transition temperature as shown in Figure 3.

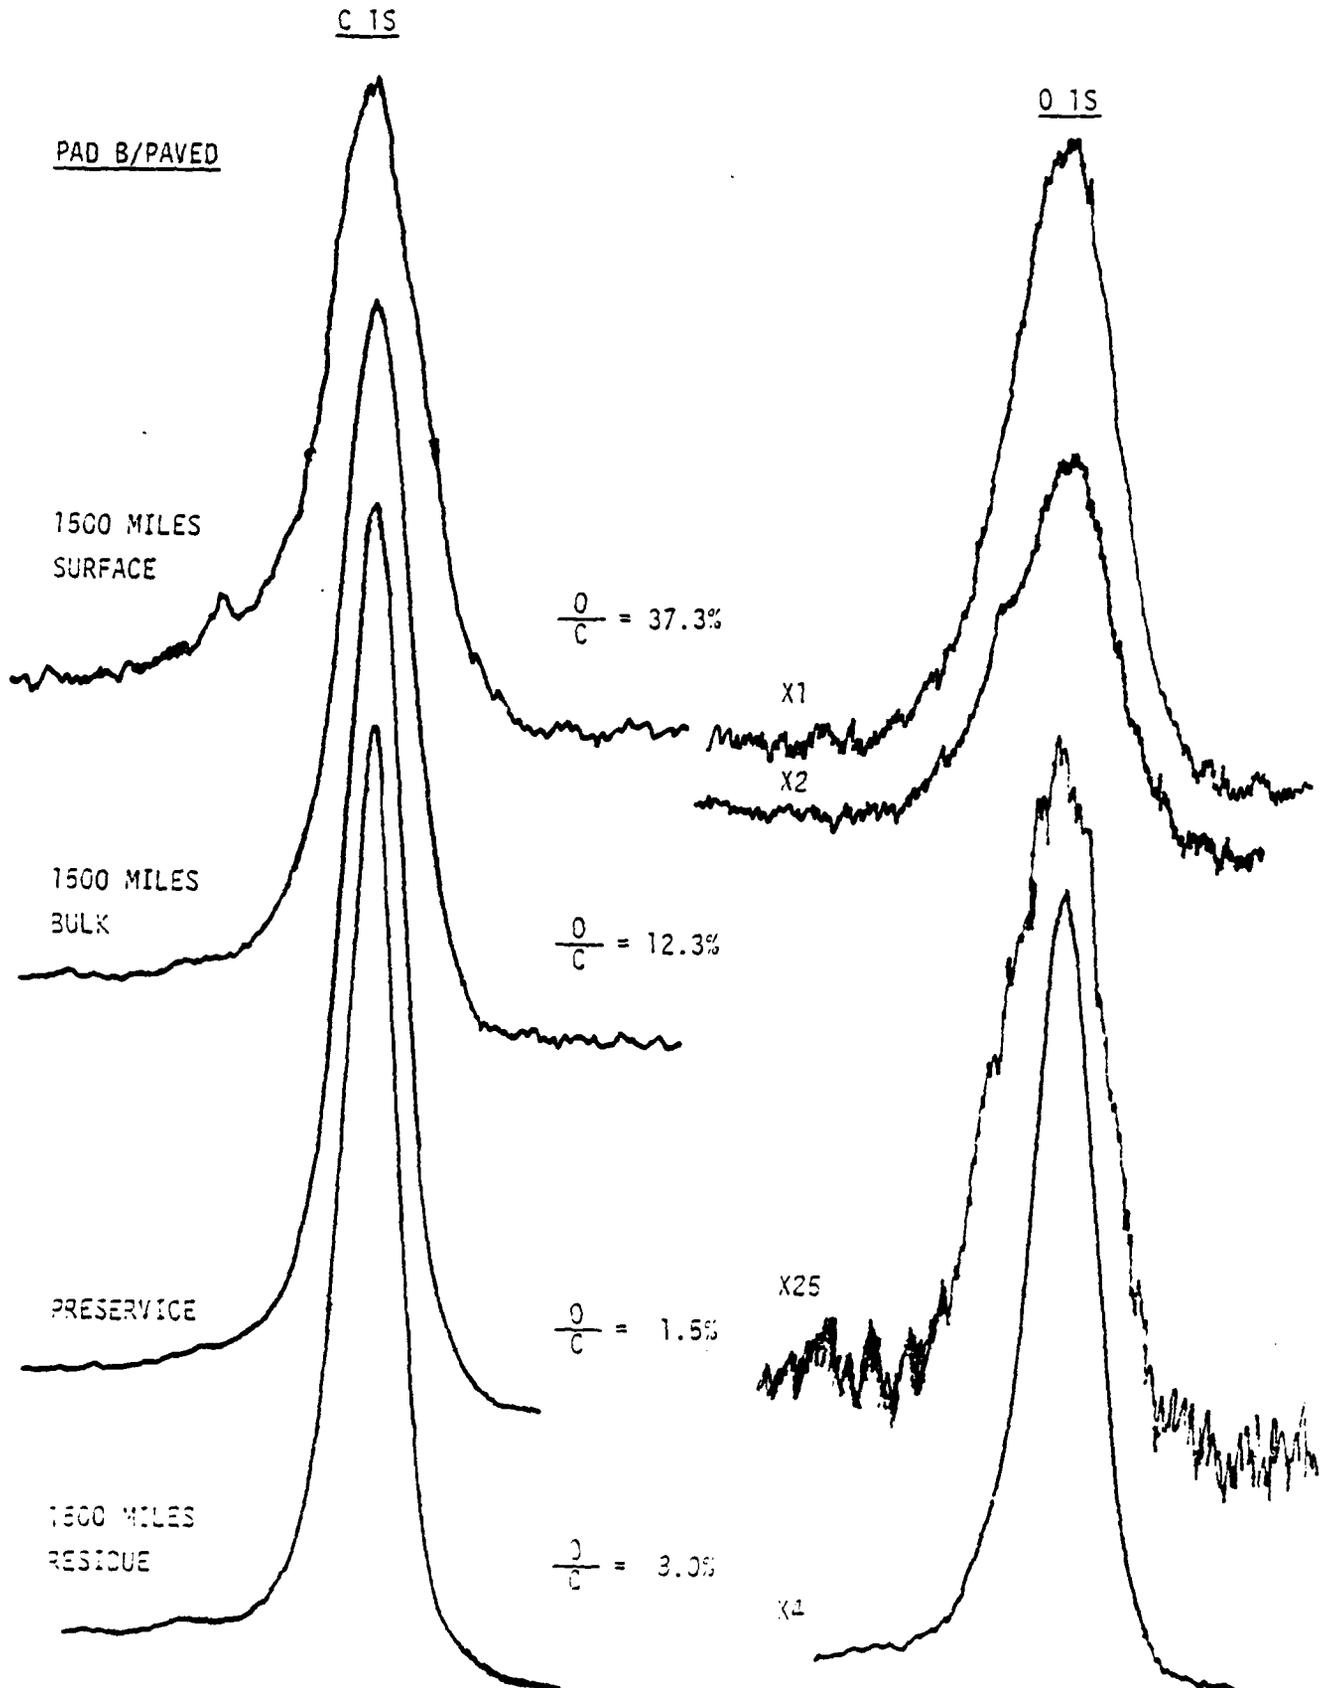
Figure 4. Comparison of Carbon and Oxygen 1s ESCA Spectra for Firestone Pad

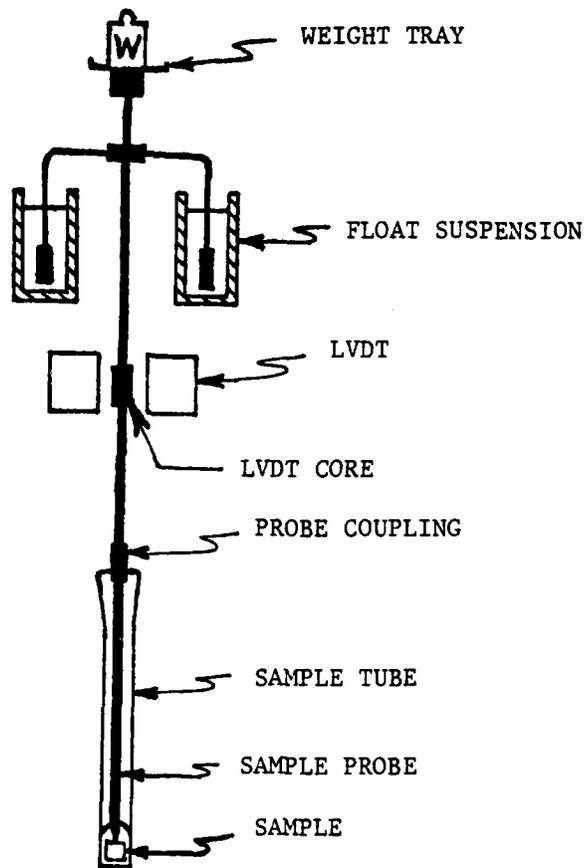
Figure B-1

The apparatus is a Perkin-Elmer Model TMS-2 schematically sketched in Figure B-1. The quartz probe which indents the sample is coupled to a weight tray through an LVDT core. The LVDT senses the penetration distance into the sample caused by the weight. Because of the float suspension, the weight tray requires a mass in the range of 2.1 to 2.8 gm in order to make the probe tip just touch the surface of the sample (zero-weight condition). Additional weight on the loading platform will cause indentation.

Schematic Diagram of Perkin-Elmer TMS-2 Thermal Mechanical Analyzer

One basic probe of the Perkin-Elmer Model TMS-2 is the penetration probe, the tip of which is a small rod of known cross section ($6.2 \times 10^{-3} \text{ cm}^2$). For a given weight on the loading platform, the constant pressure can then be calculated. The TMA output shown on either a voltmeter or a chart recorder

indicates the amount of penetration owing to the applied stress. Since the stress is maintained throughout the test, the time-dependent compressive creep of the sample is observed as loads are placed on or removed from the platform. Therefore, increasing stress added to the sample and the resultant strain measured on the TMS yield a compressive stress-strain curve for a fixed test time. For small loads the stress-strain relationship is linear and continuous at both the tensile and compressive regions⁷ allowing the calculation of Young's Modulus from the slope. The modulus obtained is just relative since the probe tip is flat instead of the round tip used in the theoretical treatment.

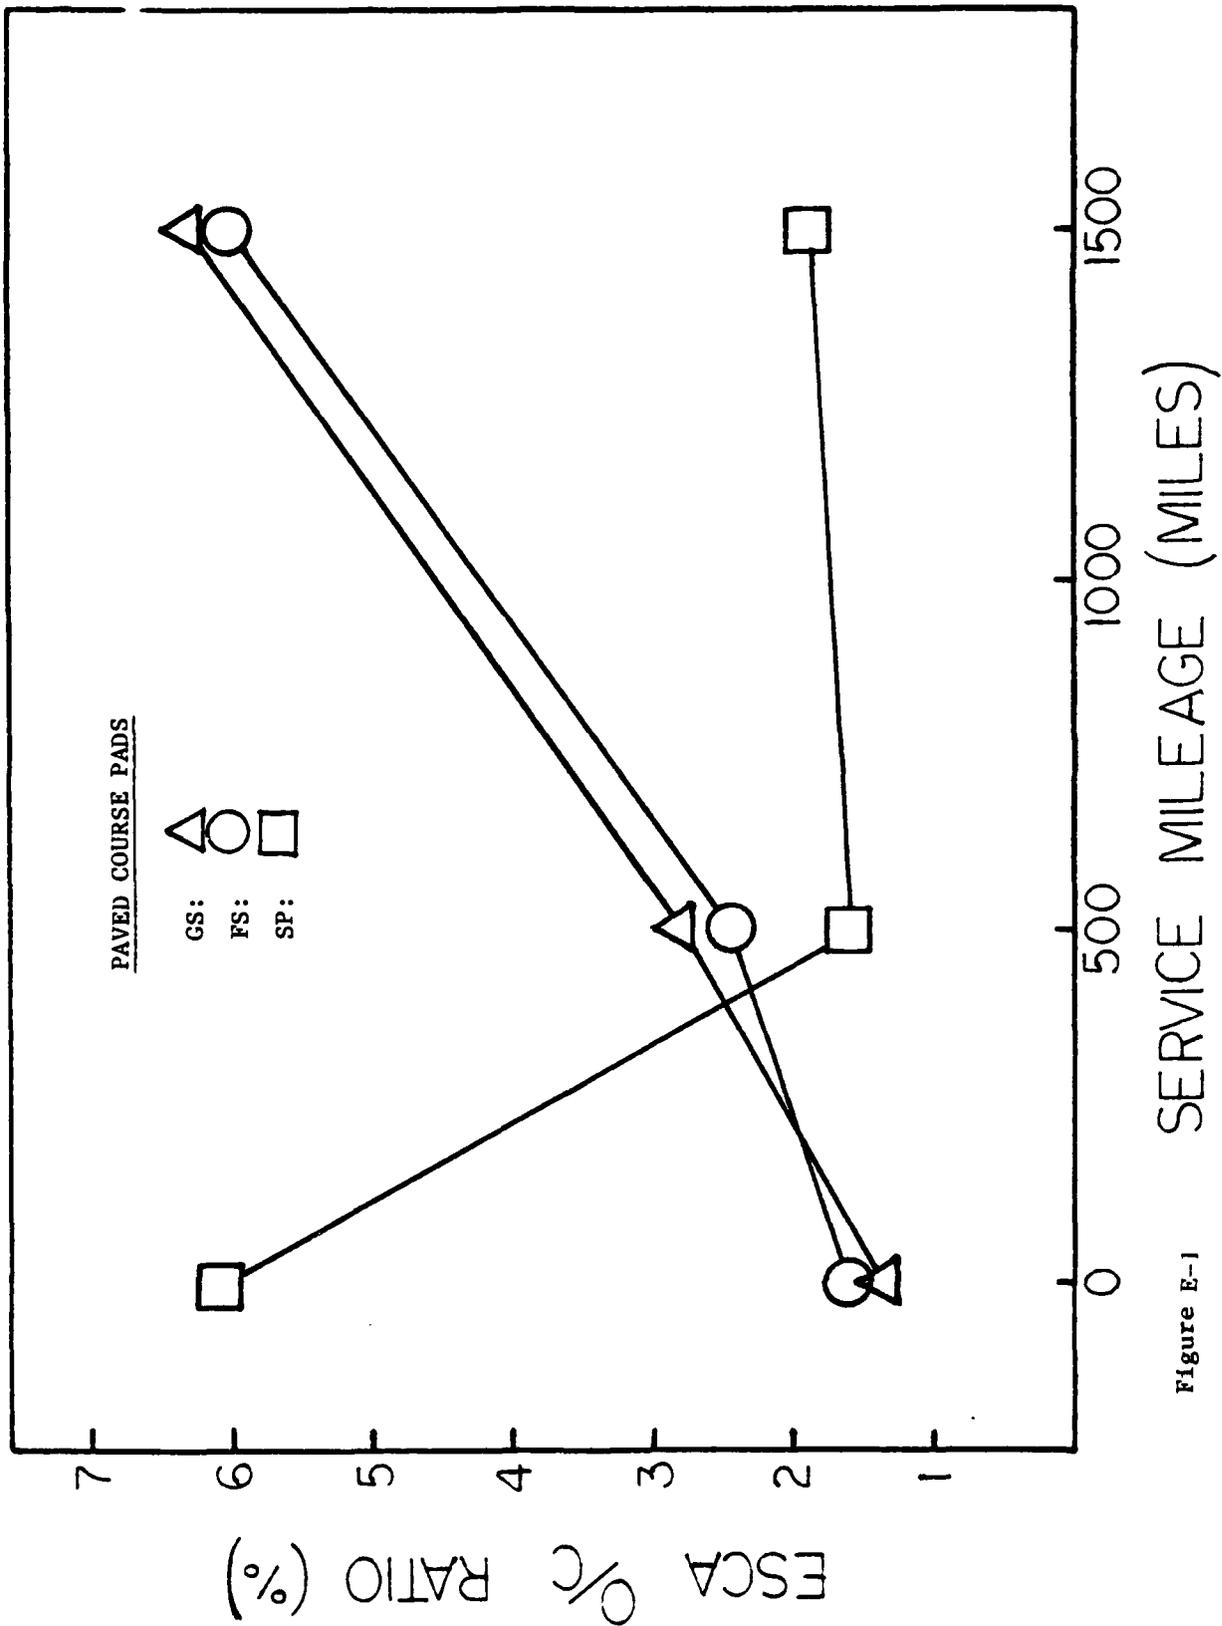
The oxidative degradation of track pad is clearly the most interesting topic in this study. The O/C ratio vs the service mileage was studied and shown in Figures E-1 and E-2. Figure E-1 shows the O/C ratio changes in pavement service, while Figure E-2 shows the cross-country course. The correlation among O/C ration, T_g and volatile content is indicated in Figure 3. The detailed ESCA composition information on most of the track pads is listed from Table E-1 to E-6.
