MISCELLANEOUS PAPER SL-81-7
REPORT NO. ONWI-247
REPORT NO. SAND 81-7109

EXAMINATIONS OF SIMULATED BOREHOLE SPECIMENS

Structures Laboratory
U. S. Army Engineer Waterways Experiment Station
P. O. Box 631, Vicksburg, Miss. 39180

May 1981
Final Report

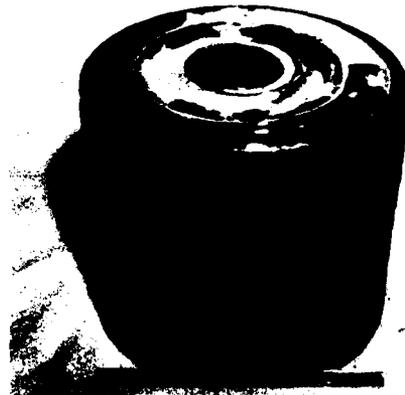
Figure 1. Specimen A10 as cast, X0.3. The uneven white masking on the top surface shows why slices were cut normal to the vertical axis to examine cleaner sawed surfaces. The central circular plug is grout, the surrounding annulus is anhydrite, the outer annulus is grout, and the exterior restraining ring is 6-in.-ID steel pipe

4. Three specimens were prepared in the laboratory using 4-in.-OD anhydrite (anhydrous orthorhombic CaSO_4) cores as the host rock. Figure 1 shows the size and appearance of the specimens. Each was intended to

11. Figure 1 shows the general appearance of a simulated borehole specimen. The surfaces that were examined after cutting or fracturing were all normal to the vertical axis of specimens like the one shown.

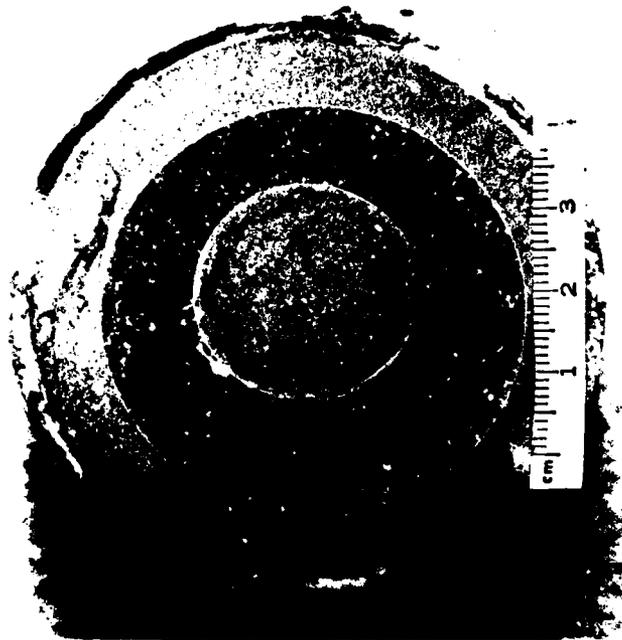
Figure 5. A typical SBB fracture surface shows a metal restraining ring on the outside perimeter next to the outer grout ring. Inside this grout is the anhydrite annulus filled with grout. This inside contact is the one that is examined. The SBB specimens range in size from that shown above, approximately 3 in. in diameter, to a larger size used for permeability testing, approximately 7 in. in diameter.

28. The appearance of a fresh fracture surface of an SBH specimen is shown in Figure 5.
