STATE UNIVERSITY OF NEW YORK COLL AT FREDONIA DEPT O--ETC F/8 B/8
CATTARAUGUS CREEK HARBOR, NEW YORK GENERAL DESIGN MEMORANDUM, P--ETC(U)
MAR 76

REPORT DOCUMENTATION PAGE		READ INSTRUCTIONS BEFORE COMPLETING FORM
1. REPORT NUMBER	2. GOVT ACCESSION NO.	3. RECIPIENT'S CATALOG NUMBER
	AD-A102282	
4. TITLE (and Subtitle) Cattaraugus Creek Harbor, New York General Design Memorandum Phase 11	5. TYPE OF REPORT & PERIOD COVERED Final

APPENDIX E

LITTORAL PROCESSES AND SEDIMENTATION
IN THE CATTARAUGUS EMBAYMENT, NEW YORK

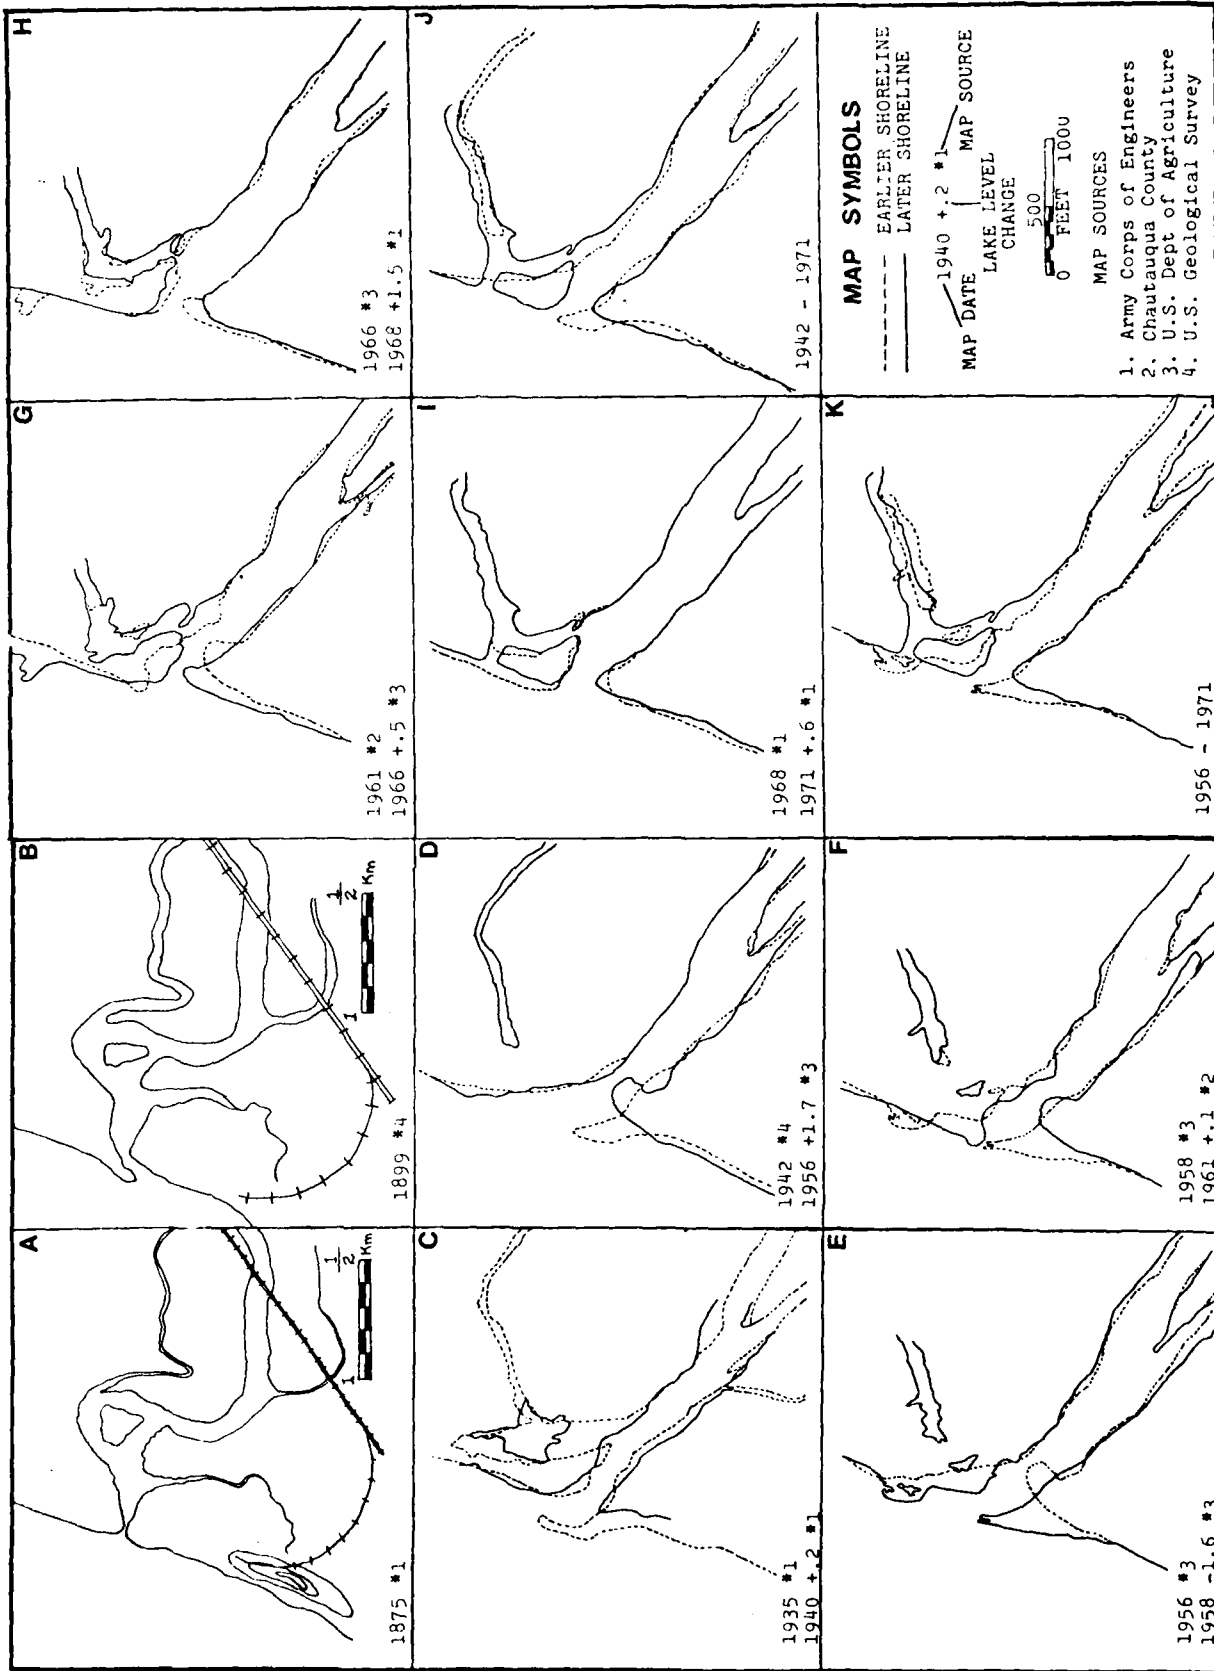
Figure 3. Maps of the mouth of Cattaraugus Creek and the adjacent shoreline from 1875 to 1971. Maps from a U. S. Army Corps report on "Littoral Processes and Sedimentation in the Cattaraugus Embayment, N. Y.," by Nummedal, Hayes and Fahnestock, 1974.
