CULTURAL OVERVIEW
OF THE
BEAR CREEK LAKE AREA
COLORADO

**CULTURAL OVERVIEW
OF THE
BEAR CREEK LAKE AREA
COLORADO**

Prepared for:
U.S. Army Corps of Engineers
Omaha District, Nebraska

August 25, 1980

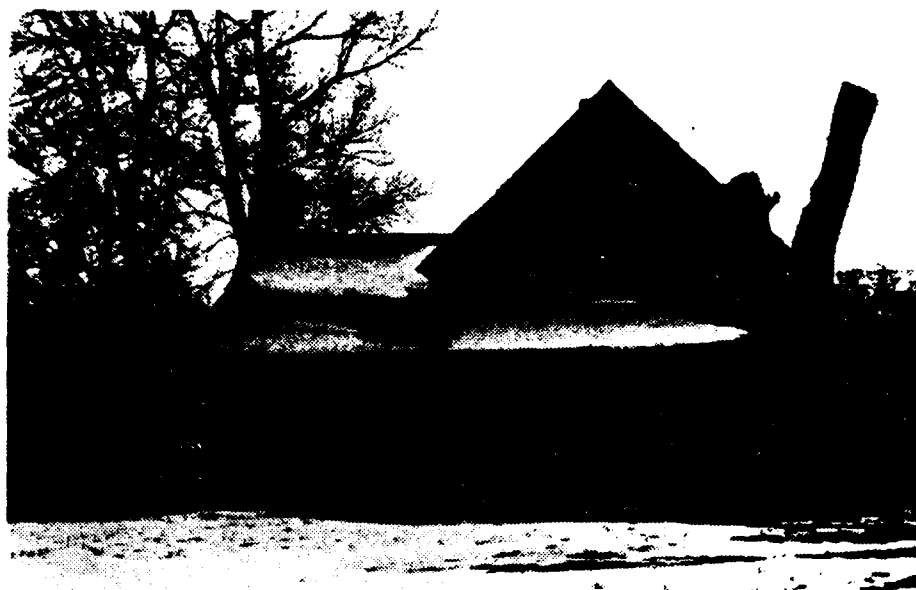
Figure 4. Front view of the Ticen House showing decorative cornice and windows. View is to the south.

Construction of the two additions eliminated several windows; however, the three windows above and to either side of the front entrance appear to be original equipment, as evidenced by irregularities in the glass and wooden-peg construction in the frames (Figures 8 and 9). The windows are of the six-over-six variety. The window lintels above the frames are slightly gabled (Figure 4).

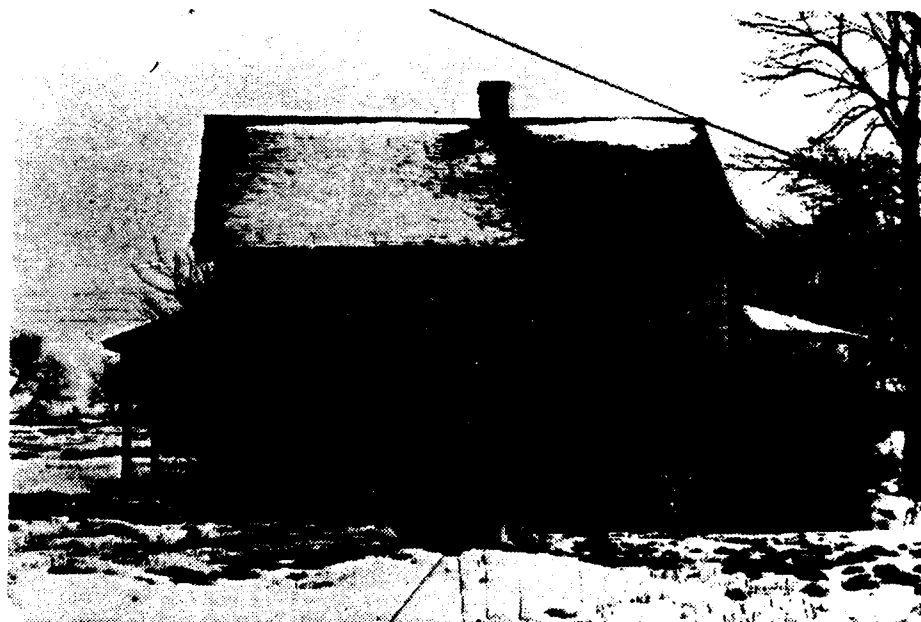
Figure 5. West side of the Ticen House showing front porch.

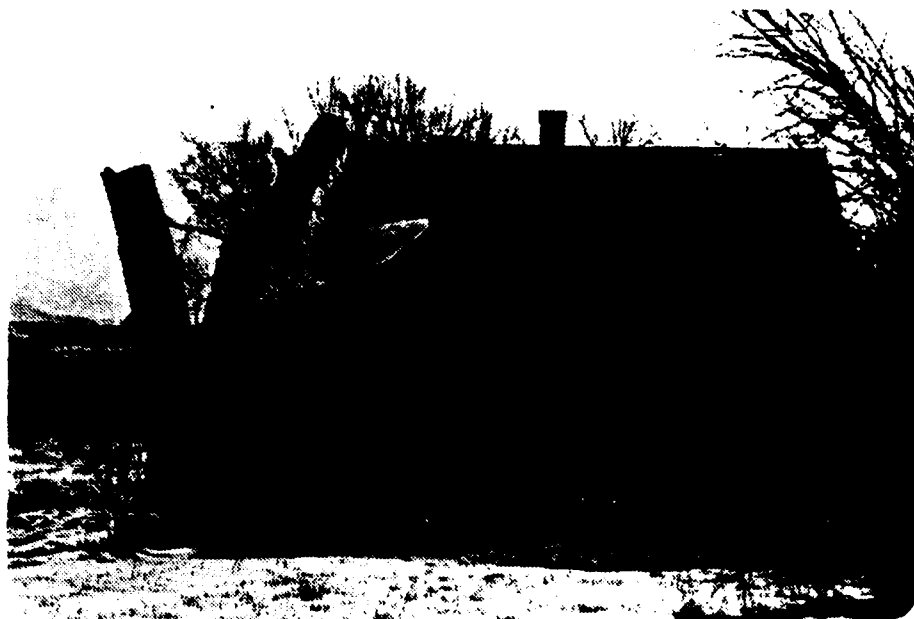
Figure 6. East side of the Ticen House showing additions.

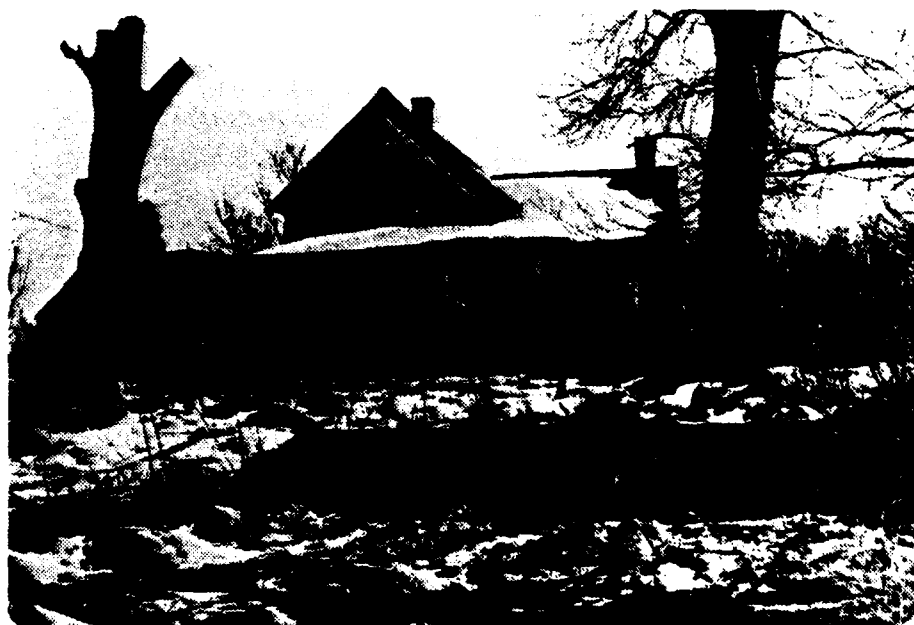
Figure 7. South side of the Ticen House.

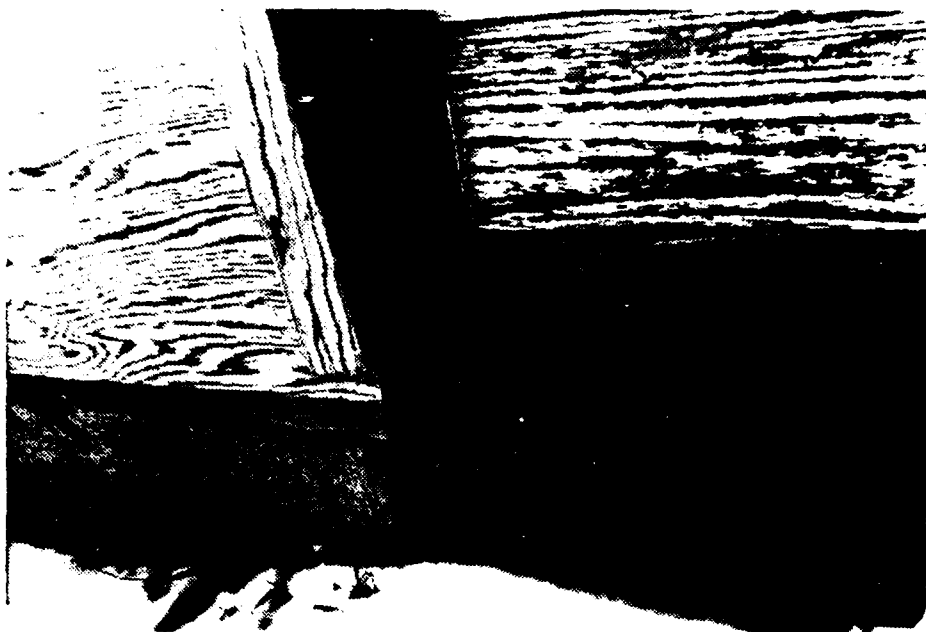
The foundation of the house is constructed of unpatterned mortared sandstone; the structure's floor joists rest directly on the stone. At various points wooden wedges have been driven between the joist and the stone foundation to level the structure (Figure 10). The flush-and-nail method was employed for the construction of the corner joints.

Figure 10. Detail of the Ticen House foundation.

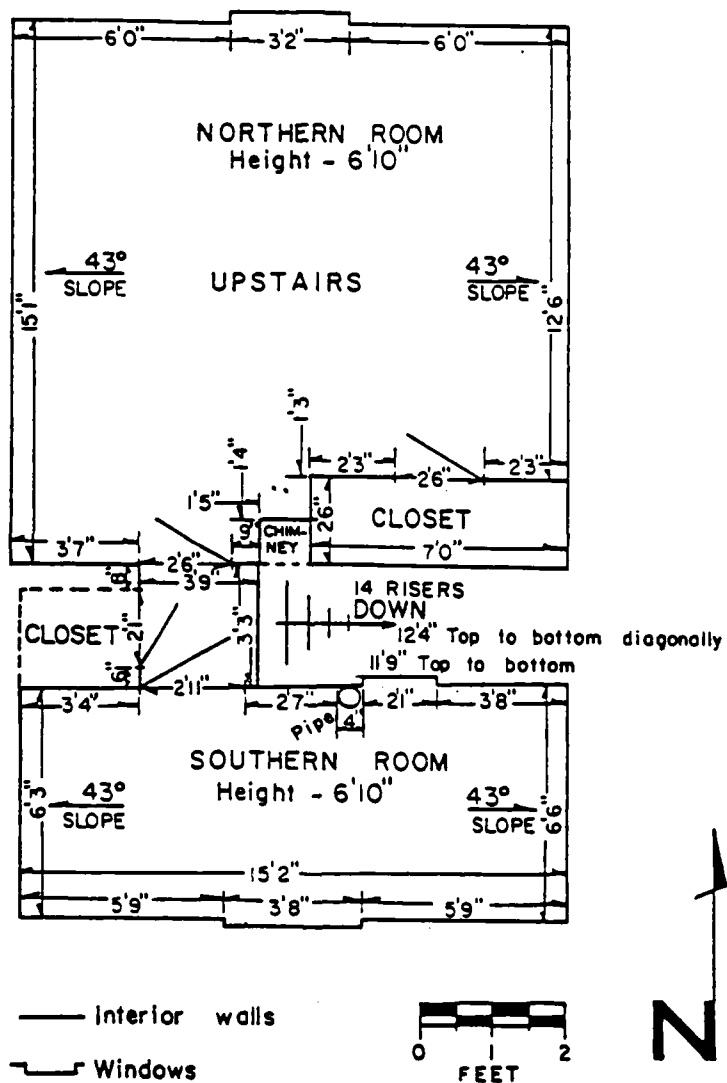
On the second floor of the west wing are two rooms divided by a staircase that originates in the kitchen (Figure 13.) The ceilings of the two rooms are directly inside the gabled roof, giving them a steeply angled appearance. The walls of the northern room are of plywood panelling, obviously a recent addition.

Figure 13. Second story floor plan of the Ticen House.

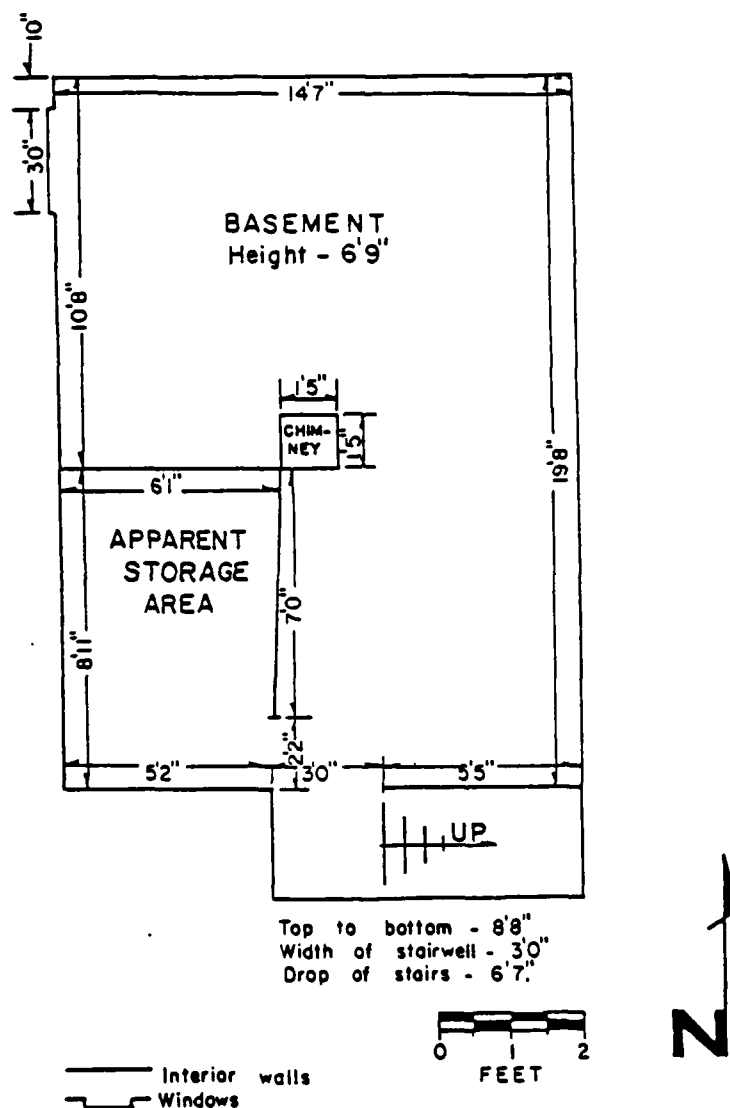
The basement of the house extends under the west wing (Figure 14). A small storage room was built in the southwest corner of the basement. The basement walls are of

Figure 14. Basement floor plan of the Ticen House.

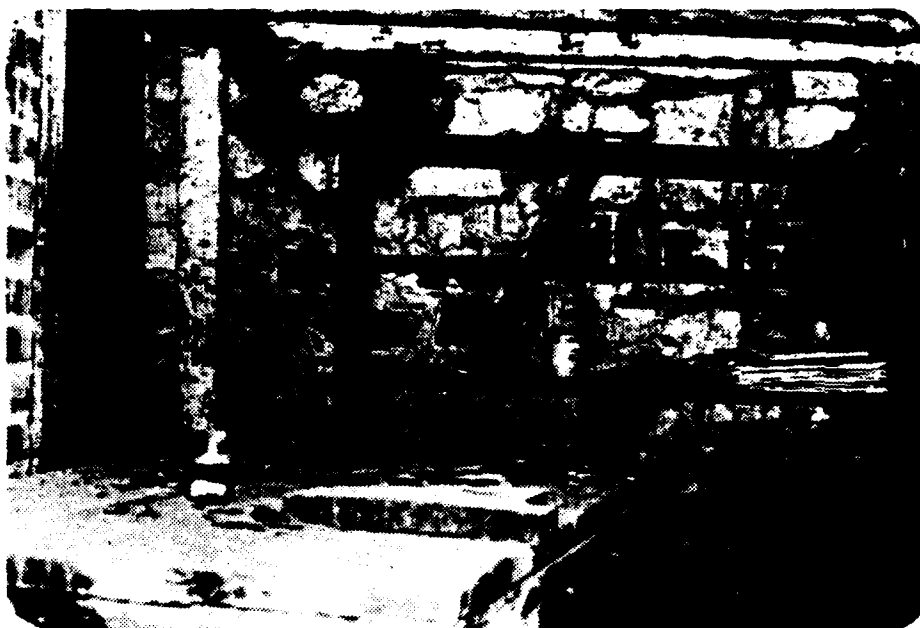
the same stone as the foundation and are mortared (Figure 15). As previously mentioned, a fairly modern brick chimney is centered in the basement. The floor of the basement is also of sandstone. Due to the extensive weathering, it was not possible to determine if it had been mortared in place.

Figure 15. Basement of the Ticen House showing stone and mortar along north wall.

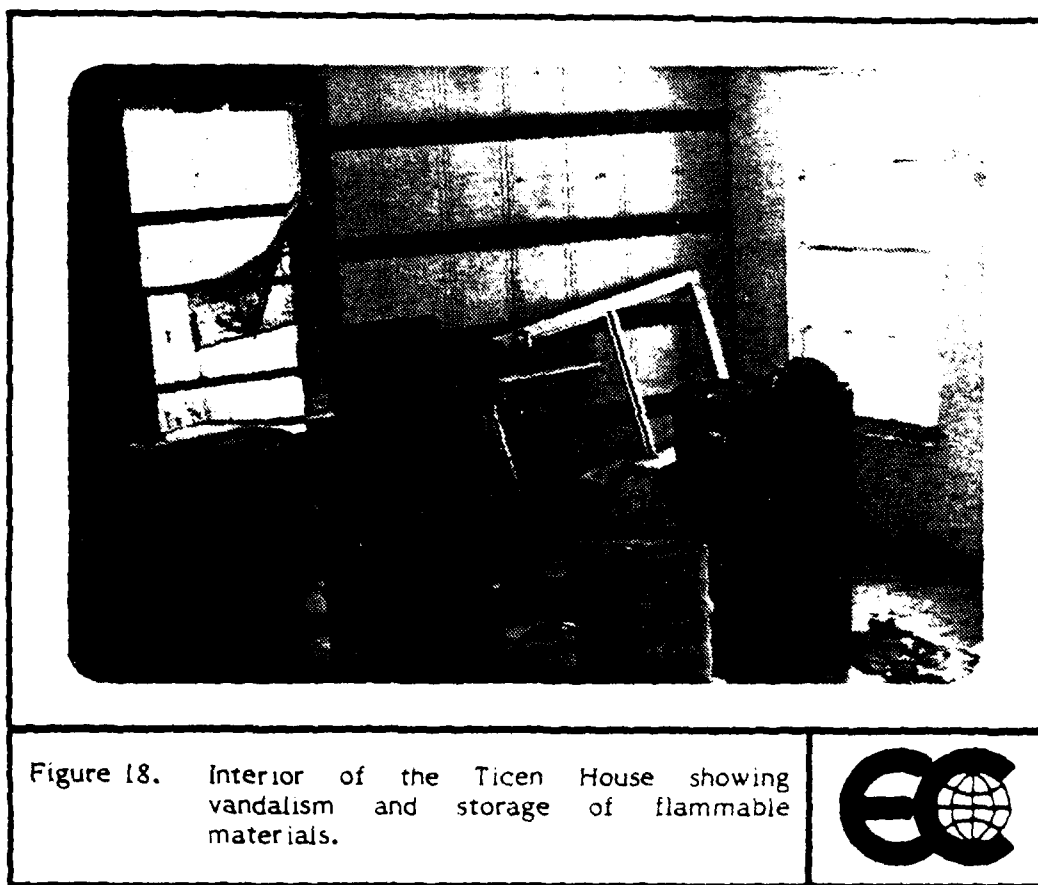
The interior of the Ticen House has been extensively vandalized. Many window panes have been broken, graffiti covers the walls, and assorted flammable chemical containers are scattered throughout the house (Figure 18). The possibility of destruction by fire is ever-present. In addition, sections of the interior walls have been torn off, exposing the superstructure. At the present rate of deterioration the house will soon become unsalvageable.
