Report No. FPRC 80-A-F1

HYDRAULIC SYSTEM ACOUSTICAL DIAGNOSTICS

FINAL REPORT

**PERSONNEL OF THE
FLUID POWER RESEARCH CENTER
OKLAHOMA STATE UNIVERSITY
STILLWATER, OKLAHOMA**

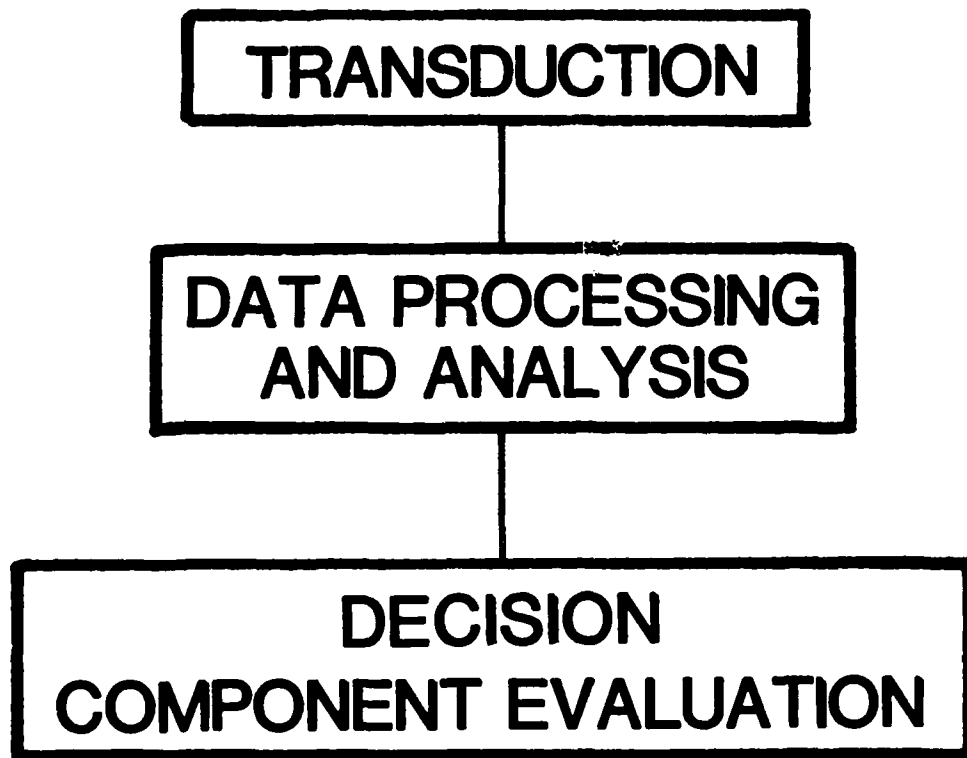
FIG. 2-1. Non-Intrusive Diagnostic System

The hardware of diagnostic systems consists of transducers and a microprocessor to transform the data into the desired format and to proceed through the necessary data reduction. Fig. 2-2 illustrates the possible extent of a diagnostic system and was used as a guide throughout the project. The figure proposed three different systems that

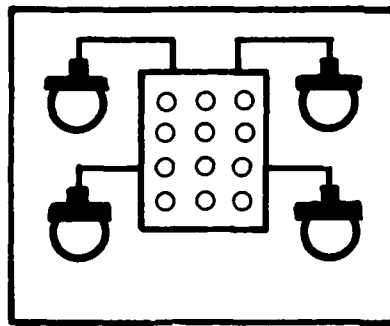
FIG. 2-2. Diagnostic System for Field Application

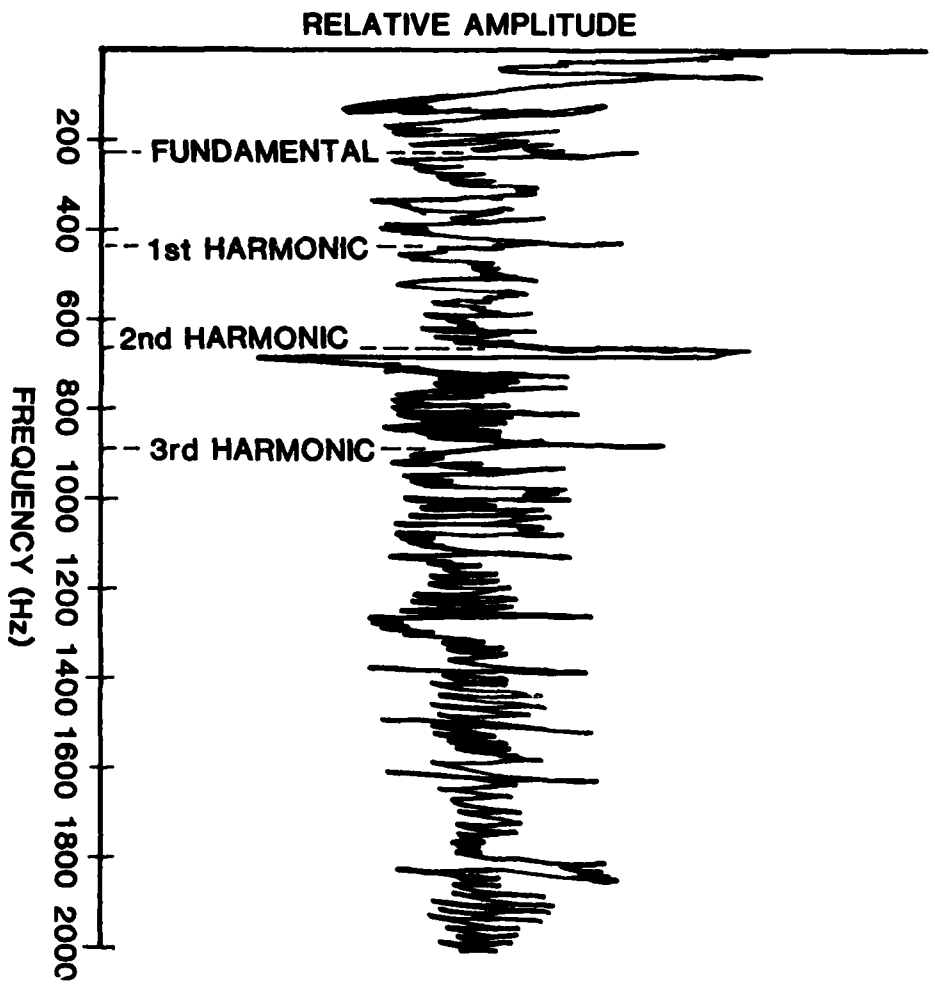
FIG. 3-4. Vane Pump Frequency Spectrum by Microphone in Normal Operation

From the test data shown in Figs. 3-3 to 3-8, it is obvious that the frequency spectra change when degradation occurs. The change of amplitudes at fundamental and harmonic frequencies of the frequency spectra are summarized in Figs. 3-9 and 3-10. Fig. 3-9 shows the change of amplitudes due to cavitation and vane damage as monitored by an accelerometer. Cavitation decreases only the second and the third harmonic amplitudes significantly, while vane damage decreases all fundamental, first, second, and third harmonic amplitudes down to 40 percent of the original values.

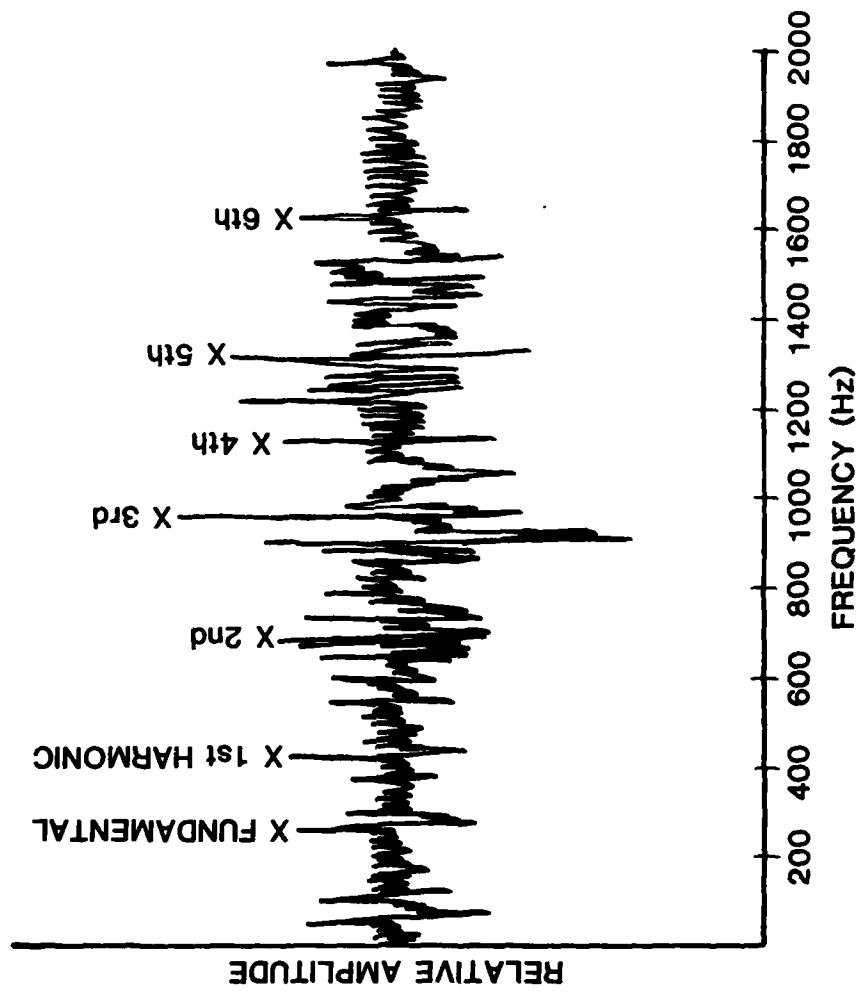
FIG. 3-5. Vane Pump Frequency Spectrum by Accelerometer in Cavitation

Cavitation data recorded with the accelerometer and microphone are shown in Figs. 3-5 and 3-6, respectively. To obtain cavitation, the charge pump was removed from the inlet side of the pump, and inlet pressure was lowered by throttling the line. Otherwise, the operating parameters are identical to those in the previous tests. The vane passage fundamental frequency with its first few harmonics can again be seen. The accelerometer data in Fig. 3-5 contain harmonics up to the sixth. While the higher order harmonics do not coincide exactly with the appropriate multiple of the fundamental frequency, this is to be expected in a V-belt drive system. The important point is that the microphone data in Fig. 3-6 also contain the higher order harmonics but they are covered up by "noise".

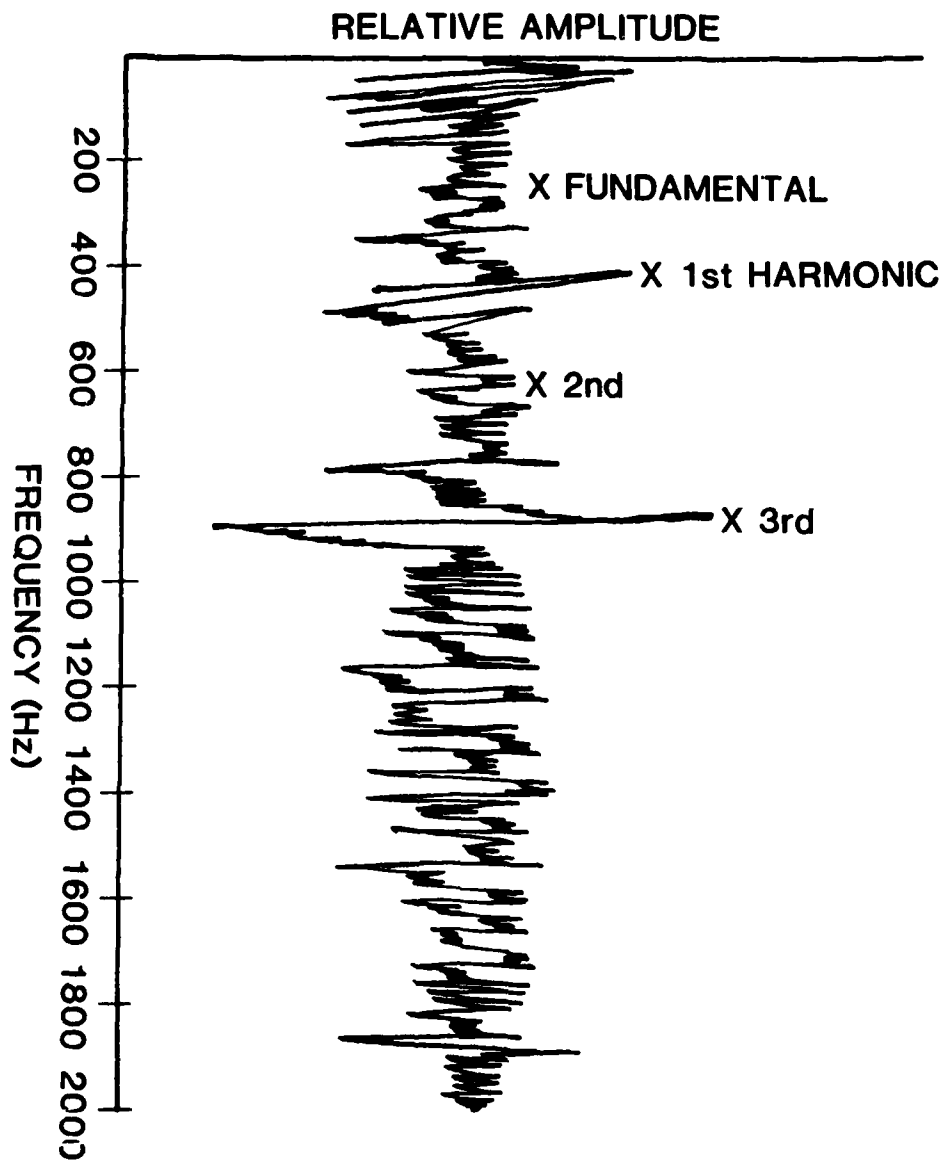
FIG. 3-6. Vane Pump Frequency Spectrum by Microphone in Cavitation

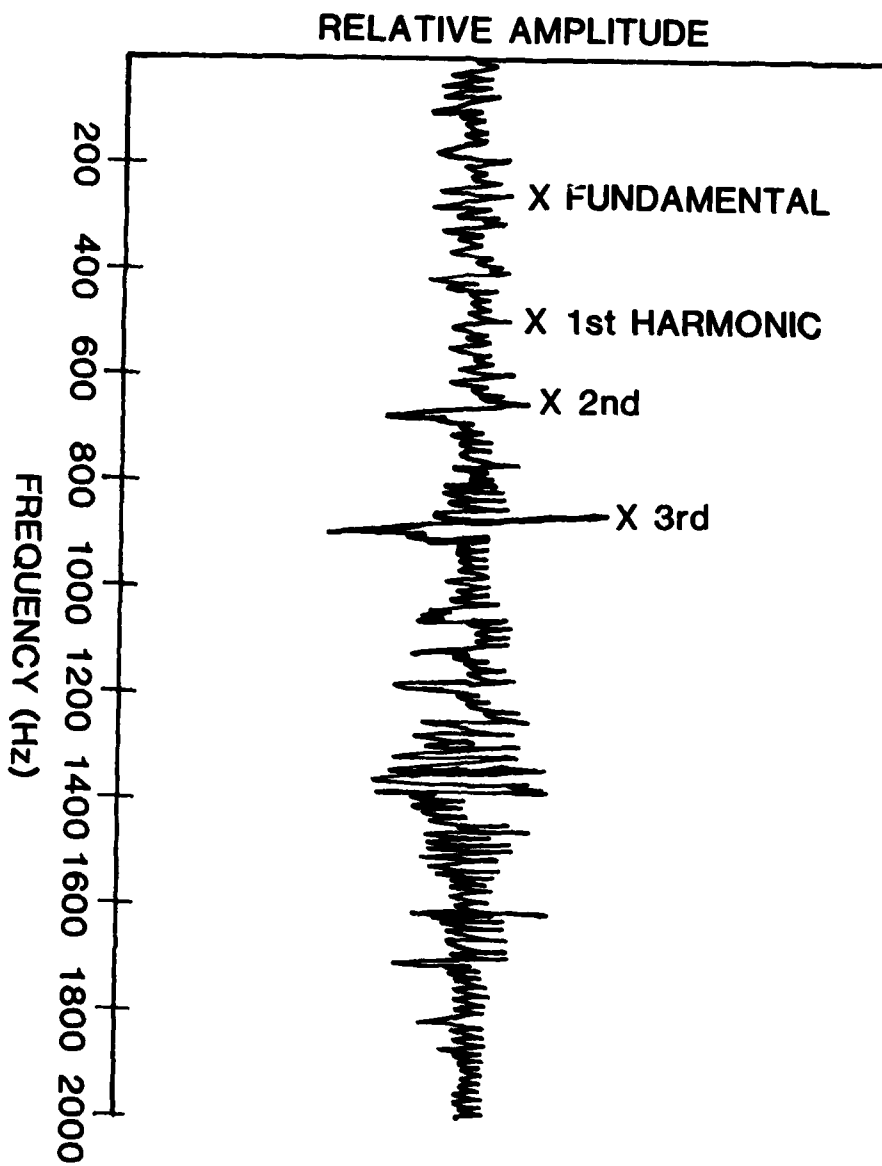
FIG. 3-7. Vane Pump Frequency Spectrum by Accelerometer with Vane Damage

The final test involved vane damage similar to that which could occur in the field. The pump was disassembled and a small groove was made with a file on the wiping edge of a single vane. The pump was then installed in the system with other operating parameters remaining unchanged. In order to simulate vane damage only, the charge pump was

reinstalled in the pump inlet line. Figs. 3-7 and 3-8 represent accelerometer and microphone data, respectively, for induced vane damage.

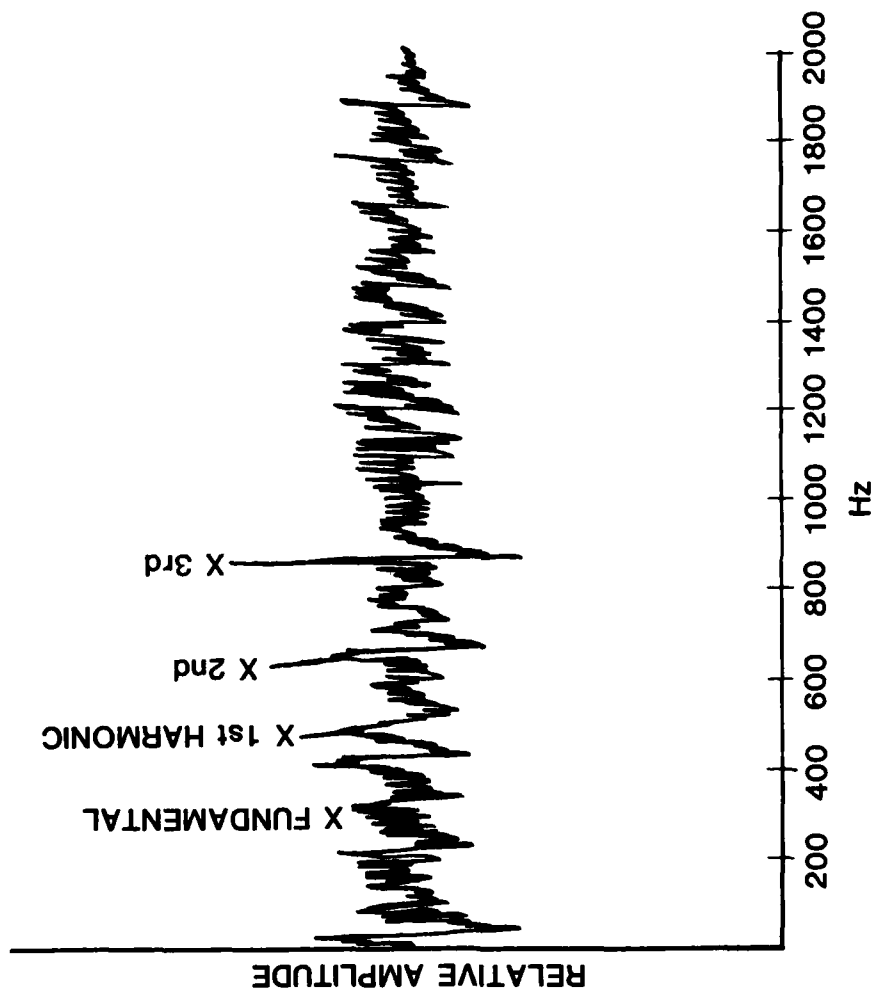
FIG. 3-8. Vane Pump Frequency Spectrum by Microphone with Vane Damage

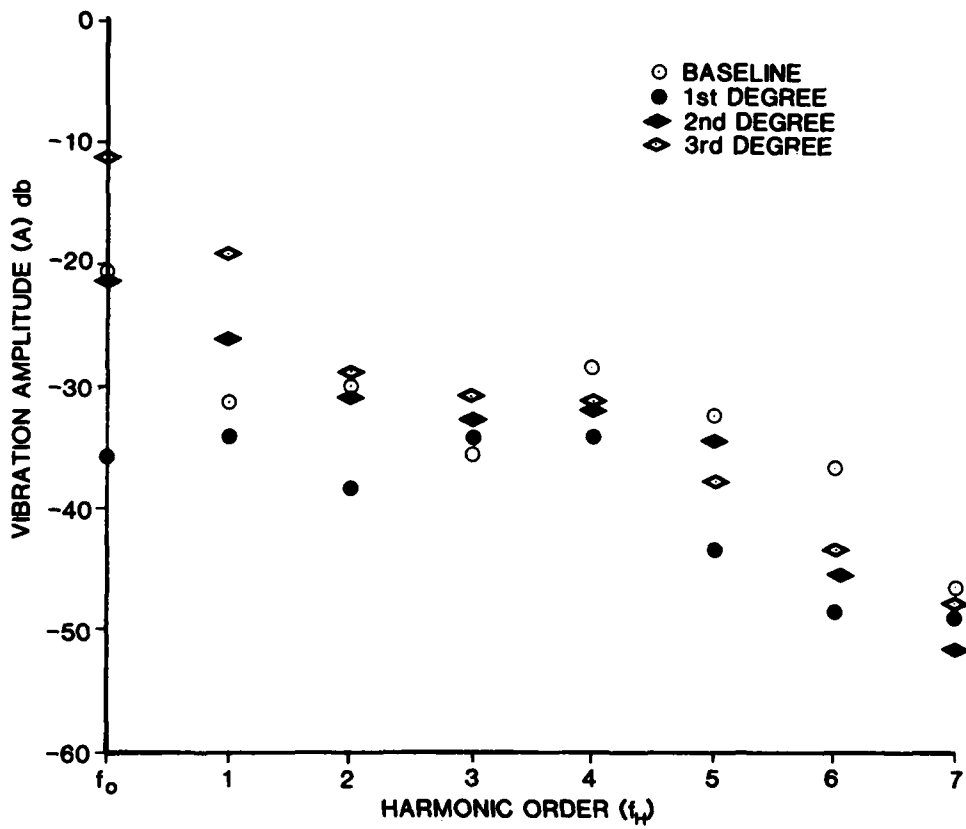
FIG. 5-1. Cavitation - Vibration Amplitude vs Harmonic Order

Fig. 5-1 is a representation of the vibration signature for the first seven harmonics resulting from the three different severity levels of cavitation. The figure shows an actual decrease in the vibration amplitude throughout the first level of severity. This indicated that the inlet pressure at the first degree of severity is above the incipient pressure corresponding to the operating conditions of the pump.

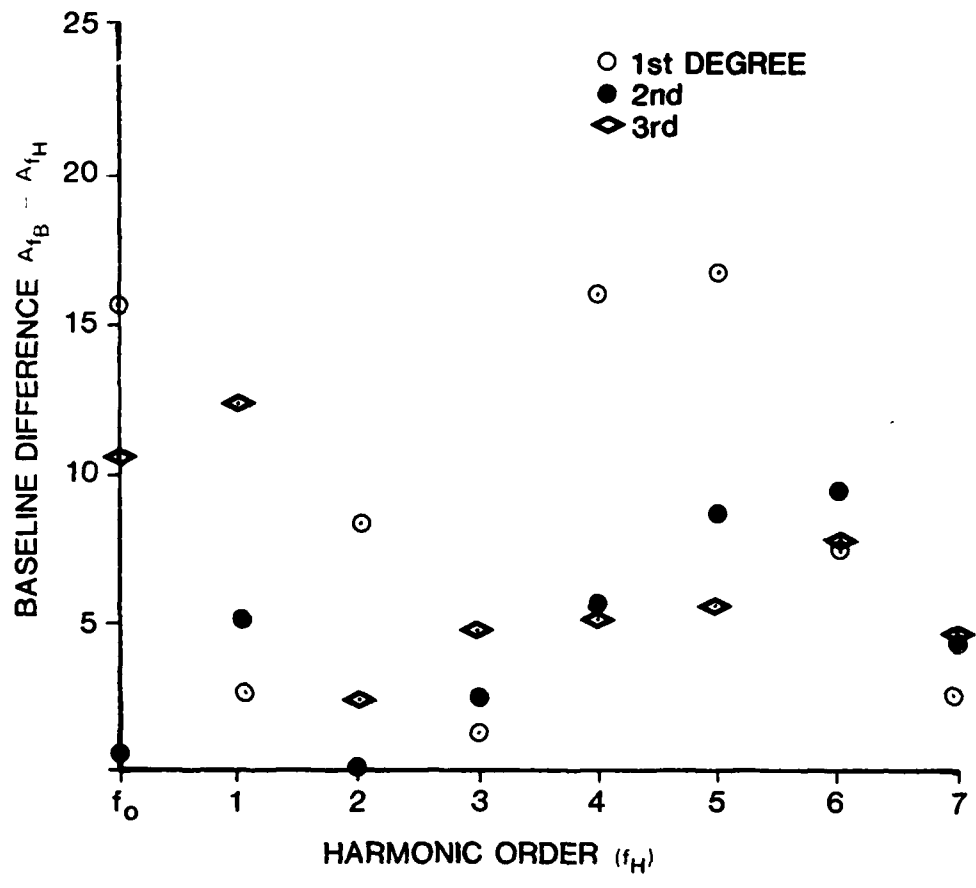
FIG. 5-2. Cavitation Baseline Difference vs Harmonic Order

The analysis methods applied to the cavitation situation are shown in Figs. 5-2 and 5-3. Fig. 5-2 shows the baseline difference analysis, and Fig. 5-3 shows the signature difference analysis. For the detection of cavitation situation, the baseline difference, Fig. 5-2, lacks consistency; however, the signature difference analysis offers a clear

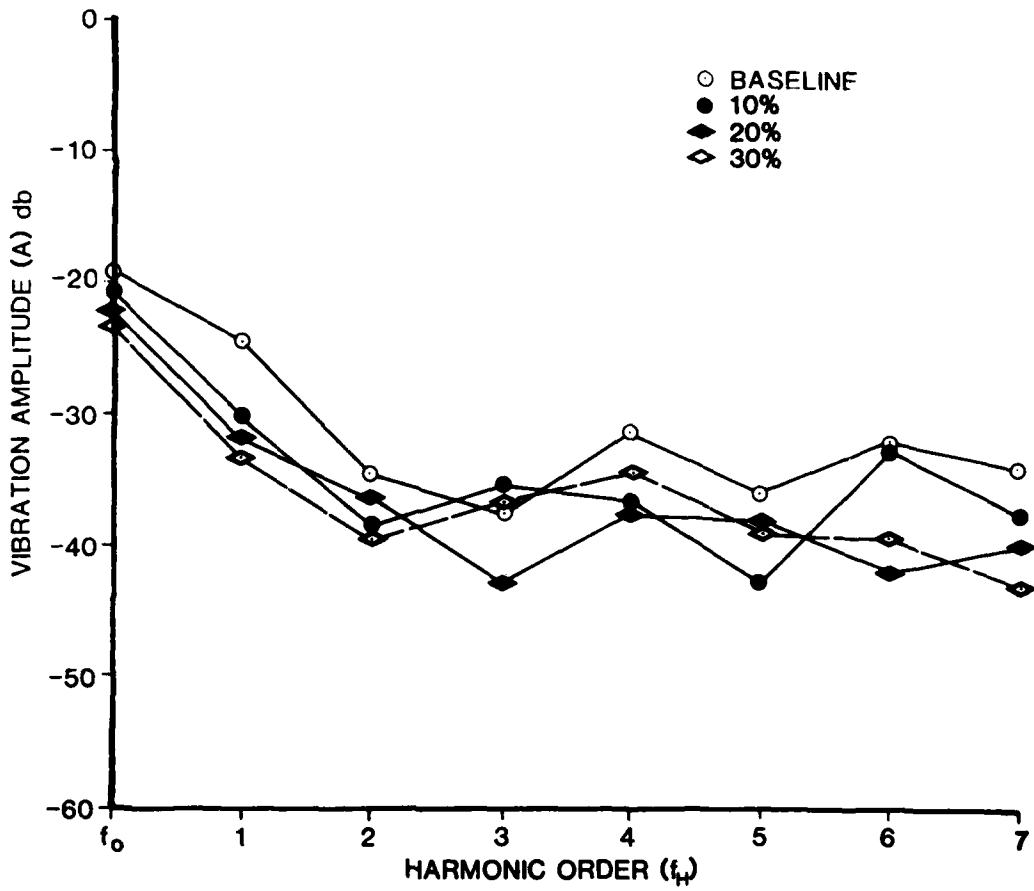
FIG. 5-4. Wear Vibration Amplitude vs Harmonic Order

Fig. 5-4 represents the amplitude levels of the first seven harmonics. The amplitude variations corresponding to three levels of flow degradation (10, 20, and 30 percent) were analyzed by both methods. The baseline difference and signature difference are shown in Figs. 5-5 and 5-6, respectively.

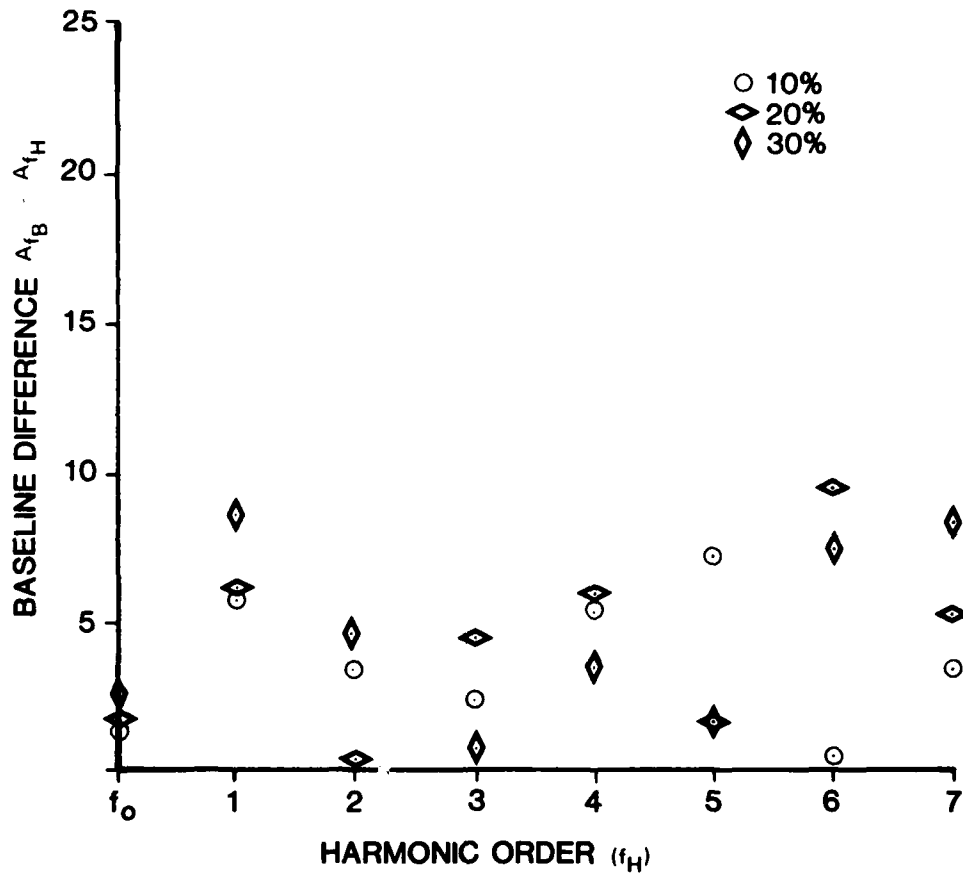
FIG. 5-5. Wear Baseline Difference vs Harmonic Order

Both methods showed a good correlation with a degree of flow degradation at seventh harmonic; however, a good correlation could not be

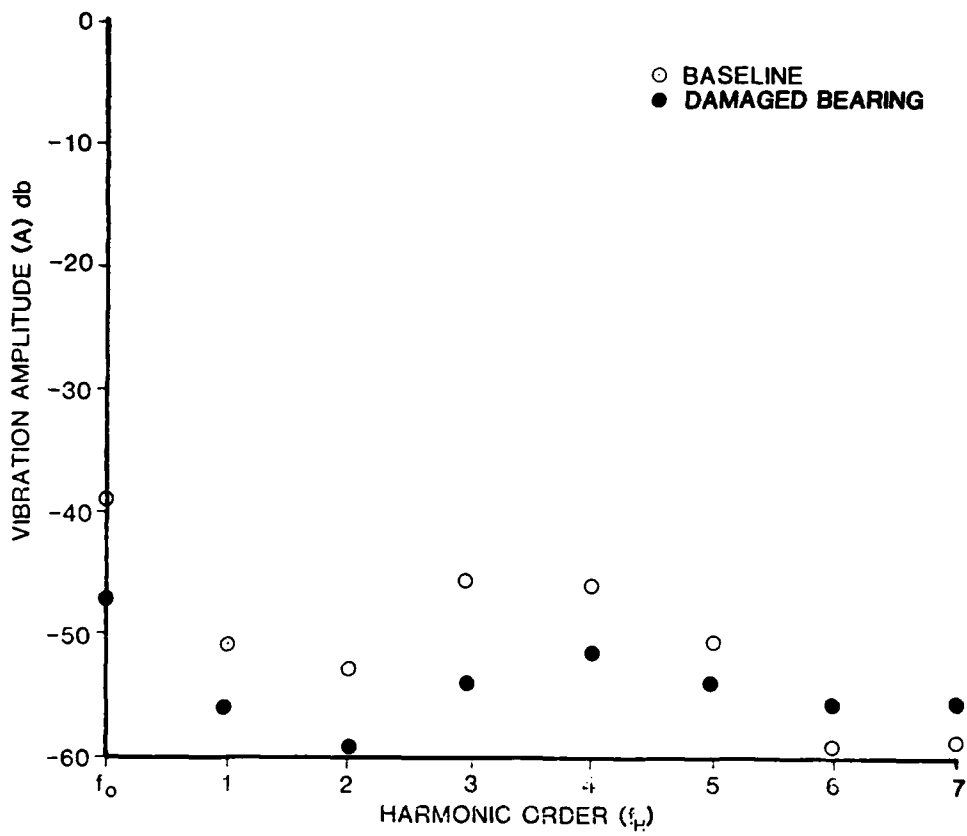
FIG. 5-7. Bearing Damage Vibration vs Harmonic Order

The pumps utilized sealed, roller, non-friction bearings. The system consisted of seven roller bearings in which one was scored for test purposes. The vibration amplitudes are shown in Fig. 5-7. The baseline and signature difference methods are shown in Figs. 5-8 and 5-9, respectively. Since there was only one bearing damage situation introduced to the test pump, it is not possible to discuss a trend of the baseline differences; however, the baseline difference itself can be

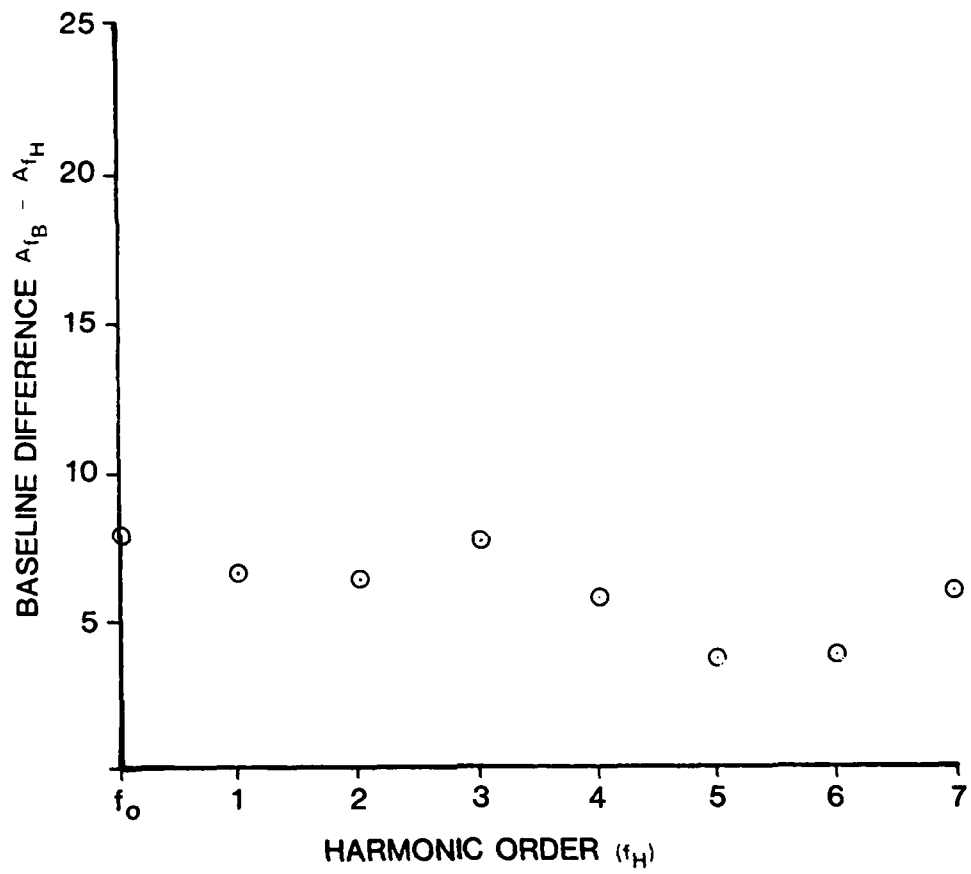
FIG. 5-8. Bearing Damage Baseline Difference vs Harmonic Order

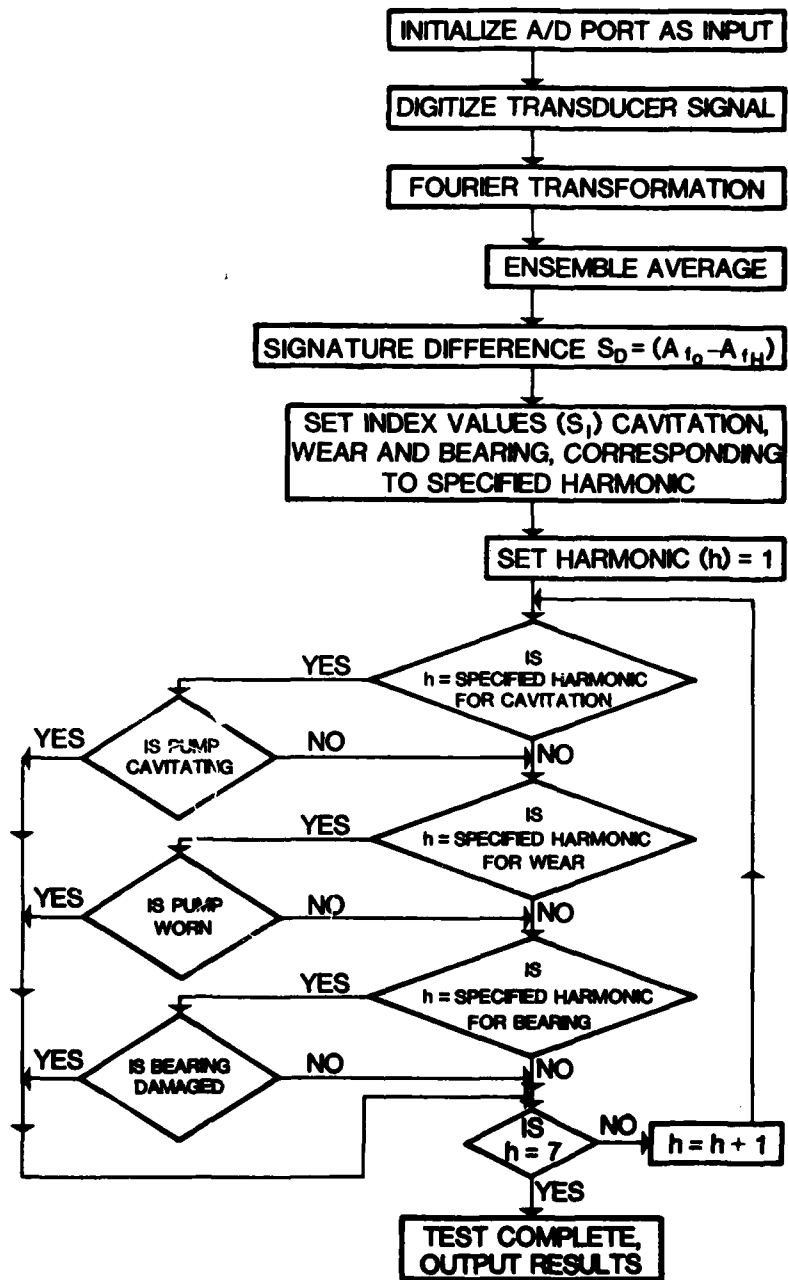
FIG. 5-12. Logic Chart

The development of a non-intrusive diagnostic method would consist of an analysis technique which would involve a minimal amount of human interface for the diagnostic evaluation of the vibration signature. The diagnostic method to be utilized including frequency range and the waveform analysis technique would be part of a dedicated software program used in a microprocessor spectrum analyzer. Fig. 5-12 illustrates a flow chart that would accompany the signature difference analysis method used in Figs. 5-3, 5-6, and 5-9. A large transition exists from the test results of the project and Fig. 5-12; however, this serves to illustrate the ideology behind the proposed diagnostic method. The parameters to be entered into the analysis program would consist of values of the signature difference and corresponding harmonics which would set vibrational setpoints from which to compare the vibrational amplitudes of hydraulic components in service. The setpoints would represent limit values in relation to the incoming signal for values of wear, cavitation, or damaged bearings.
