THE DELAYED FRACTURE OF ALUMINUM ALLOYS

End of Year Report

March 1982

MARTIN MARIETTA CORPORATION
Martin Marietta Laboratories
1450 South Rolling Road
Baltimore, MD 21227-3898

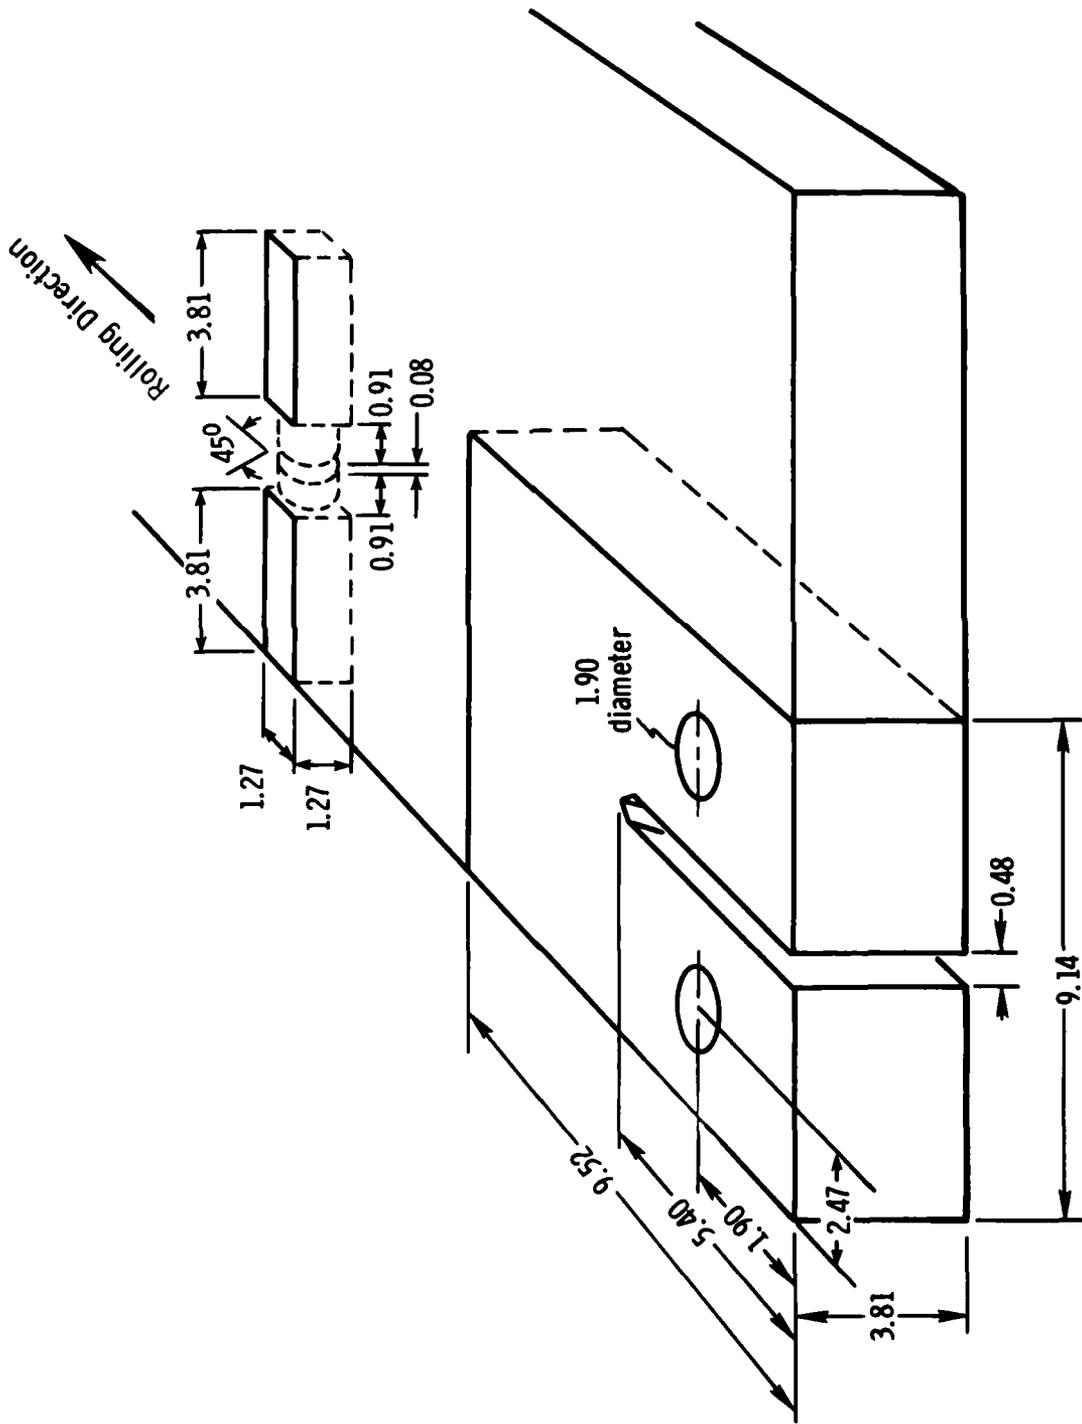
Figure 1. Orientation of compact tension (Mode I) and torsion (Mode III) specimens from 5083 plate. (dimensions in cm)

For Mode III, we used a torsion apparatus similar to that used by Green et al.,⁽⁵⁾ but modified their cylindrical specimen configuration by sharpening the notch (Fig. 1); we introduced fatigue precracking by imposing a constant bending moment on each notched specimen in a lathe for 15 min at 120 rpm. To estimate the initial precrack size after fracture, we measured the area of the initial test ligament using a Hewlett-Packard digitizer, found the radius of a circle having the same area, and subtracted the value of this radius from the size of the test

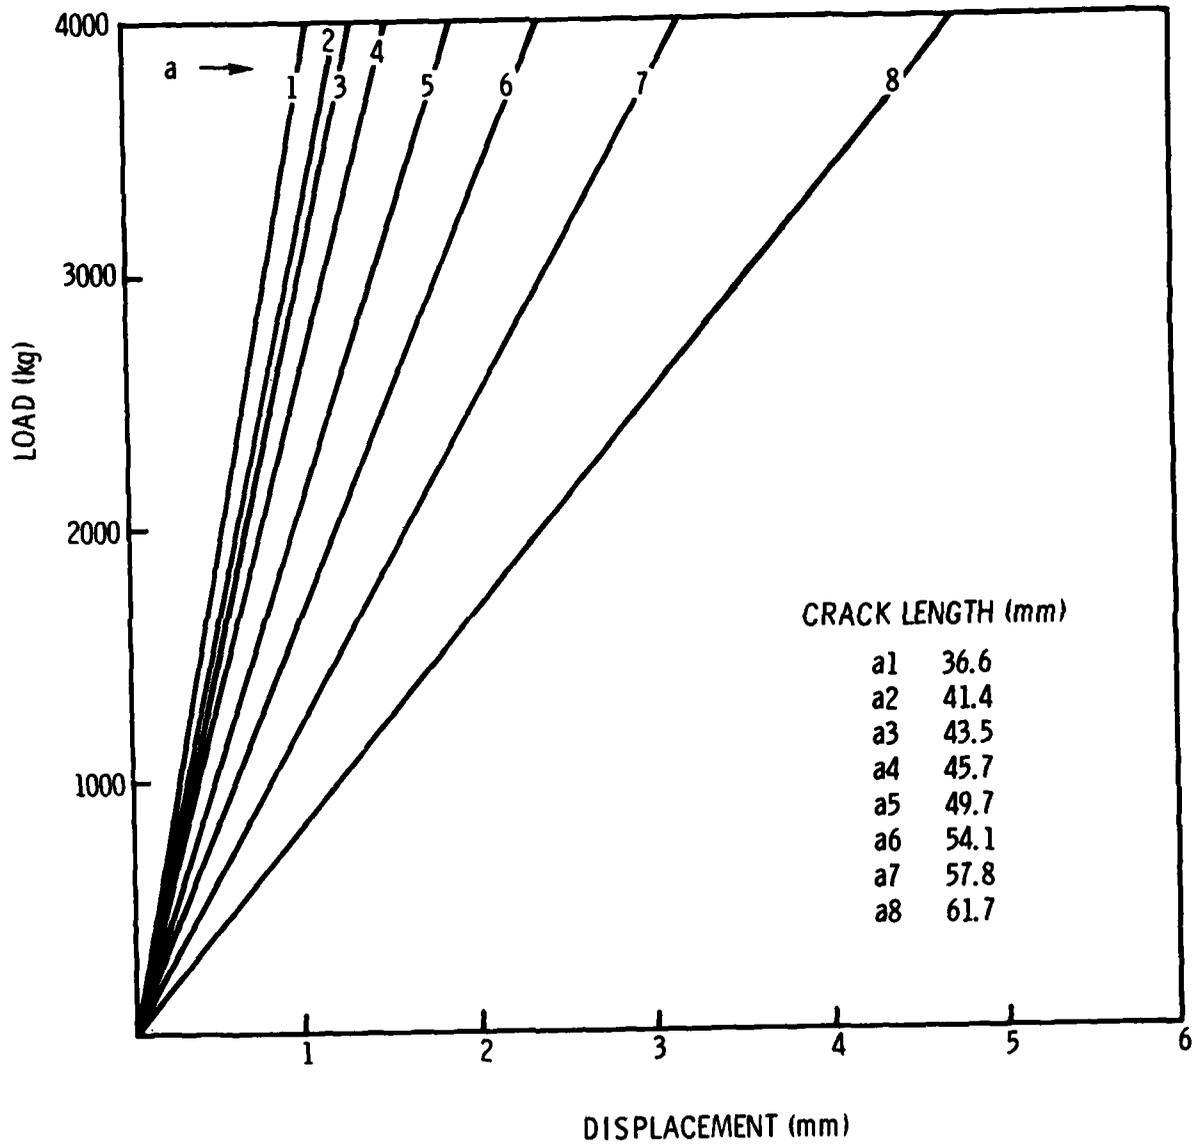
Figure 2. Load displacement curves from which compliance calibration was made.

We performed a compliance calibration and stressed the specimens under constant load in an MTS servo-hydraulic test system with a 10,000-lb capacity. The specimens were subjected to "alternate immersion" (10 min wet and 50 min dry) in the test solution. The displacement of the loading pins was measured and plotted as a function of time. This information, along with the compliance calibration, enabled us to generate curves of crack velocity vs stress intensity.

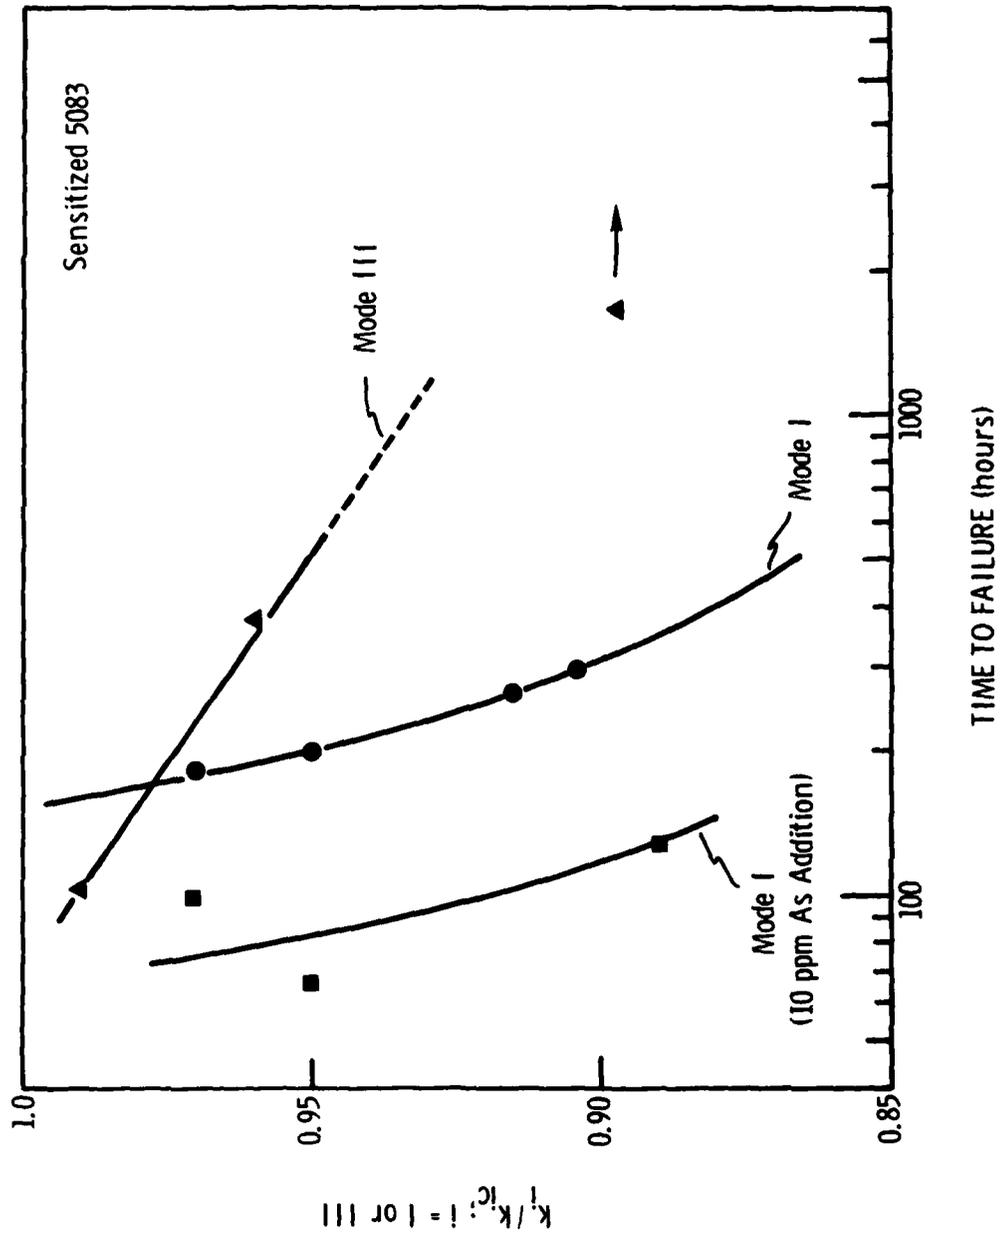
Figure 3. Effect of loading mode on time to failure in salt-dichromate-acetate solution (alternate immersion) for sensitized 5083.

With accurate values of K_{IC} and precise (although possibly not accurate) values of K_{IIIIC} , the SCC data in each mode can be compared. Figure 3, a plot of K_I/K_{IC} and K_{III}/K_{IIIIC} vs ttf, reveals a much longer life in Mode III than in Mode I. In fact, at $K_{III}/K_{IIIIC} = 0.9$, a Mode III specimen did not fail in 1,500 hours. As shown in Fig. 3, the addition of arsenic to the SCC environment substantially decreased ttf in Mode I.

The above observations strongly indicate that HE contributes significantly to stress-corrosion cracking in 5083. That is, the farther the Mode I curve is displaced to the left of the Mode III curve (see Fig. 3), and the farther the additional displacement of the Mode I curve in the presence of As, the greater the contribution of HE.

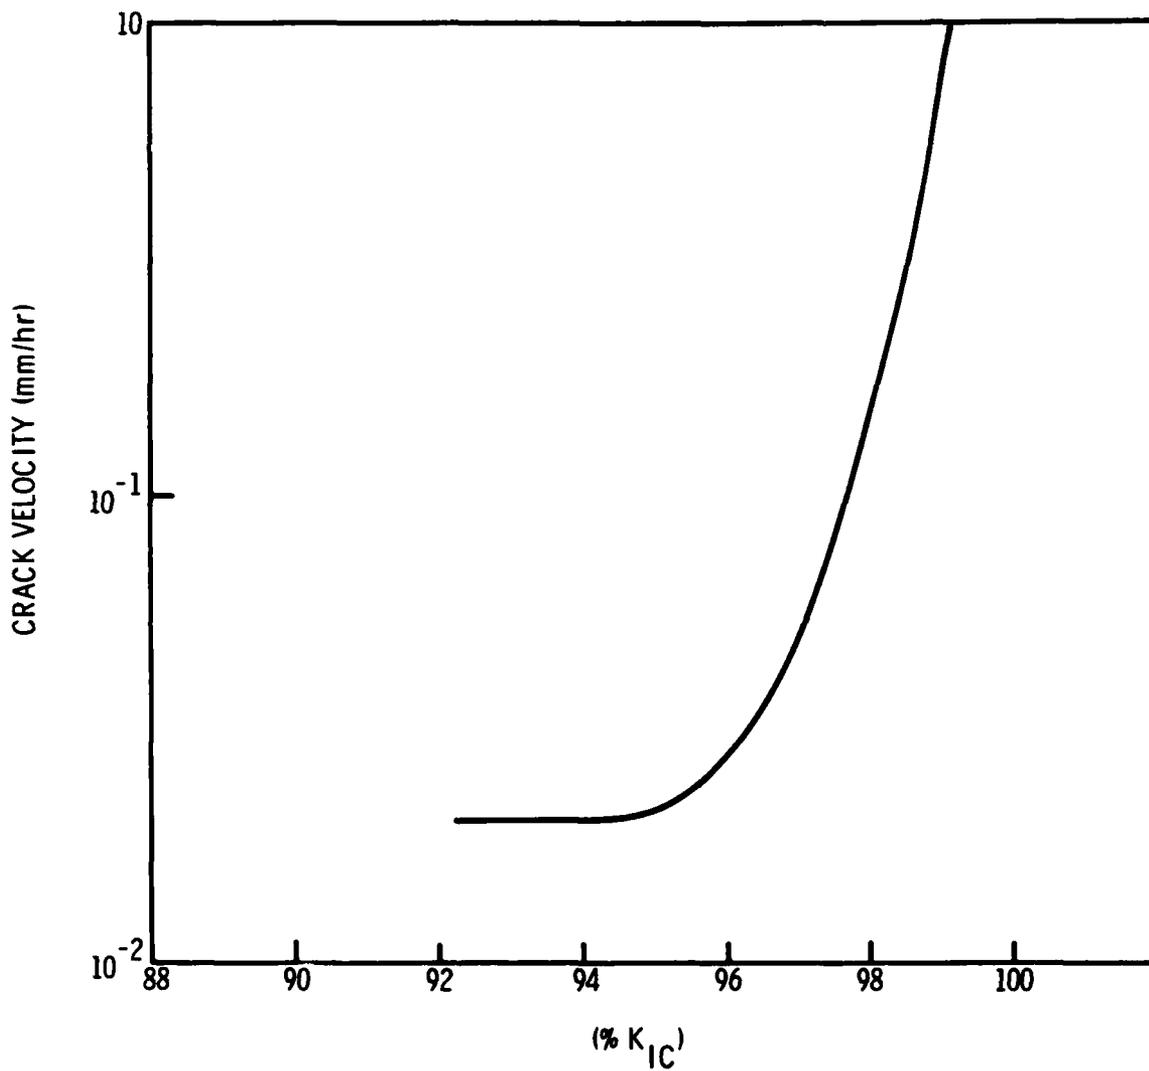
Figure 4. Crack velocity vs K_I curve for sensitized 5083.

The crack velocity (v) curve, $\log v$ vs $\log K_I$, reveals a plateau velocity of 2×10^{-2} mm/hour (Fig. 4), but the SCC threshold was not obtained.* The stress-corrosion crack velocity in Mode III could not be accurately measured but appears to be an order of magnitude less than that in Mode I, based on the observed crack advance preceding failure and the elapsed time.

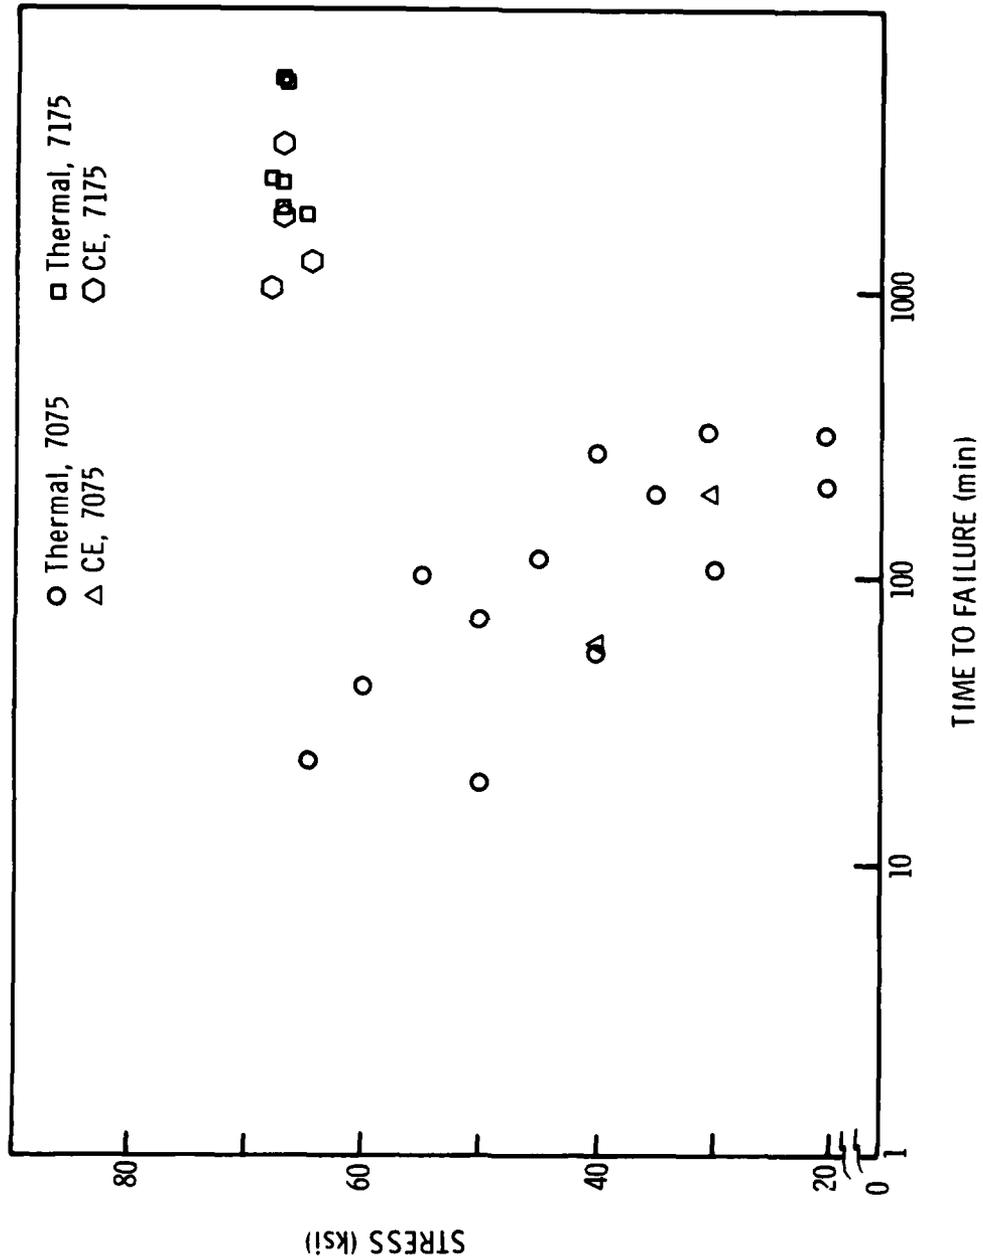
Figure 7. Stress vs time to failure for 7xxx series commercial alloys.

For both alloys, the removal of the thermal oxide by the CE technique failed to reduce SCC susceptibility (see Fig. 7), in contrast to the

case for the high-purity ternary alloy examined previously.⁽¹²⁾ The scatter in the data is substantial, but we found that susceptibility in the 7175 alloy, as expected, was lower than in the 7075 (as shown by the longer ttf).

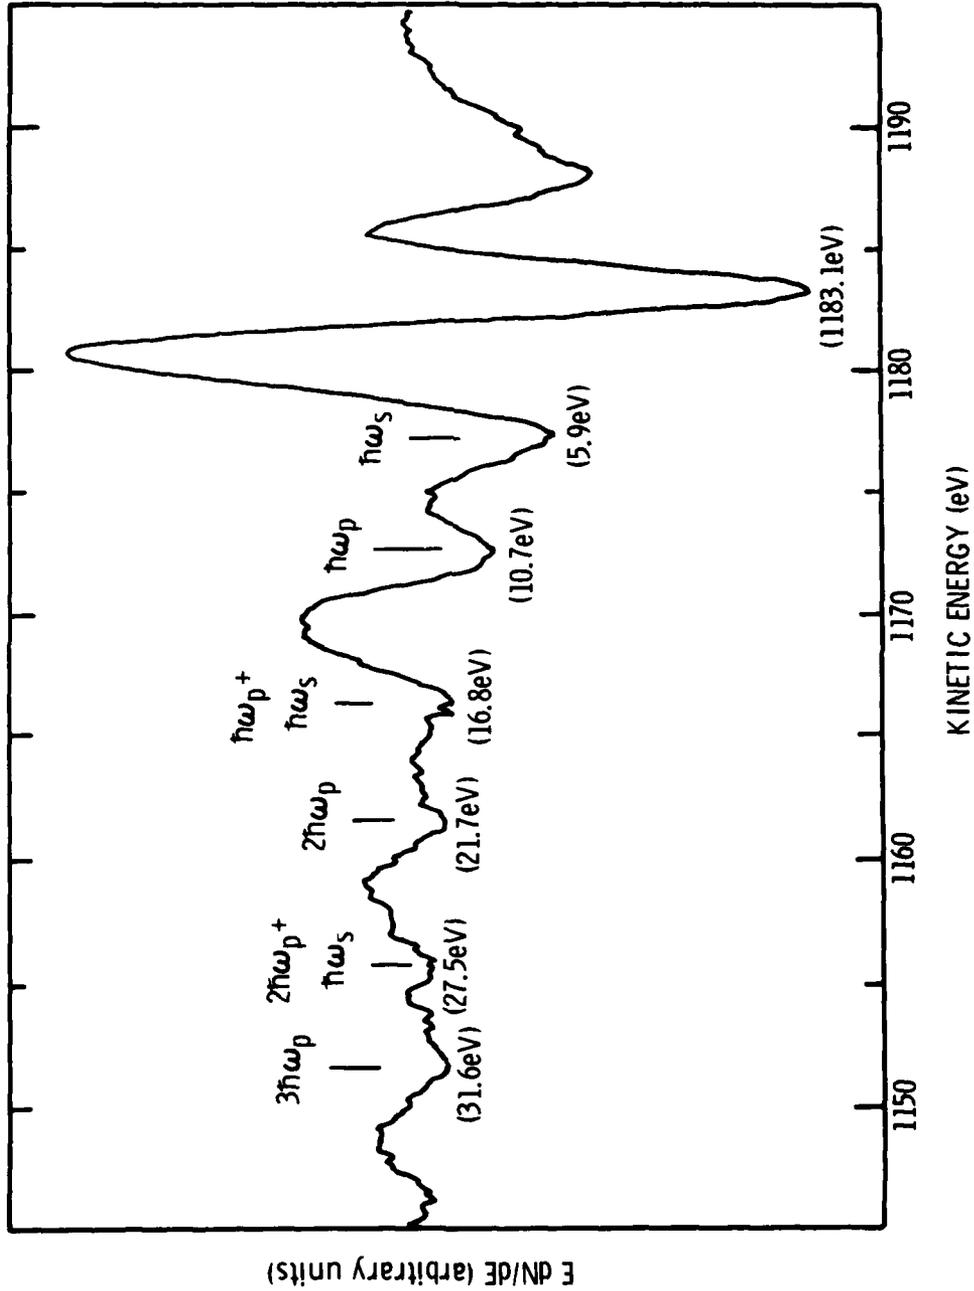
Figure 10. High resolution Auger scan of high purity elemental Mg. Energies in parenthesis denote energy below main Mg peak at 1183.1 eV. Surface plasmons are denoted $\hbar\omega_s$ and bulk plasmons are denoted $\hbar\omega_p$.

The high-resolution Auger scan of pure Mg is shown in Fig. 10. The energy of the bulk plasmon is 10.7 eV, which is lower than that of the "free" Mg on the fracture surfaces found in earlier work.⁽¹⁰⁾ This can be explained by noting that an Auger electron released from free Mg on an in-situ fracture surface may lose energy by exciting surface plasmons in the Mg layer or bulk plasmons in the substrate. The bulk

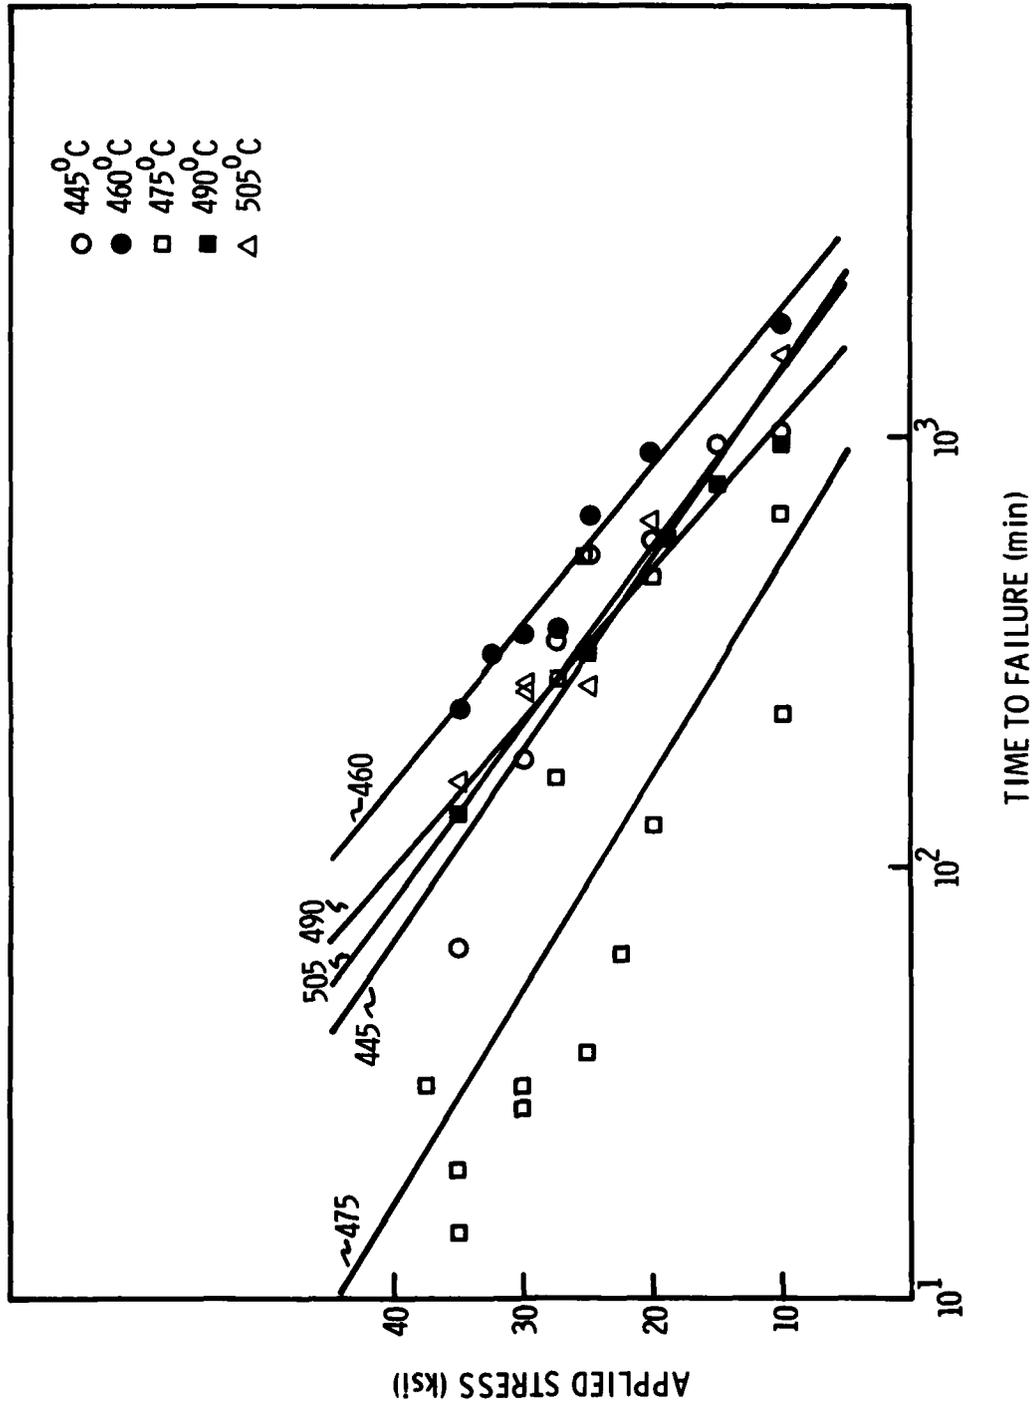
Figure 11. Linear regression of stress vs ttf for the five SHT groups.

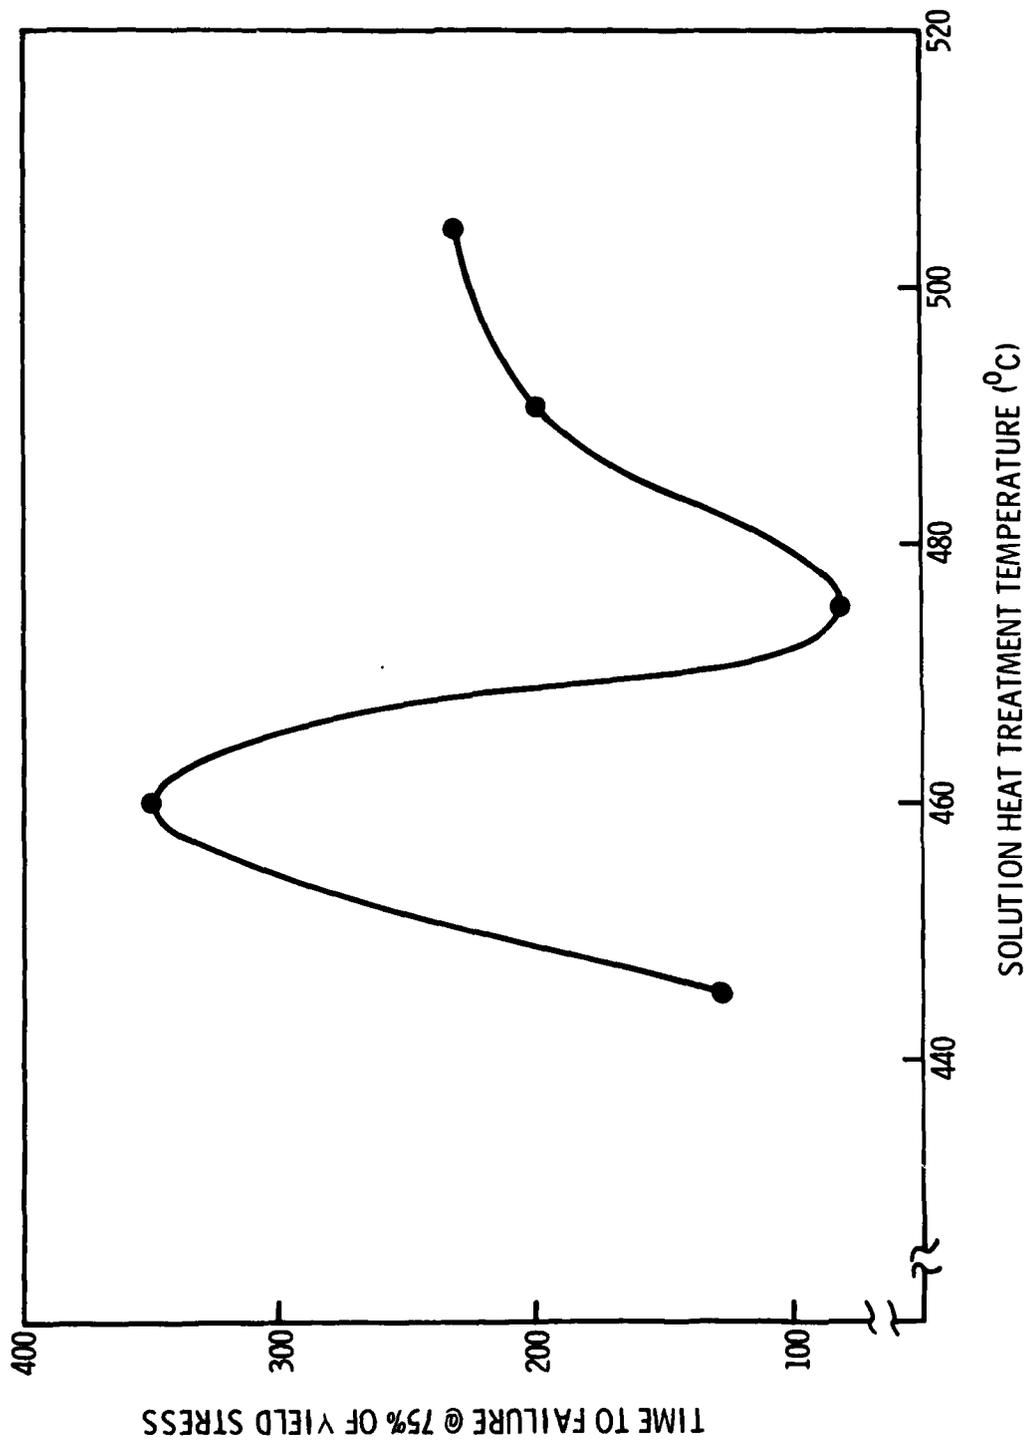
Figure 12. ttf at 75% of the yield stress vs SHT.

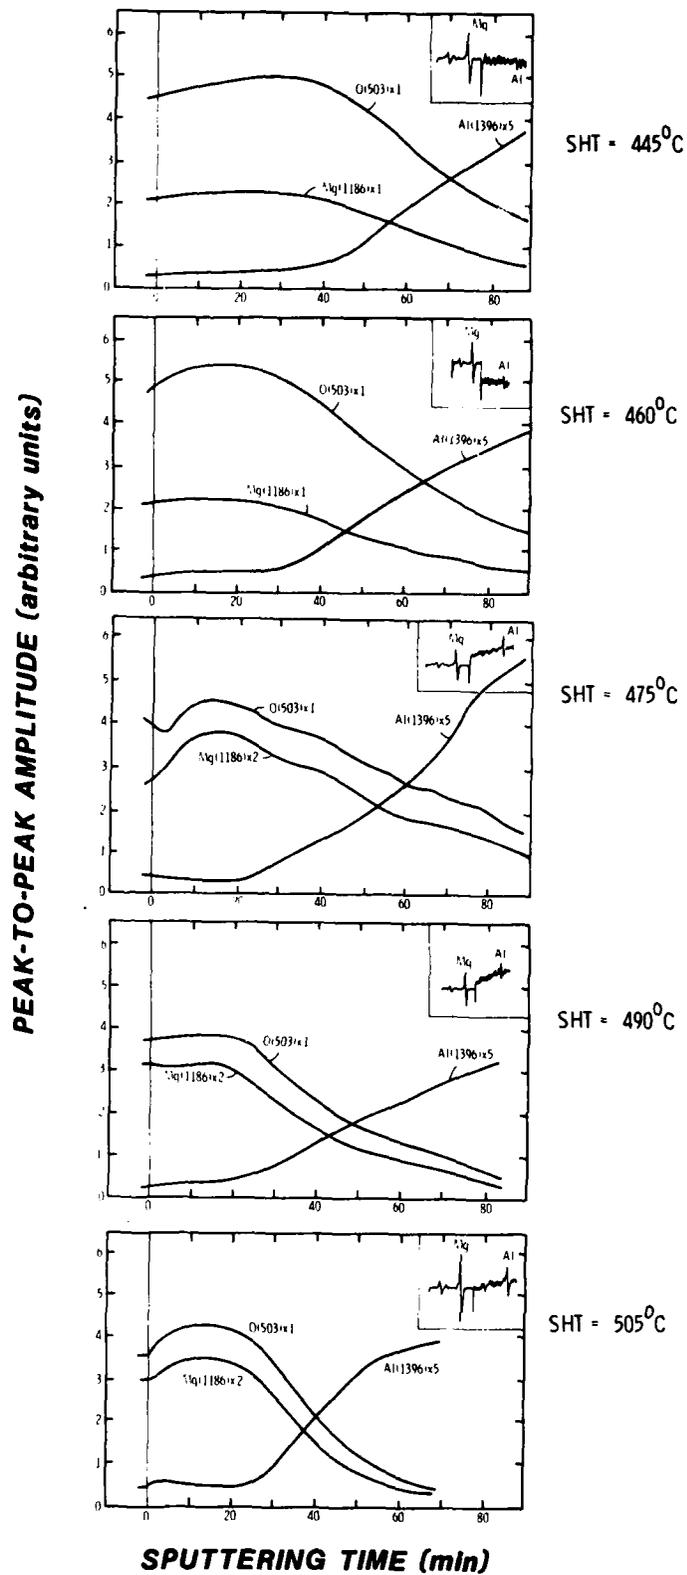
Figure 13. Auger depth profile of thermal oxide films formed at different SHTs. Insert accompanying each profile contains the Auger scan on the surface of each oxide. The number following chemical symbols are the Auger energies and note that the Mg scaling factor is not the same in each figure. Sputtering rate = 30 A/min.

The Auger scans and depth profiles of the surface oxide films did not reveal information that could be clearly correlated with SCC susceptibility. The five depth profiles of the oxide films are in Fig. 13; surface scans are inset. Each oxide film was enriched with Mg. Examination of the oxide morphologies in the STEM also did not reveal differences that could be correlated with SCC susceptibility.
