BDM/W-81-029-TR

AFESC/ESL-TR-81-39

THE STUDY OF FOREIGN OBJECT DAMAGE CAUSED BY AIRCRAFT OPERATIONS ON UNCONVENTIONAL AND BOMBDAMAGED AIRFIELD SURFACES

4. TITLE (and Subtitle) The Study of Foreign Object Damage Caused By Aircraft Operations on Unconventional and Bomb-Damaged Airfield Surfaces		5. TYPE OF REPORT & PERIOD COVERED Final Report September 1980-June 1981

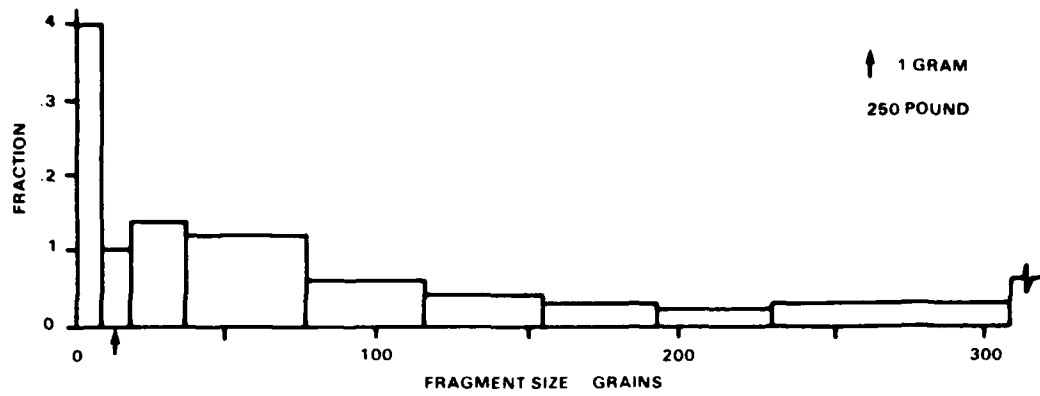
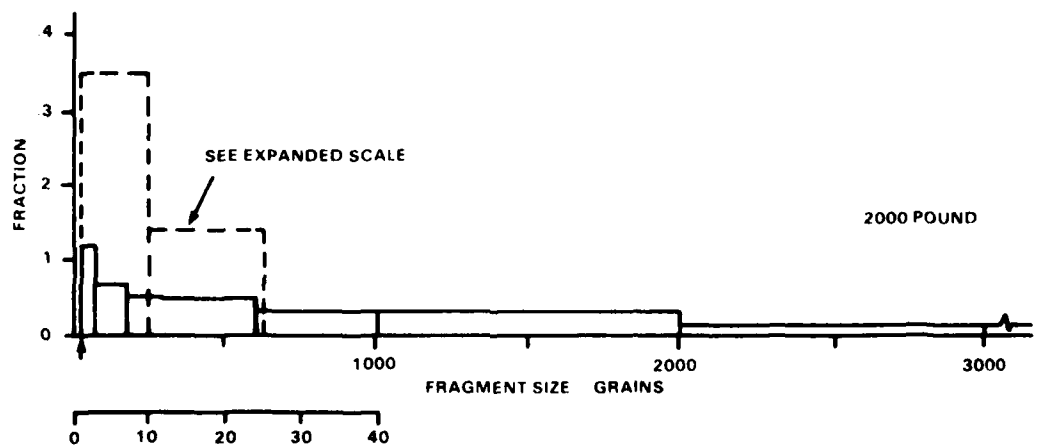
Figure 3. Fragment Distribution of General-Purpose Bombs.

The evidence shown in Figure 3 shows that damage from a 1 gram particle of steel may cause catastrophic damage to an engine. As

can be seen from Figure 3 more than 40 percent of all bomb fragments are larger than this size. Hence almost half of the bomb fragments are larger than a size which, if ingested, could cause damage to an engine. Objects larger than 20 grams (300 grains) comprise about 6 percent of the fragments from small general purpose bombs and as much as 13 percent for general purpose bombs in the 2000 lb class. These larger fragments (greater than 300 grains) would probably cause damage, since they are about the size of smaller compressors and turbine rotor blades or the small size aircraft steel bolt Table 6, Group I, e.g., to cause immediate engine shutdown by the FAA. Hence, there is little doubt that the ingestion of some of the larger bomb fragments could result in mission abort.

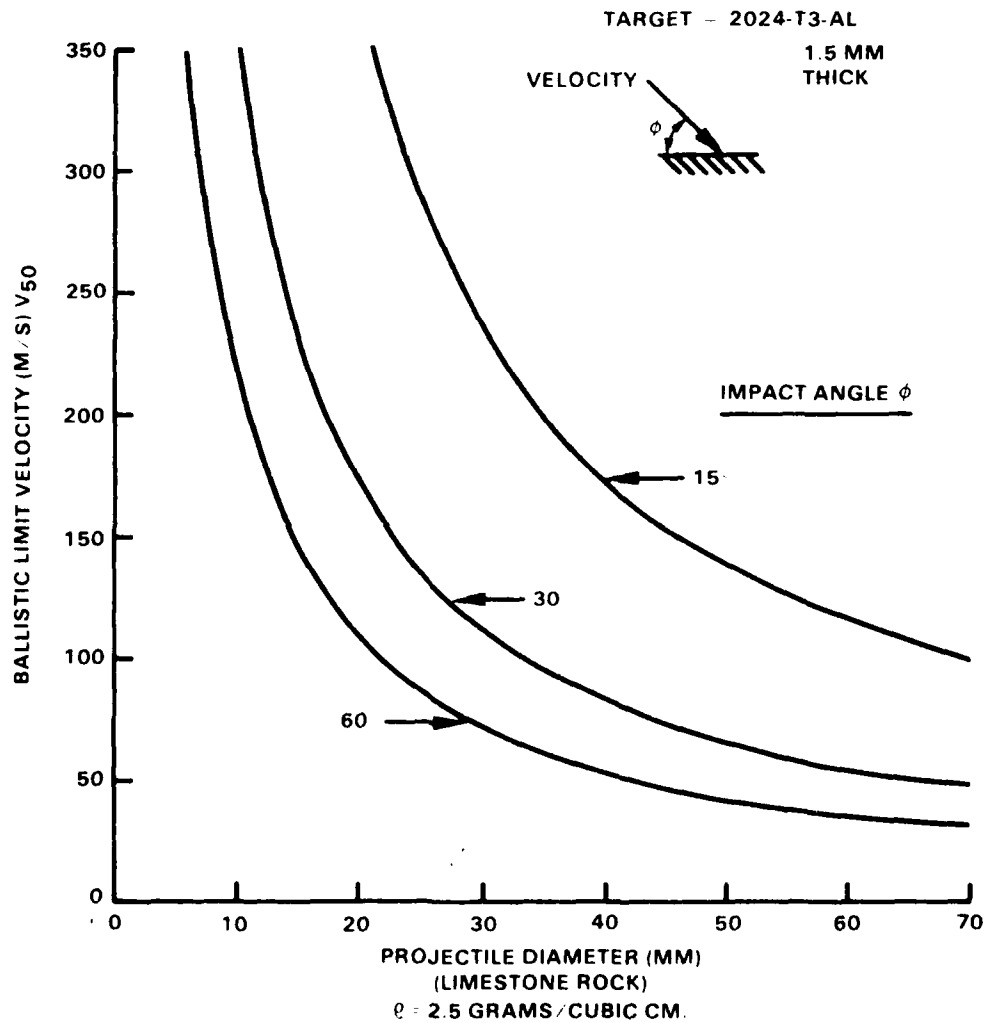
Figure 4. Ballistic Limit Velocity Versus Projectile Diameter for Various Impact Angles.

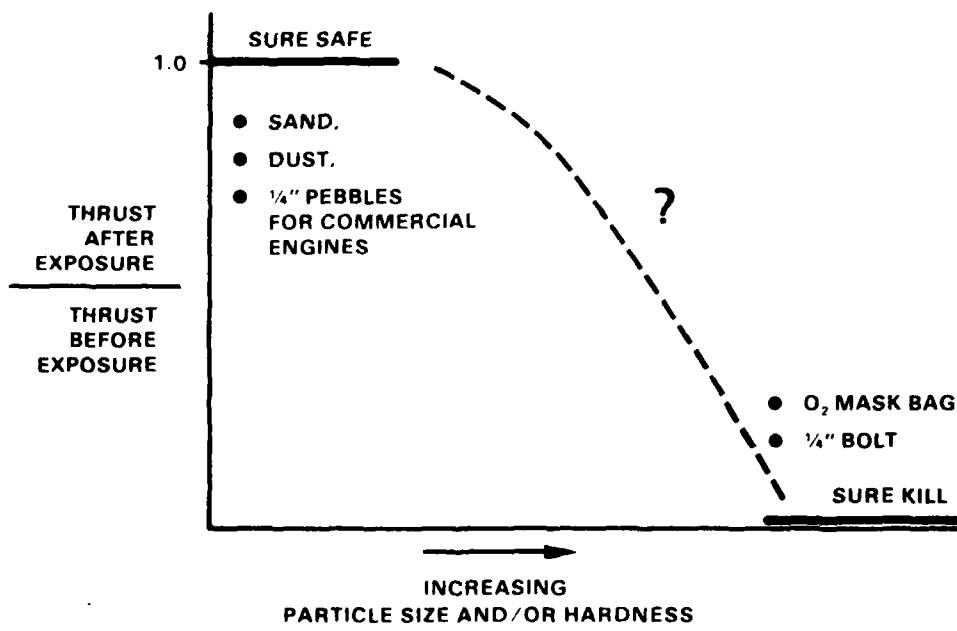
Figure 9. Susceptibility of Aircraft Engines to Damage by Foreign Objects.

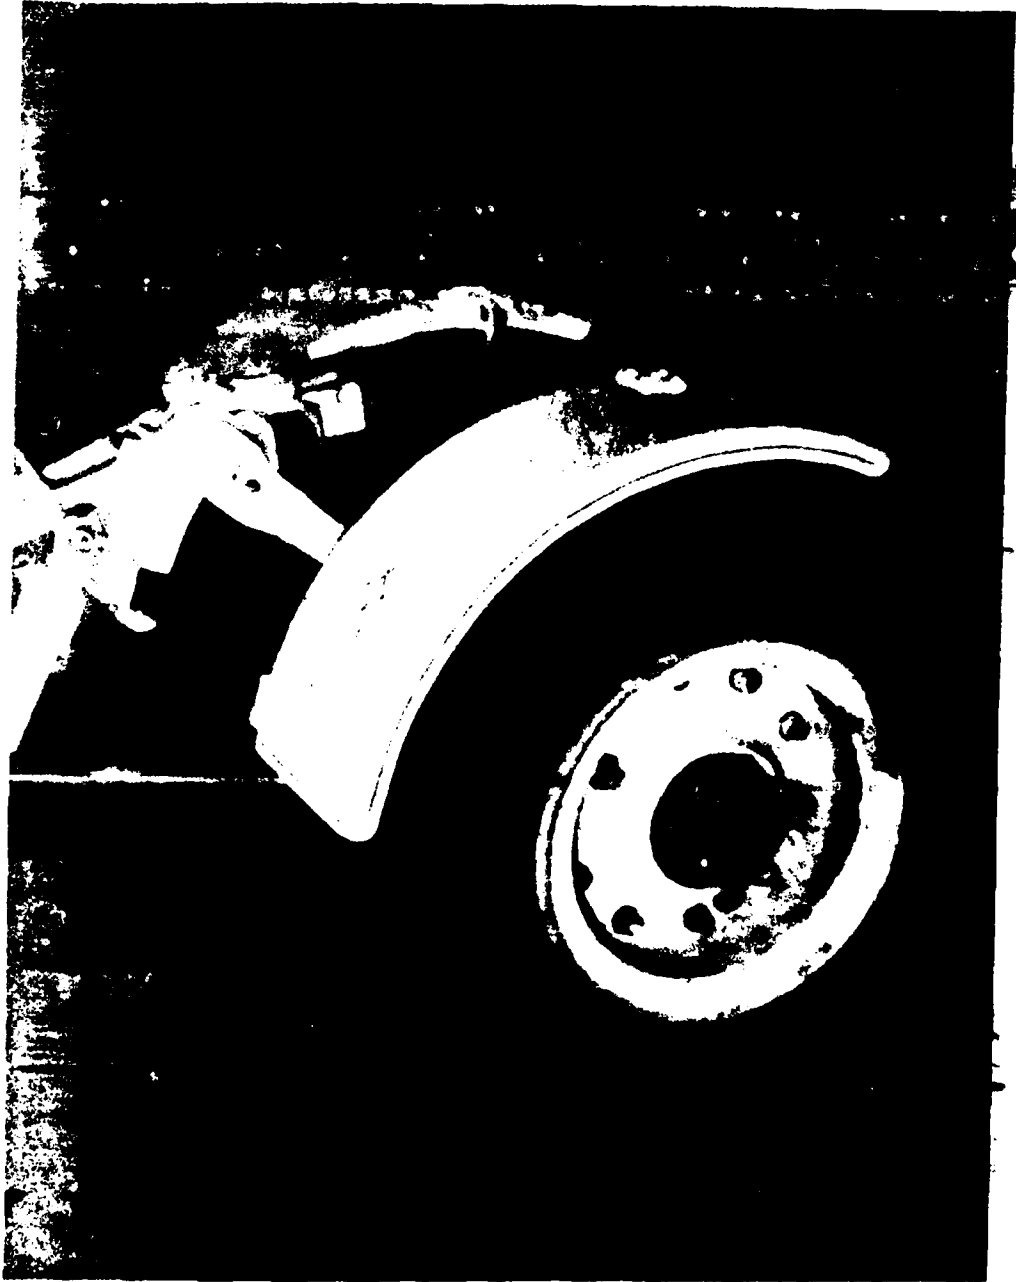
Figure 16. Experimental F-14 Nosewheel Deflector.

The experimental nosewheel deflector was designed to withstand wind loadings in flight, but no flight tests have been conducted. It has been installed, however, on an F-14 aircraft and ground checked to ensure that adequate wheel well clearance exists when the nosewheel is retracted. The deflector was then removed from the aircraft and sent to the NASA Langley Research Center for tests.

conducted during 1978. However, because of higher priority workload on the Landing Loads Track (related to the Space Shuttle), the tests were delayed. An F-14 nose landing gear has been mounted on a carriage together with the arrays of bins, sized for the dimensions of the engine inlet flow patterns, to capture the debris (Figure 17). High speed camera coverage of the spray pattern will be obtained by cameras mounted ahead, above, and to each side of the landing gear.

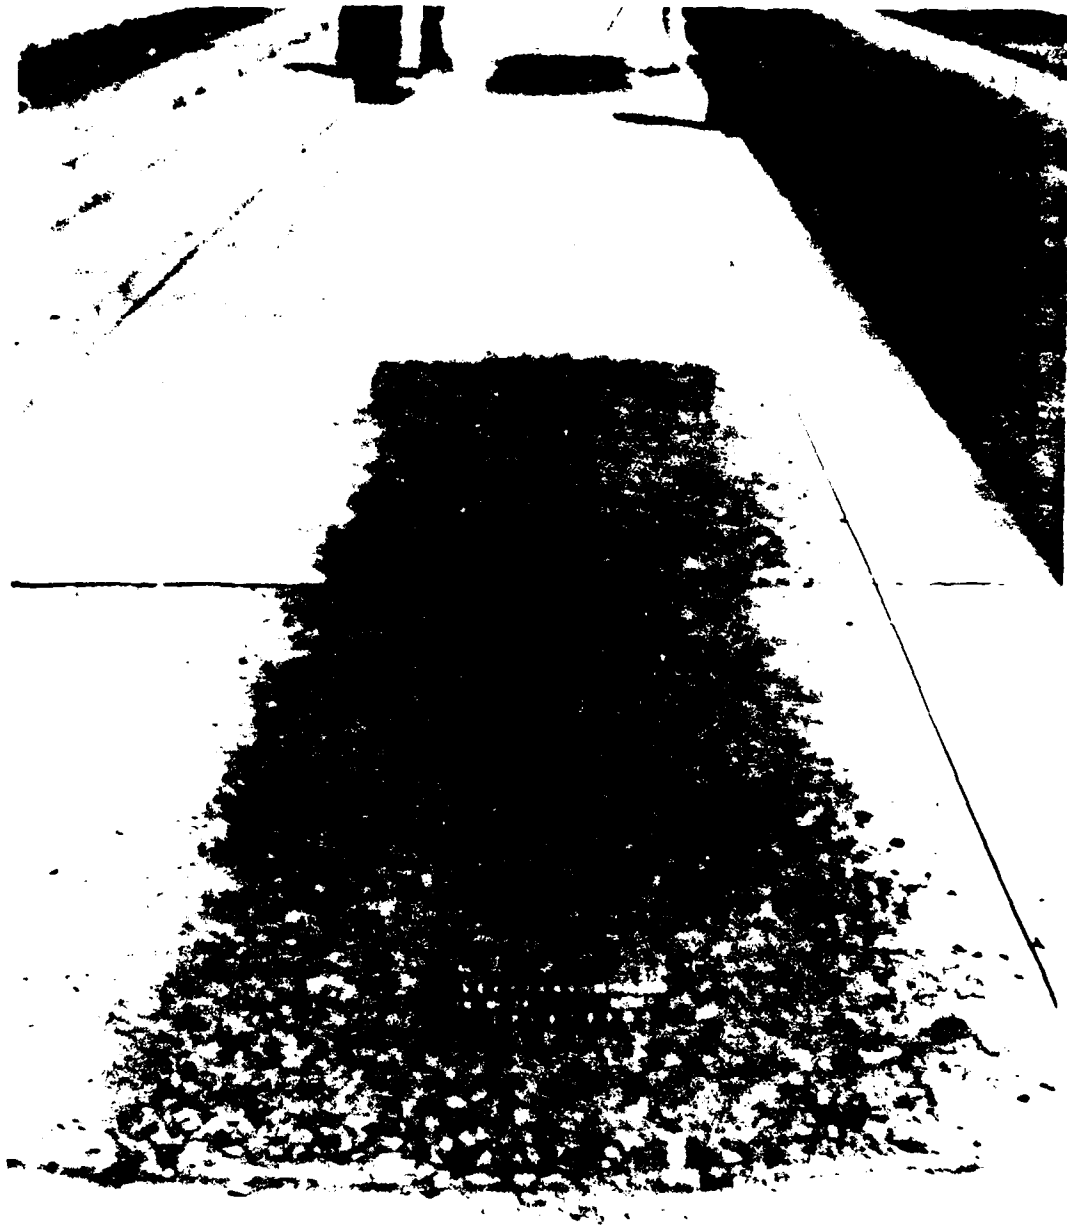
Figure I-1. Crushed Stone Distribution for F-16 Nose Landing Gear Test.
