LIGHTWEIGHT FIRE FIGHTING MODULE EVALUATION(U) COAST
GUARD RESEARCH AND DEVELOPMENT CENTER GROTON CT
F X MCCARTHY JAN 83 CGR/DC-17/79 USCG-D-77-79

1. Report No. CG-D-77-79		2. Government Accession No. AD-A123286		3. Recipient's Catalog No.	
4. Title and Subtitle LIGHTWEIGHT FIRE FIGHTING MODULE EVALUATION				5. Report Date January 1983

1.0 INTRODUCTION

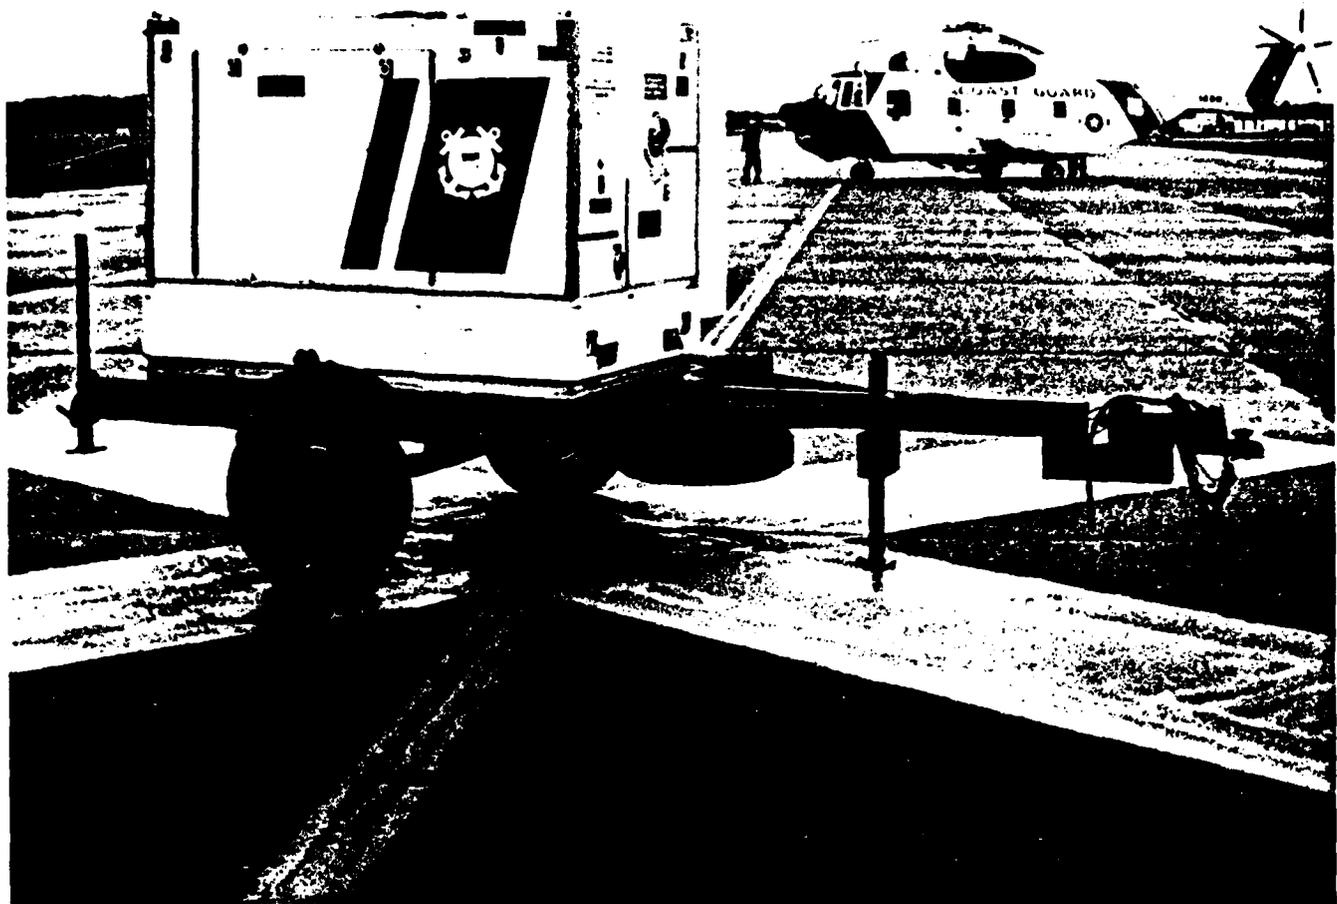
FIGURE 1. 2,000 GPM LIGHTWEIGHT FIRE FIGHTING MODULE AND TRAILER

The module is intended to remain in long-term unattended and unprotected storage ready for immediate deployment to a fire scene over the road by trailer, onboard Coast Guard vessels and by helicopter. It could be used for fighting fires in and around the waterfront, ships at sea or in port, and on offshore platforms. Figure 1.

Module	Fiberglass reinforced plastic housing with stainless steel lifting straps down each corner. Overall dimensions are 72" long x 60" wide x 48" high.
Fuel Tank	100 gallons diesel oil in base of module.
Engine	349 HP gas turbine Allison Model 250-C20
Pump	Two stage aluminum housing with aluminum impellers and inducer 2000 GPM rated discharge at 150 psig
Suction Hose	10" dia. fiberglass reinforced plastic
Discharge Hose	4" dia. fire hose 25' in length
Monitors	Two 3.5" in diameter with 1 1/2" and 2" nozzles
Trailer	Two wheel flat bed rated up to 50 mph highway speed

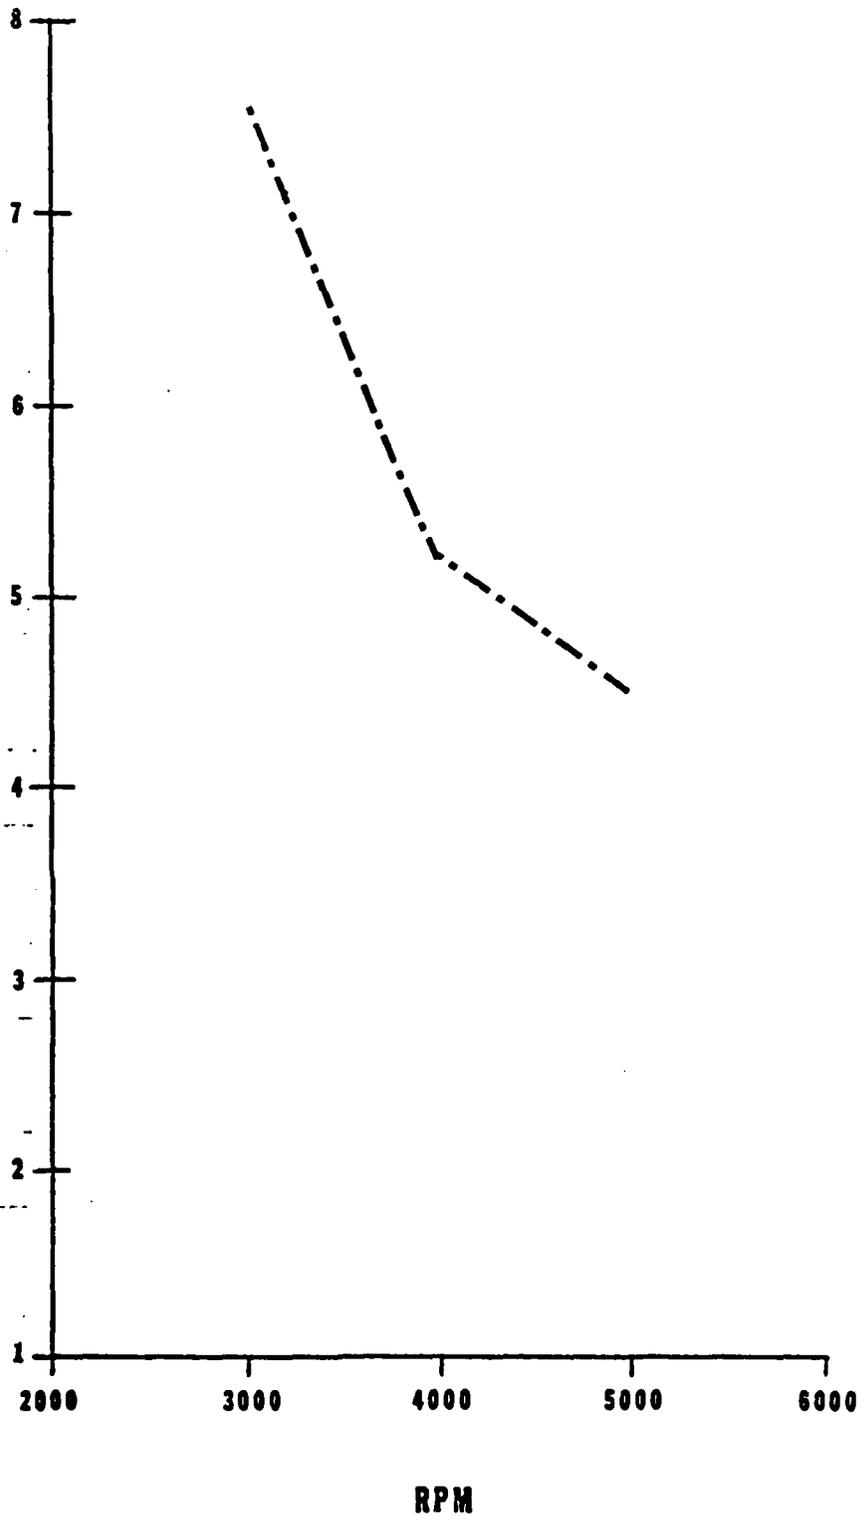
FIGURE 2. FUEL OIL CONSUMPTION

The built in fuel oil tank on the unit was filled to capacity, and the pump was operated under load at various speeds to determine how long the pump could operate on a full tank of fuel oil. The results of these tests are plotted in Figure 2.

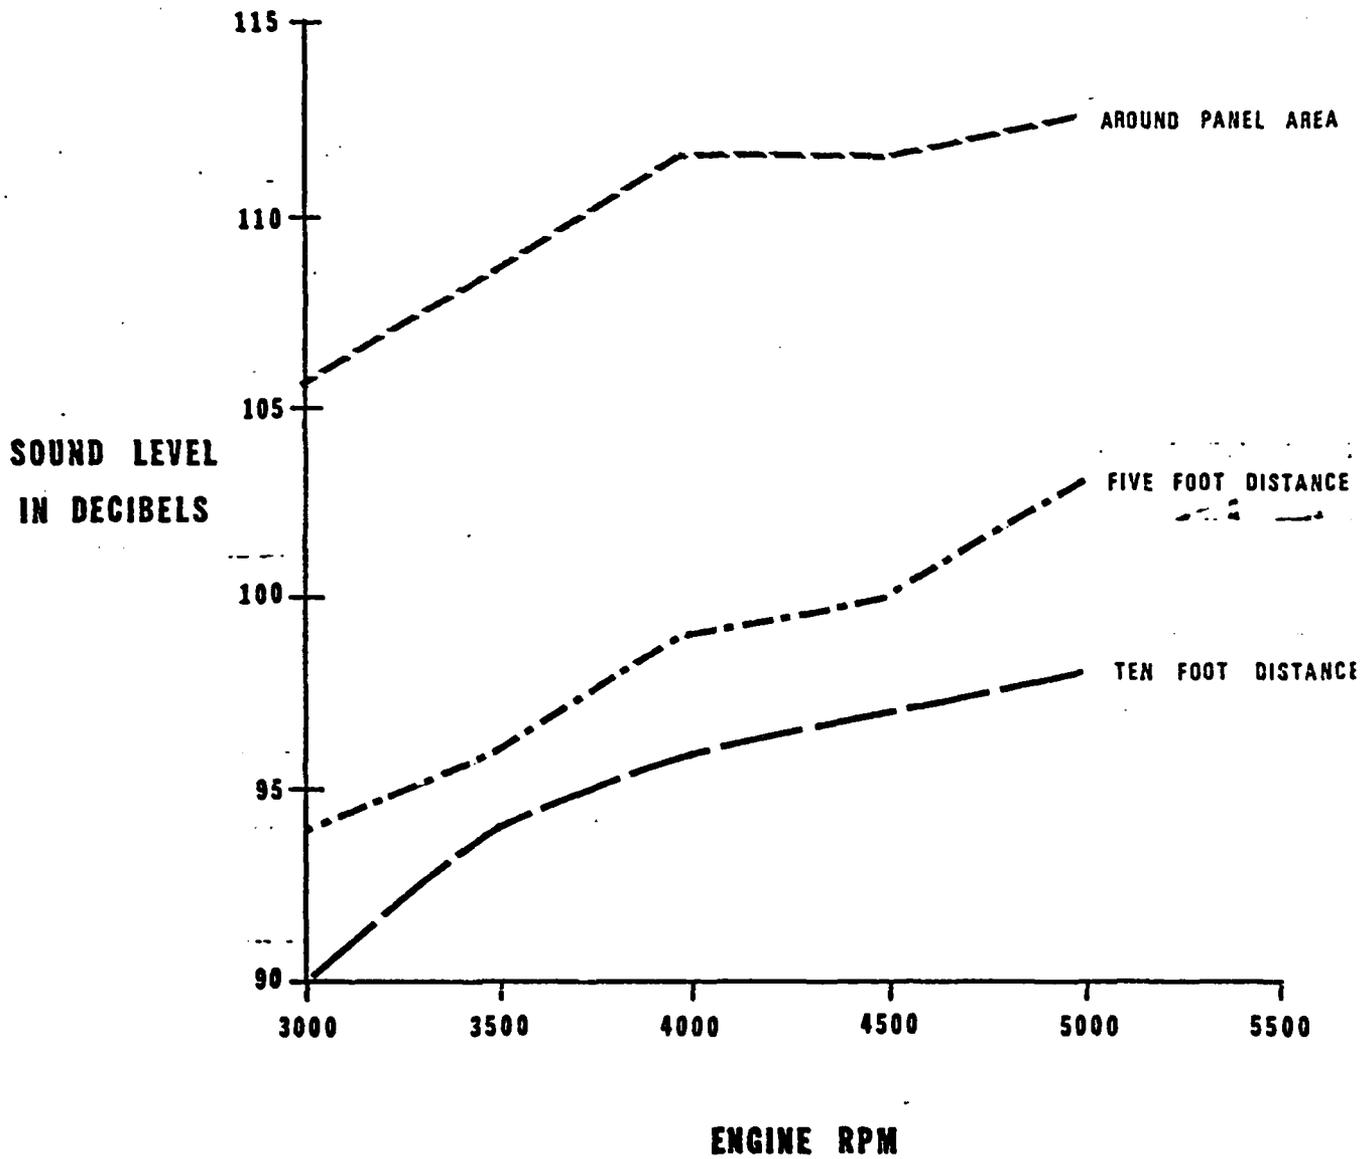
FIGURE 3. SOUND LEVEL EVALUATION

Sound level measurements were taken at various points around the module to determine the level of sound to which operating personnel would be exposed. The normal levels were obtained with a Bruel and Kjaer sound level instrument. The results are plotted in Figure 3.

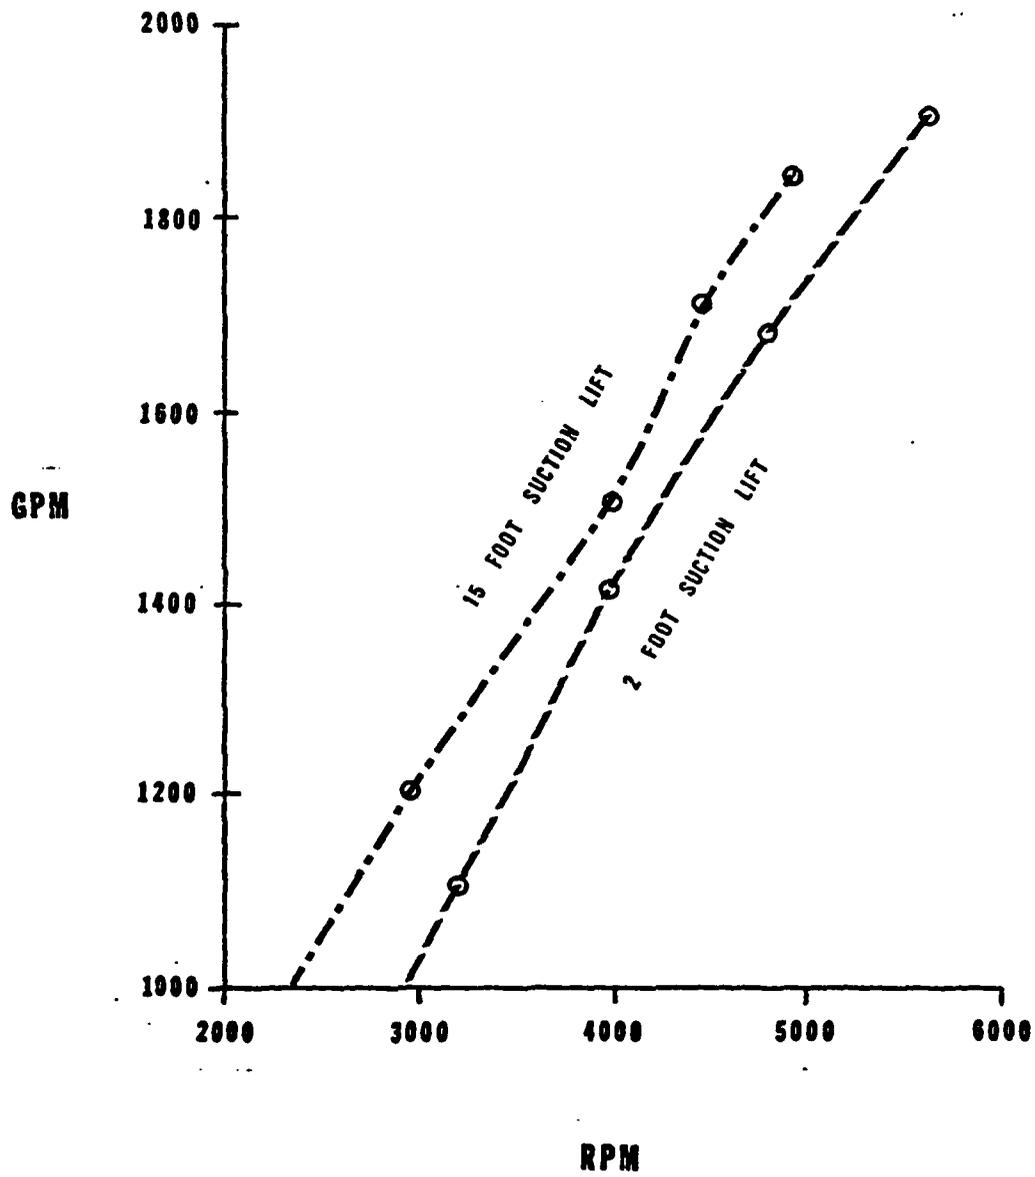
FIGURE 4. PUMP PERFORMANCE

Pump flow rates were obtained by installing a Dieterick "Eagle Eye" meter in each discharge line at their monitors. The pump was operated at various speeds to measure the flow rate. The suction lifts during this test varied as the tide changed. Results are shown in Figure 4.

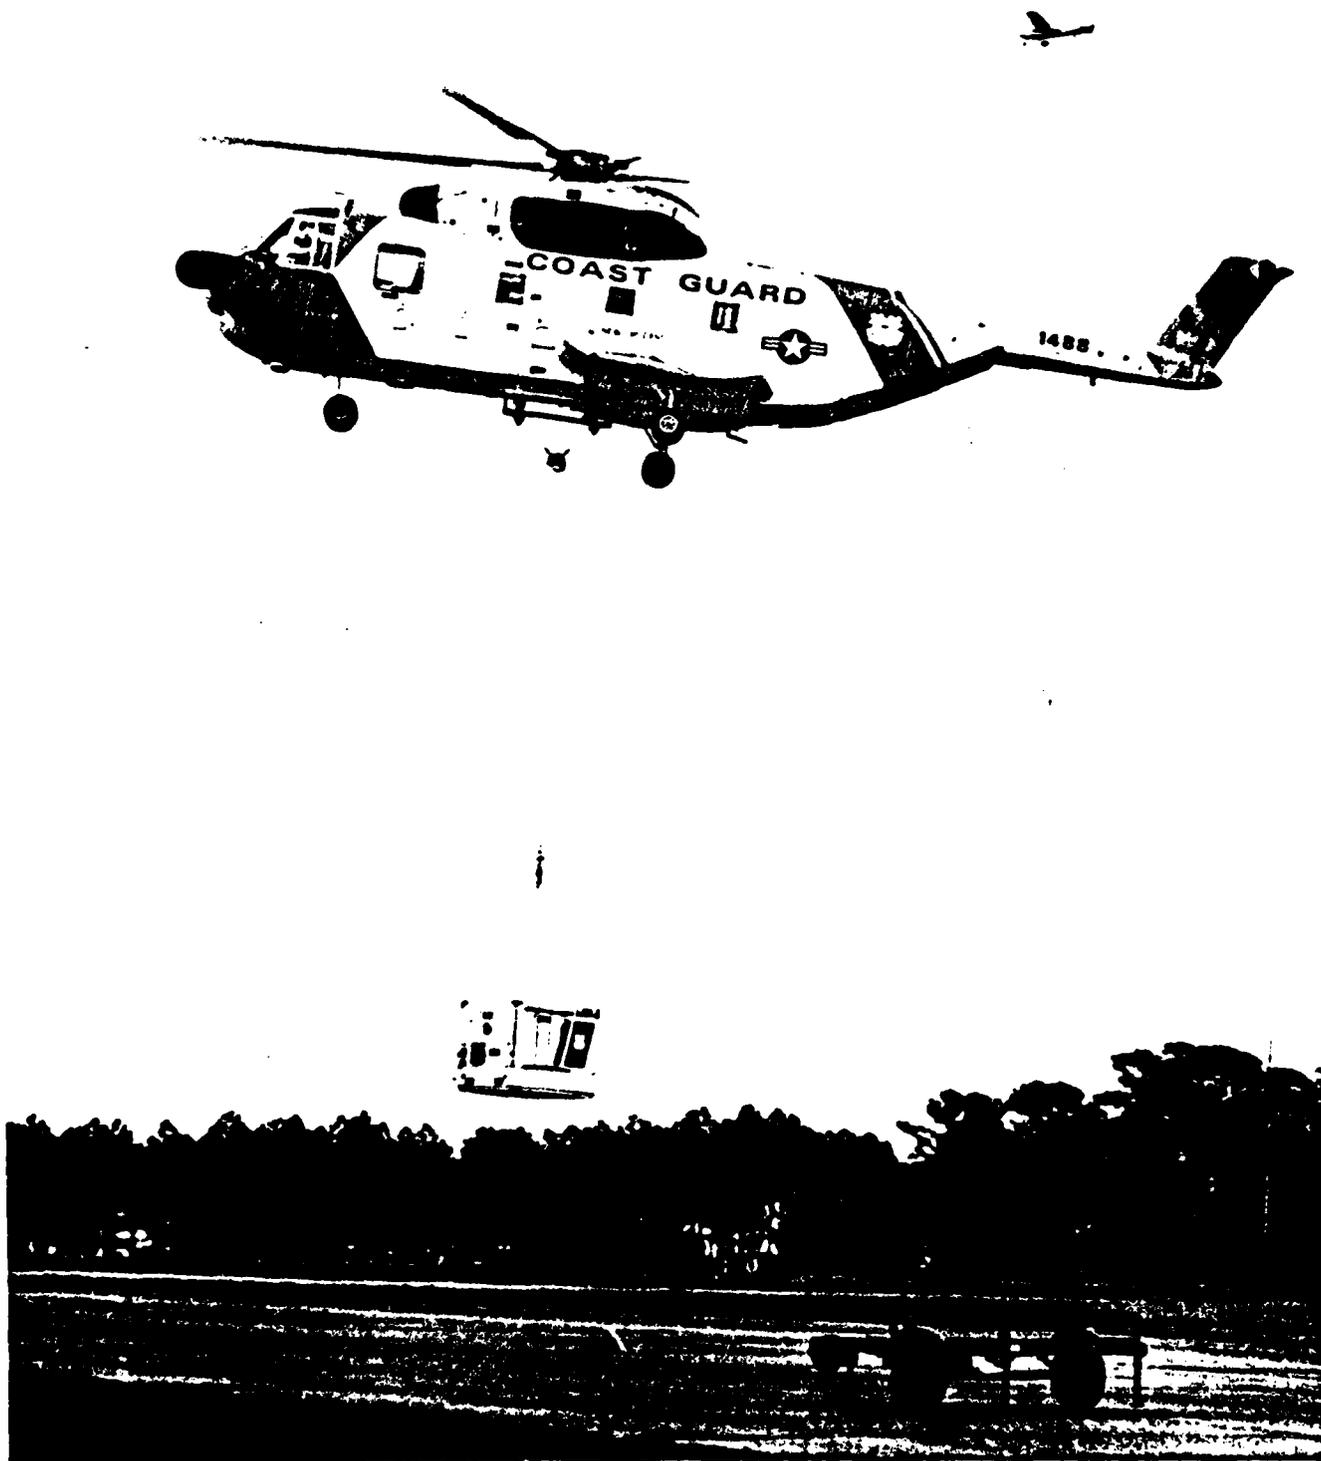
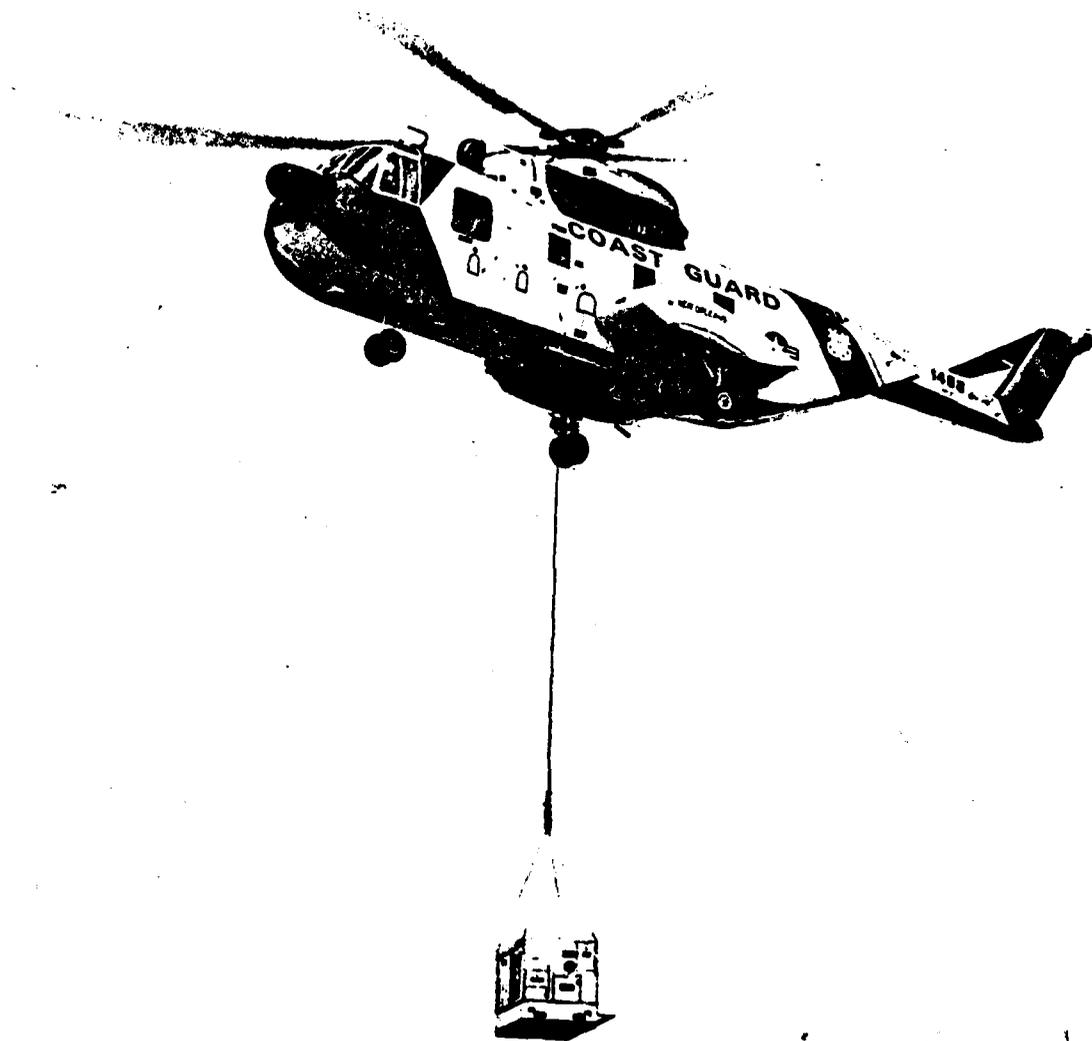
steel wire pennant of at least ten feet and a ball bearing swivel was needed for lifting the module. The suction pipe support bracket had to be removed, and the securing devices for the suction pipe and the suction pipe bracket were not considered adequate for flight operations. On the second day, the module was ready for flight operations. The module was lifted and transported over Mobile Bay, and returned to the pickup point. The helicopter could not place the module back on its trailer. Following the flight the pilot was debriefed. He made the following comments:

- a. The pennant was too long (20 feet),
- b. In flight the module rotated approximately fifteen times a minute, with a jerking motion
- c. The weight of the module and its equipment was of concern because the aircraft had to be lightened by 1 1/2 hours of fuel weight in order to carry the module. This would leave only 30 minutes of fuel for transporting, delivering, and returning. Figures 5 and 6 show the module during the helicopter transport trials.

FIGURE 5. HH HELICOPTER LIFTING MODULE FROM ITS TRAILER

FIGURE 6. IN FLIGHT TRANSPORT OF THE MODULE BY HH-3 HELICOPTER

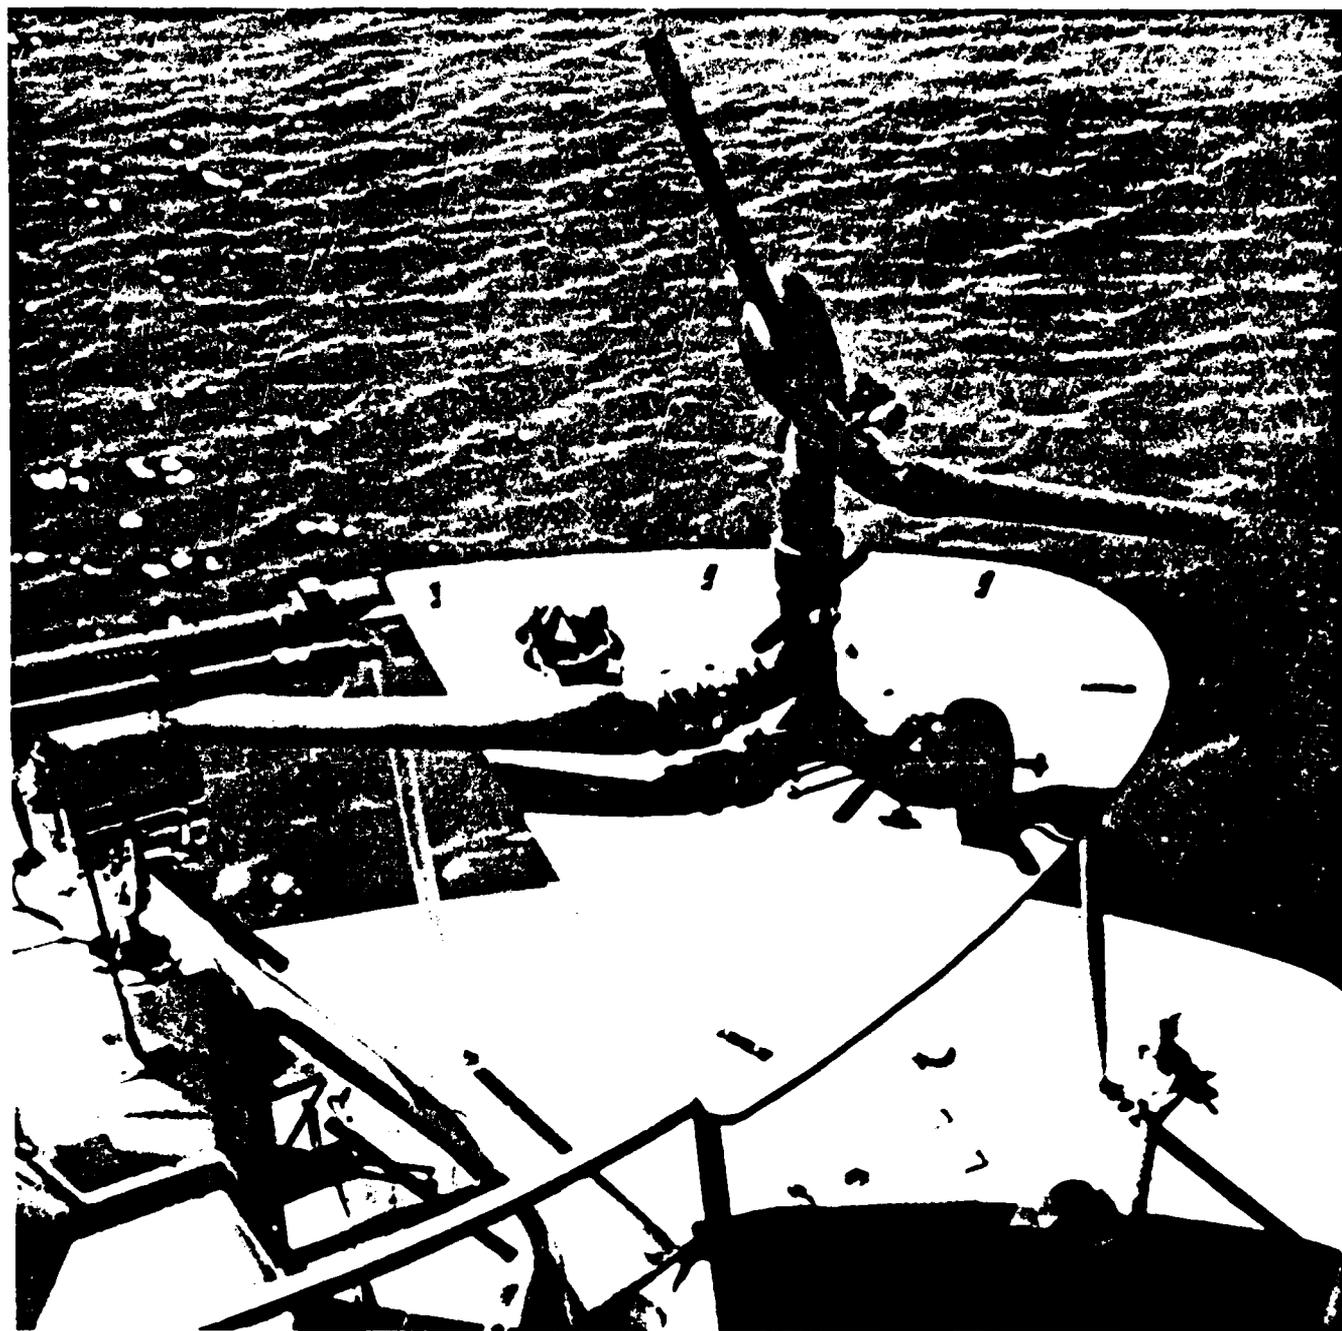
FIGURE 7. SINGLE MONITOR MOUNTED ON THE BOW OF 32' PWB

A 32' PWB with a three man crew was provided by MSO Mobile, AL, for this phase of the evaluation. The module was set on the deck of the PWB aft of the deckhouse, and rigged for operation. The monitors had to be secured by means other than bolting through the deck of the PWB. One monitor mounted on the bow on a piece of 3/4 inch plywood, cut to the configuration of the handrail around the bow and secured by U-clamps. Figure 7. The second monitor was aft, as secured to a 4 x 8 foot piece of plywood on which the module was placed. Figure 8.

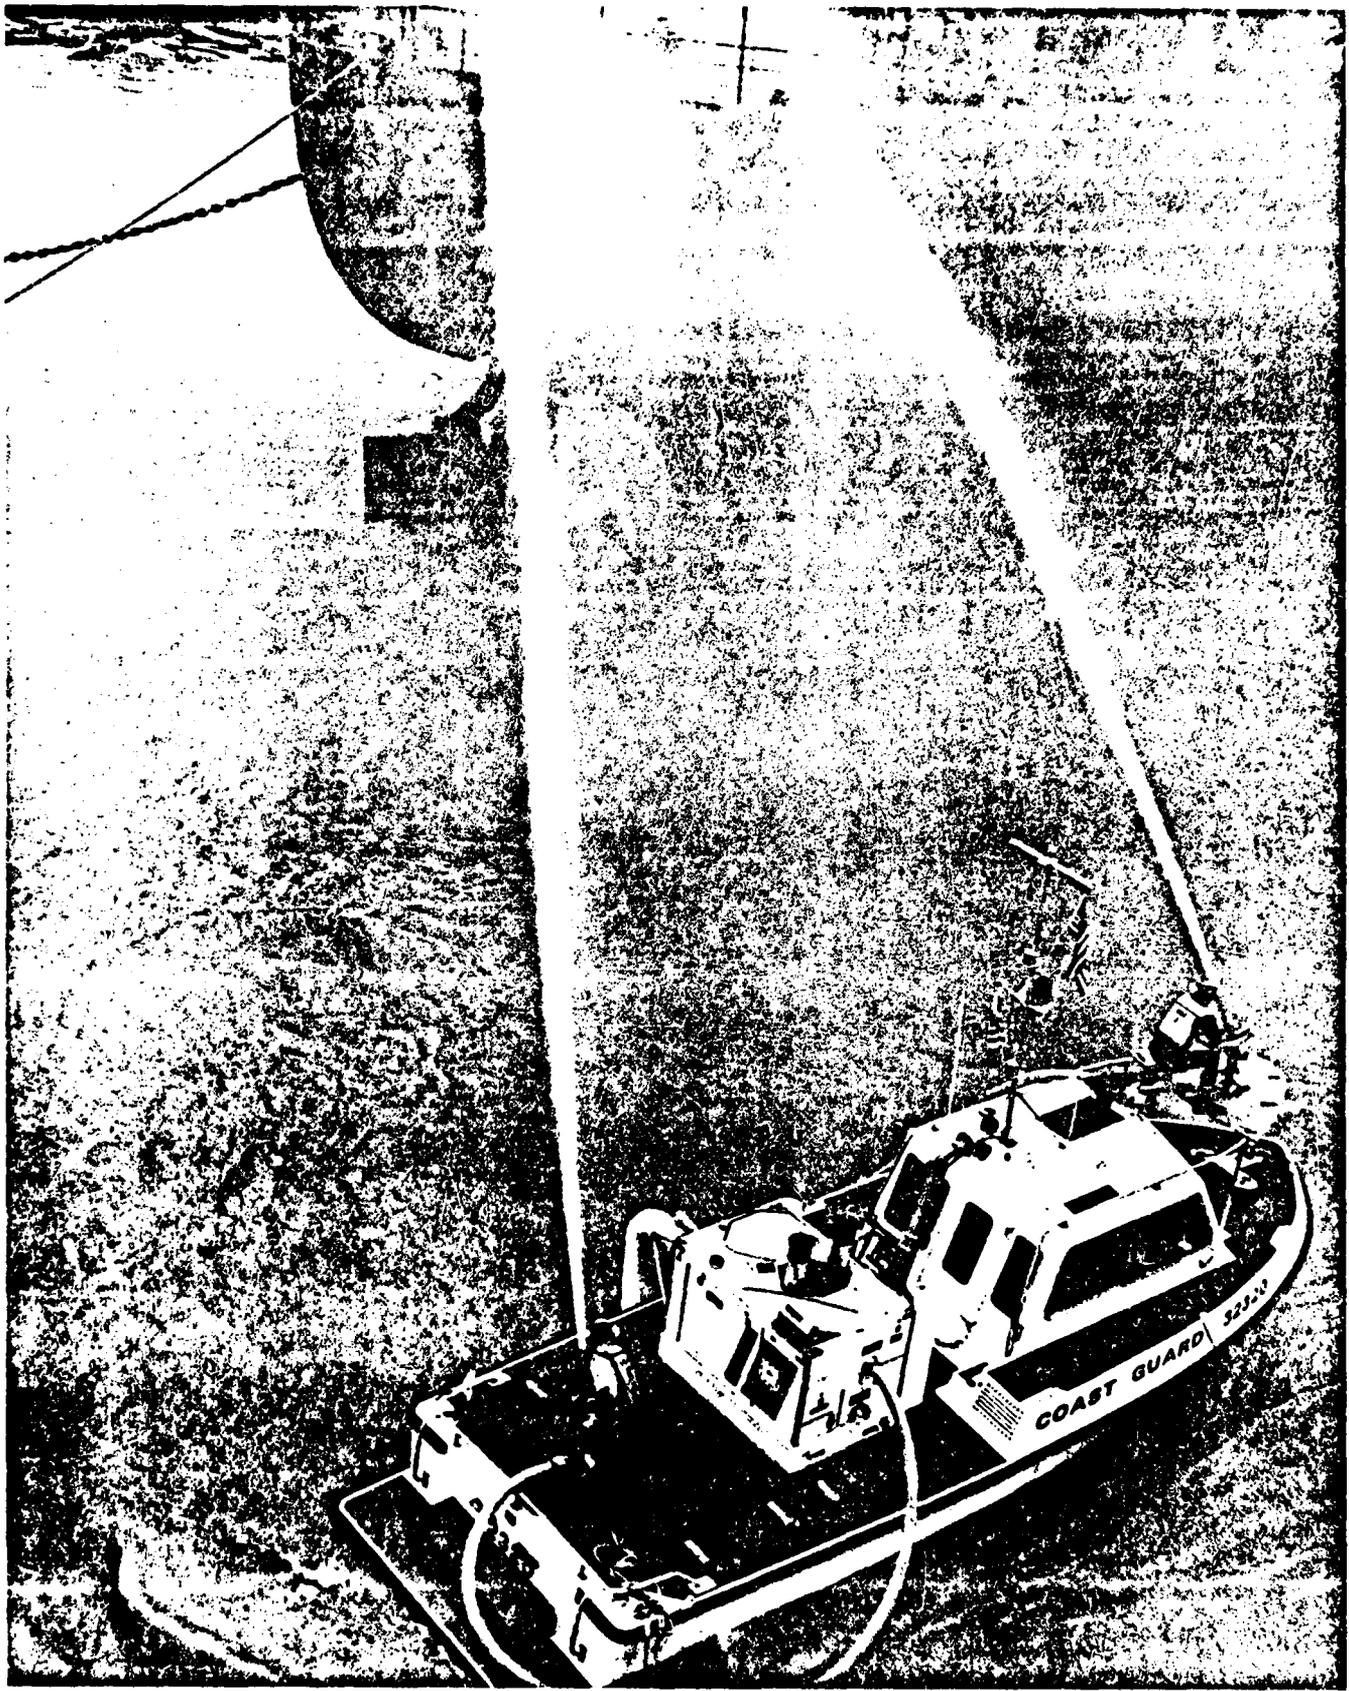
FIGURE 10. FIGHTING SIMULATED FIRE ON BOARD TEST SHIP MAYO LYKES
FROM 32' PWB

The stern of the F&STD test ship MAYO LYKES was used to simulate fighting a fire onboard ship. Figure 10. Smoke bombs were ignited in compartments on the stern of the LYKES, and the PWB was maneuvered in position to extinguish the simulated fire. The PWB responded very poorly in close quarters as the pressure from the monitors overpowered the engine and rudder control of the boat. The monitor on the stern was used to help the boat's coxswain control the heading of the boat by discharging the monitor into the water around the stern of the boat. Figure 11.

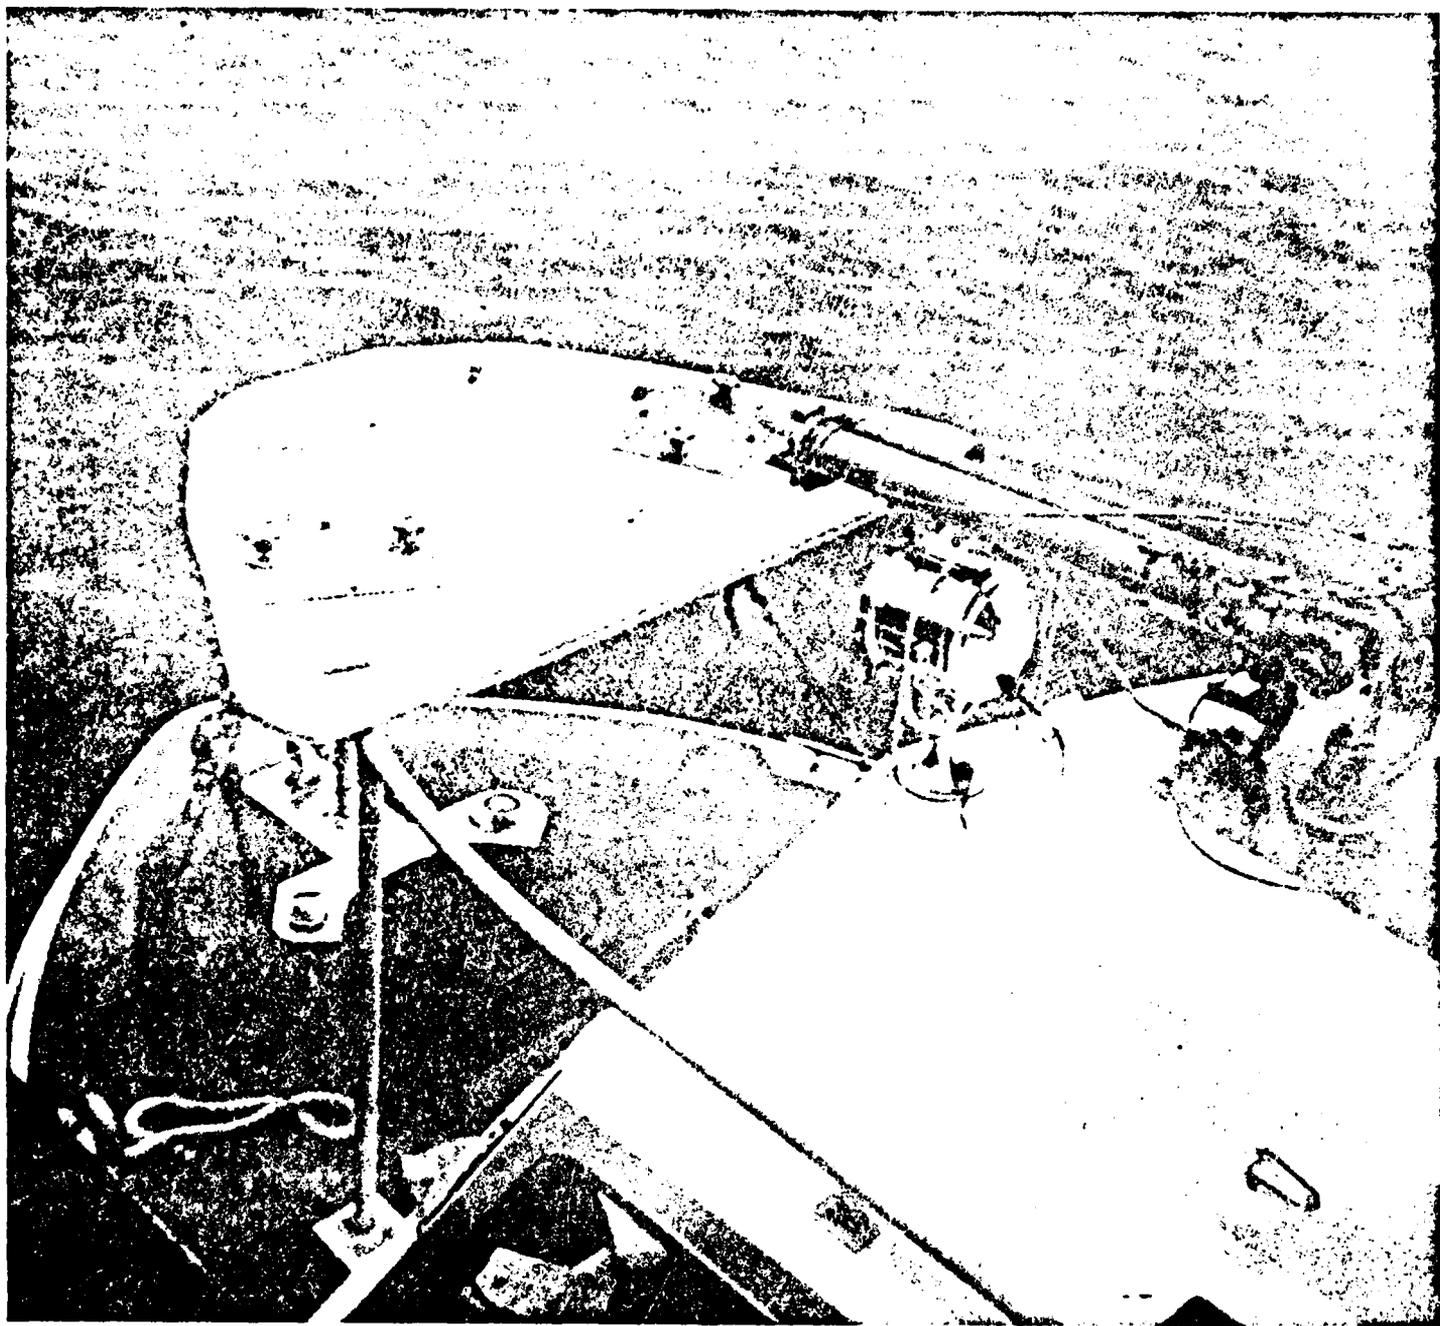
FIGURE 12. ARRANGEMENT DETAILS BOTH MONITORS ON BOW OF 32' PWB

Subsequently both monitors were installed on the bow and then on the stern of the PWB. The monitors on the bow were secured by adding an additional piece of 3/4 inch plywood on the bow for support. This piece was bolted to the first piece. To stiffen up the bow handrails, two come-a-longs were placed one on each side from the handrail to the deck cleat and secured.

Both monitors were also mounted on the stern by securing a 1/4-inch steel plate on top of each corner of the taff rail around the stern. The stern of the MAYO LYKES was utilized again for the simulated fire fighting procedure. Although there was a 100% improvement over control of the PWB, and both monitors could be applied to fire fighting operations, the coxswains view aft was obstructed by the module when maneuvering in the astern mode. Figures 12, 13, 14, 15 and 16.

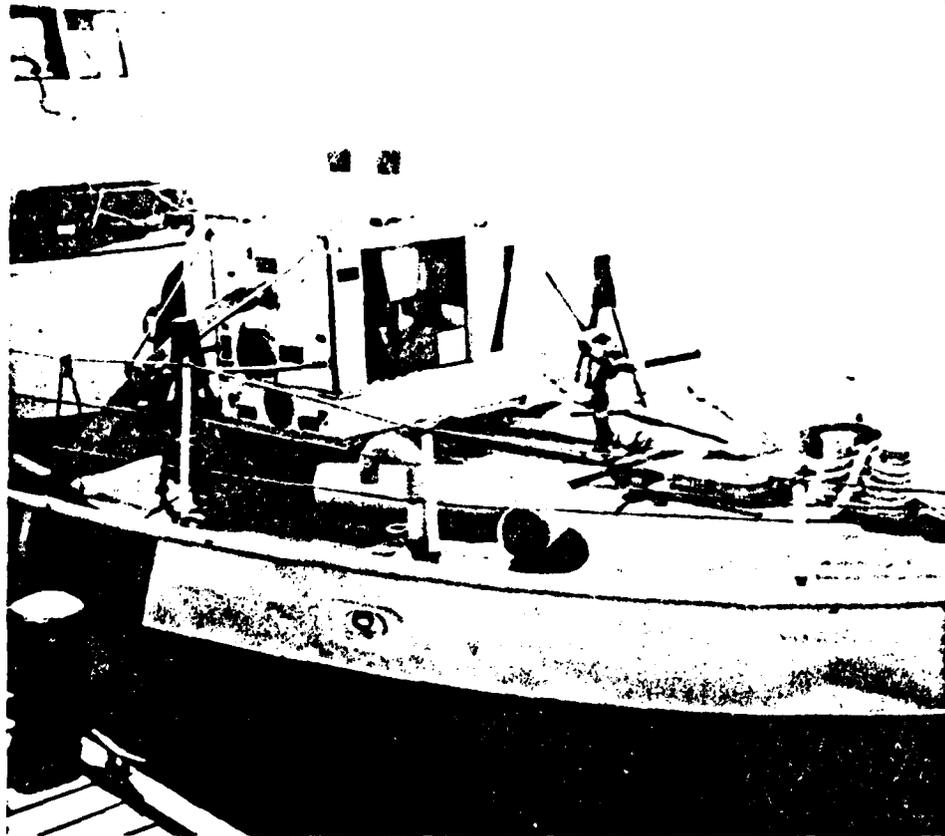
FIGURE 17. MODULE AND MONITOR ARRANGEMENT ON BOW OF 82' WPB

In order to evaluate the module's operation from an 82 foot patrol boat (WPB), arrangements were made through CG Group Mobile for the use of USCGC POINT VERDE (CG-82311). The module was placed forward of the deck house and rigged for operation using two, six-foot sections of suction pipe, along with the two-foot strainer section, Figure 17. The monitor on the bow was secured by using the 4 x 8 foot piece of plywood used on the 32-foot PWB. The monitor on the stern was secured by cutting a piece of 3/4 inch of plywood the same size as the lazarette hatch. The plywood was then secured by U-clamps to the hatch securing dogs. Figure 18.
