*A case study of land treatment in
a cold climate — West Dover, Vermont*

CRREL Report 82-44

December 1982

J.R. Bouzoun, D.W. Meals and E.A. Cassell

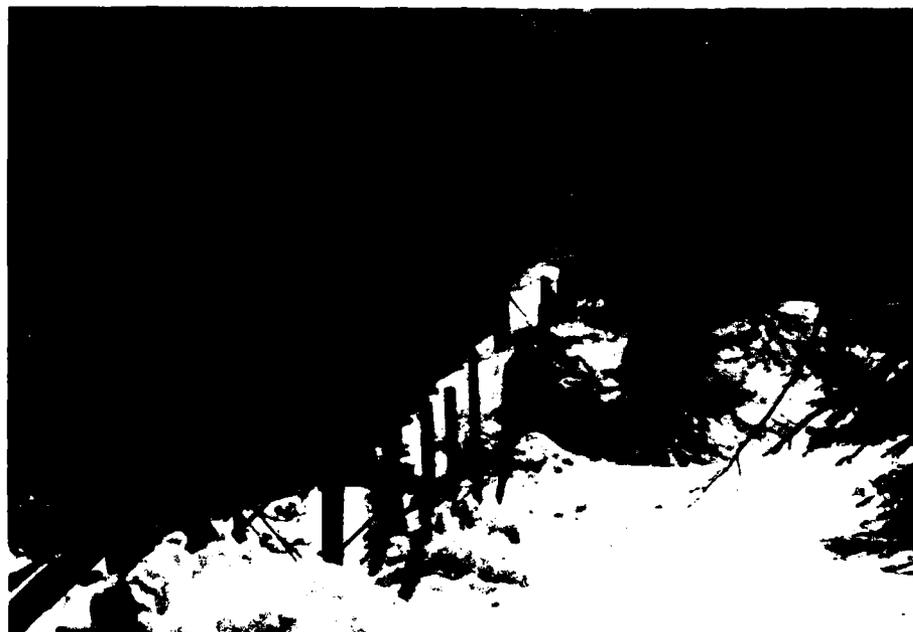
a. Lateral 7.

Figure 10. Typical spray laterals.

b. Lateral 9.

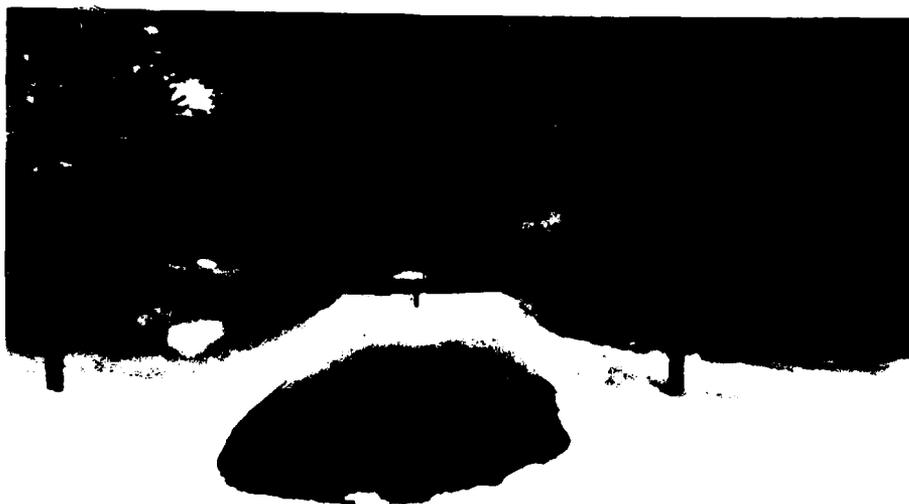
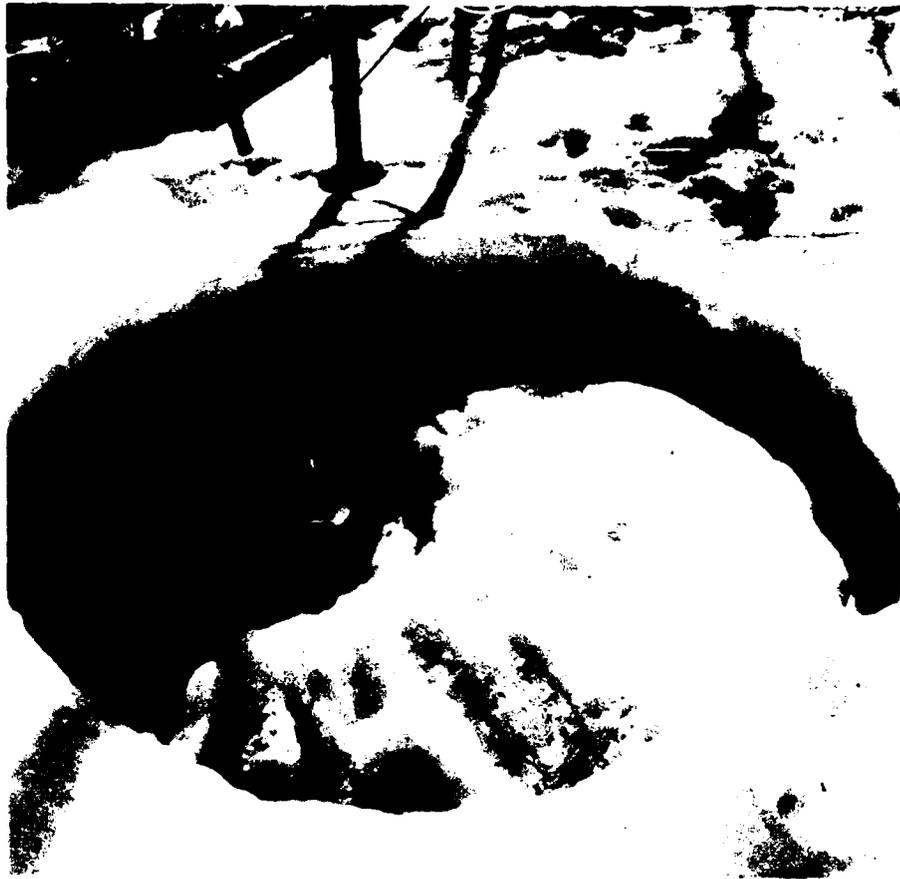
a. Lateral 2.

Figure 11. Downward spraying nozzle.

b. Lateral 8.

Originally, Parasol 1/2 E40 nozzles, manufactured by the Spraying Systems Co., were installed at the 66 low points along the spray laterals. Their purpose was to drain the low sections of the spray lateral after completion of a spray cycle. During the first winter of operation (1975-76) it was found that Parasol nozzles effectively drained most of the wastewater within 1 hour of the completion of a spray

cycle. However, a small quantity of wastewater continued to drip from these nozzles for several hours. This wastewater had a temperature of about 40°F when it was within the lateral, but it froze at ambient air temperatures as high as 27°F when it dripped out. During the next spraying cycle, the nozzles remained frozen and would not spray. The frozen nozzles became a problem at the end of a spray cycle because there was no way for the wastewater to drain from the low points in the laterals. The laterals were then susceptible to damage caused by the progressive freezing of the wastewater left in them.

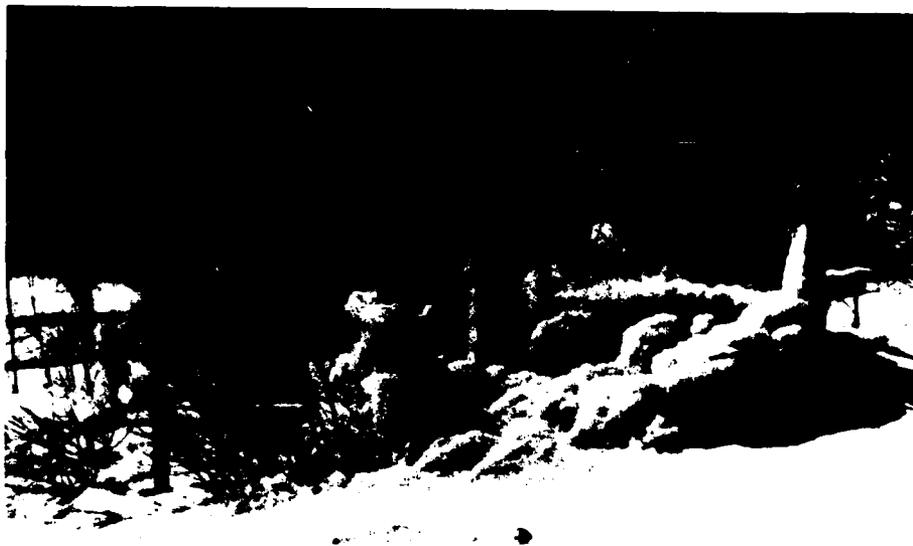
Figure 14. Snow and ice buildup near spray nozzle.

As spraying continued throughout the winter, large amounts of snow and ice formed under the spray laterals, particularly within the spray circle of the nozzles. During the winter of 1977-78, only laterals 5 through 9 were used (see Fig. 6). Typically, the operator would operate two of these laterals all day. On the next day he would use two different laterals while he tried to remove the ice that had built up during the previous day. Although the operator worked hard to remove the ice from the laterals, a large amount did accumulate around the spray nozzles (Fig. 14). As these mounds continued to build, their weight actually caused sags in the spray laterals (Fig. 15). Because there was no way of draining them, these low points were susceptible to freezing and bursting, or plugging.

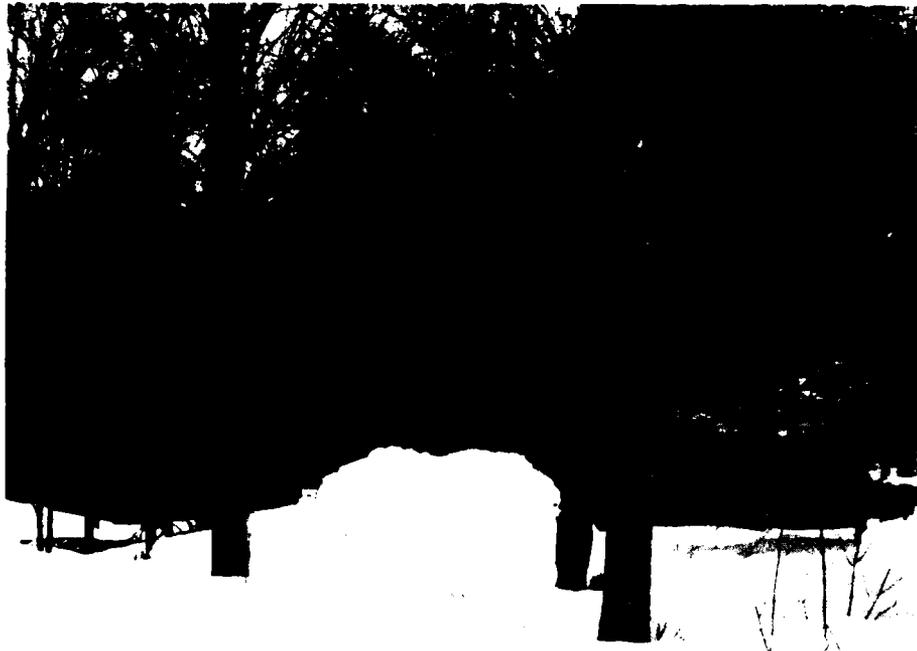
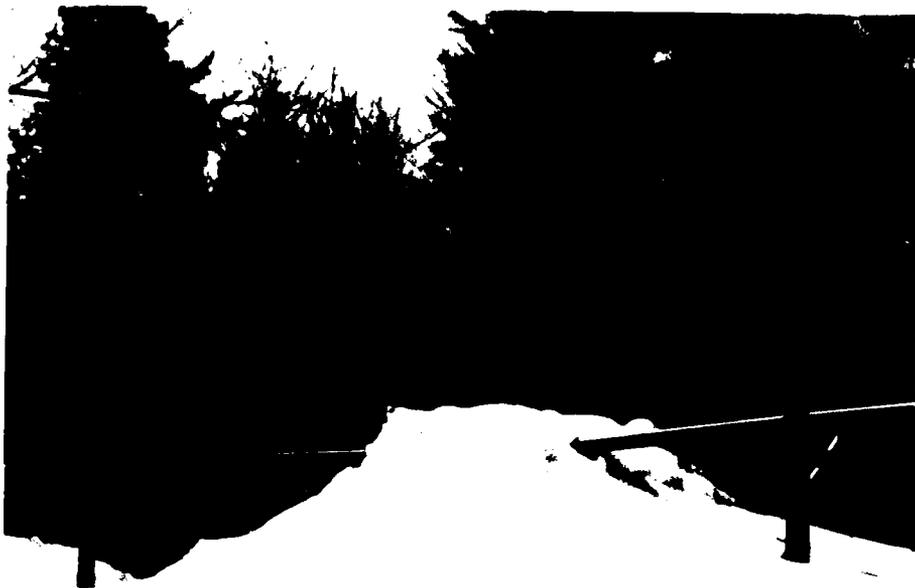
Figure 15. Sags in spray lateral 10.

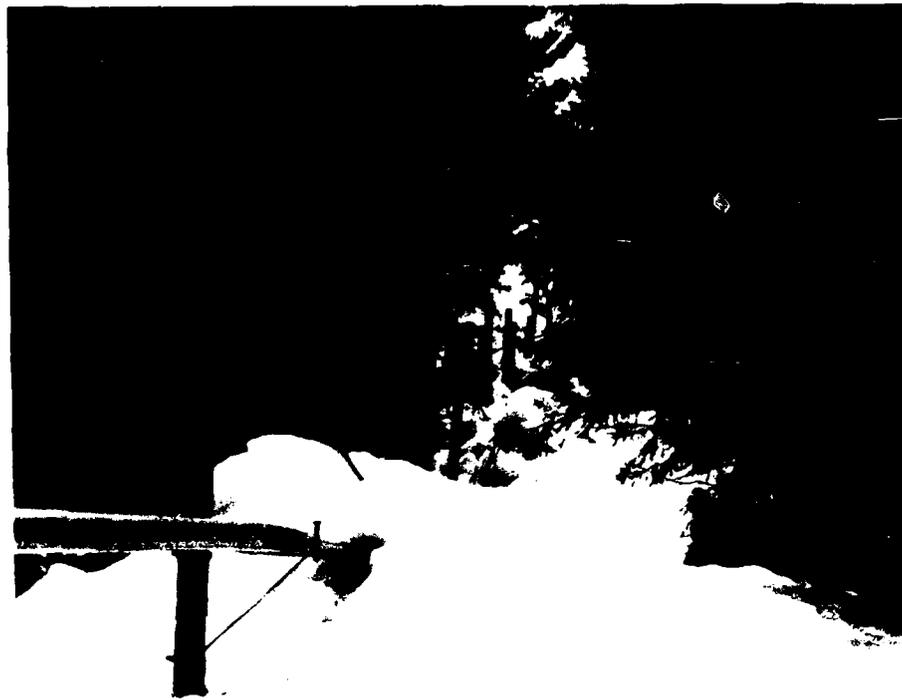
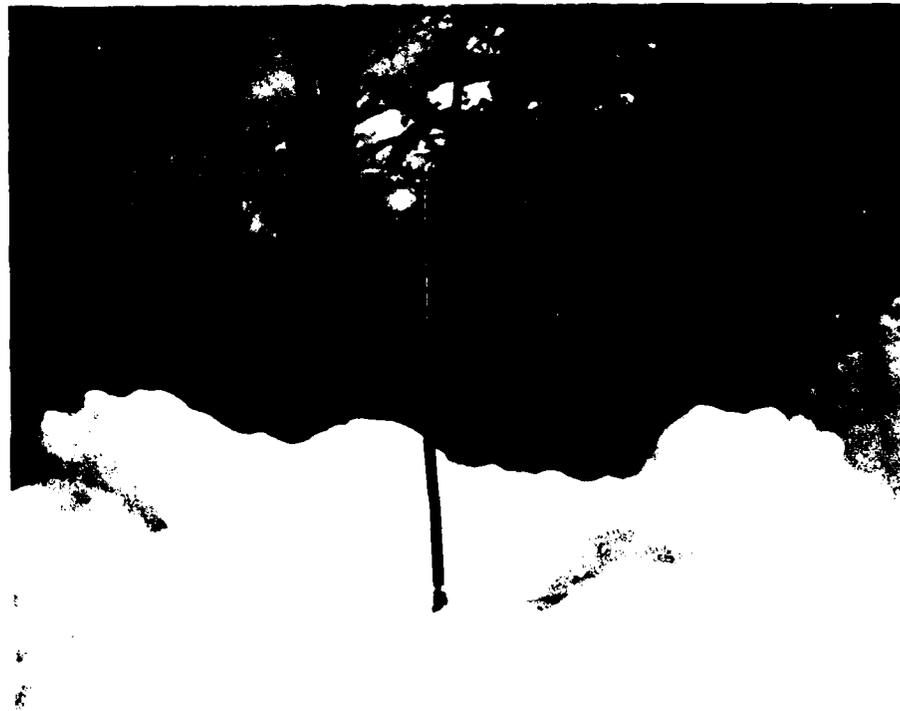
b. Laterals.

Figure 16. Experimental risers on spray laterals

To minimize the buildup of ice and snow on the laterals, the operator, acting on the recommendations of Dufresne-Henry (Dufresne-Henry 1977), removed the spray nozzle from the lateral and placed it on top of a copper riser, about 30 to 36 in. long. Angling the riser approximately 20 to 30 degrees from the vertical directed the spray away from the lateral. Figure 16 shows two of these experimental risers on spray laterals. The results were excellent, and the operator intends to install these risers along the entire length of several laterals. Also, he plans to have all the risers on one lateral lean towards the west and those on the next lateral lean towards the east. Then he can select laterals where the spray will not be blown back on them by the wind.

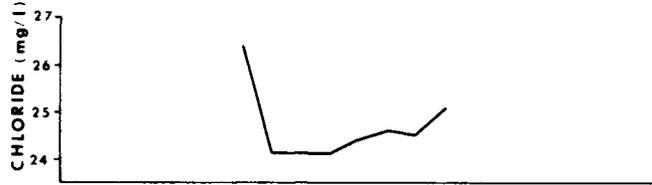
Figure A7 (cont'd). Concentration and mass export of three wastewater constituents during event 7. Hydrograph of ditch flow is included at the top of each figure group for comparison.

c. Chloride.
