CULTURAL RESOURCES RECONNAISSANCE REPORT
FOR THE SAIPAN SMALL BOAT HARBOR STUDY AREA,
SAIPAN, COMMONWEALTH OF THE
NORTHERN MARIANA ISLANDS

U.S. Army Corps of Engineers
Pacific Ocean Division
Contract No. DACW84-79-C-0028

March 1980

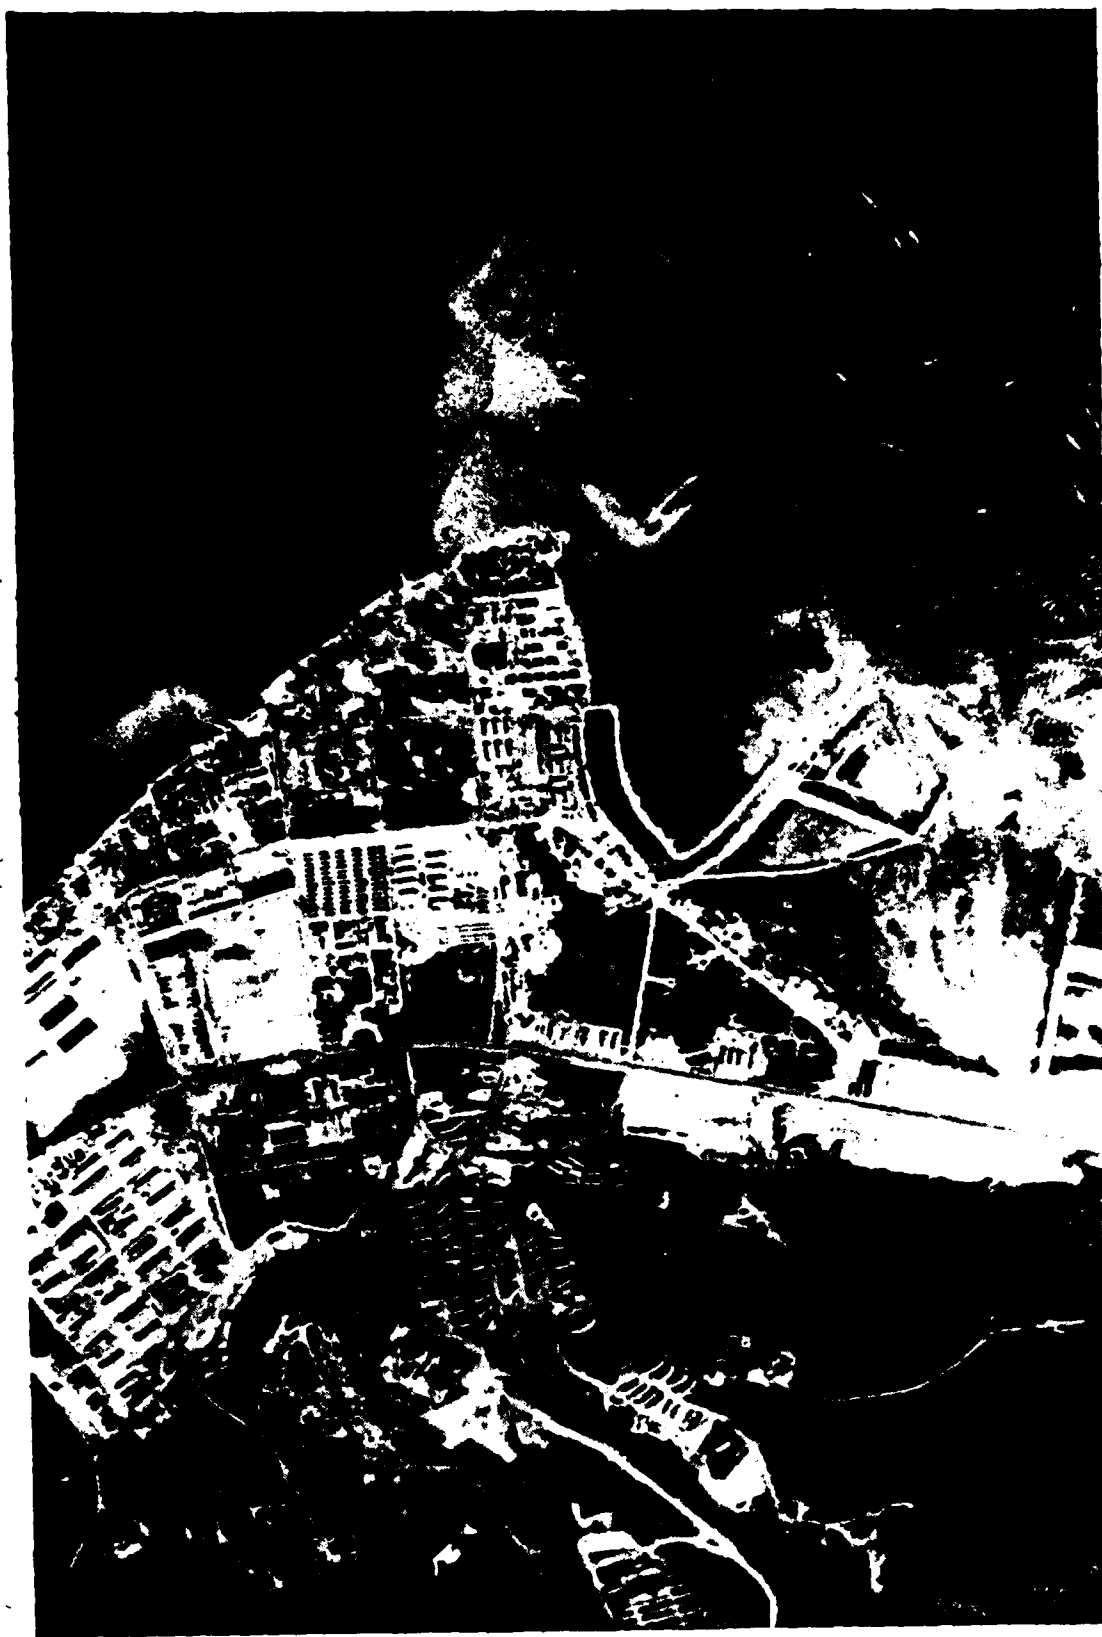
FIGURE 6: 1946 AERIAL PHOTOGRAPH OF MICRO BEACH AREA
(From the Saipan Museum)

In the Micro Beach area the survey resulted in the discovery of several objects from the World War II period (a post-war aerial photograph, Figure 6, reveals the extent of modification

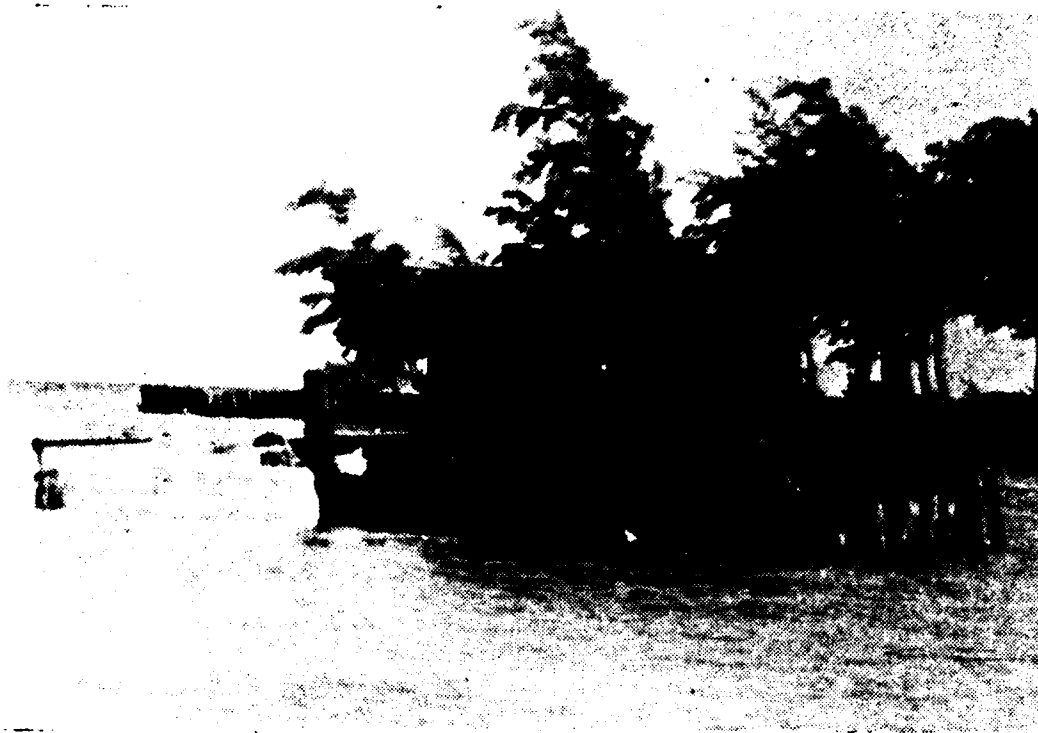
Object number one was reported by informants to be the remains of a Japanese Tugboat which was employed in the 1930's. As may be seen in Figure 7, the boat is in very poor condition.

Figure 7: Remains of a Japanese tugboat (Object 1) aground near the Small Boat Harbor entrance.

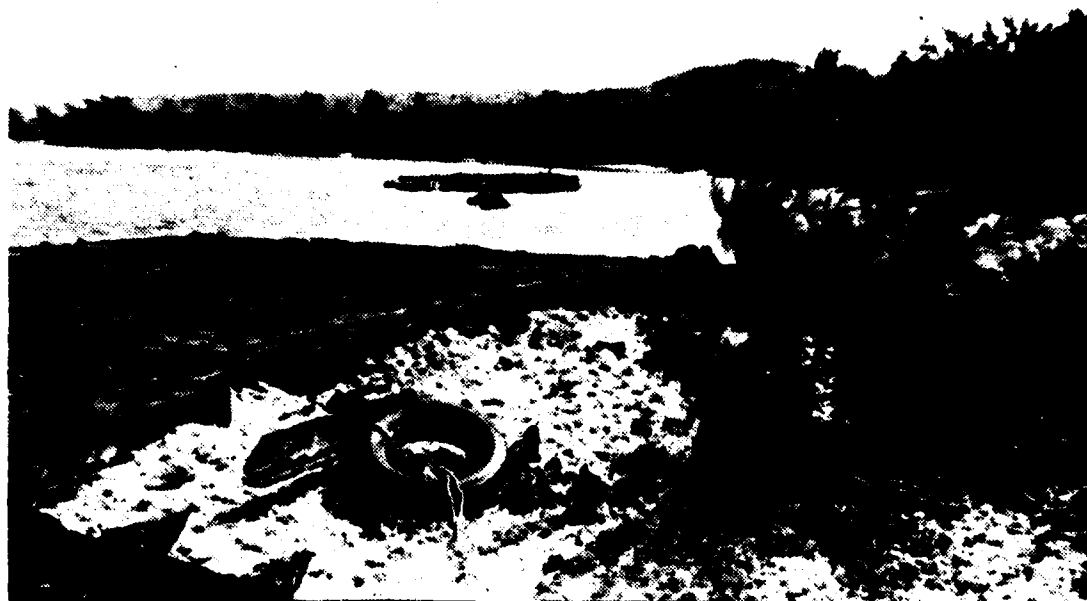
Objects five, six, seven, ten and twelve are all remains of rectangular multi-purpose steel pontoons. These are common in Saipan, and virtually everywhere the American Navy supported ground forces, their wide variety of uses accounting for their ubiquity. As indicated in Figure 11 their condition is generally poor.

Figure 11: Multipurpose steel pontoons (Objects 6 and 7) aground in the Micro Beach area.

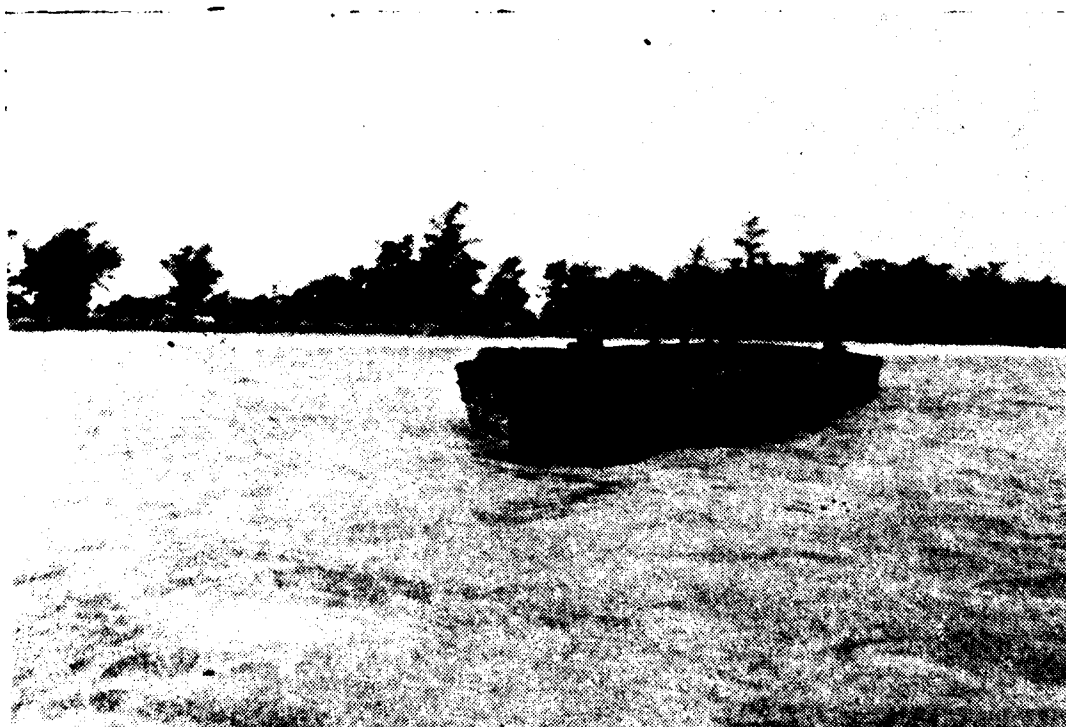
Object nine is a Japanese Harbor dredge (Figure 12) associated with it is the bucket with which it once kept the harbor free of silt. According to local informants there were two such imported dredges operating in Saipan before the war, but the location of the second is unknown. The steel hull and deck of the boat are in fair condition when compared with the pontoons in the same area, but it is doubtful that the boat could be moved.

Figure 12: Steel harbor dredge (Object 9) used by the Japanese before World War II.

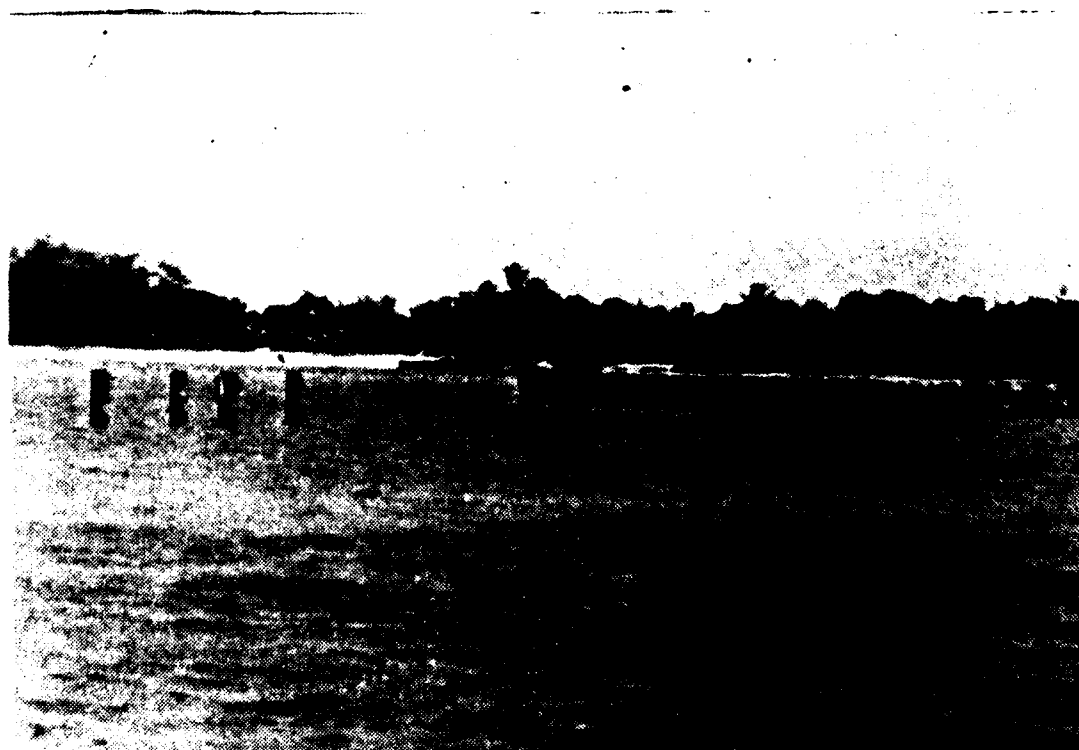
by the Japanese in the same area as the earlier German and possibly even a Spanish dock. The northern-most dock consists of a concrete wharf fronted by wooden pilings (Figure 14). Also according to local informants, this structure was the public and commercial dock for the city of Garapan during the German and Japanese eras. The southern dock (Figure 15) was not as large, and today consists of a pile of rubble near the shore fronted by wooden pilings, as in the case of the northern dock. Again according to local informants, the southern dock was the official Japanese dock supporting customs, immigration and coastguard facilities. It is unknown whether this southern dock also existed during the German period. After the American invasion of Saipan in 1944 the docks were repaired and used extensively to off-load support equipment and supplies. With the withdrawal of American forces after the war, maintenance of the docks lapsed, allowing them to deteriorate to their present condition.

Figure 14: Northern Fishing Base Dock in the Garapan area.

In terms of the docks themselves, further investigation will be required to determine their eligibility for the National Register, but they are considered of historic significance. The original docks in the Garapan area may have been constructed during the Spanish period, but evidence has not yet been collected to support this supposition. By the German period (i.e. around

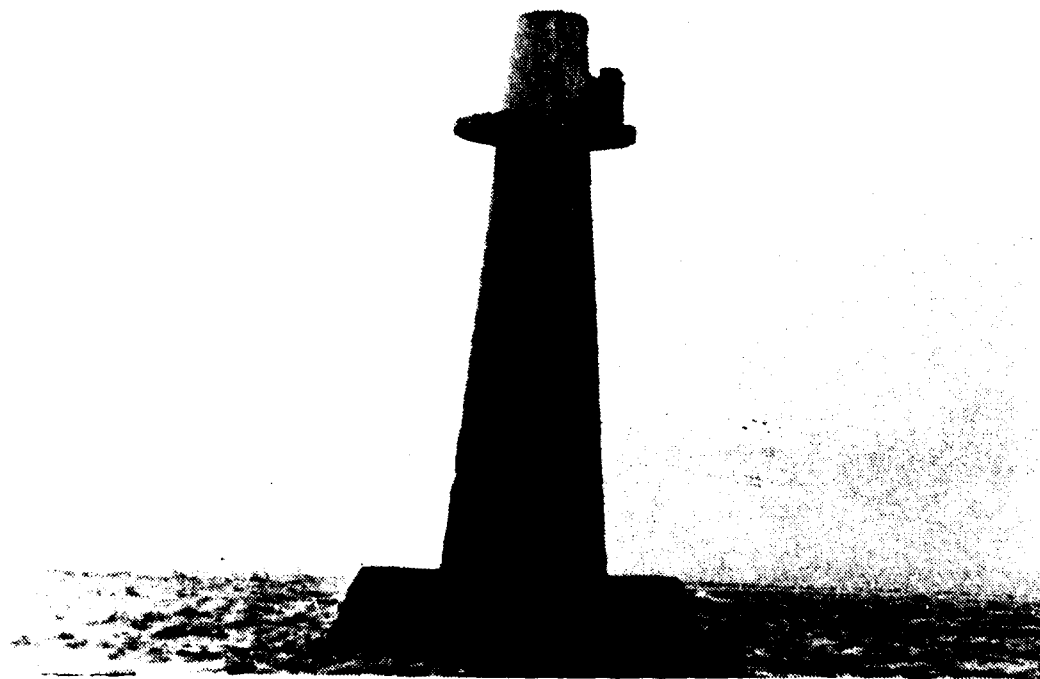
Object seventeen is a small concrete channel marker which stands on the barrier reef at the southern edge of the channel entrance (Figure 20). The structure, referred to as a lighthouse, has three components. The base is a large concrete trapazoid standing in 1.5M of water at mean low tide. The second component is a concrete pillar with a height of approximately 3M. On the north face of the pillar is the remains of a row of metal rungs which were used to climb to light the lamp. As may be seen in the photograph the rungs have vanished leaving only their sockets in the concrete. At the top of the concrete pillar is a collar of the same material which is broken on the north face to admit a climber. The collar supports a metal box on the seaward side housing the kerosene lamp which marked the channel. Whether or not a roof or some additional structure topped the pillar could not be ascertained as the pillar can no longer be climbed.

According to local informants the lighthouse was constructed by at least the early 1920's, although none remembered its actual construction, and was part of the Japanese coastal navigation system.

Today, the lighthouse marking Garapan channel is structurally sound and in generally good condition despite the pounding it takes when the seas are rough.

Figure 20: Japanese channel marker (Object 17) on the reef west of Garapan docks.

Regarding object seventeen it is recommended that construction plans be designed which do not endanger the integrity of the structure either directly, by removal of the coral on which it rests, or indirectly by exposing it to greater wave action from channel traffic. Further, more intensive investigation

might reveal more of the history of the lighthouse, and might explore the possibility that the lighthouse could be re-used or restored as an aid to navigation. In addition, further investigation into the construction and use of the docks at Garapan should be undertaken in order to determine their eligibility for nomination to the National Register of Historic Places.
