CAPACITOR HARDNESS DEMONSTRATION PROGRAM(U) MAXWELL  
LABS INC SAN DIEGO CA A RAMRUS ET AL. AUG 83 MLR-1339A  
AFRPL-TR-82-090 F04611-80-C-0048

Final Report  
for the period  
September 1980 to  
April 1982

# Capacitor Hardness Demonstration Program Final Report

Maxwell Laboratories, Inc.  
8835 Balboa Avenue  
San Diego, CA 92123

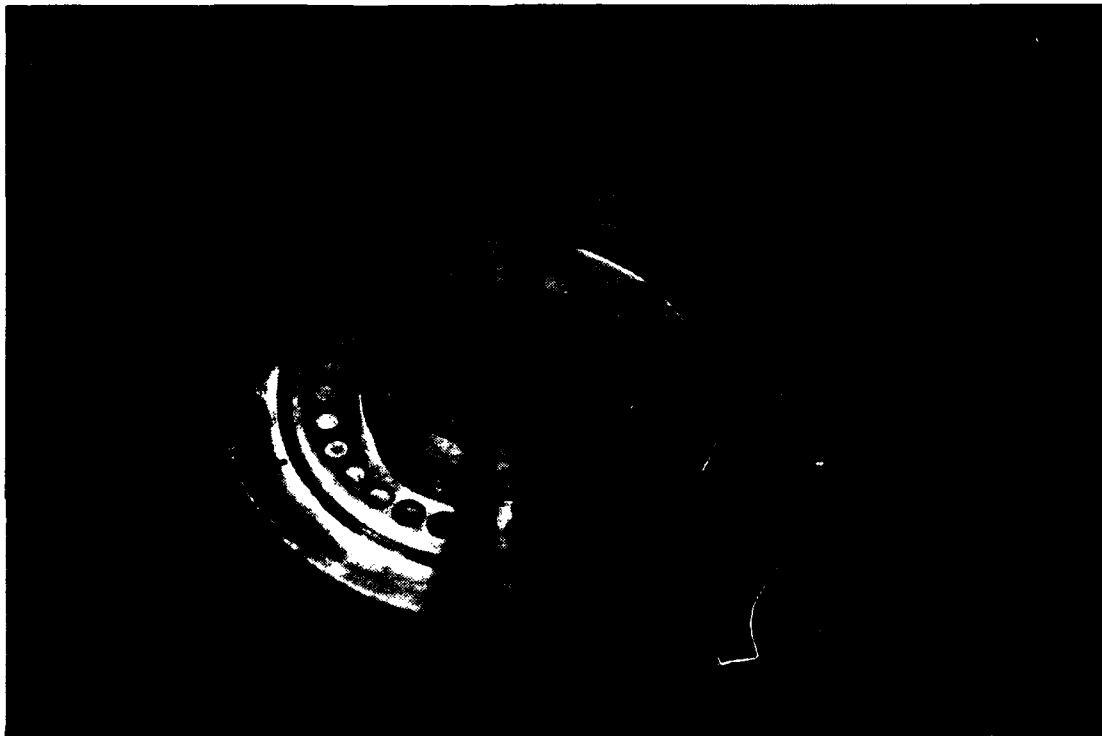
MLA-4595

7-2. A special seal was made for the center stud.

After insertion of the winding into the capacitor case, the center pin electrode of the capacitor winding was welded into the center stud of the capacitor case. Then, the leak check of the center-stud assembly was repeated (without the special O-ring seal discussed above). Three capacitors were found to leak. One was rewelded and then passed inspection. The other two (Serial Numbers 142527 and 142534) leaked and were soldered in order to make a seal. These two capacitors may serve as spares in future tests. Qualification tests of these capacitors are shown in Table 7-1.

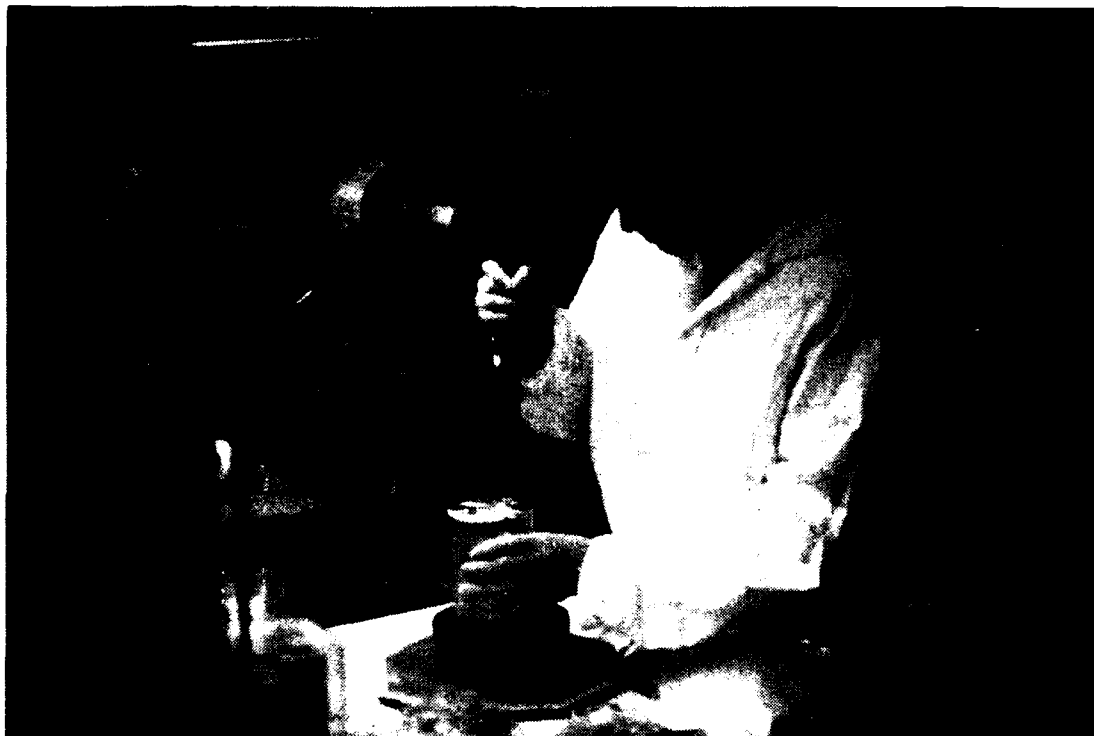
MLA-4597

7-4. Swagging of extended foils.
