REVEGETATION STUDY OF ADOBE DAM PHOENIX ARIZONA TASK 6
EVALUATION OF THREE (U) ARIZONA STATE UNIV TEMPE CENTER
FOR ENVIRONMENTAL STUDIES C MOORE ET AL. 18 AUG 83
DACW89-80-M-1205 F/G 2/4

Report to the U. S. Army Corps of Engineers
Los Angeles District

Task No. 6

Evaluation of Three Watering and Mulching Techniques
on Transplanted Trees at Adobe Dam

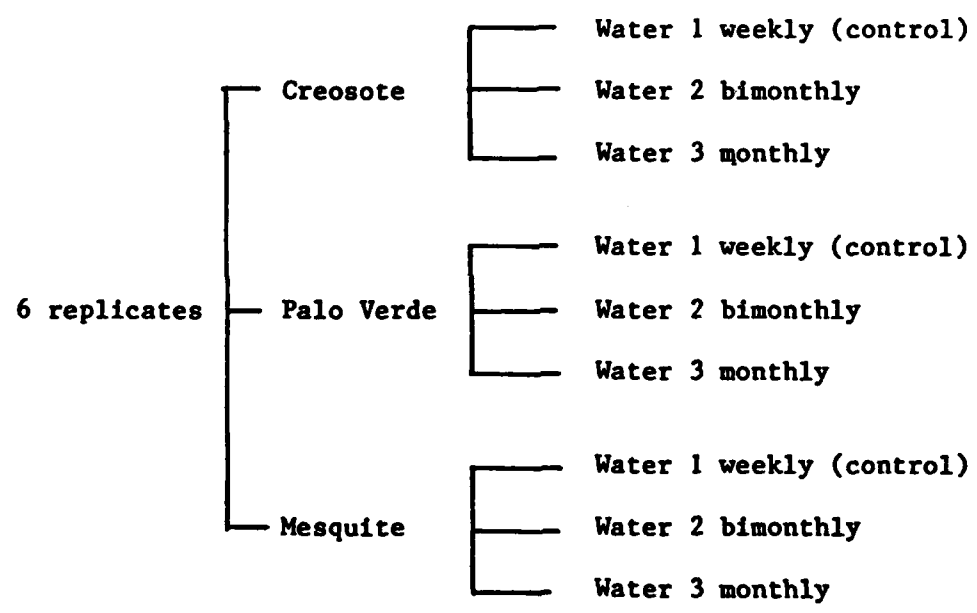
The following chart illustrates the factorial design implemented in the east section of the dam site.

For the first study, on east section transplants, a simple factorial design was selected to test watering regimes. After one month of weekly watering, three regimes were followed: weekly, bimonthly, and monthly watering. Army Corps specifications called for weekly watering of all transplants; this regime was selected to serve as the control. Rainfall of one inch or more per week was considered by the Corps to be sufficient to preclude watering. However, rainfall of less than one inch often prevented watering because site conditions were too wet for watering vehicles.

Eighteen five-gallon specimens of Cercidium floridum (Blue Palo Verde), Prosopis juliflora (Mesquite), and Larrea divaracata subsps. tridentata (Creosote) were randomly selected and assigned to the three watering regimes by use of a random numbers table. Six replications of each water treatment were included to insure a statistically testable sample. All plants were fenced.

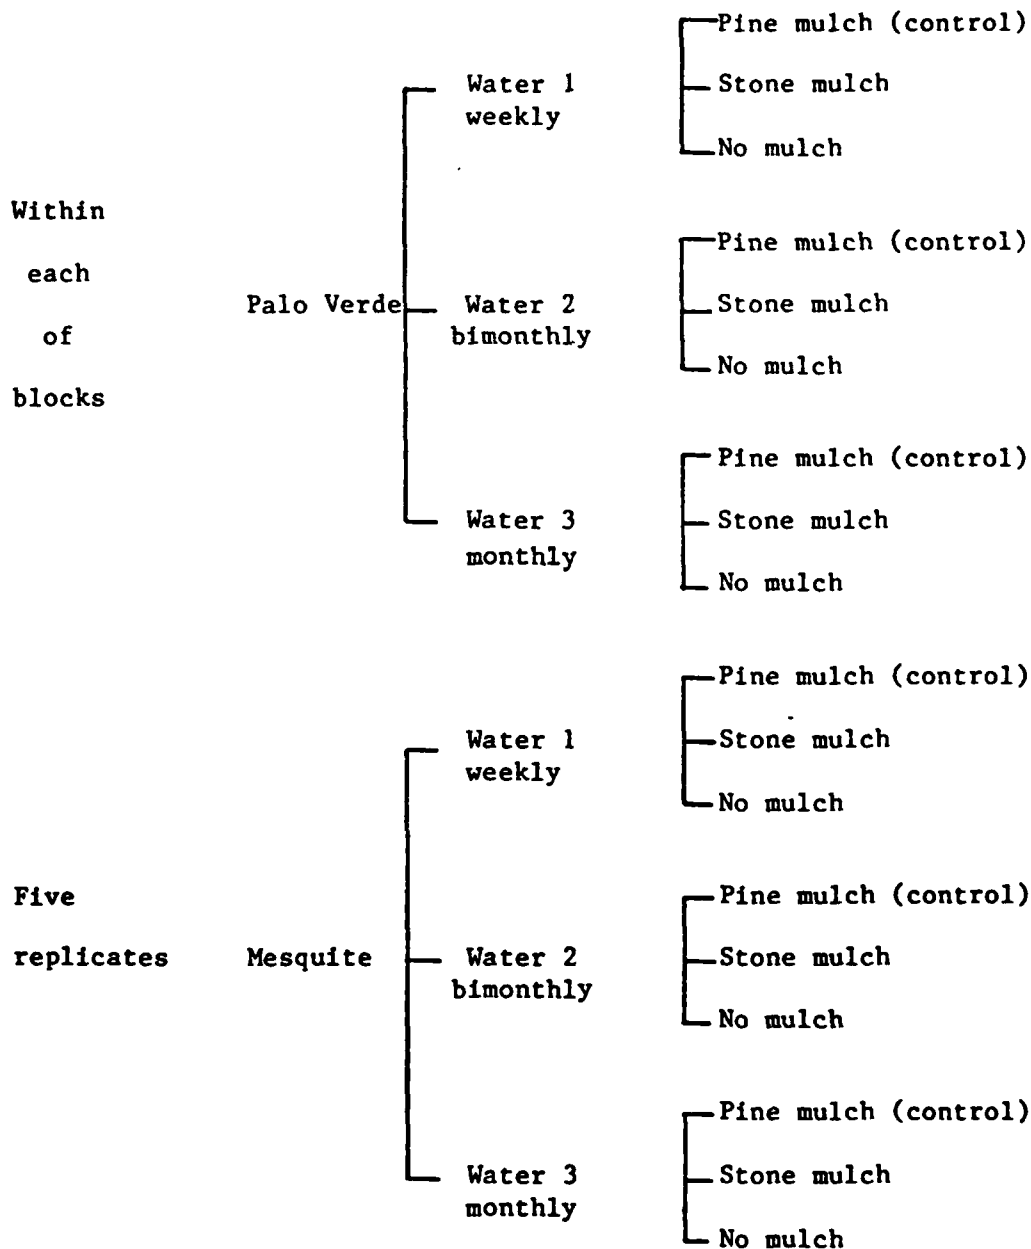
The three watering regimes established in the east section of the dam were again utilized in the west areas. Additionally, three mulch treatments were tested. These included, a pine mulch (as per Army Corps specifications), a stone mulch (material taken from on-site) and a no mulch treatment. Mulches, where applied, covered each tree well to a minimum depth of three inches. The following chart illustrates the randomized block factorial design and the simple factorial design for Mesquite utilized in the west section of the site.

The west section of the dam was planned as a randomized block factorial design. Five blocks contained replicates of the experiment. Within each block, transplants were randomly selected and assigned to treatments through the use of a random numbers table.

This design was complicated because the landscaping scheme called for a small number of Mesquite on the west section of the site. Because these Mesquite were clumped they were studied by a simple factorial design with five replicates.
