DESIGN, CONSTRUCTION, AND TEST OF A 0.61-METER-DIAMETER, EPOXY IMPREGNATED SUPERCONDUCTIVE MAGNET

PROPULSION AND AUXILIARY SYSTEMS DEPARTMENT RESEARCH AND DEVELOPMENT REPORT

DTNSRDC/PAS-81/18

October 1983

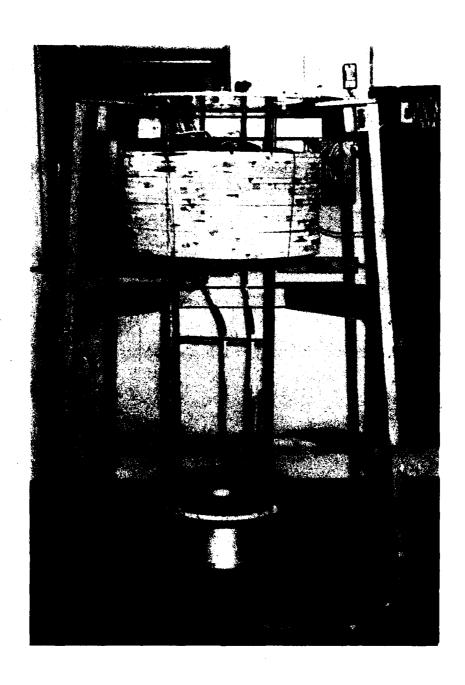
Figure 12 - Completed Test Coil and Support System

The completed test coil, assembled in its suspension-type mount with its instrumentation cables and current leads connected and ready for installation in a open mouth dewar, is shown in Figure 12. Also shown is a heat shield for the upper portion of the dewar bore made from stacked alternate layers of plastic foam, cryogenic insulation, and sheets of super insulation.
