Investigation of Cold Cathode and RF
Excitation

Long Life CO₂ Waveguide Lasers

Final Report
for Contract AFOSR-82-0058

by
U. Hochuli
March 1983

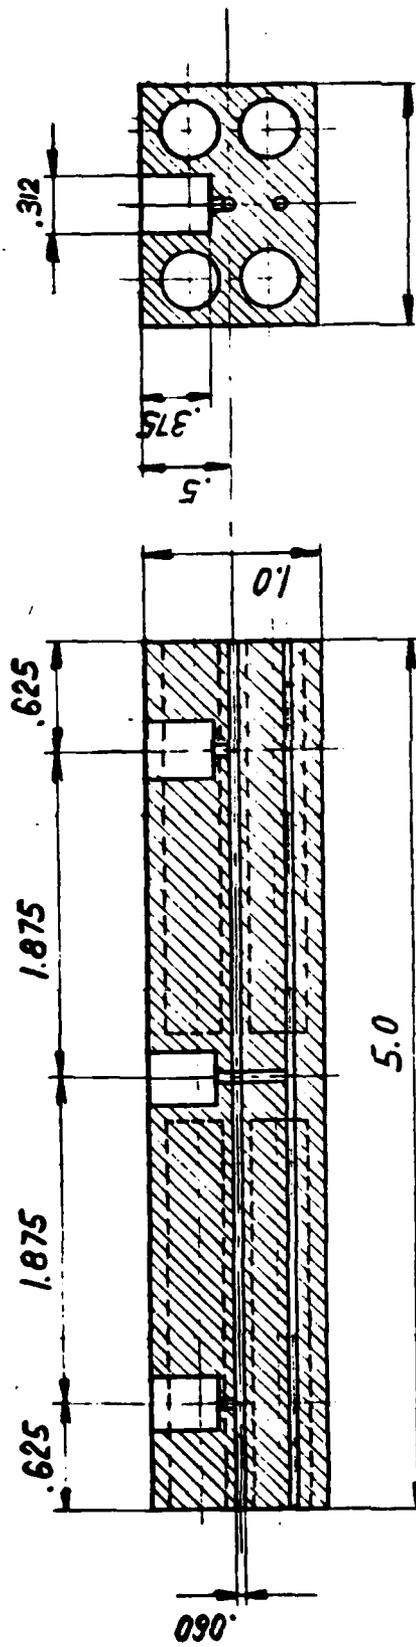
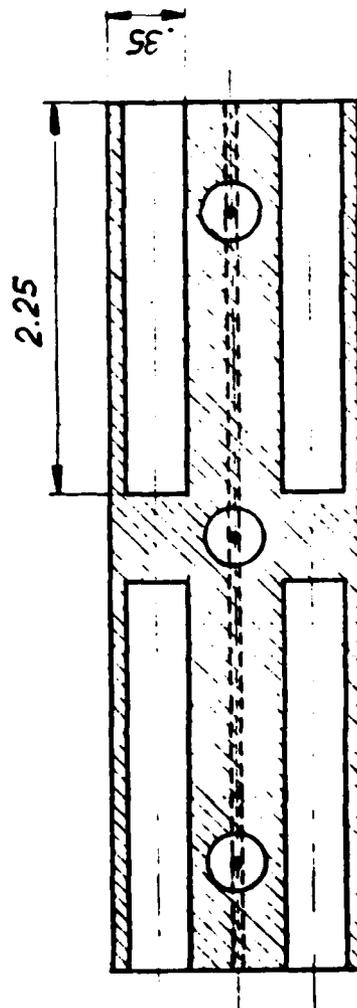
FIG. 2

LASER STRUCTURE
(BeO)

Two of these structures, shown in Figure A-1 (Crosssection shown in Figure 2) were assembled and put on life tests. The first laser had one Pt anode at each bore end and a common 4mA Ag-Li compound cathode in the center. Life test results, shown in Figure 3, indicate a disappointingly low life of 1900 hours for the first run. The laser was then evacuated and refilled for a second test. The initial power output for the second test was slightly higher than for the first test, an indication that so far no serious mirror degradation had taken place. Laser life turned out to be even shorter, only 450 hours. We discovered later that the laser envelope had developed a vacuum leak at one of its seals. Inspection of the cathode indicated fairly heavy erosion. In one place the cathode spot had produced a hole clear through the cathode wall out to the sputtershield. Unfortunately we do not know if the cathode current of 4mA was excessive or if the presence of air was responsible for this result. We felt that this test had failed and no further analysis was made on this laser.

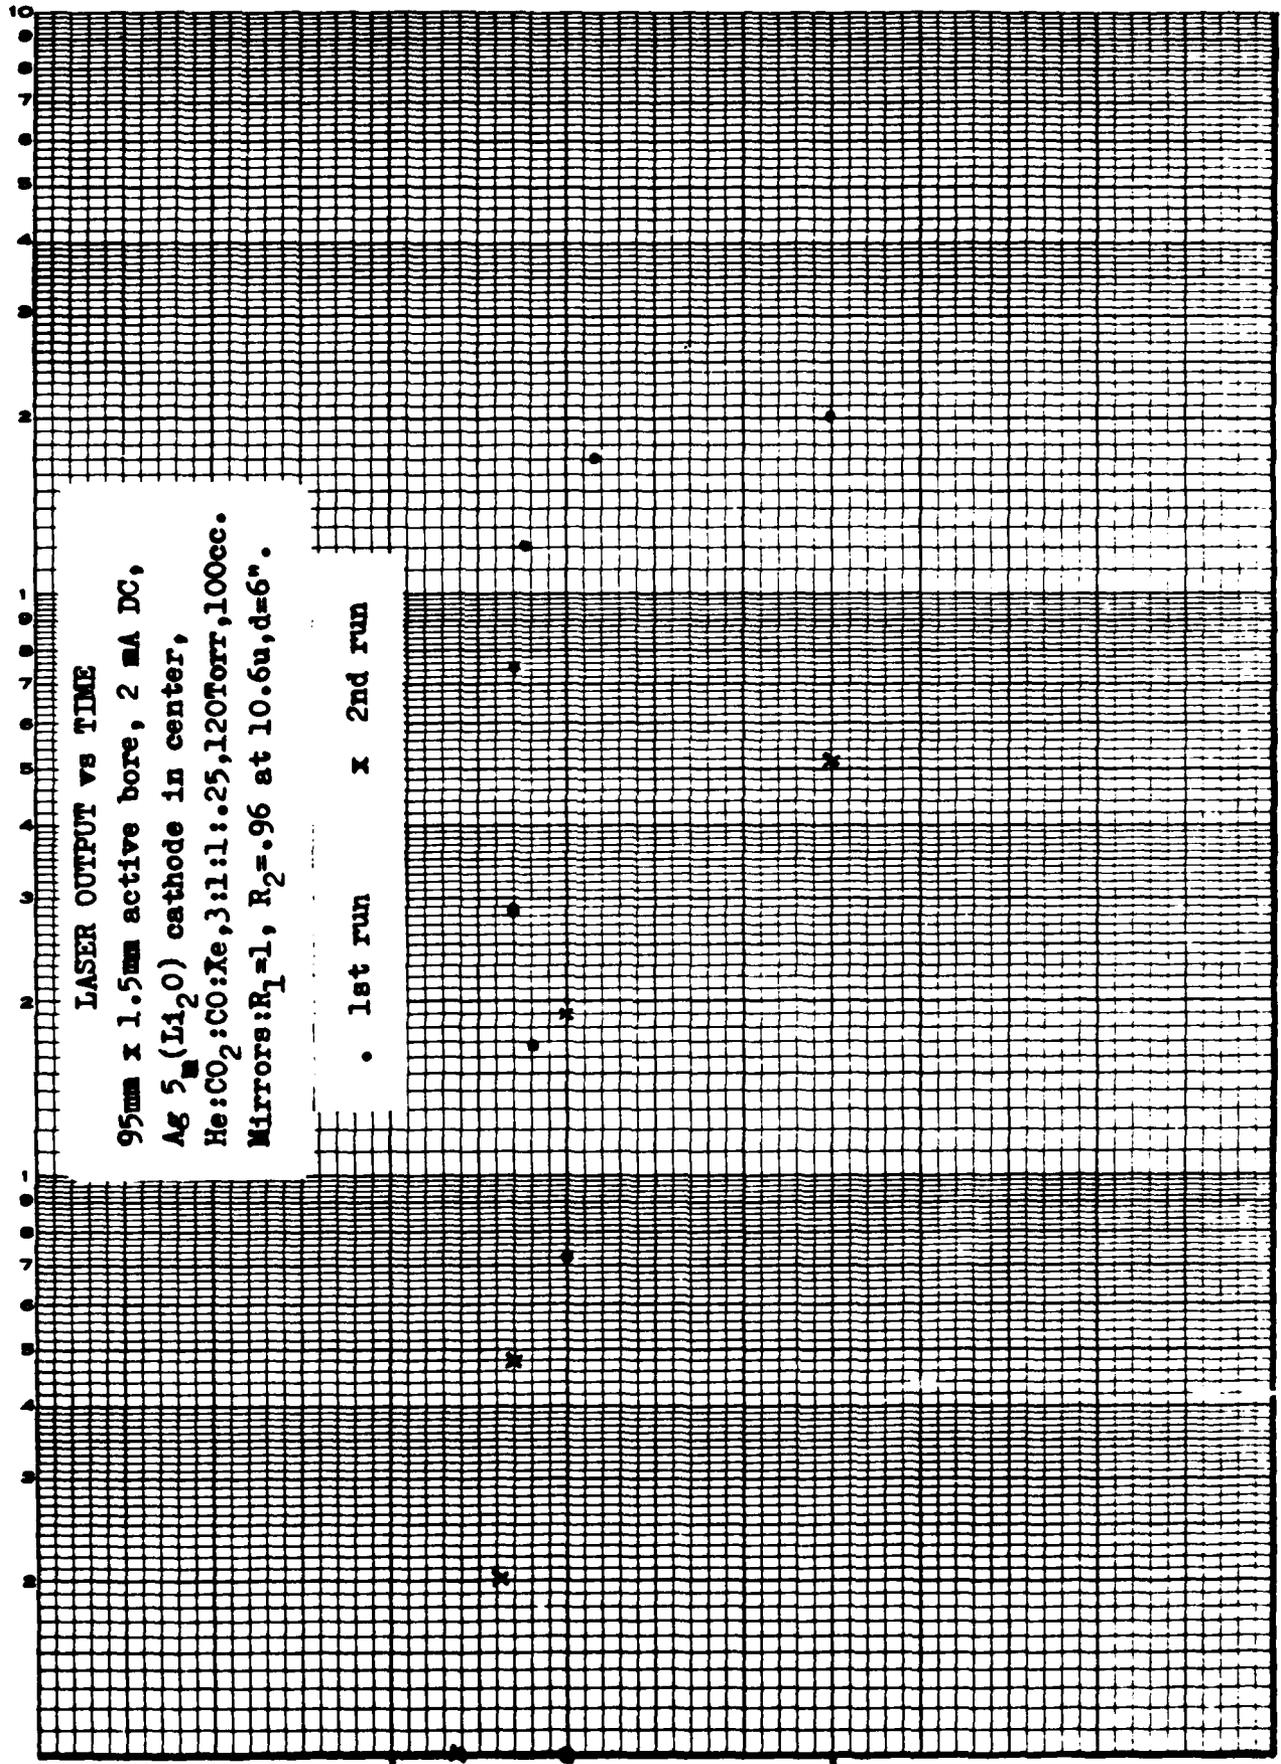
FIG. 3

LASER OUTPUT VS TIME

95mm x 1.5mm active bore, 2 mA DC,
Ag 5_m (Li₂O) cathode in center,
He:CO₂:CO:Xe, 3:1:1:25, 120Torr, 100cc.
Mirrors: R₁=1, R₂=.96 at 10.6u, d=6".

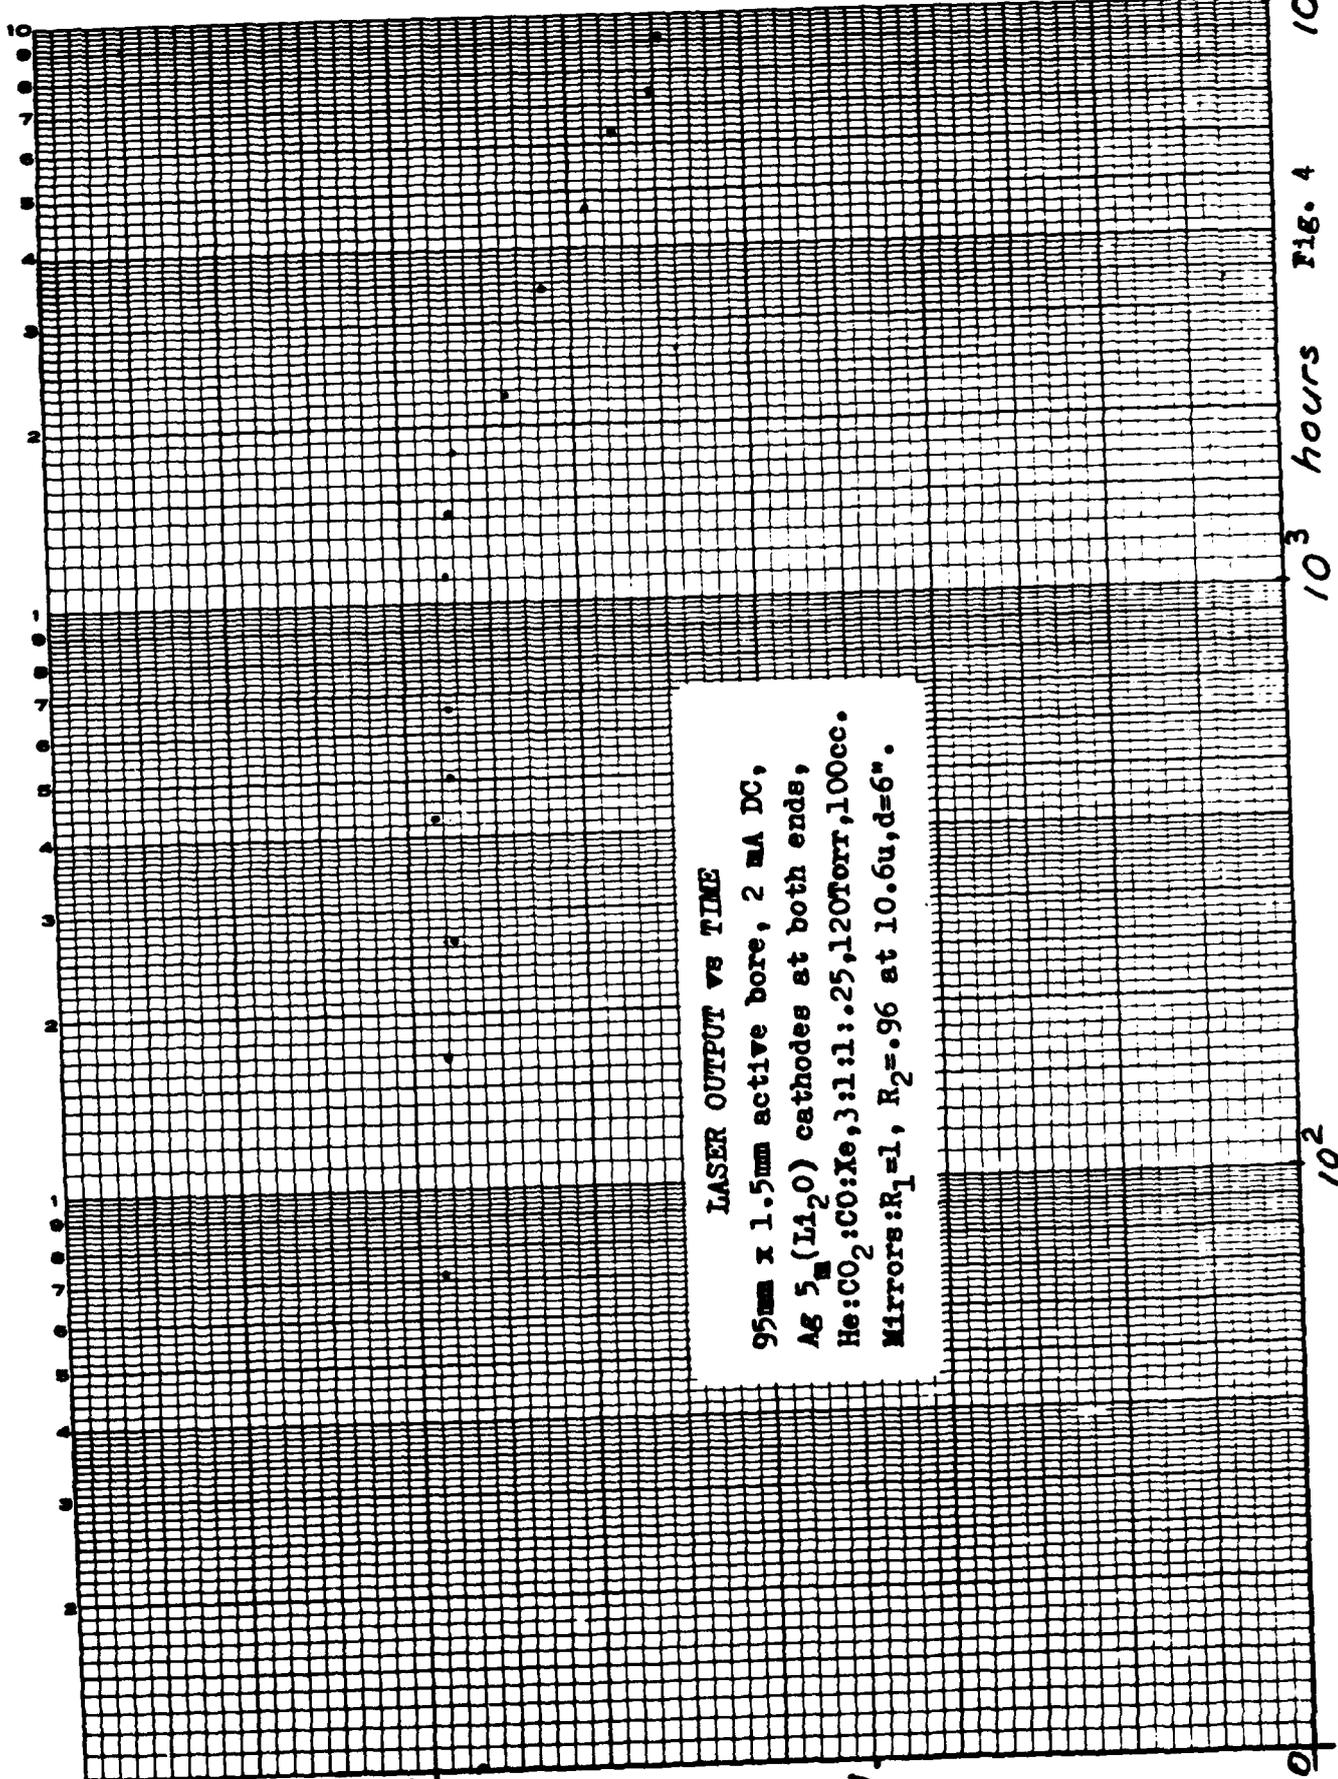
10⁴
10³ hours
Fig. 4
10²
0

The second laser used three similar Ag-Li compound electrodes: one at each bore end served as a 2mA cathode and one functioned as the common 4mA anode at the center. Test results for this laser are shown in Figure 4 and indicate that this laser still produced

72% of its original power output after 9200 hours of continuous operation. This is quite an impressive result but only a necessary and not sufficient condition for a viable laser. The "acid test" requires the absence of all loose sputtering products inside of the laser. Before opening the laser it was first carefully pumped down and refilled. The new gas mixture resulted only in an insignificant power increase over the old one. Evacuation with the vacion pump for two days at 100°C followed by a refill did not increase the power either. This is usually an indication that mirror damage has occurred.

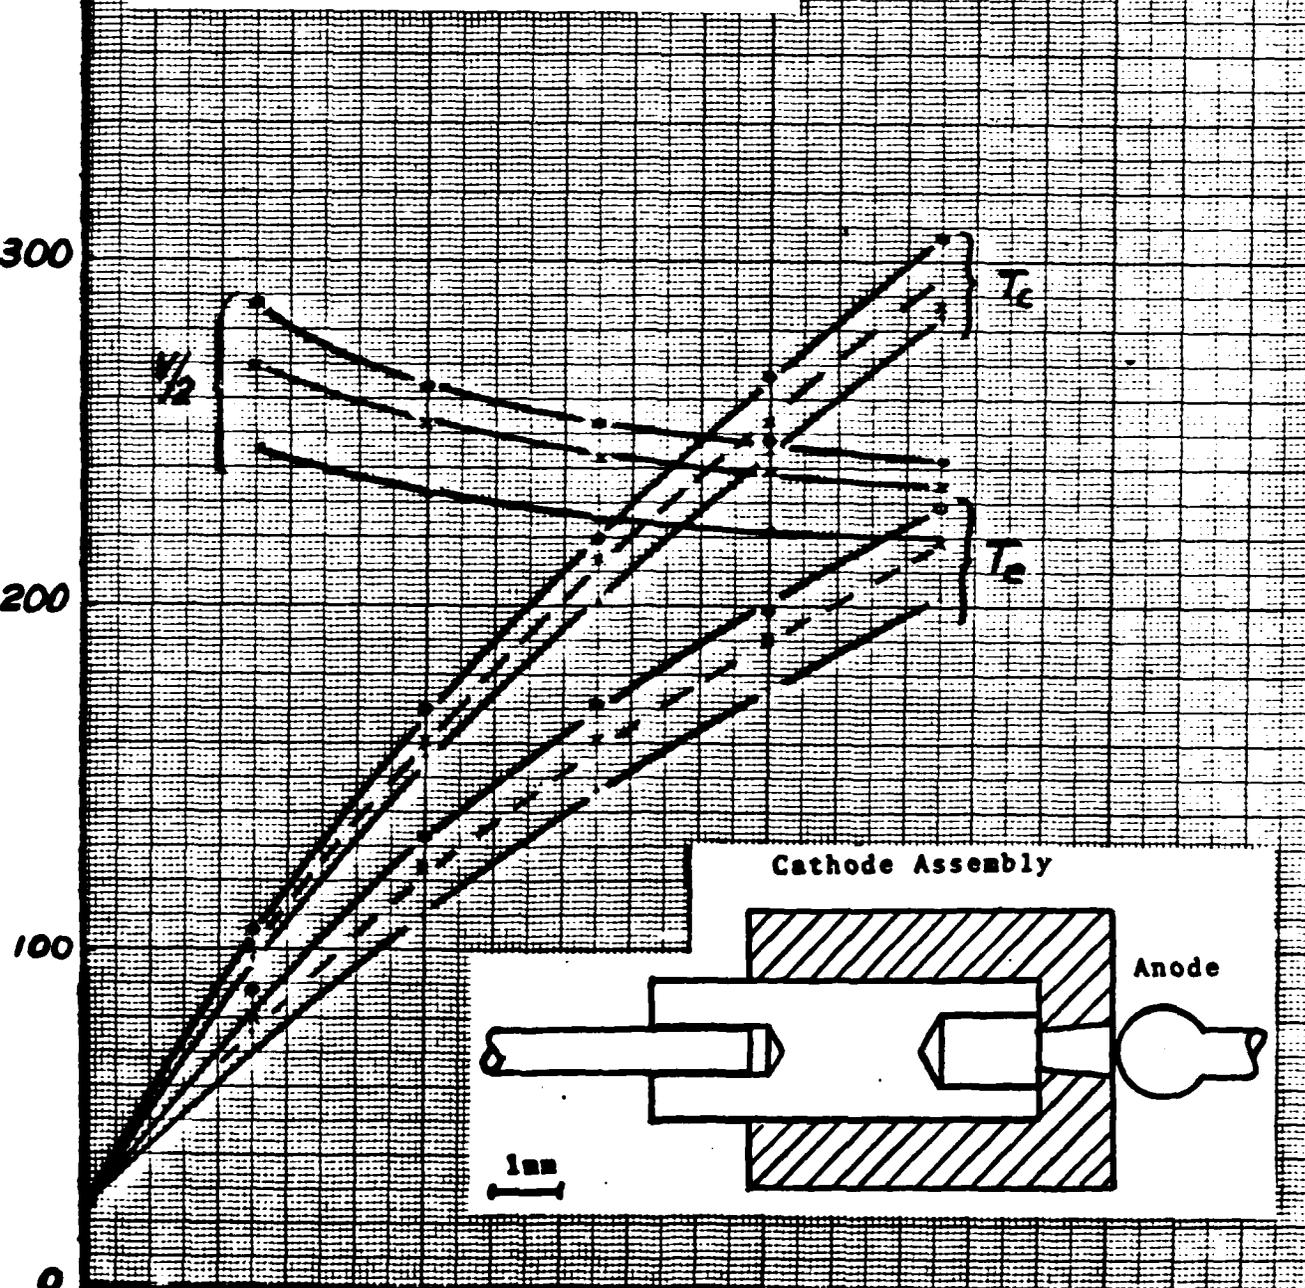
Fig. 5

Cathode Temperature }
Cathode Assembly Voltage } vs Cathode Current
Envelope Temperature }

o 200 He-CO₂-CO-Xe
x 150 Torr
. 100 4-1-1-0.25

1 mm Cu Cathode in 6mm Pyrex Tube

Cathode Assembly

Anode

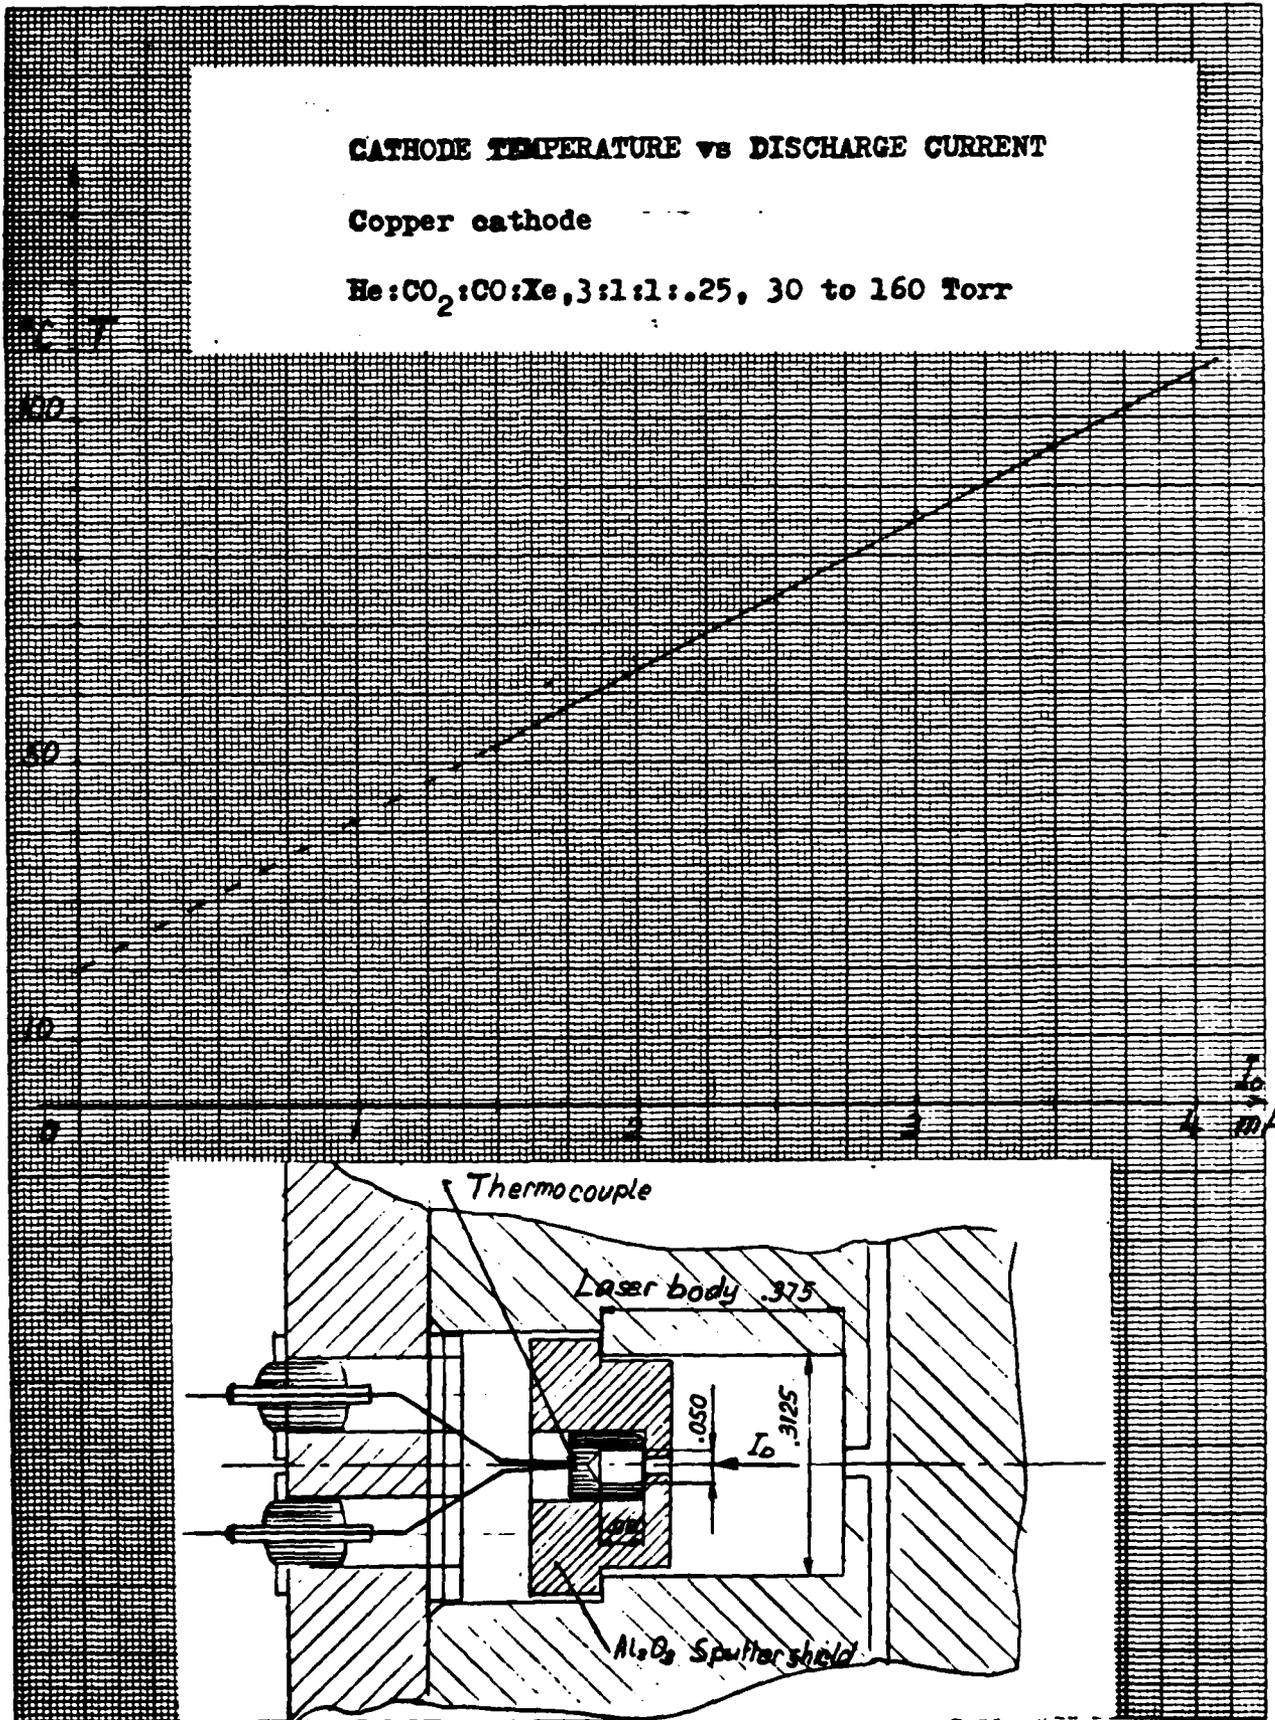
Fig. 6

The laser was then opened and carefully inspected. We found one loose, black particle of roughly 0.03mm in diameter in one of the 0.313" holes in the BeO block that accepts the cathode assembly. Both cathode sputtershields had black front surfaces and even the anode shield showed some black deposits. Figure A-3 allows comparison of these three electrode shields with the one from the discharge tube. These results clearly show that the laser cathodes behaved quite differently from the one in the discharge tube. The most likely explanation is the difference in the cathode temperatures. Figure 5, representative of the discharge tube cathode, shows a cathode temperature of 215°C for a cathode current of 3mA. Temperature measurements of the similar cathode in the well cooled BeO body of the laser are shown in Figure 6 and reveal a cathode temperature of only 63°C.

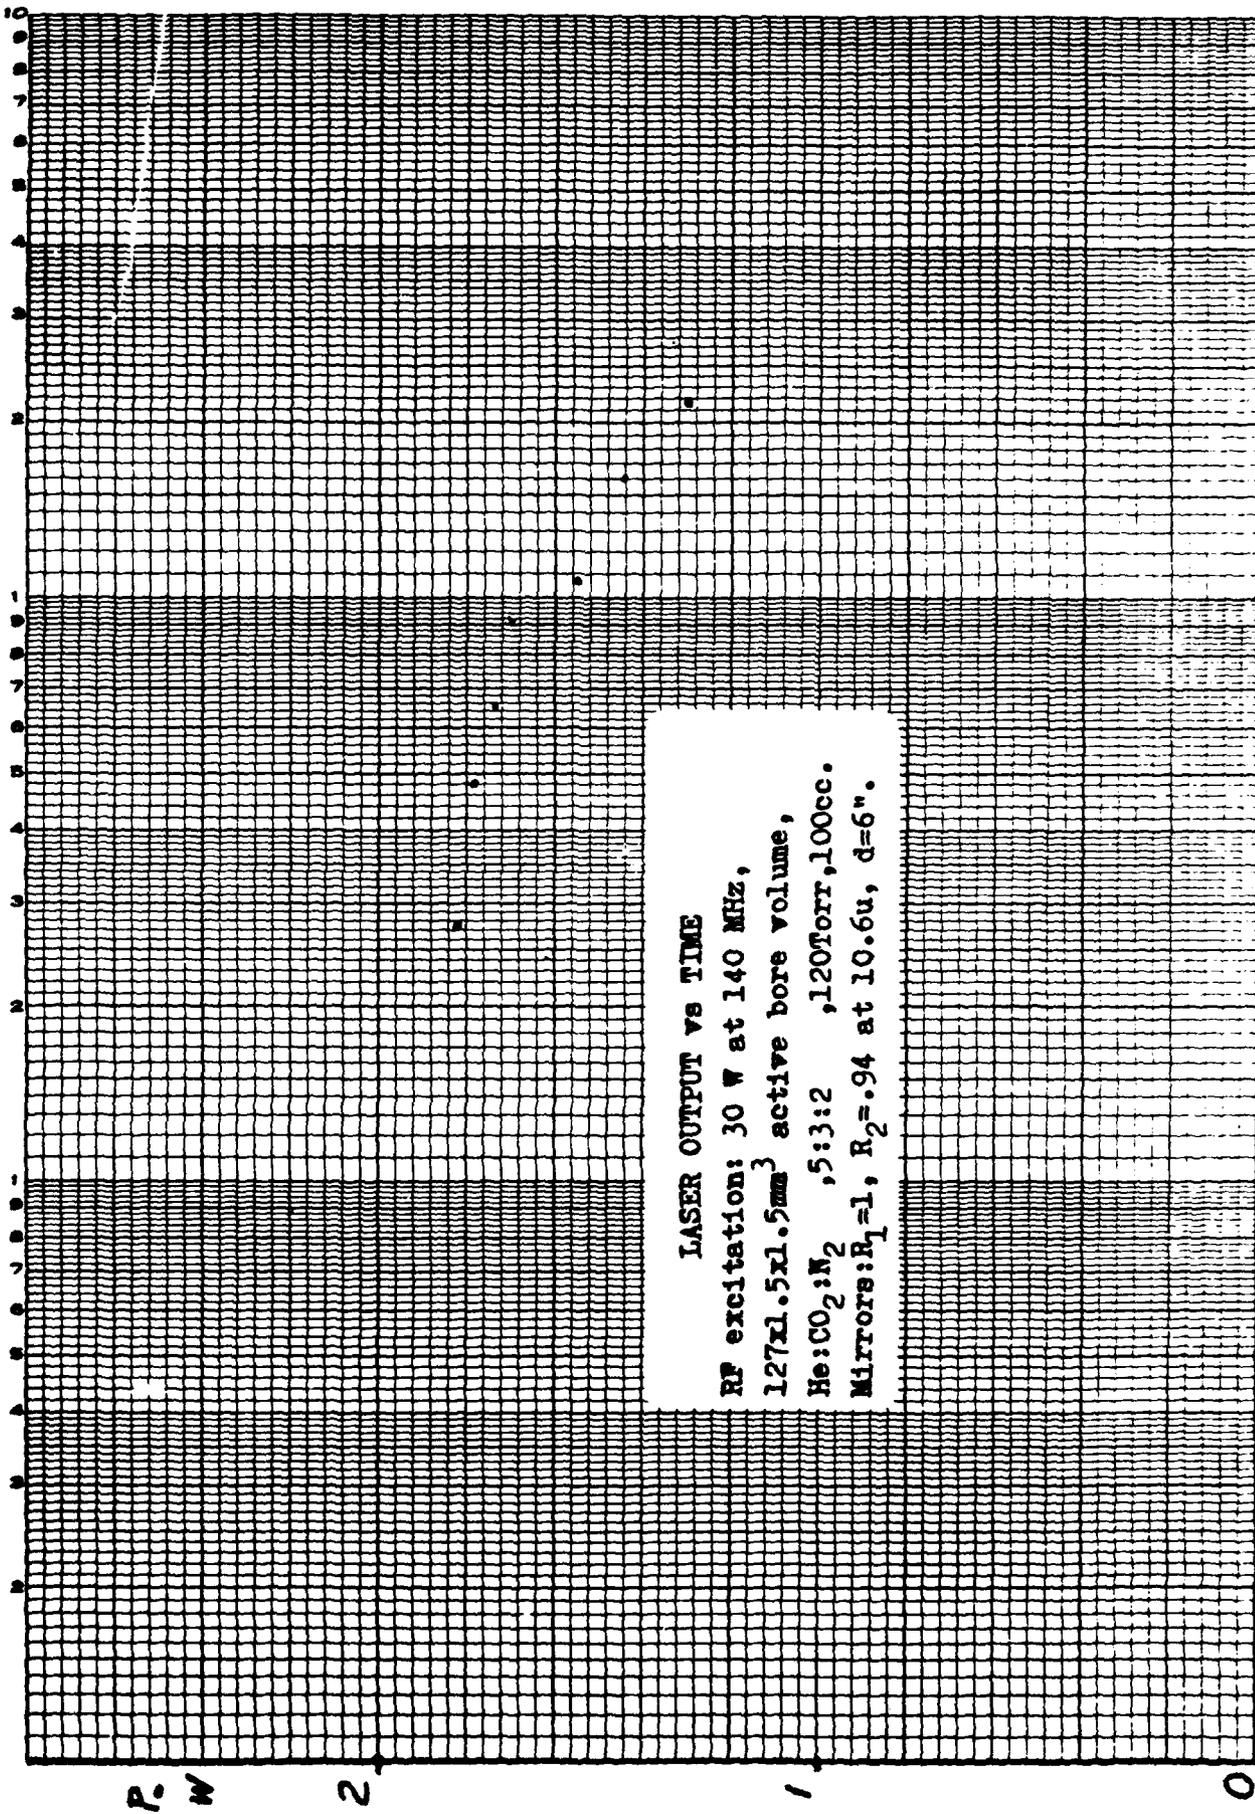
10³ h FIG. 8

LASER OUTPUT vs TIME

RF excitation: 30 W at 140 MHz,
127x1.5x1.5mm³ active bore volume,
He:CO₂:N₂, 5:3:2, 120Torr, 100cc.
Mirrors: R₁=1, R₂=0.94 at 10.6μ, d=6".

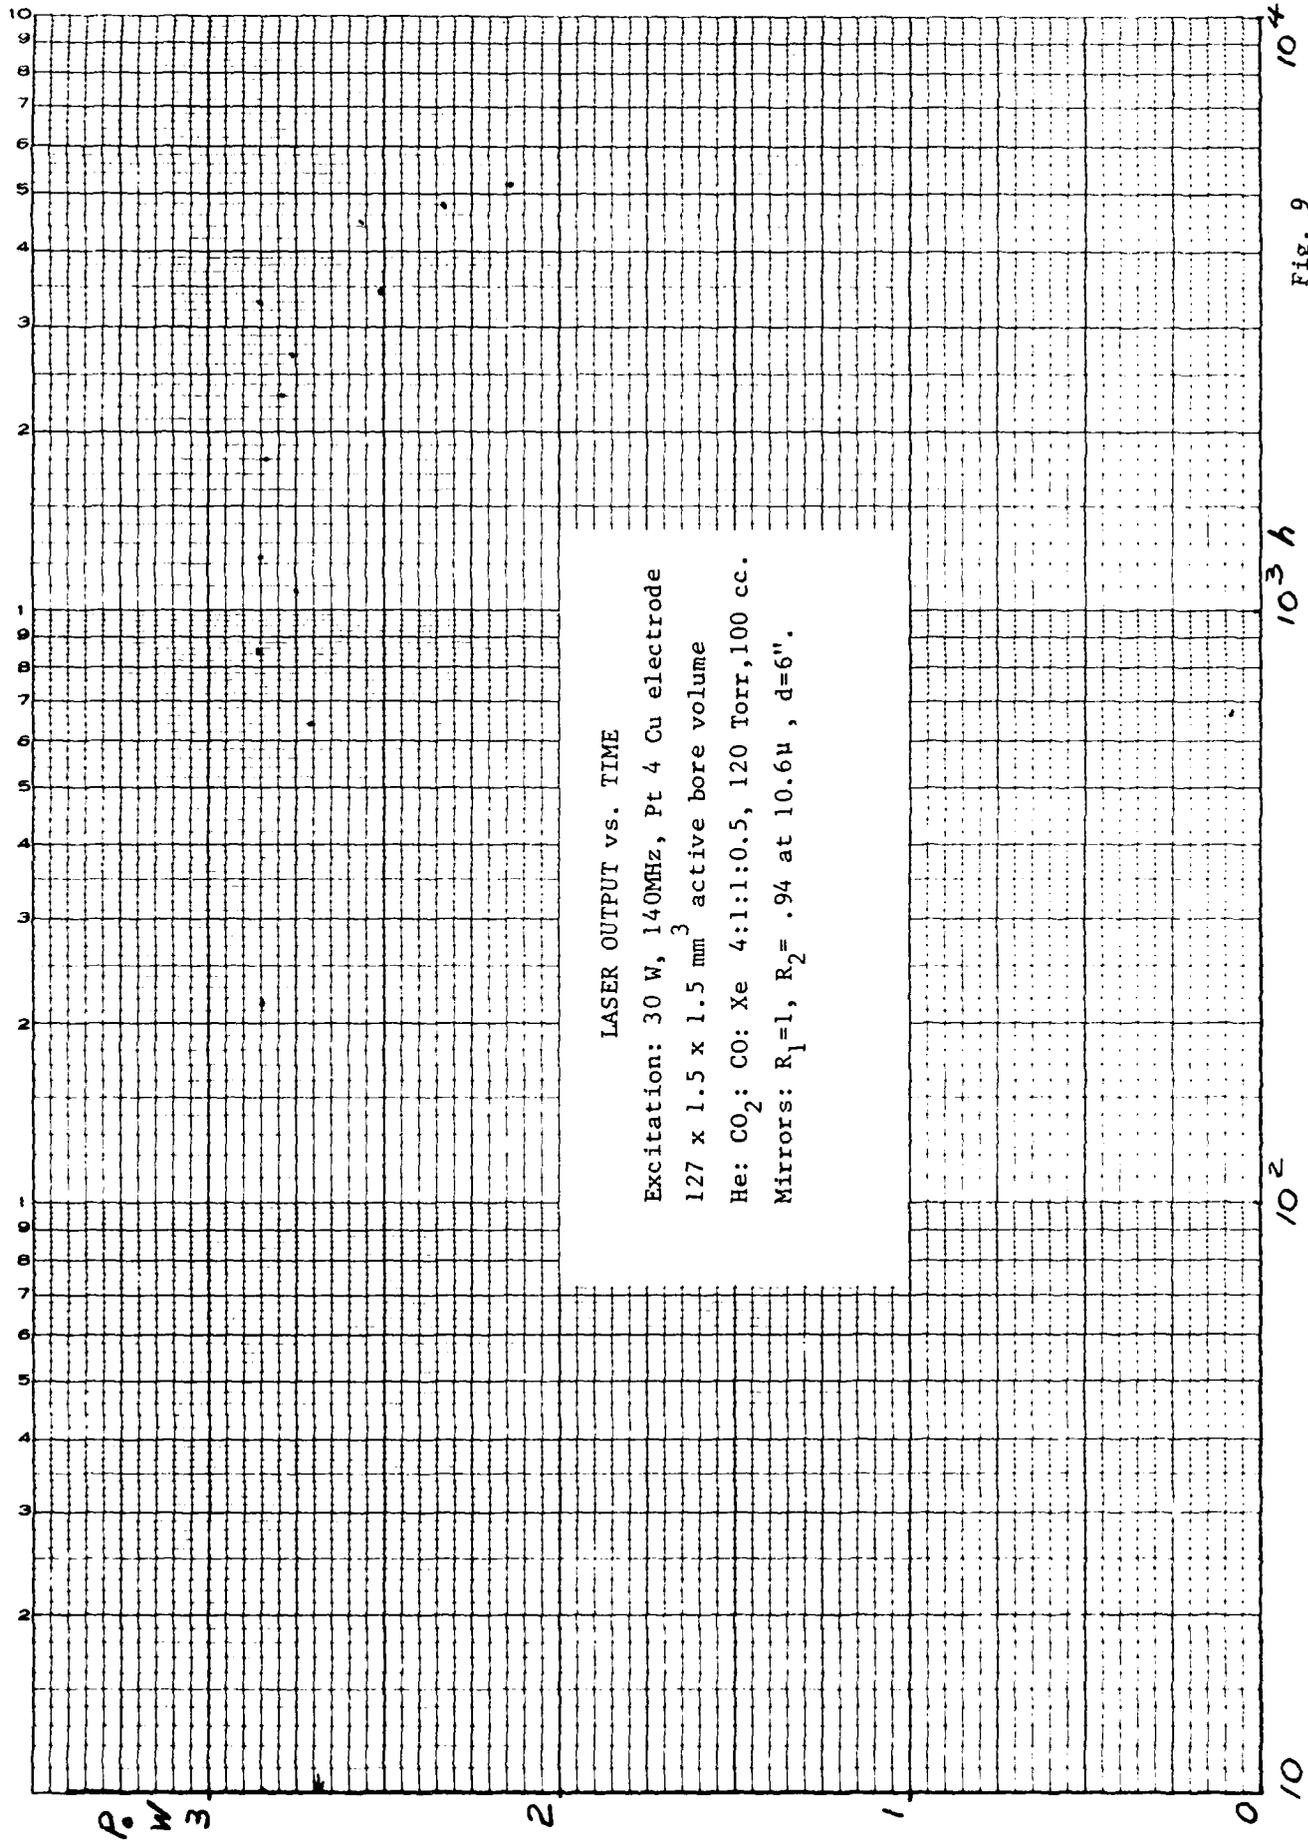
Fig. 9

Up to date life test results for a laser with such a platinum alloy electrode are quite encouraging and are shown in figure 9. This particular laser still delivers 74% of its initial, power output of 2.85W after continuous operation over a period of 5200 hours.
