IMPROVED PAINT REMOVAL TECHNIQUE

FINAL REPORT

WARNER ROBINS AIR LOGISTICS CENTER
DIRECTORATE OF MAINTENANCE
AIRCRAFT DIVISION
ALC/PPWMA

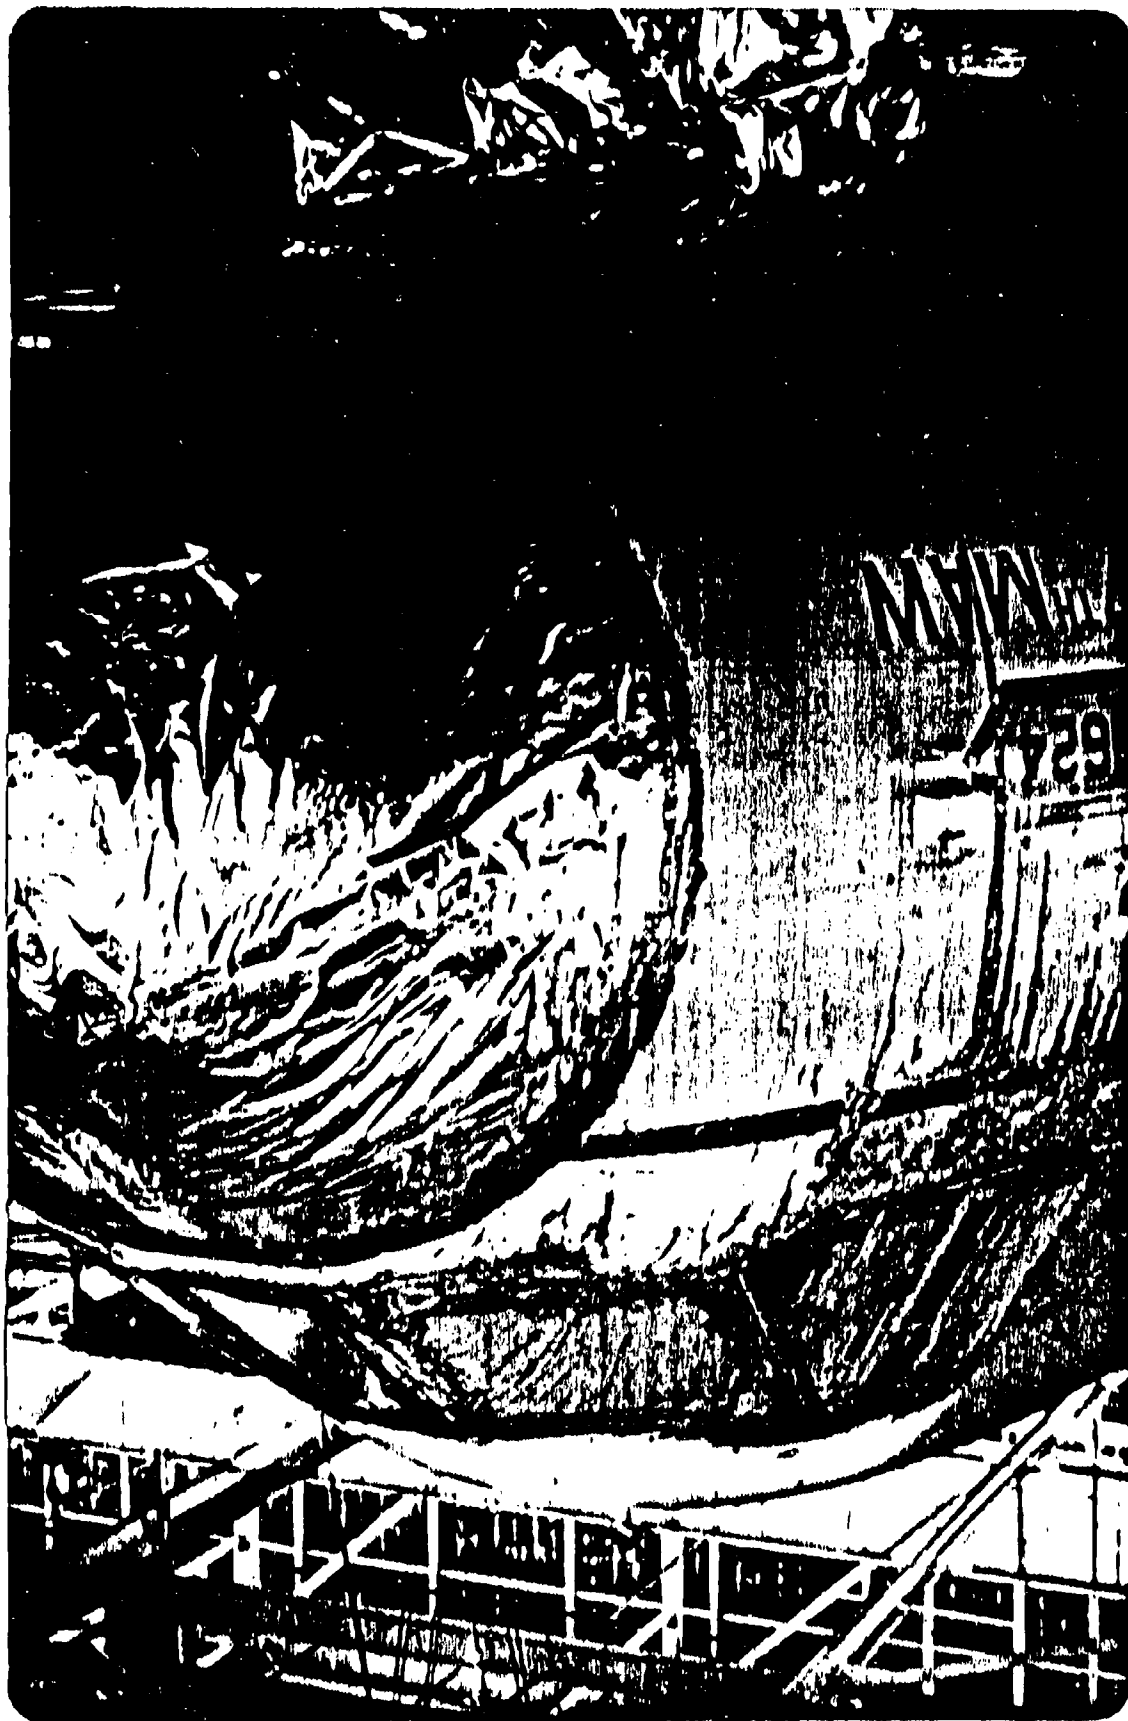
FIGURE 2. COCKPIT WINDOW FRAME STRIPPING

Much effort was taken to protect cockpit windows. The window surfaces were completely covered with tape strips and the frame around the windows was then hand stripped (Figures 1 and 2). A secondary sheet of aluminum masking paper was then taped over the entire window area (Figure 3). It was noted that the tape was difficult to remove from the windows when stripping was completed. A precut sheet of paper could be taped to the window around the edges only and should provide adequate protection in view of the care in which stripper is applied around the frame.

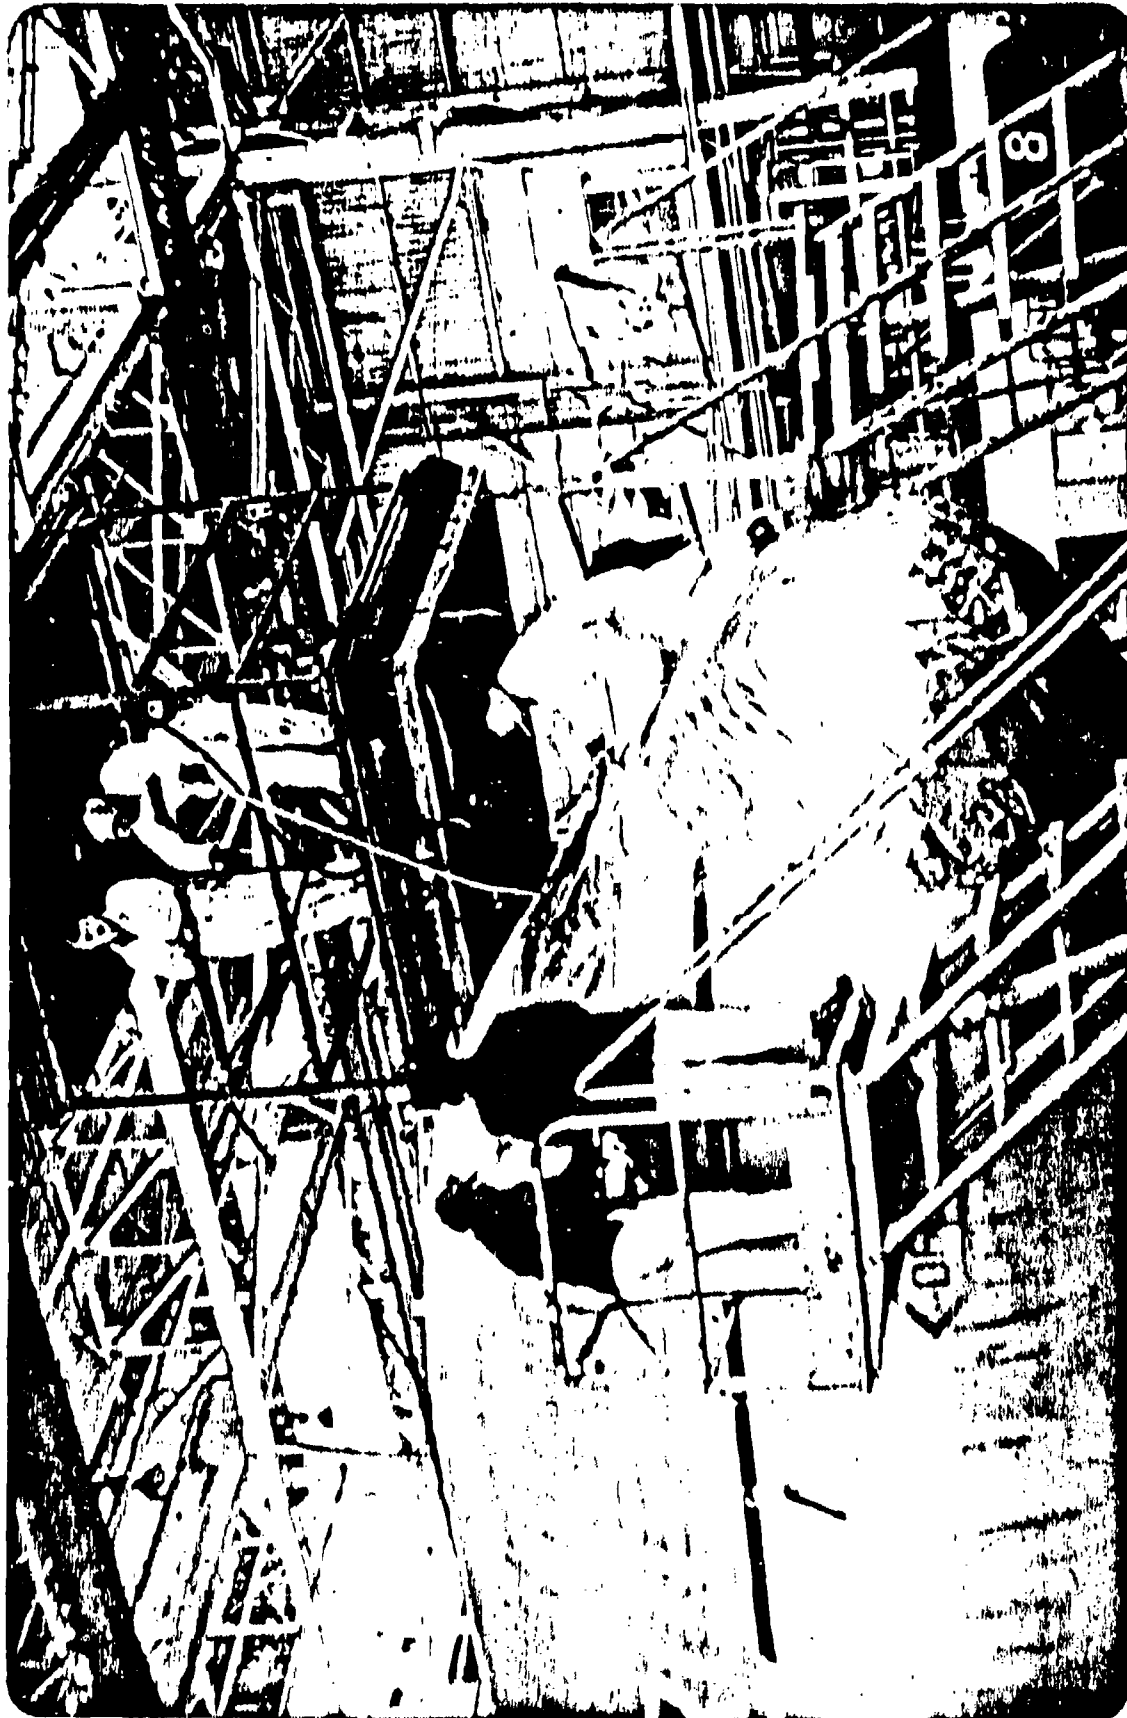
FIGURE 3. COCKPIT WINDOW MASSING

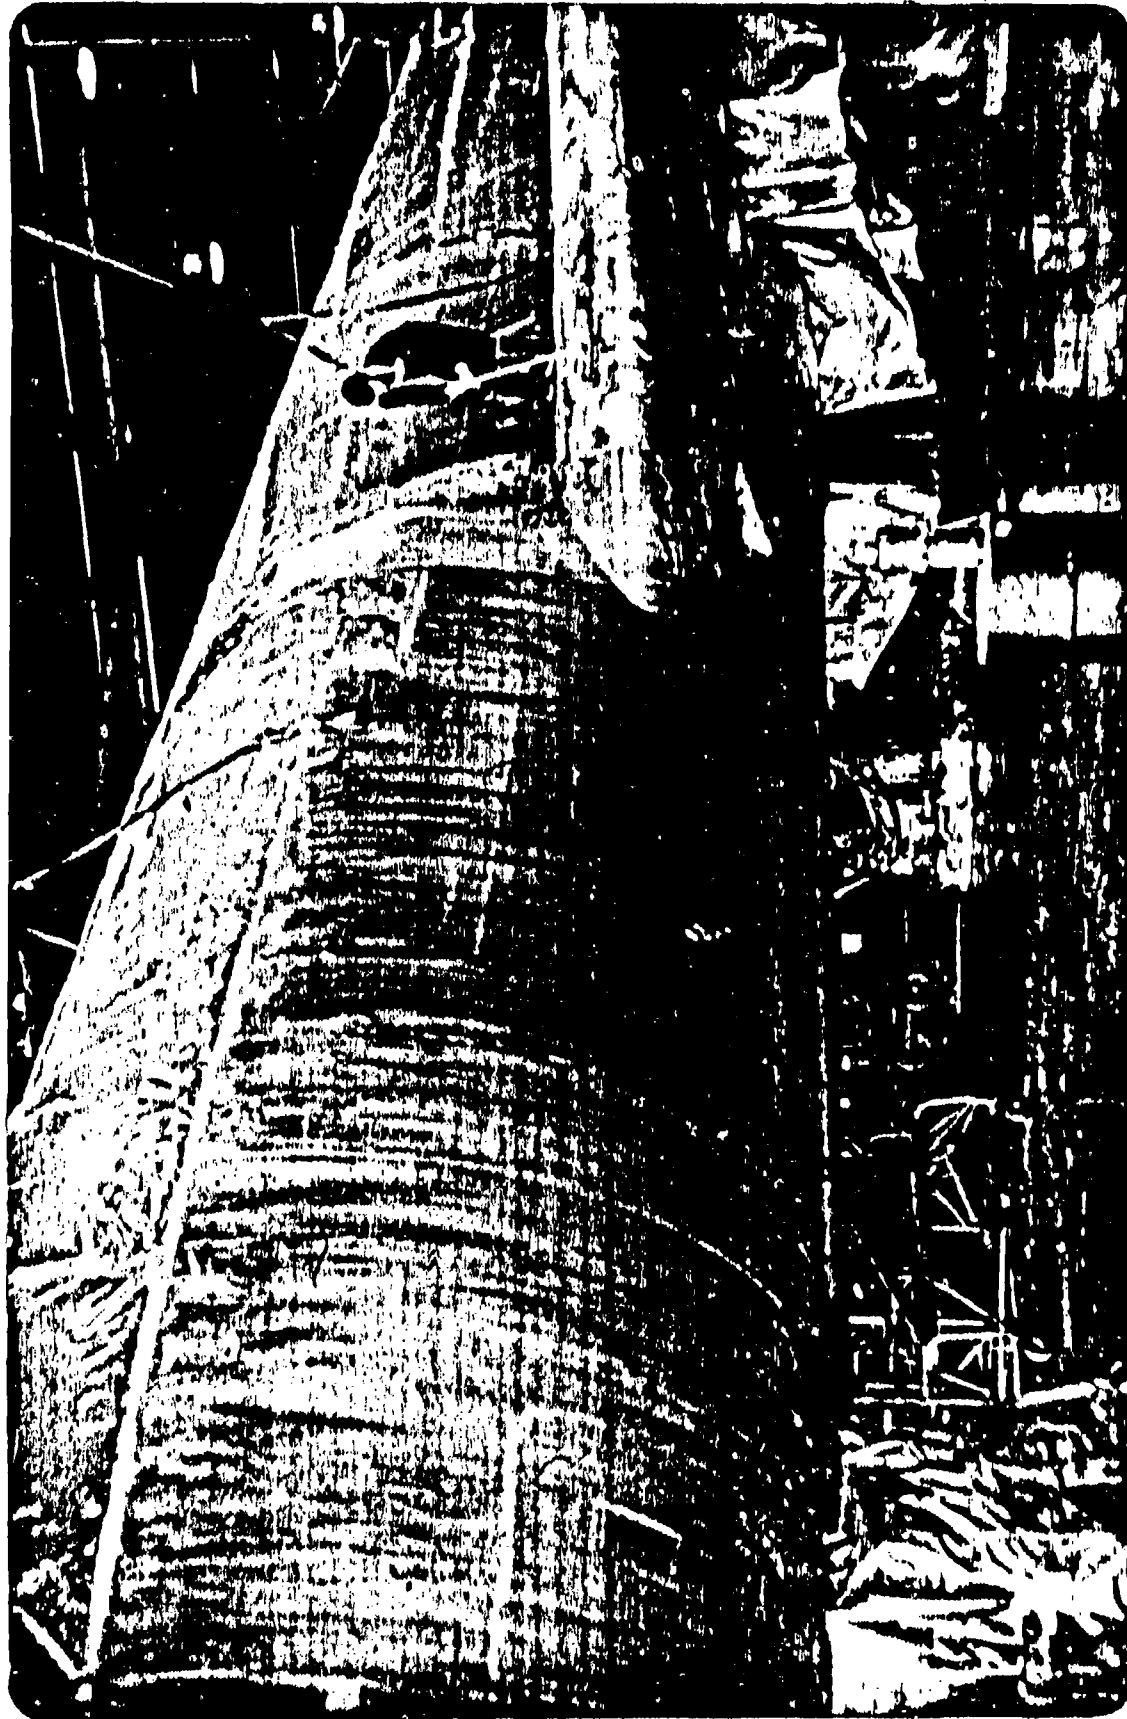
FIGURE 8. STRIPPING PAINT FROM A KCI35 AT TINKER AFB

A KC-135 aircraft was observed being partially stripped at Tinker Air Force Base (see Figure 8). The following are the approximate areas of the plane that were being stripped:

- (1) The bottom half of the fuselage
- (2) The top of the wings near the leading edge
- (3) The bottom surface of the wings.

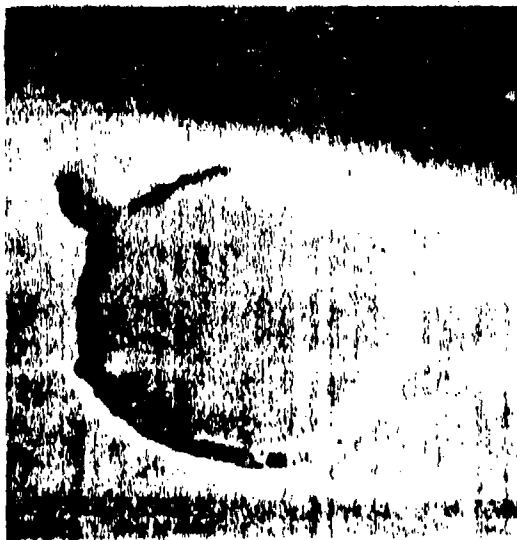
Figure 13

Commercial Paint Stripper No. 4
(Phenol)

Condition of Paint Surface
after 45 minutes

Test Procedure No. 1 on
Ribbed Aircraft Samples
From KC-131

Condition of Paint Surface
after 25 minutes

Test Procedure No. 2 on
Unidentified Aircraft Skin (10 min
exposure, rinse, 15 min exposure)
