MISCELLANEOUS PAPER GL-84-3

GEOPHYSICAL INVESTIGATIONS IN SUPPORT OF CLEARWATER DAM COMPREHENSIVE SEEPAGE ANALYSIS

May 1984
Final Report

Prepared for U. S. Army Engineer District, Little Rock
Little Rock, Ark. 72203

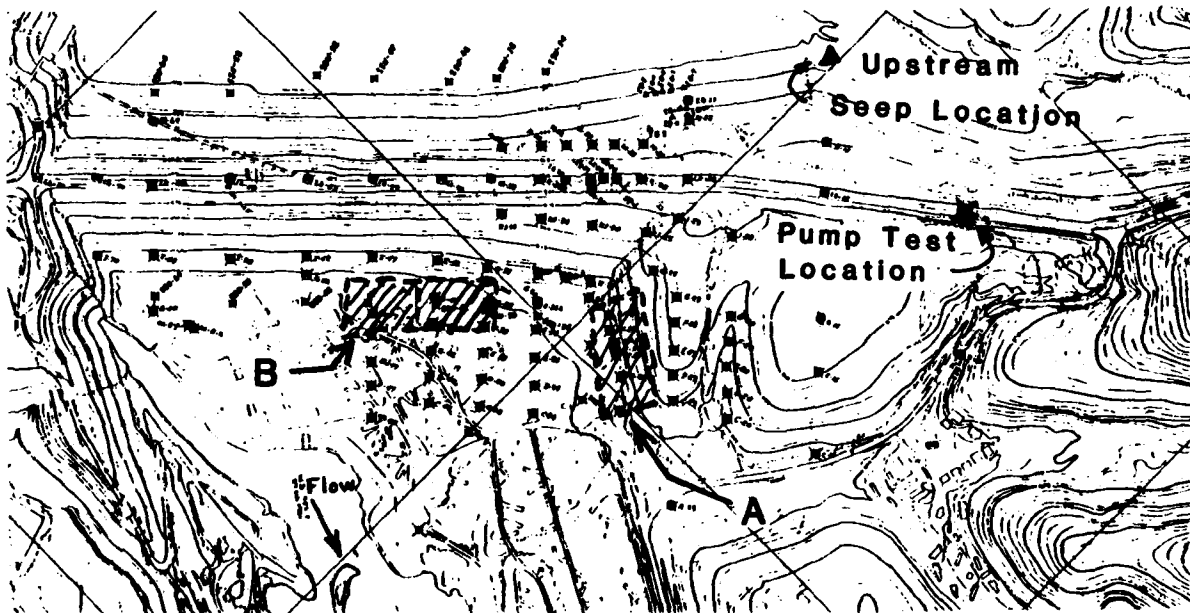
Figure 1b. Site map with test area locations:
 A--left abutment seepage area;
 B--top of rock investigation area.

2. Clearwater Dam is located in southeastern Missouri near Piedmont (Figure 1a). Seepage outlets have been observed in downstream left abutment areas (Figure 1b) when reservoir pool elevation exceeds 500 ft*; the last high pool occurrence (el 550.4 ft) occurred in May 1979. The LRD described the seepage as "unsightly both physically and psychologically" (U. S. Army Engineer District, Little Rock, 1979). A suggested test program involving seismic refraction and resistivity surveys was received from Mr. Charles Deaver, LRD. After review of the Clearwater Dam Foundation Completion Report (U. S. Army Engineer District, Little Rock, 1977) and the site map, a revised test program was planned with the concurrence of Mr. Deaver. The surveys were planned in two areas (Figure 1b): (a) in the downstream left abutment areas above suspected possible seepage paths; and (b) in the floodplain along downstream toe of dam to investigate an area where a piezometer boring encountered rock at 70 ft, about 40 ft deeper than the average depth to the top of rock for the area.

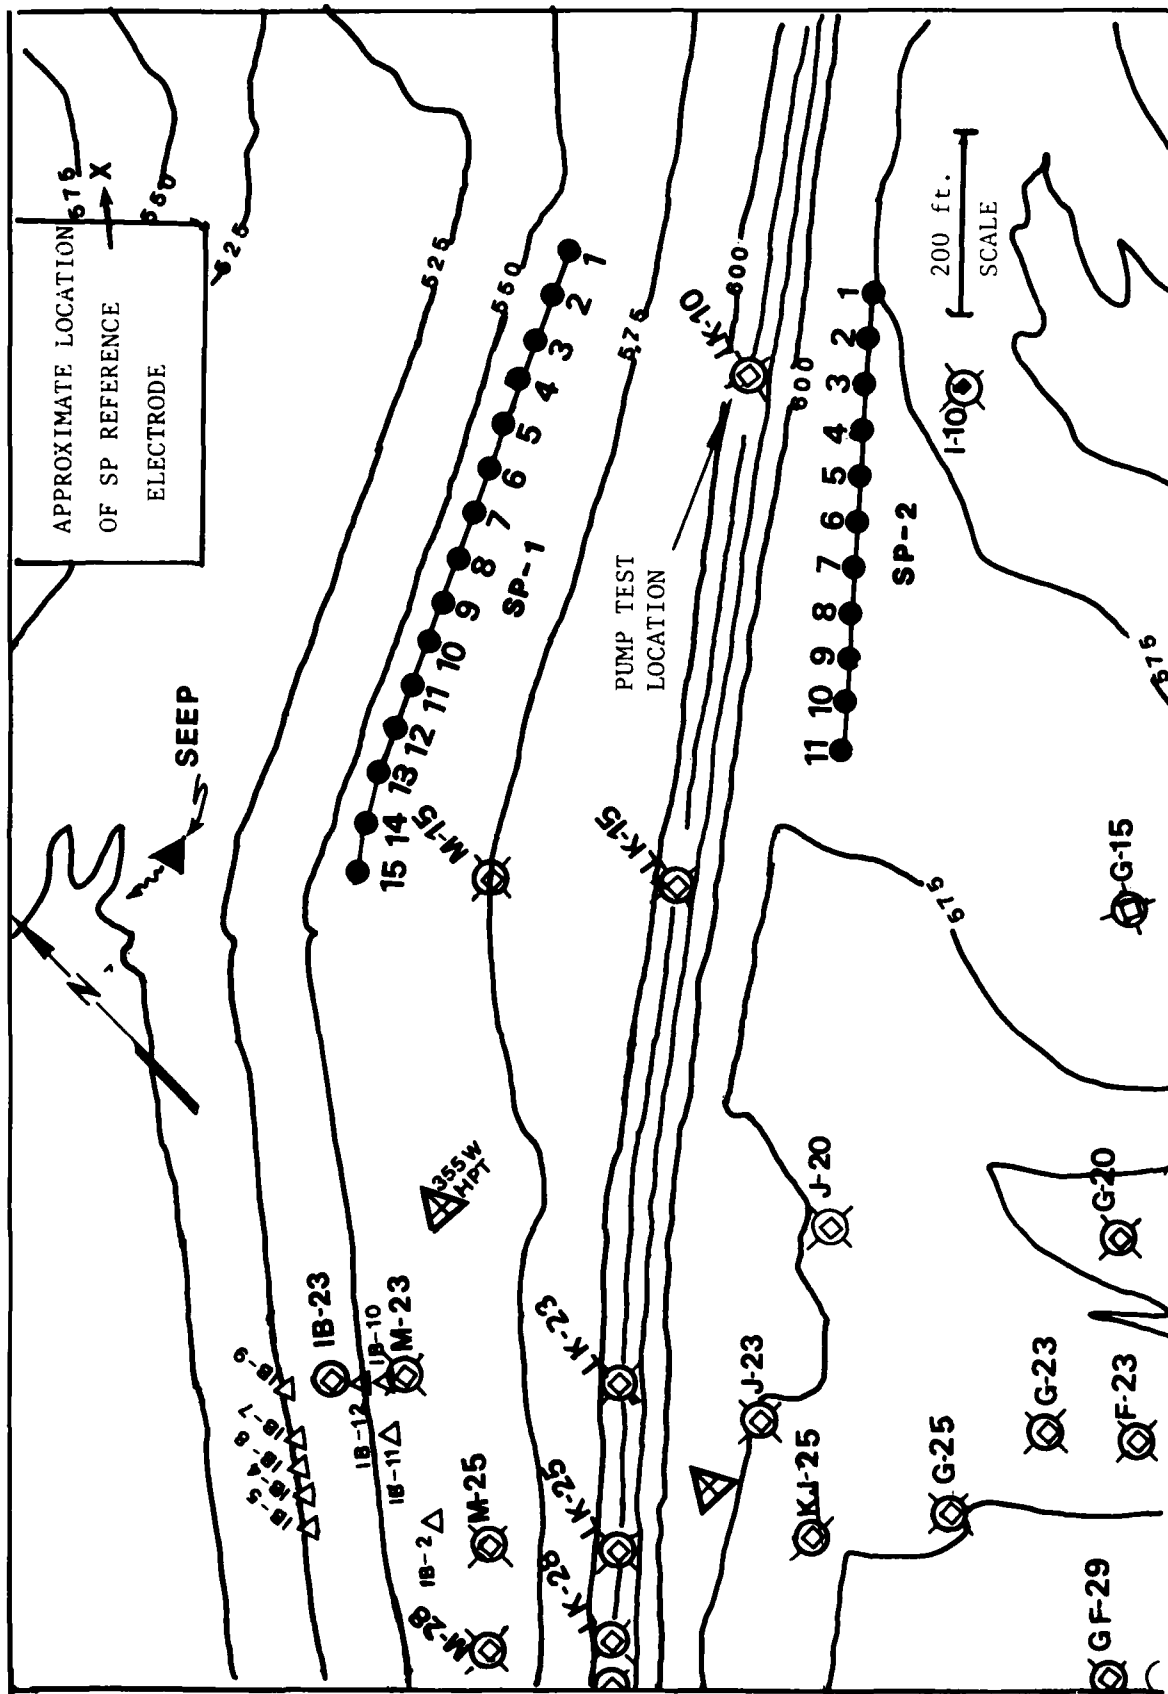
Figure 2. SP array locations

7. The location and layout of the two SP surveys are shown in Figure 2. The basic objective of SP surveys is to detect potential differences (voltages) on the surface generated by flowing (seeping) water in the subsurface. The generation of SP by water flowing through soil and rock, as well as by other sources, is reviewed in Telford et al. (1976) and Cooper, Koester, and Franklin (1982). The field procedure consists of emplacing electrode arrays in grid or profile patterns and measuring voltages between each of the electrodes and a reference electrode. The reference electrode is placed far from the arrays where the potential remains constant relative to the arrays.

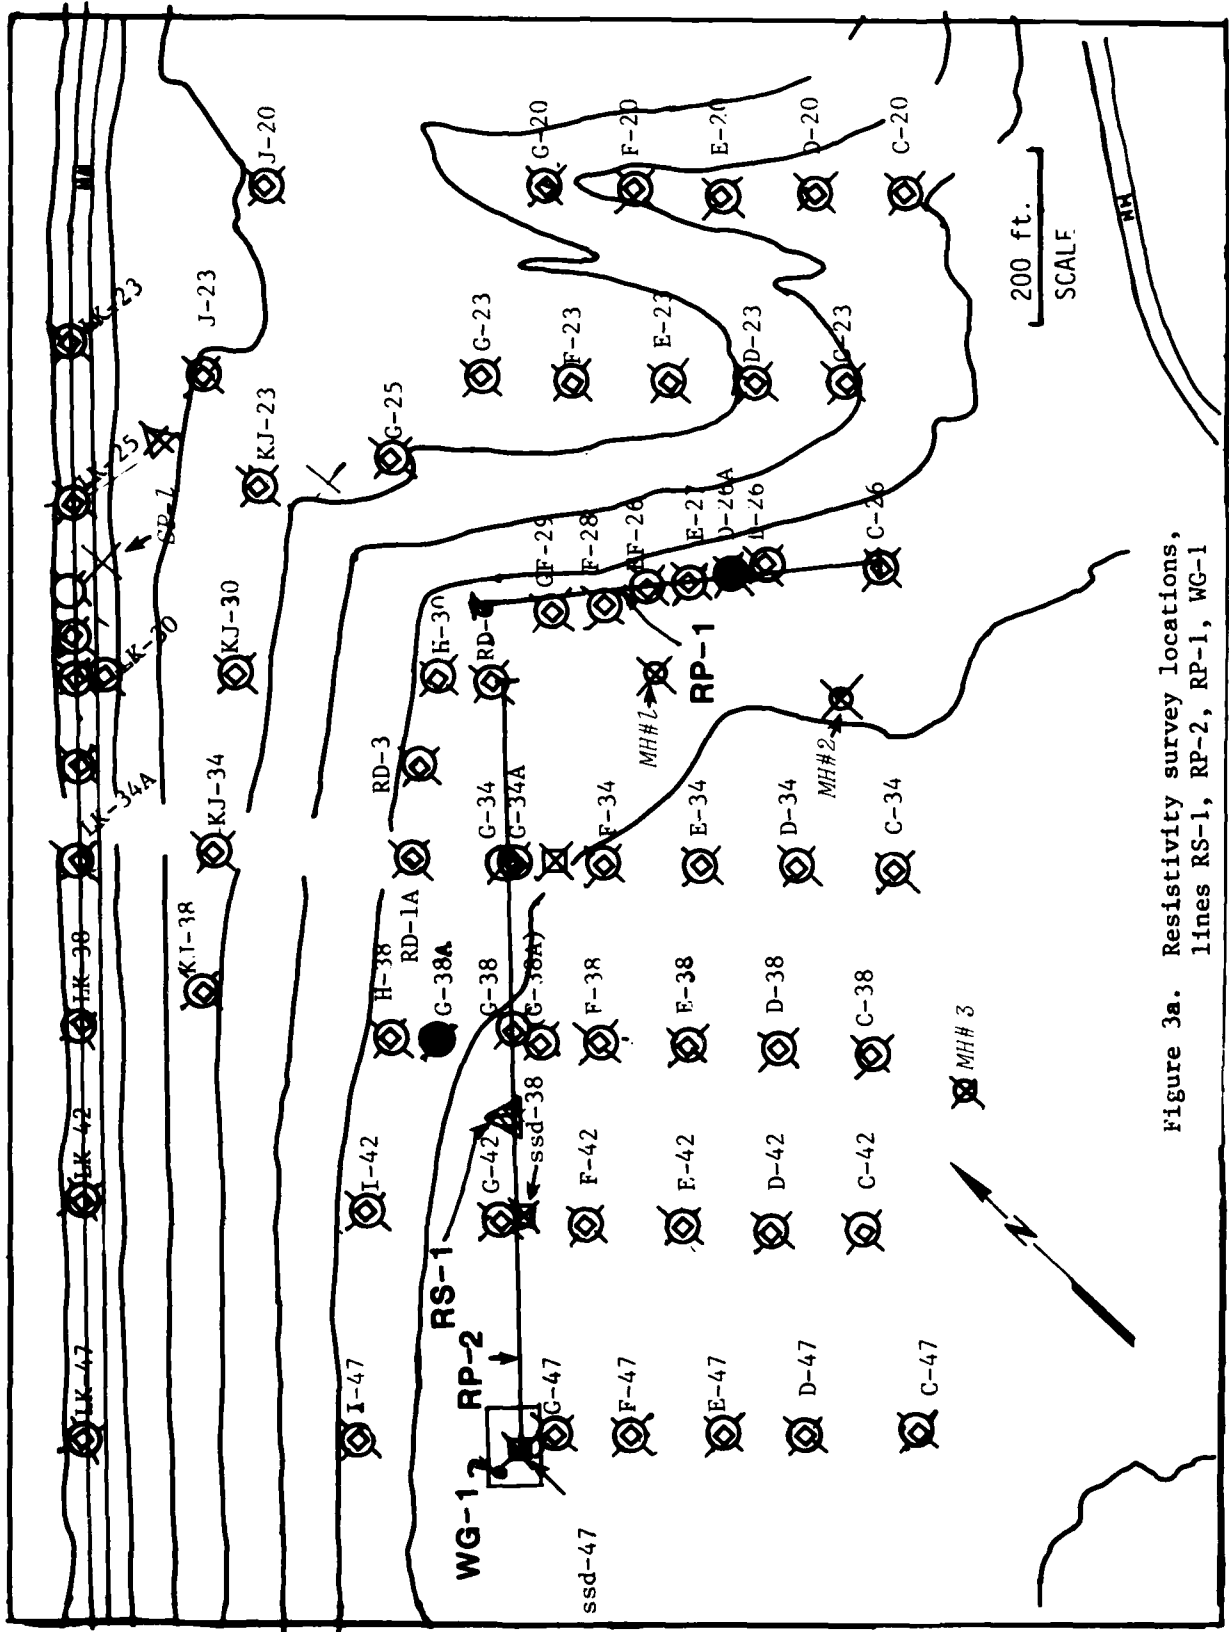
Figure 3a. Resistivity survey locations, lines RS-1, RP-2, RP-1, WG-1

12. Details of the resistivity surveys are given in the following tabulation with reference to Figures 3a and 3b:

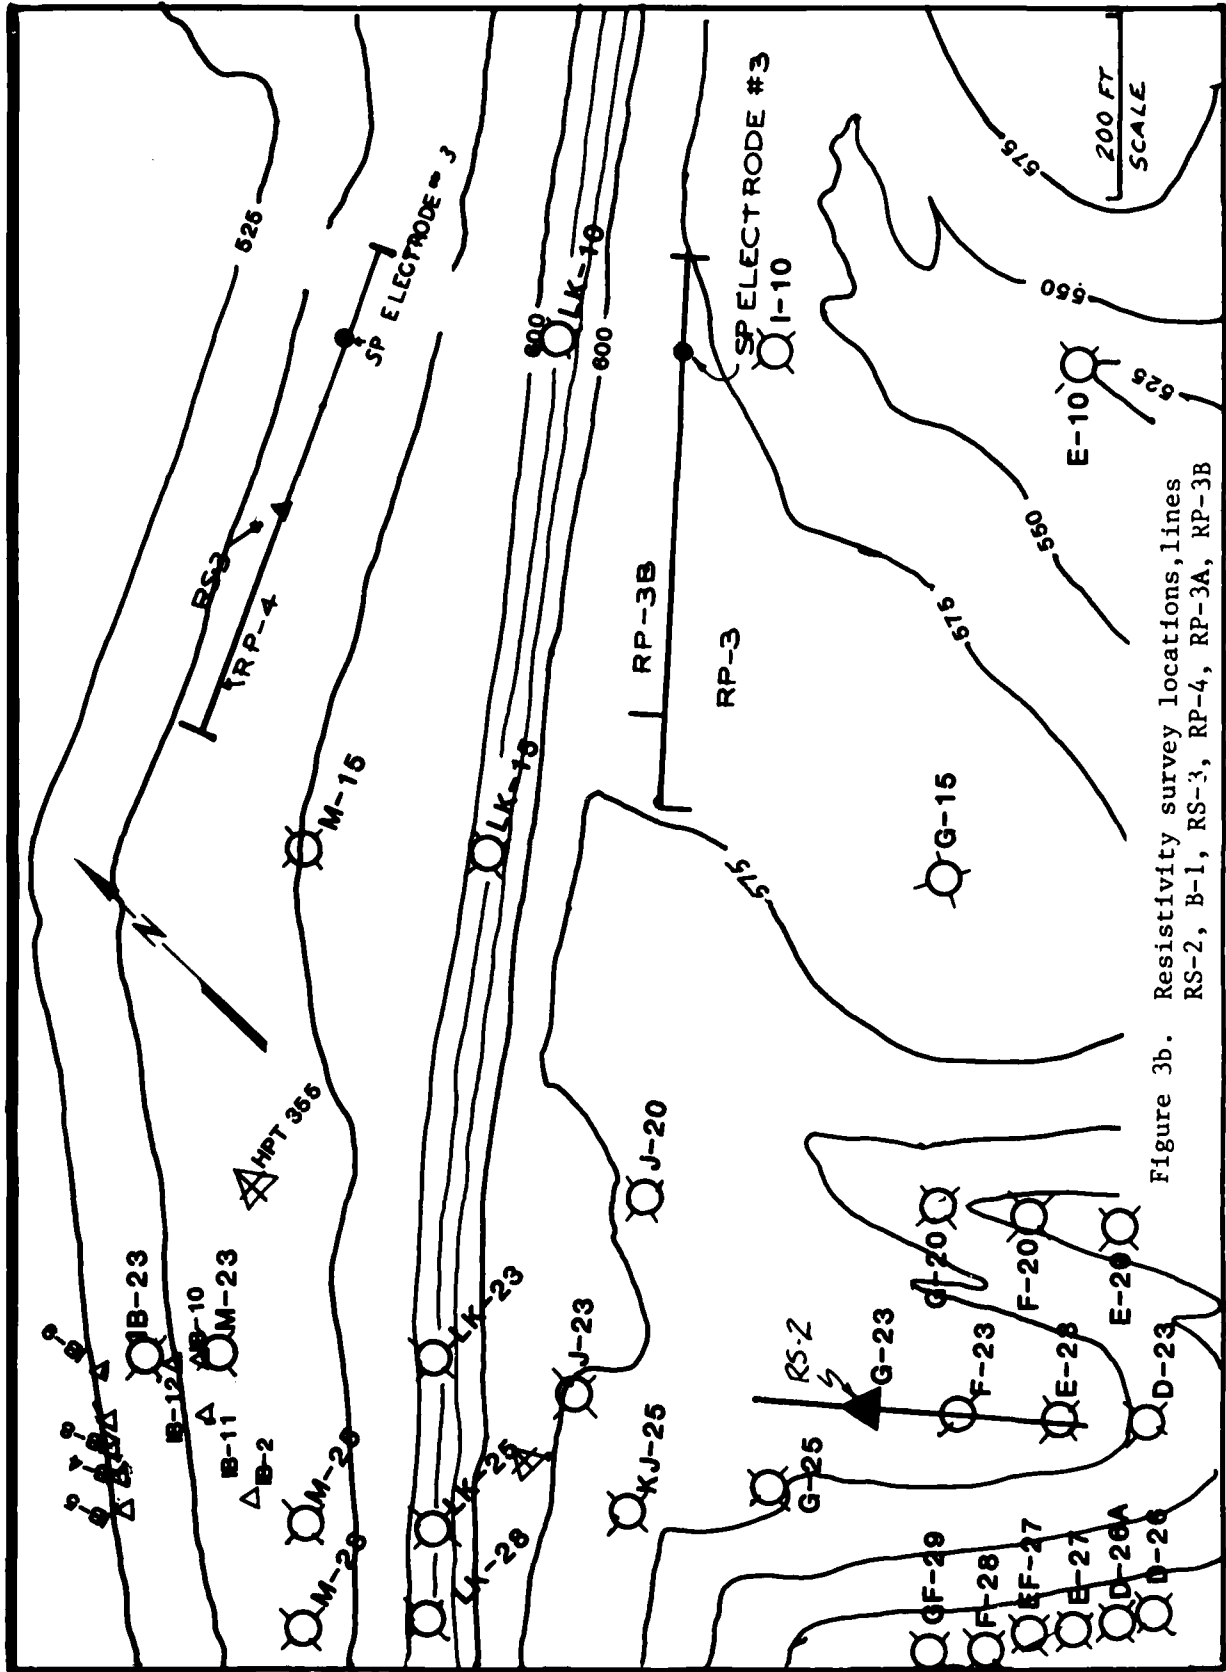
Figure 3b. Resistivity survey locations, lines
 RS-2, B-1, RS-3, RP-4, RP-3A, RP-3B

35. A pole-dipole resistivity survey on the first left abutment ridge crest (Figure 3b, line B-1) indicates conditions possibly representing a significant solution feature. This feature is interpreted to be partially water- or clay-filled. A recommended drilling location is indicated in Figure 19, and it is suggested that the borehole be extended to a nominal depth of 150 ft.* It is possible that this feature, if proven by drilling to exist, could provide a seepage path for significant amounts of the surface seepage observed during high pool levels on the side and at the base of the ridge. Other anomalies indicated in the geophysical survey results are shown in the figures and described in the text.

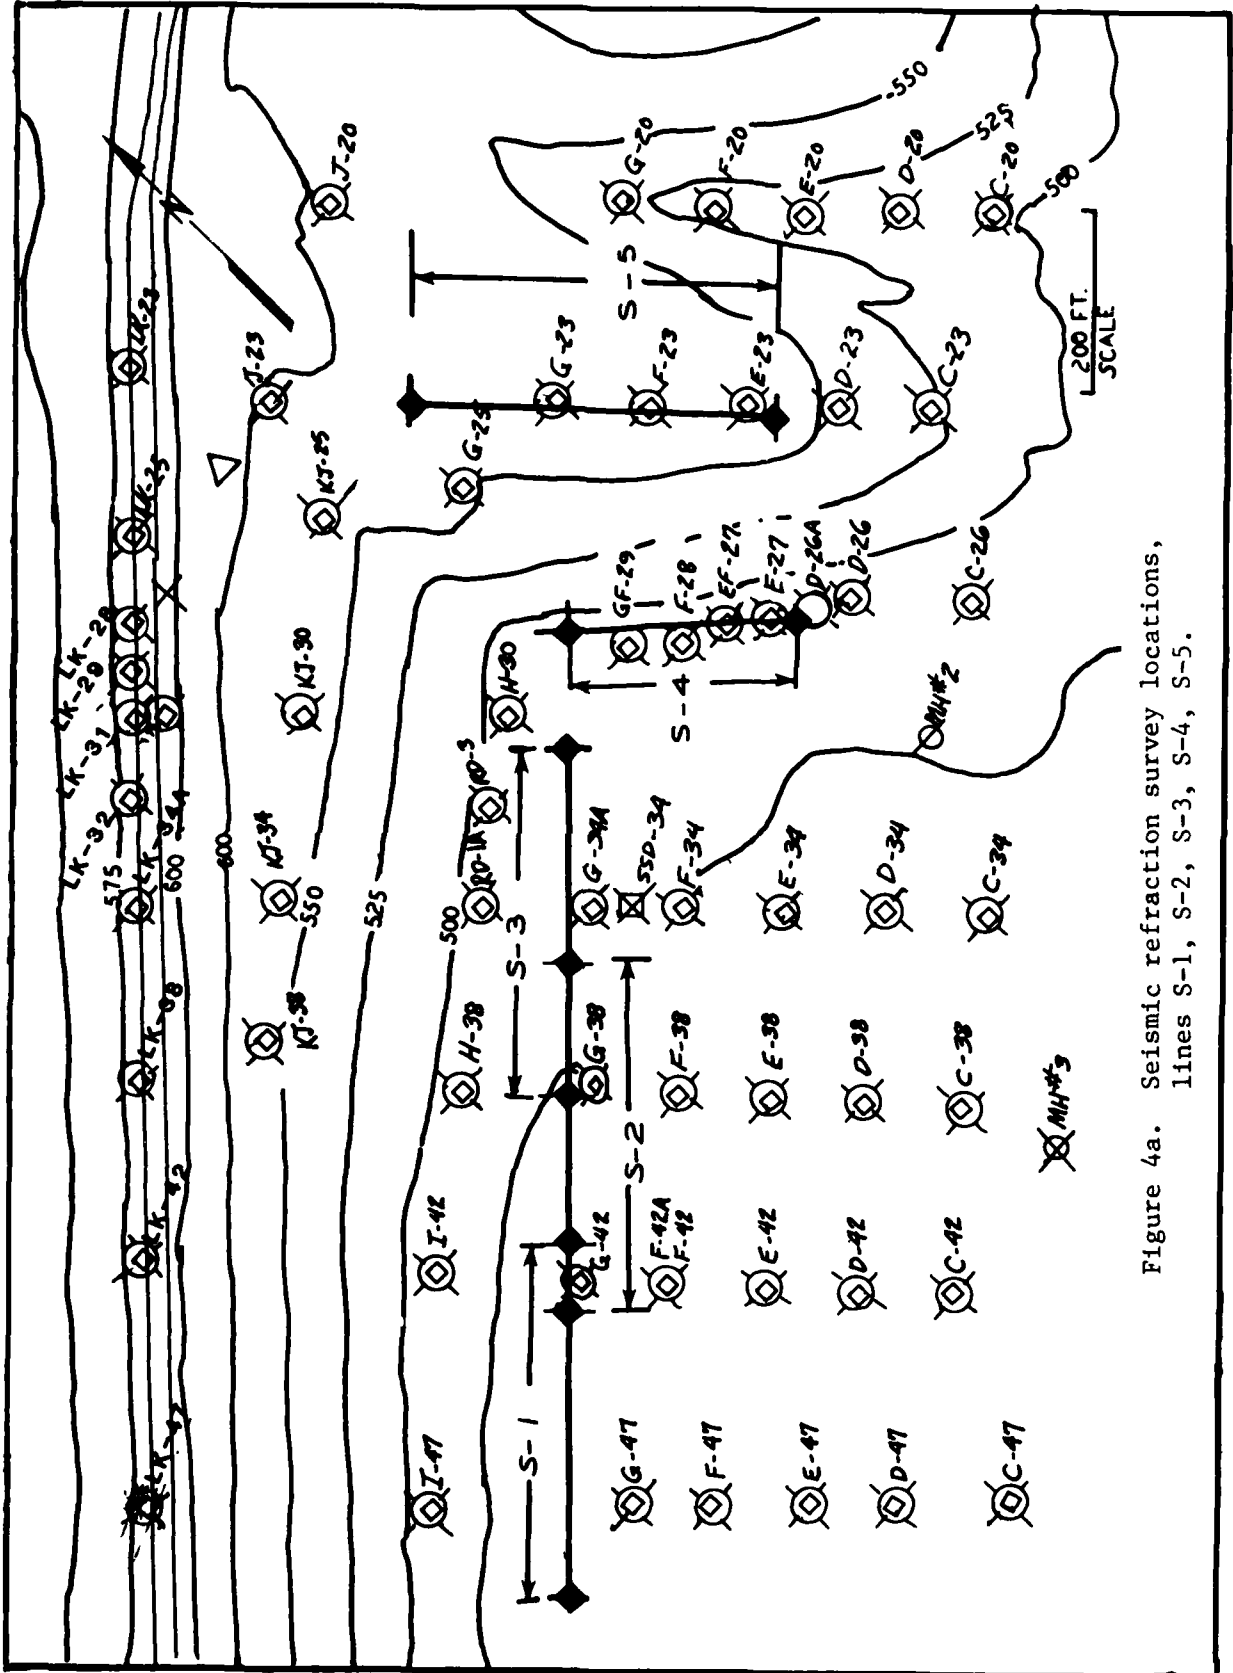
Figure 4a. Seismic refraction survey locations, lines S-1, S-2, S-3, S-4, S-5.

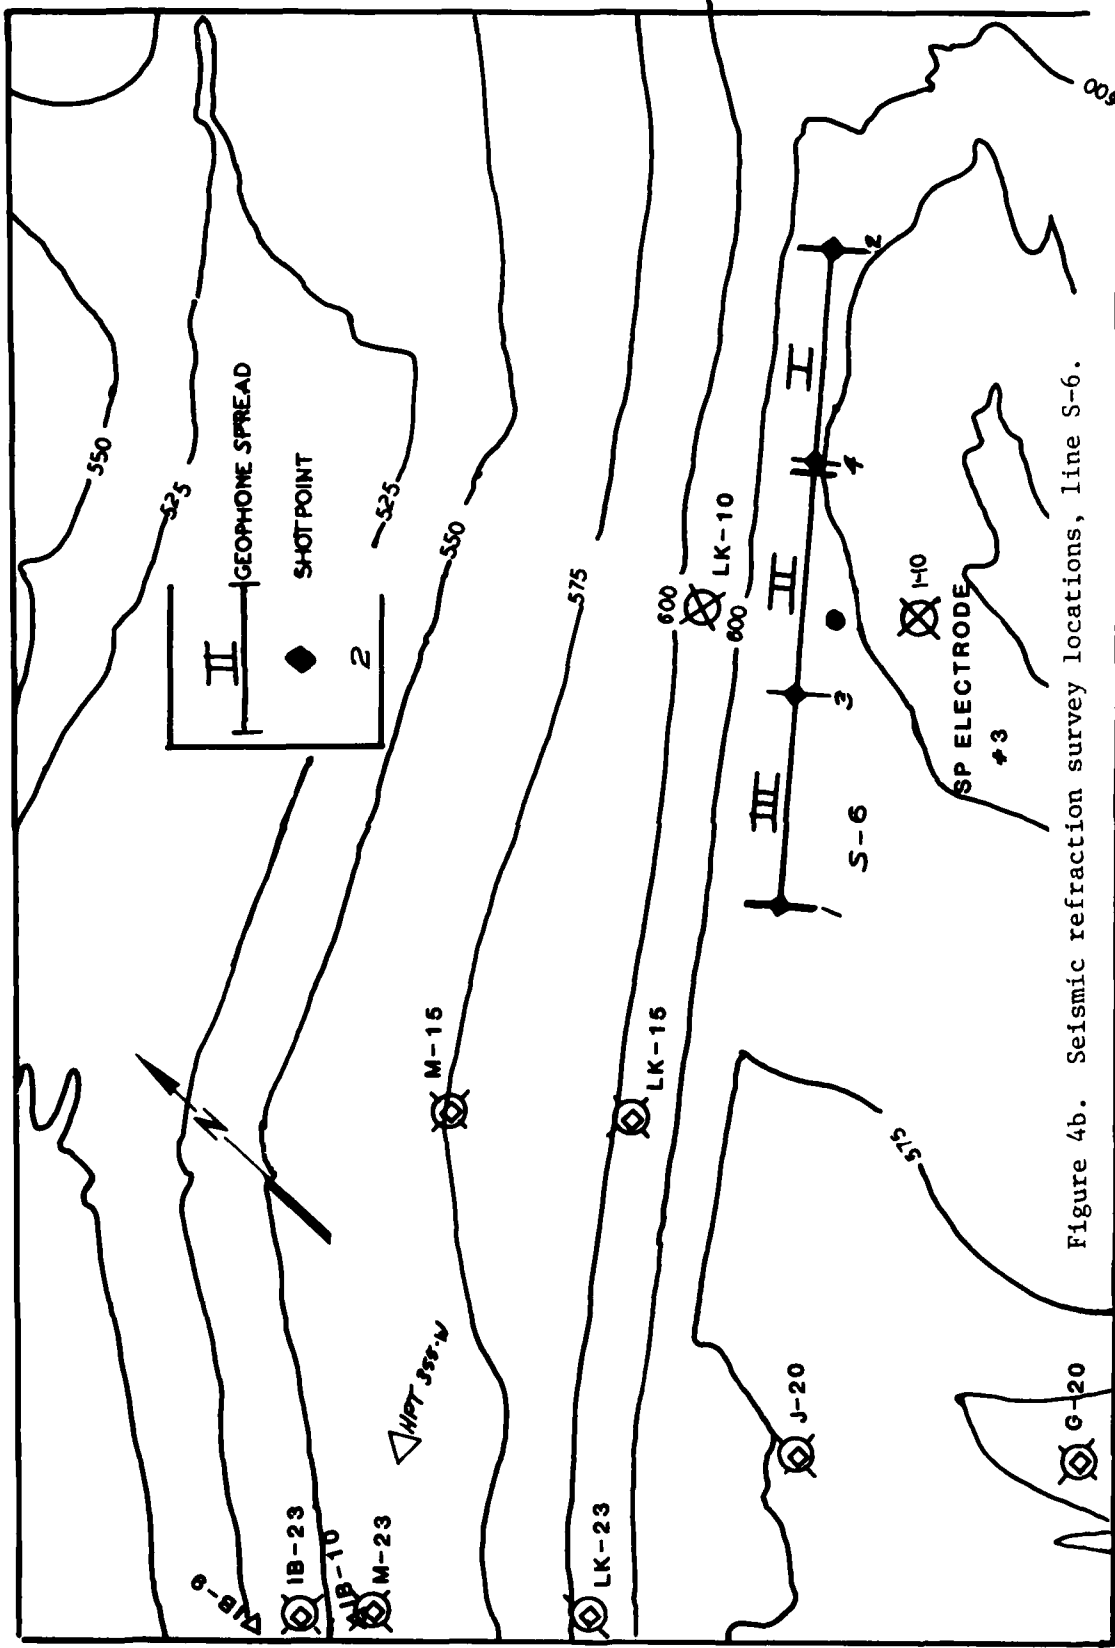
Figure 4b. Seismic refraction survey locations, line S-6.

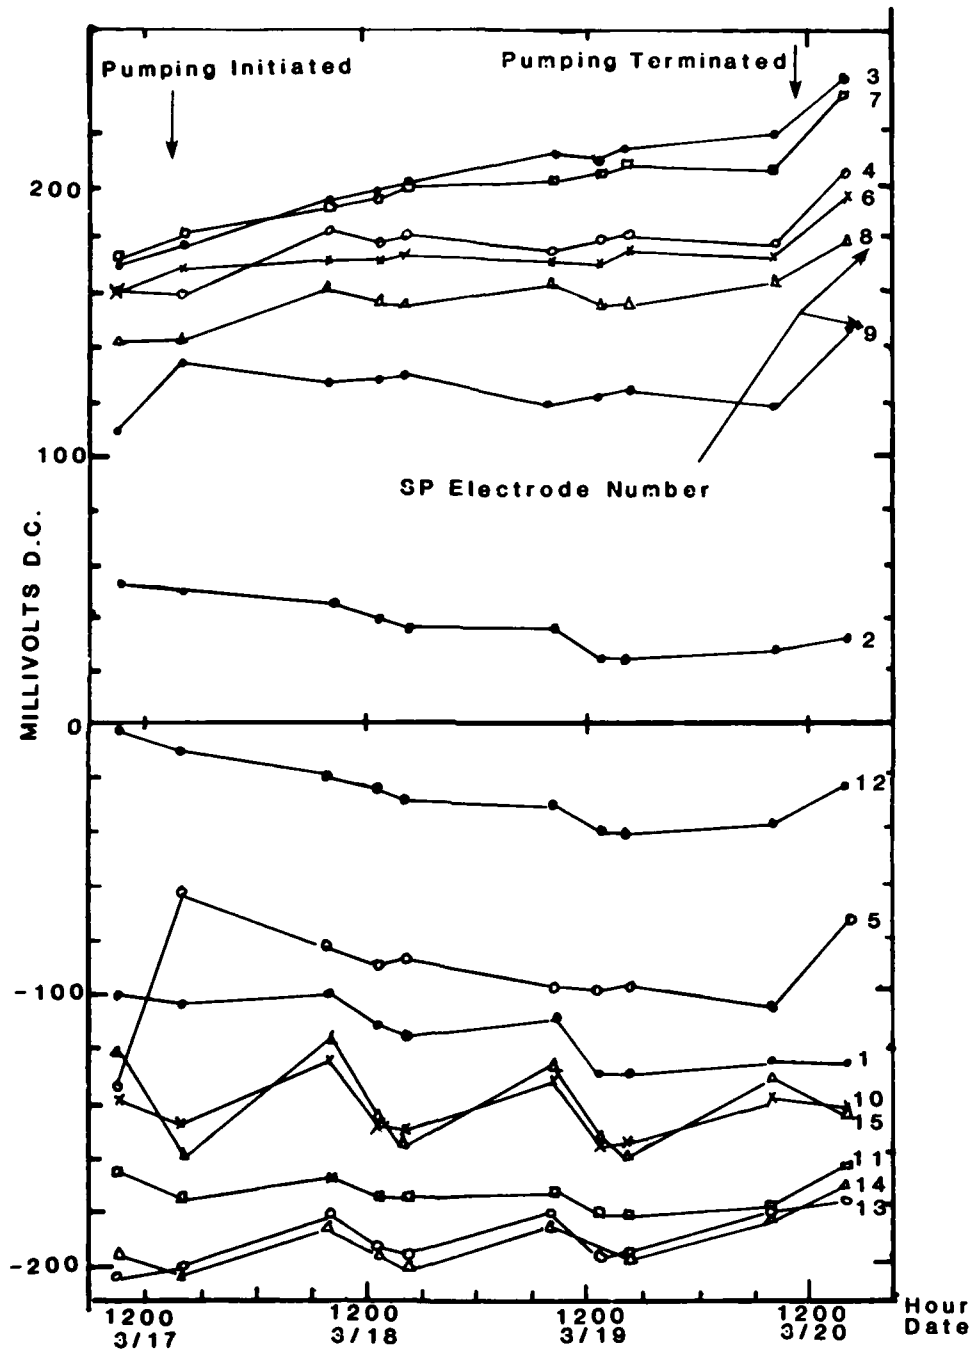
Figure 5. Upstream SP Electrode Voltages as a Function of Time.

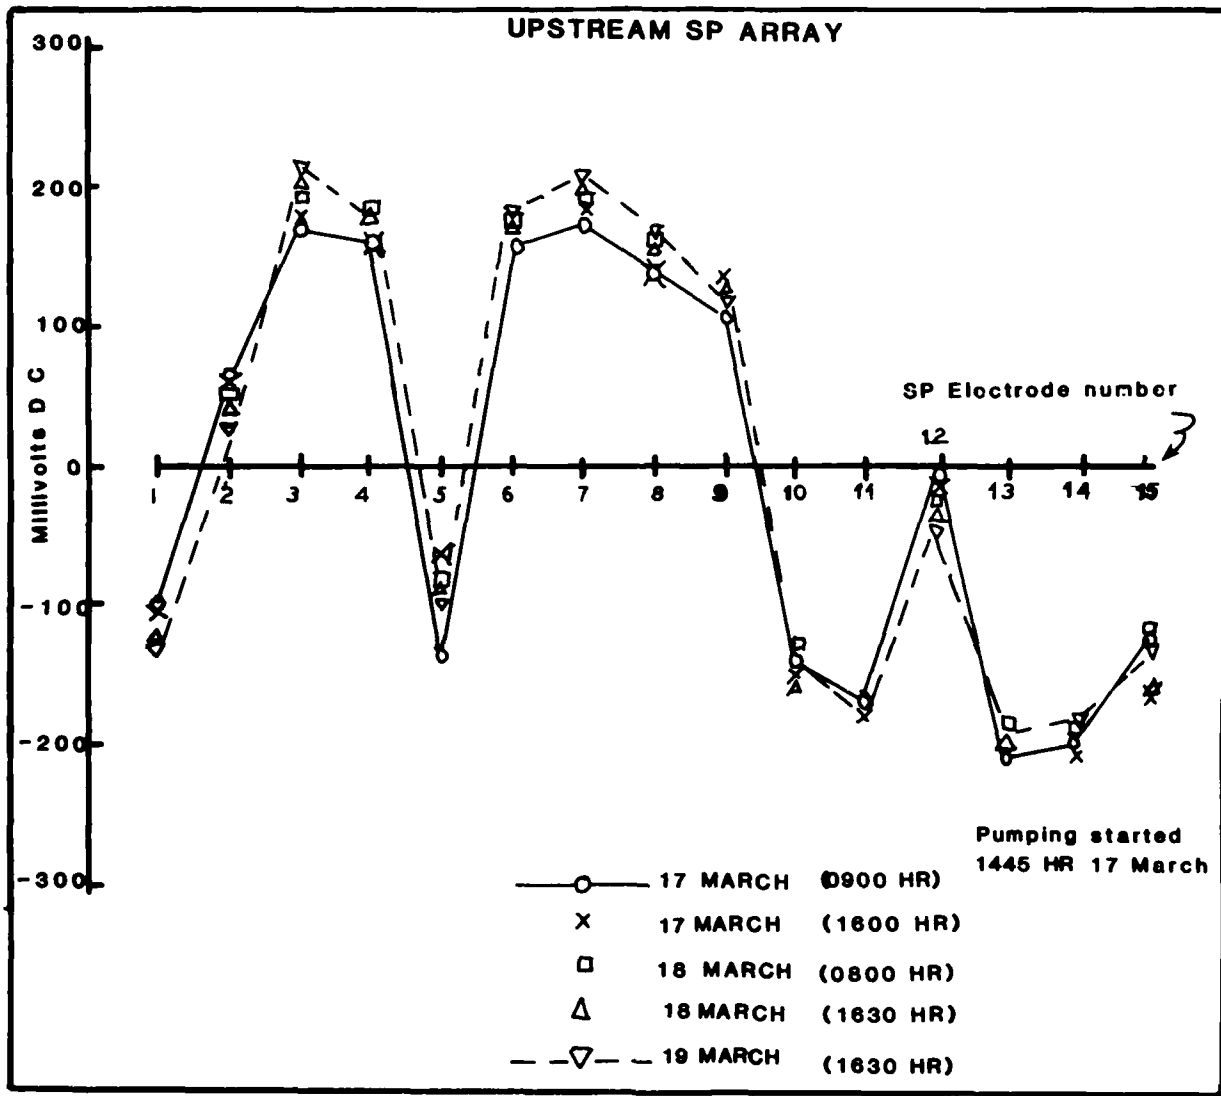
Figure 6. Static SP Profiles for Upstream Array.

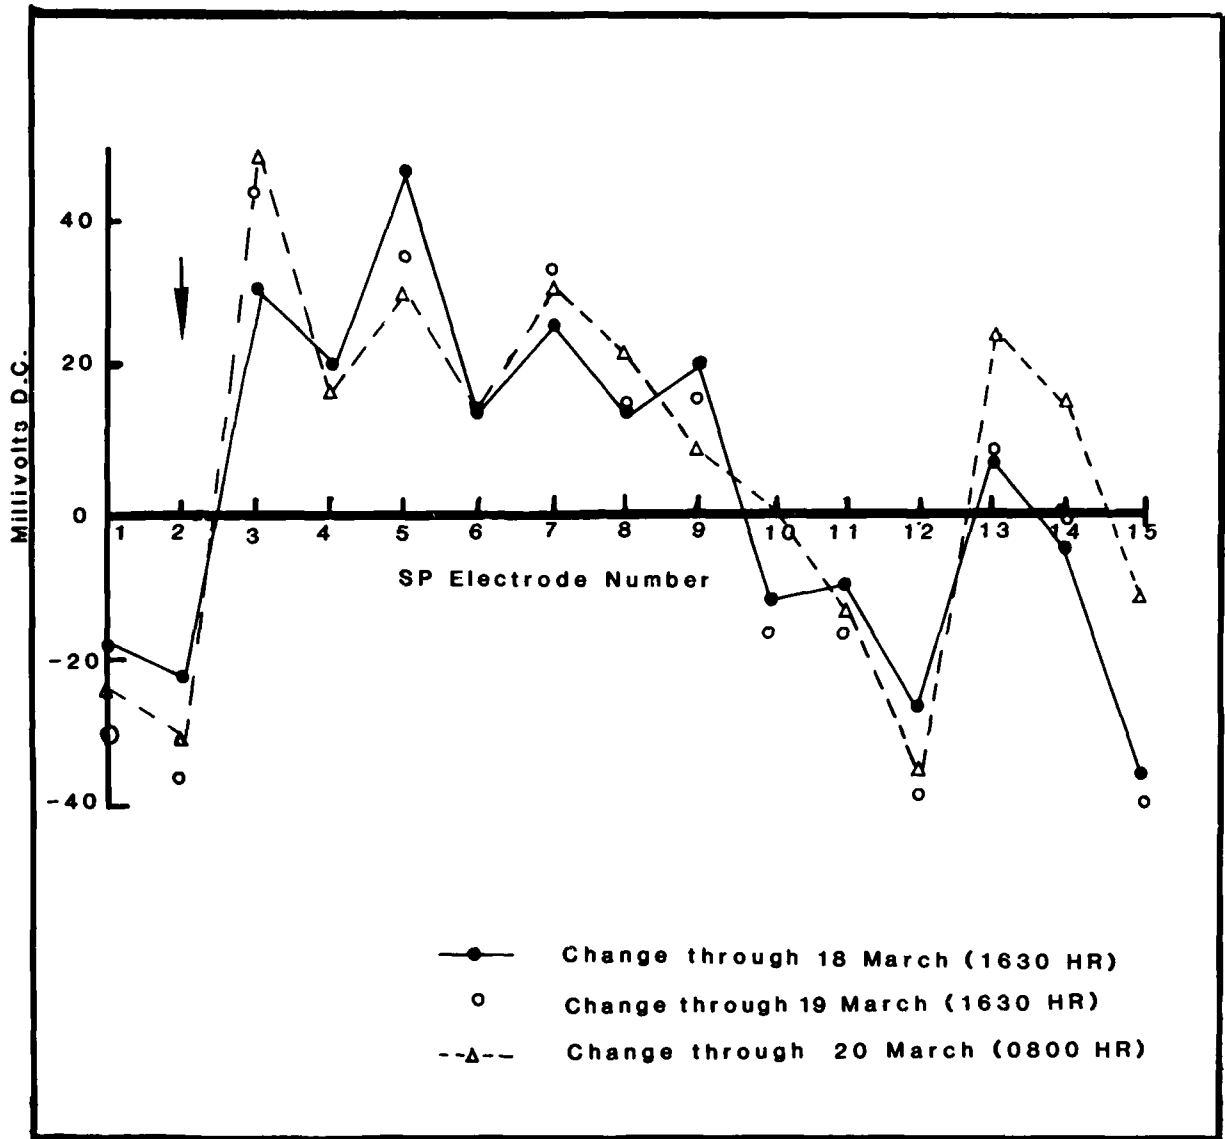
Figure 7. Change in SP values at upstream array relative to reference values on March 17 (0900 HR).

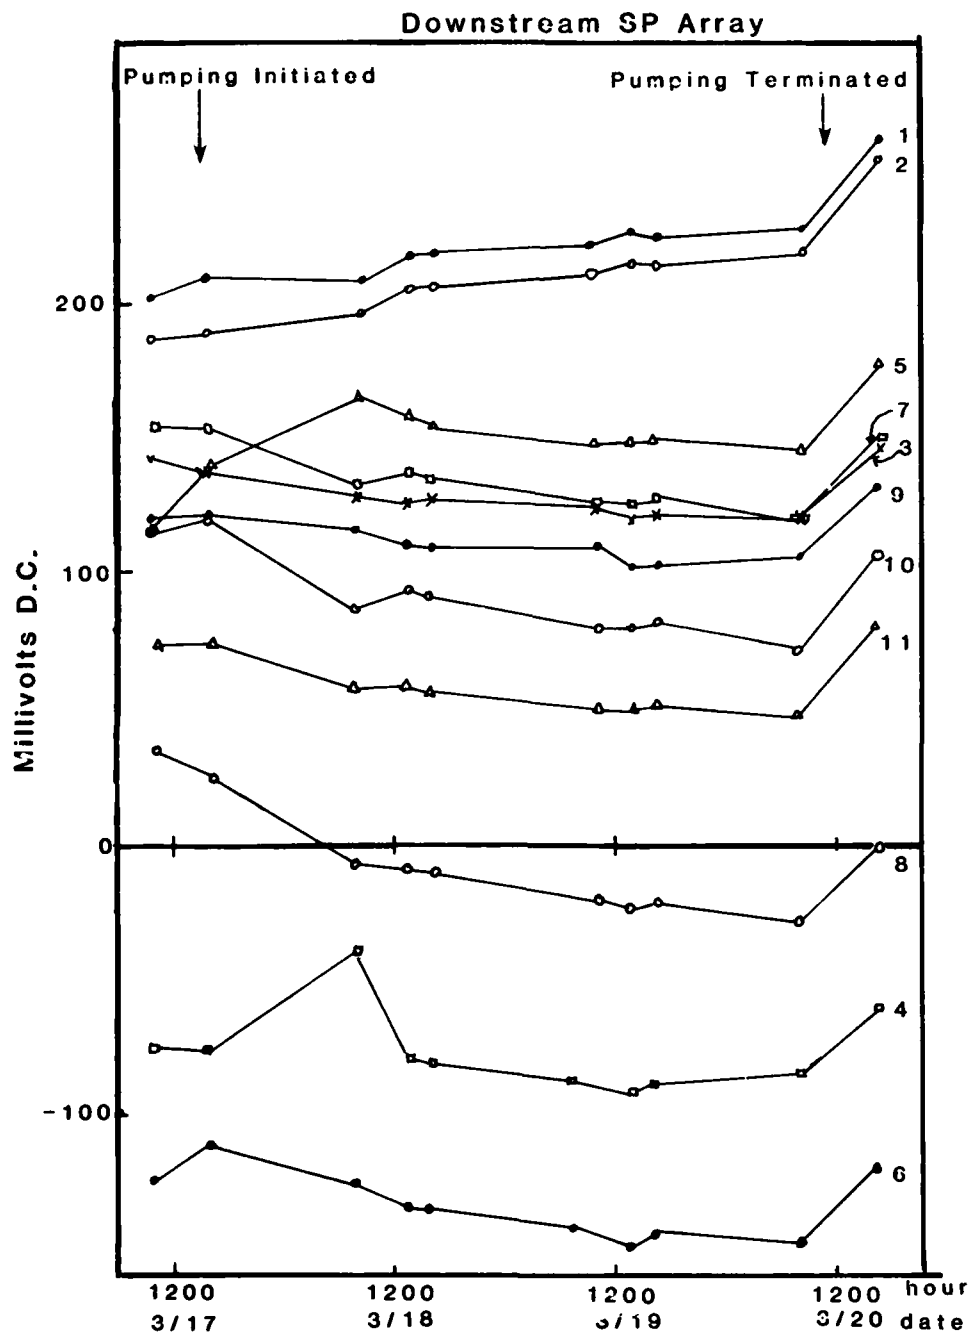
Figure 8. Downstream SP Electrode Voltages as a Function of Time.

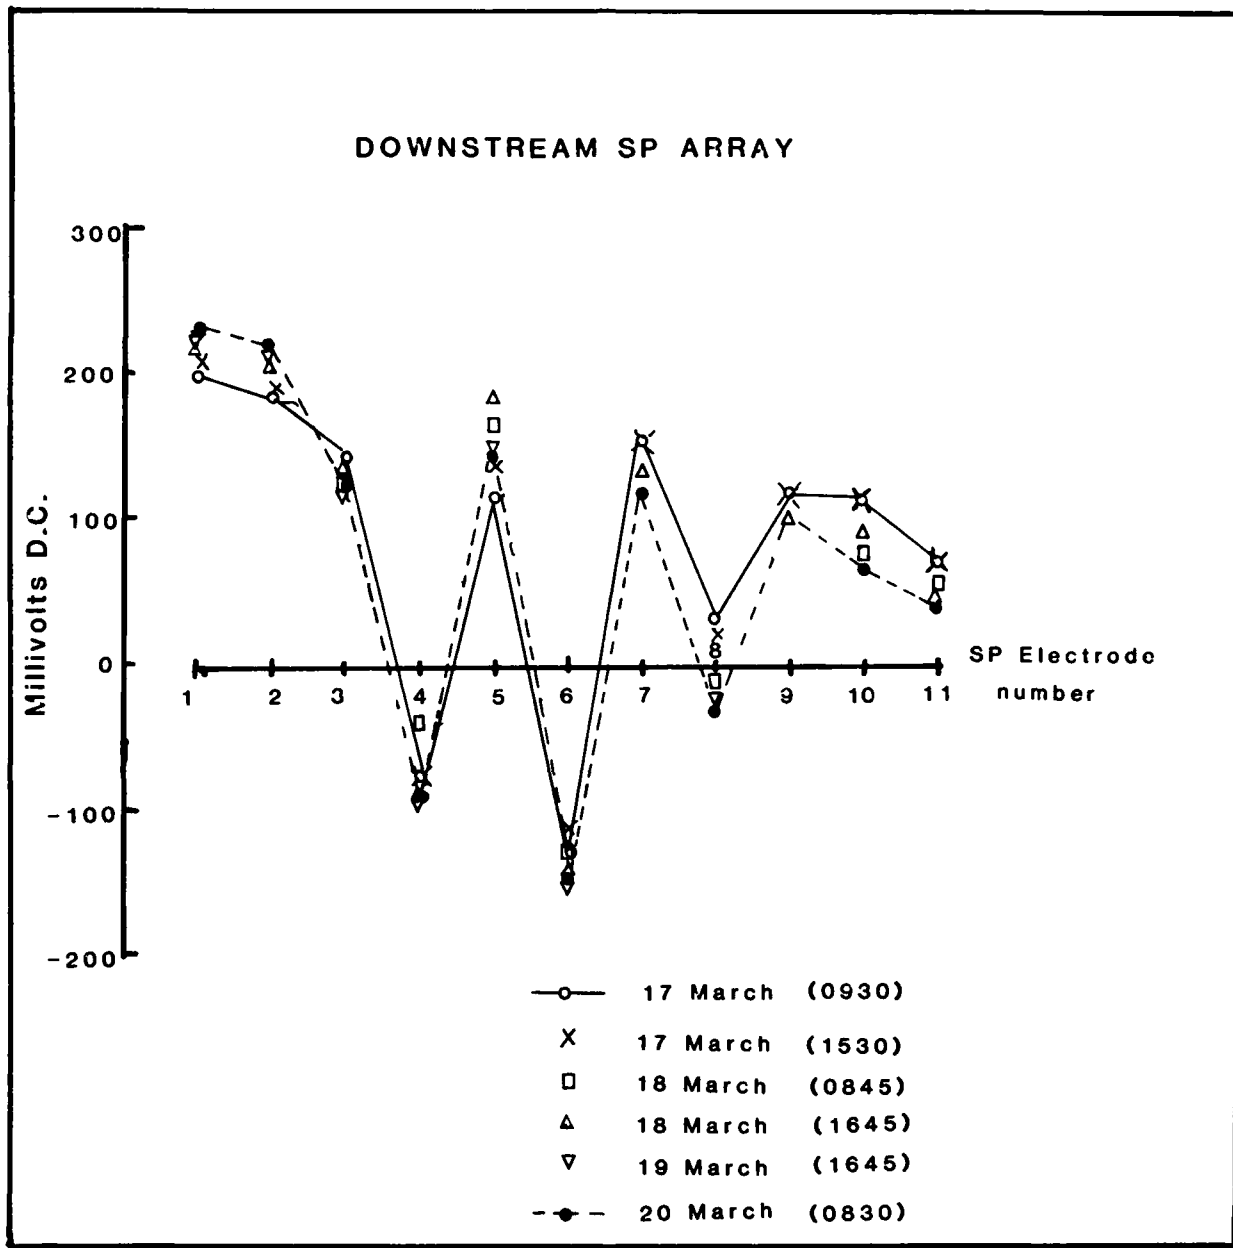
Figure 9. Static SP Profiles for Downstream Array.

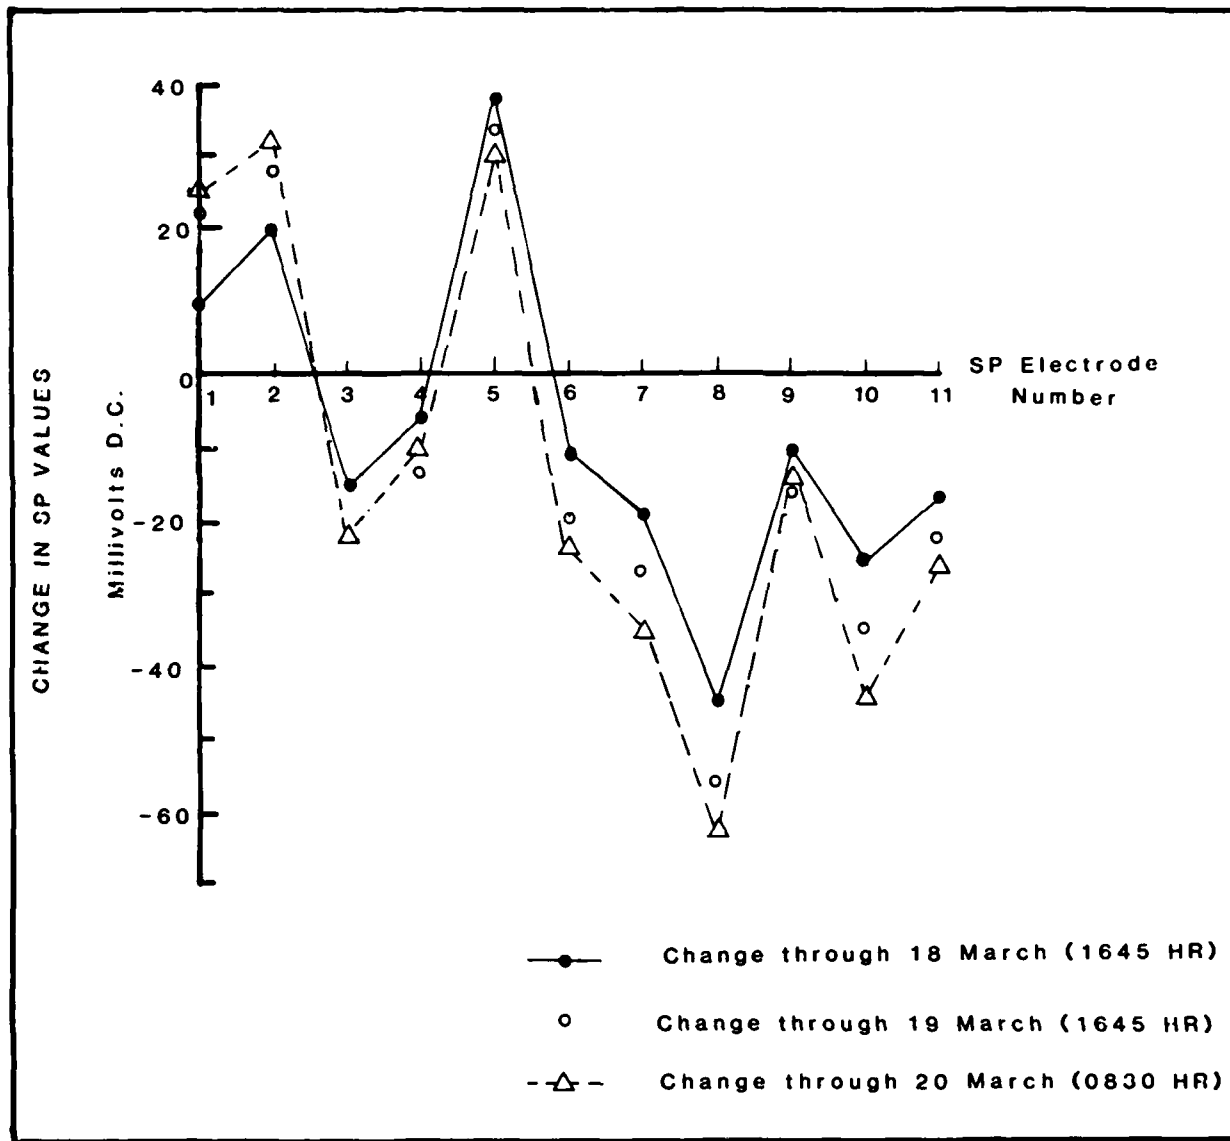
Figure 10. Change in SP Values at Downstream Array Relative to Reference Values on March 17 (0900).

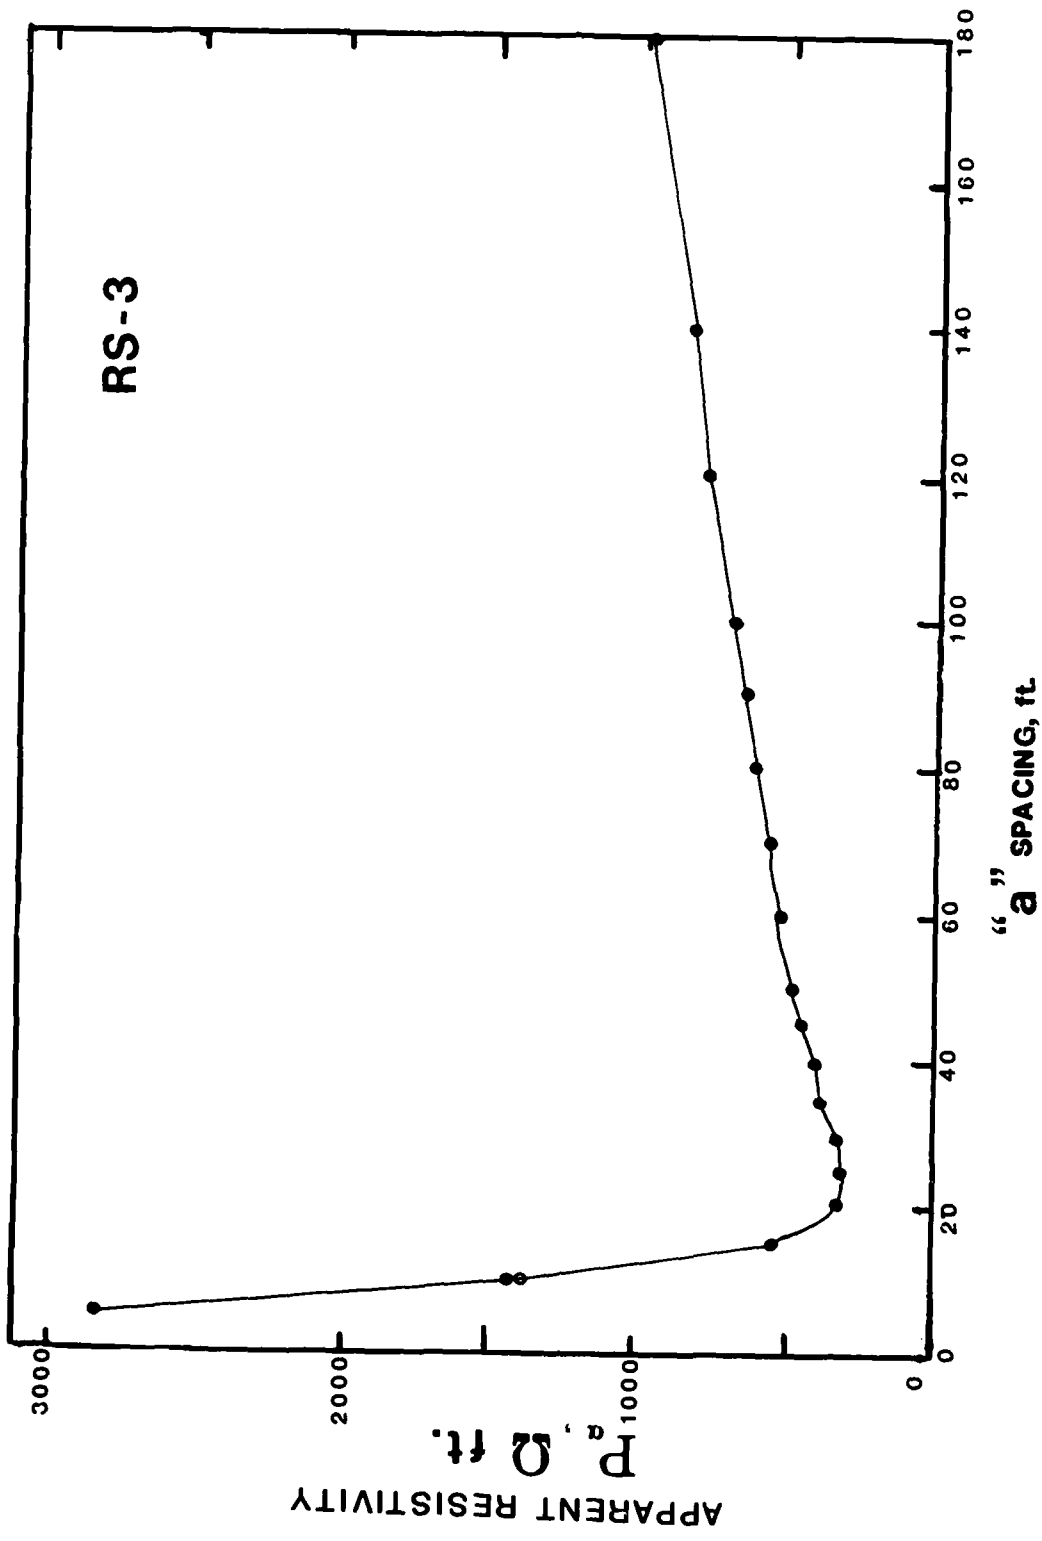
Figure 11a. Resistivity Sounding (Wenner Array) Curve (RS-3).
Centered on Upstream SP Electrode 7.

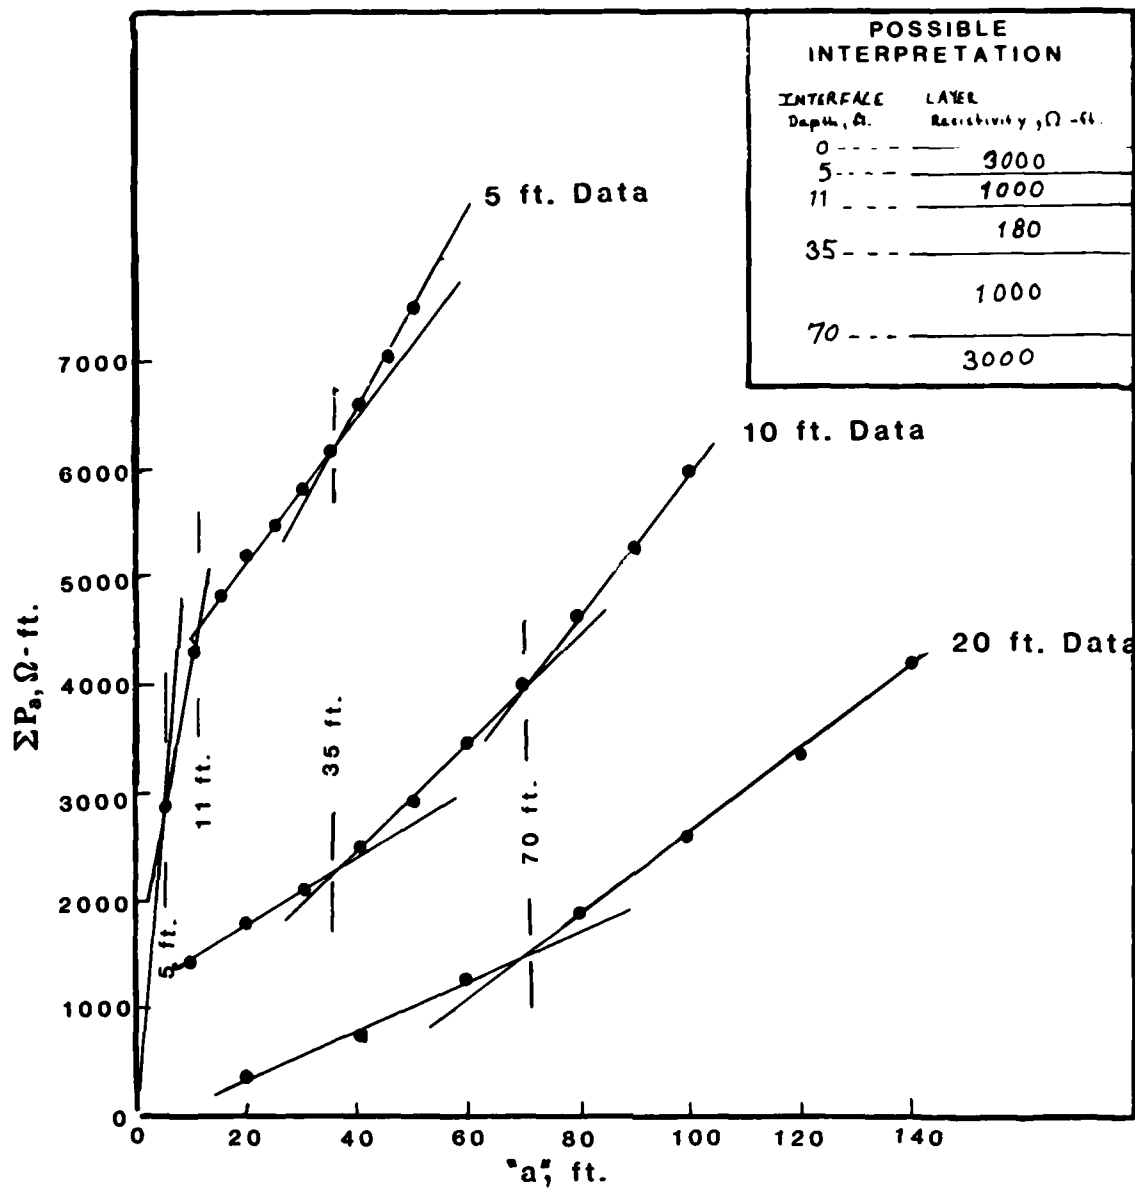
Figure 11b. Cumulative Resistivity Plot for RS-3.
