MISCELLANEOUS PAPER GL-84-3

GEOPHYSICAL INVESTIGATIONS IN SUPPORT OF CLEARWATER DAM COMPREHENSIVE SEEPAGE ANALYSIS

May 1984
Final Report

Prepared for U. S. Army Engineer District, Little Rock
Little Rock, Ark. 72203

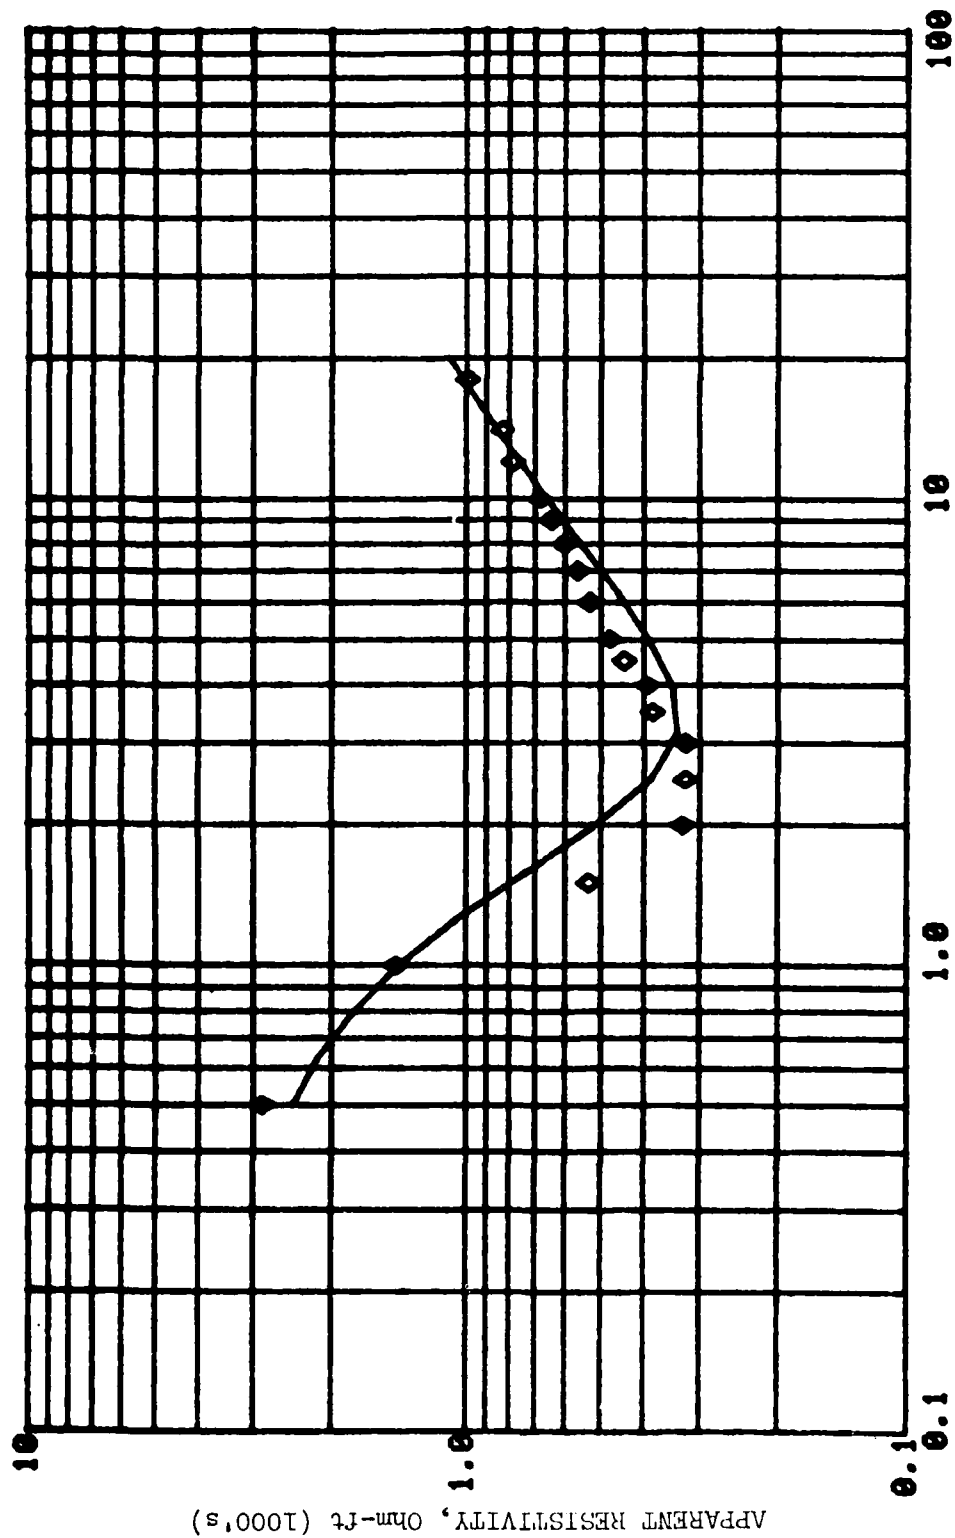
Figure 11c. Comparison of resistivity models from Figure 11b (solid line) with field data (symbols) for Wenner Sounding RS-3.

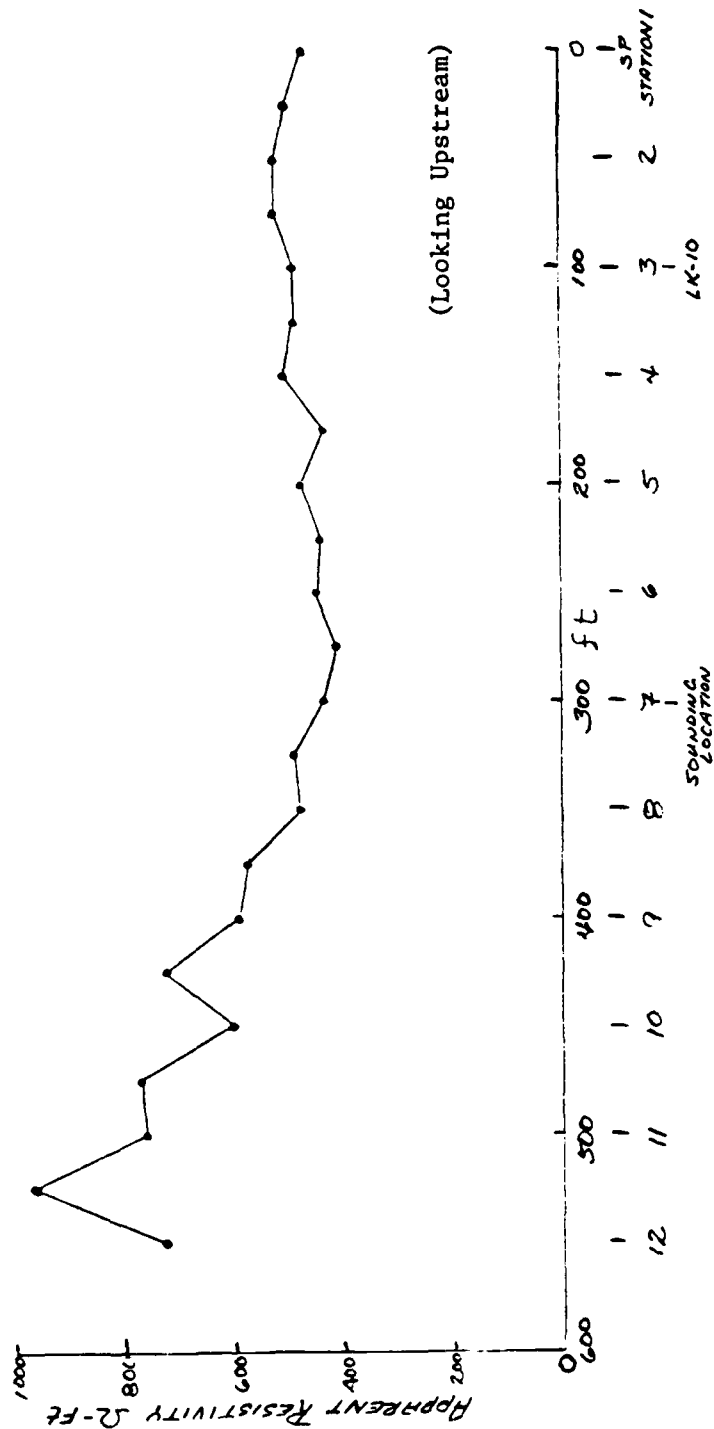
RP-4

Figure 12. Horizontal Resistivity Profile Along Upstream SP Array (Wenner Array, a = 50 ft), RP-4.

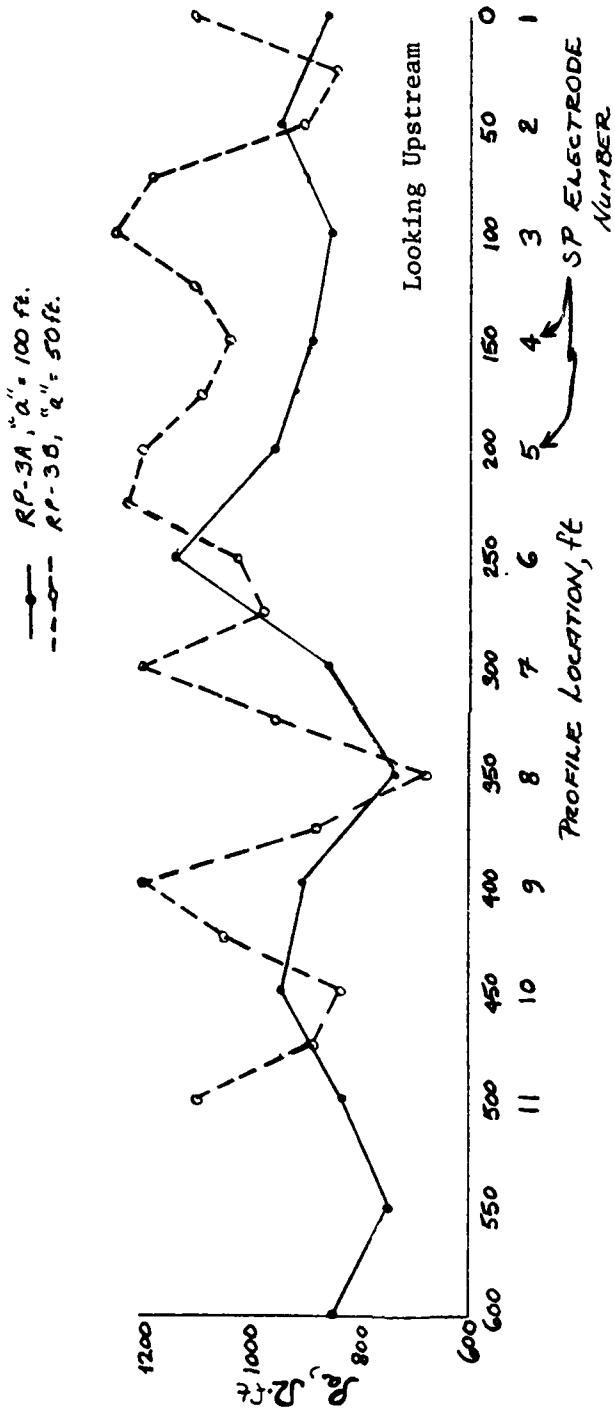
Figure 13. Horizontal Resistivity Profiles Along Downstream SP Array for a = 50 ft (RP-313) and a = 100 ft (RP-3A).

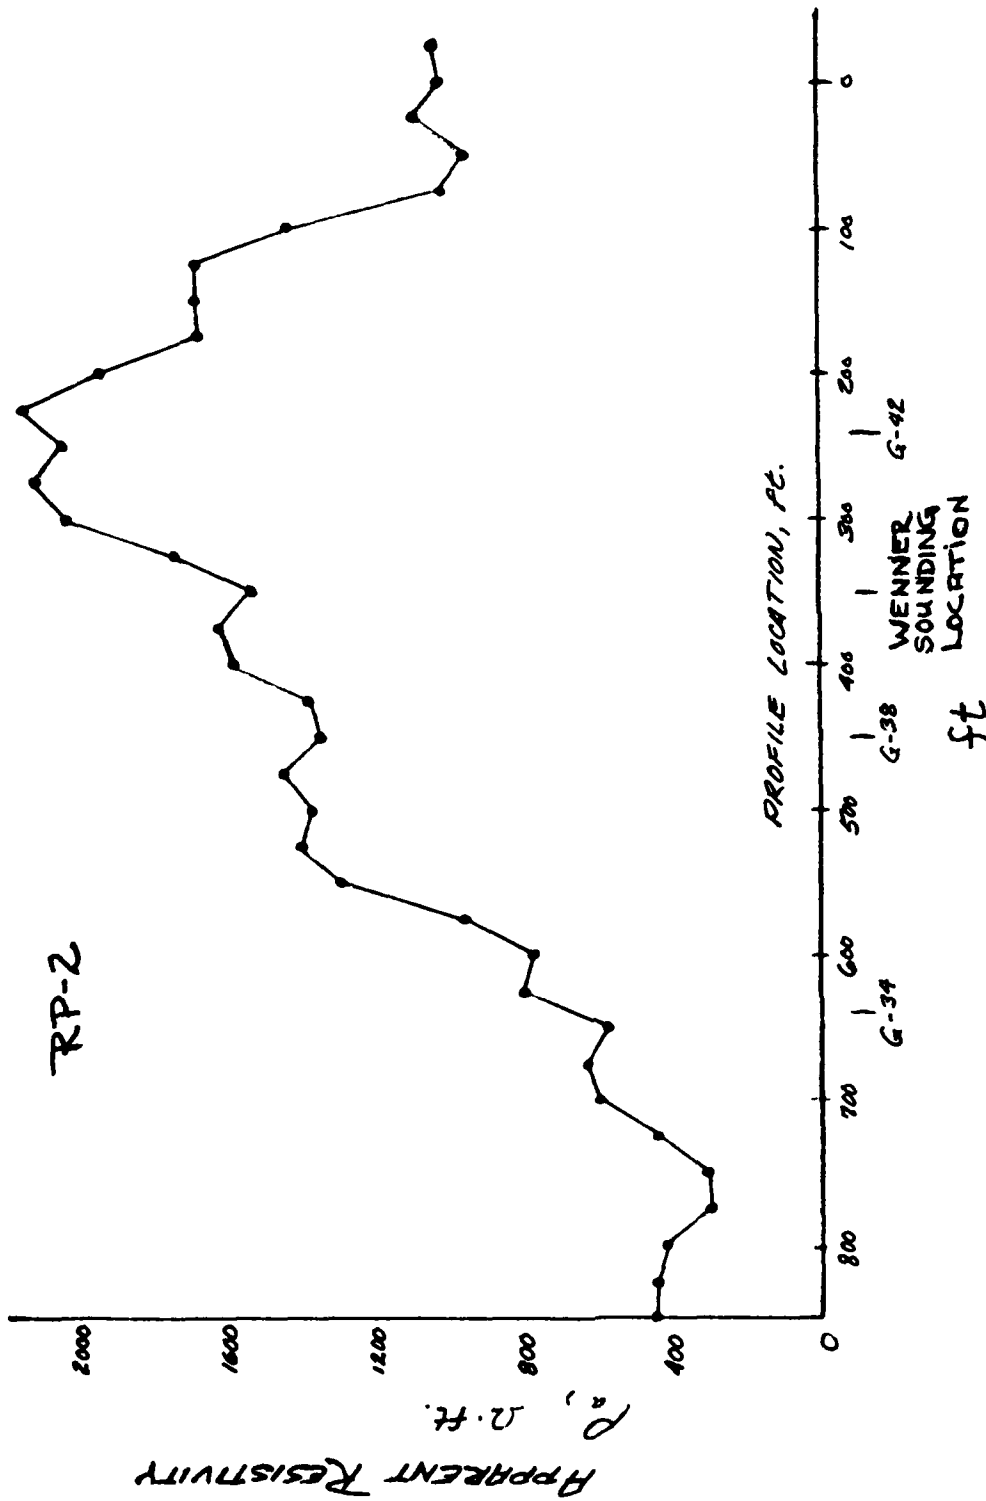
Figure 14. Horizontal Resistivity Profile Along Downstream Toe Piezometer Line (a = 50 ft). Boring Locations Indicated.

24. Downstream toe of dam. Results of horizontal resistivity profile RP-2 are shown in Figure 14 and results of vertical resistivity sounding RS-1 are shown in Figures 15a and 15b. The sounding curve in Figure 15a indicates the possibility of significant effects due to lateral resistivity variations (variations not due to changes in conditions beneath the sounding location), and indeed it was not possible to obtain a geologically reasonable model (layer thicknesses and resistivities) to satisfy the data. The interface suggested by the cumulative resistivity plot in Figure 15b at 15 to 18 ft may correspond to the water table and the interface at 88 ft may correspond to an impermeable zone (tight, no significant solution activity) noted in U. S. Army Engineer District, Little Rock (1977) at depths of about 70 ft in this area, although any interface depths interpreted from Figure 15b must be viewed with considerable reservation due to the preceding comments. The source of a significant lateral variation which probably affected the sounding is indicated in Figure 14, where a prominent resistivity high occurs between 200 and 300 ft of the profile line. This is superimposed on a broader high extending from 100 to 550 ft. Except for boring SSD-47, which indicated a depth to the top of rock at 70 ft, all borings along the profile line encountered rock at an average depth of 30 ft with variations of only 2 to 3 ft. A large limestone pinnacle could explain the high from 200 to 300 ft, although none of the borings confirms this condition in the general area. The drop to lower resistivity values from 25 to 75 ft is likely due to the significant amounts of clay observed in G-47 and SSD-47 which were not seen in other borings (such as

G-42 and G-38) and/or the greater depth to the top of rock. Likewise, the drop to lower resistivity values which extend from 600 and 850 ft is probably due to the significant amounts of clay observed in G-34 and RD-6. The small resistivity low at 750 to 778 ft may be due to the new collector system.

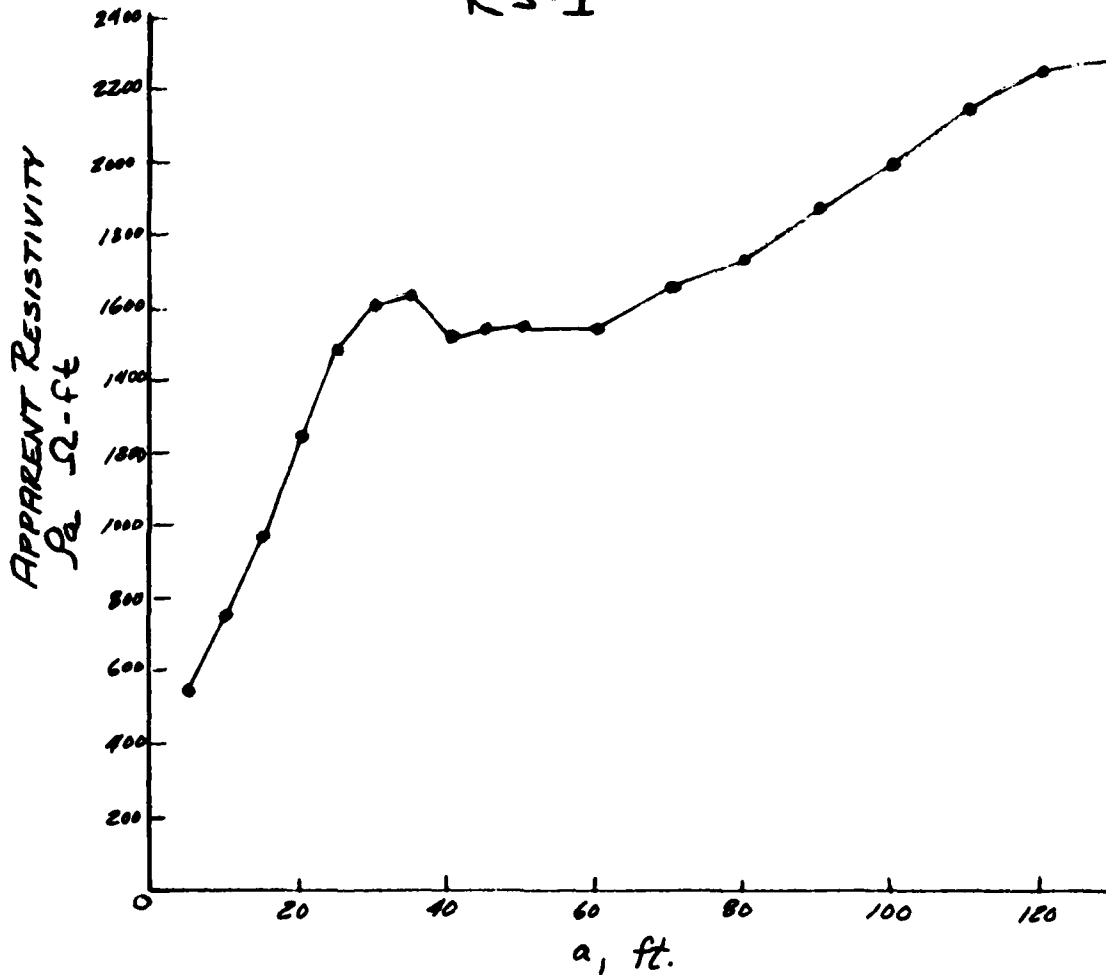
RS-1

Figure 15a. Vertical Resistivity Sounding, RS-1, Centered Between G-42 and G-38 (100 ft from G-38)

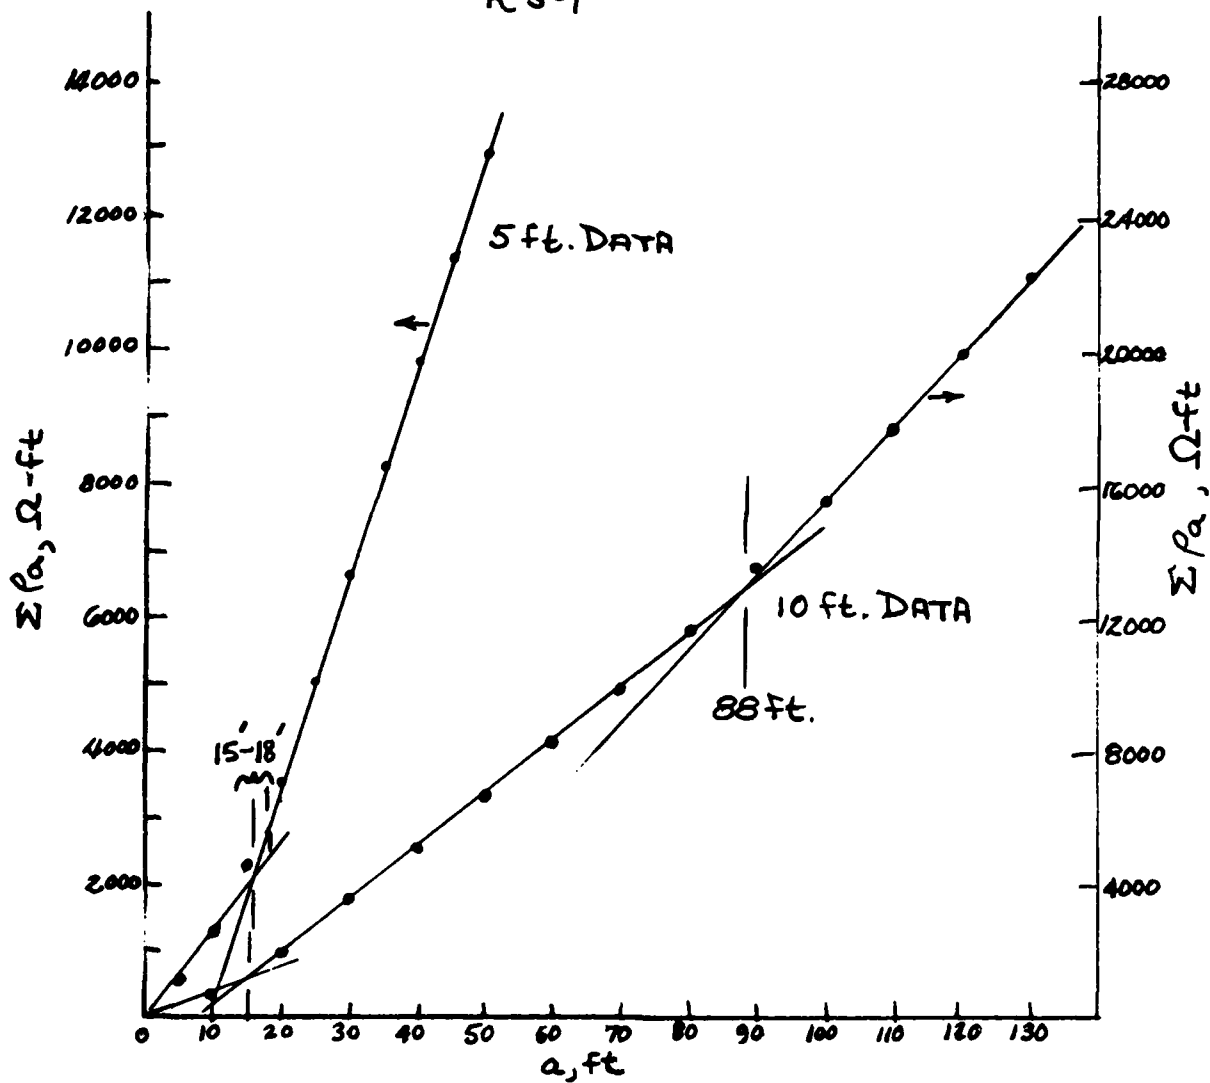
Figure 15b. Cumulative Resistivity Plot for RS-1

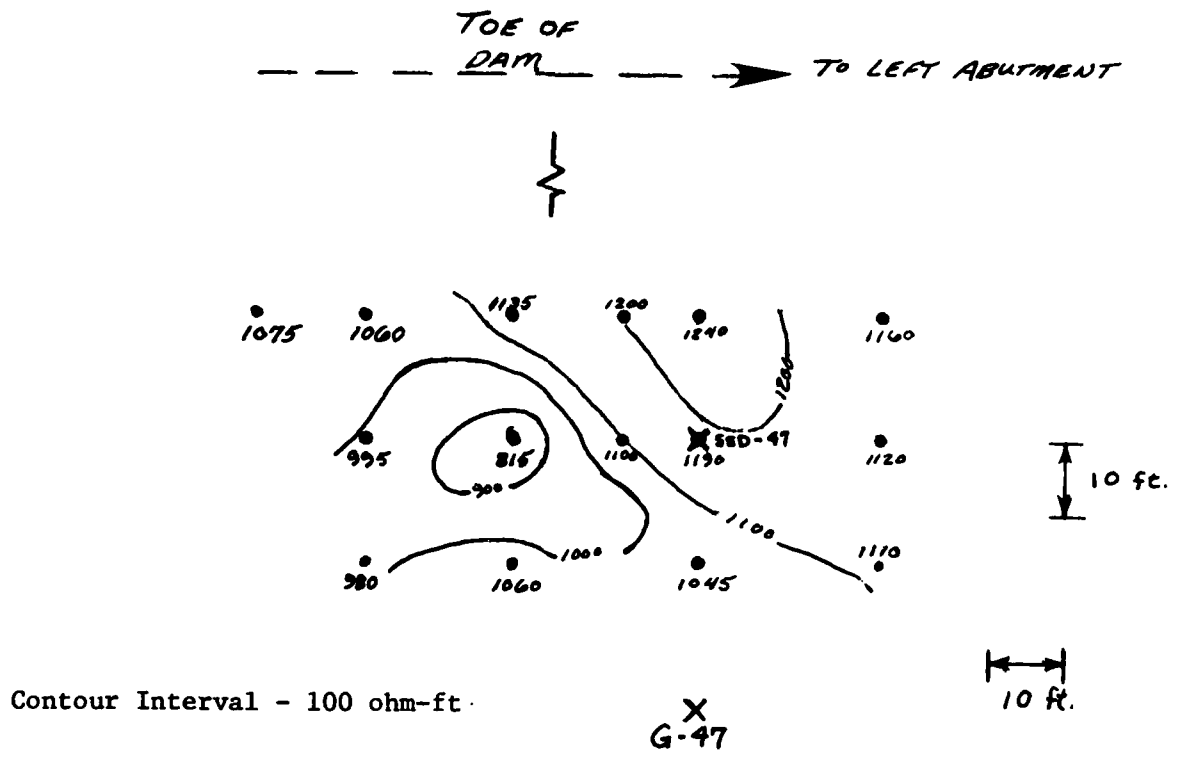
(Note: Resistivity for a = 80 ft centered on 550-47 = 1670 ohm-ft)

Figure 16. Resistivity Values on Grid Around Boring 550-47,
Wenner Array - a + 50 ft, WG-1

25. Results of the Wenner grid survey, WG-1, are shown in Figure 16 in the form of a contour plot. The results of WG-1 do not suggest that greater depth to the top of rock or greater clay content is present at SSD-47. The data indicate a closed negative anomaly feature centered 25 ft toward the right abutment from SSD-47. This negative feature could reflect increased depth to rock and/or greater clay content. SSD-47 may have encountered a vertical pipe or narrow, clay-filled fissure which would not have affected the resistivity with $a = 50$ ft. A measurement at SSD-47 with $a = 80$ ft indicated an apparent resistivity of $\rho_a = 1670$ ohm-ft, consistent with incorporating greater volumes of rock in the measurement and very close to the value at the RS-1 sounding location for $a = 80$ ft.

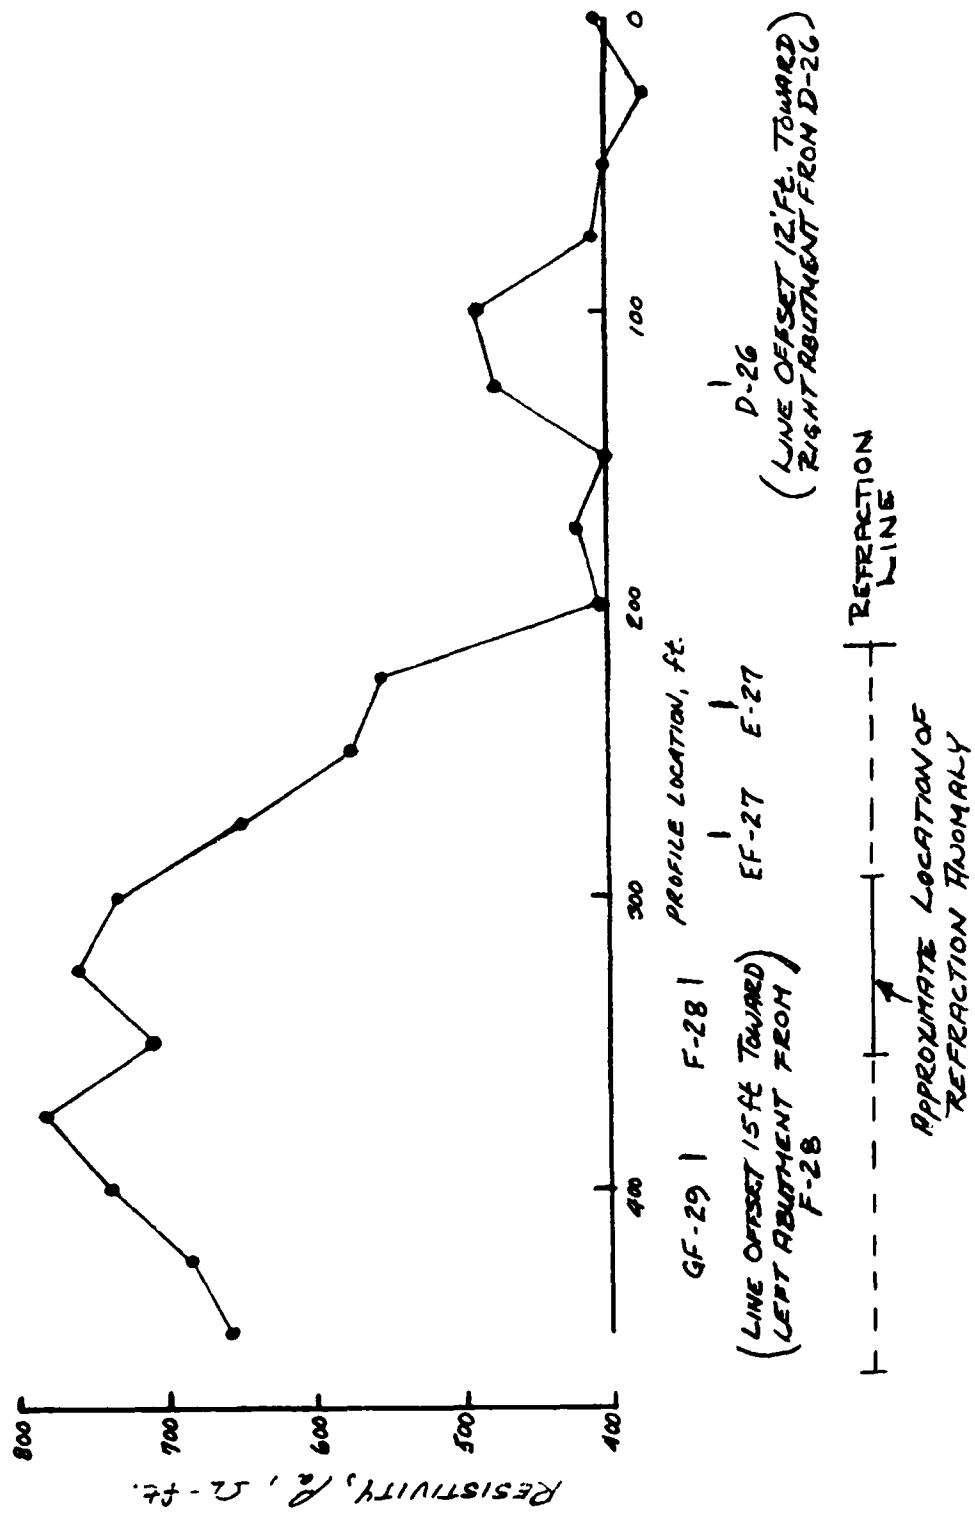
Figure 17. Horizontal resistivity profile along base of left abutment ridge, a = 50 ft, line RP-1

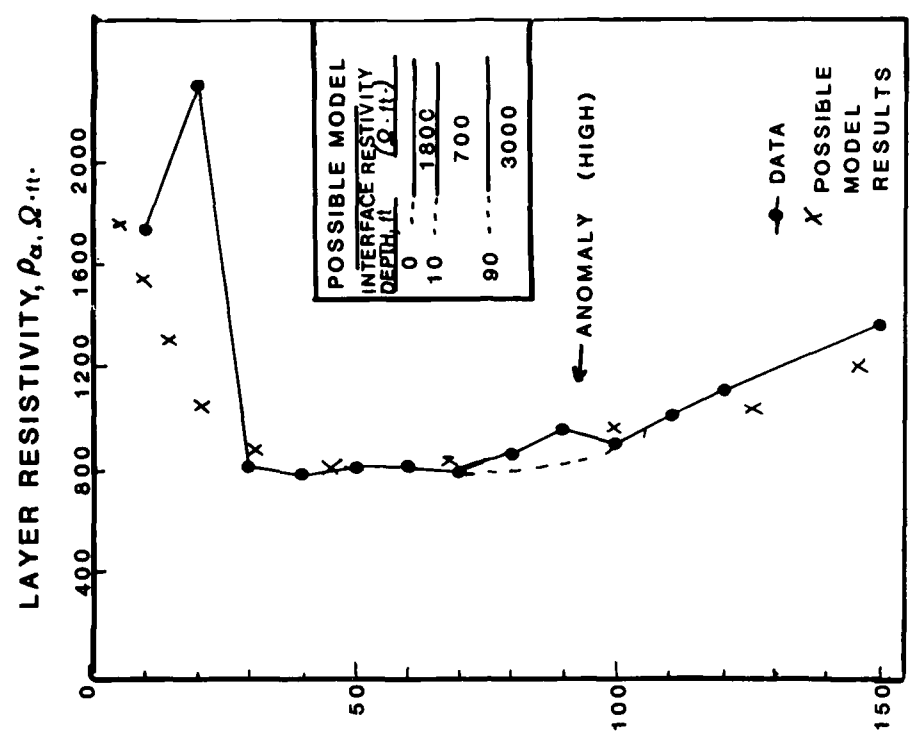
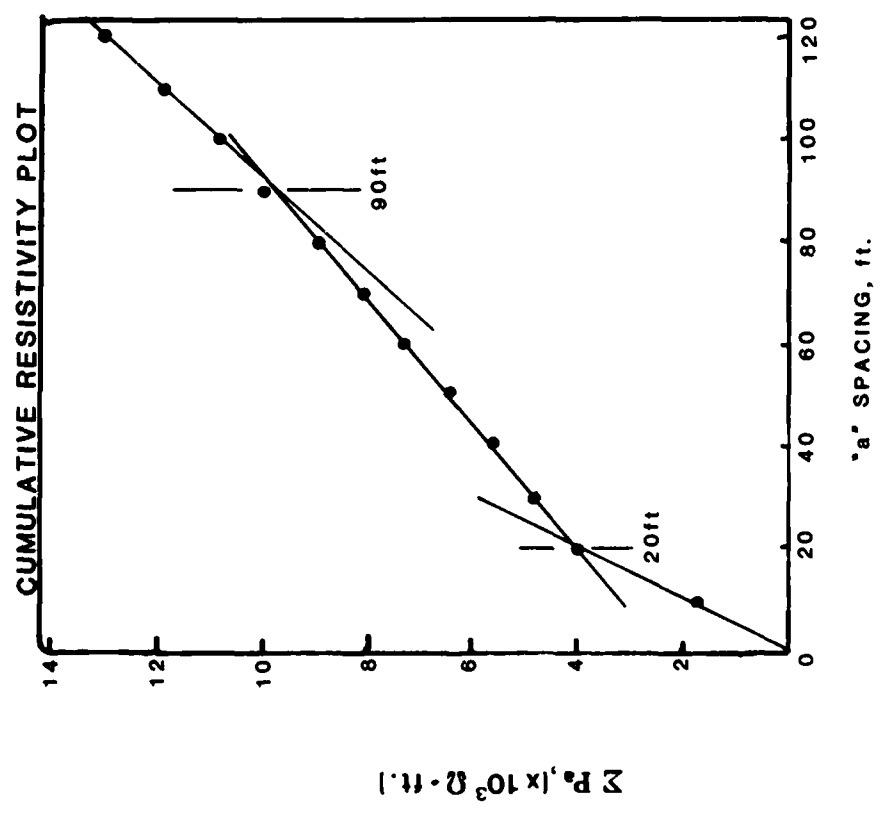
Figure 18. Vertical Resistivity Sounding centered at Boring G-23 on First Left Abutment Ridge. RS-2.

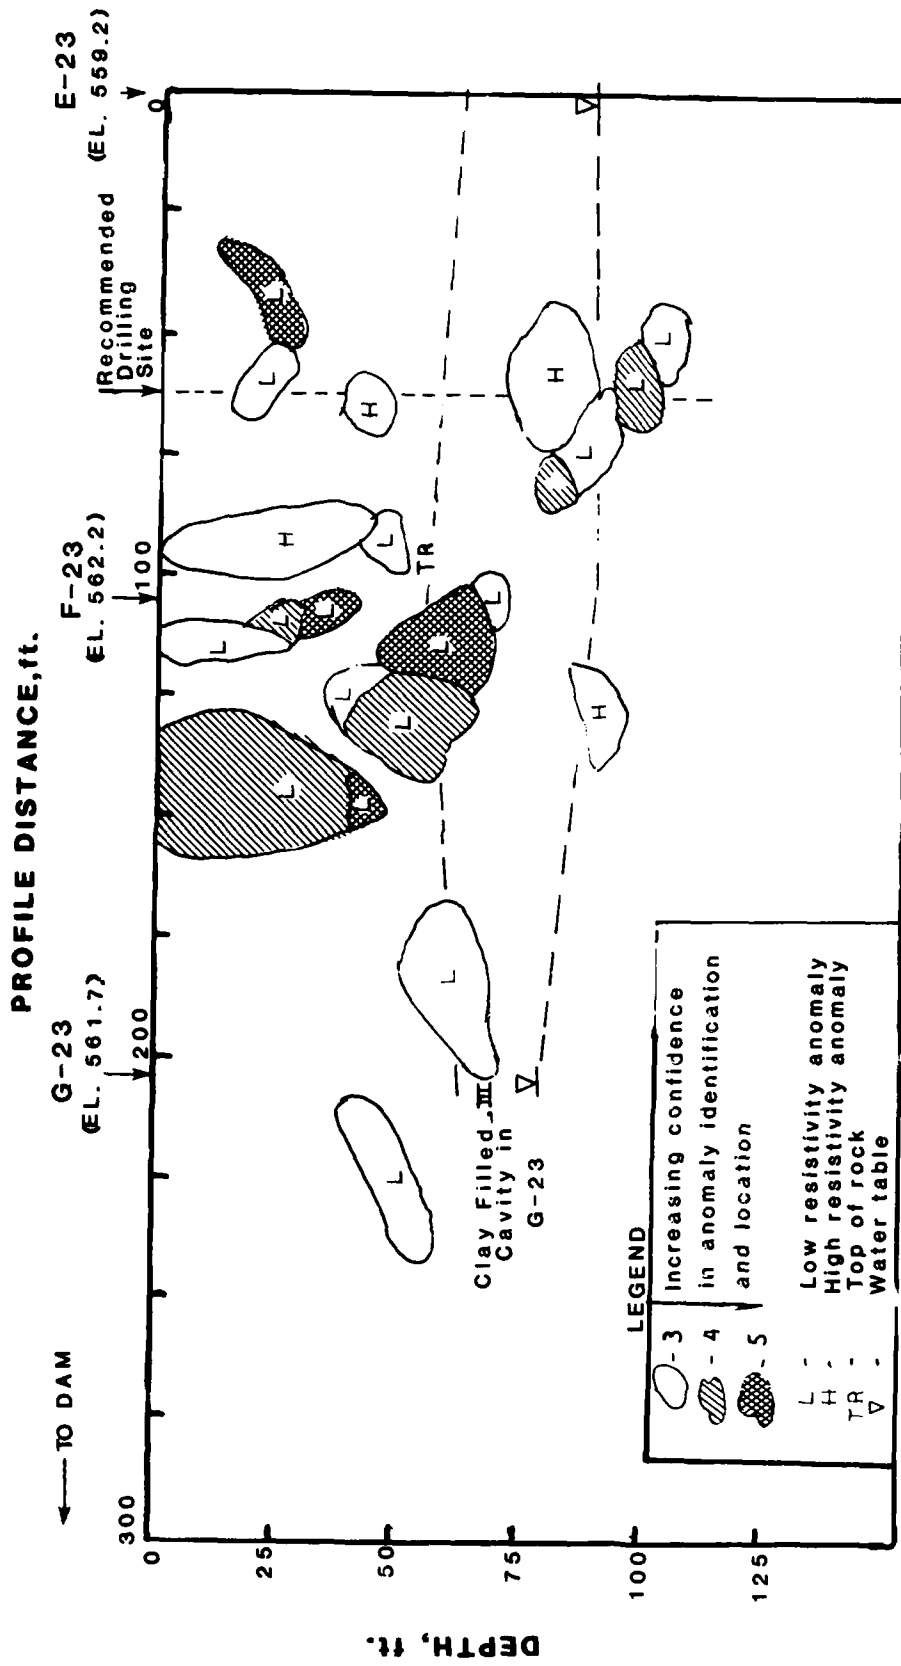
Figure 19. Pole-dipole survey results, B-1, top of first left abutment ridge, to axis of dam.

35. A pole-dipole resistivity survey on the first left abutment ridge crest (Figure 3b, line B-1) indicates conditions possibly representing a significant solution feature. This feature is interpreted to be partially water- or clay-filled. A recommended drilling location is indicated in Figure 19, and it is suggested that the borehole be extended to a nominal depth of 150 ft.* It is possible that this feature, if proven by drilling to exist, could provide a seepage path for significant amounts of the surface seepage observed during high pool levels on the side and at the base of the ridge. Other anomalies indicated in the geophysical survey results are shown in the figures and described in the text.

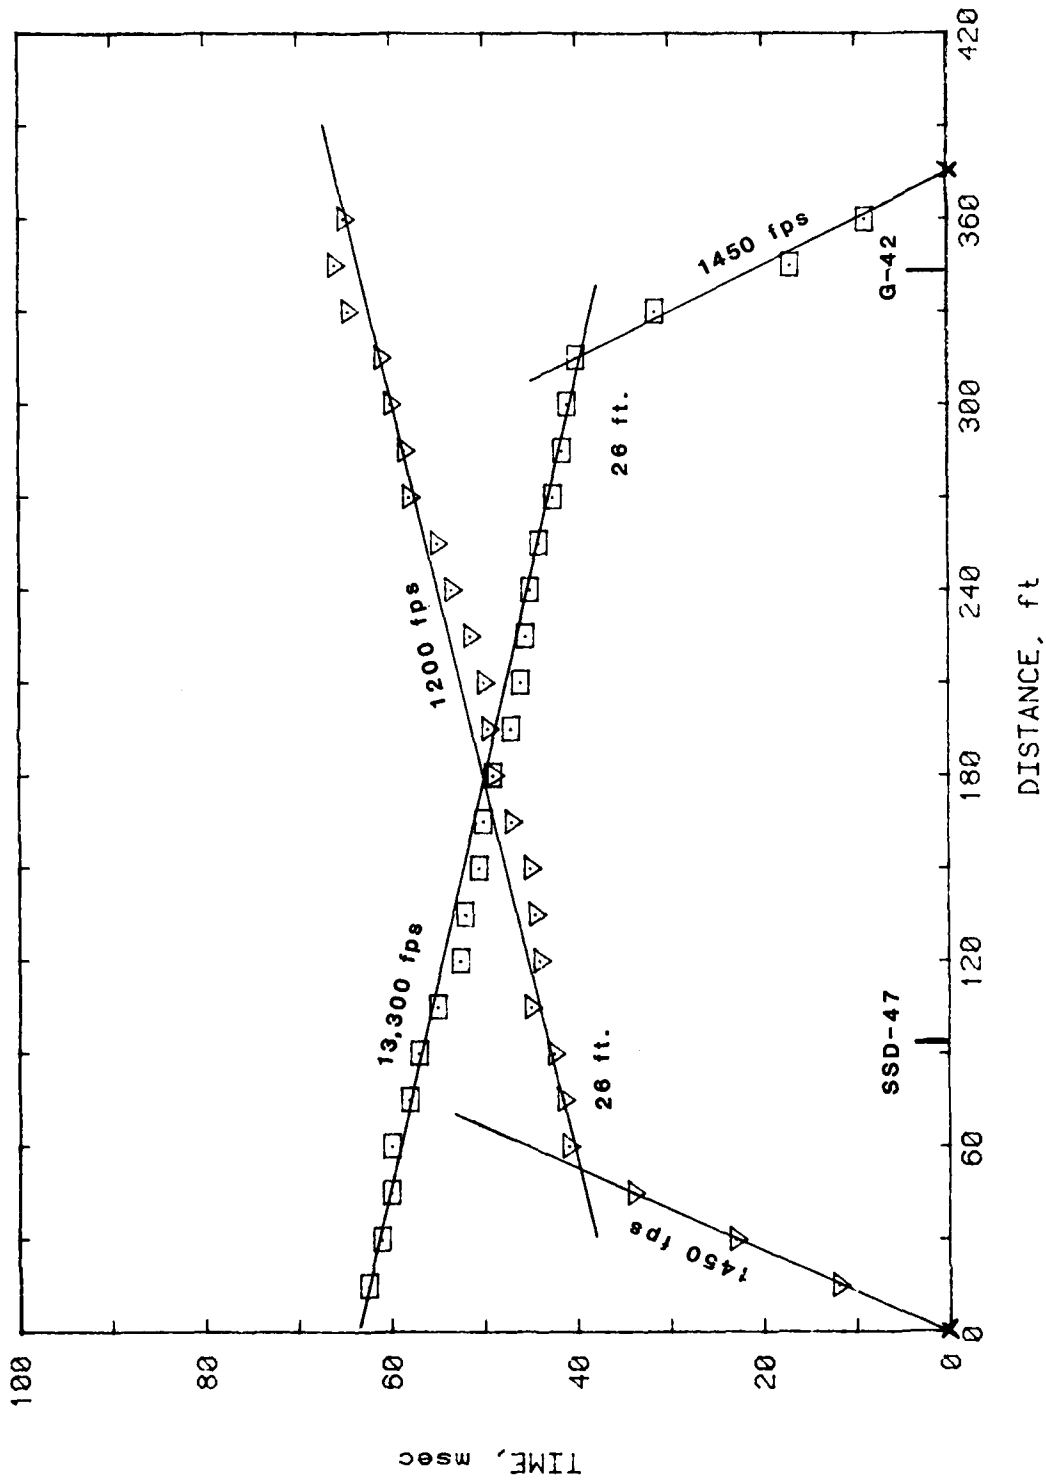
Figure 20. Time versus distance plot for refraction line S-1

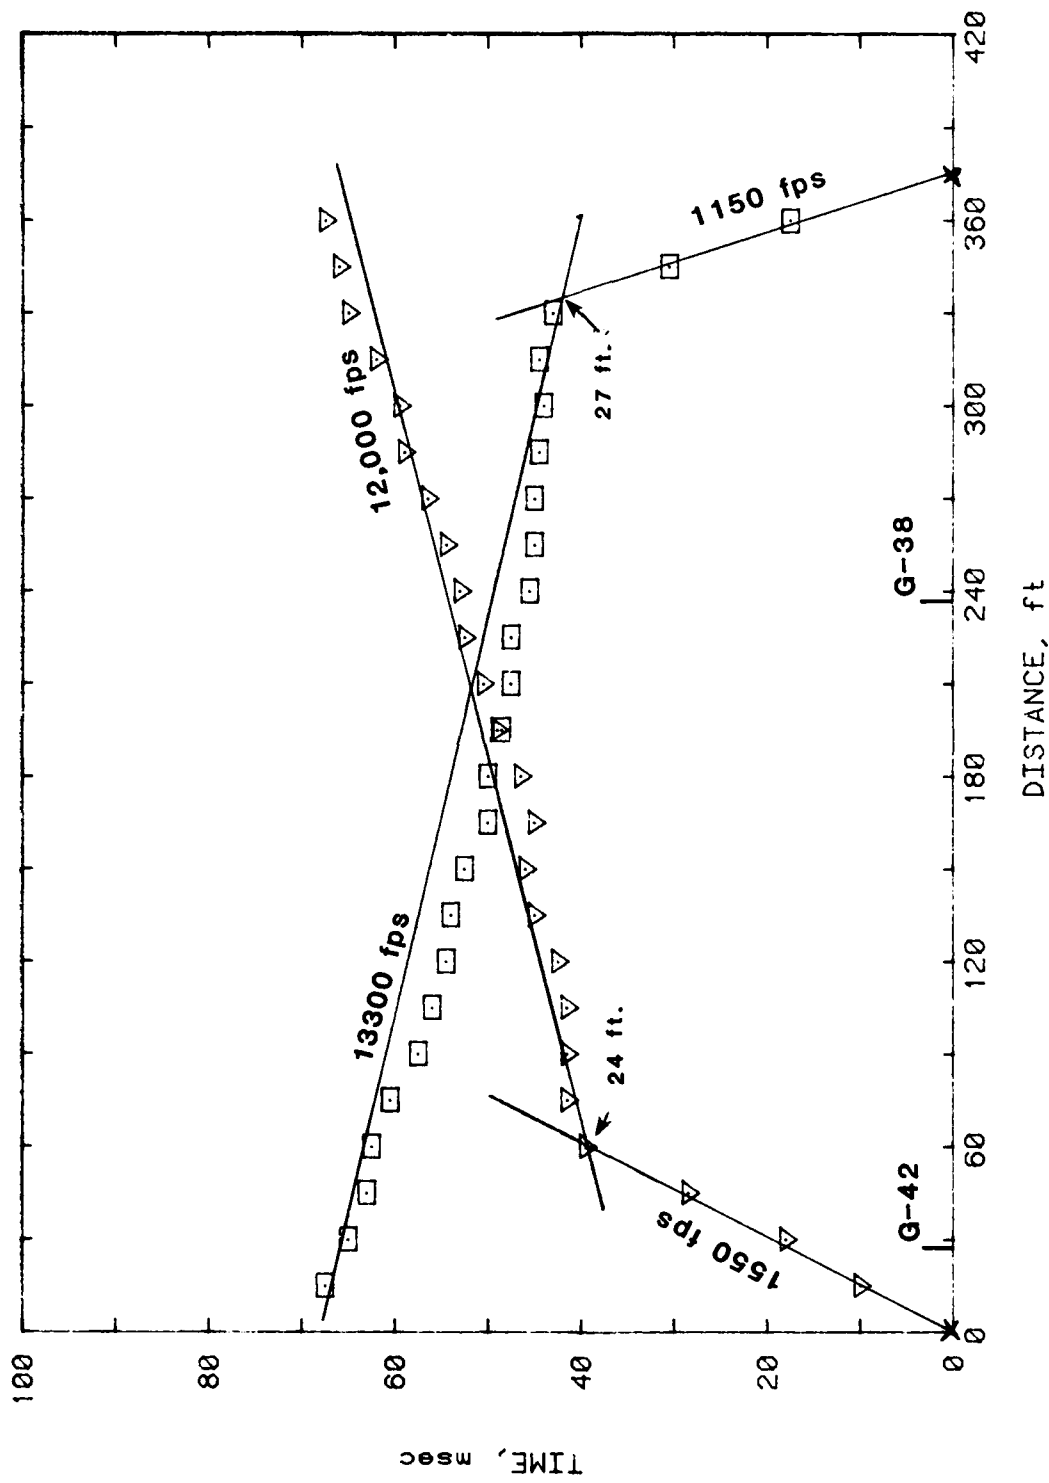
Figure 21. Time versus distance plot for refraction line S-2

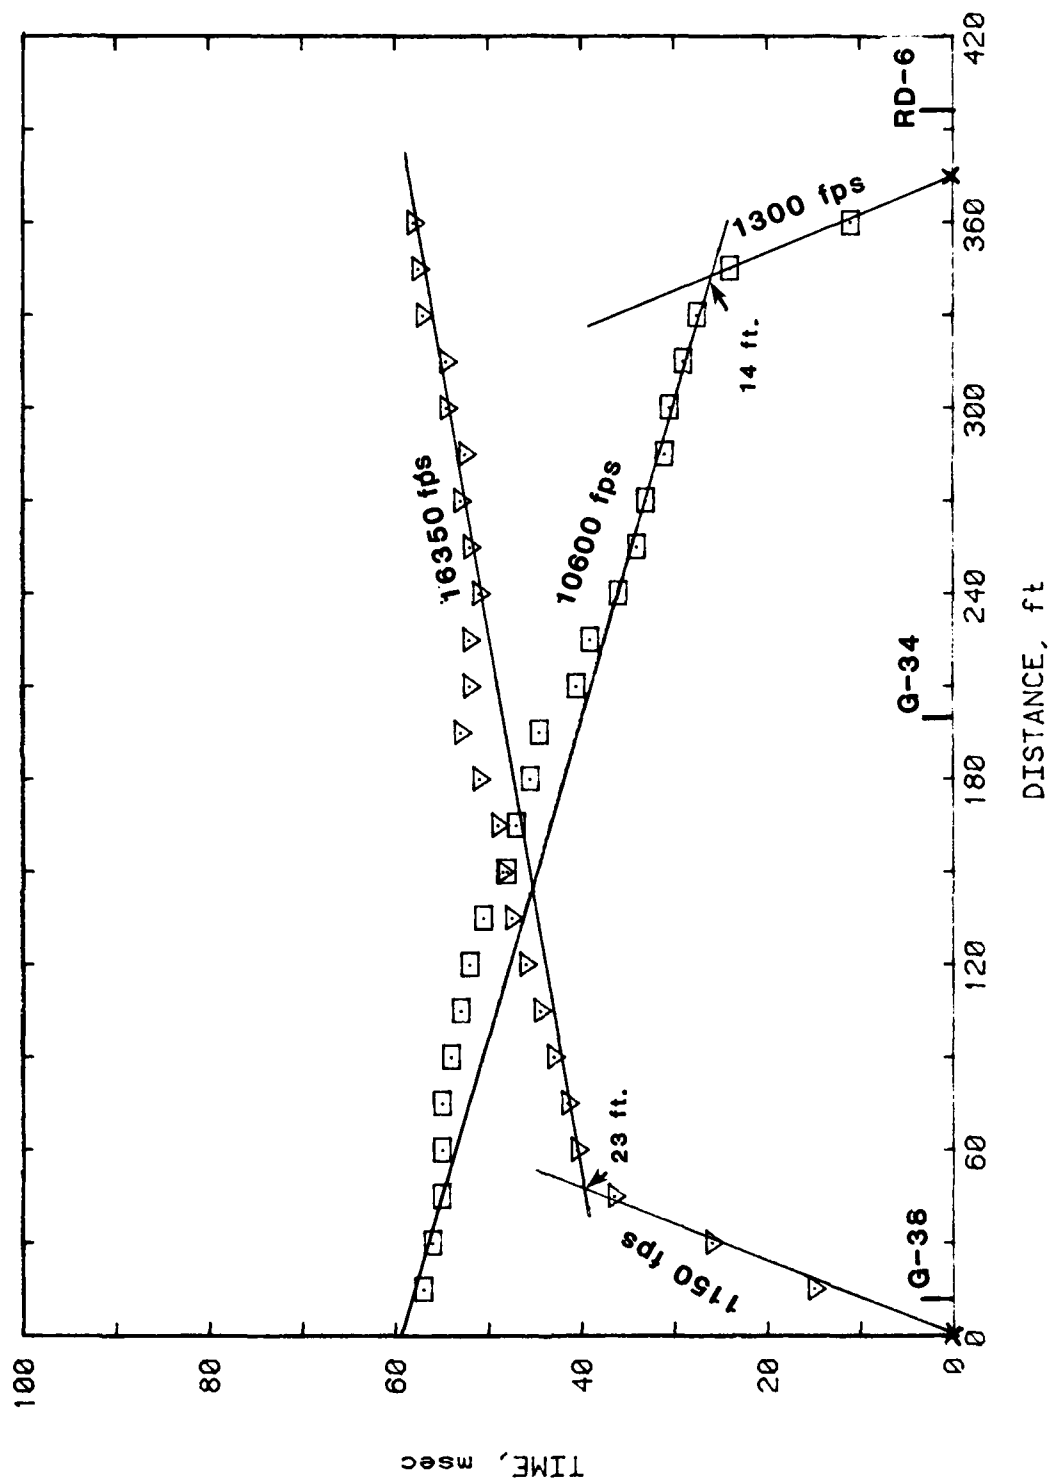
Figure 22. Time versus distance plot for refraction line S-3

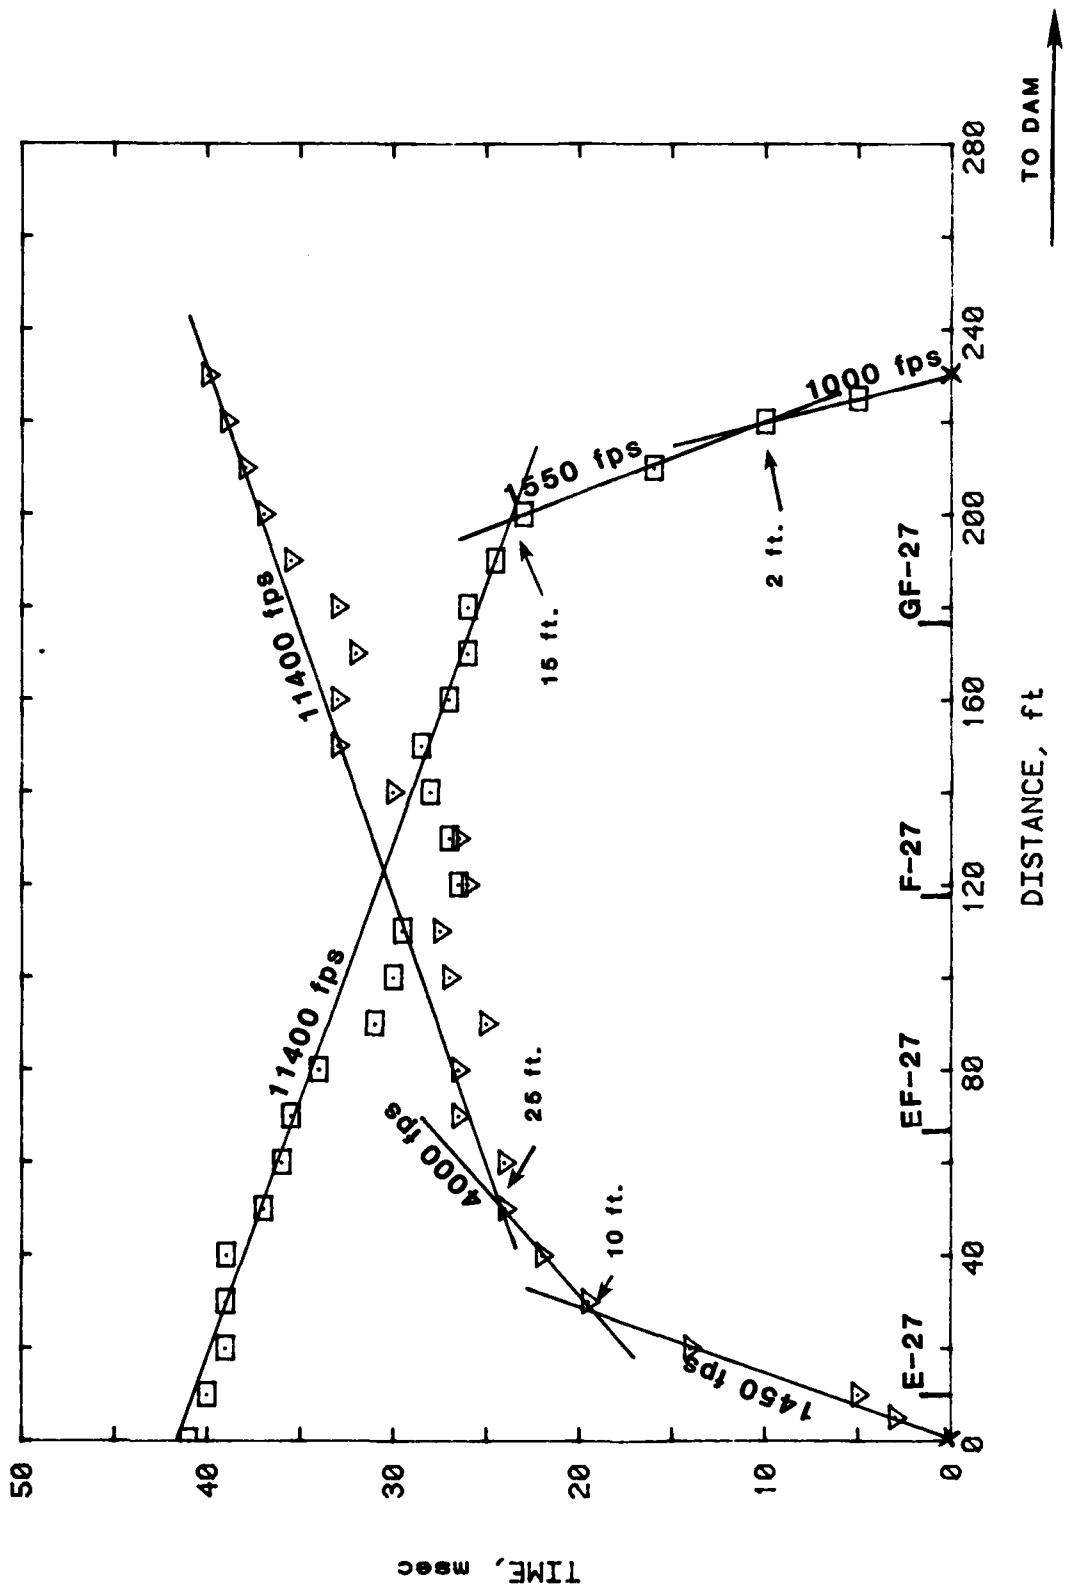
Figure 23. Time versus distance plot for refraction line S-4

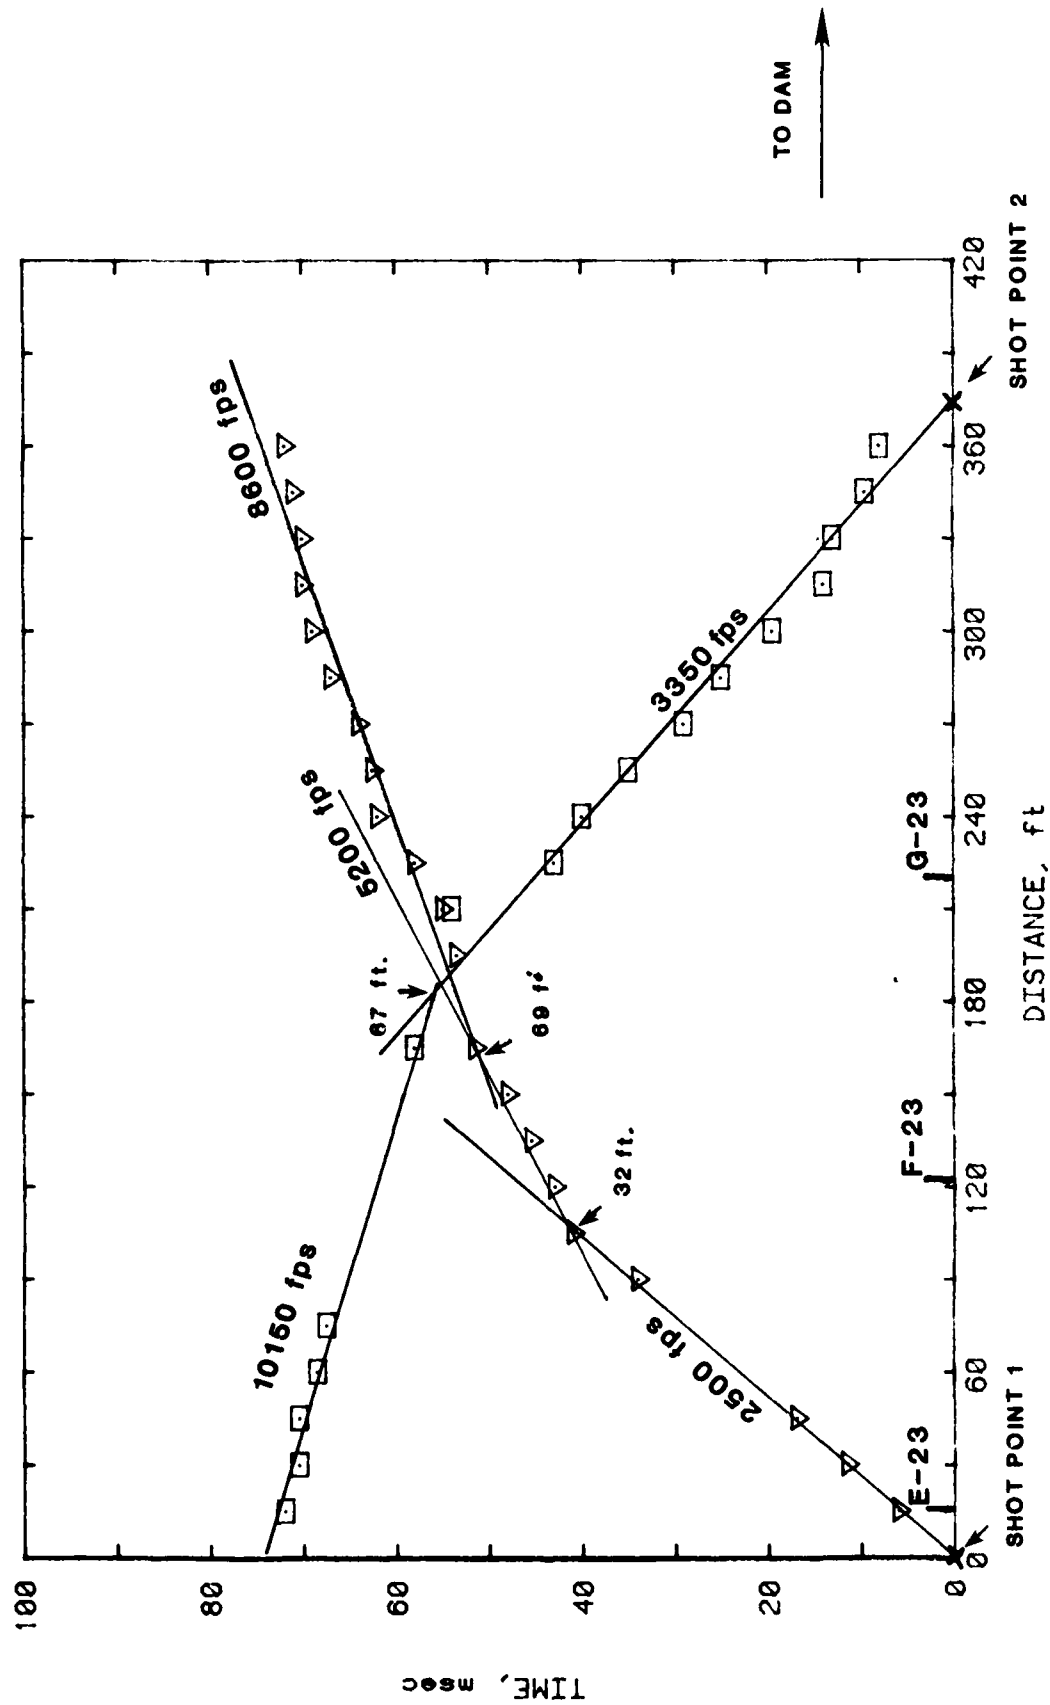
Figure 24. Time versus distance plots for refraction line S-5
