MISCELLANEOUS PAPER GL-84-3

GEOPHYSICAL INVESTIGATIONS IN SUPPORT OF CLEARWATER DAM COMPREHENSIVE SEEPAGE ANALYSIS

May 1984
Final Report

Prepared for U. S. Army Engineer District, Little Rock
Little Rock, Ark. 72203

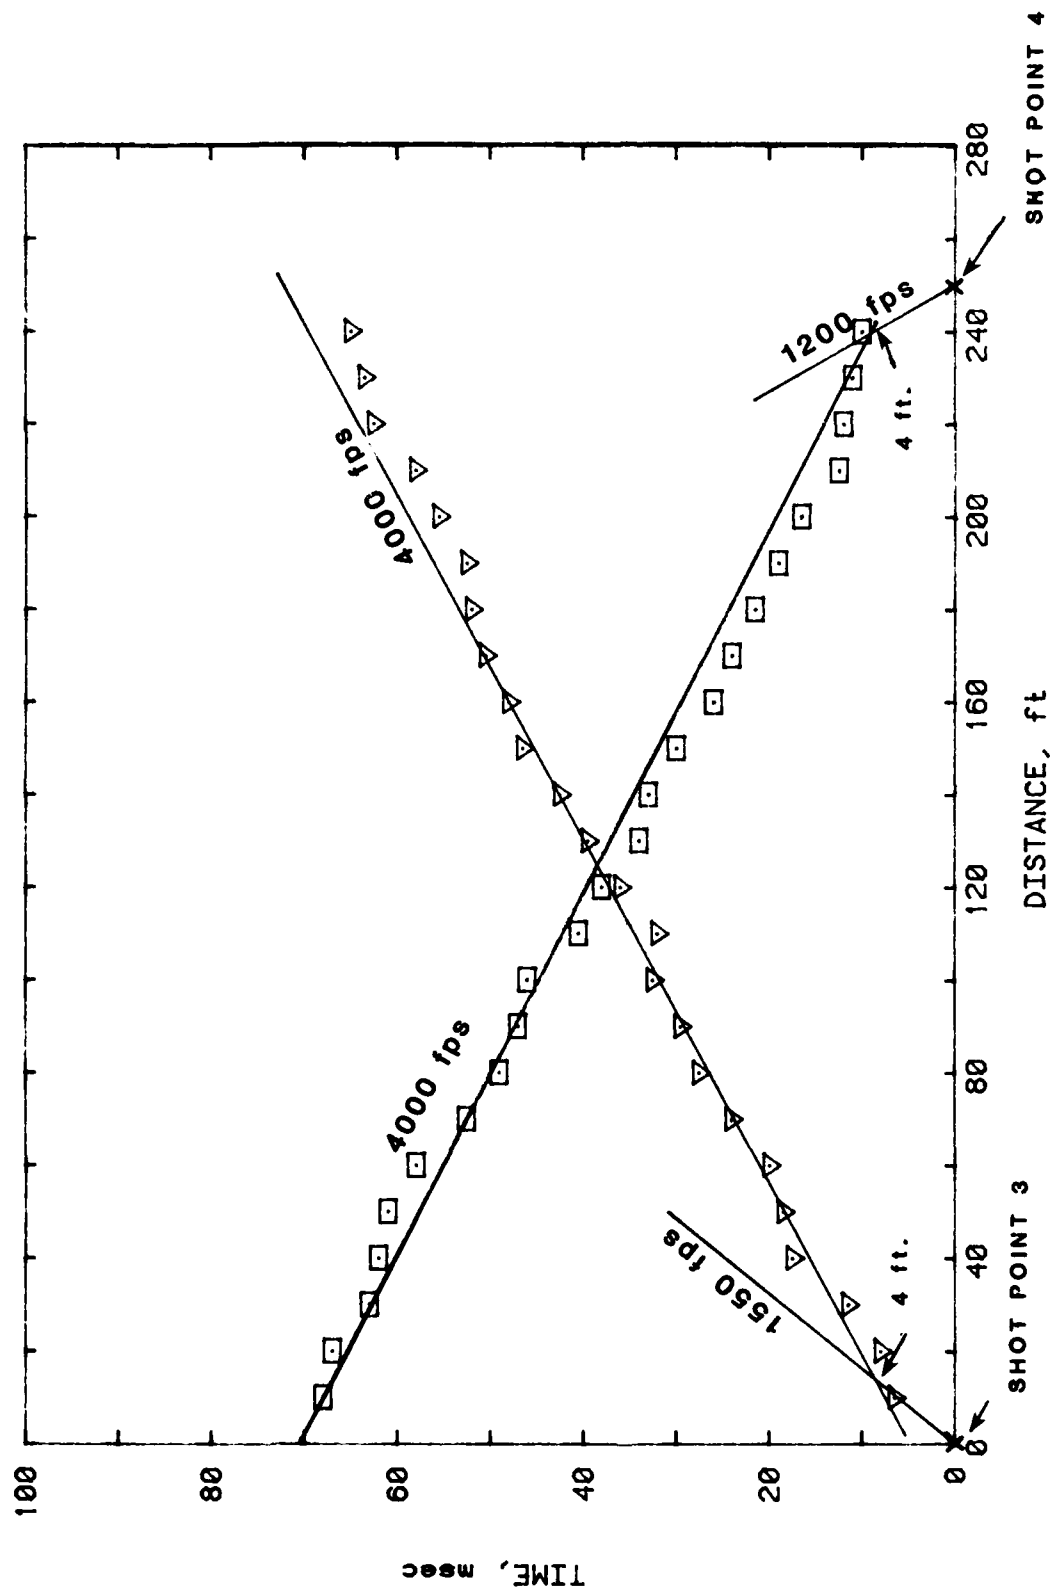
Figure 25. Time versus distance plot for refraction line S-6B

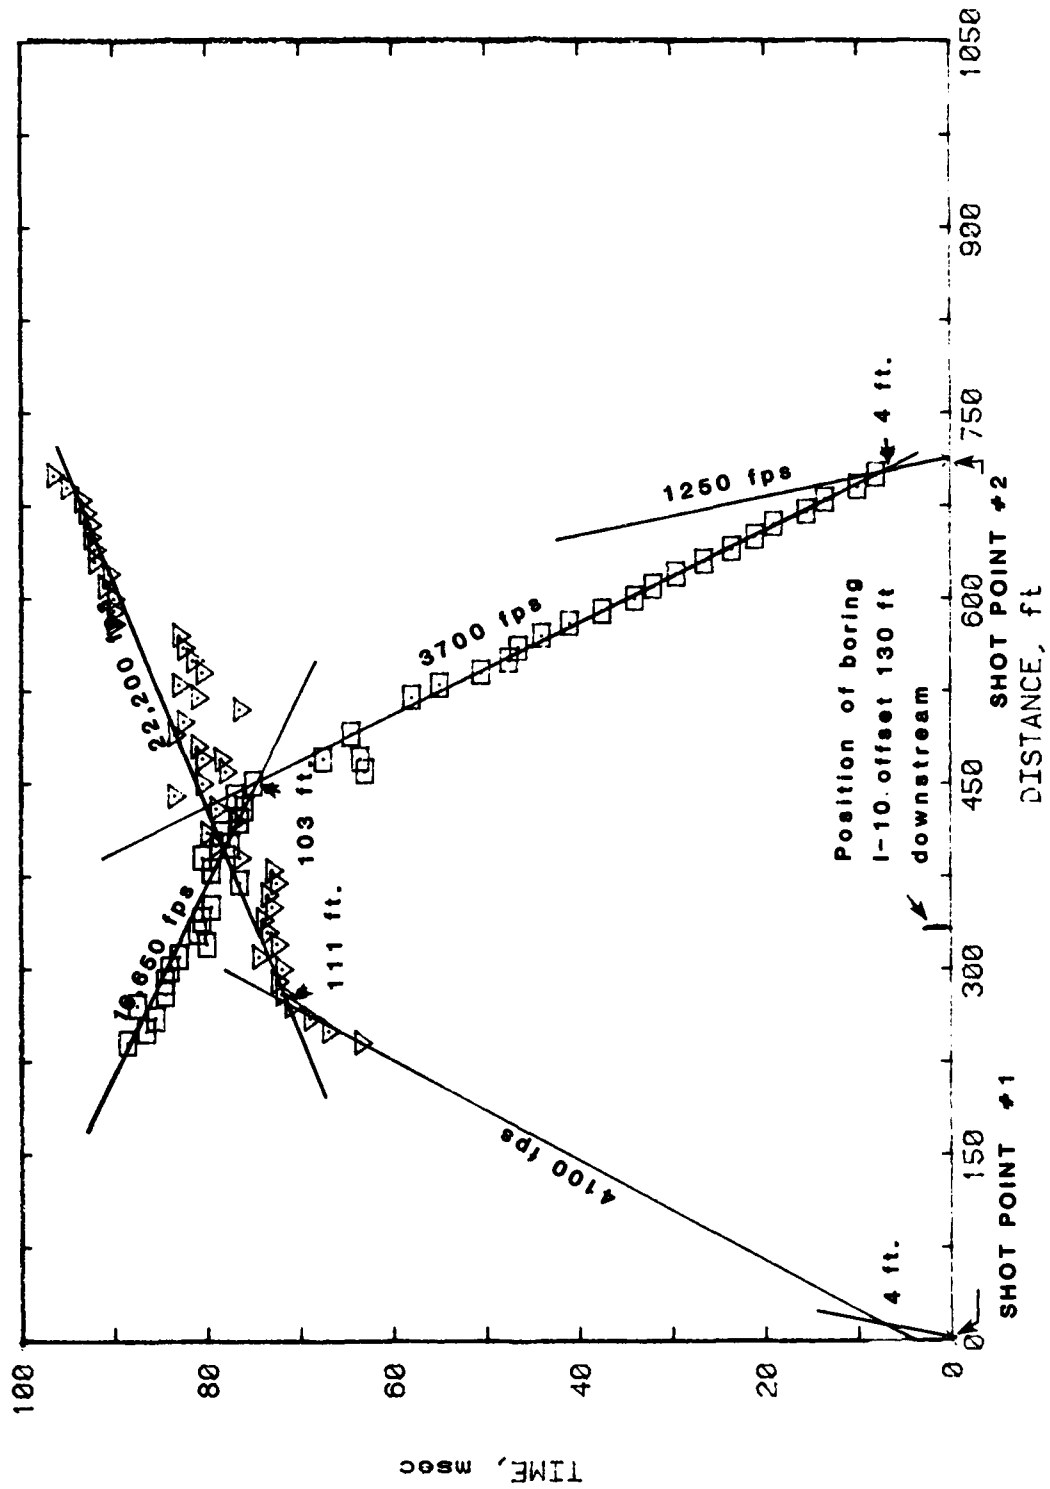
Figure 26. Time versus distance plot for refraction line S-6A

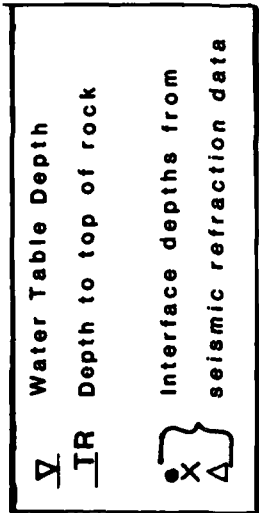
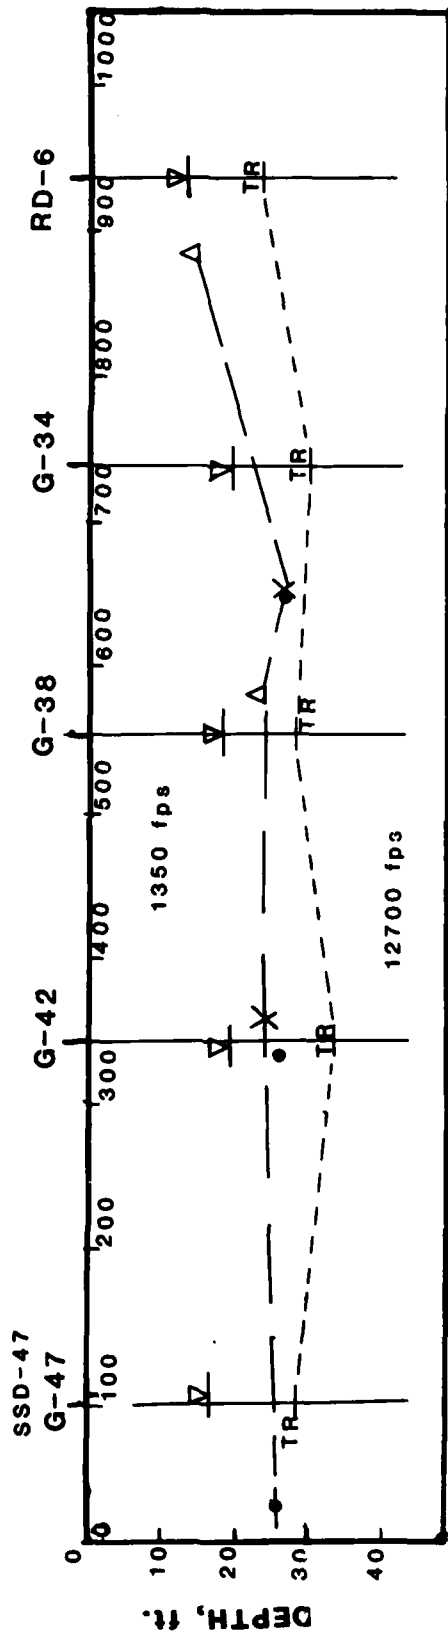
Figure 27. Cross-Section Data Along Downstream toe of dam, Seismic Refraction Lines S-1, S-2, and S-3.

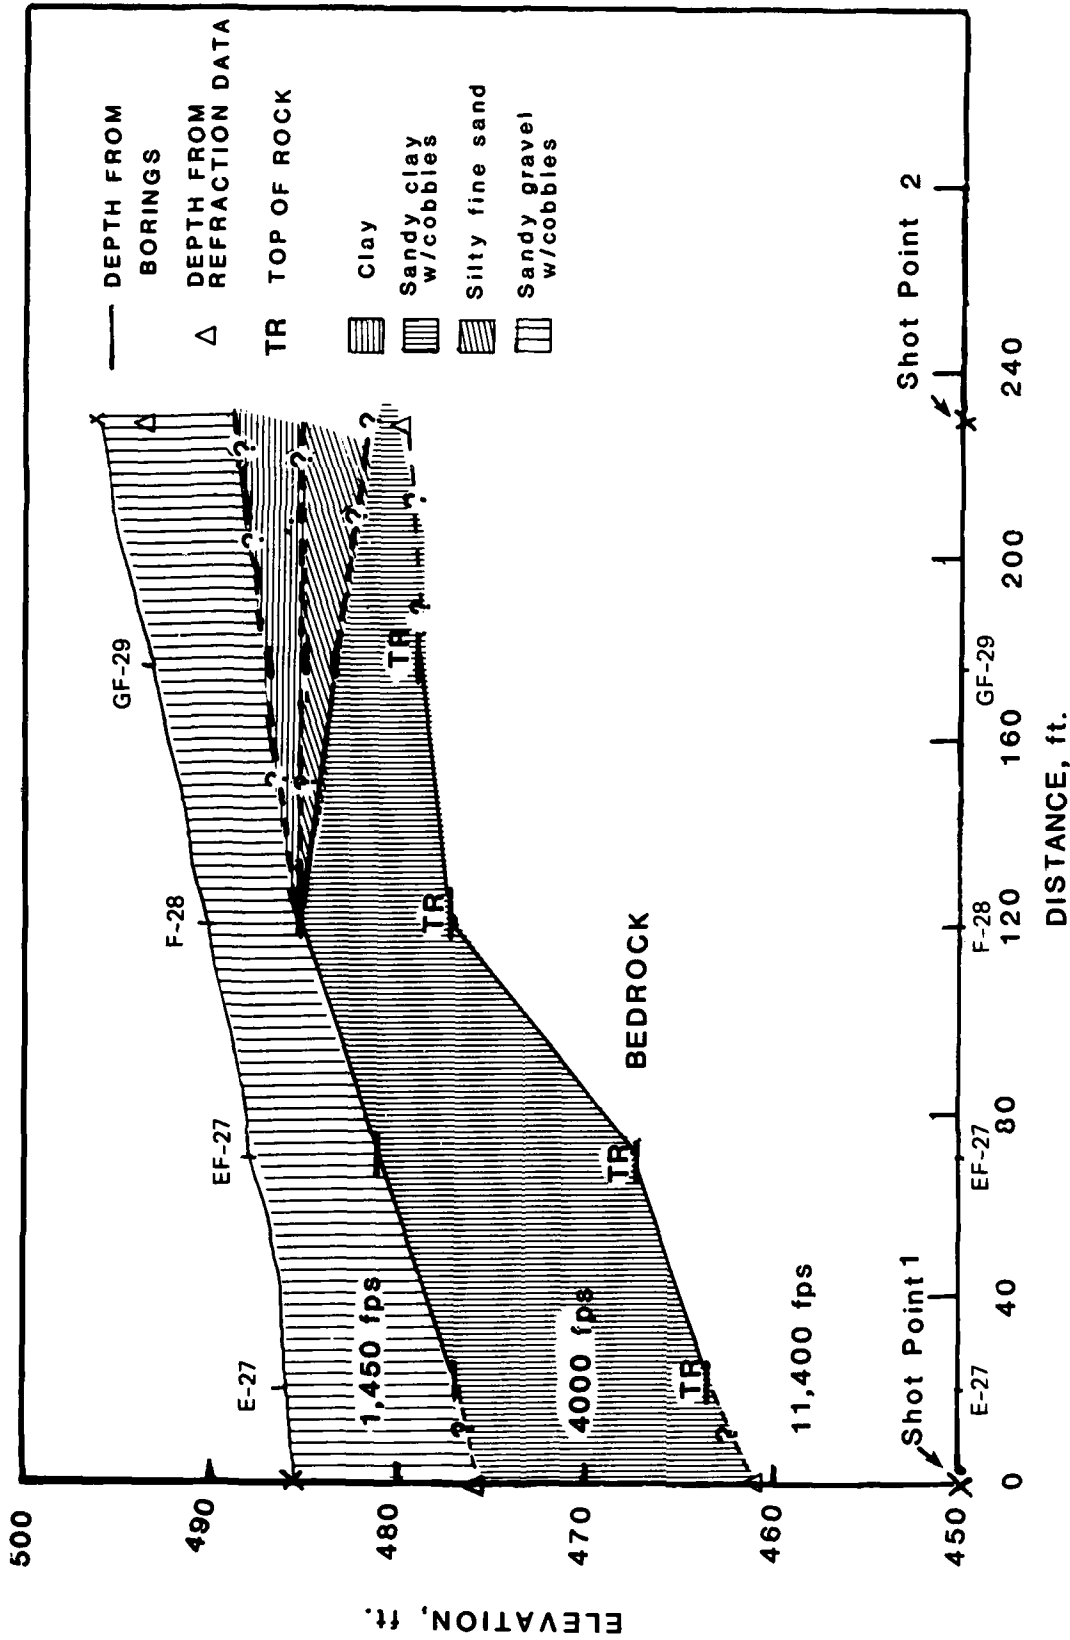
REFRACTION LINE S-4

Figure 28. Cross section along base of left abutment ridge showing refraction interpretation and borehole data.

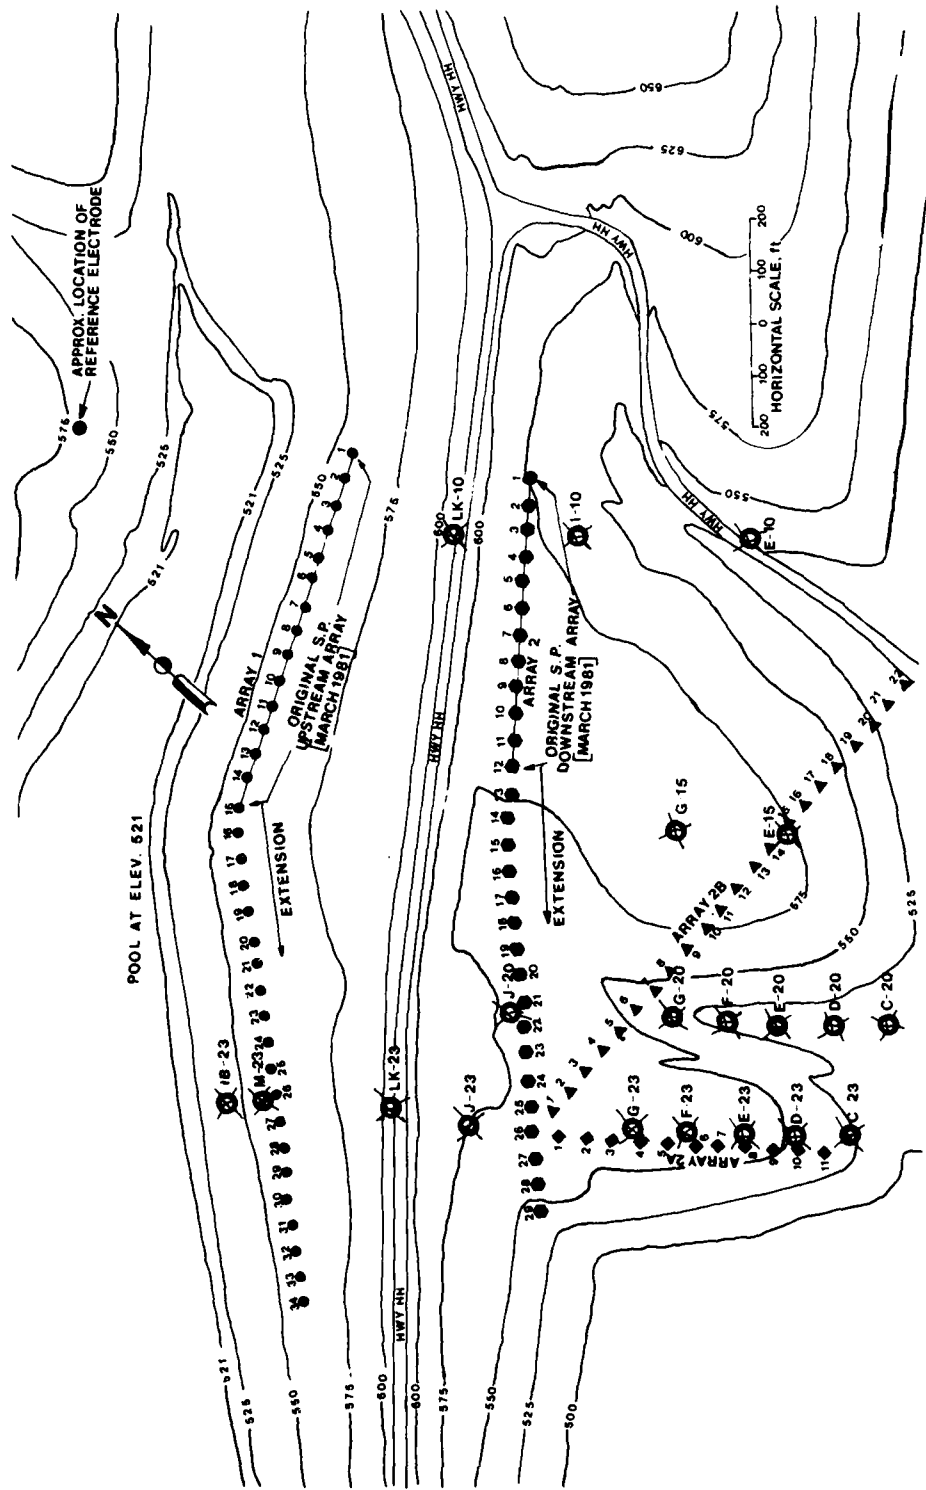
Figure 29. Spontaneous-potential electrode locations

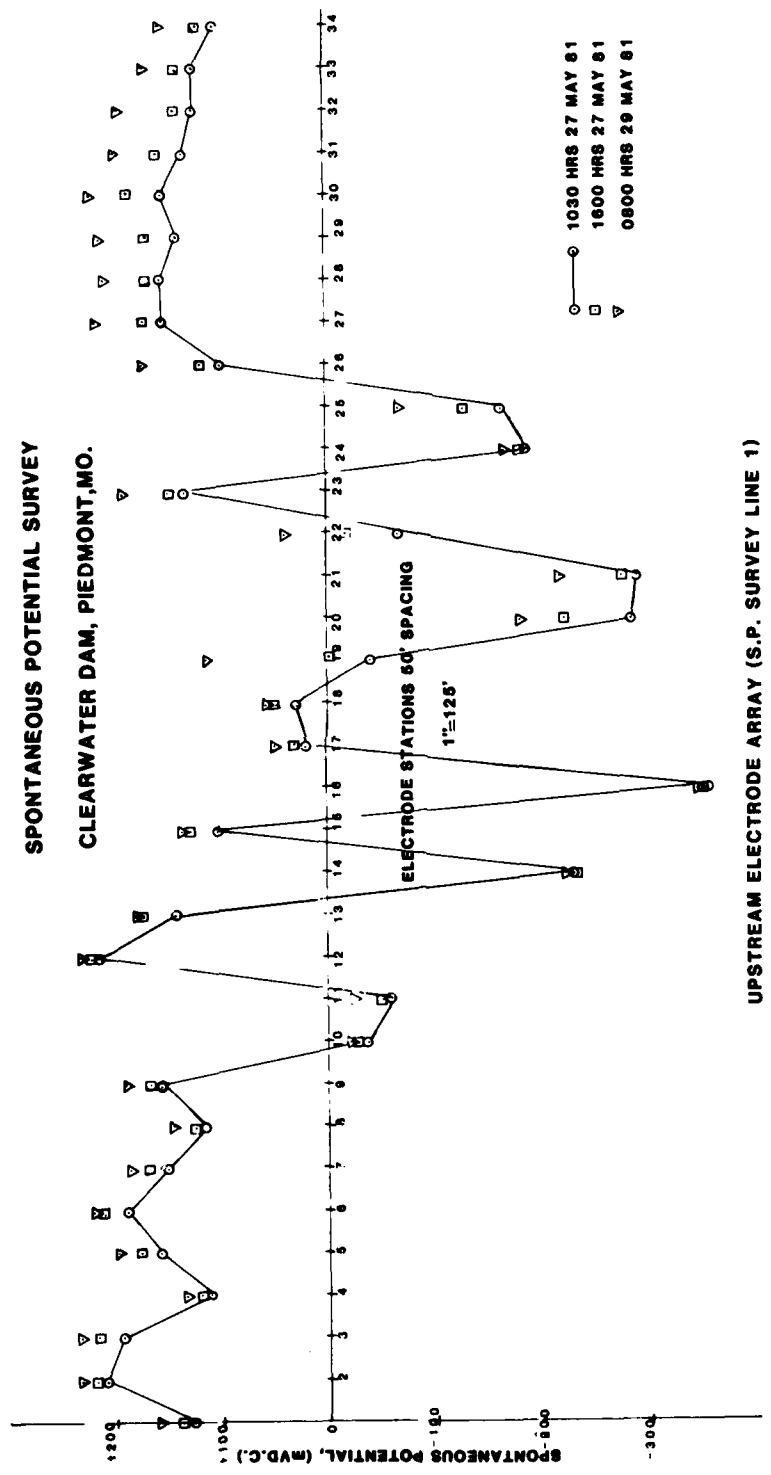
Figure 30. SP survey results, array 1

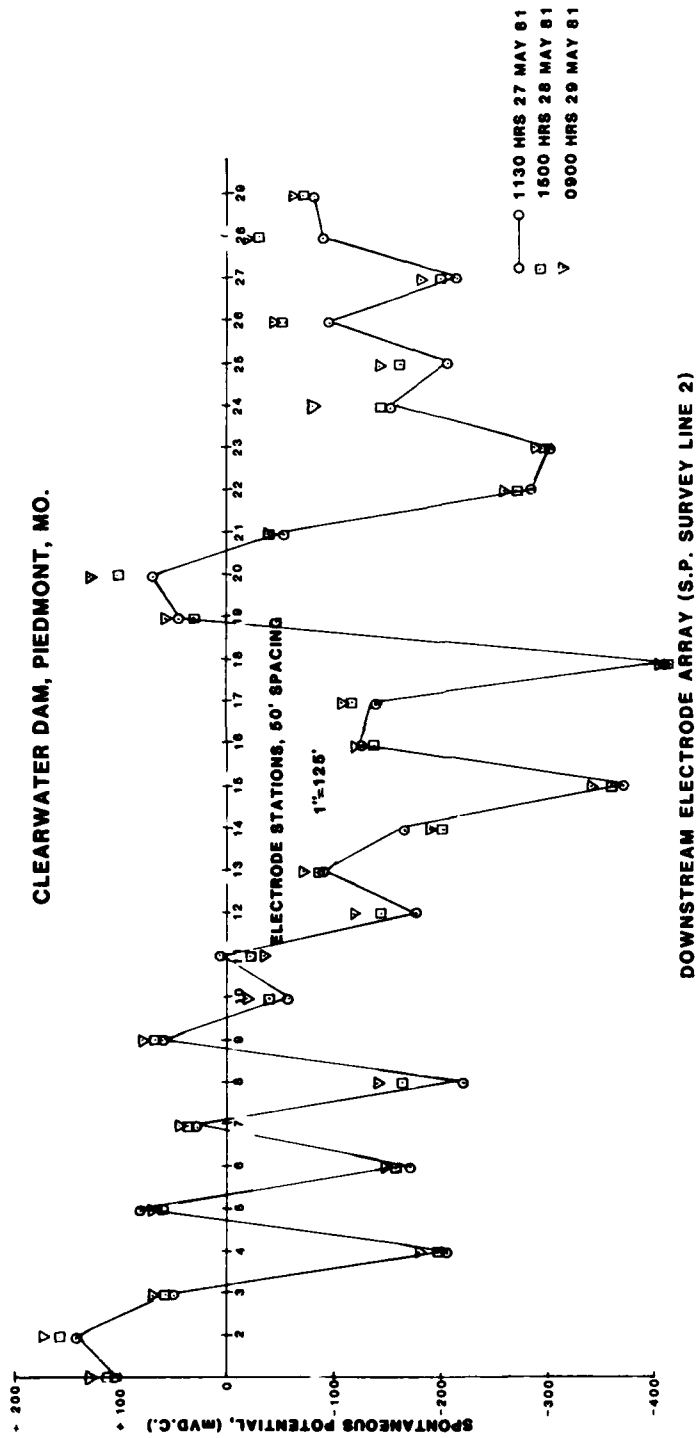
Figure 31. SP survey results, array 2

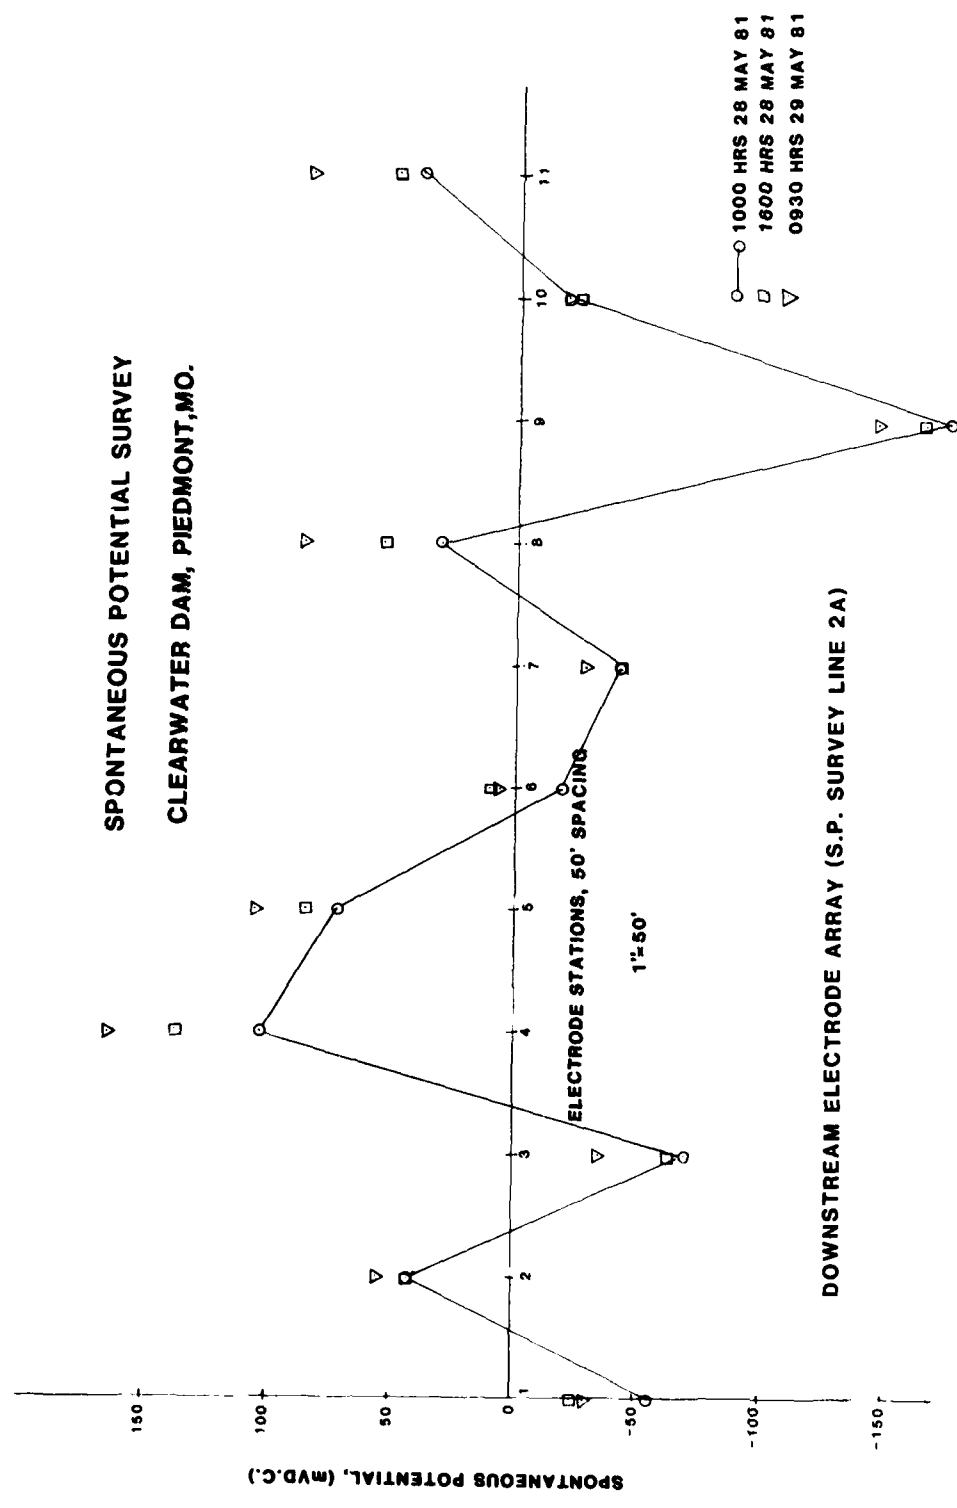
Figure 32. SP survey results, array 2A

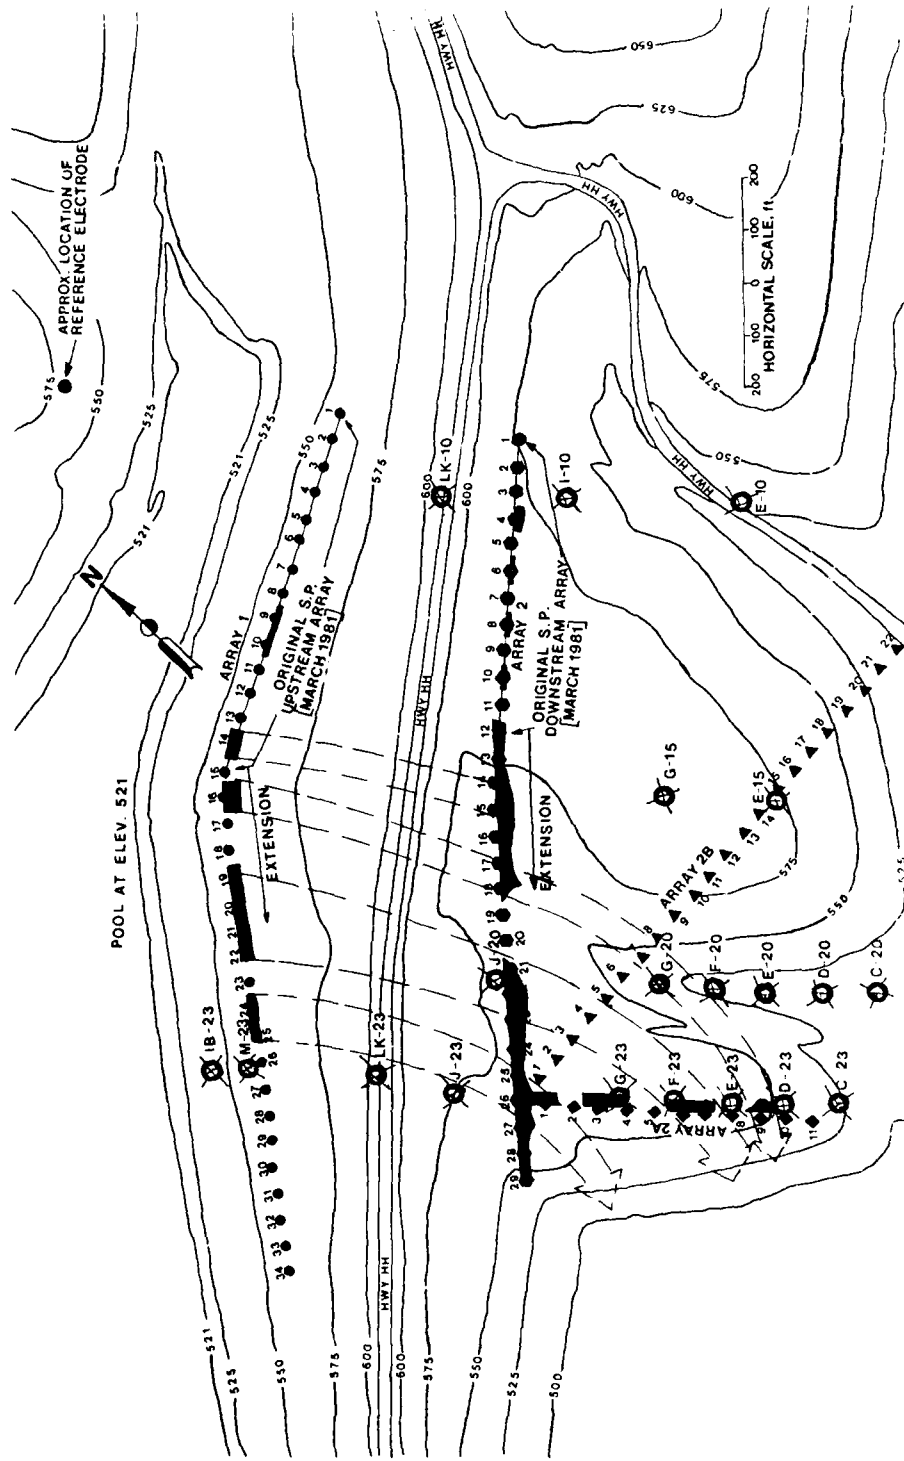
Figure 33. Preliminary interpretation of results, arrays 1, 2, and 2A

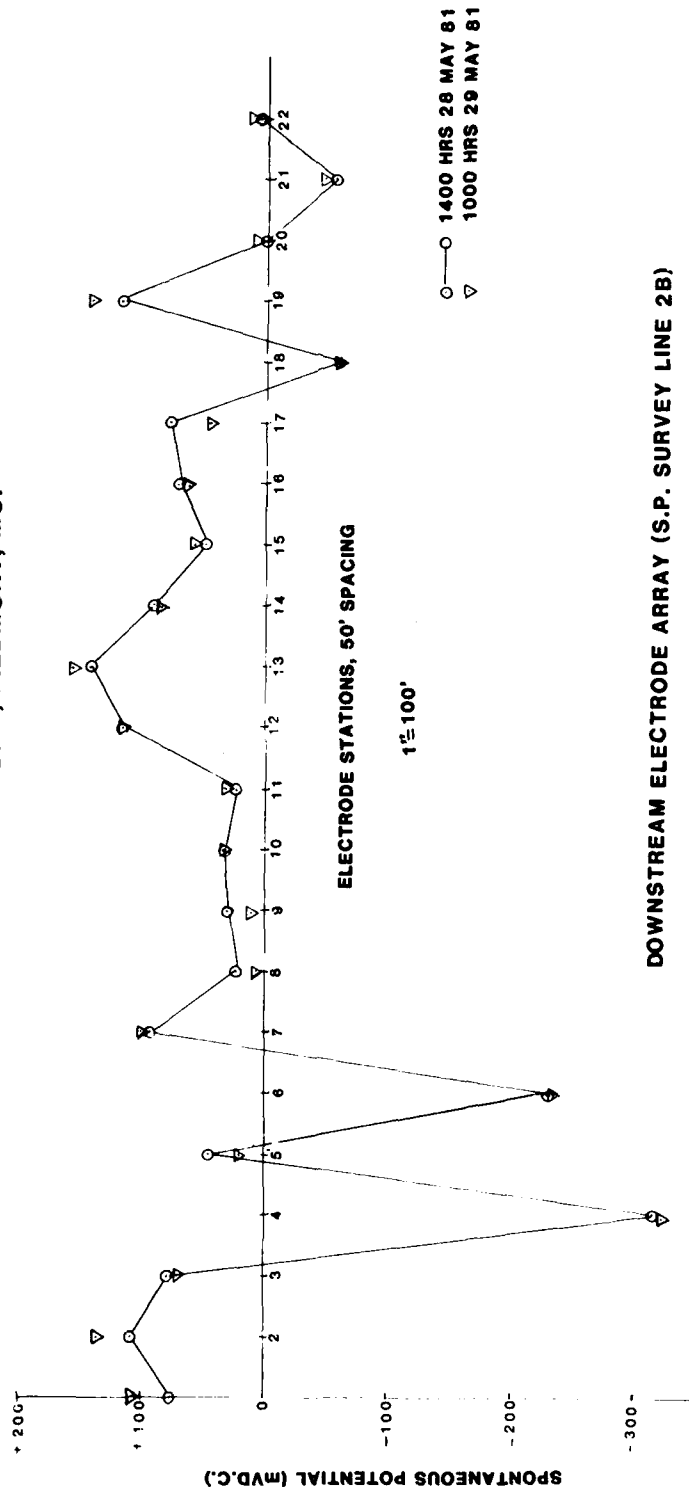
Figure 34. SP survey results, array 2B

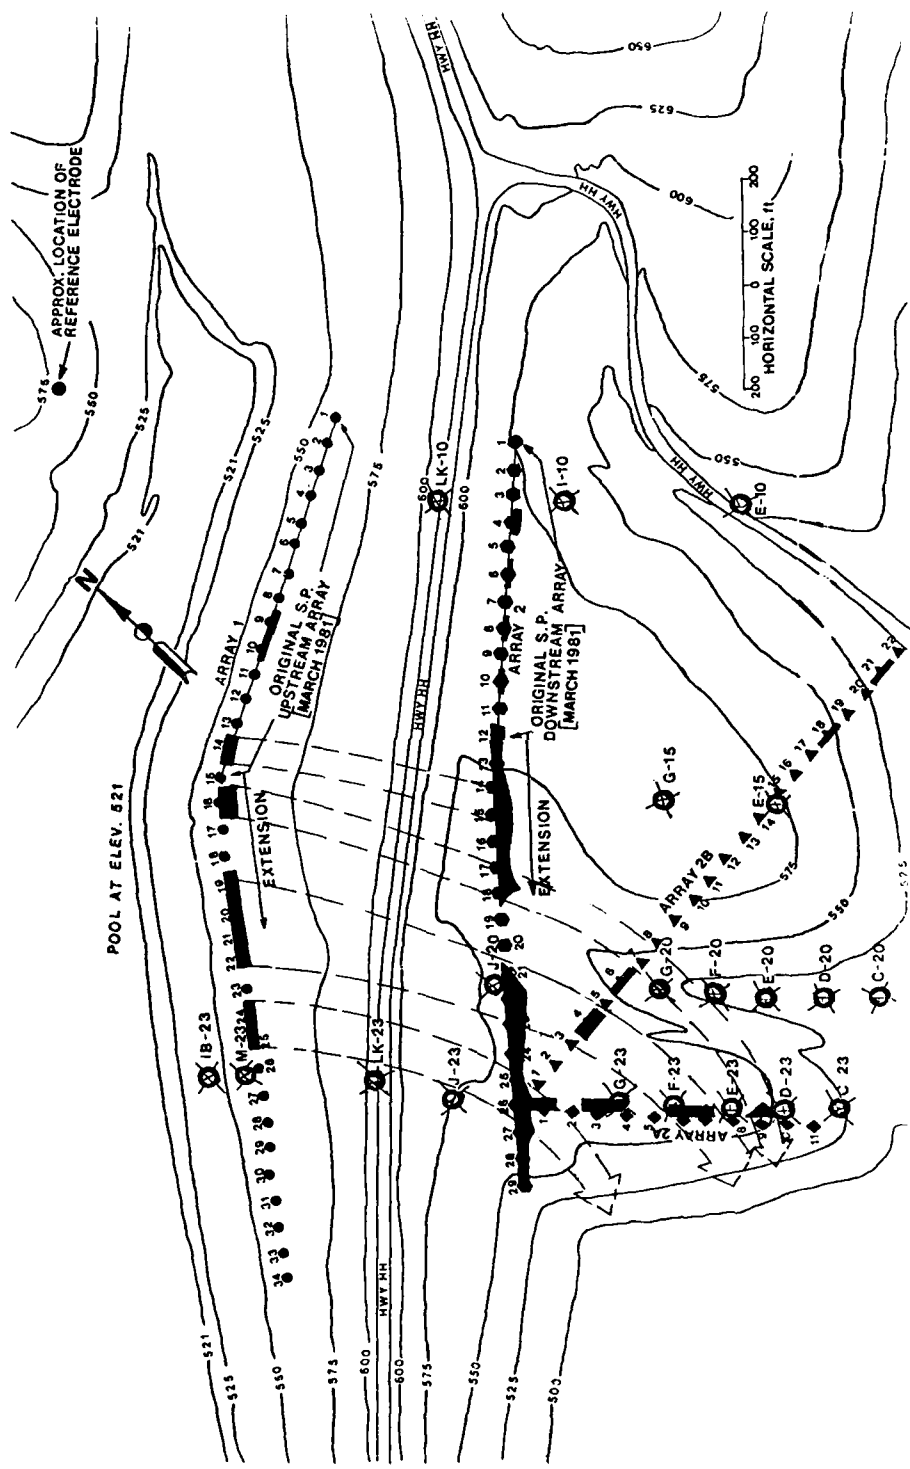
Figure 35. Confirmation of preliminary interpretation with array 2B

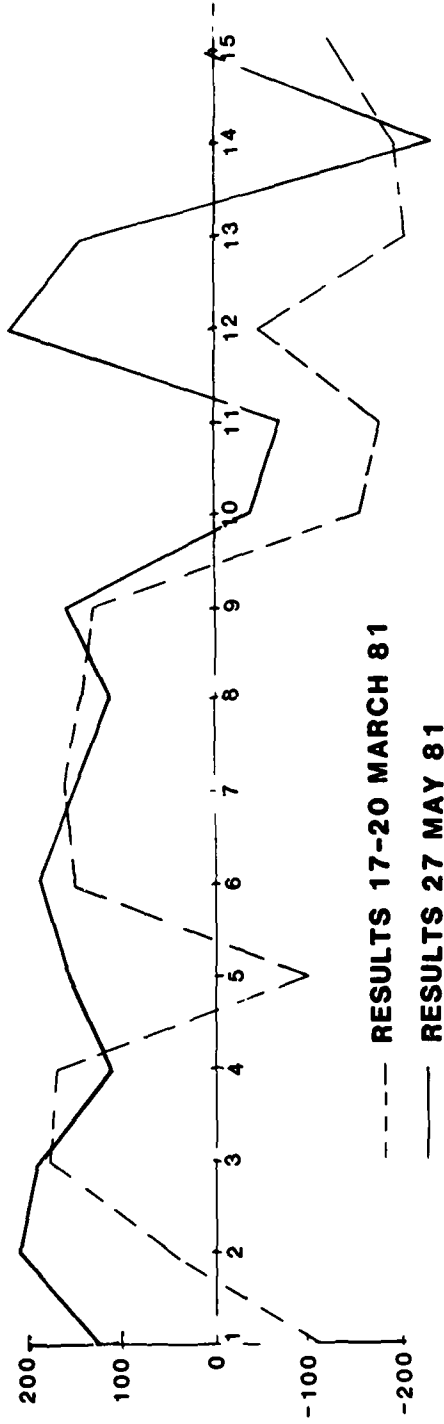
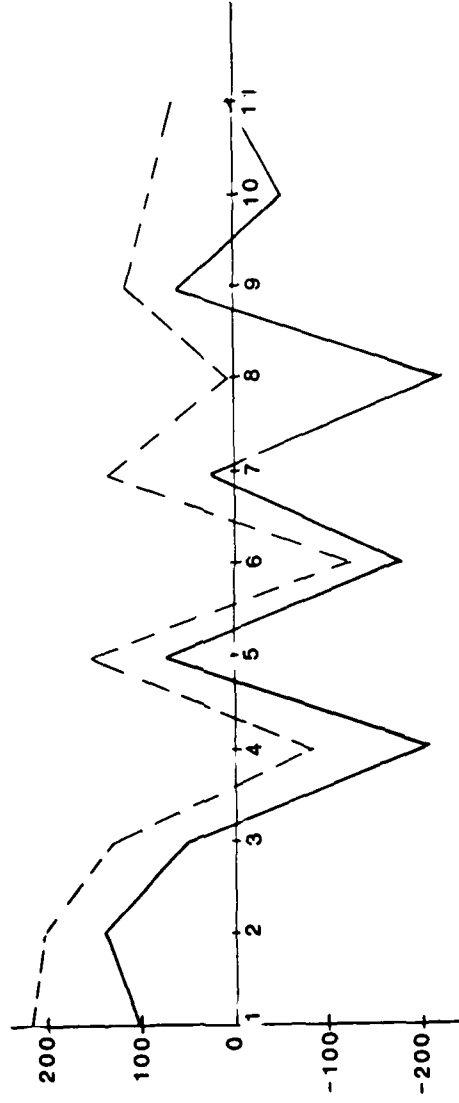
A. UPSTREAM S.P. ARRAY (SURVEY LINE 1, STA. 1-15)

B. DOWNSTREAM S.P. ARRAY (SURVEY LINE 2, STA. 1-11)

Figure 36. Superposition of March and May SP survey results

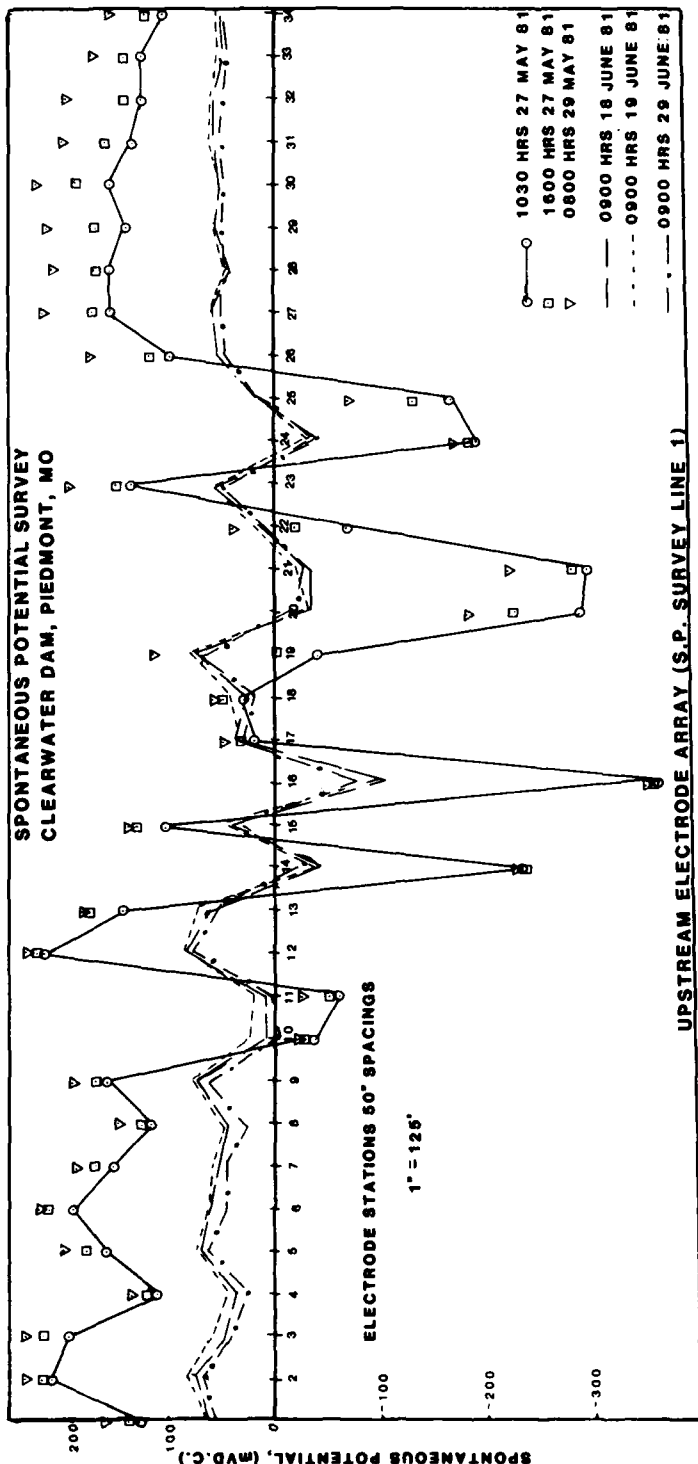
Figure 37. SP survey results, May-June, array 1

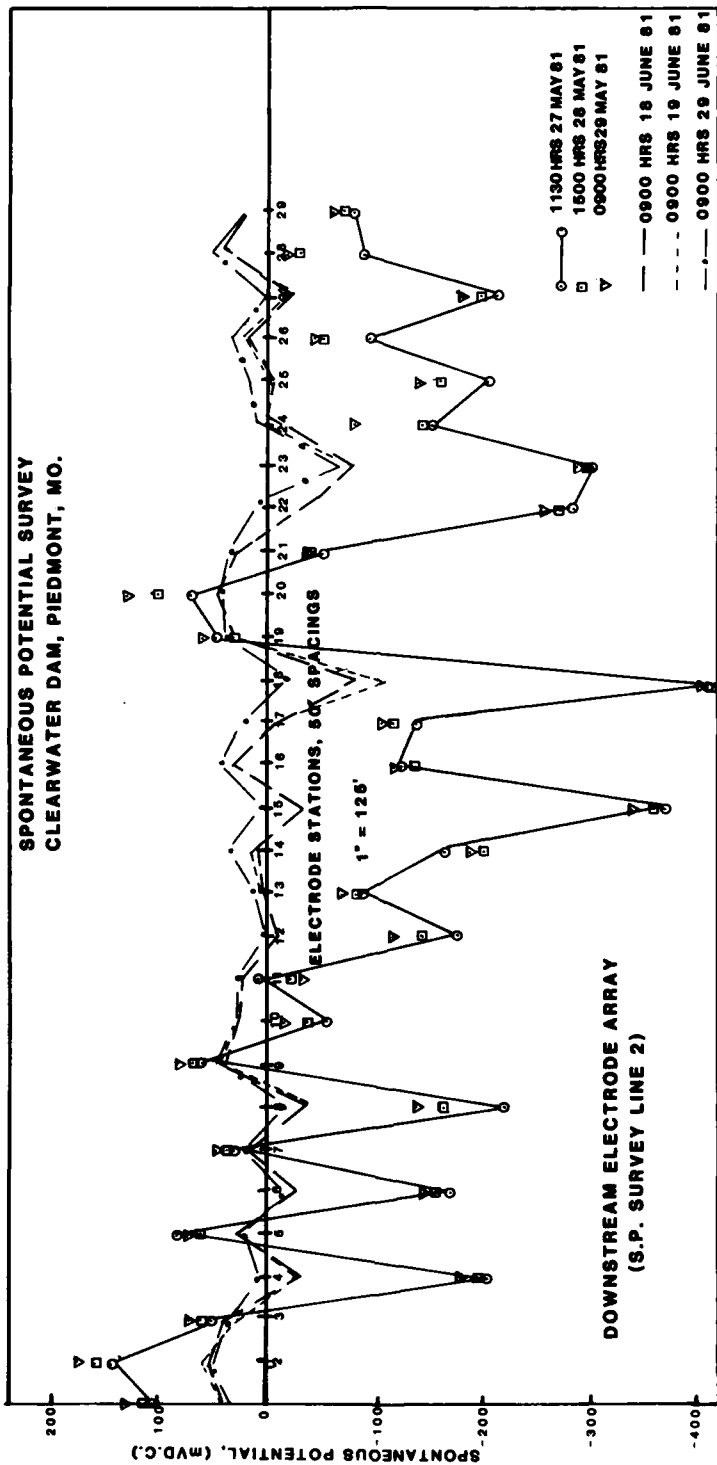
Figure 38. SP survey results, May-June, array 2

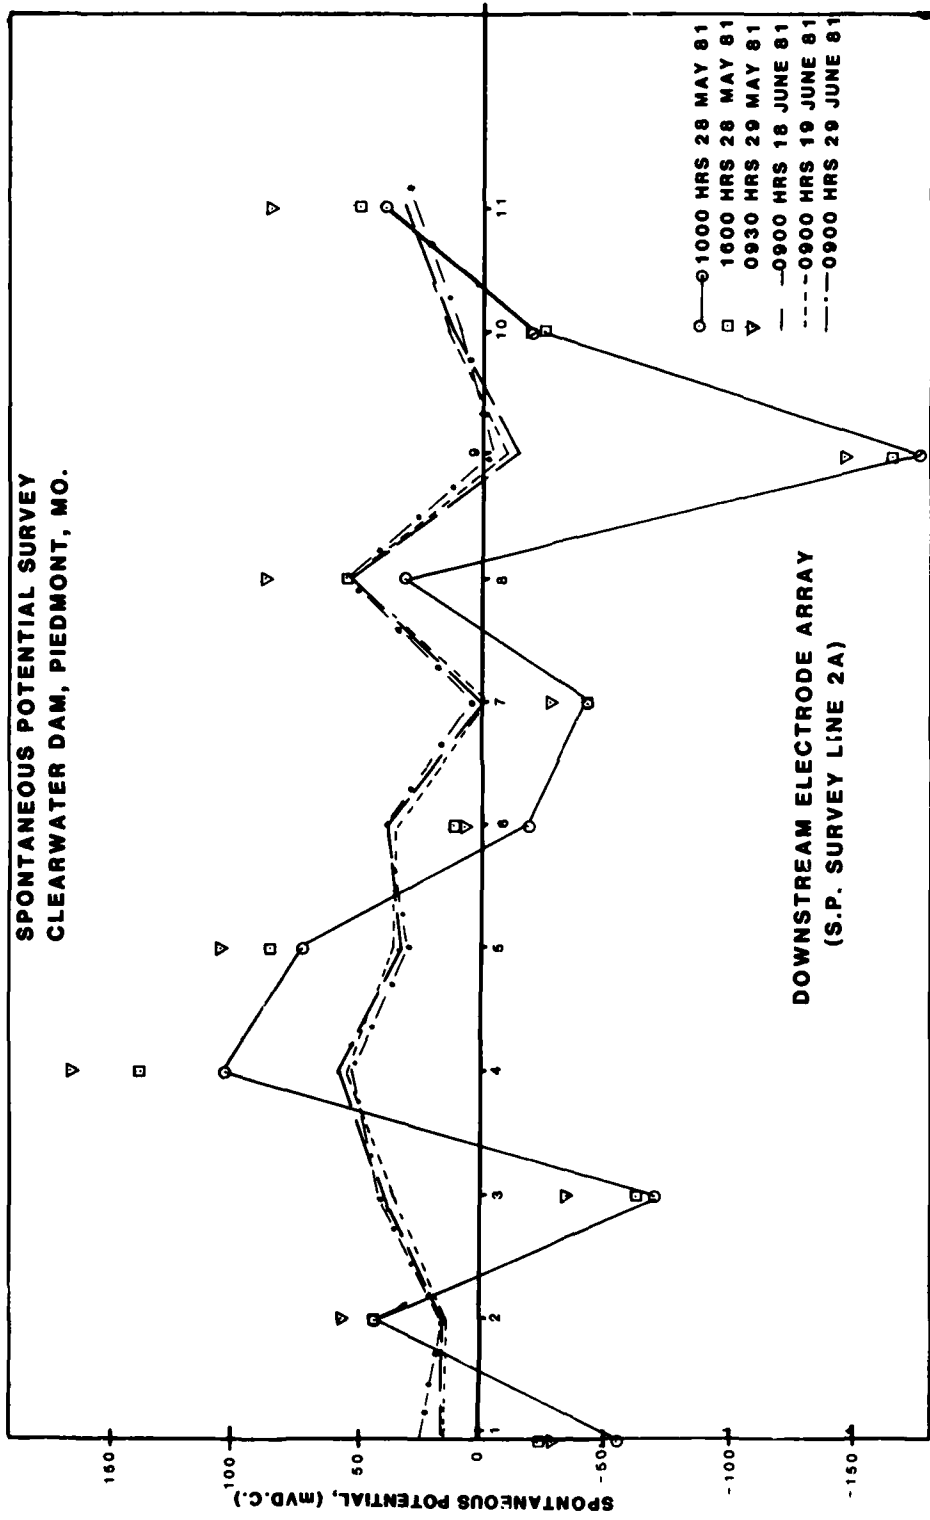
Figure 39. SP survey results, May-June, array 2A

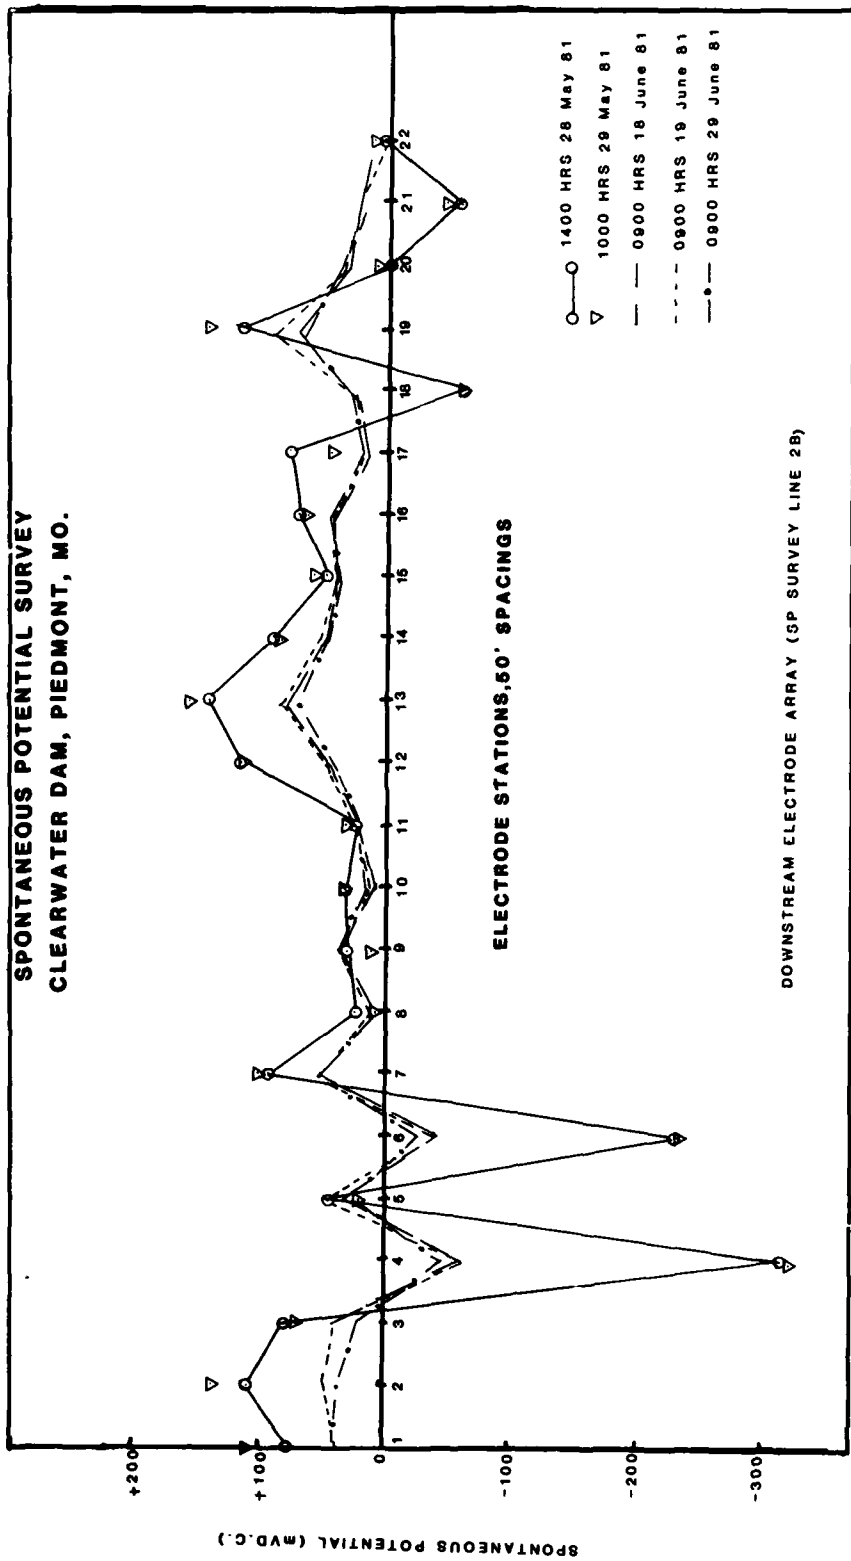
Figure 40. SP survey results, May-June, array 2B

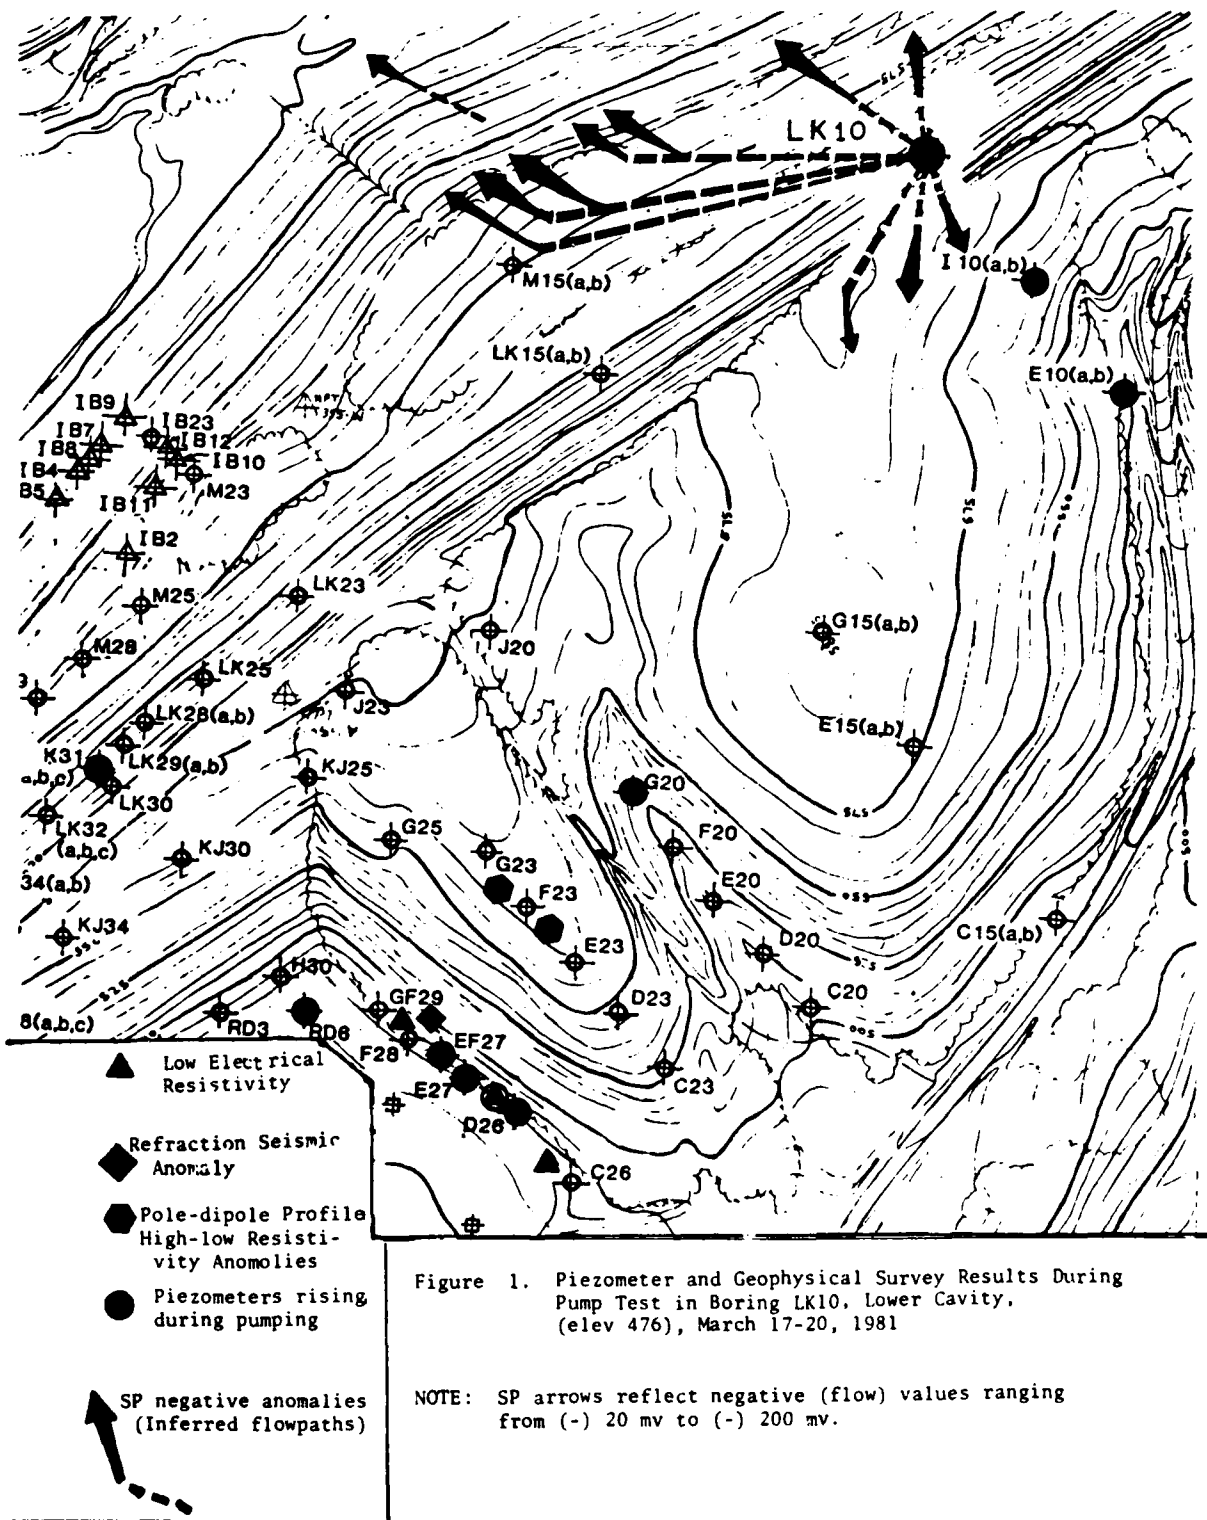
Figure 1. Piezometer and Geophysical Survey Results During Pump Test in Boring LK10, Lower Cavity, (elev 476), March 17-20, 1981

NOTE: SP arrows reflect negative (flow) values ranging from (-) 20 mv to (-) 200 mv.
