MISCELLANEOUS PAPER GL-84-3

GEOPHYSICAL INVESTIGATIONS IN SUPPORT OF CLEARWATER DAM COMPREHENSIVE SEEPAGE ANALYSIS

May 1984
Final Report

Prepared for U. S. Army Engineer District, Little Rock
Little Rock, Ark. 72203

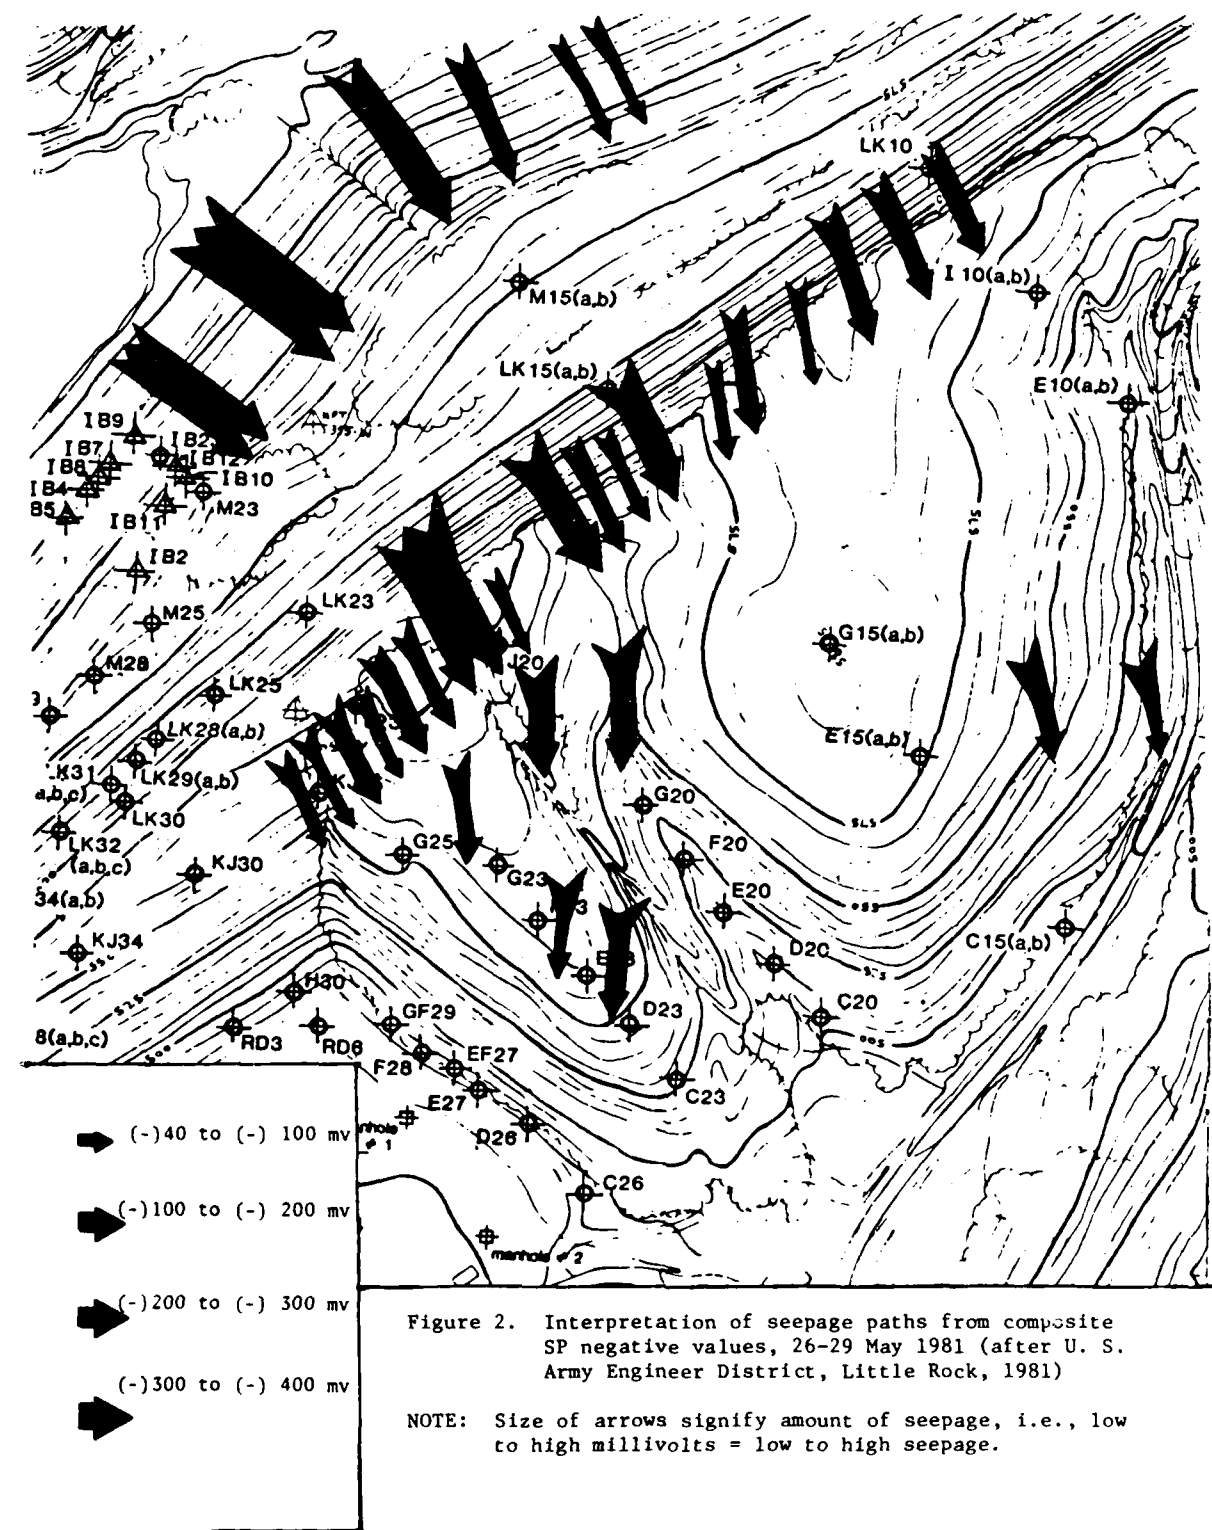
Figure 2. Interpretation of seepage paths from composite SP negative values, 26-29 May 1981 (after U. S. Army Engineer District, Little Rock, 1981)

NOTE: Size of arrows signify amount of seepage, i.e., low to high millivolts = low to high seepage.

The composite interpretation by WES personnel of the results of this survey becomes very significant when it is complemented with data and results of the other seepage investigations and tests, which will be shown in the final analyses and conclusions. Another interpretation of this survey is shown in Figure 2. The points of the arrows are all located at electrodes in the survey line that recorded negative voltage (suspect seepage flow) areas. The arrows are proportioned according to the recorded negative value; i.e., largest arrow electrode recorded (-)420mv (large flow) and smallest arrows recorded (-)40 to (-)60mv (smaller flow). The credence of both this survey and the earlier SP survey are further enhanced when negative arrows are matched upstream and downstream of boring LK10; i.e., the same electrodes (arrows) are significantly negative in
