INSTALLATION RESTORATION PROGRAM
PHASE I: RECORDS SEARCH
WILLOW GROVE AIR RESERVE FACILITY
WILLOW GROVE, PENNSYLVANIA

UNITED STATES AIR FORCE RESERVE
ROBINS AFB, GEORGIA 31098

NOVEMBER 1984

Roy F. Weston, Inc.
Weston Way
West Chester, Pennsylvania 19380

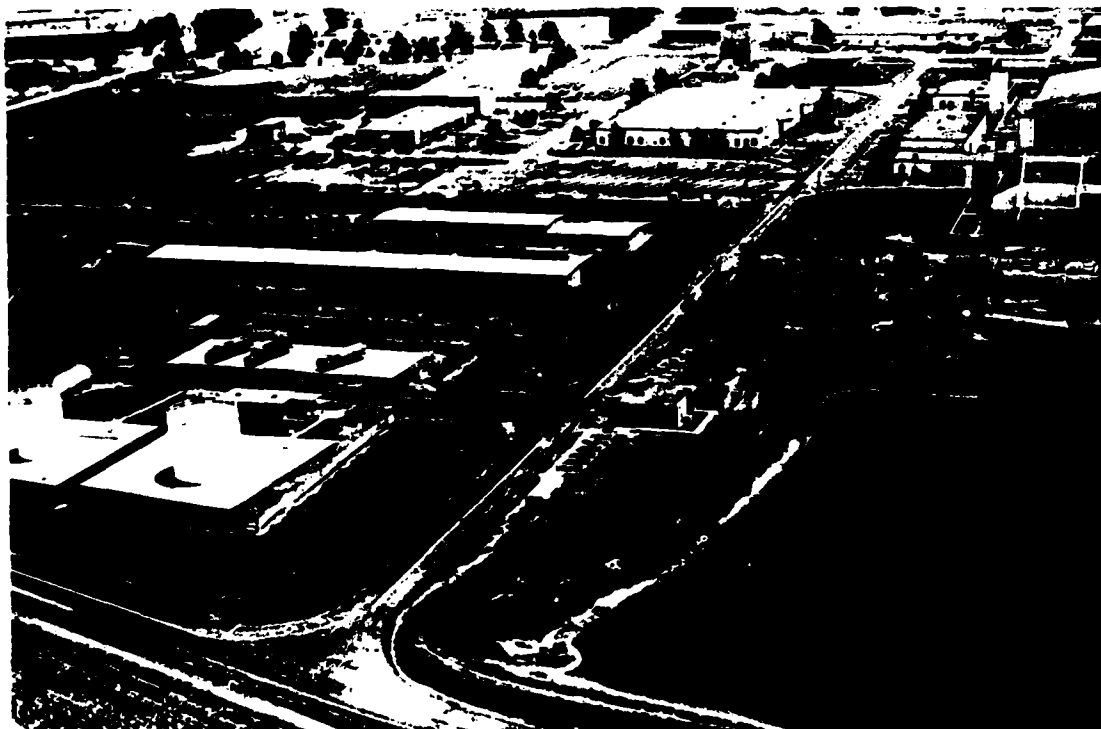
SITE NO. 1 - POL AREA

POL AREA, AERIAL VIEW FROM SOUTH
SHOWING PROXIMITY TO PONDING BASIN

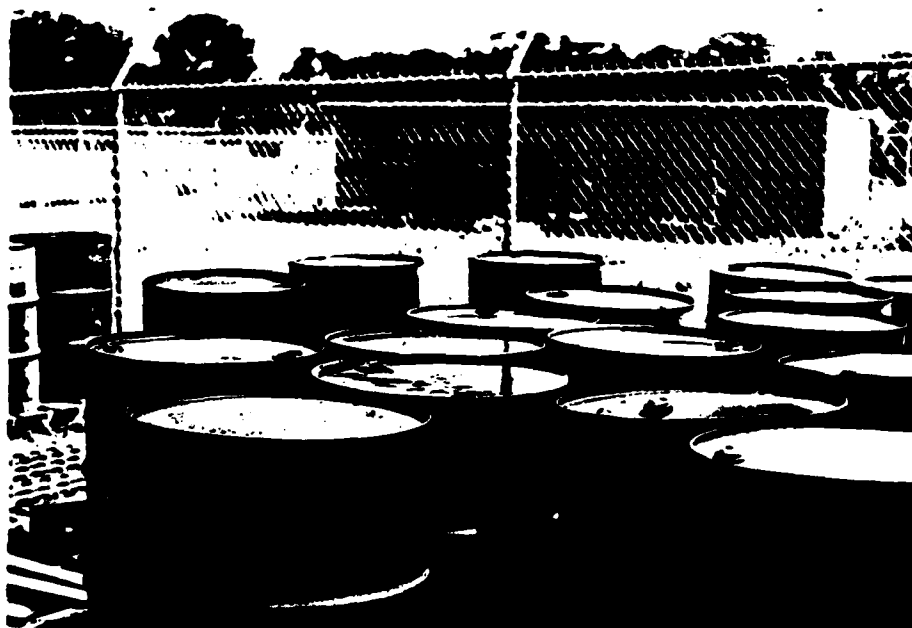
SITE NO. 2 - OPEN STORAGE AREA #42

DRUMS OF WASTE ENGINE OIL AND HYDRAULIC OIL

of six (one from each boring) and a maximum of 18. Parameters for analysis are listed in Table 6-3. It is recommended that the borings be drilled following a grid pattern within the fenced portion of the storage area.

To adequately assess presence or absence of contamination in groundwater, it is recommended that four wells be installed on the perimeters of the #42 Open Storage Area. The wells should penetrate 20 feet into bedrock and be screened above the water table to ensure that the upper portion of the shallow aquifer, including any floating product on top of the water table, is sampled. Minimum well construction requirements are listed in Table 6-2. Wells should be located approximately at 90° from each other around the site, following the orientation of dip and strike, or lineation evident in an aerial photography study to be performed prior to drilling. One monitor well should be placed next to Bolling Street, between Open Storage Area #42 and the POL area.

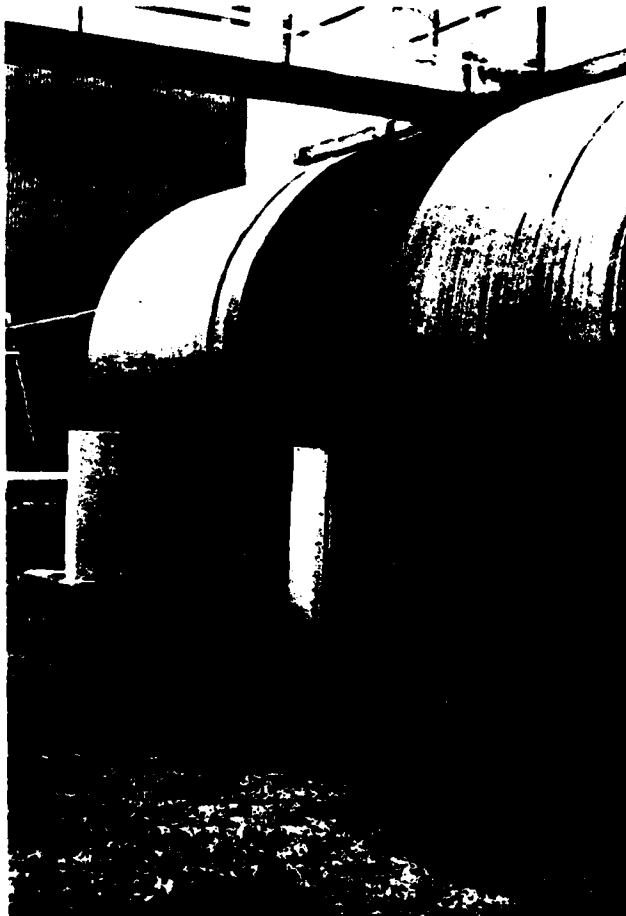
SITE NO. 6 - HEATING PLANT

activities at the heating plant Tank #221. The spill was contained within the concrete dike area, but no cleanup of the earthen base was performed.

NO. 6 FUEL OIL SPILL BENEATH TANK #221
