NSWC TR 84-66

# CHEMICAL AND PHOTOGRAPHIC EVALUATION OF RIGID EXPLOSIVE TRANSFER LINES

RESEARCH AND TECHNOLOGY DEPARTMENT

MAY 1984

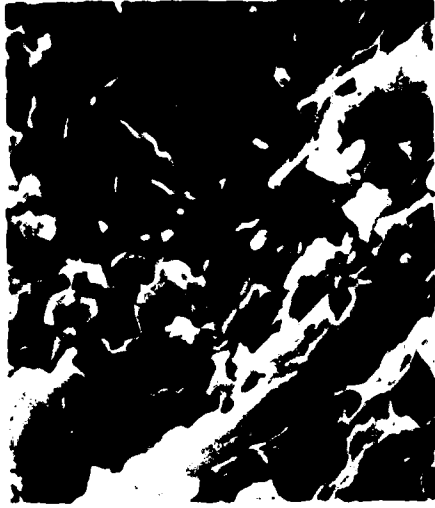
AV. WT. % HNS+HNBiB = 93.7  
3 YEARS TOTAL AGE,  
+400° F FOR 50 HOURS

AV. WT. % HNS+HNBiB = 98.0  
4.7 YEARS TOTAL SERVICE,  
5.1 YEARS TOTAL AGE

AV. WT. % HNS+HNBiB = 99.8  
NO SERVICE,  
3 YEARS TOTAL AGE

FIGURE 9. PHOTOGRAPHIC ANALYSES OF AH-1S BOOSTER TIP EXPLOSIVE

Color macrophotographs and scanning electron micrographs provided qualitative corroboration for the chemical analyses by high performance liquid chromatography. The results of these chemical and photographic analyses were also corroborated by actual functional tests as described in reference 7. The color macrophotographs show a darkening of the explosive material with increased thermal inputs (Figures 9-11, 13, 15-20). SEM photographs (Figures 9, 10, 12, 14-20) indicate a gradual roughening of the particles, as degradation increased, leading finally to a perforated "swiss cheese"-like texture.

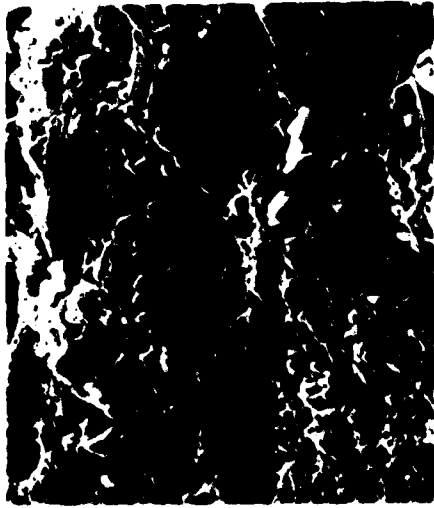
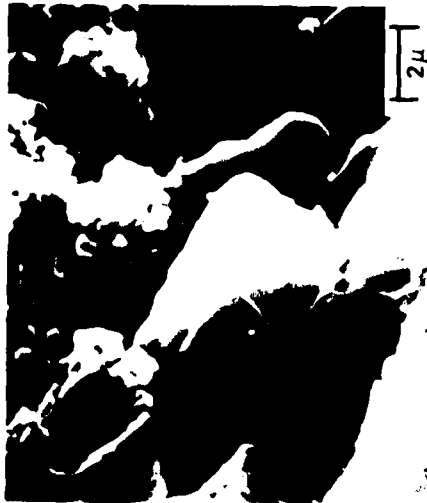
AV. WT. % HNS=88.1  
3 YEARS TOTAL AGE,  
+400° F FOR 50 HOURS

AV. WT. % HNS=99.8  
4.7 YEARS TOTAL SERVICE,  
5.1 YEARS TOTAL AGE

AV. WT % HNS= 97.0  
NO SERVICE,  
3 YEARS TOTAL AGE

FIGURE 10. PHOTOGRAPHIC ANALYSES OF AH-1S TRANSFER LINE EXPLOSIVE

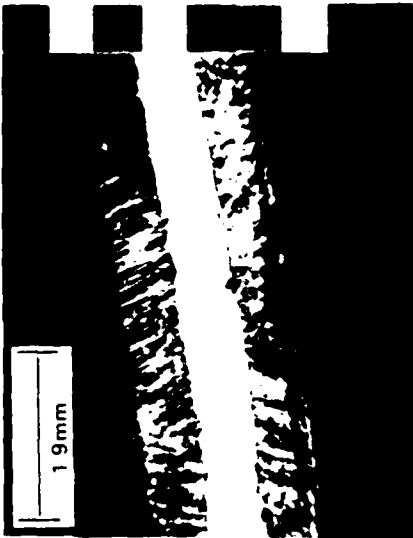
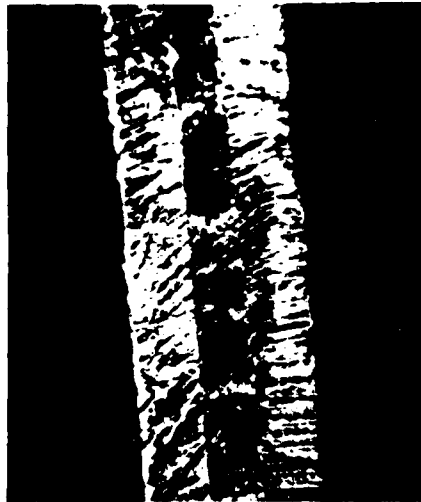
AV. WT. % HNS + HNBiB = 97.1%

AV. WT. % HNS + HNBiB = 82.2%

AV. WT. % HNS + HNBiB = 98.0

FIGURE 13. COLOR MACROPHOTOGRAPHS OF AH 1G TRANSFER LINE EXPLOSIVE. ALL LINES ARE 9 YEARS OLD

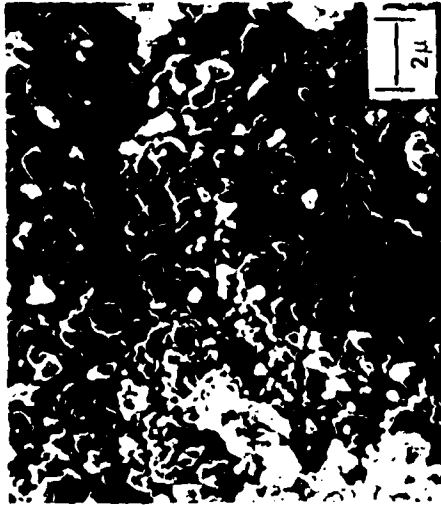
FIGURE 14. SCANNING ELECTRON MICROGRAPHS OF AH-1G TRANSFER LINE EXPLOSIVE: ALL LINES ARE 9 YEARS OLD

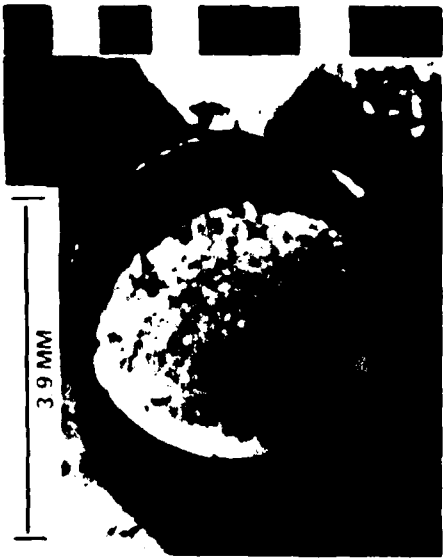
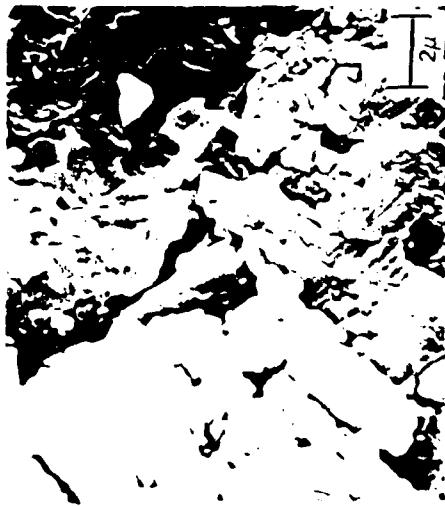
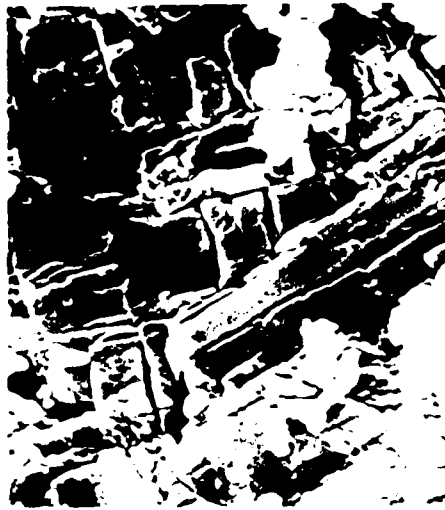
AV. WT. HNS + HNBIB - 98.6%  
3 YEARS SERVICE AND  
6.5 YEARS TOTAL AGE

AV. WT. % HNS + HNBIB = 99.6%  
3 YEARS SERVICE AND  
9 YEARS TOTAL AGE

FIGURE 15. PHOTOGRAPHIC ANALYSES OF F-14 BOOSTER TIP EXPLOSIVE

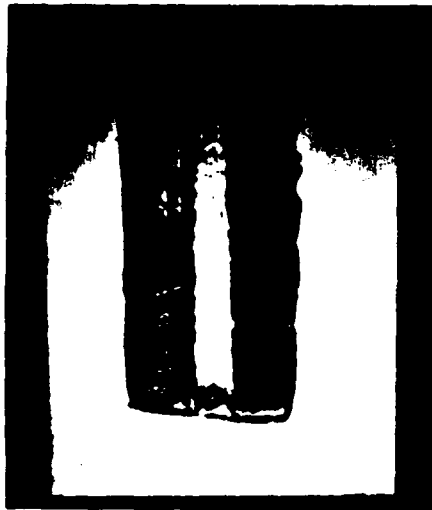
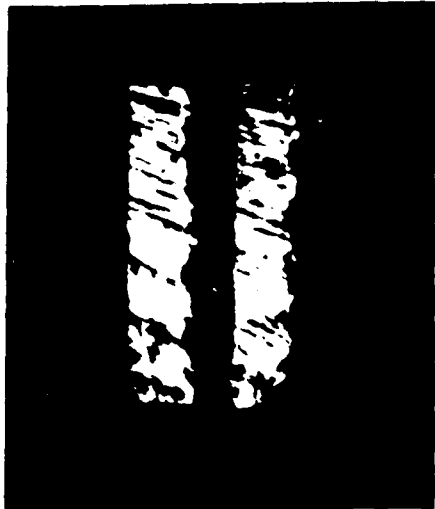
AV. WT. % HNS = 100%  
3 YEARS SERVICE AND  
6.5 YEARS TOTAL AGE

FIGURE 16. PHOTOGRAPHIC ANALYSES OF F-14 TRANSFER LINE EXPLOSIVE
